SD 19
2020 Annual Report

2020 Annual Report

Touquoy Gold Mine

Industrial Approval No. 2012-084244-08

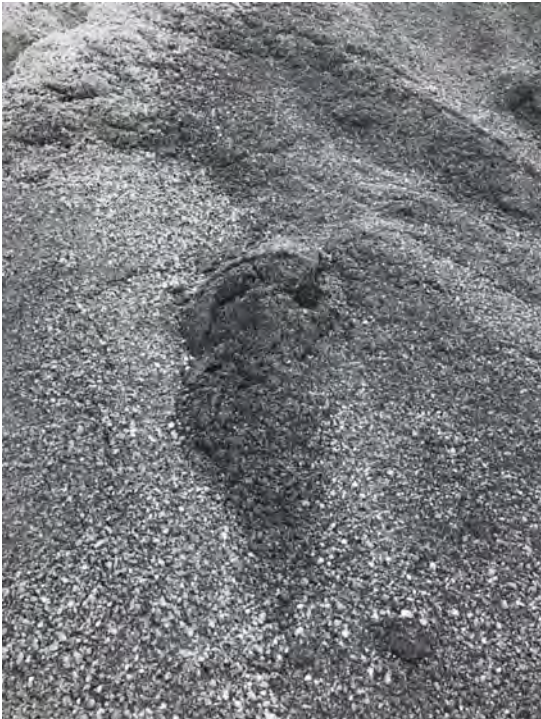
Photograph ID: 6

Photo Location: Type 2 stockpile at crusher pad	
Image Date: 6/11/2020	
Photo Direction: N/A	
Comments: Material stockpiled from 2019. Ultimately failed due to high fines content. File Name: IMG_3426.JPG

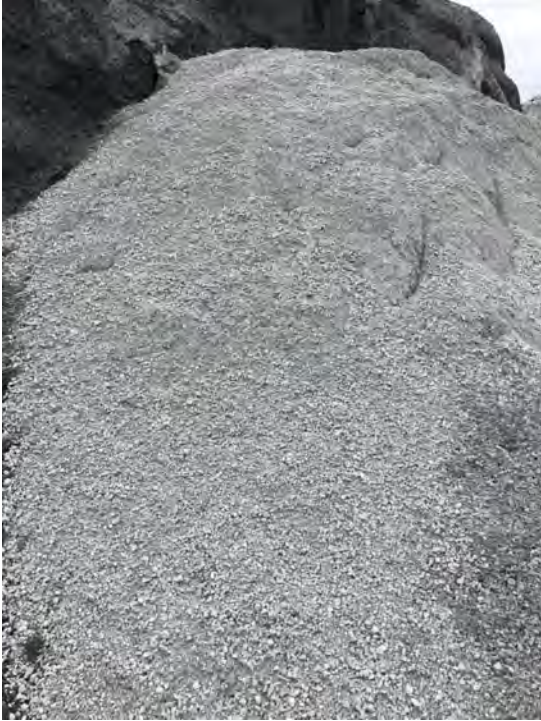
Client:	Atlantic Mining NS Corp	Project:	Spring 2020 Touquoy TMF DSI
Site Name:	Touquoy Mine Site	Site Location:	Middle Musquodoboit, NS
Photograph ID: 7

Photo Location: Type 2 stockpile at crusher pad			
Image Date: 6/11/2020			
Photo Direction: N/A			
Comments: Greywacke rich area of failed stockpile.			
File Name: IMG_3427.JPG			
Photograph ID: 8

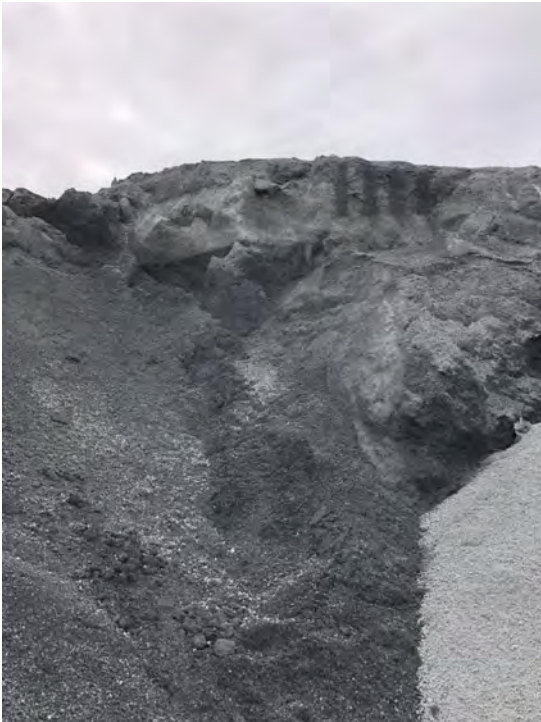
Photo Location: Type 2 stockpile at crusher pad			
Image Date: 6/11/2020			
Photo Direction: West			
Comments: Material stockpiled from 2019. Ultimately failed due to high fines content. Shaded bands indicate argillite dark, greywacke light grey.			
File Name: IMG_3428.JPG

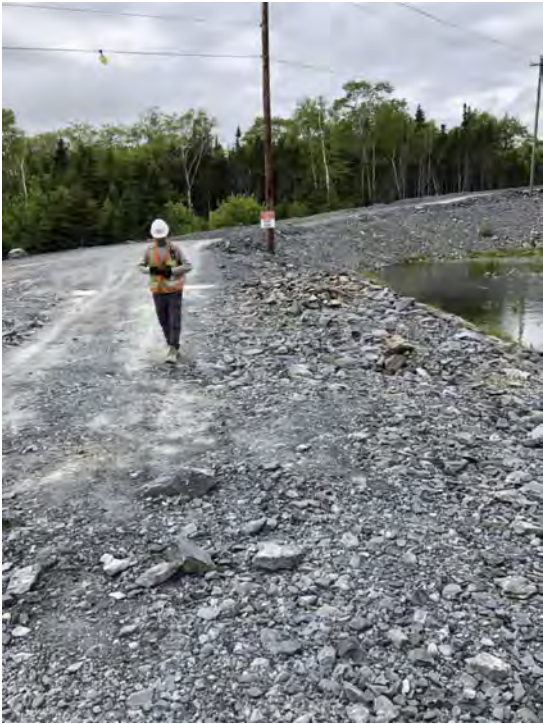
Photo Location: Engineered Wetland West End			
Image Date: 6/11/2020			
Photo Direction: West			
Comments: Disturbed spillway area			
File Name: IMG_3464.JPG

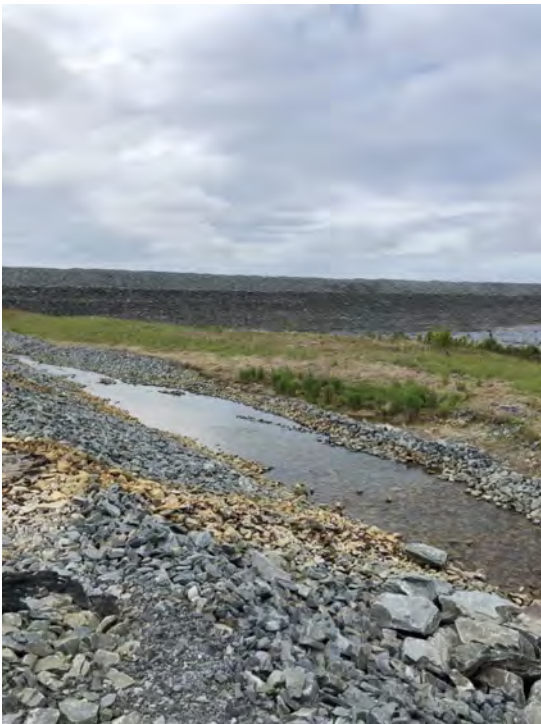
Photo Location: Geobag Area			
Image Date: 6/11/2020			
Photo Direction: North			
Comments: Geobag collection ditch. Area showing downstream berm erosion to be repaired			
File Name: IMG_3473.JPG

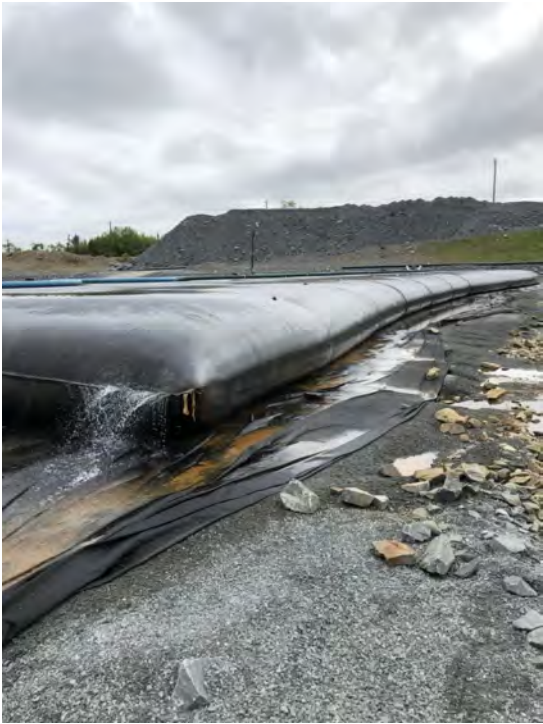
Photo Location: Geobag Area			
Image Date: 6/11/2020			
Photo Direction: Southwest			
Comments: Geobag #1 showing geotextile and previously damaged geobag underneath			
File Name: IMG_3475.JPG

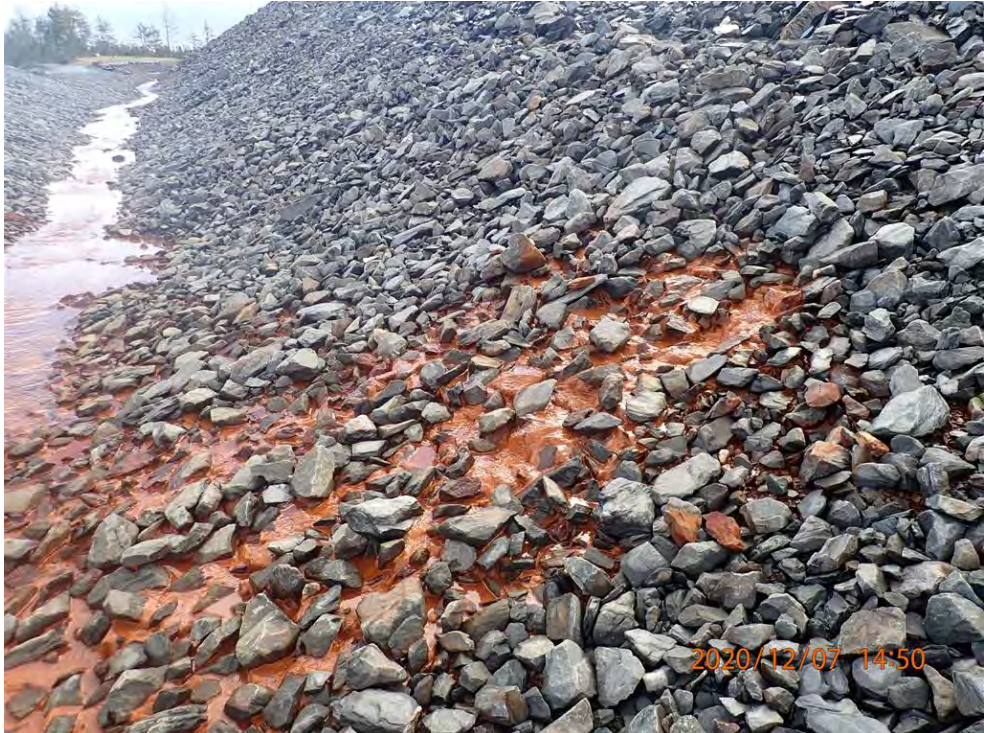
Photograph ID: 30

Photo Location: TMF Pond/Dam. East Seepage Ditch near Station 2+000	
Image Date: 12/7/2020	
Photo Direction: South	
Comments: East Seepage Ditch water iron stained near Station 2+000.

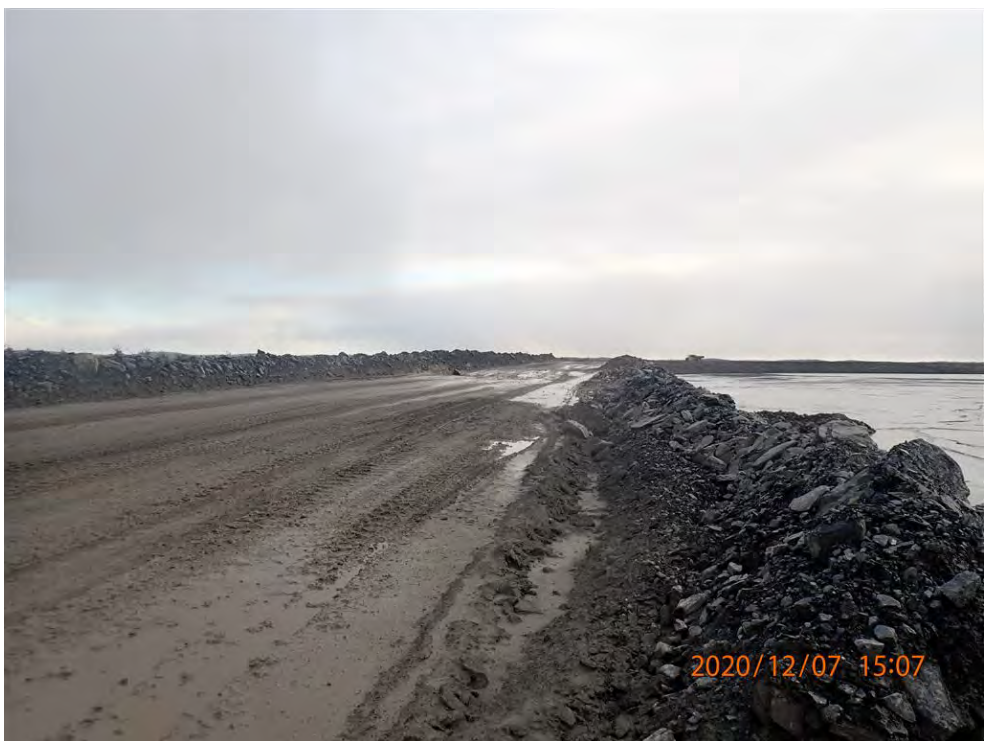
Photo Location: TMF Pond/Dam. Northeast TMF near Station 2+250			
Image Date: 12/7/2020			
Photo Direction: South			
Comments: Rutting on Dam surface on downstream side to be repaired.

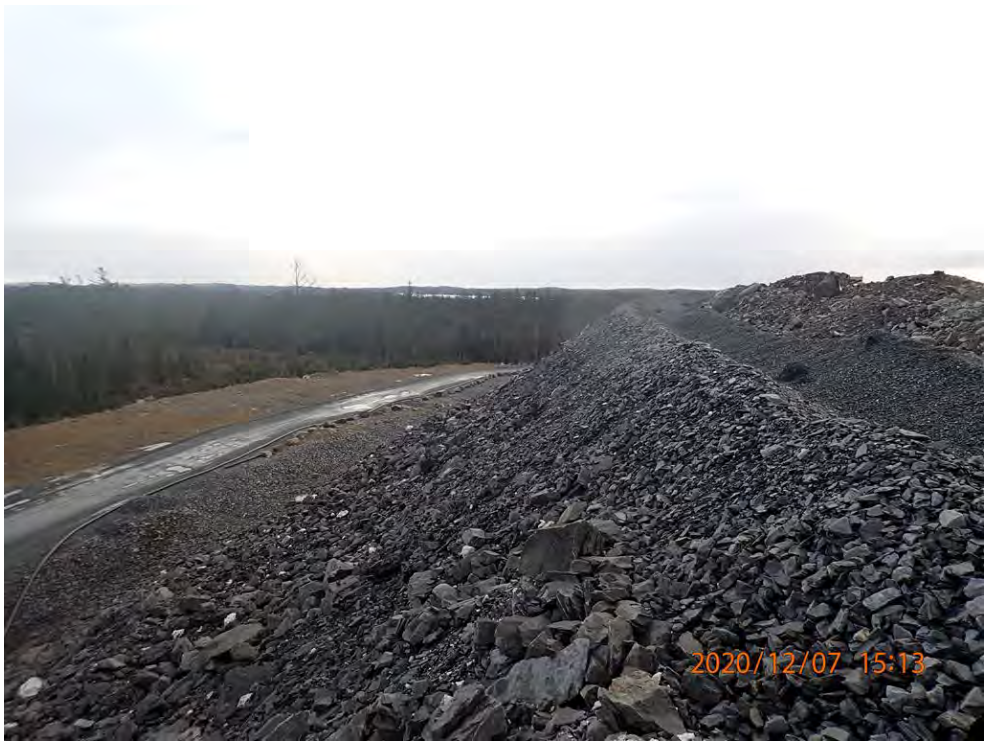
Photo Location: TMF Pond/Dam. Downstream Slope of East TMF near Station 2+050			
Image Date: 12/7/2020			
Photo Direction: South			
Comments: Downstream slope slightly irregular, as observed in Spring 2020 DSI. No indications of slope instability. Crest of dam incomplete at time of inspection (under construction)			
Photograph ID: 44

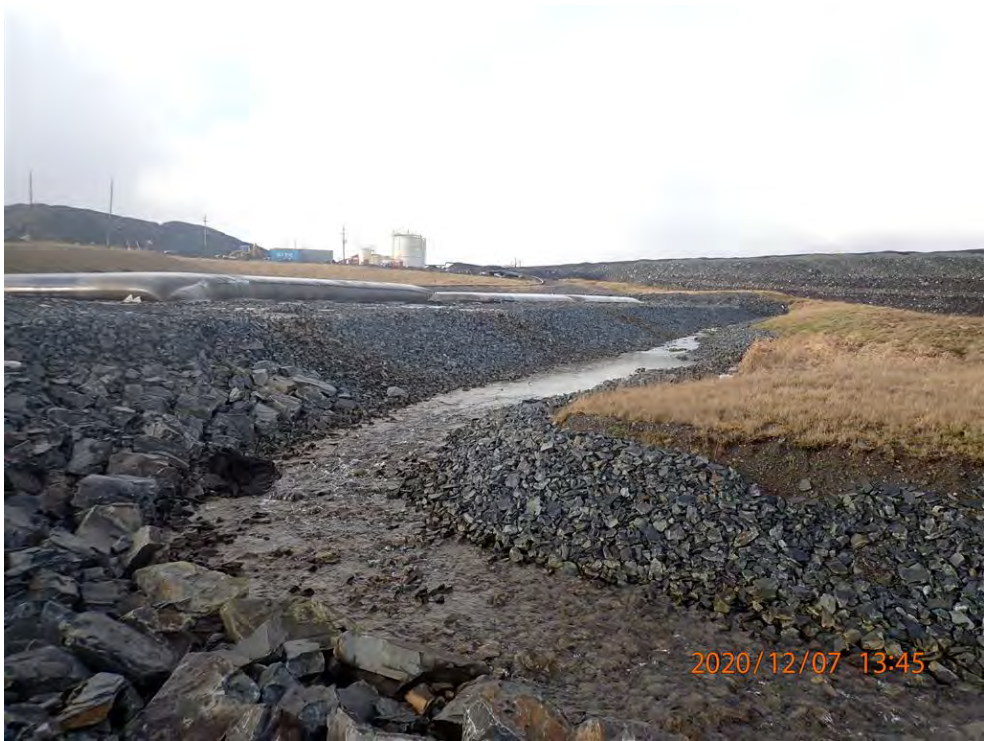
Photo Location: Geobag Area	
Image Date: 12/7/2020	
Photo Direction: Northwest	
Comments: Geobag collection ditch. Area showing downstream berm erosion to be repaired.

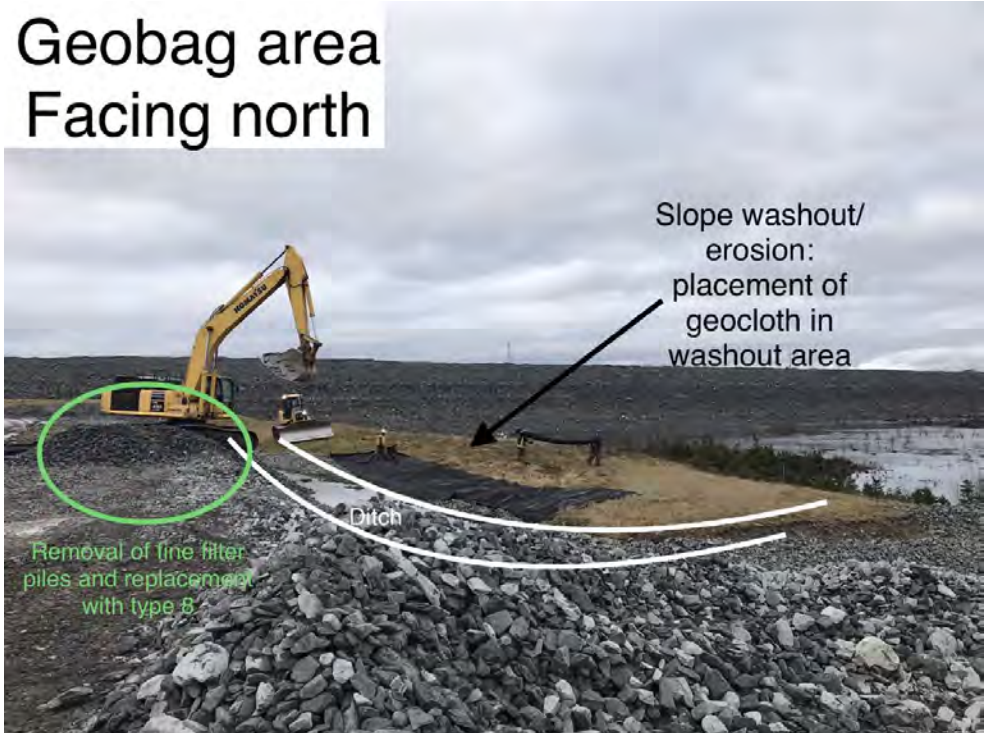
Photo Location: Geobag Area	
Image Date: 12/9/2020	
Photo Direction: North	
Comments: Previously eroded section of channel at the geobag discharge was repaired by placing a geotextile separator on the underlying soil and covering with rip rap. (Photo provided by S.McQuat, Stantec)

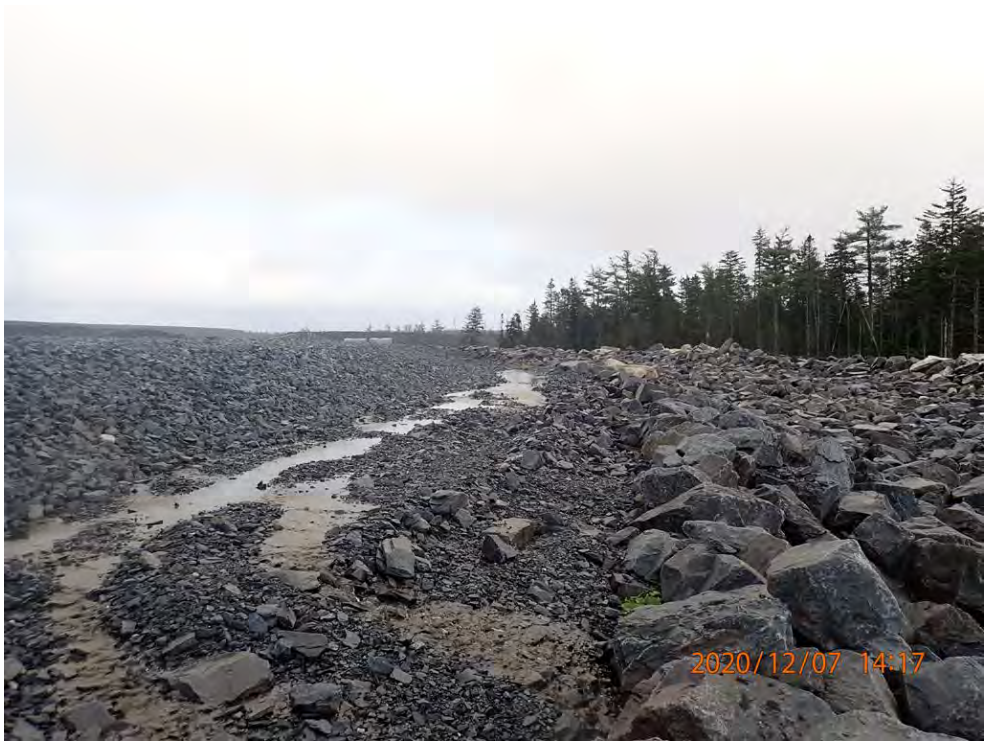
Photo Location: Polishing Pond			
Image Date: 12/7/2020			
Photo Direction: Northeast			
Comments: Seepage between Engineered Wetland and Polishing Pond Emergency Spillway			
Photograph ID: 76

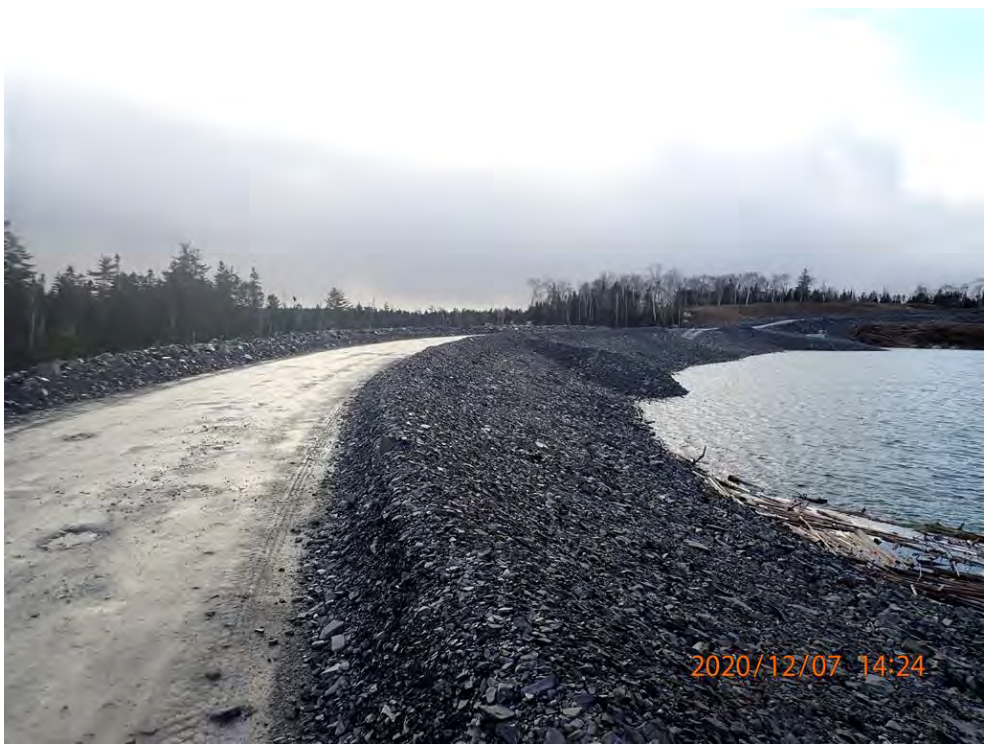
Photo Location: Polishing Pond			
Image Date: 12/7/2020			
Photo Direction: Southwest			
Comments: Upstream slope of Polishing Pond bump out. Timber debris noted at toe of slope.

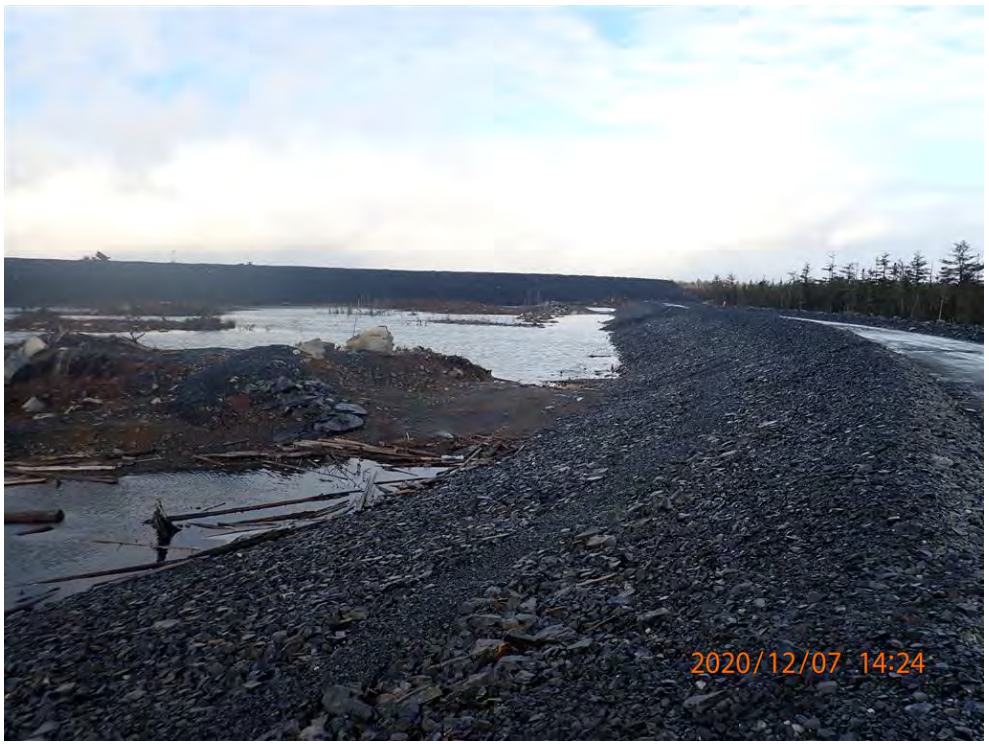
Photo Location: Polishing Pond			
Image Date: 12/7/2020			
Photo Direction: Northeast			
Comments: Timber debris accumulating. To be removed.			
Photograph ID: 78	 		
Photo Location: Polishing Pond			
Image Date: 12/7/2020			
Photo Direction: North			
Comments: Water accumulating at the toe of the downstream slope. Station 0+250

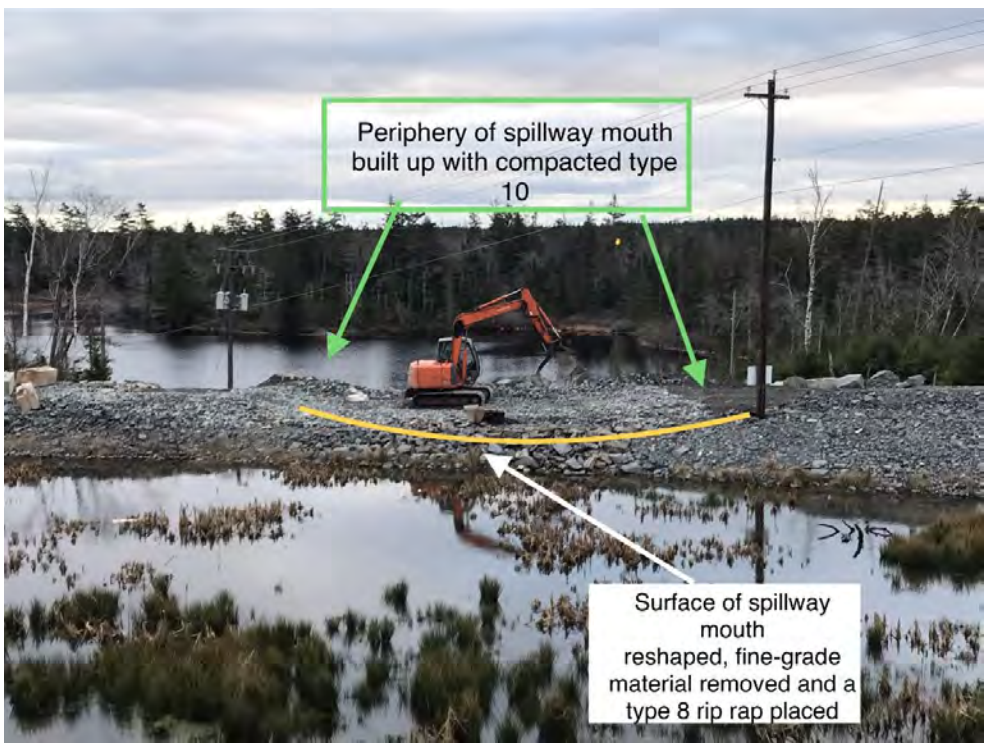
Photo Location: Engineered Wetland	
Image Date: 12/9/2020	
Photo Direction: South	
Comments: Localized low point at Engineered Wetland Berm was infilled with Type 10 rockfill to allow passage of runoff. Type 8 riprap placed at mouth of spillway. (Photo provided by S.McQuat, Stantec)
