## 1.0 INTRODUCTION

Carey Geoenvironmental Engineering (CGE) has completed a geotechnical investigation at the site of the proposed seven (7) Wind Turbine installations in Lingan near New Waterford, Nova Scotia. The assignment was completed for Cape Breton Power Ltd. Glace Bay, N.S.

Lingan Site  
Cape Breton Wind Power

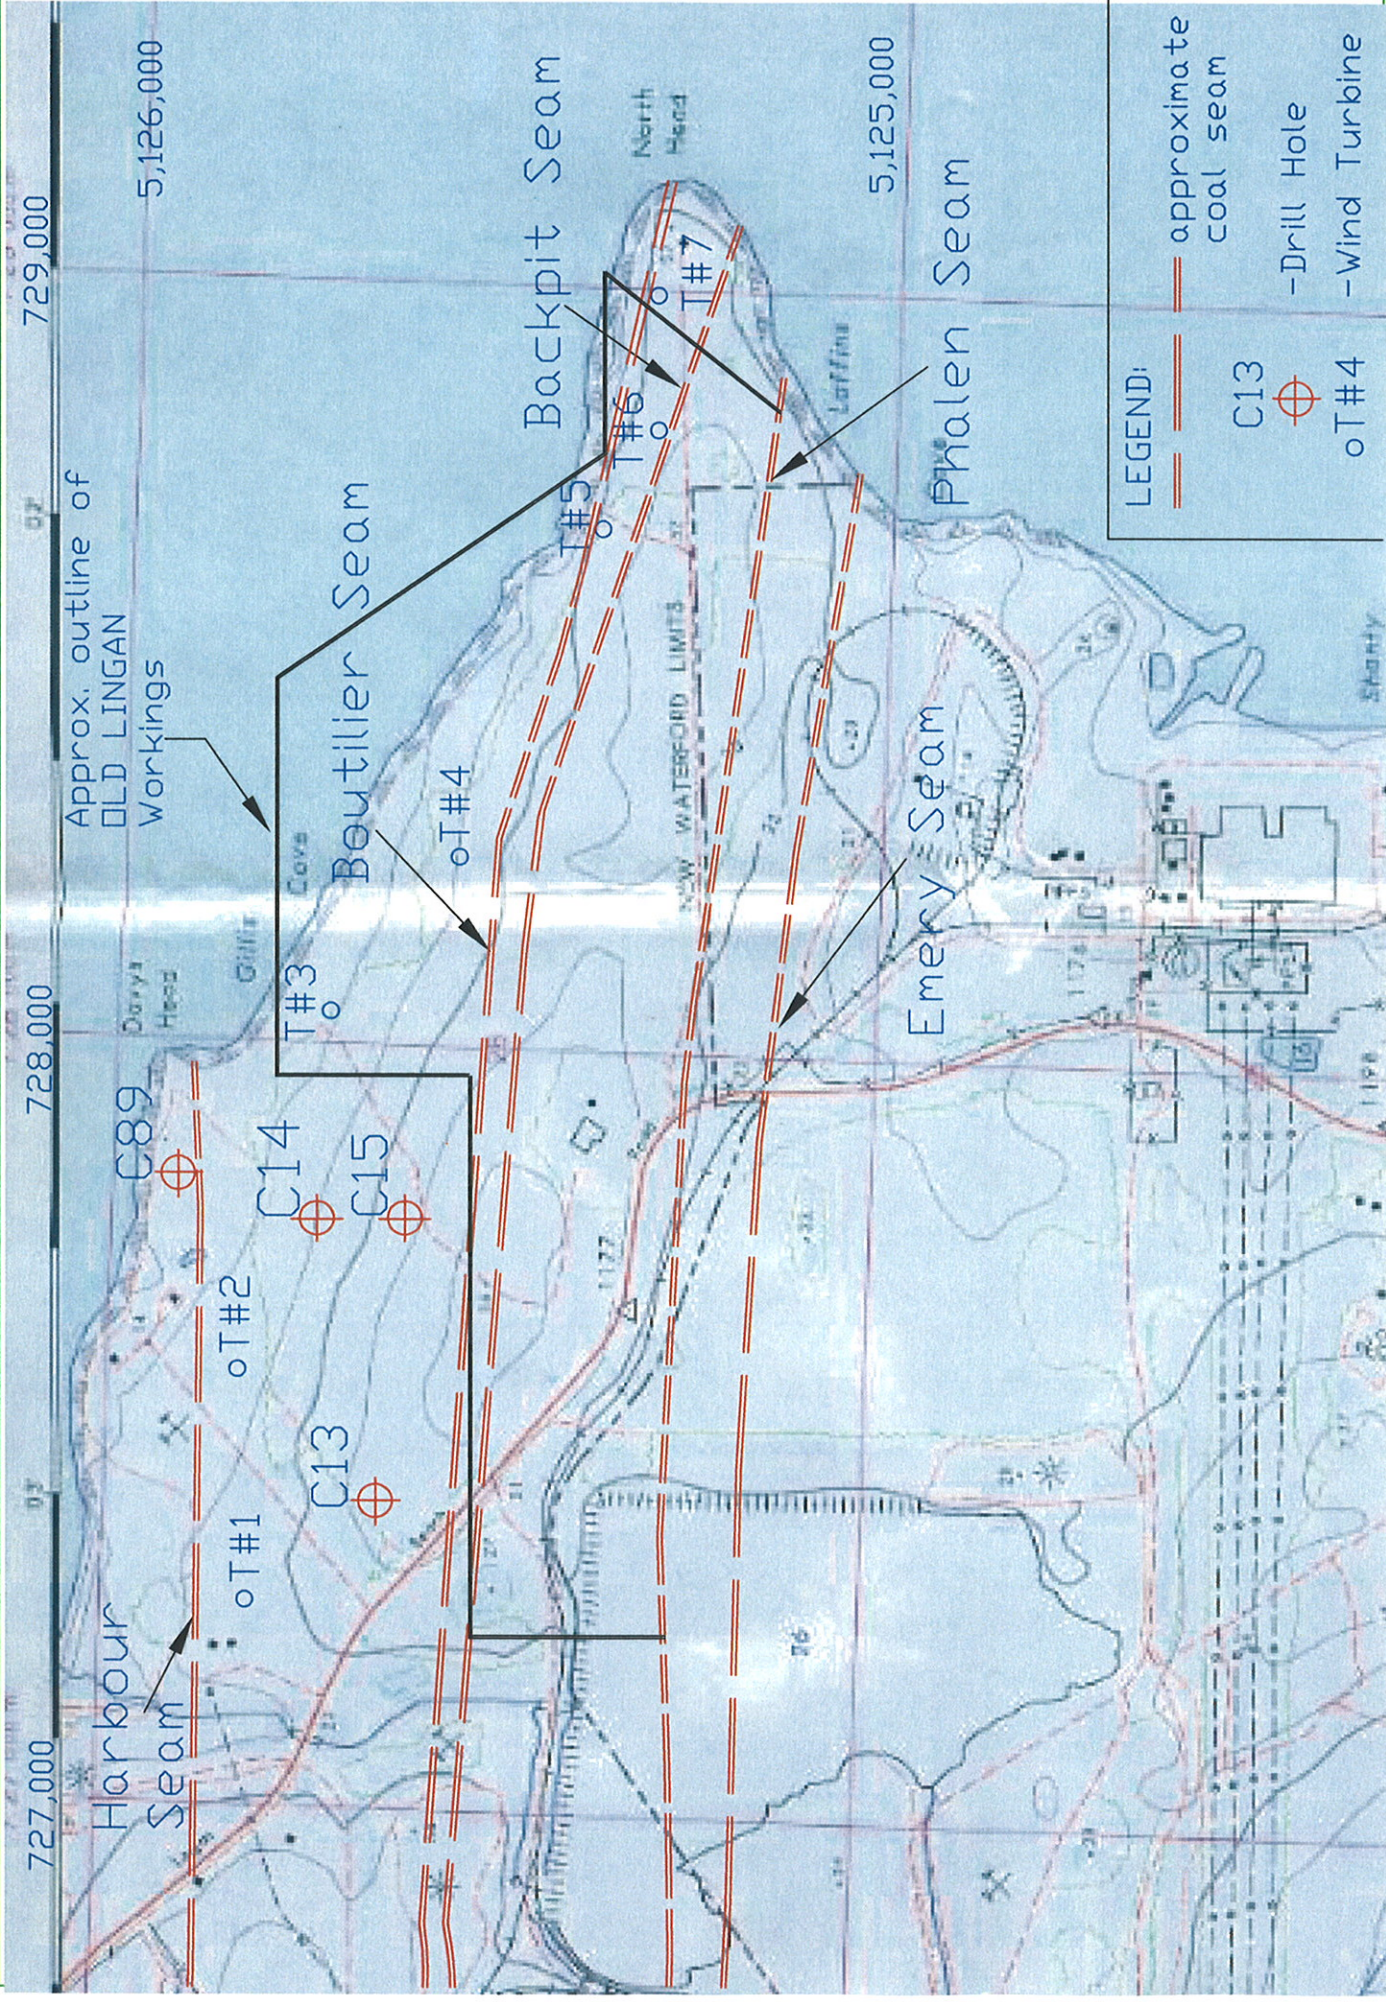
FIGURE 2  
 COAL MINING INFORMATION  
 LINGAN WIND TURBINE PROJECT  
 CAPE BRETON POWER LTD.

Figure #2 shows the approximate location of the Phalen Seam and the other surrounding coal seams underlying the proposed Wind Turbine Development. The Figure also shows the approximate location of Drill Holes C-13, -14, -15 and -89 relative to the Wind Turbine project development.

The Project site is underlain by abandoned coal mining activity associated with the Dominion Coal Mining Corporation. Specifically, the Old Lingan Mine in the Phalen Seam is located beneath the majority of the project site. Figure #2 shows the outline of the Old Lingan Mine works in the Phalen Seam. A copy of the mapping is included in Appendix A. Colliery # 15 is located to the west of the project site. The main decline for the recently abandoned Lingan-Phalen mine also passes approximately 200 metres from the West boundary.

The Old Lingan Mine workings were terminated immediately west of proposed Turbine #7 location as shown on Figure #2 and #3. Turbines #1 and #2 are approximately 200 m northwest of the nearest Old Lingan Mine workings. The coal seam would be "in tact" beneath these locations and therefore are considered to be in a stable condition.

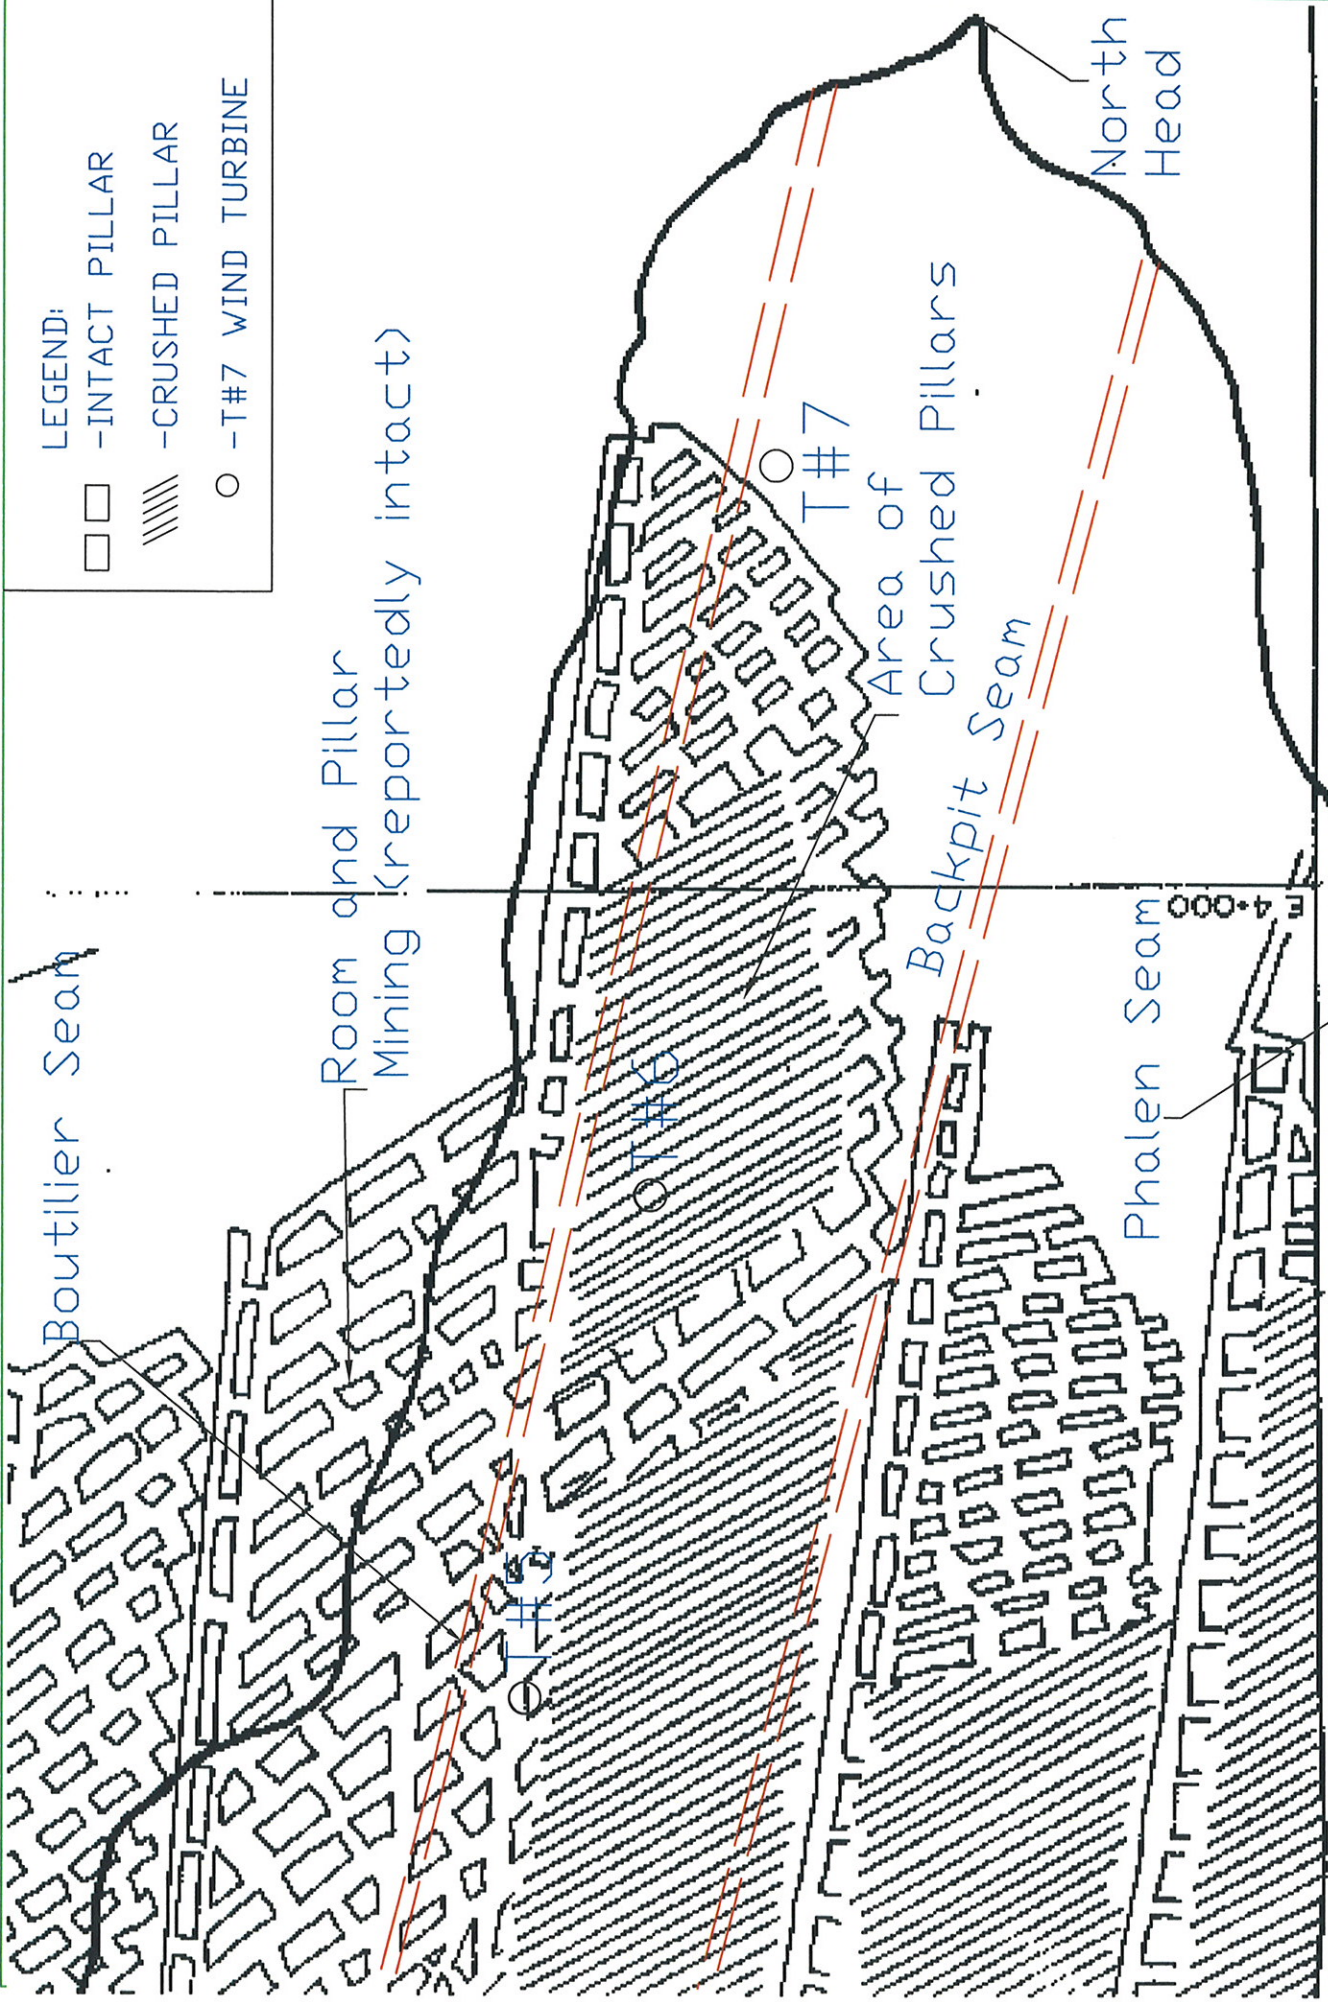
FIGURE 3  
 OLD LINGAN MINE LAYOUT  
 LINGAN WIND TURBINE PROJECT  
 CAPE BRETON POWER LTD.

After reviewing the Dominion Coal Company mapping it was determined that the proposed Turbine # 6 is located over a portion of the mining workings affected by the Pillar crushing. Figure # 3 shows the approximate location of Turbine #6 over the crushed pillar mining workings and Turbine # 5 site near the interface with the intact mine pillars. These workings are located approximately 300 metres west of the North Head coastline. The depth of Bedrock stratum over these workings is approximately 210 to 230 ft. It can be assumed that extensive caving occurred in this area after mine closure (late 1990's).

**Wind Turbine #5:** Turbine should be situated in area where there approximately 200 to 230 feet over underground workings in the Phalen Seam. Turbine very near an area of crushed coal pillars

**Wind Turbine #6:** Turbine should be situated in area where there approximately 180 to 200 feet over underground workings in the Phalen Seam. Turbine location is over an area of crushed coal pillars

3. Relocating Turbine # 5 approximately 100 metres to the northwest should improve conditions with respect to potential deep subsidence problems. Relocating Turbine # 6 in either an easterly direction toward Turbine # 7 or northwesterly toward # 5 would improve the risk of mining related damage.

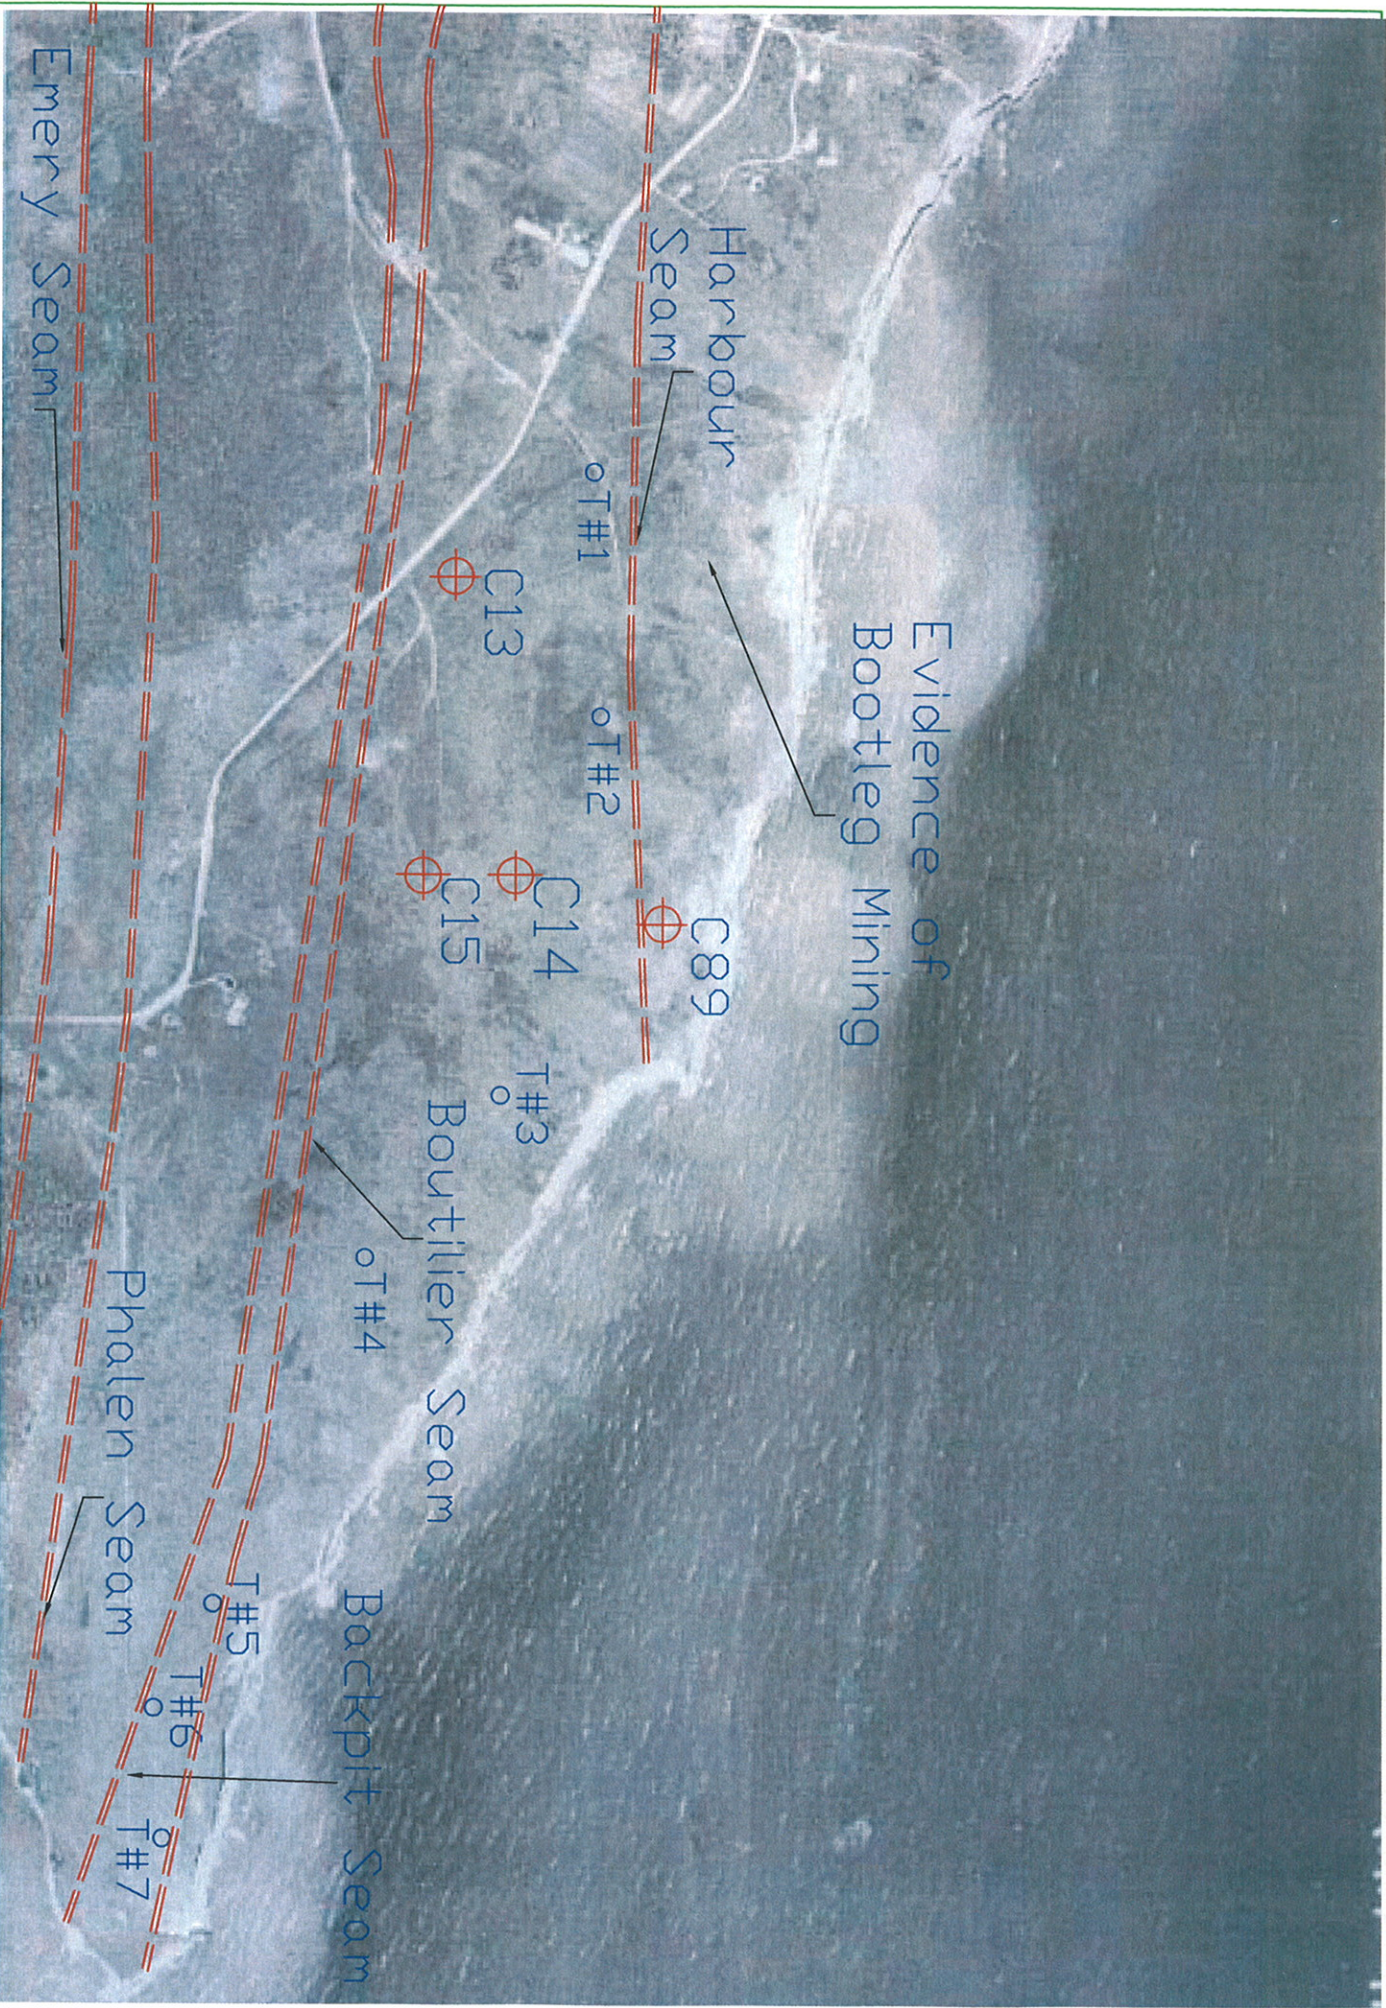
LOCATION OF HARBOUR SEAM  
LINGAN WIND TURBINE PROJECT  
CAPE BRETON POWER LTD.

Visual observations and illegal (bootleg) mining of the Harbour Seam was conducted in the area west of Davy's Head. According to drill hole log C-89 and NSDNR records; the Harbour Seam is approximately 45 to 55ft. below ground surface near Davy's Head. Figure #4 shows the approximate location of the bootlegged working in the Harbour Seam.

The surface mining in the Harbour is evident in the 1953 aerial photography on the development site. These illegal outcrop pits appear to be relatively extensive and may have reached 30 to 50 feet below original surface in some locations.
