As-Built Report for the East River, Highway 103, HADD Compensation Project (DFO HADD Authorization 04-G8-050): Fish Ladder and Culvert Baffles

Dr. Bob Pett, Environmental Services
October 2006

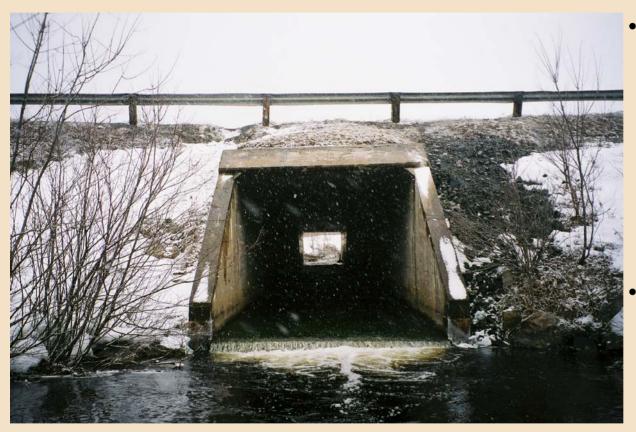
Downstream end of the box culvert at the Highway 103 crossing, April 2004. During lower flow periods, fish passage is severely compromised or not possible to the upper 845 ha of the East River Watershed.

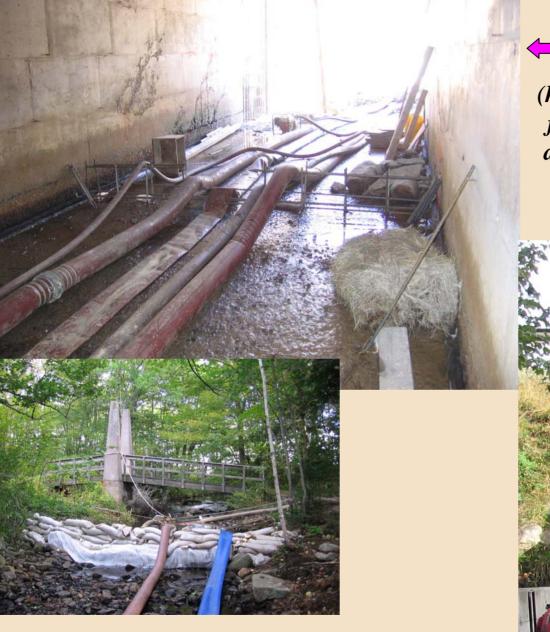
Baffle formwork; September 2, 2005

(hoses were used to convey the East River flow through the construction site; flow dammed upstream and water pumped as required to maintain water control)

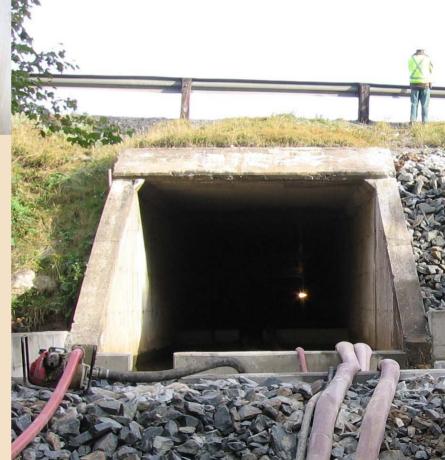
Baffles complete, September 29, 2005

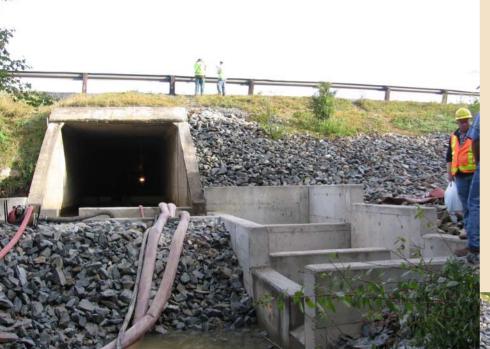
Fish ladder complete, September 29, 2005

Fishway boxes were cleaned and a new plunge pool built prior to returning water flow to the stream channel

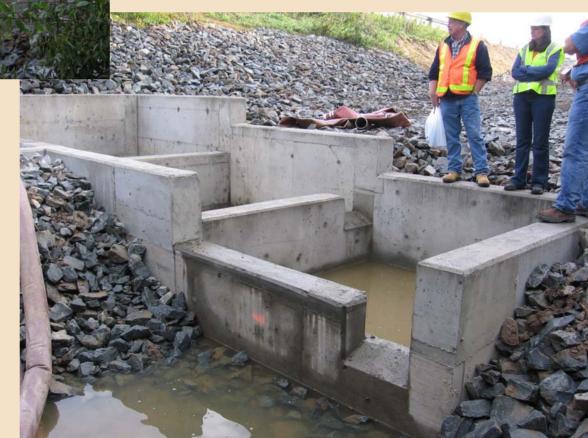
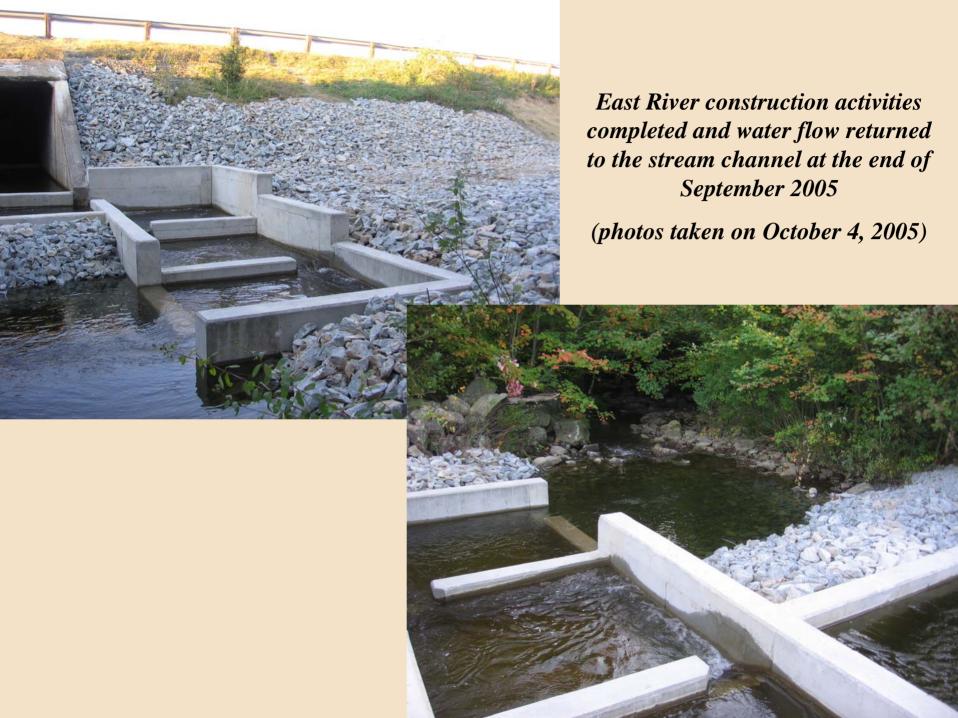
Storm flow conditions at the fishway on October 13, 2005

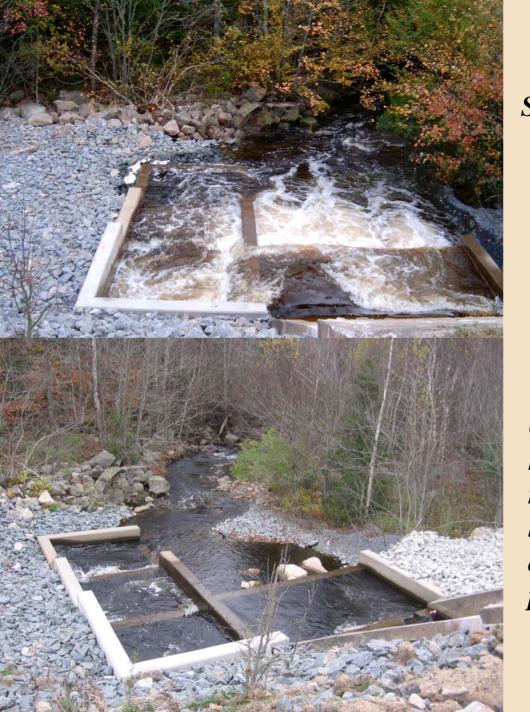
One year later – functioning well; high flow periods over the year had re-distributed the surge rock that buttressed the upper fishway box and formed the upper margin of the plunge pool (October 28, 2006)
