**Governors Brook / Nine Mile River
Compensation/ Restoration Project
As Built Report 2006
Monitoring Reports 2006-2008**

**Prepared by The Sackville Rivers Association
for
Nova Scotia Transportation and Public Works / Environmental Services**

Contract No. TPW-ESG File No. 4.133

November 28, 2008

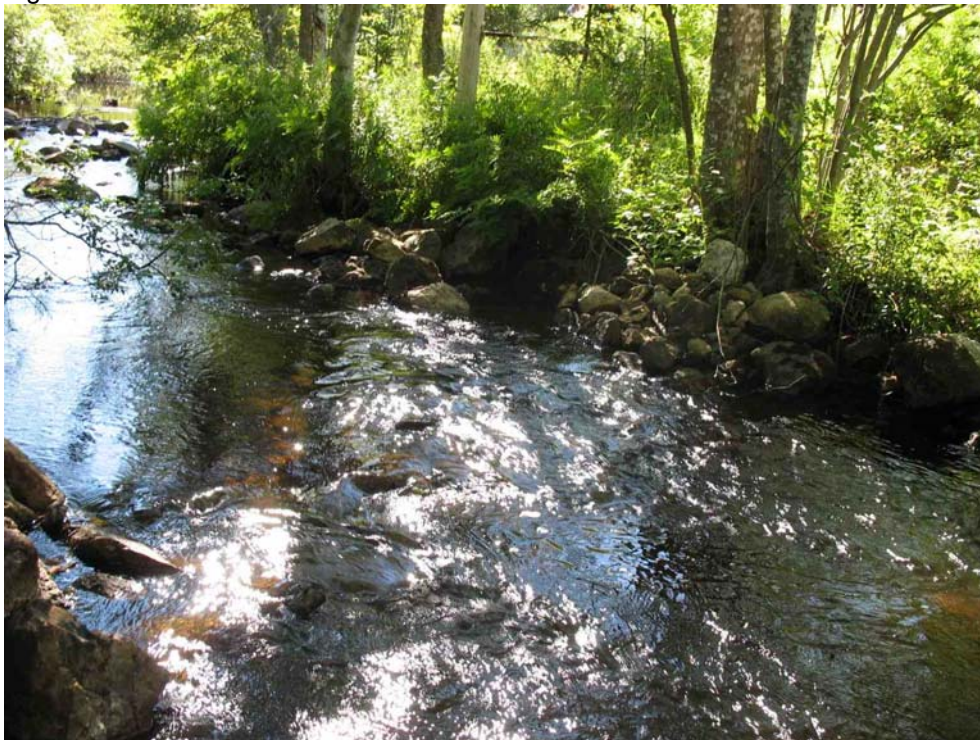
Figure 1. Rock sill at site 1

Structure is in good condition (Figure 1). There isn't a noticeable concentration of water flow at the upstream end of the structure (Figure 1), however water levels were unseasonably high. The

Recommendation: Dig out the pool to help further pool development.

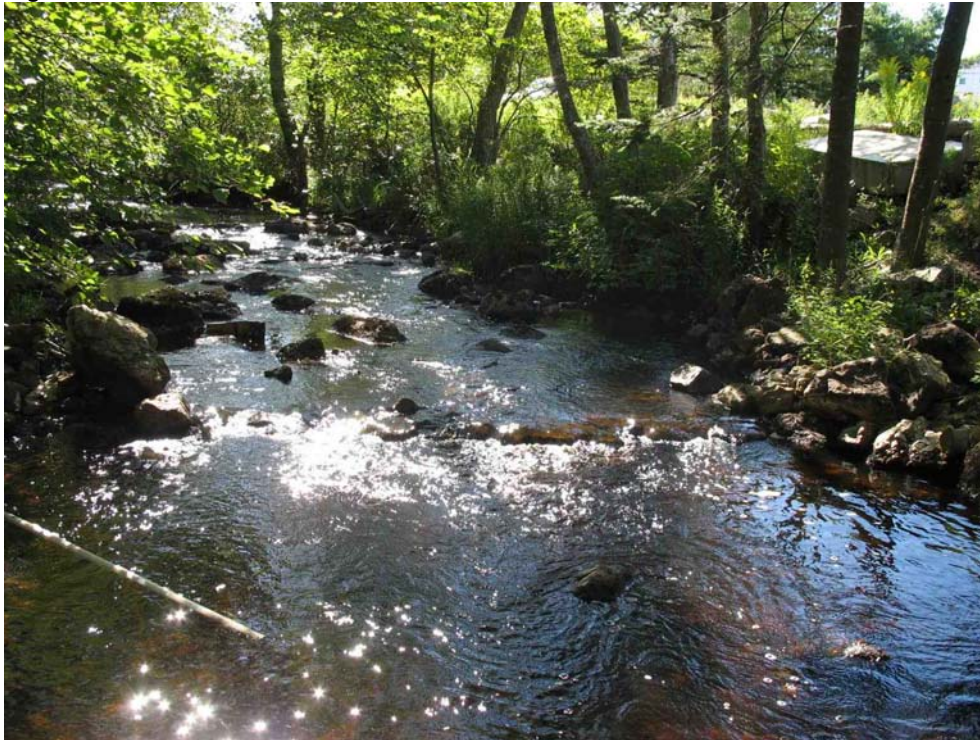
Figure 2. Rock sill at site 2

Structure is in good condition (Figure 2). Water flow is appropriately concentrated and the sill is sized properly. The structure does appear to be digging (Table 4) and the substrate in pool is not embedded.

Recommendation: Dig out the pool to help further pool development.

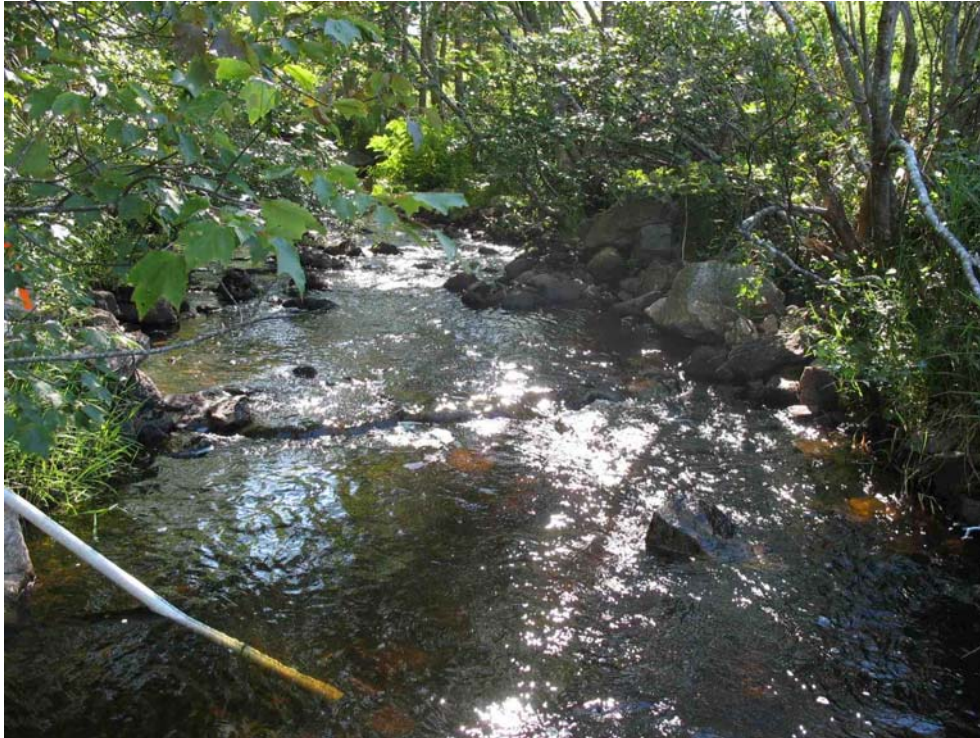
Figure 3. Rock sill at site 3

Structure is in good condition (Figure 3). Water flow is appropriately concentrated and the sill is sized properly. The structure does appear to be digging (Table 6) and the substrate in pool is not embedded.

Recommendation: Dig out the pool to help further pool development.

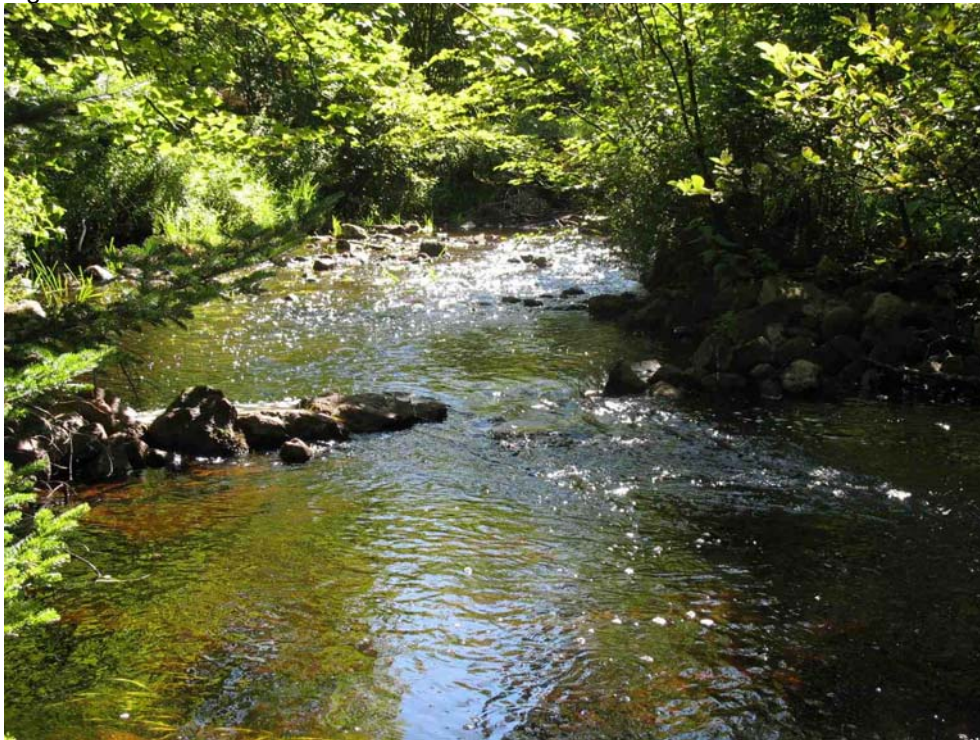
Figure 4. Rock sill at site 4

Structure is in fair condition (Figure 4). Majority of flow is concentrated appropriately, however water is also flowing through the downstream end of the structure. Downstream end of the structure is larger than required, but does not need to be changed. Structure is digging (Table 8), but more sediment is present where the pool should be.

Recommendation: Dig out the pool to help further pool development and rebuild ramp leading to the structure to decrease the amount of water flowing through the downstream end of the structure. Decreasing the size of the structure would be desirable, but not required.

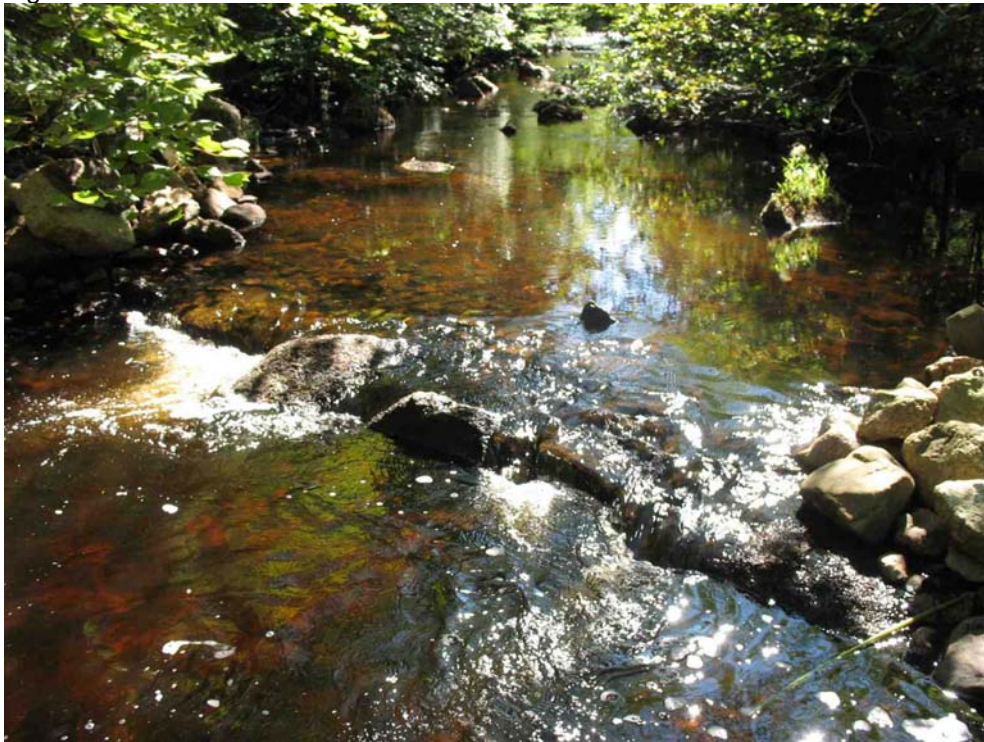
Figure 5. Rock sill at site 5

Structure is in good condition (Figure 5), however it is too large and has created a pool upstream from the structure (Figure 6). The concentration of water flow passes over the very upstream end of the structure. It is digging somewhat (Table 10).

Recommendations: Rebuild structure to appropriate size, with water concentration (low point) 1/3 of the total distance from the upstream end and no more than 3-4 inches from the natural stream bottom. Bank construction to assist with eliminating the pool created upstream of the structure will also be required. Dig out pool to help further pool development

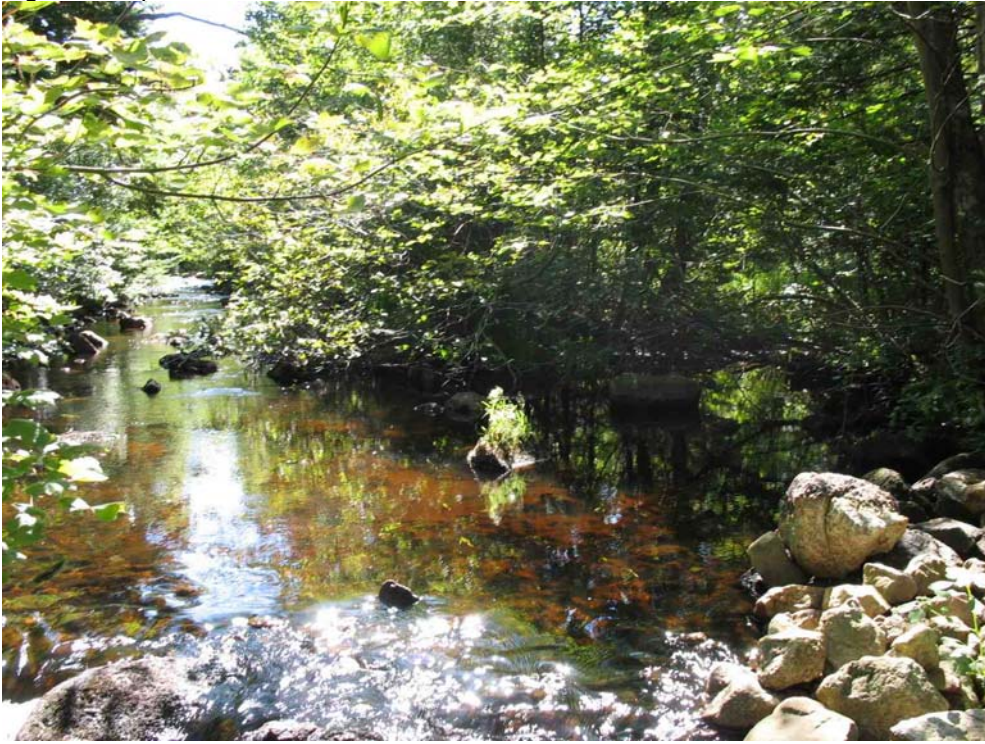
Figure 6. Upstream from site 5

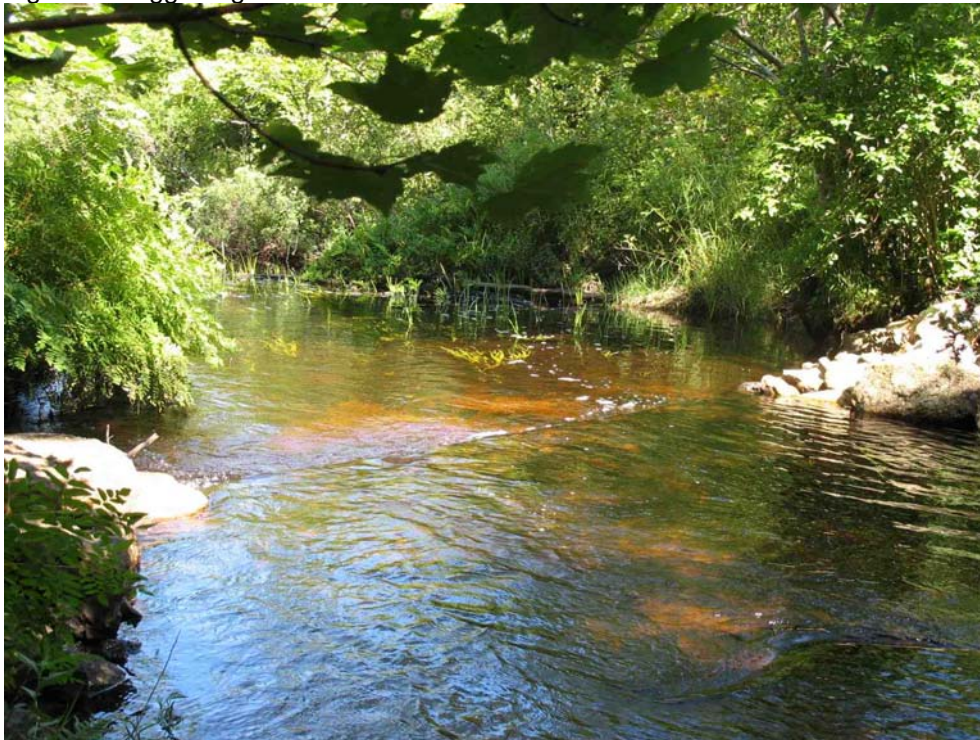
Figure 7. Digger log at site 6

Structure is in good condition, and has undercut well (Figure 7). However, it does not seem to be digging very well as the pool below is shallow (Table 12) and many fines remain where the pool should be located. A required section of bank just downstream from the upstream end was not built or has washed out (Figure 8).

Recommendation: Construct bank at upstream end of the structure and dig out pool.

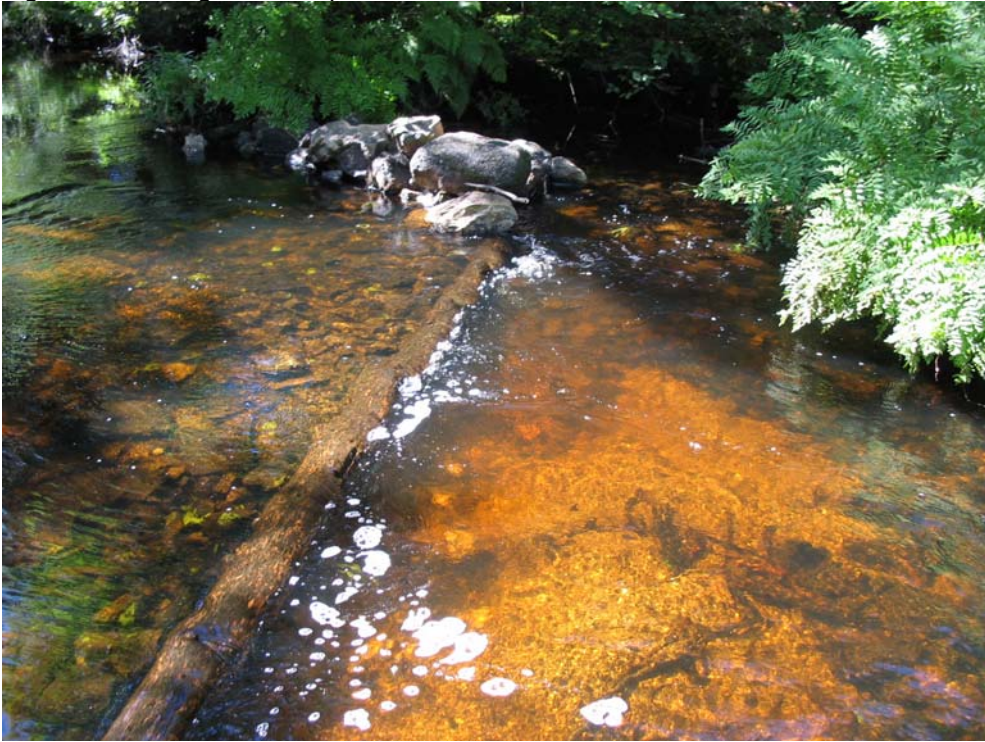
Figure 8. Missing bank at upstream end at site 6

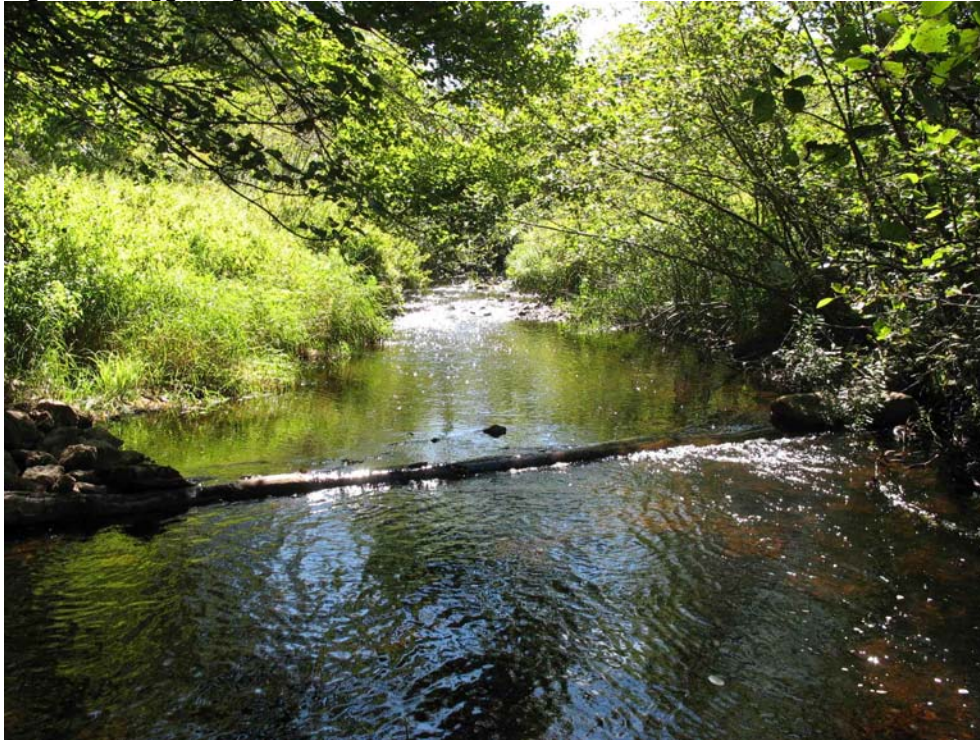
Figure 9. Digger log at site 8

Structure is in good condition (Figure 9). Structure doesn't appear to be digging (Table 14), which is surprising as the substrate consists of small rocks and fines.

Recommendation: Dig out the pool to help further pool development.

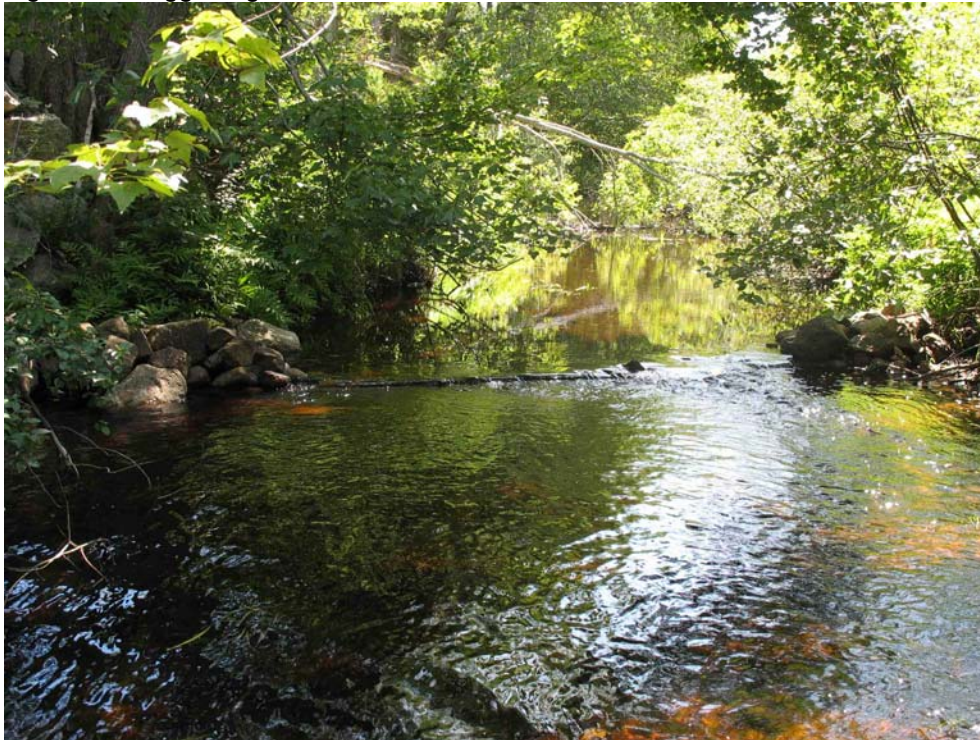
Figure 10. Digger log at site 10

Structure is good condition. Structure doesn't appear to be digging (Table 18), which is surprising as the substrate consists of small rocks and fines.

Recommendation: Dig out the pool to help further pool development.

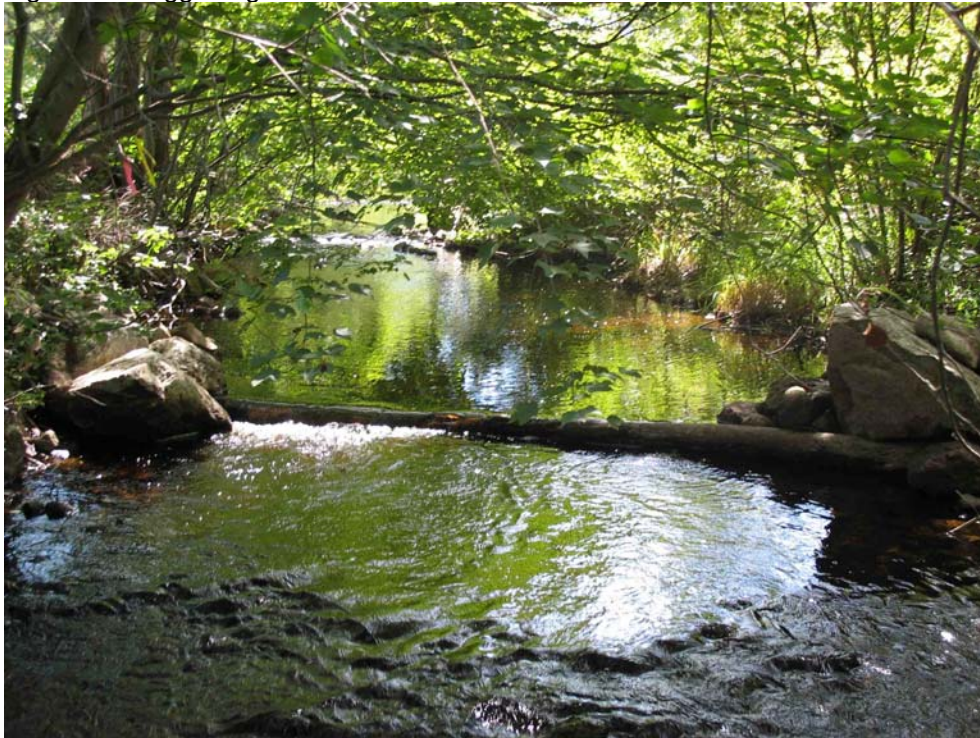
Figure 11. Digger log at site 11

Structure is in good condition and appears to be digging (Table 20). The structure appears to be set too high and has created a pool upstream.

Recommendation: Lower structure to an appropriate level to drain upstream pool and dig out the pool to help further pool development.

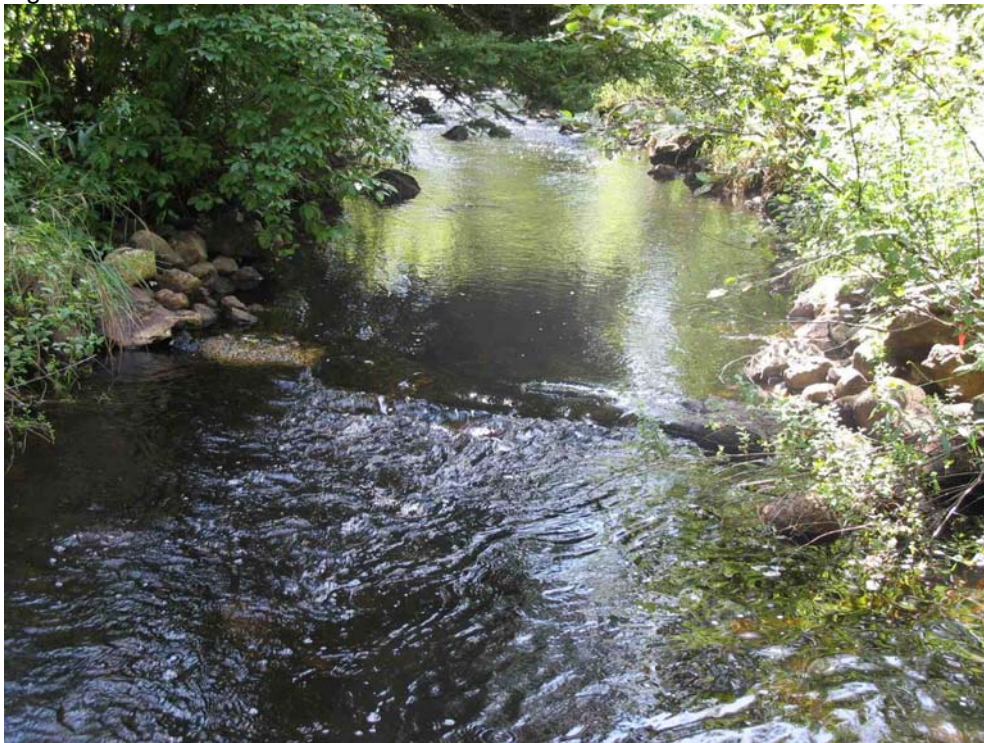
Figure 12. Rock sill at site 13

Structure is in good condition (Figure 12) and appears to be digging (Table 22), despite the presence of larger substrate. Water flow is concentrated in the middle of the structure.

Recommendations: Fix water flow concentration and dig out the pool to help further pool development.

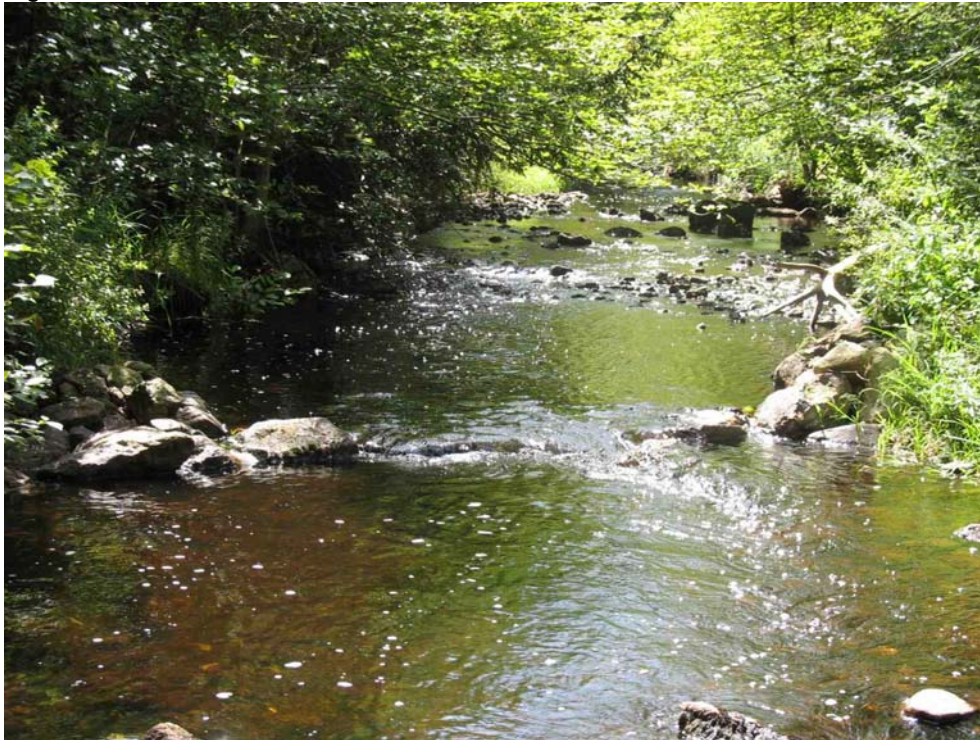
Figure 13. Rock sill at site 14

Structure is in good condition (Figure 13) and appears to be digging (Table 24). Good concentration of water flow.

Recommendations: Dig out the pool to help further pool development.

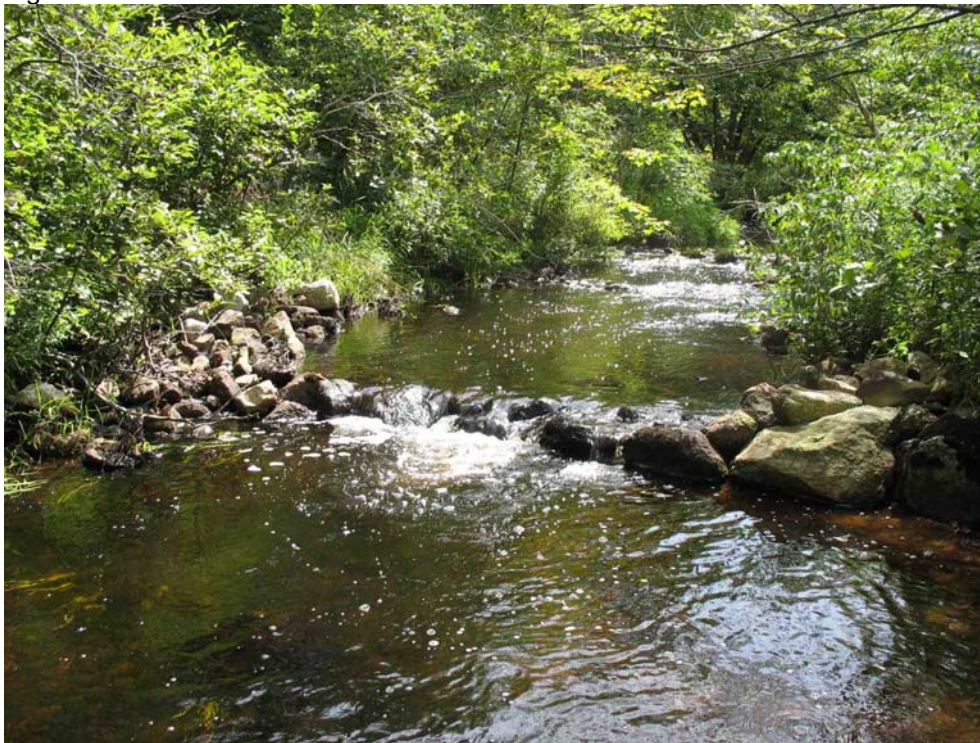
Figure 17. Rock sill at site 17

Structure is in good condition (Figure 17) and appears to be digging (Table 30); however, it is much too large. Water is concentrated over the center of the structure.

Recommendations: Rebuild structure to appropriate size and water concentration. Dig out the pool to help further pool development.

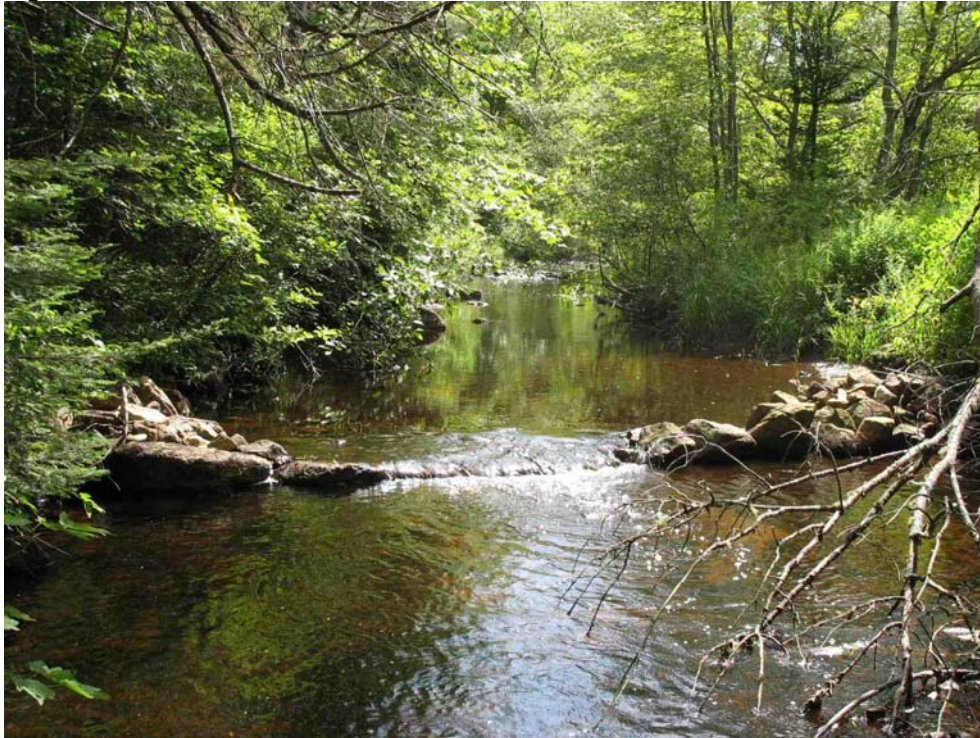
Figure 18. Rock sill at site 18

Structure is in good condition (Figure 18) and appears to be digging (Table 32). Water flow is concentrated in the center of the structure.

Recommendations: Realign water flow concentration appropriately and dig out the pool to help further pool development.

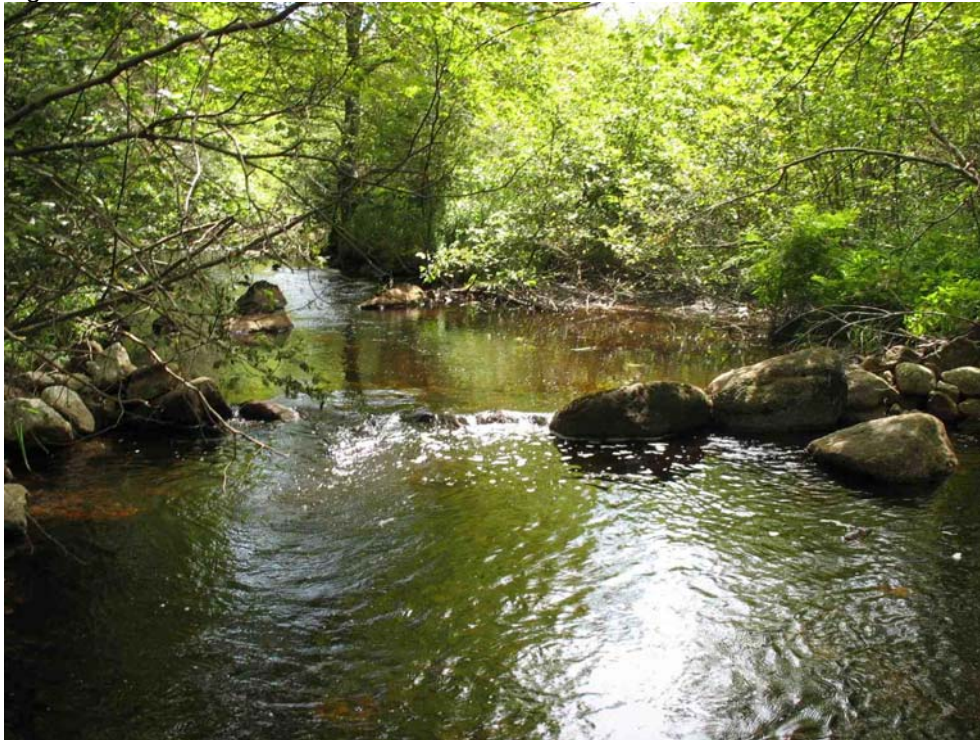
Figure 19. Rock sill at site 19

Structure is in good condition, and appropriately sized (Figure 19) for its location. It appears to be digging (Table 34).

Recommendations: Dig out the pool to help further pool development.

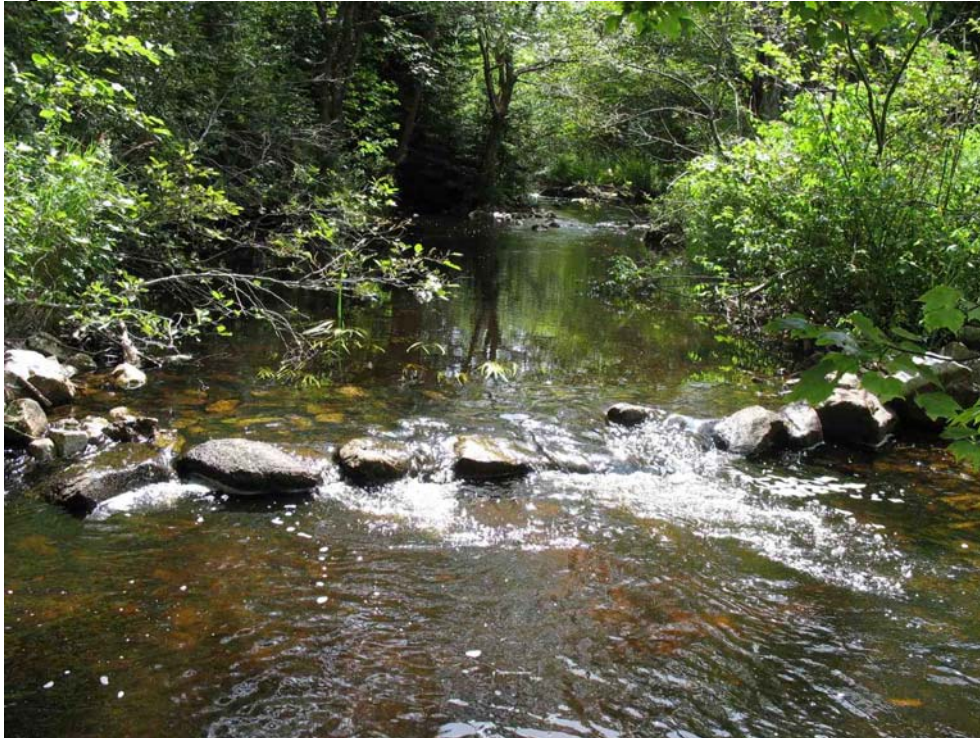
Figure 20. Rock sill at site 20

Structure is in decent condition (Figure 20), and appears to be digging (Table 36). Concentration of water flow is appropriate, however the downstream end of the structure could be improved to reduce the amount of water that is passing through it.

Recommendation: Fix downstream end of the structure and dig out the pool to help further pool development.

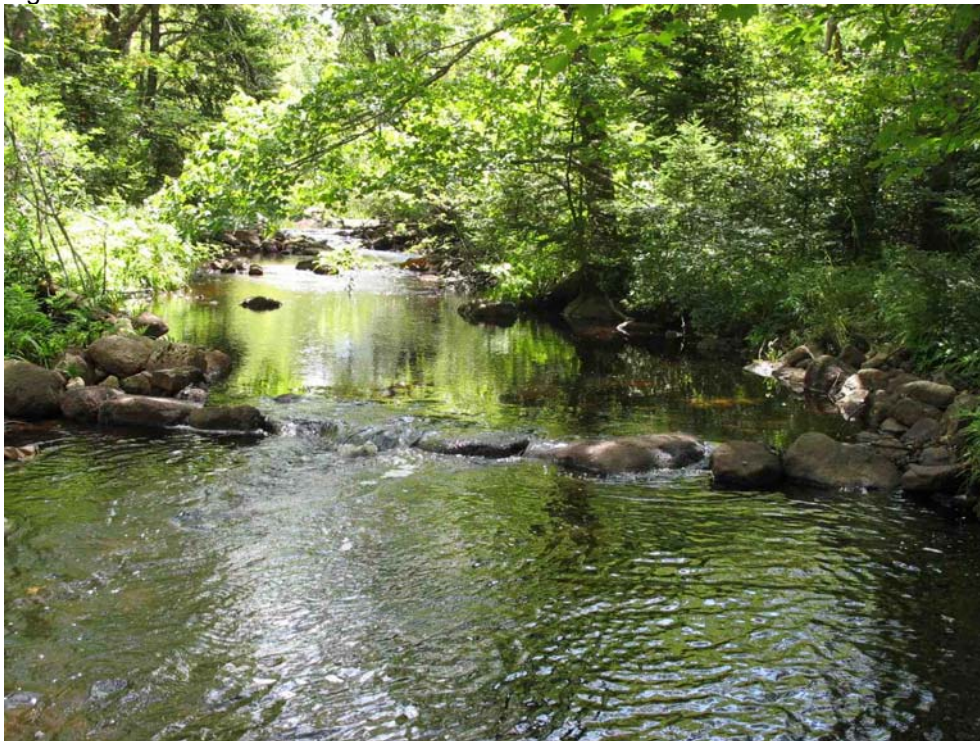
Figure 21. Rock sill at site 22

Structure is in good condition (Figure 21) and appears to be digging (Table 38). Bank construction/stabilization located upstream is still in place. Stream is twice as wide as it should be (or more) below the structure.

Recommendation: Dig out the pool to help further pool development. If it is possible, the section of the brook would greatly benefit from extensive bank construction downstream of the site.

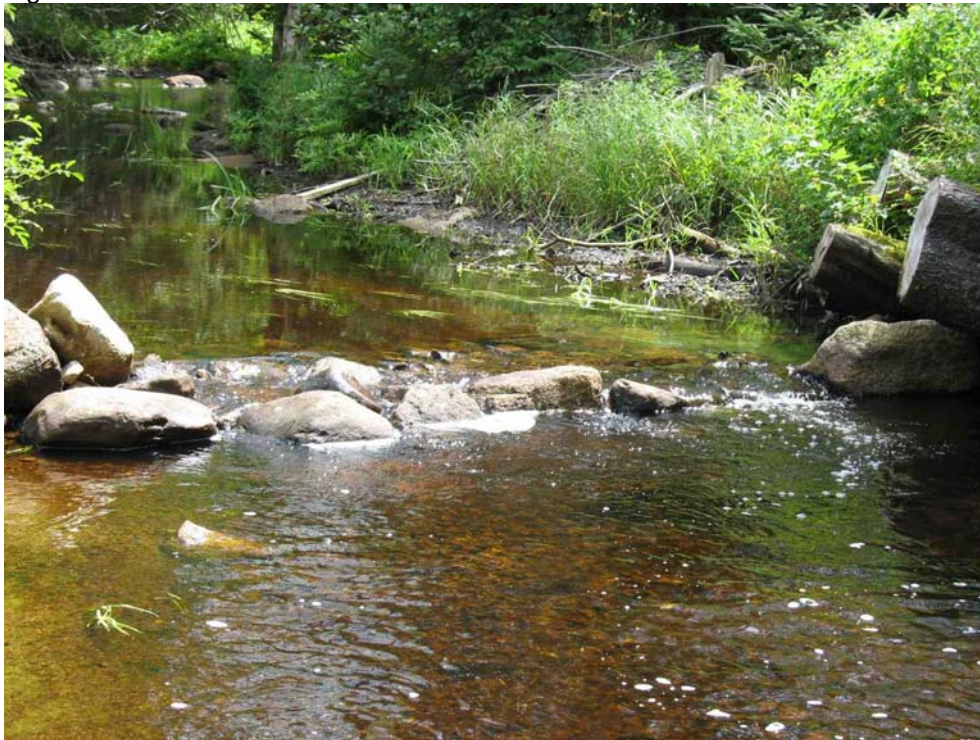
Figure 22. Rock sill at site 23

Structure is in decent condition (Figure 22), has appropriate water flow concentration and appears to be digging (Table 40). Rocks comprising the downstream end of the structure were loose.

Recommendation: Re-set the downstream section of the sill and dig out the pool to help further pool development.
