**Watercourse Fact Sheet: Fish Habitat - Page 1**

WATERCOURSE INFORMATION	
Watercourse ID:	<b>Watercourse BL-WC201a-3772</b>
General Site Location:	Bear Lake
Watercourse Assessor(s):	CJ,CM
Affiliation:	CBCL Limited
Field Assessment Date:	Nov 4 2022
UTM Coordinates:	Wp. 1587
Datum:	NAD 1983
HABITAT QUALITY	
Overall Habitat Quality	Good
Spawning	Good
Rearing	Moderate
Foraging	
Migration	
Overwintering	Moderate
POTENTIAL FOR FISH PRESENCE	
Overall Fish Potential	High
FISH OBSERVED	
No	
WATER QUALITY AND VELOCITY	
Temperature (Deg. C)	8.1
pH	4.6
Dissolved Oxygen (mg/l)	12.65
Dissolved Oxygen (%)	108
Conductivity (µs/cm)	33.33
Salinity (mg/L)	0.02
Total Dissolved Solids (g/L)	
Turbidity (NTU)	
Average Velocity (m/sec)	4.69
Velocity Location	Crossing

**Watercourse Fact Sheet: Fish Habitat - Page 2**  
**Watercourse ID: Watercourse BL-WC201a-3772**

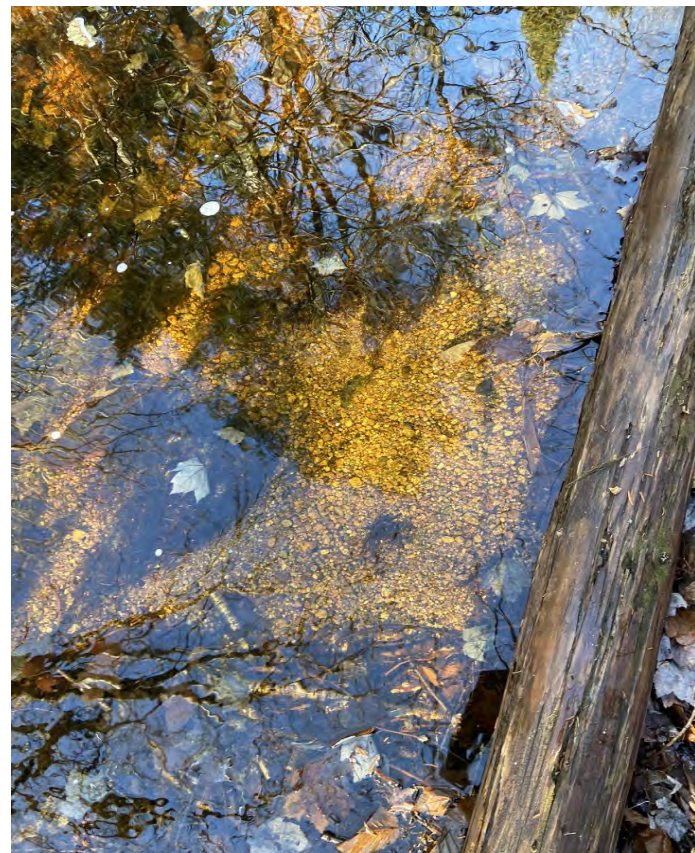
RIPARIAN VEGETATION SPECIES		
#	Common Name	Scientific Name
1	Balsam Fir	<i>Abies balsamea</i>
2	Yellow Birch	<i>Betula alleghaniensis</i>
3	Red Maple	<i>Acer rubrum</i>
4	Sphagnum	#N/A
5		#N/A
6		#N/A
7		#N/A
8		#N/A
9		#N/A
10		#N/A
RIPARIAN INFORMATION		
Crown Closure %	51-75%	
Bank Texture	Fines, gravel, cobble, boulder	
Bank Shape	Sloped, overhanging	
Bank Stability		
Vegetation Stage	Mature Forest	
IMPORTANT FEATURES OBSERVED		
Spawning Area / REDD	<input checked="" type="checkbox"/>	
Beaver Dam	<input type="checkbox"/>	
Beaver Pond	<input type="checkbox"/>	
Underground Sections	<input type="checkbox"/>	
Waterfall or Cascade	<input type="checkbox"/>	
No Defined Channel	<input type="checkbox"/>	
Hanging Culvert	<input type="checkbox"/>	
Blocked or Damaged Culvert	<input type="checkbox"/>	
Bridge	<input type="checkbox"/>	
ADDITIONAL NOTES		
Velocity Location: Wp. 1587, Transitional areas: Consistant with small perm WL. Water Quality collected instream at Wp. 1590 @ 11:25 *WQ-PH4-02(. No barriers to fish passage in assessed reach. No fish observed in reach. pH is a little low but within tolerance for Brook Trout. Potential REDDs observed

**Photo 3: Potential REDD**

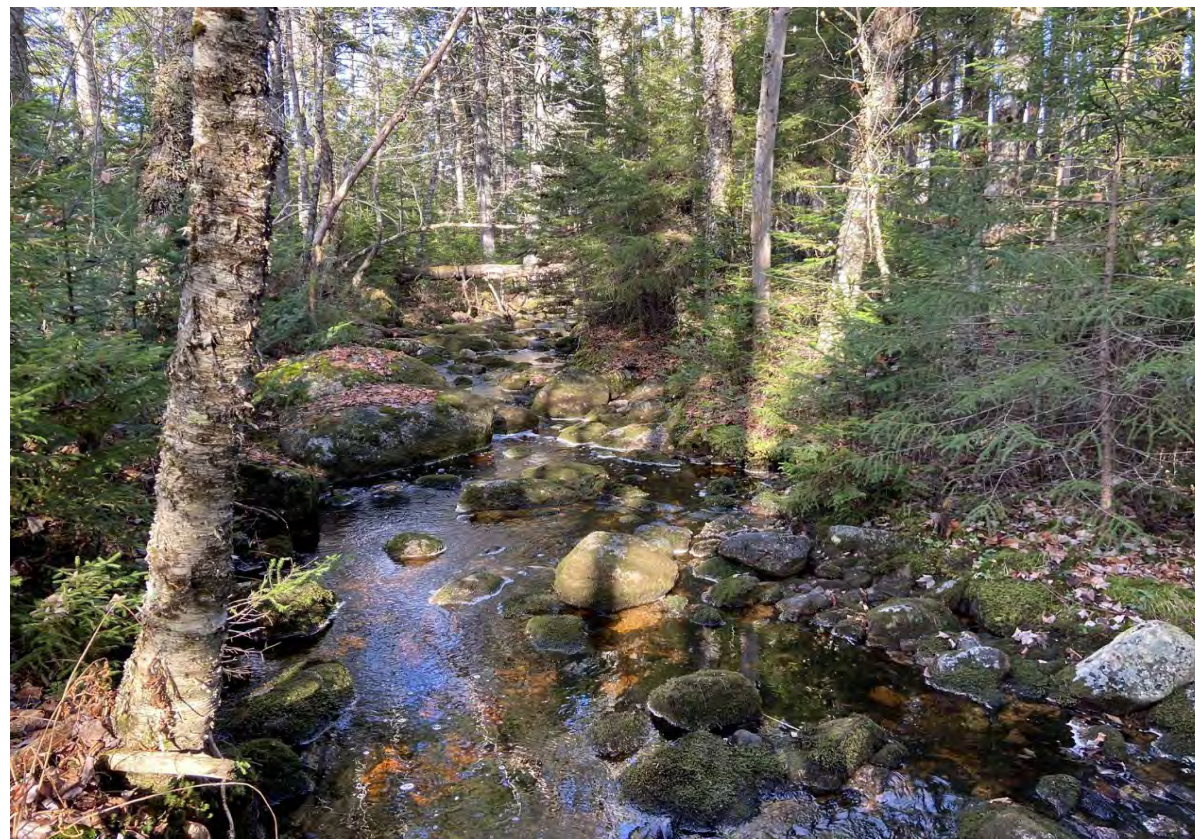
**Photo 4: Upstream general habitat**

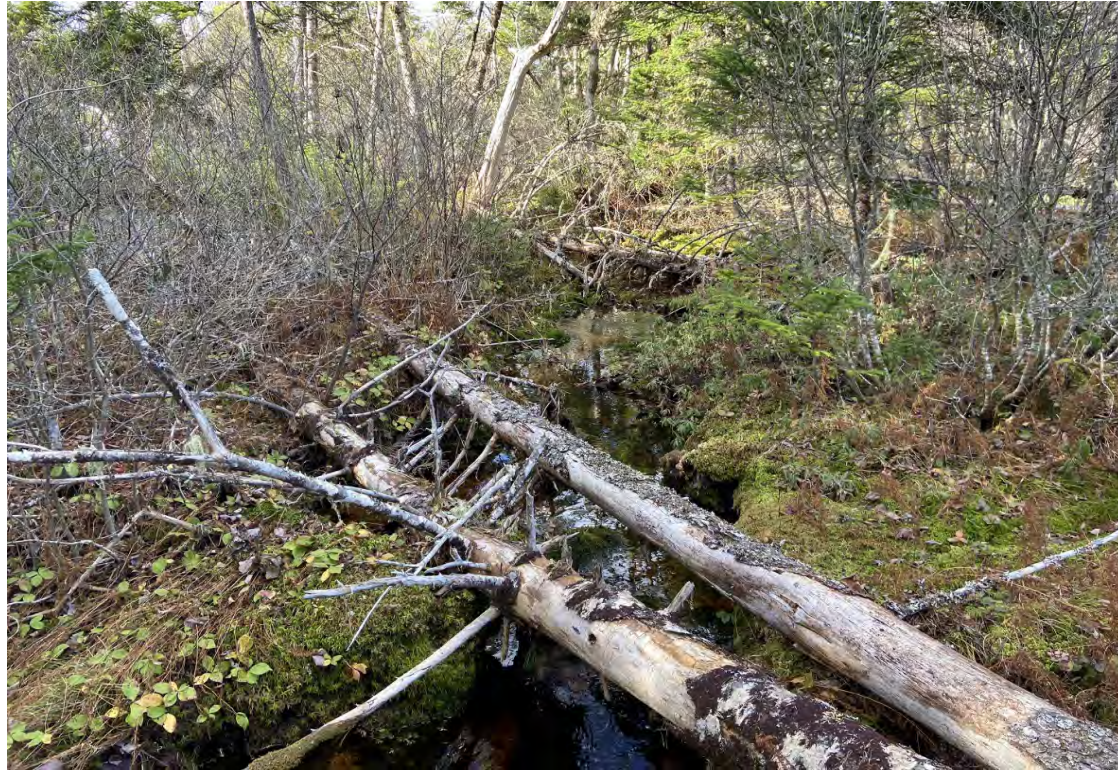
**Photo 1: Upstream at Crossing**

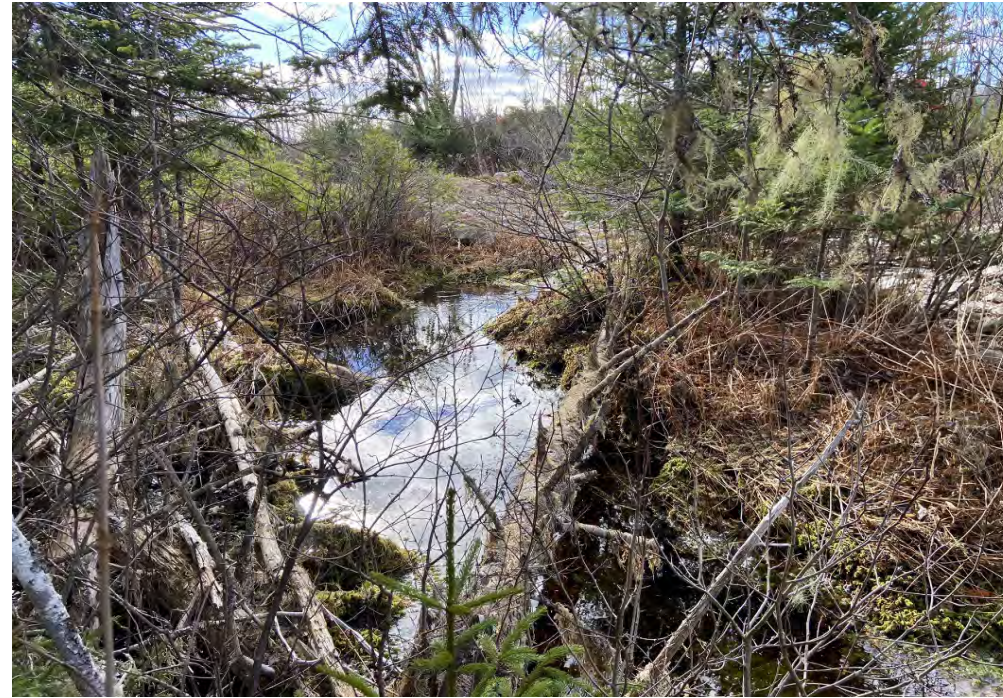
**Photo 2: Downstream at Crossing Location**

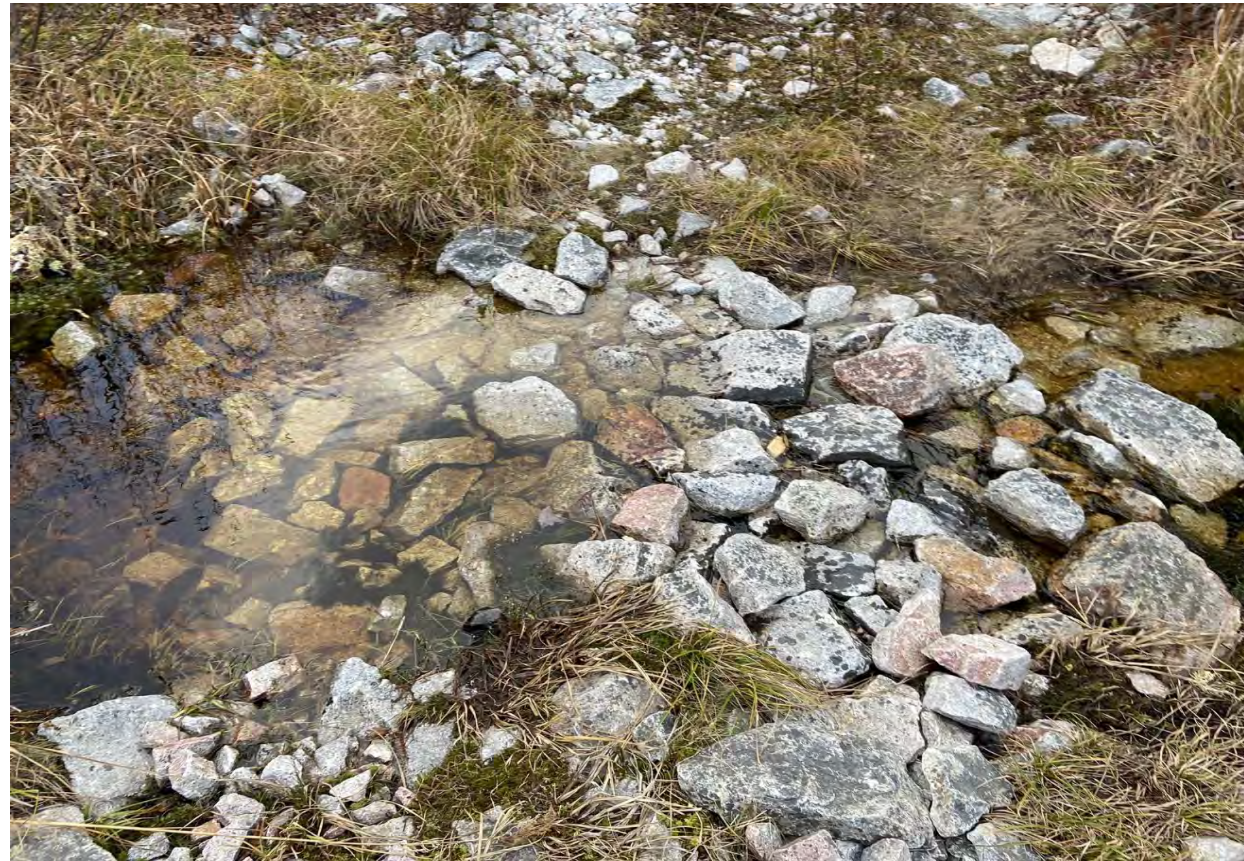
RIPARIAN VEGETATION SPECIES		
#	Common Name	Scientific Name
1		#N/A
2		#N/A
3		#N/A
4		#N/A
5		#N/A
6		#N/A
7		#N/A
8		#N/A
9		#N/A
10		#N/A
RIPARIAN INFORMATION		
Crown Closure %		
Bank Texture		fines,
Bank Shape		undercut
Bank Stability		
Vegetation Stage		
IMPORTANT FEATURES OBSERVED		
Spawning Area / REDD	<input checked="" type="checkbox"/>	
Beaver Dam	<input type="checkbox"/>	
Beaver Pond	<input type="checkbox"/>	
Underground Sections	<input type="checkbox"/>	
Waterfall or Cascade	<input type="checkbox"/>	
No Defined Channel	<input type="checkbox"/>	
Hanging Culvert	<input type="checkbox"/>	
Blocked or Damaged Culvert	<input type="checkbox"/>	
Bridge	<input type="checkbox"/>	
ADDITIONAL NOTES		
Wetland in upstream, Groundwater sources, no culvert-washout, Wp. 1923 Partial barrier .50cm some areas fish can get through in high flow resident fish could be living upstream and blocked for certain times of year. Lots of blow down here.

**Photo 3: Partial barrier downstream**

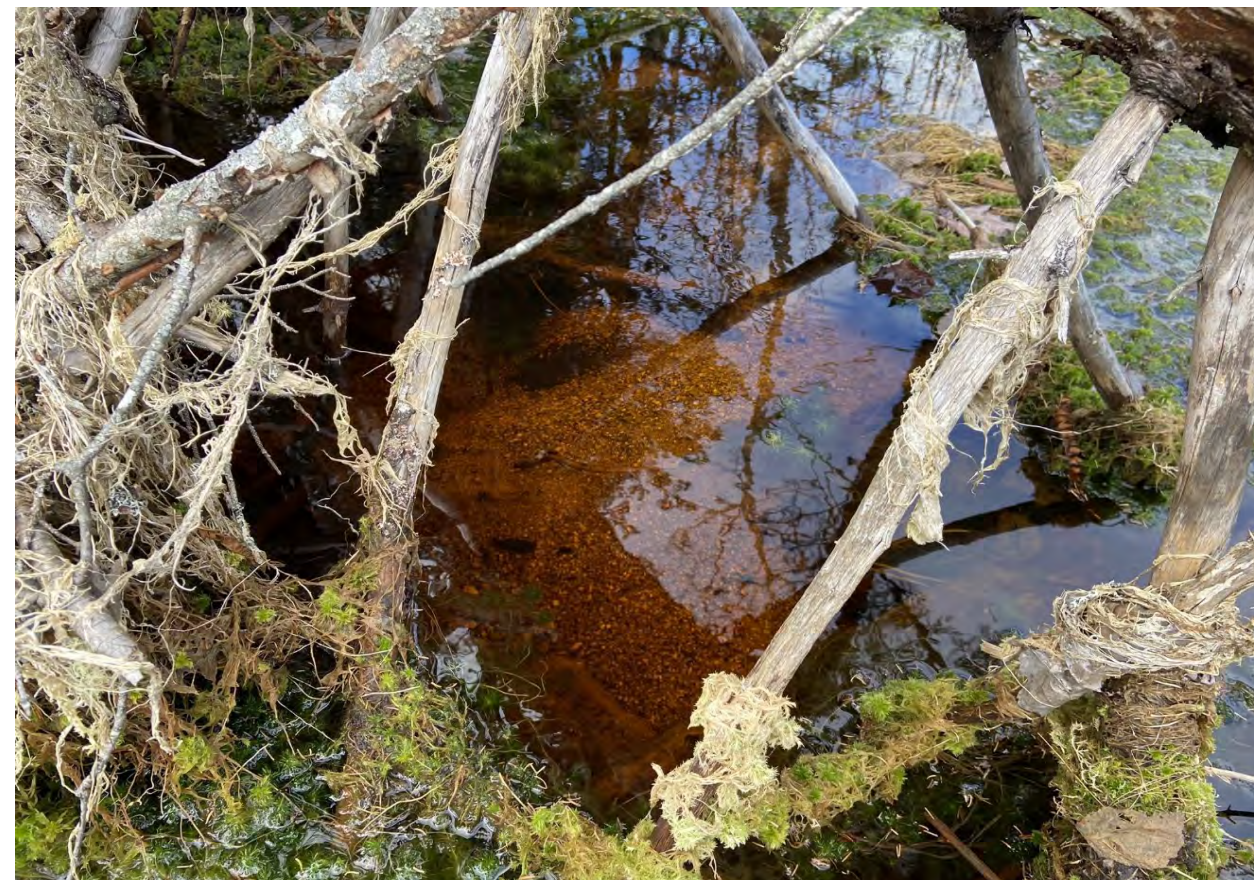
**Photo 4: Downstream, Potential REDD**

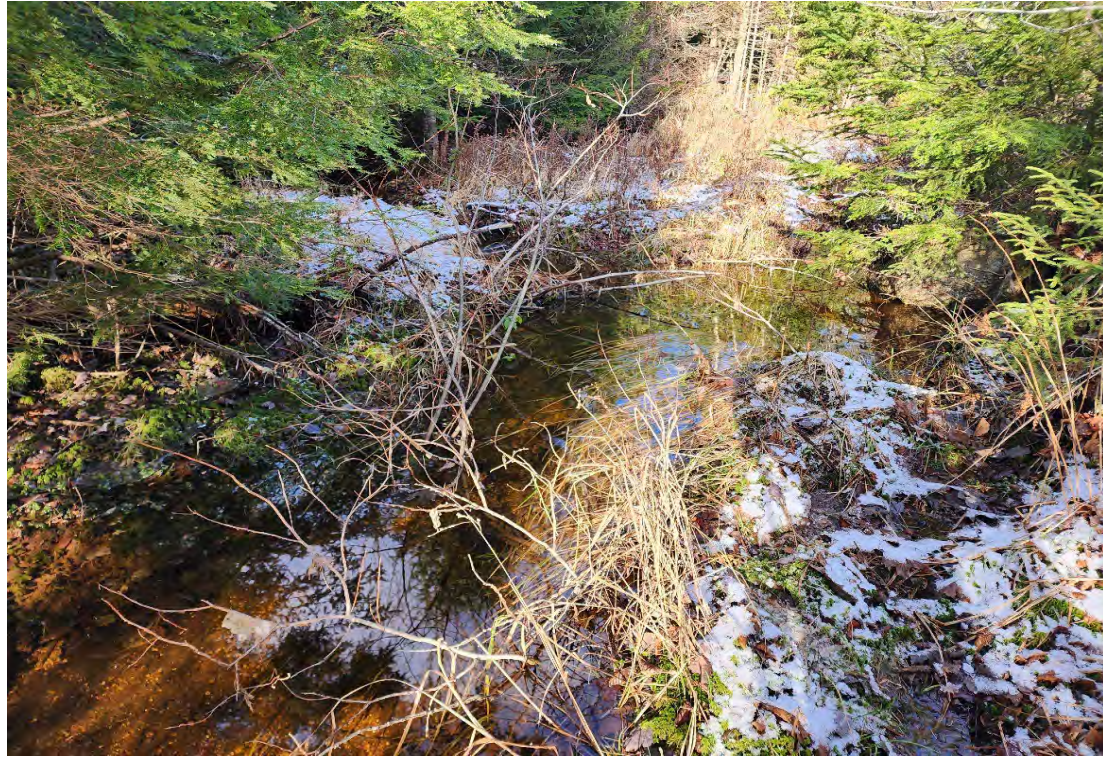
**Photo 1: Upstream at Crossing Location**

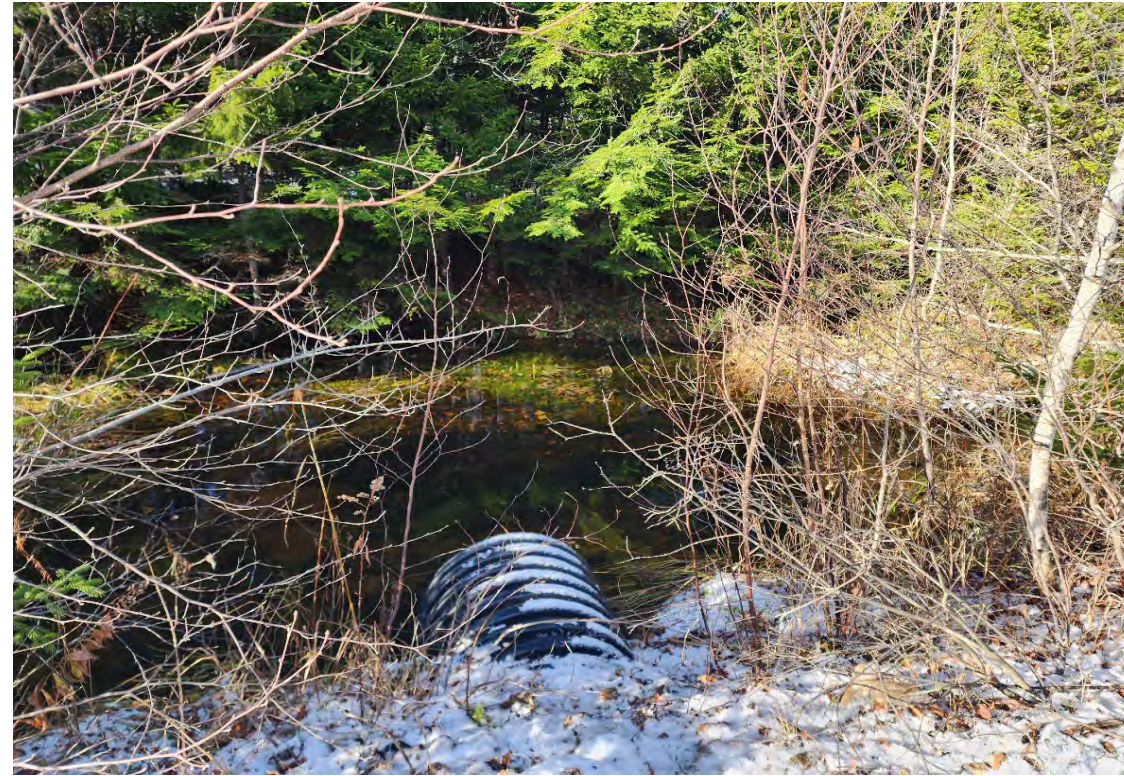
**Photo 2: Culvert at crossing Location**

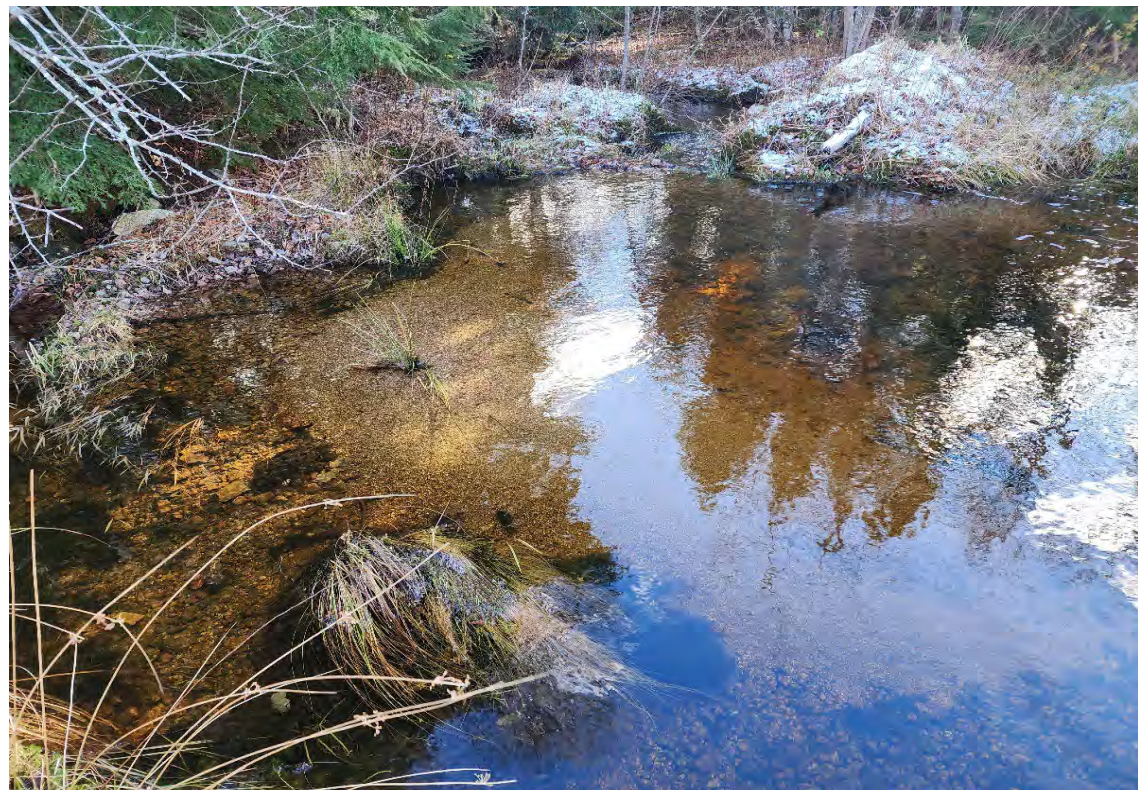
**Photo 3: Feature 1 (pool within assessed channel area.)**

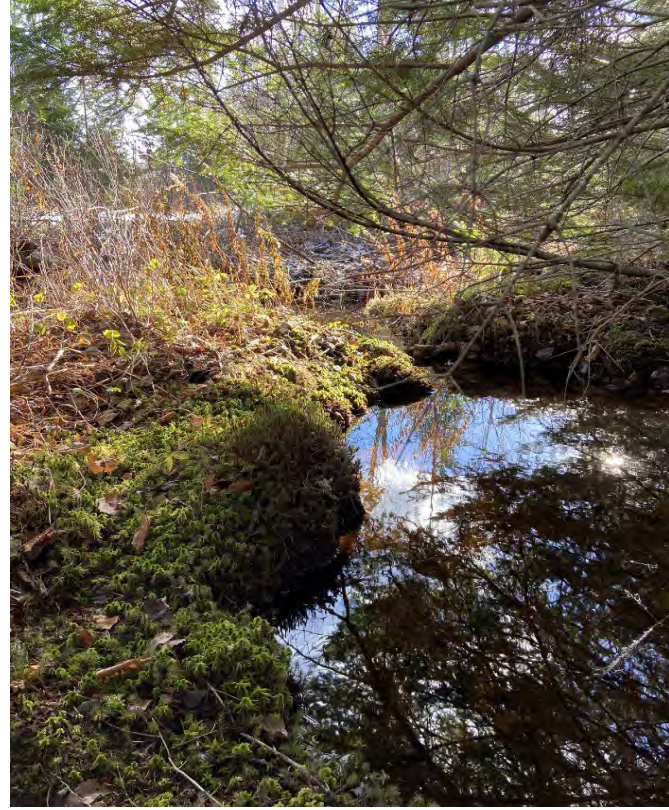
**Photo 1: Upstream at Crossing Location**

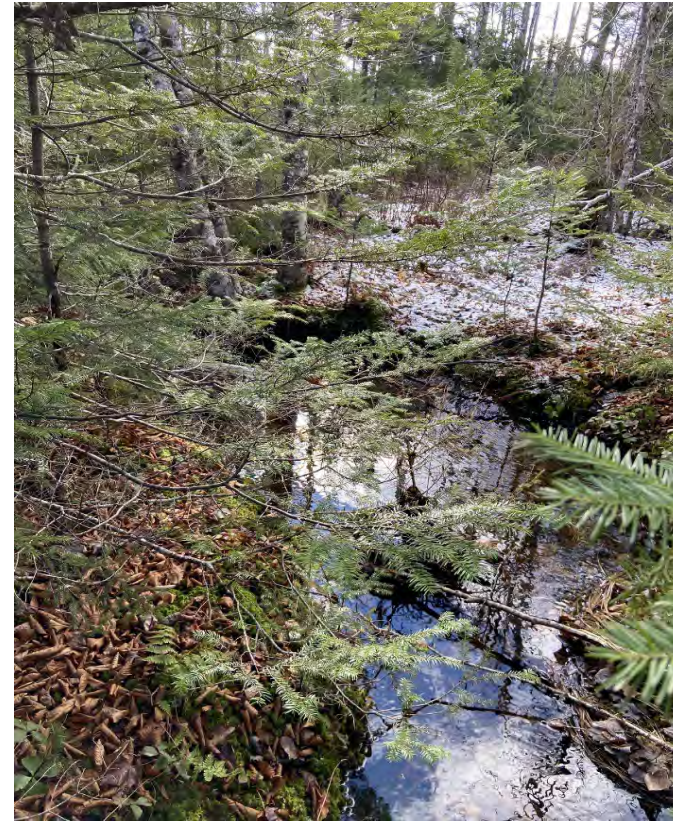
**Photo 2: Upstream general habitat**

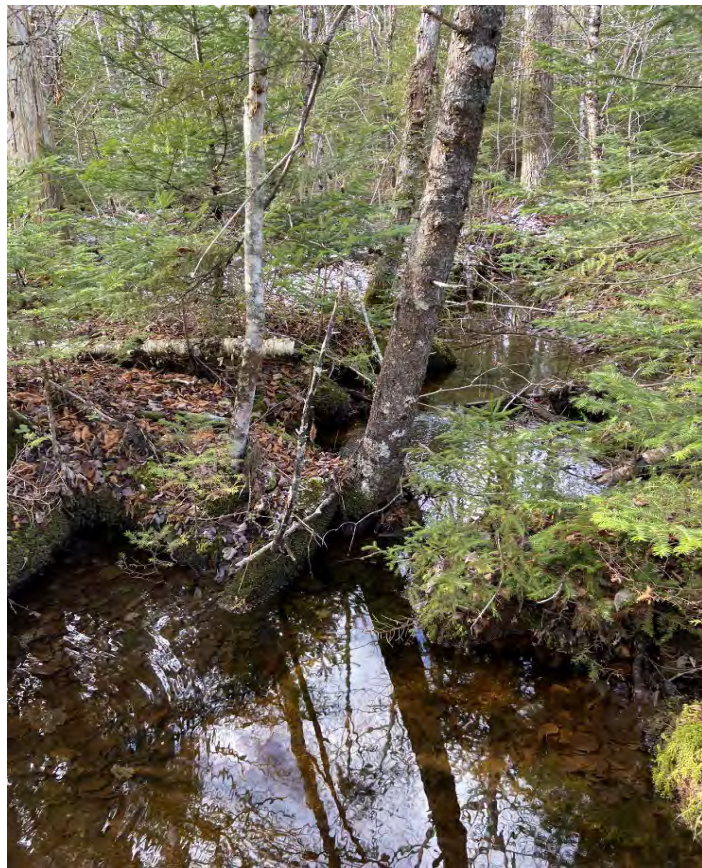
**Photo 3: Upstream example of undercut bank**

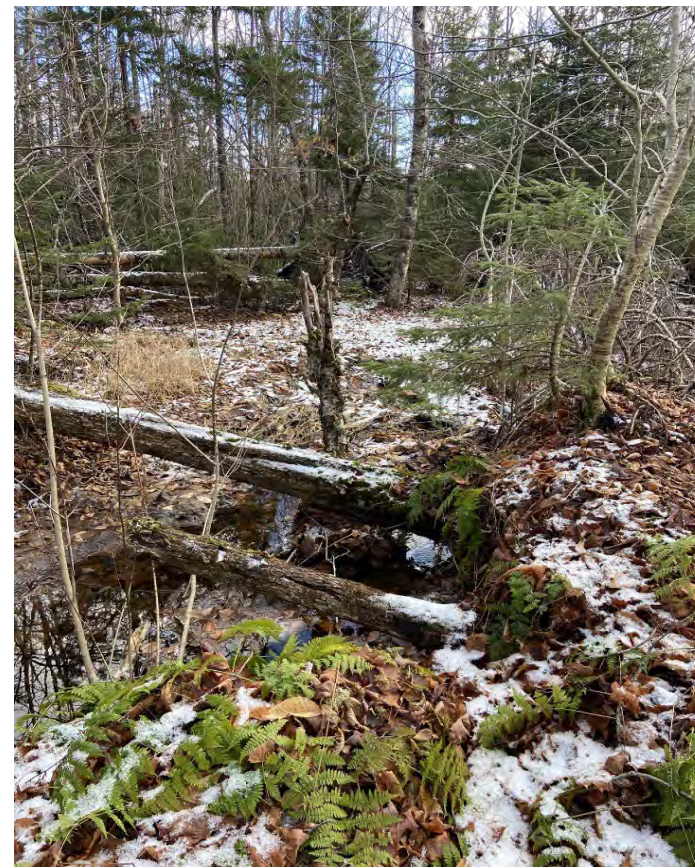
**Photo 4: Upstream underground section**

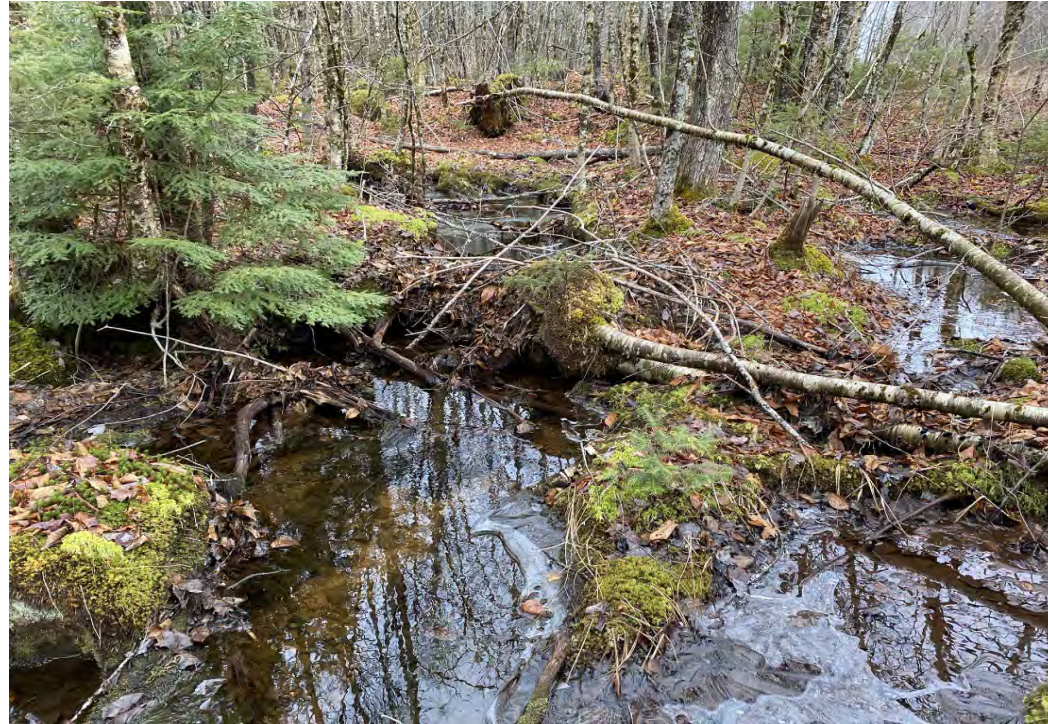
**Photo 1: Upstream at Crossing Location**

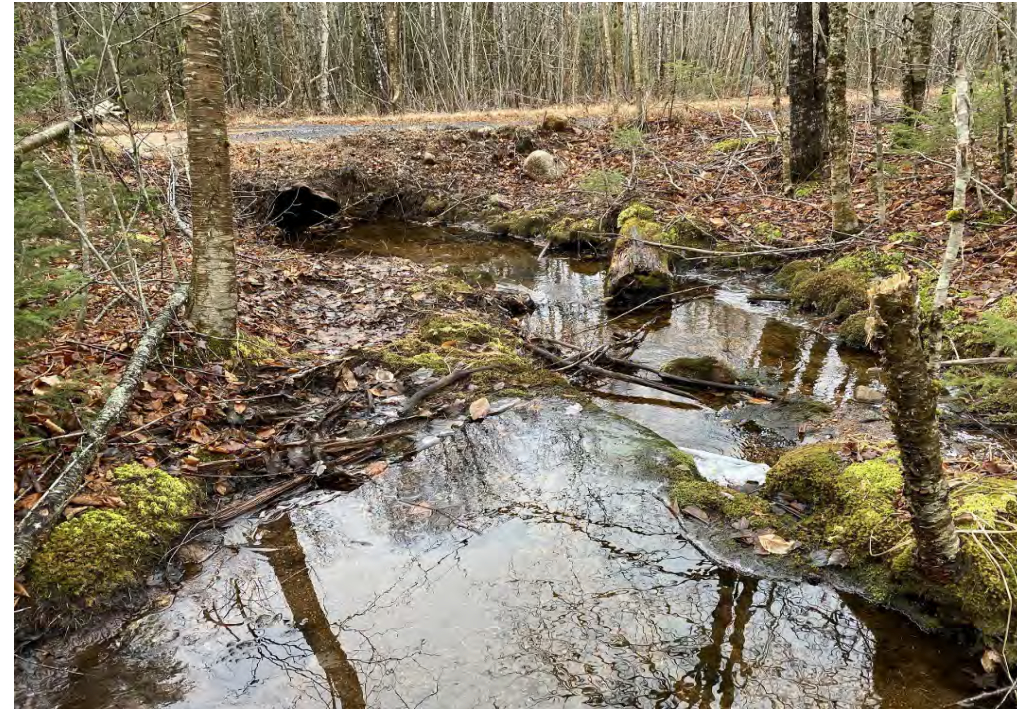
**Photo 2: Downstream at Crossing Location**

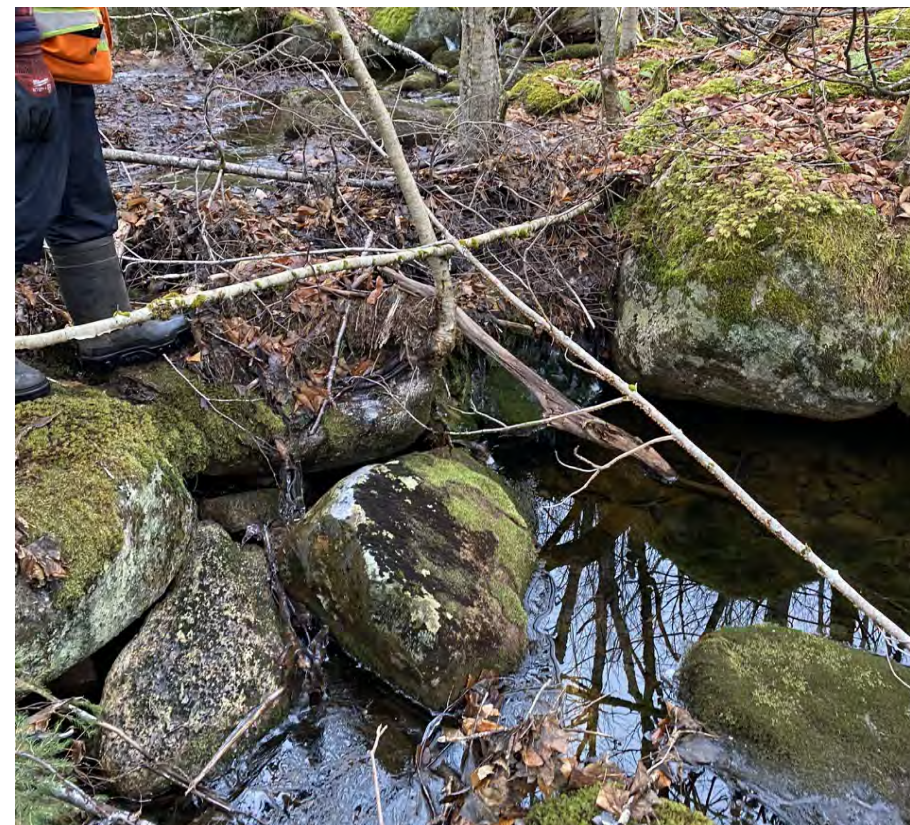
**Photo 4: Potential Fish Barrier**

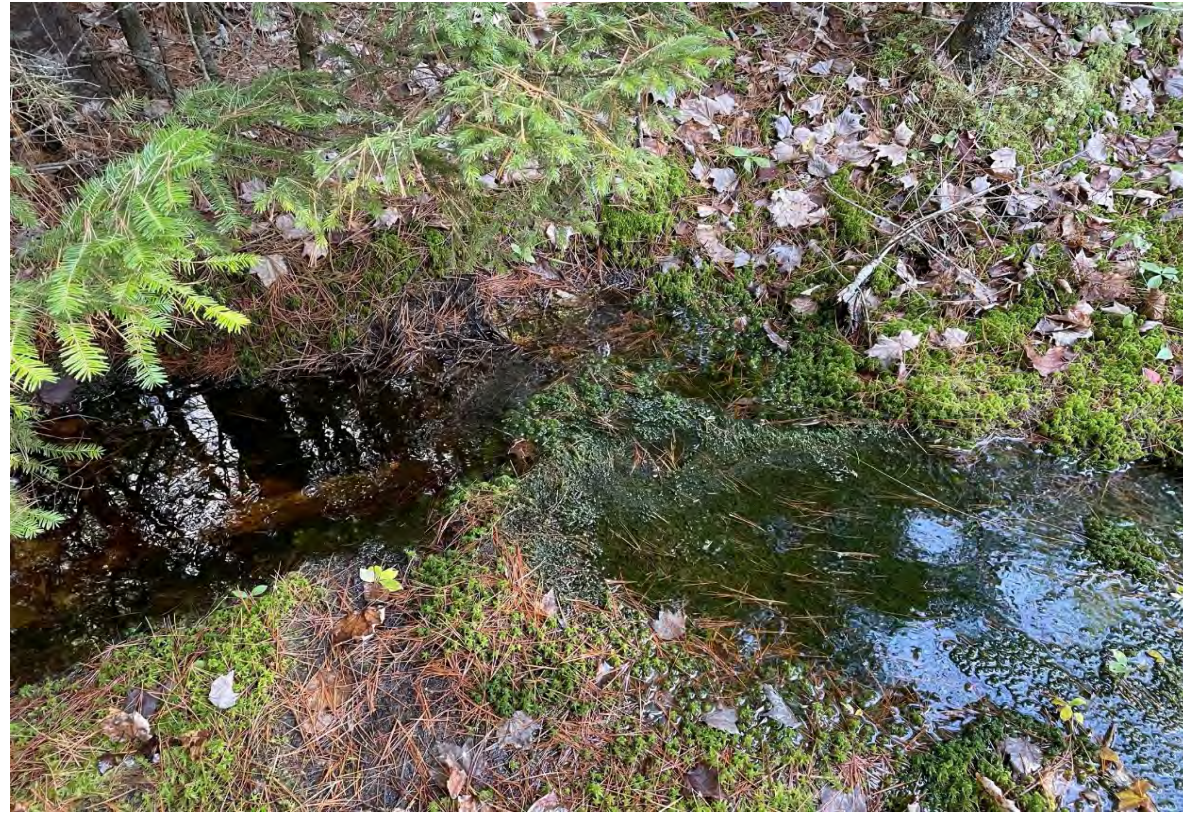
**Photo 1: Upstream at crossing location**

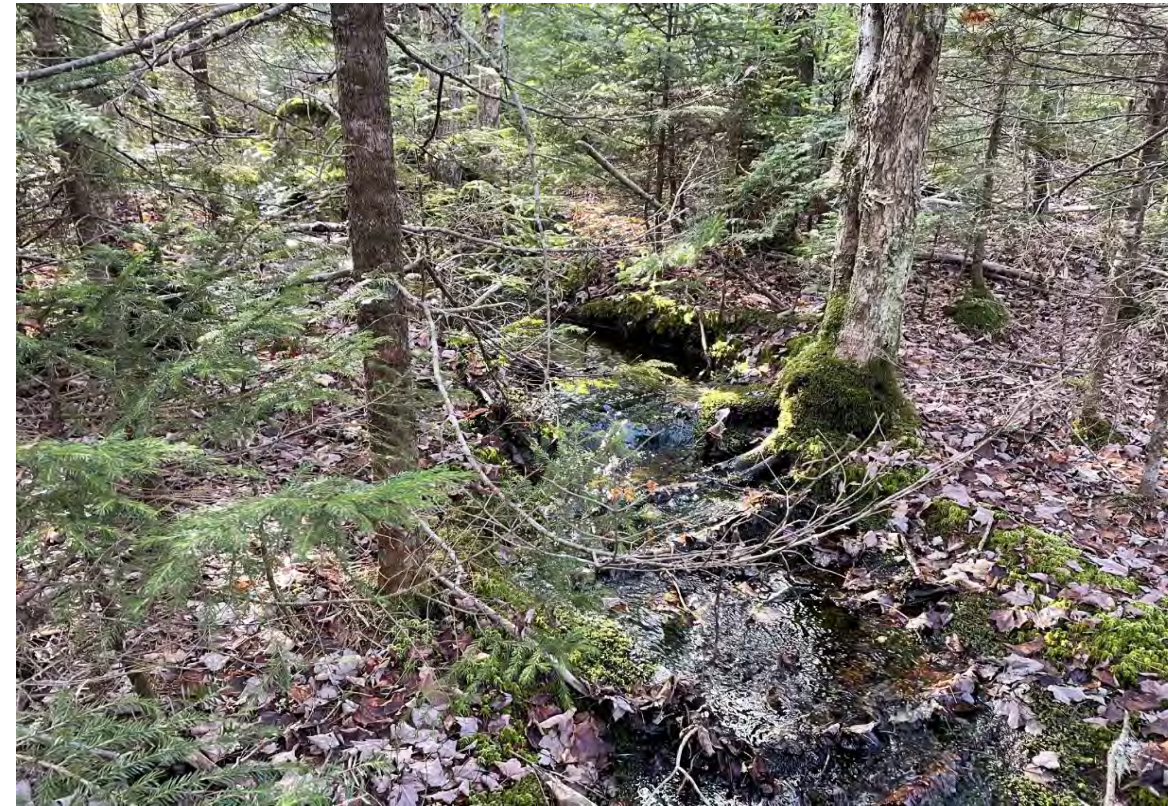
**Photo 2: Downstream at crossing location**

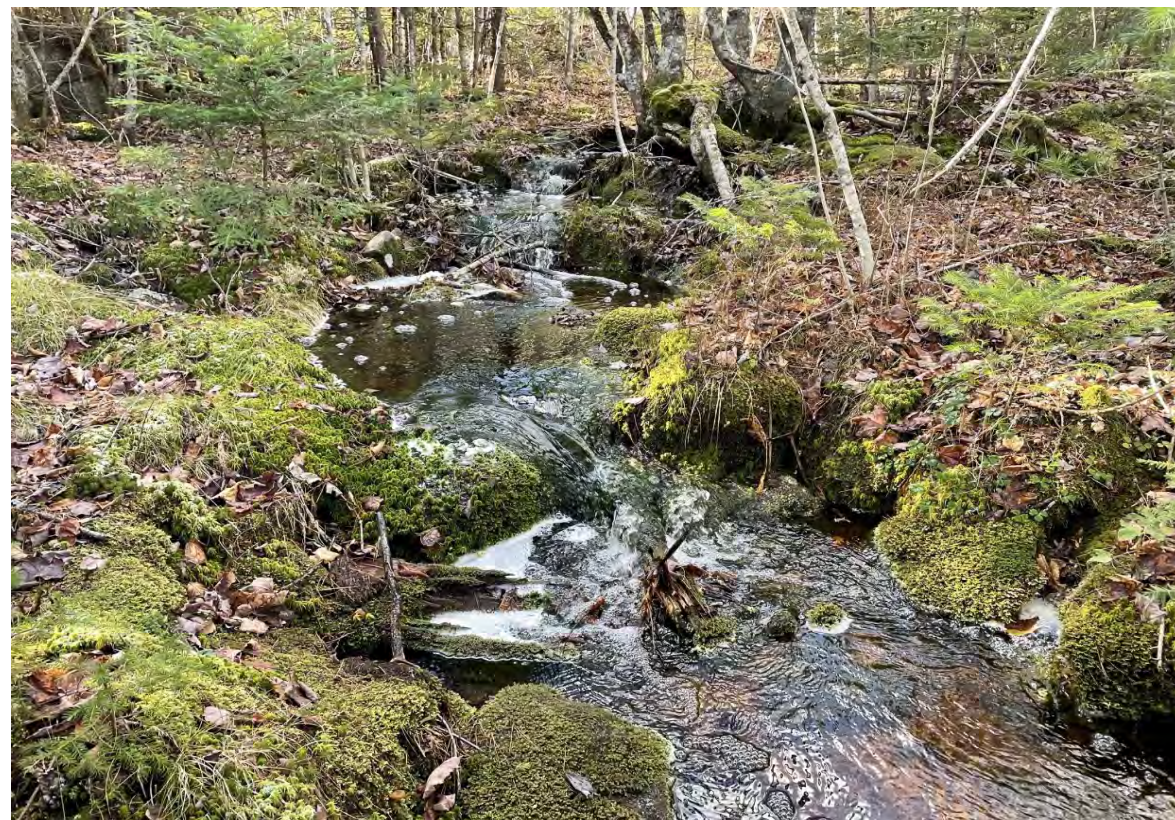
**Photo 3: Small cascade feature upstream**

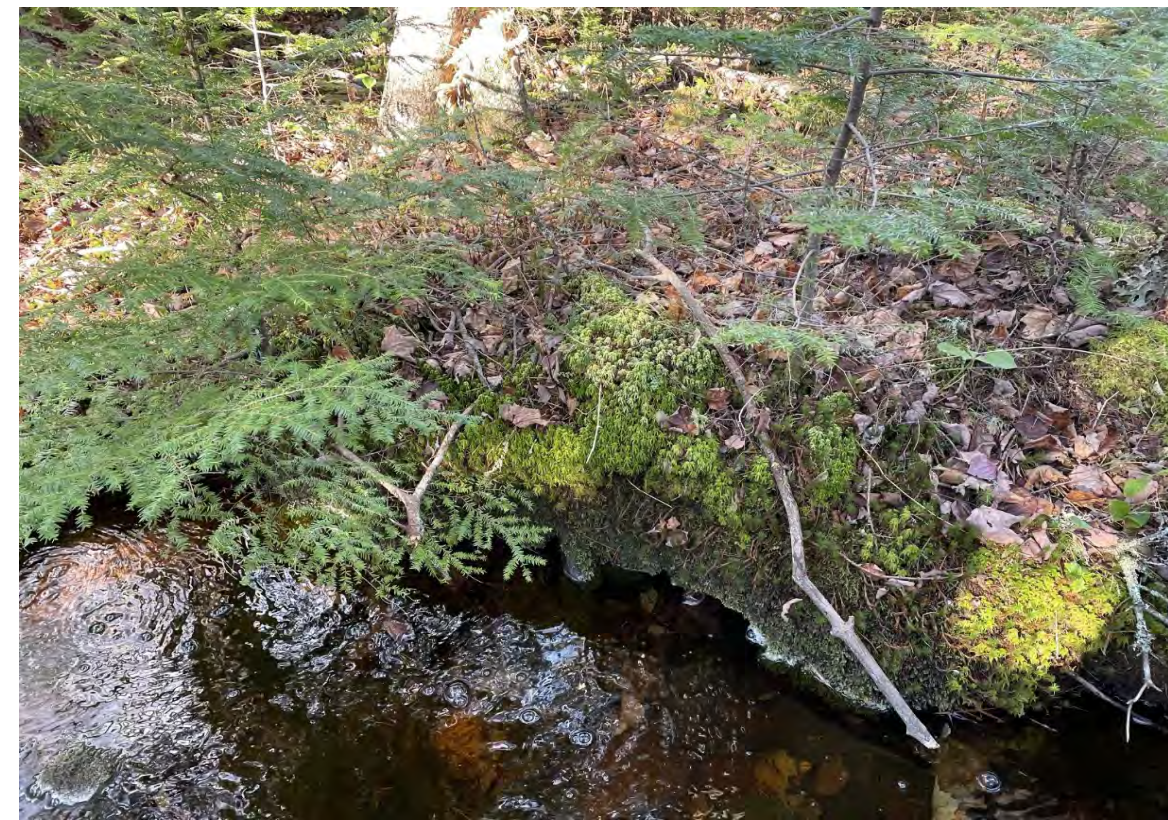
**Photo 4: Example of undercut bank, potential cover for fish**

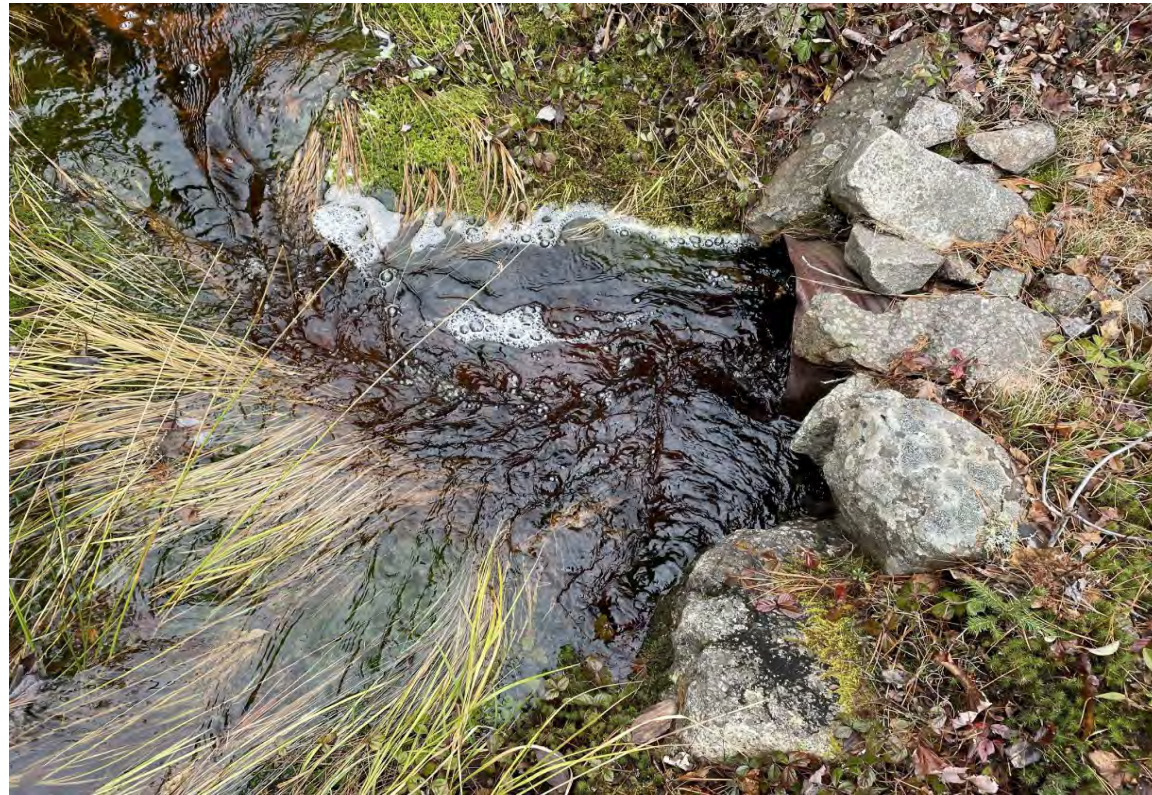
**Photo 1: Upstream at Crossing Location with Culvert**

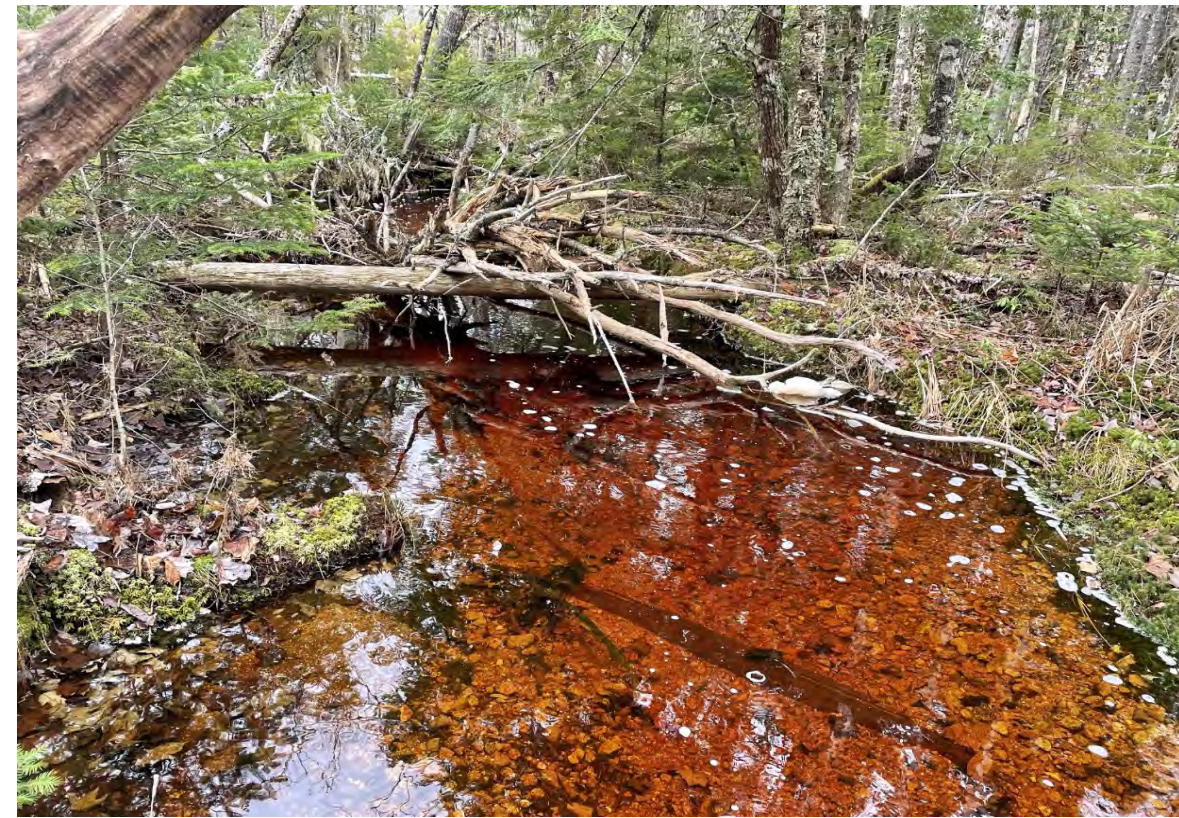
**Photo 2: Downstream, general WC habitat, suitable habitat**

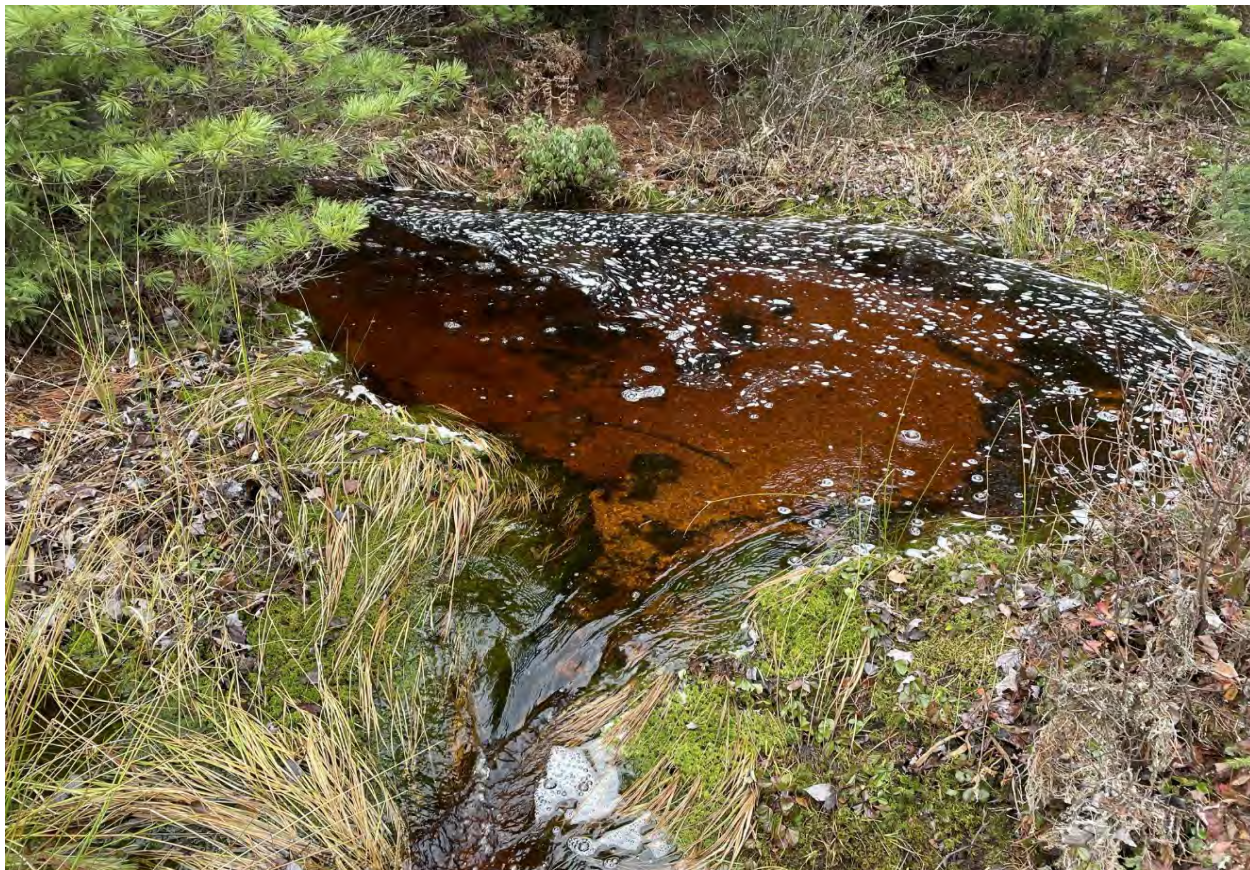
ADDITIONAL NOTES		
Wp.2696 Culvert @ road, Culverts @ road crossing @11:26 (NH Pics) =Twin 60cm dia corrugated steel pipes. East Pipe completely blocked, and road is washed out. Cascade feature DS - potential rearing barrier. pH-low across all assessed WC @ BL

**Photo 3: Blocked culvert near road, causing washout**

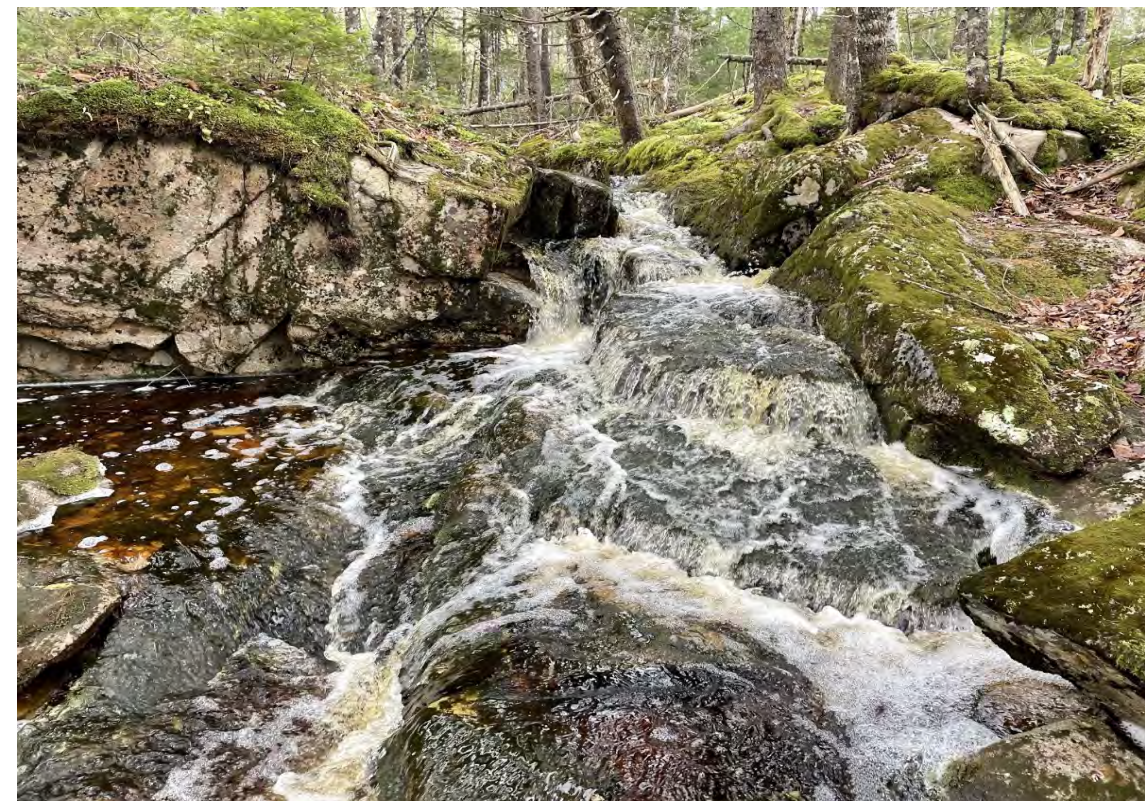
**Photo 4: Cascade feature, possible barrier to fish**

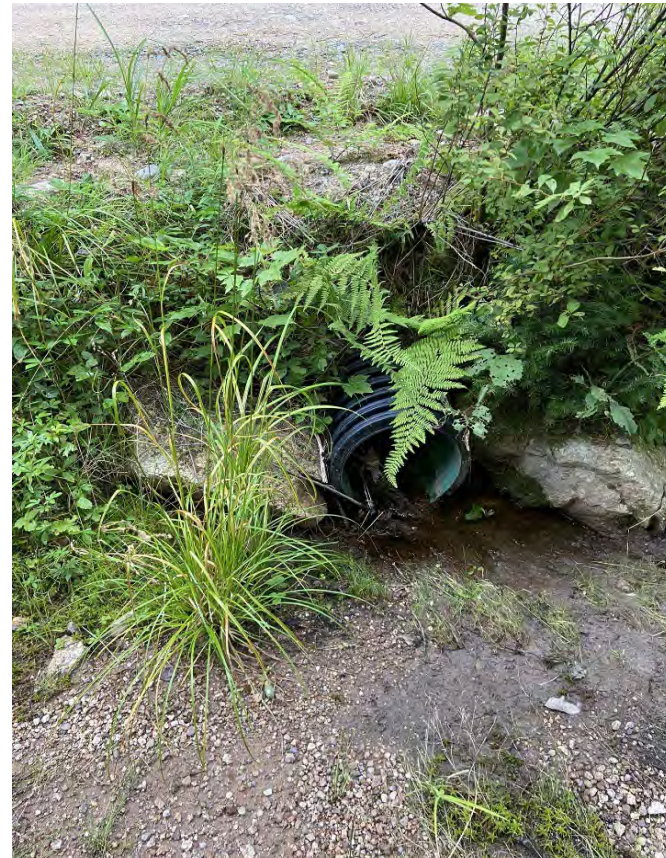
Photo 1: Culvert at the crossing, no water.

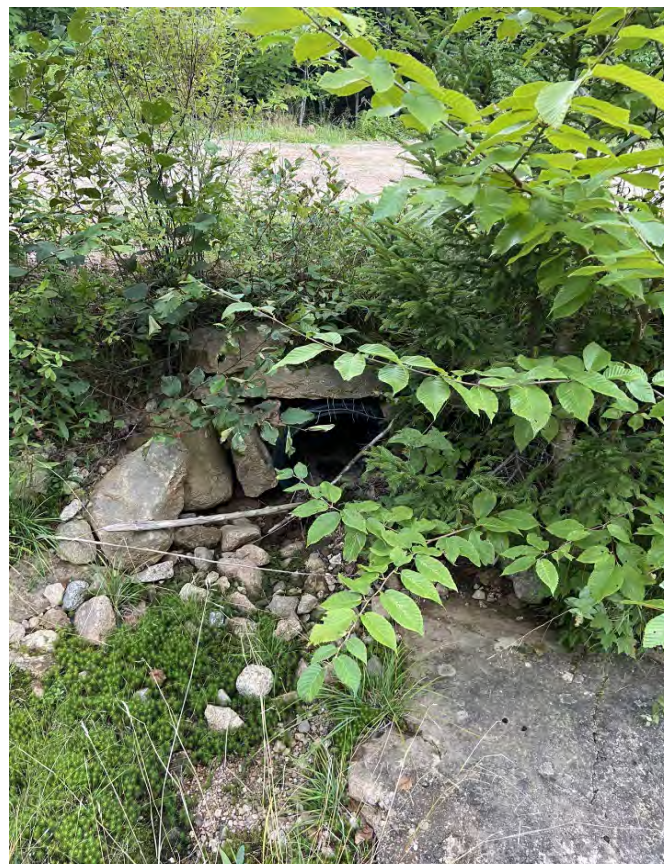
Photo 1: Upstream at crossing, culvert present.
