**HYDROTECHNICAL EVALUATION OF THE
PROPOSED HIGHWAY 104 BYPASS
ANTIGONISH, NOVA SCOTIA**

PROJECT NO. 02029

**Hydro-Com Technologies Limited
445 Urquhart Crescent
Fredericton, NB E3B 8K4
Tel:(506) 455-2888
Fax:(506) 455-0193**

October 04, 2002

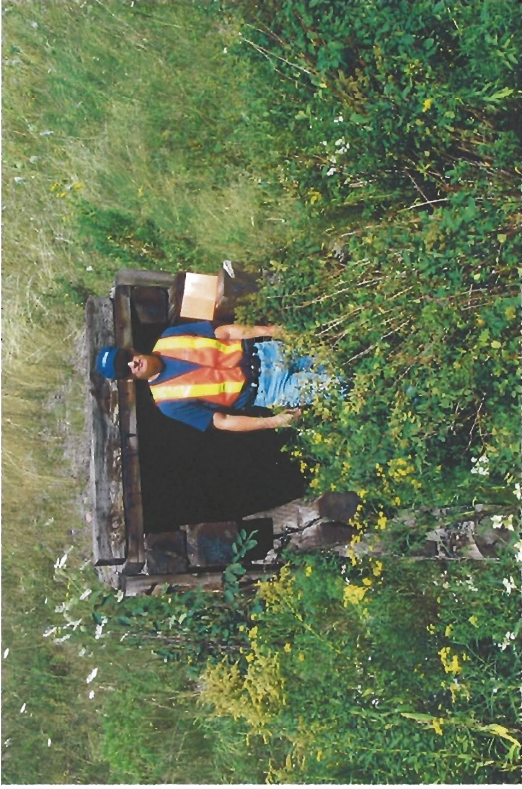
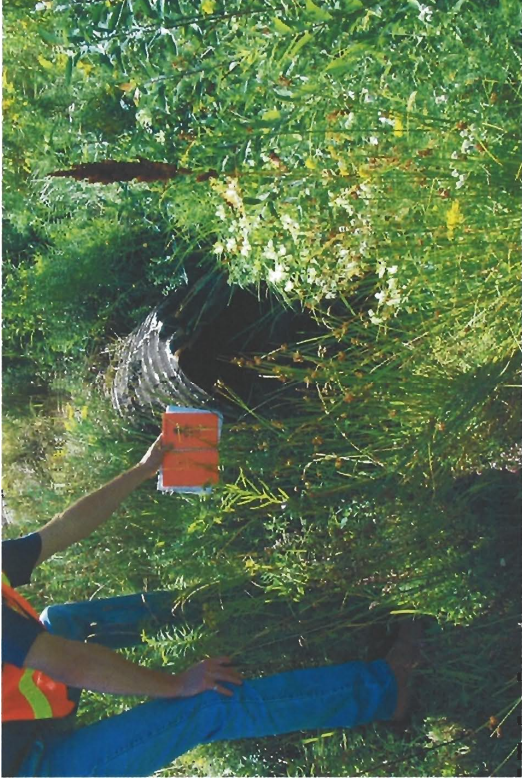
- The structure is comprised of a rectangular timber cribwork culvert (approximately 1.8 m H by 1.5 m W) which is in good condition.
- No flow was observed in the culvert at the time of the inspection.
- The channel bottom upstream was comprised of rocks and gravel.
- The channel bottom downstream was comprised of dark soil and organics (indicating low flood flows).
- No high water marks or ice scarring were observed at the site.
- Main channel is poorly defined (indicating flows are likely intermittent).
- Channel upstream and downstream is vegetated with grasses (indicating low flood flows).
- Terrain is relatively flat without a well defined floodplain (indicating flood flows with small magnitudes).
- It appears that this culvert is for local drainage and may receive surface flows from the existing highway 104 roadway.

Photograph 1 – Un-named 0+100
Existing timber culvert upstream side

Photograph 2 – Un-named 0+100
Local drainage culvert to upstream side

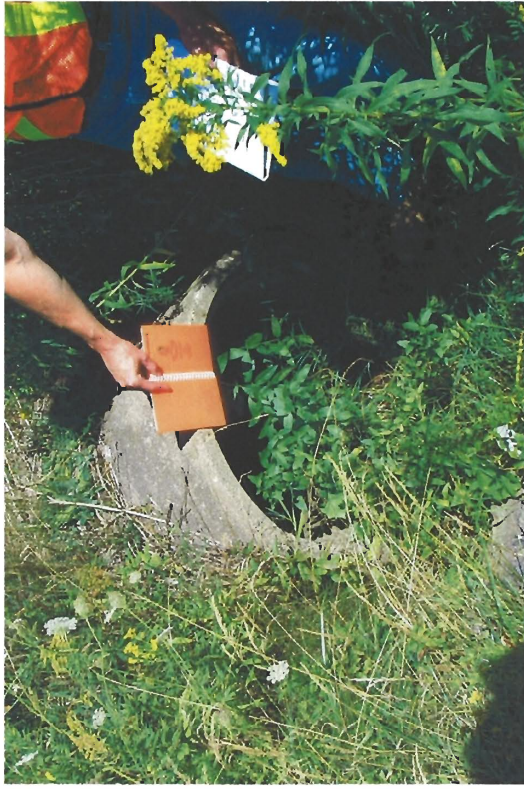
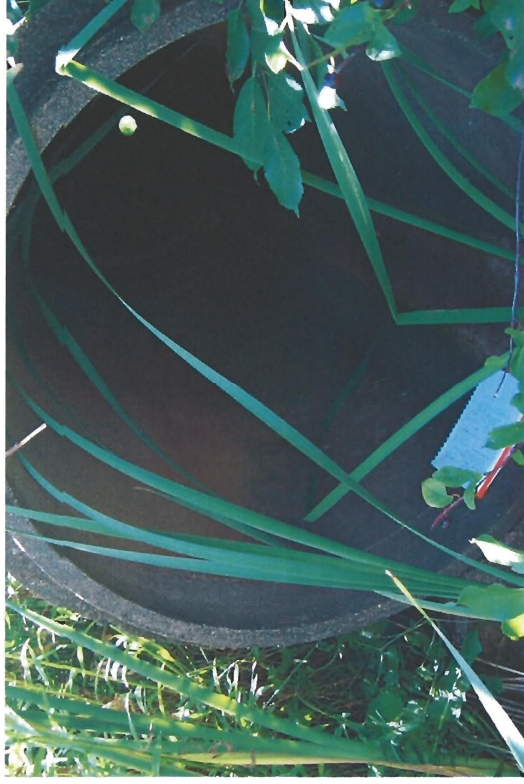
- The structure is comprised of a concrete culvert (0.75 m diameter) which is in good shape, however, the last section of pipe downstream is separated and undercut.
- No flow was observed in the culvert at the time of the inspection.
- The channel bottom upstream was comprised of dark soil and organics (indicating low flood flows).
- The downstream end of the culvert is located approximately 0.60 m (2') above the channel bottom.
- No high water marks or ice scarring were observed at the site.
- Main channel is poorly defined (indicating flows are likely intermittent).
- Channel is vegetated with grasses.
- It appears that this culvert is for local drainage and may receive surface flows from the existing highway 104 roadway.
- Evidence of high flows in pipe (staining), therefore system may be “flashy”.

Photograph 3 – Un-named 0+275
Existing concrete culvert upstream side

Photograph 4 – Un-named 0+275
Existing concrete culvert downstream side

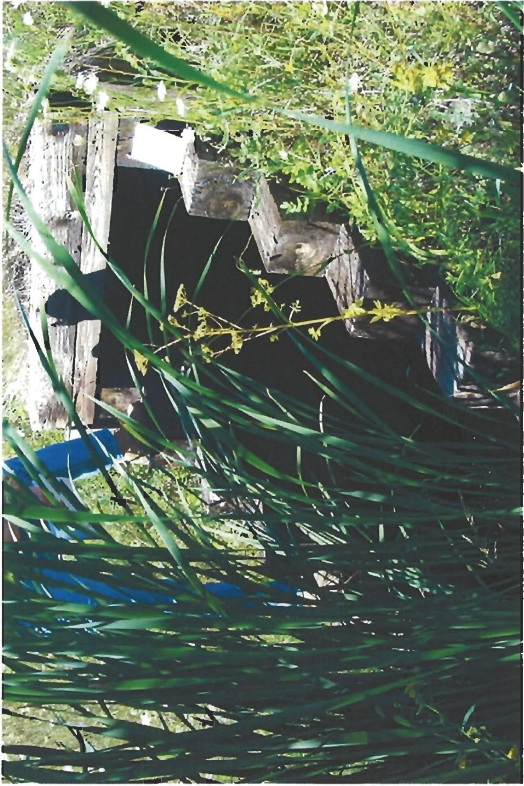
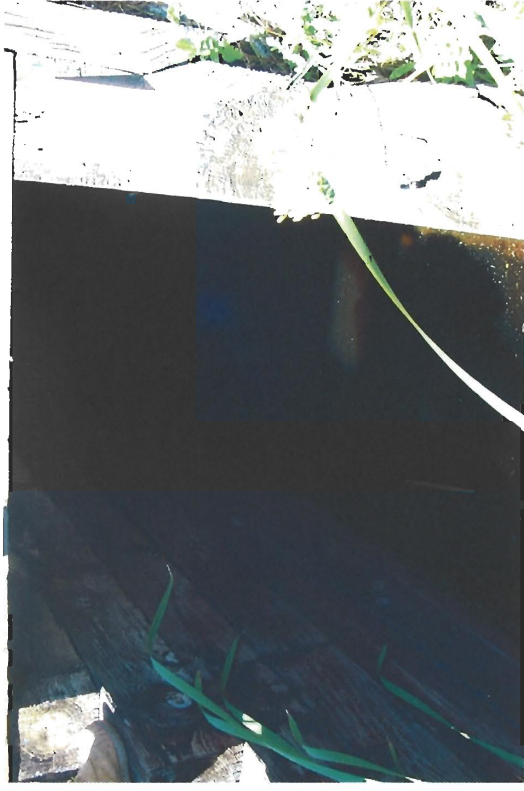
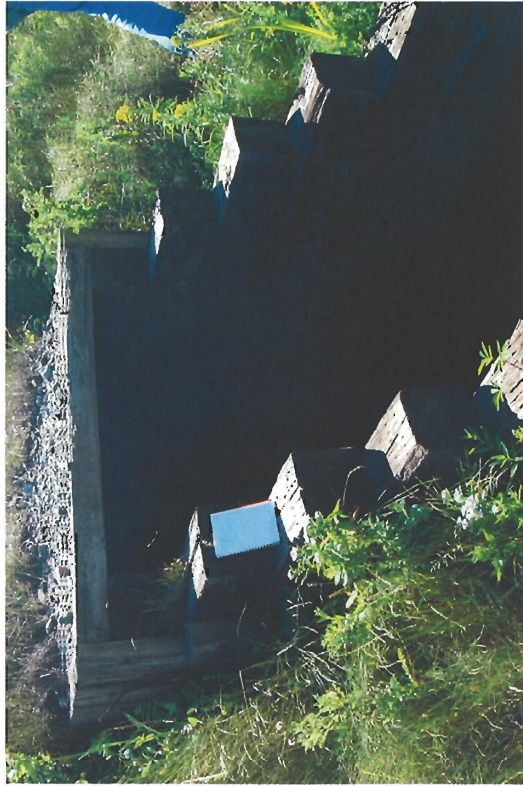
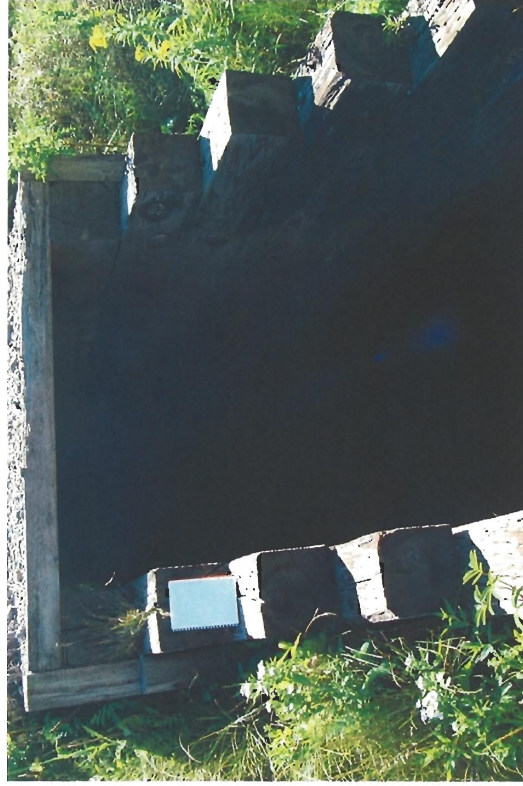
- The watercourse is an existing wetland habitat located adjacent to the existing highway 104 with a culvert under the roadway located at approximately 0+750.
- The existing structure is comprised of a timber cribwork culvert (1.5 m H by 1.2 m W) in fair condition (slight sagging of roof in the middle of the culvert).
- No flow was observed in the culvert at the time of the inspection.
- No high water marks or ice scarring were observed at the site.
- Upstream wetland habitat is significant size.
- Channel is highly vegetated upstream and downstream (indicating flood flows with small magnitudes).
- Terrain is relatively flat upstream and downstream.
- Standing water depth at time of inspection was between 0.10 to 0.30 m.

Photograph 5 – Un-named 0+600 to 0+850
Existing timber culvert upstream side at 0+750

Photograph 6 – Un-named 0+600 to 0+850
Existing timber culvert upstream side at 0+750

Photograph 7 – Un-named 0+600 to 0+850
Existing timber culvert downstream side at 0+750

Photograph 8 – Un-named 0+600 to 0+850
Existing timber culvert downstream side at 0+750

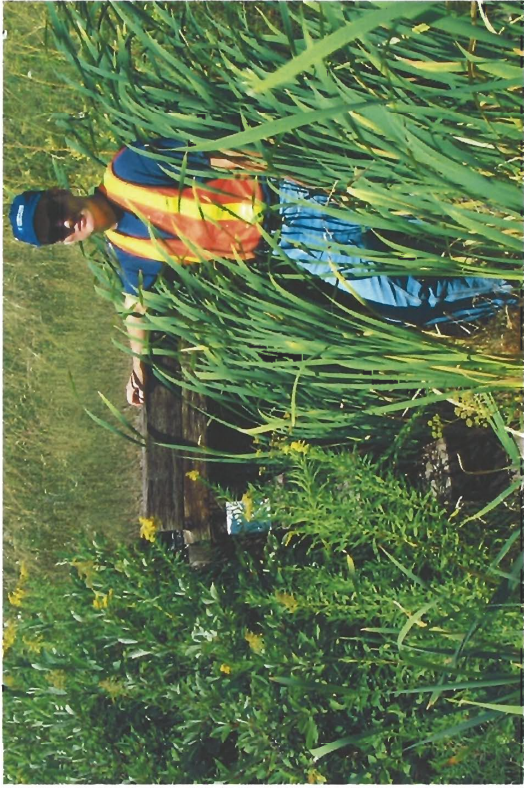
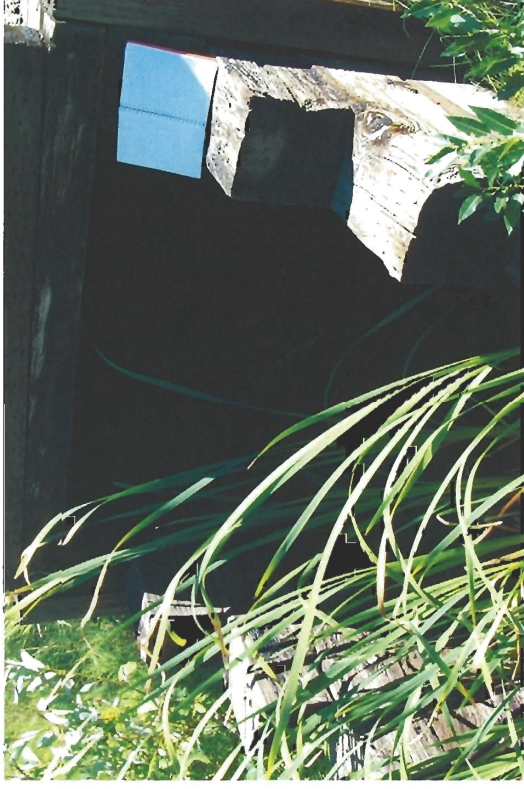
- The existing structure is comprised of a square timber cribwork culvert (1.2 m by 1.2 m) in good condition.
- No flow was observed in the culvert at the time of the inspection.
- No high water marks were observed at the site.
- Channel upstream is vegetated with grasses (indicating flood flows with small magnitudes).
- It appears that this culvert is for local drainage and may receive surface flows from the existing highway 104 roadway.

Photograph 9 – Un-named 1+400
Existing timber culvert downstream side

Photograph 10 – Un-named 1+400
Existing timber culvert upstream side

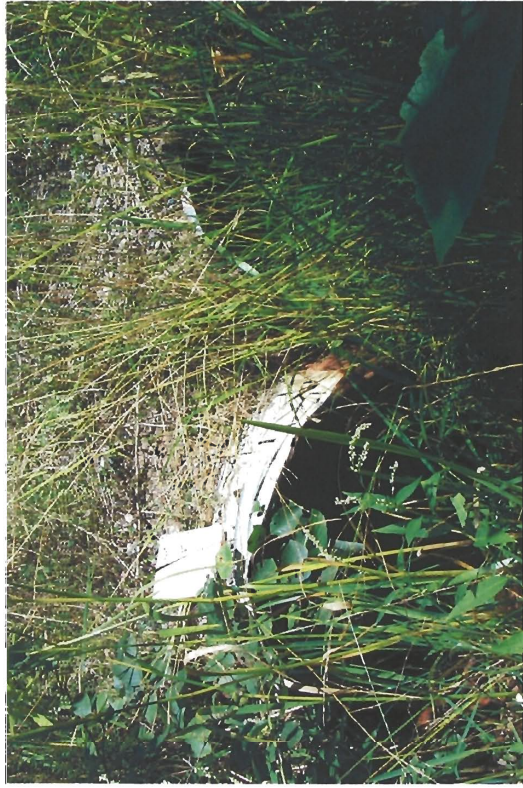
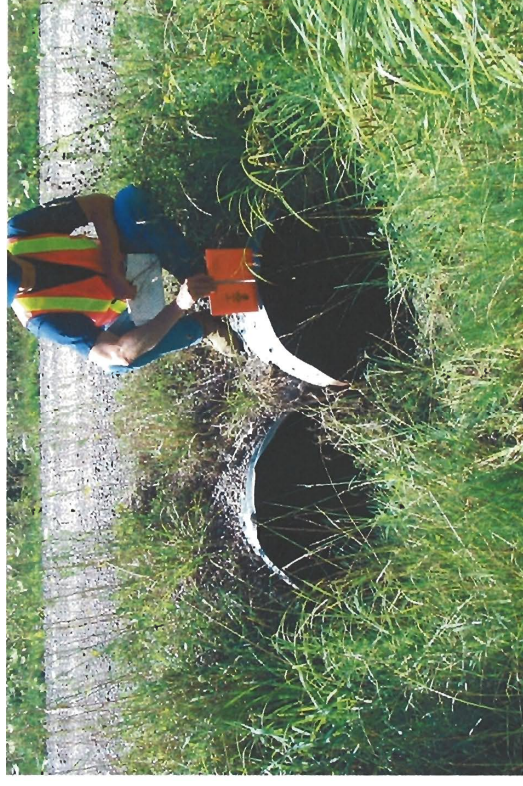
- The existing structure is comprised of two (2) offset corrugated steel culverts (0.750 m diameter) in fair condition.
- No flow was observed in the culverts at the time of the inspection.
- No ice scarring was observed at the site.
- Channel upstream and downstream is vegetated with grasses (indicating flood flows with small magnitudes).
- Terrain is relatively flat without a well defined floodplain (indicating flood flows with small magnitudes).
- High water mark indicated by rust line located at half depth of upper culvert.
- The lower culvert was approximately half full of silt and sand.

Photograph 11 – Un-named 2+075
Existing culverts upstream side

Photograph 12 – Un-named 2+075
Existing culverts downstream side

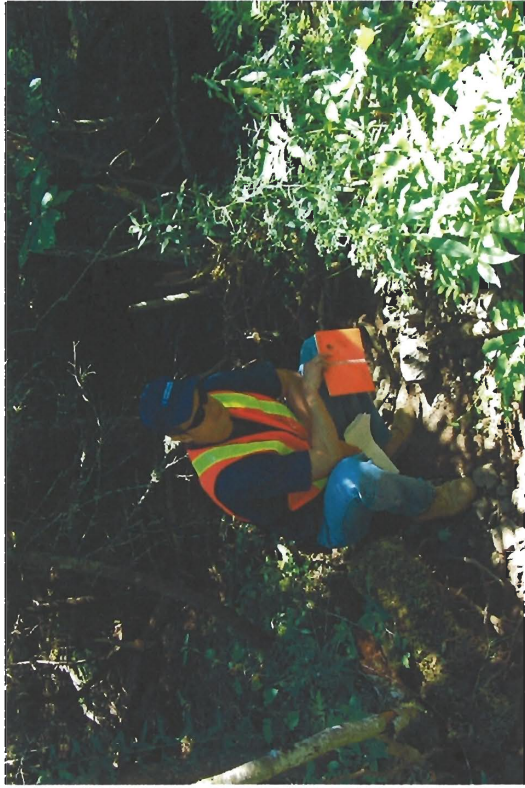
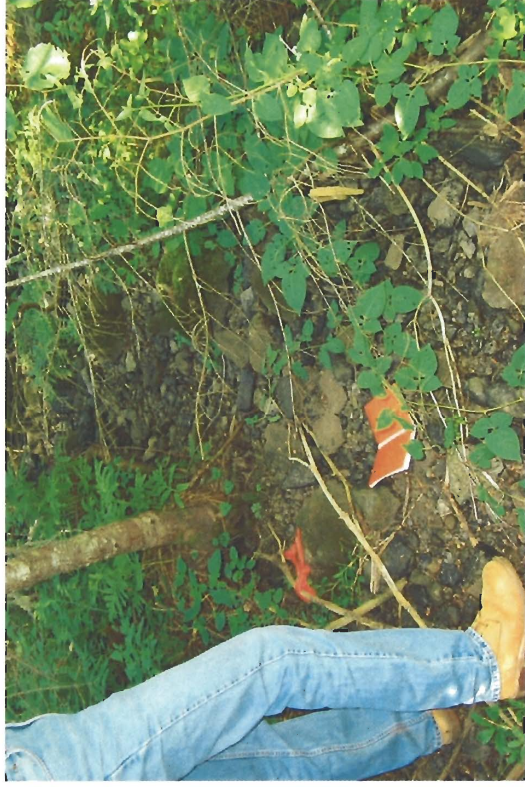
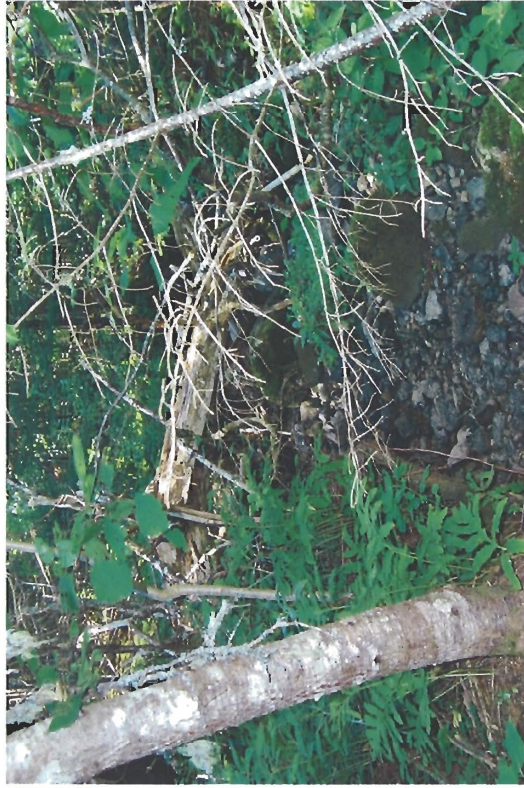
- Terrain is relatively flat without a well defined floodplain.
- No flow at the time of inspection.
- Channel width approximately 1.5 to 2.0 m.
- Stable rock size, d_{50} , approximately 0.10 m.
- Positive chainage bank at proposed crossing location is fairly steep.
- Negative chainage bank at proposed crossing location is shallow.
- No evidence of erosion in the floodplain.
- No evidence of ice scour or scarring, however, believe this location to have ice jamming potential.

Photograph 13 – Un-named 2+420
Channel at crossing location looking downstream

Photograph 14 – Un-named 2+420
Channel at crossing location stable rock

Photograph 15 – Un-named 2+420
Channel at crossing location looking upstream

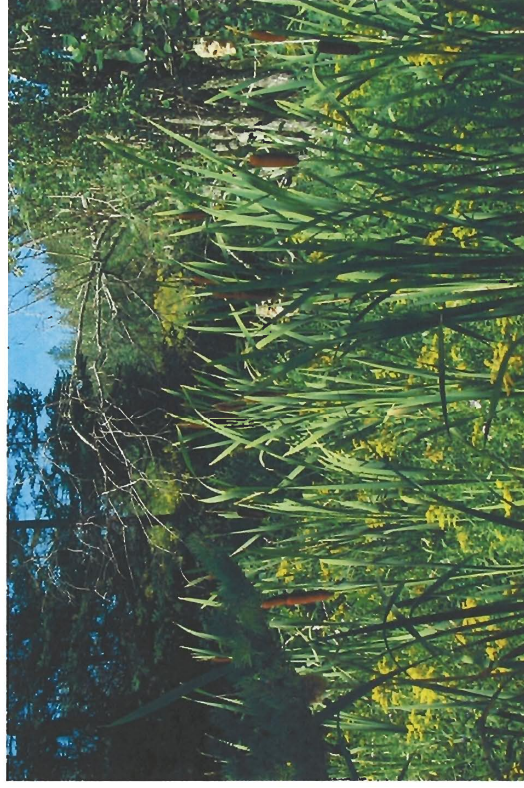
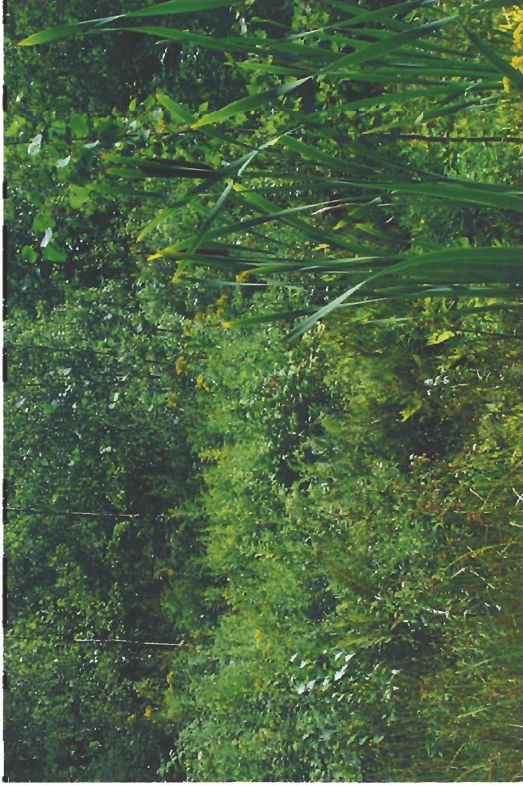
- Main channel is not defined (indicating flows are likely intermittent).
- Channel is vegetated with grasses (indicating flood flows with small magnitudes).
- Terrain is relatively flat without a well defined floodplain (indicating flood flows with small magnitudes).
- No flow at the time of inspection.
- No hydrotechnical concern.

Photograph 16 – Un-named 2+500
At crossing location looking upstream

Photograph 17 – Un-named 2+500
At crossing location looking downstream

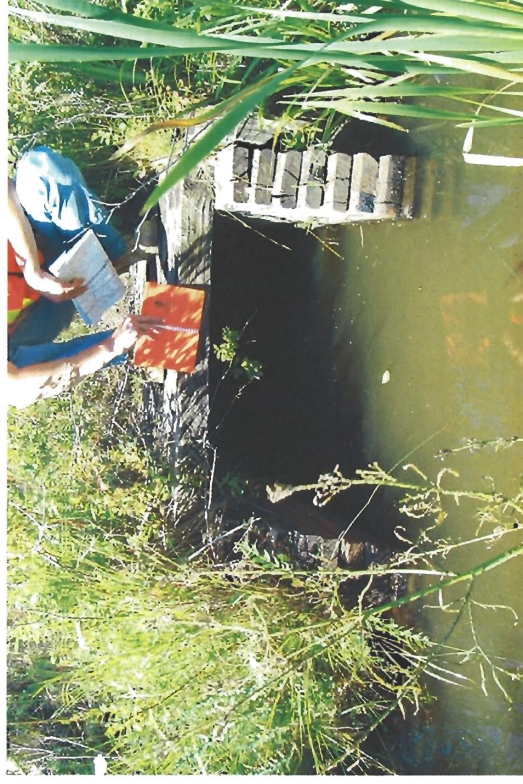
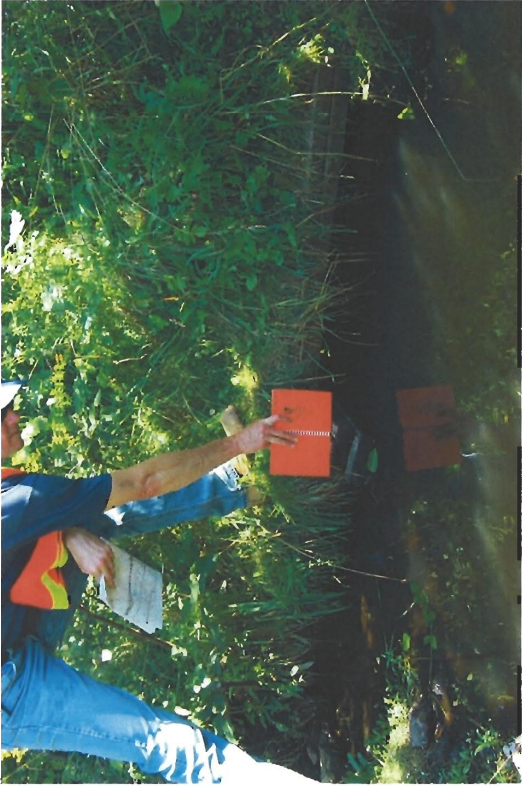
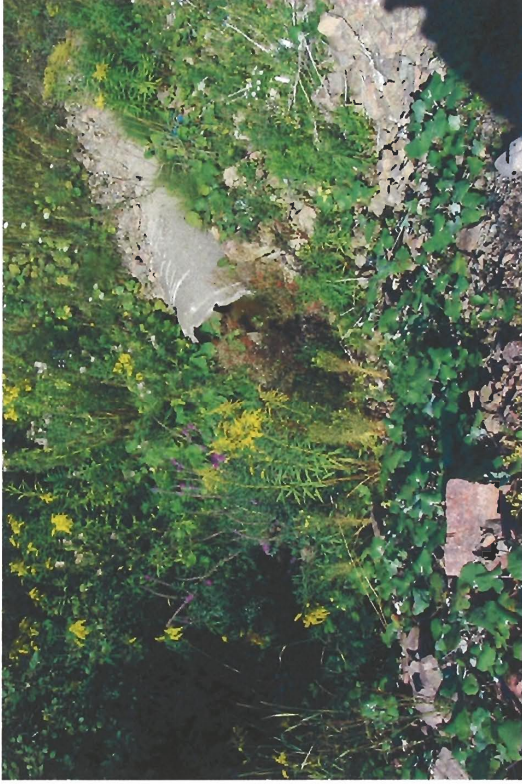
- The structure is comprised of a square timber cribwork culvert (0.9 m by 0.9 m) in a fair to poor condition (slight lean to structure).

- Little or no flow was observed in the culvert at the time of the inspection.
- Standing water in the culvert approximately 0.45 m at upstream end.
- The downstream end of the culvert was mostly submerged at the time of the inspection.
- A storm culvert was located draining to the downstream side of this structure.

Photograph 20 – Existing structure at highway 104
(downstream of un-named 3+910 and 4+150) u/s side

Photograph 21 – Existing structure at highway 104
(downstream of un-named 3+910 and 4+150) d/s side

Photograph 22 – Existing structure at highway 104
(downstream of un-named 3+910 and 4+150) storm culvert

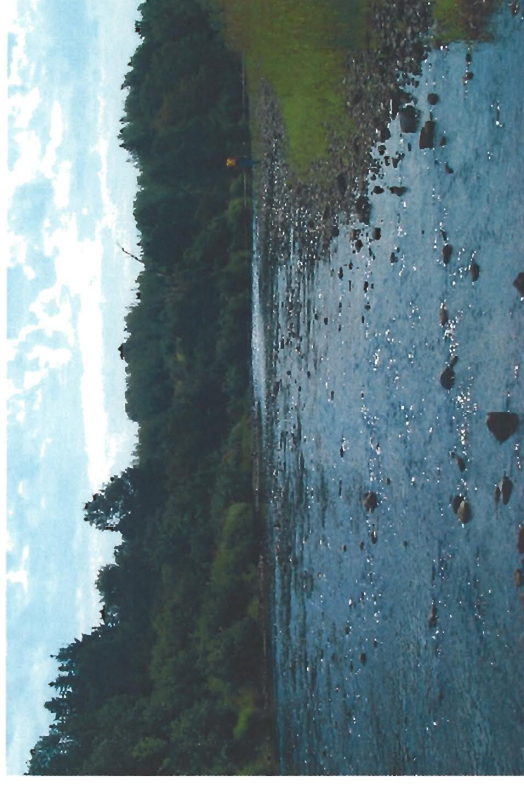
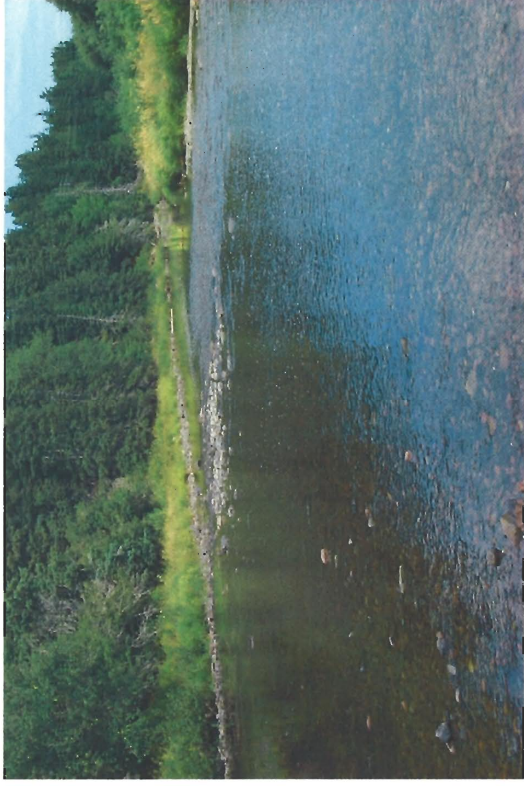
- No evidence of erosion in the floodplain.
- No evidence of ice scour or scarring.
- No high water marks located at proposed crossing location.
- Due to the width of the crossing and the steep bank on the negative chainage side, recommend a bridge structure at this location.

Photograph 28 – West River 5+700
At proposed crossing location looking upstream

Photograph 30 – West River 5+700
At proposed crossing location looking downstream

Due to the wide channel width and the steep negative chainage bank that exists at the West River (5+700) crossing, it is recommended that a free-spanning structure be considered at this location. As the crossing at Un-named 8+150 is a good habitat and steep banks also exist at this location, it is recommended that a spanning structure (arch-span culvert, bridge, etc.) be considered at this location.
