**HADD Compensation Project:  
Restoration of Cantley Creek Fish Habitat**

Submitted April 2005

Atlantic Coastal Action Program-Cape Breton

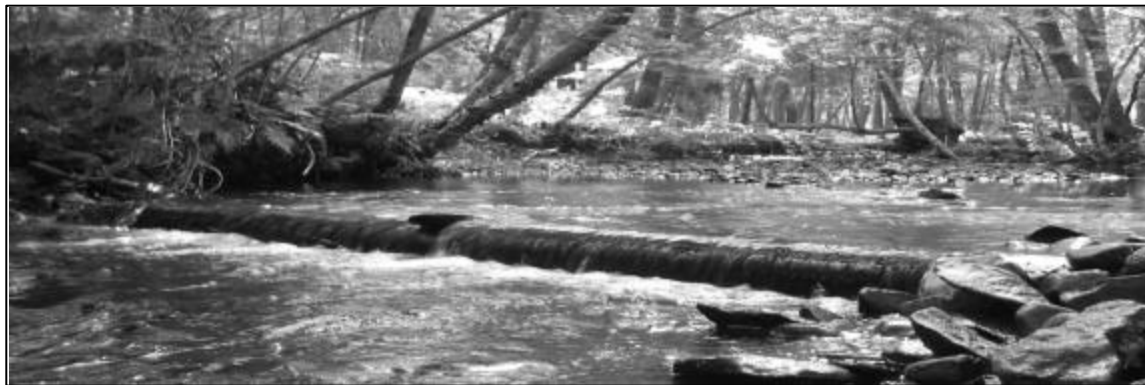
**Figure 2.** Digger Log installed by ACAP-Cape Breton on Cantley Creek August, 2004.

DFO Habitat Specialist, Darren Hiltz provided on-site consultation to determine digger log spacing and ensure that correct installation methods were followed. Placement sites for digger logs along the target 650 meters of Cantley Creek was determined using the “every 6-channel width” rule. Channel width was estimated to be 2 m on the lower section of Cantley making digger log placement every 12 m. On the upper section channel width decreased to 1.33 m making digger log placement every 8 m. A total of 43 logs were installed within the 650 m stream section.

All logs were sized on site to be no more than  $\frac{1}{4}$  of the bank height and averaged 15 cm to 20 cm in diameter. They were placed across the stream on a 30° angle from the perpendicular. The upstream end of the log was set lower than the downstream end to direct flow on the pool-side of the brook and allow for improved fish passage. Logs were drilled every 2 m to tightly accommodate a 1.5 cm rebar 1.25 m long, which was driven through the log. Fifteen centimeters of the rod was bent over to keep the log from floating up. Both ends of the log were well rocked with stream cobble and small boulder to non-vegetated channel height (Figure 3). A cobble/small boulder ramp was constructed on the upstream side of the log on a 2:1 slope using material from the downstream side where the pool was to form. This ramp protects the log from ice and debris damage and forms a base upon which gravels, sorted by the flow over the next couple of years, collects to form spawning and fry nursery areas.

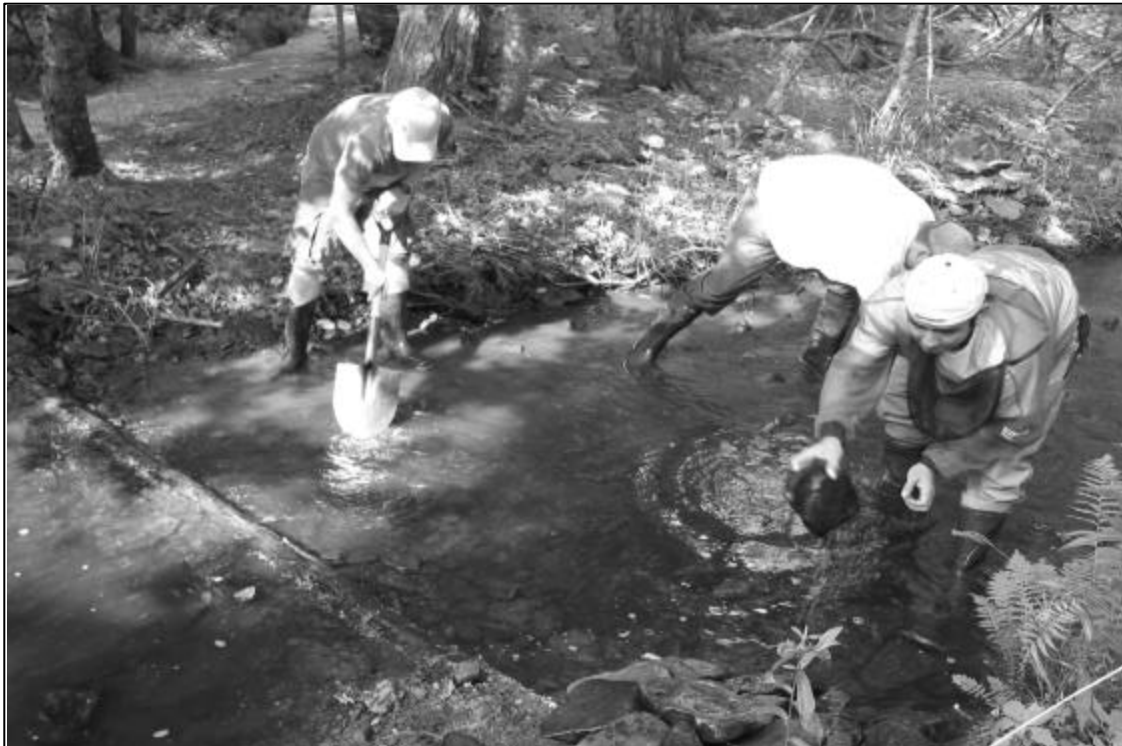
**Figure 3.** Installation of digger log by ACAP staff, August 2004.

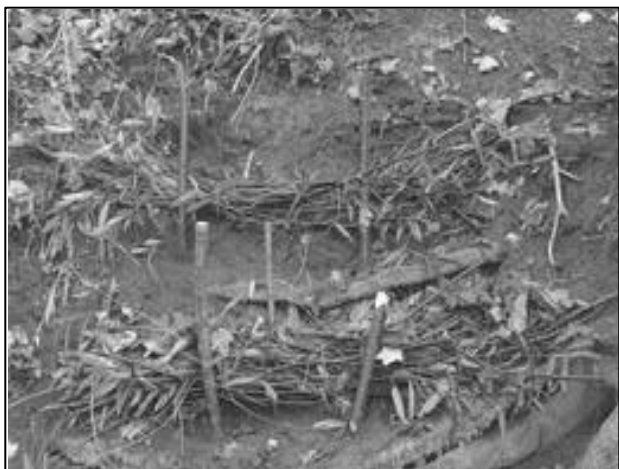
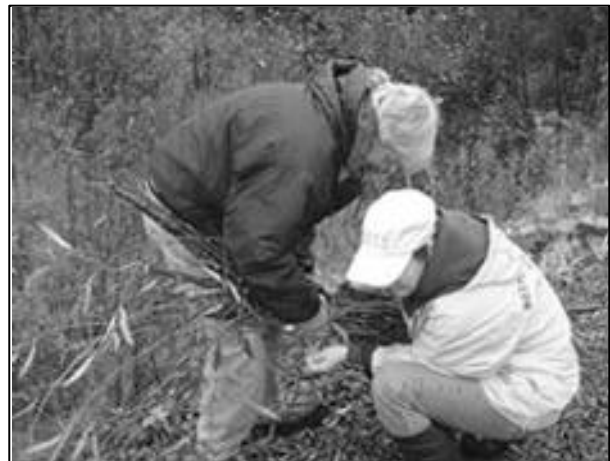
In October, 2004 18 waddles were placed on the steep eroding embankment occurring in the upper stream portion of the restoration area (Figure 1.). The waddles consisted of a bundle of branches belonging to a 'self-rooting' tree (Figure 4). These waddles act as barriers, stopping soil and water from running down into the stream during rainfall. The waddle structure also helps maintain bank stability by mechanically preventing erosion. Eventually, as the stakes and branches root, these structures will also provide biological protection against erosion with trees acting as buffers for runoff and their roots holding soil in place.

**Figure 4.** (A) Waddles placed on steep eroding bank of Cantley Creek; (B) binding of waddles. October 2004.

For this project willows were used to construct waddles. Branches were cut from trees near the site two days prior to planting (without damaging trees). Lengths of branches varied with the majority of branches being between 3 and 5 feet long. Bundles included a range of branch sizes that were tightly bound with twine at both ends (Figure 4). The branches chosen had growing tips pointing in both directions and were approximately 3 inches in diameter. In placing waddles, two live support stakes were pounded into the ground (Figure 4). Stakes were buried  $\frac{3}{4}$  of the way into the ground with 2-4 nodes appearing above the soil. The waddle was placed behind the two stakes up the side of the slope. Another stake was pounded through the bundle into the soil to ensure the waddle stays in place until spring when the branches and stakes begin to root. Soil and detritus were used to cover the top of the waddle to help prevent the branches from drying out.

The 18 waddles installed along the steep embankment were monitored into midwinter, 2004 to ensure that the waddle structures were stable and strong enough to support the winter snowfall. No waddles were found to have broken or dislodged. In the spring, 2005 the structures will once again be observed to determine the rate at which the structures were able to root and grow. ACAP will continue to monitor the waddle structures periodically throughout the summer of 2005, and over the following years (2006-2007) to observe the growth and beneficial effects provided by these structures.

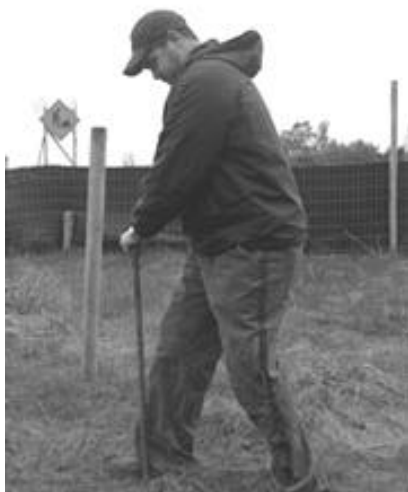
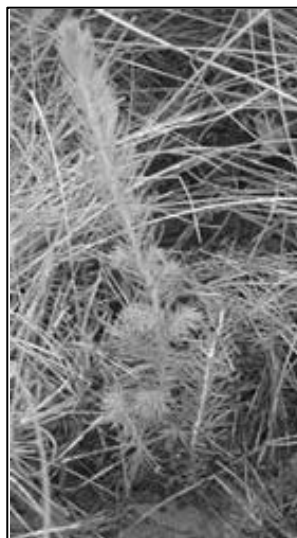
**Figure 5.** (A) Planting Black spruce seedling with dibble along lower section of Cantley Creek (silt fence from highway construction seen in background). (B) Black spruce seedling. October 2004.

The spruce was planted using a dibble or a shovel and their root plugs were so that the top of the plug was either flush or slightly below the surface of the soil (Figure 5). Care was taken not to bury sapling laterals and to ensure that the trees plugs were vertical in the soil.
