- **Nova Scotia Transportation and Infrastructure Renewal**

Hydrogeological Investigation

Kurdistan and Arrow Oily Waste Disposal Sites
Fourchu, St.Peter's-Oban and Janvrin Island

SYD-00020400-A0

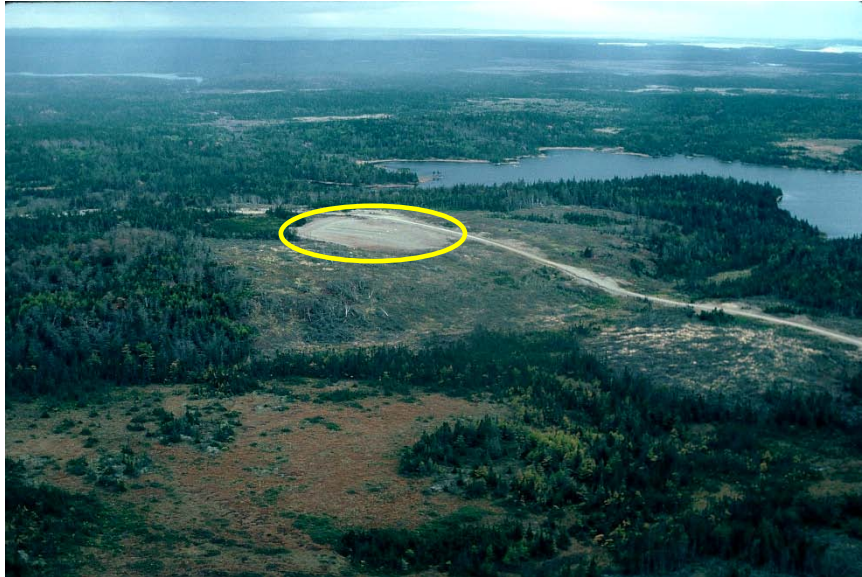
Plate 5-1: Oblique aerial view of the Fourchu site after closure (1979) looking northeast.

Prior to development for disposal, the site was clear cut (Plate 5-1). Since disposal ceased, the site is gradually growing back in with shrubs and spruce (Plates 5-2 and 5-3).

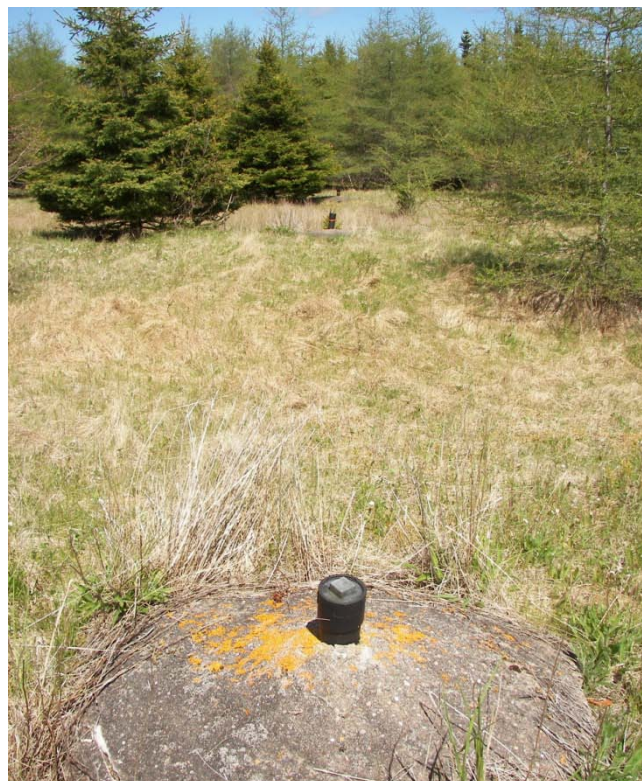
Plate 5-3: Tree growth over the cover caps and around the in-trench monitoring wells for Trenches 2 (foreground) and 3 (center background) on 26 May 2010.

The site was growing over with shrubs and spruce. The growth of latter to heights of 2 to 4 metres on the cover caps was of concern, due to potential damage to the viability of the trench caps and seals (Plate 5-3).

The site is growing over with trees, some of which are positioned on top of the cover caps, possibly degrading the viability of the seal. If not addressed, this could allow for release of contaminants through the quick-flow-system.

2. It is recommended that all trees should be cut over the former operations area. Skidders or other heavy equipment should not be utilized to remove trees, to ensure minimal damage to the cover caps. A care and maintenance schedule should be developed for the site to manually keep forest and understory development to a minimum.

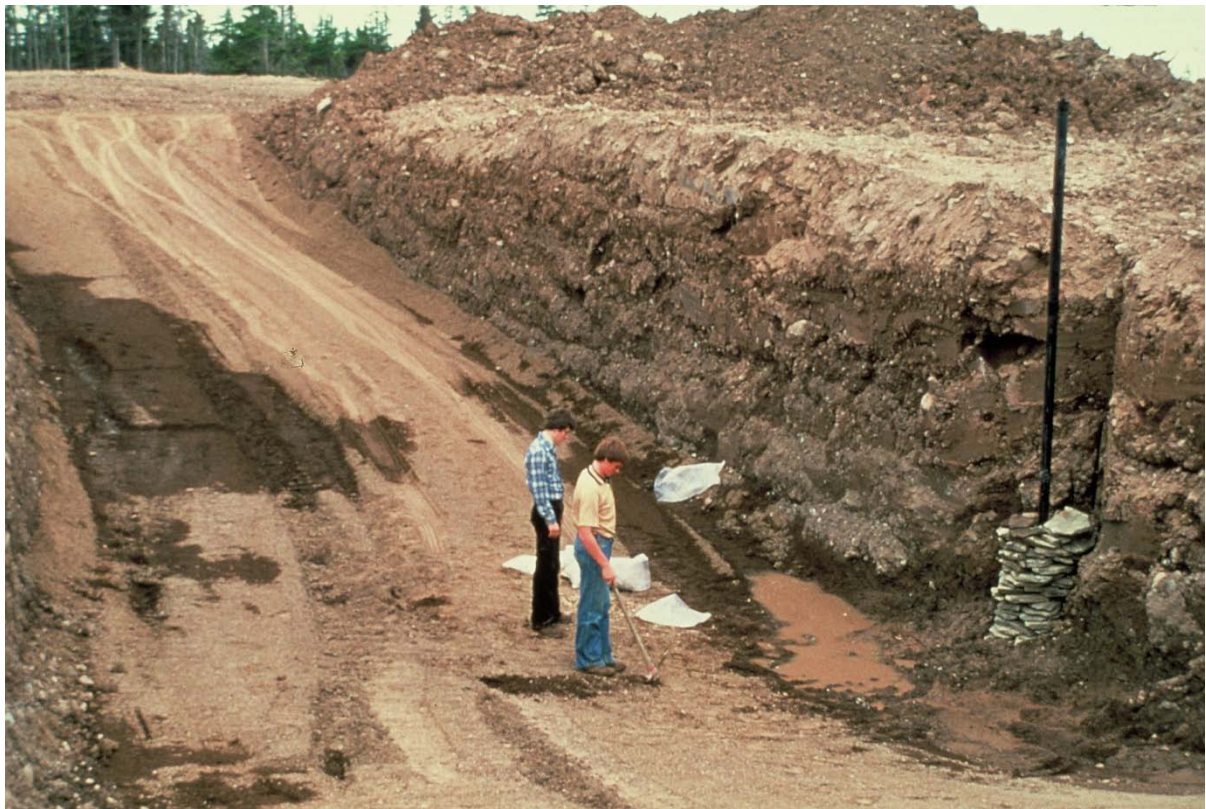
1. The site was operational between May and August 1979.
2. An entombment disposal methodology was utilized in the design. This included selection of sites with thick, low permeability, basal glacial till. Subsurface burial was within four, 3 to 3.5 metre deep trenches (Plate 5-4).

Plate 5-4: Trench 3 ready for disposal with in trench well construction commencing within the east side wall.

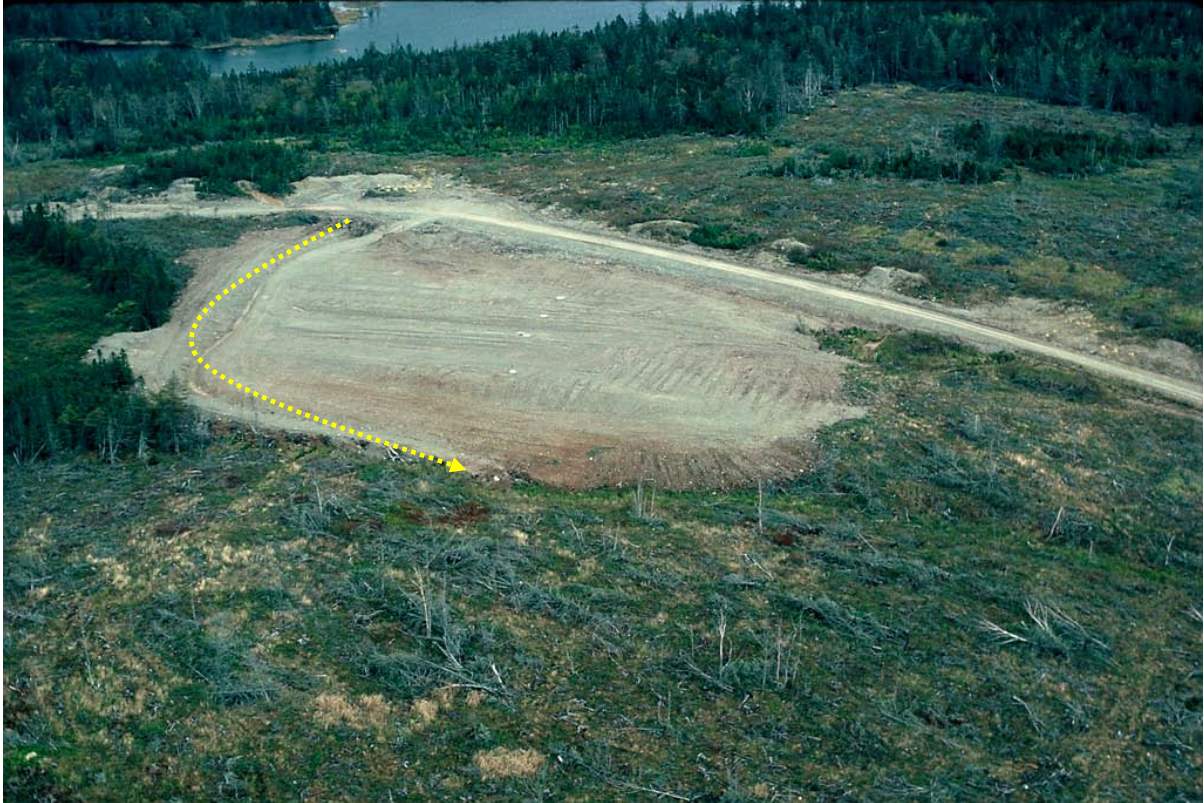
4. A seal of fill (reworked till) was emplaced to bring the trench to grade, but without any permeability specification. The trench was then mounded above grade with the same fill (Plate 5-5) and seeded to both facilitate runoff and minimize erosion.

Plate 5-5: An oblique aerial view of the site after capping looking toward the northeast. Note the French drain and swale diverting shallow groundwaters around the site.

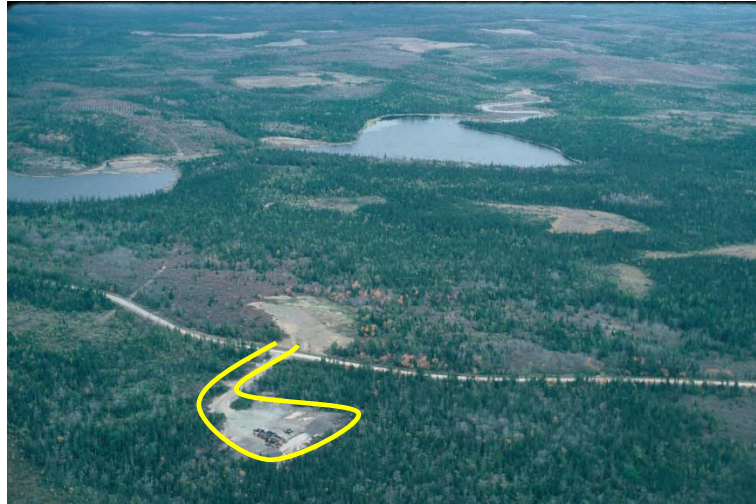
Plate 6-1: Oblique aerial view of the St. Peter's-Oban site after closure (1979) looking toward the northeast.

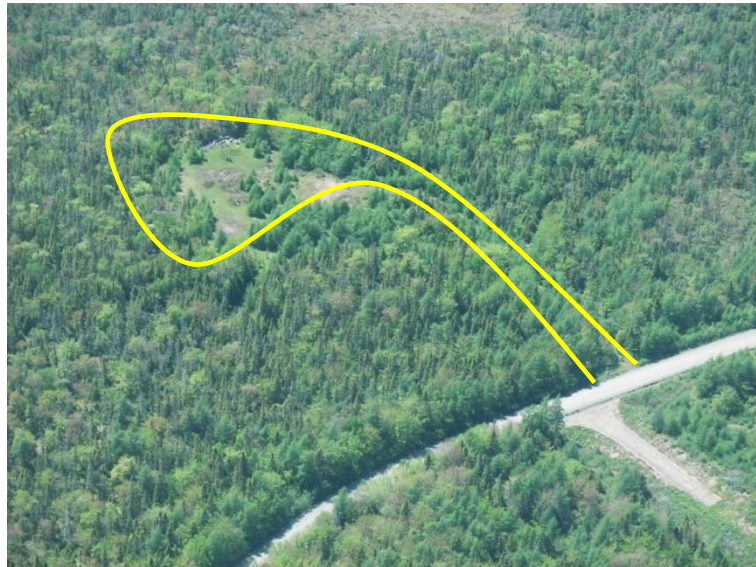
Plate 6-2: Oblique aerial view of the St. Peter's-Oban site during this assignment (2010) looking to the southwest.

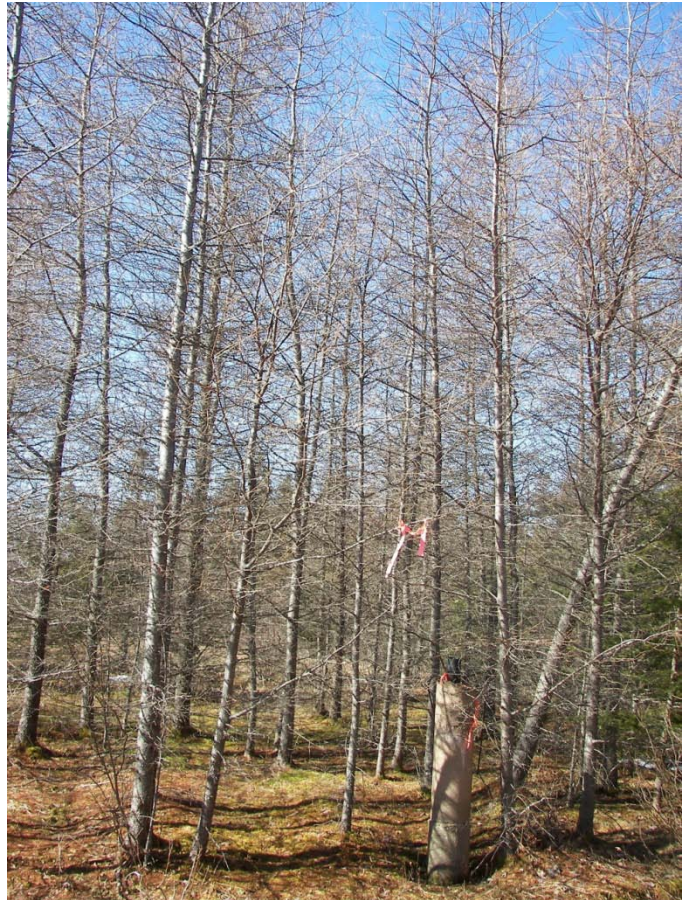
The site was growing over with shrubs and conifers. The growth of latter to heights of over 7 metres on the surface of the trenches (Plate 6-3) was of concern, due to potential damage to the viability of the seal.

Plate 6-3: Tree growth over Trench 1. In-trench monitoring well (center foreground) awaits construction of mounded cover cap.

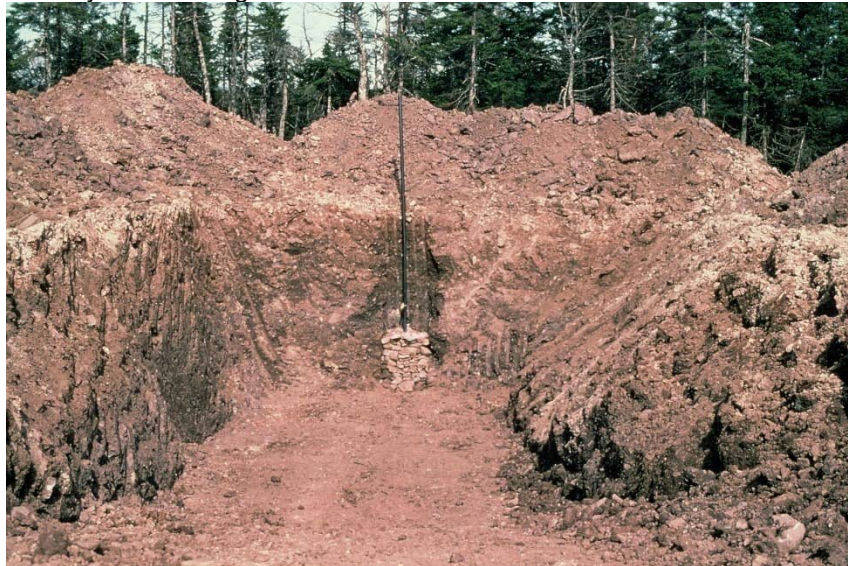
Plate 6-4: Trench 1 ready for waste disposal. Note in-trench monitoring well center background (also present in Plate 6-3).

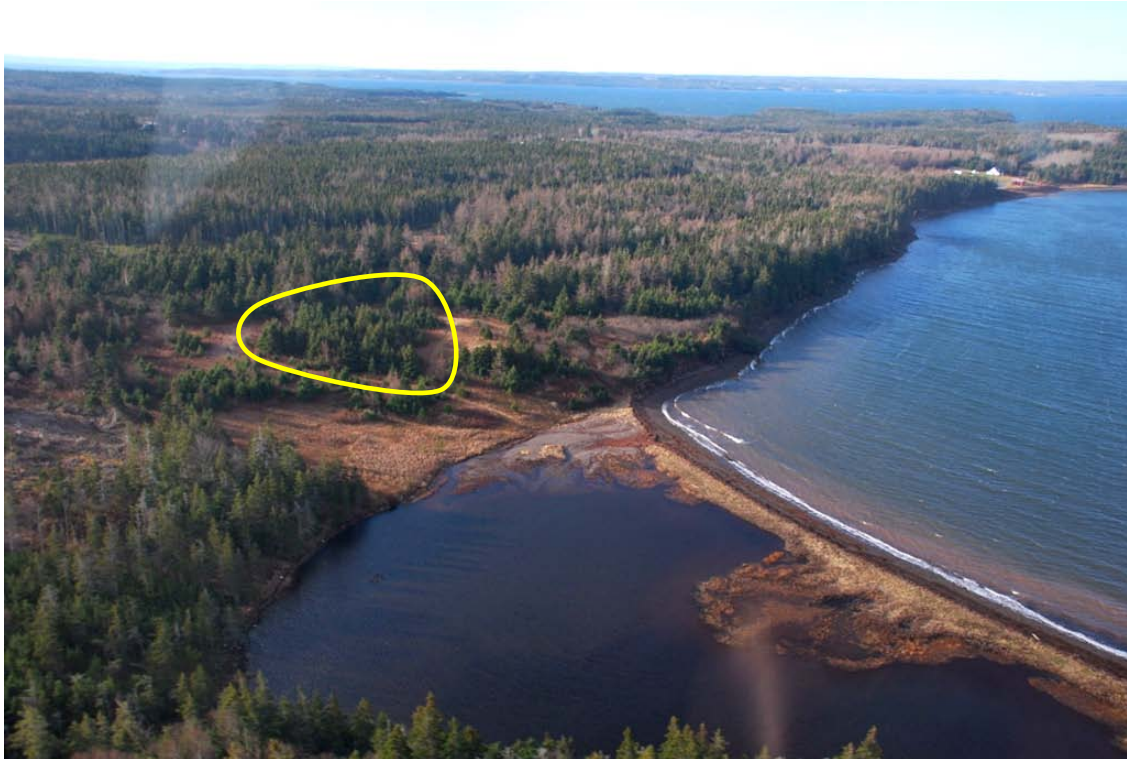
Plate 7-1: Oblique aerial view of the Janvrin Island site looking southeast (2009) – courtesy of NSE.

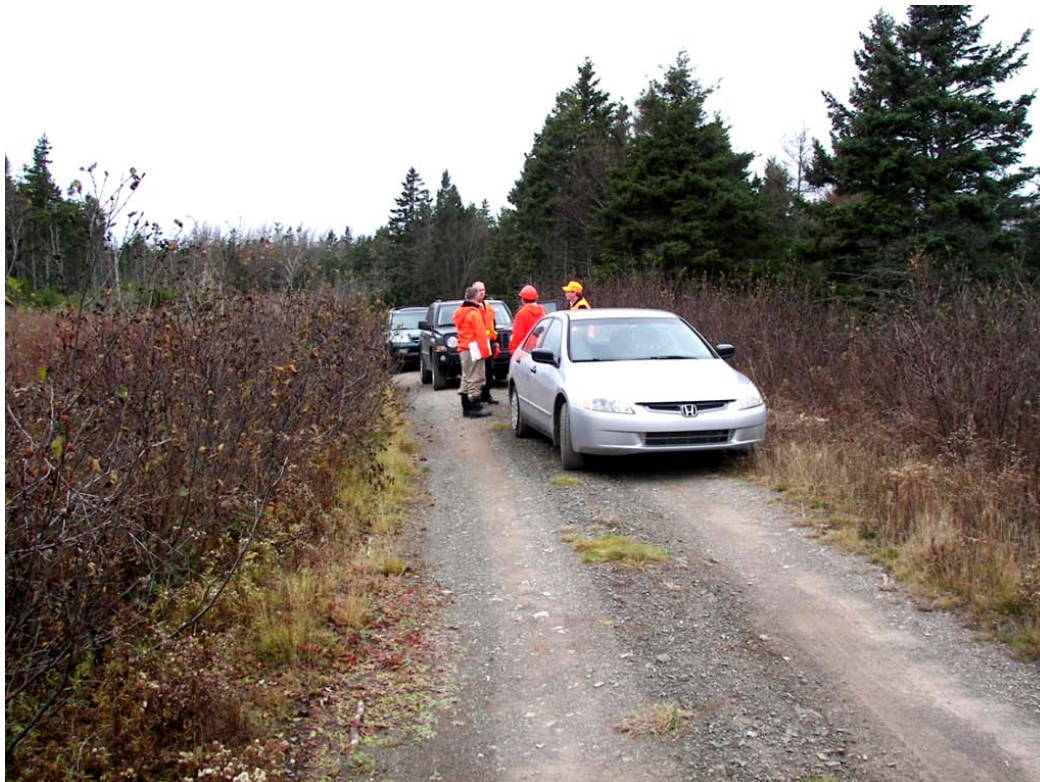
The site was growing over with shrubs and trees, primarily spruce. The growth of the latter to heights of 2 to 4 metres was of concern, due to potential damage to the viability of whatever cover cap had been employed (Plates 7-1 and 7-2).

Plate 7-2: Tree growth over the disposal area to right of vehicles during site reconnaissance.

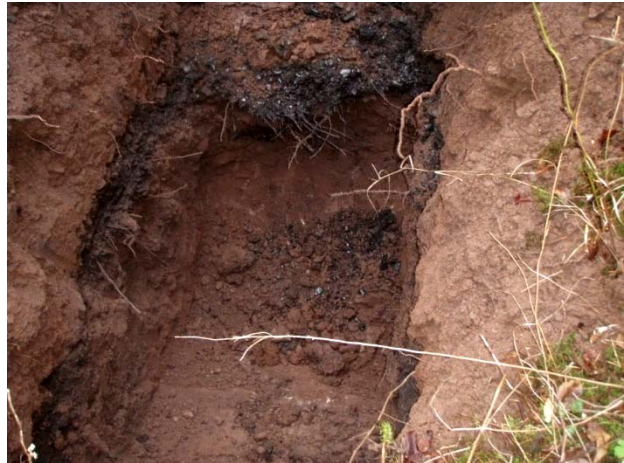
4. When present, oily wastes were 0.25 to 0.75 metres below ground surface, suggesting a thin variable cover of loose fill (reworked till) was placed over the wastes.

Plate 7-3: Lense of oily waste in Test Pit 6.
