APPENDIX H
ARCHAEOLOGICAL STUDY

Project Name Lake Major Dam Replacement Project Archaeological Shovel Testing

**LAKE MAJOR DAM REPLACEMENT PROJECT
ARCHAEOLOGICAL SCREENING & RECONNAISSANCE 2014
HALIFAX REGIONAL MUNICIPALITY
NOVA SCOTIA**

FINAL REPORT

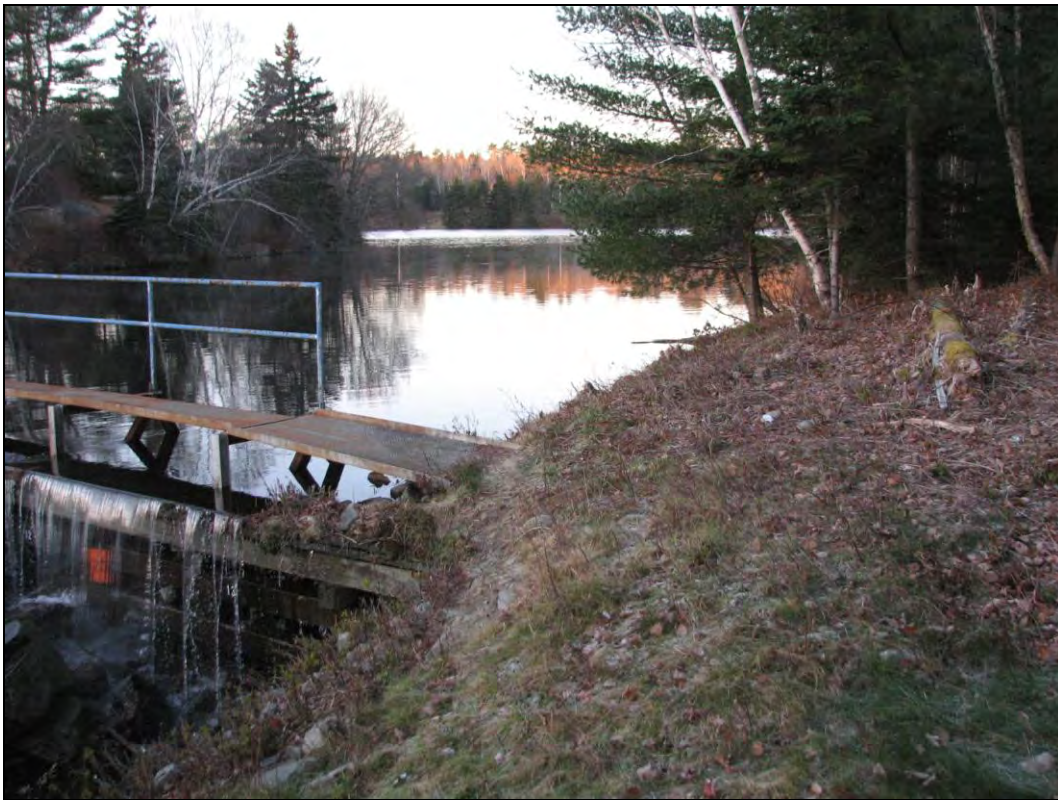
PLATE 1: Lake Major Dam Replacement study area. Existing dam structure and left bank of Lake Major. Facing west. December 5, 2014.

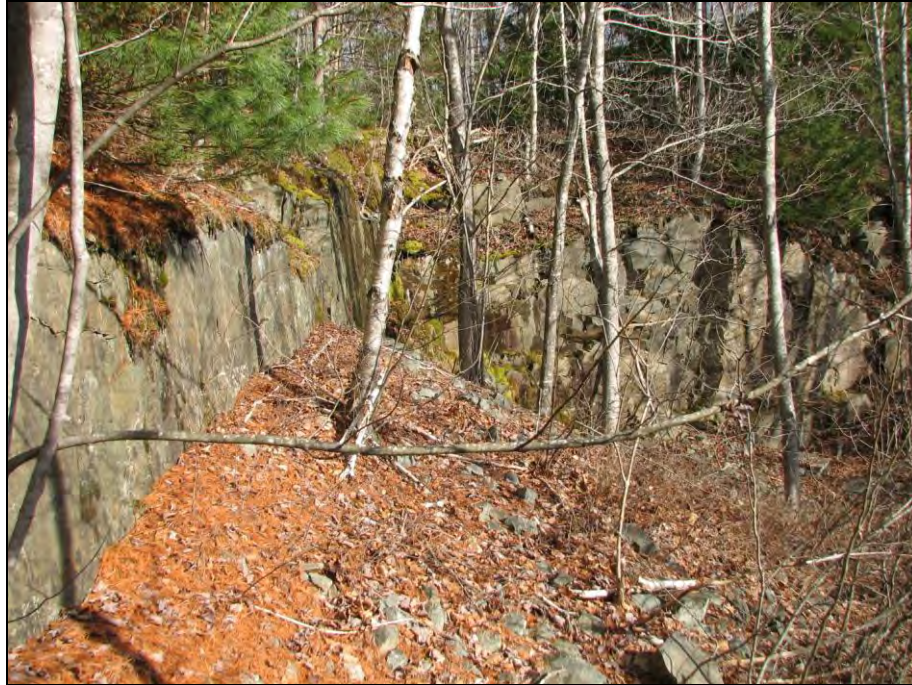
PLATE 2: Evidence of quarrying in the vicinity of Potential Impact Areas A-1 and B-1. Facing east. December 5, 2014.

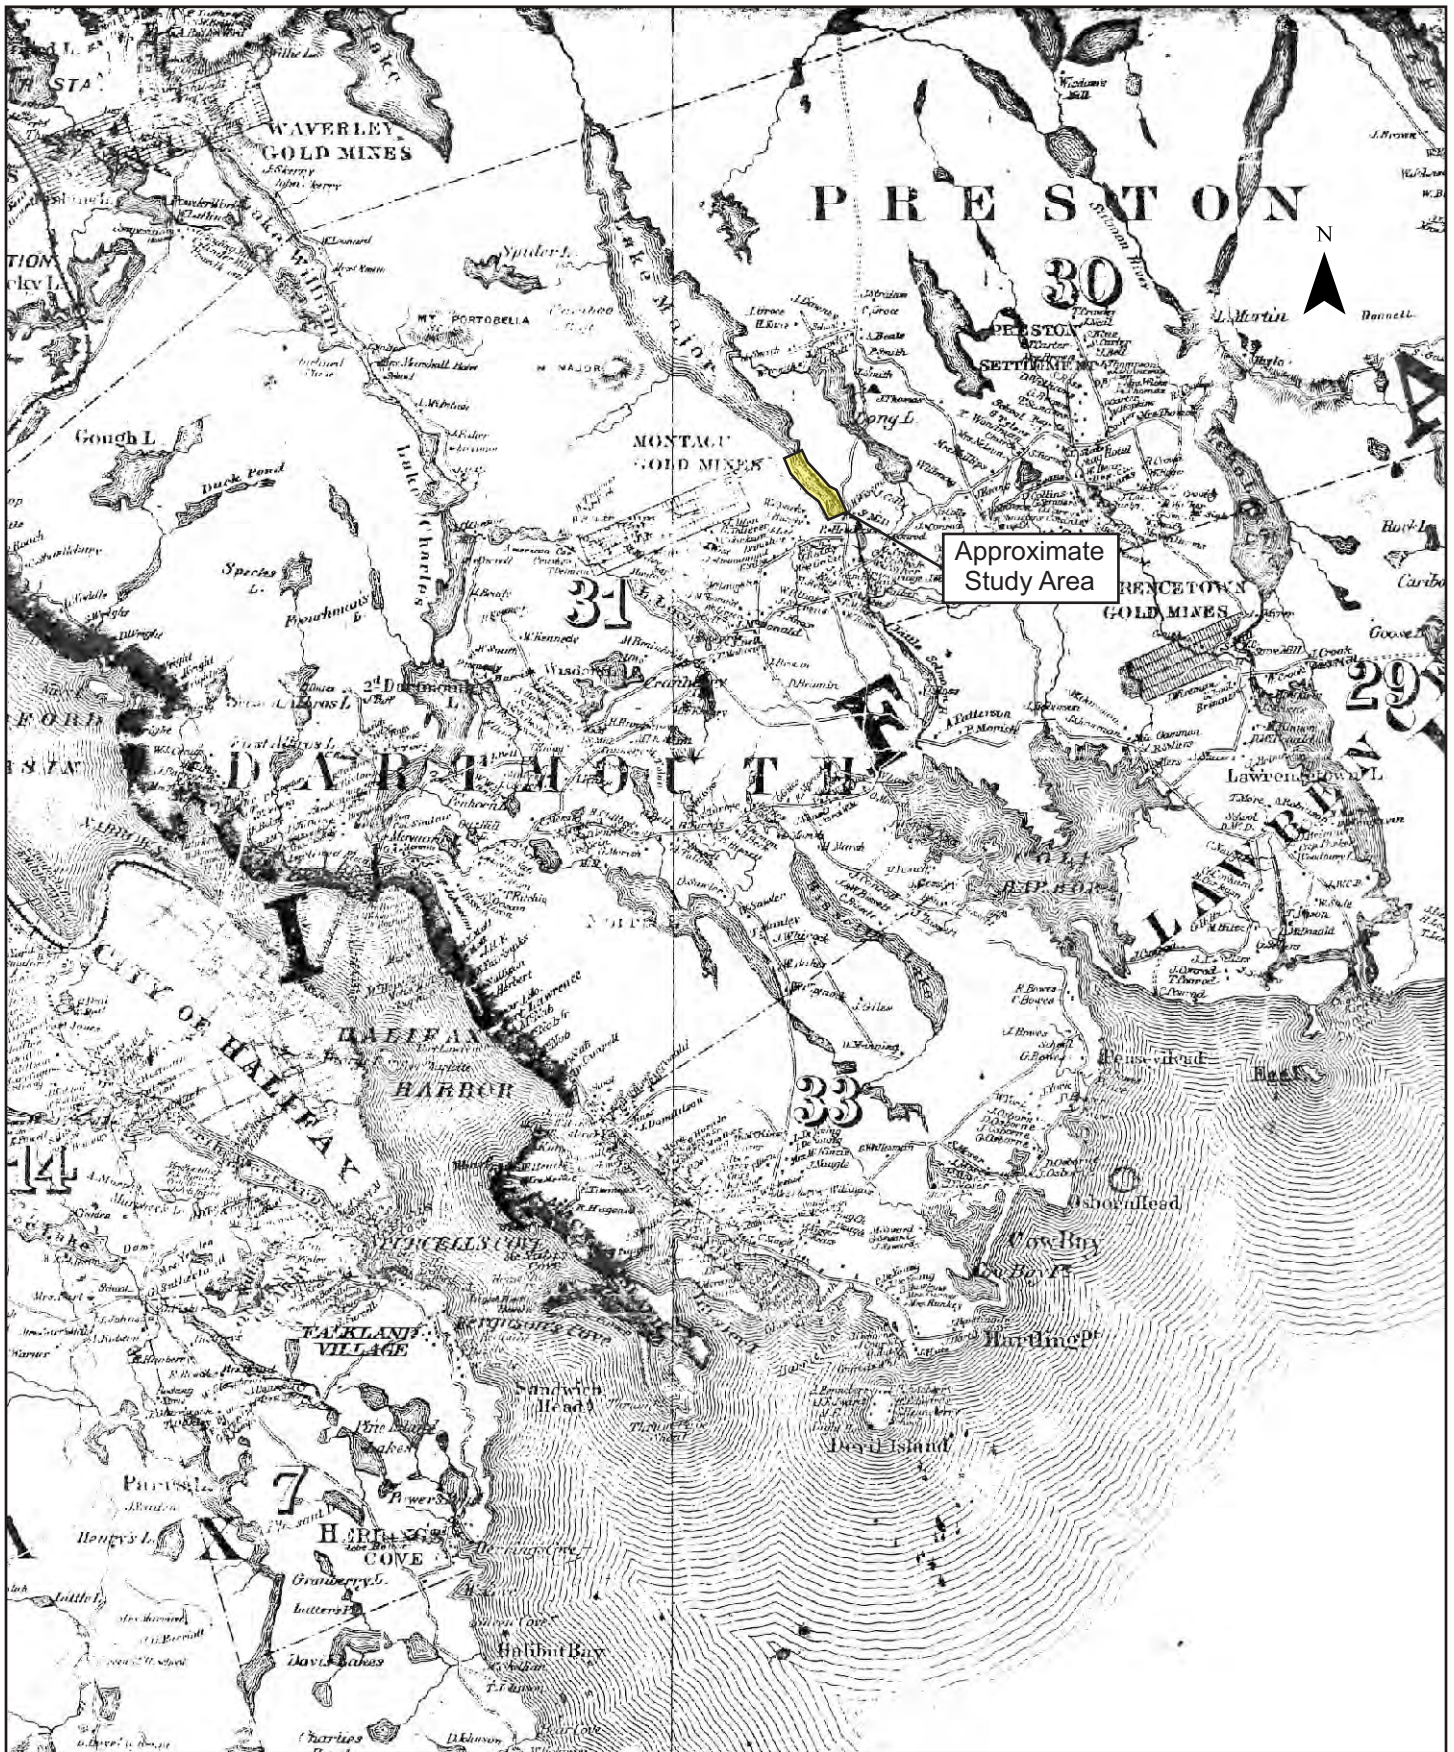
Figure 6

A.F. Church Map 1865

By the early nineteenth century, the Lake Major mill facility included a bark mill, (**Figure 5**), which would have crushed hemlock and oak bark for extraction of the tannin used for leatherworking. The facility remained active into the twentieth century and was situated only slightly downstream from the dam, immediately east of Lake Major Road and immediately north of the river (**Figures 6 & 7**). The residence of the mill owner (J. Ernst by 1908) was also located on the northern side of the river, but on the western side of the road (**Figure 7**).

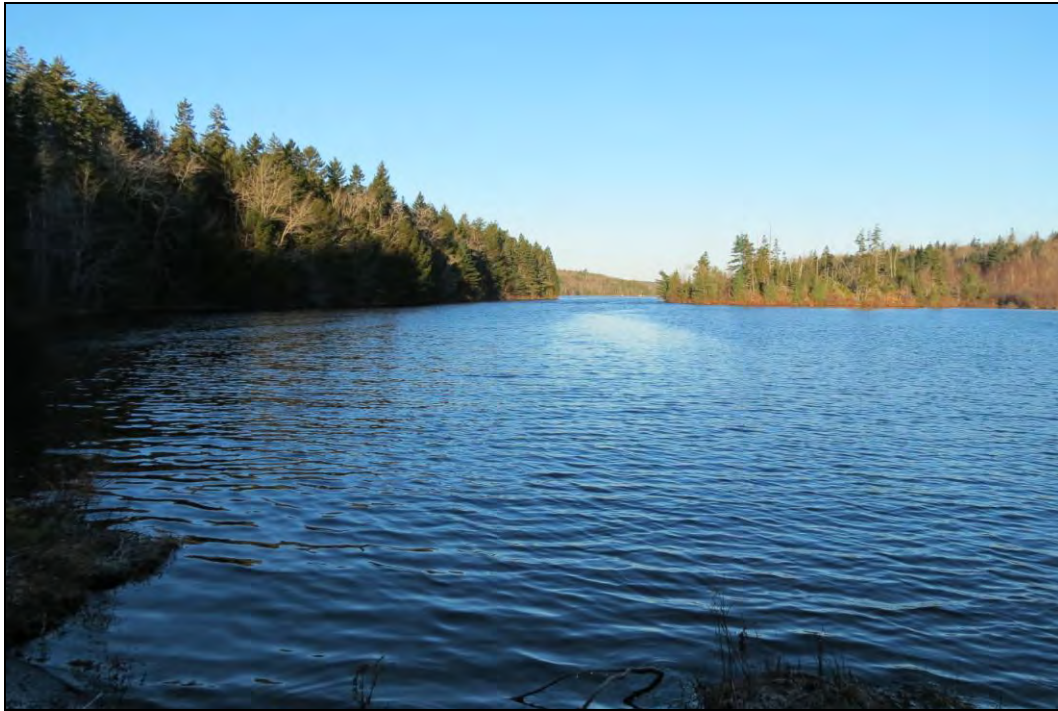
PLATE 3: Standing on Potential Impact Area B-2 and facing north with Potential Impact Area A-1 (right) and A-2 (left) in the background. December 5, 2014.

As a result of the background research and field reconnaissance, 7 of the 8 potential impact areas (A-1, A-2, B-2, C-1, C-2, F-1 and F-2), were identified as exhibiting moderate to high potential for encountering Precontact and historic Native, and/or early Euro-Canadian archaeological resources (*Figure 9*). These areas are described in detail below.

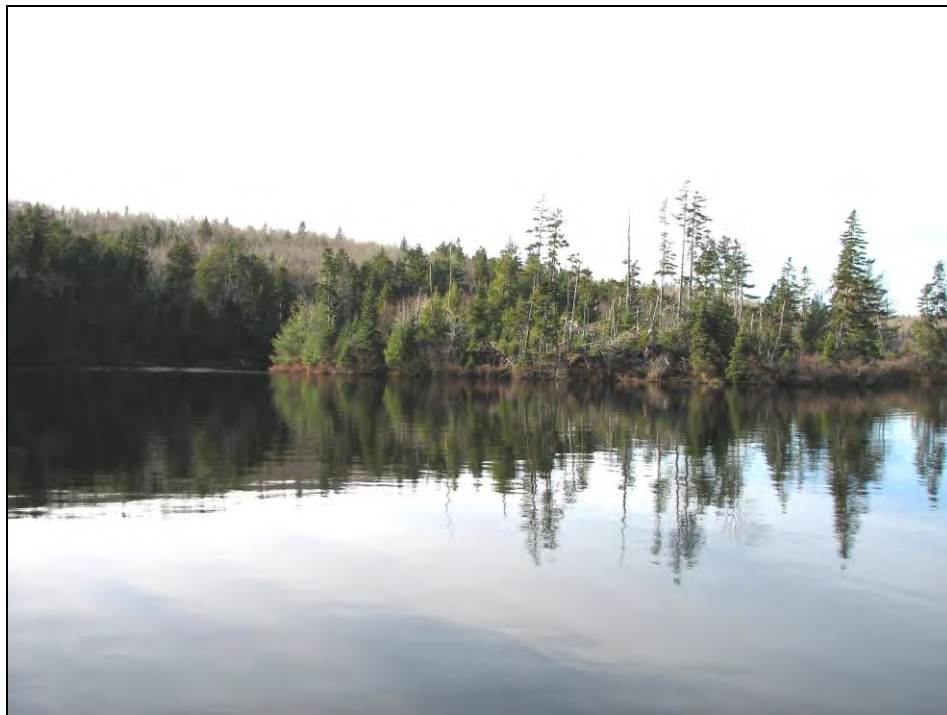
Description: Potential Impact Area A-1 is located on a small peninsula of land protruding from the left bank of Lake Major. The peninsula is considered suitable for Precontact habitation due to its flat and dry nature (**Plate 4**). Area A-1 covers a spot measuring approximately 40 meters (east/west) by 60 meters (north/south). The periphery of Area 1 is bounded to the north, south and west by Lake Major and to the east by disturbance (**Figure 8**).

Potential: The area is considered to have high potential for encountering Precontact archaeological resources.

PLATE 4: Potential Impact Area A-1. Facing northwest. December 5, 2014.

Recommendation: The area should be subjected to a program of shovel testing.

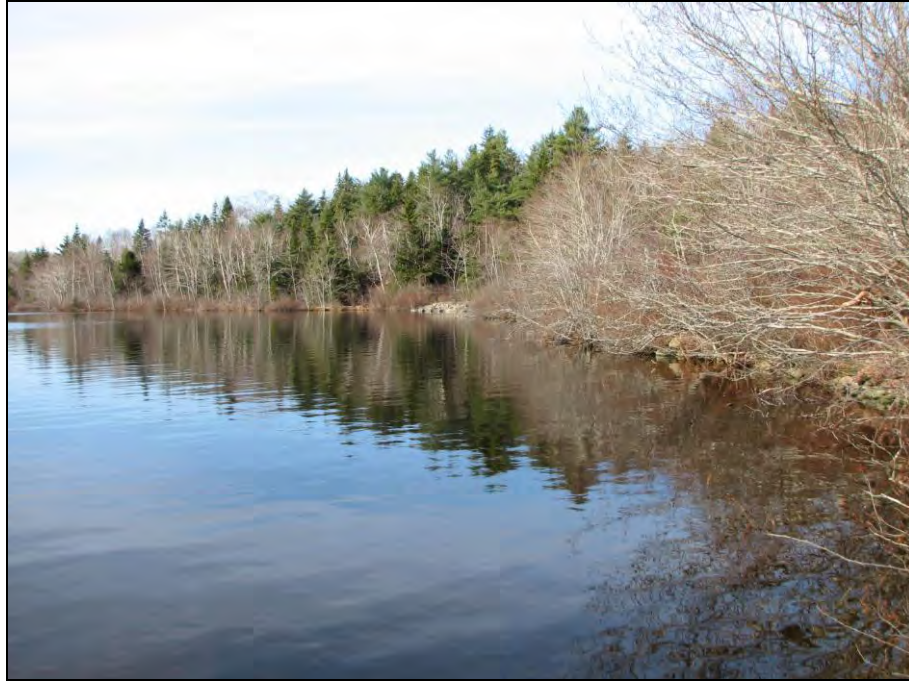
PLATE 5: Standing on peninsula of Potential Impact Area A-1. Facing northeast to disturbance on shore. December 5, 2014.

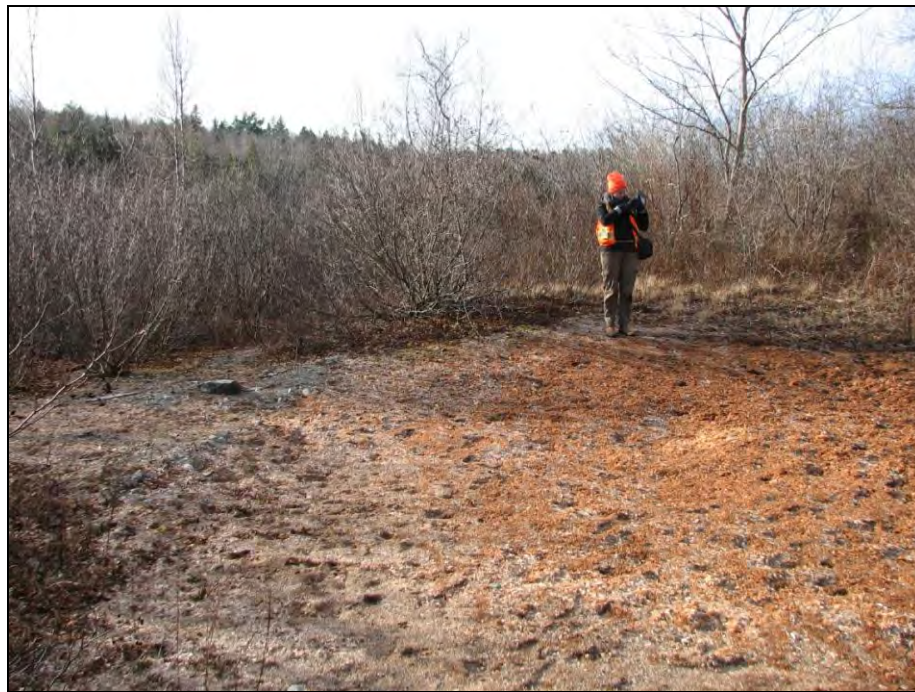
PLATE 6: Large sawdust/woodchip pile located inland from peninsula. Potential Impact Area A-1 disturbance. Facing north. December 5, 2014.

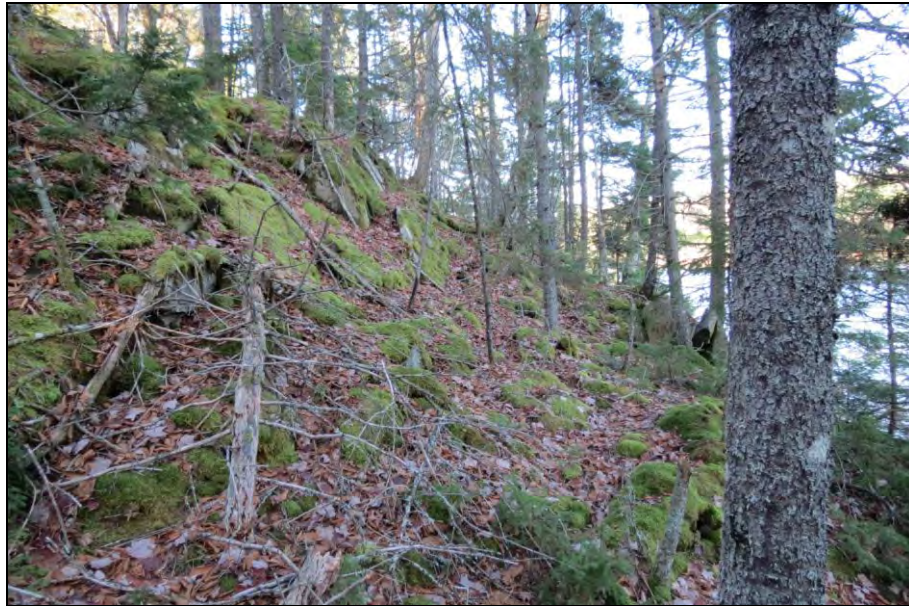
Description: Potential Impact Area A-2 is a large flat terrace located across the lake from Area A-1 on the right bank of Lake Major. The area measures approximately 80 metres north-south by 30 metres east-west. It is bounded on the north by a steeply sloped ridge and bedrock outcrop (**Plate 7**), on the west and south by a stream and standing water (**Plate 8**) and on the east by Lake Major (**Plate 9**). Potential Impact Area A-2 is considered suitable for Precontact habitation due to its flat and dry nature.

Potential: The area is considered to have high potential for encountering Precontact archaeological resources.

PLATE 7: Steep slope and bedrock bounding the north edge of the high potential area of Potential Impact Area A-2. Facing north. December 5, 2014.

Recommendation: The area should be subjected to a program of shovel testing.

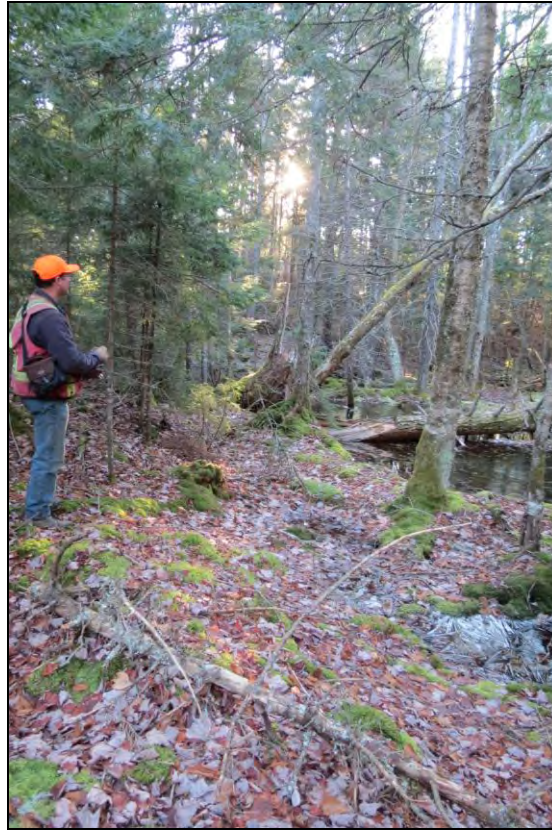
PLATE 8: Flat terrain of Potential Impact Area A-2 bounded on the west by standing water. Facing south. December 5, 2014.

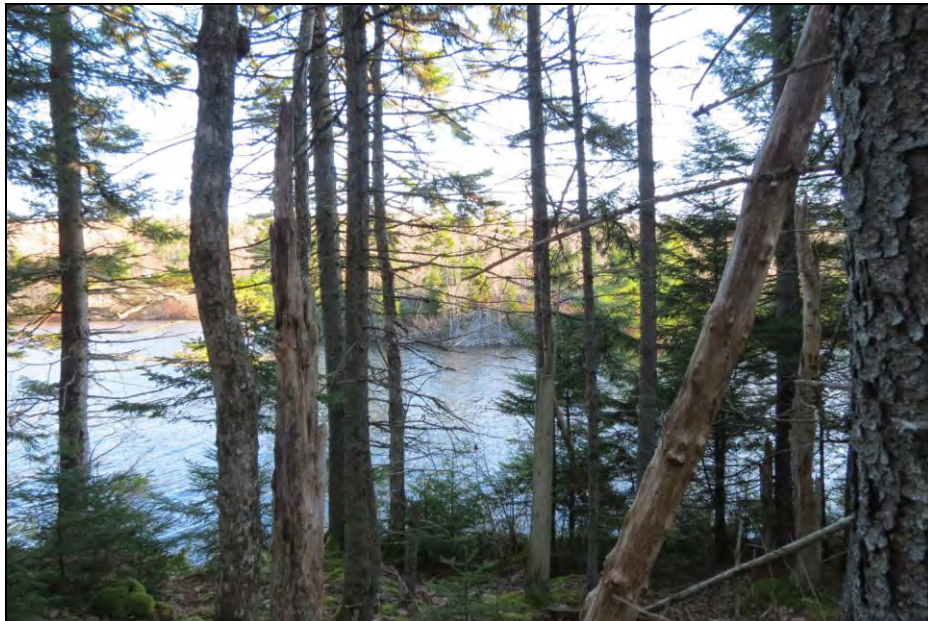
PLATE 9: Potential Impact Area A-2. Facing east. December 5, 2014.

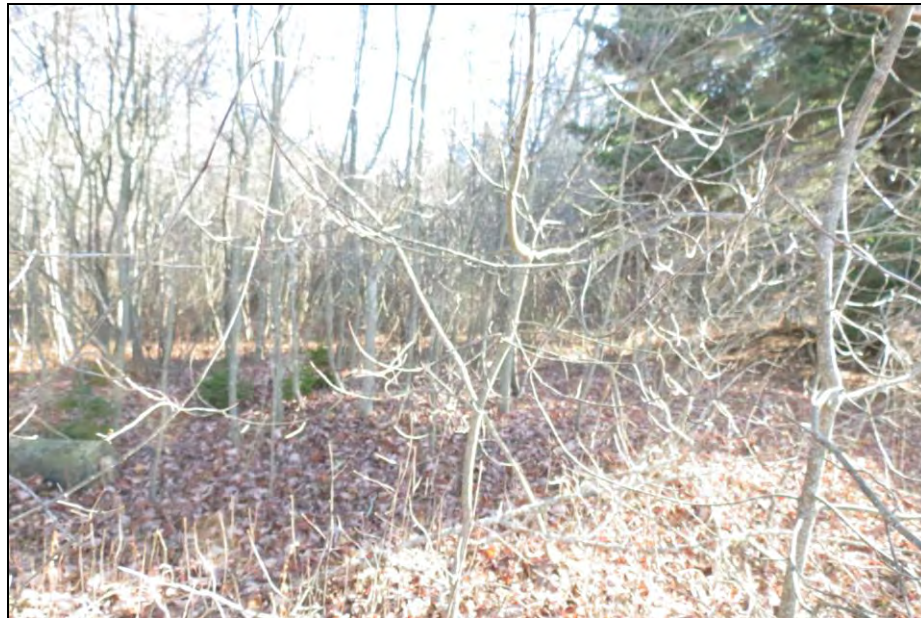
Description: Potential Impact Area B-1 is a low flat area located on the left bank of Lake Major. The area measures approximately 40 metres north-south by 25 metres east-west. It is bounded on the north by a brook flowing into the lake, on the east by a former road (Reddy Drive) but now a trail running parallel to the bank of Lake Major and on the west by Lake Major. The archaeological potential is considered to have been diminished in Potential Impact Area B-1 due to past disturbance as evident in aerial photography. Physically, the Potential Impact Area B-1 appears to be disturbed as well, as demonstrated by the extreme flatness of the surface in addition to the very new growth trees and lack of large old growth trees (**Plate 10**)

Potential: The area is considered to have low potential for encountering intact archaeological resources.

PLATE 10: Potential Impact Area B-1 showing flat terrain and new growth trees. Facing east. December 5, 2014.

Recommendation: The area should be cleared of any requirement for future archaeological investigation.

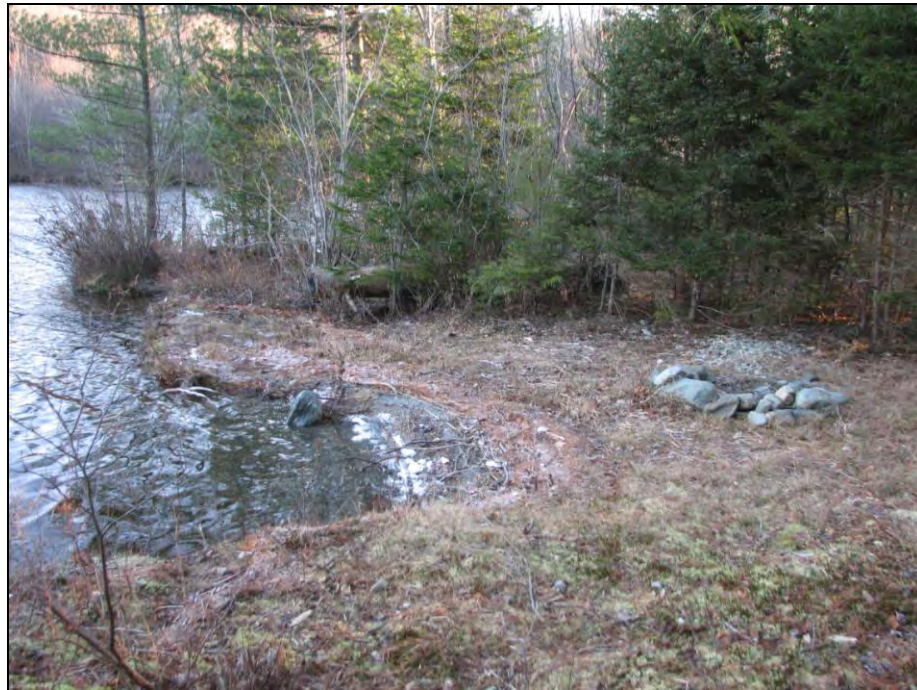
Description: Potential Impact Area B-2 is a small flat peninsula located on the right bank of Lake Major. The area measures approximately 23 metres north-south by 25 metres east-west (**Plate 11**). It is bounded on the north, east and south by Lake Major and on the west by a steep slope. The area appears to have been used recently as a camp site and is easily accessible by a clearly marked trail (**Plate 12**). The peninsula is considered suitable for Precontact habitation due to its flat and dry nature.

Potential: The area is considered to have high potential for encountering Precontact archaeological resources.

PLATE 11: Flat terrain of Potential Impact Area B-2 with modern fire pit on right. Facing east. December 5, 2014.

Recommendation: The area should be subjected to a program of shovel testing

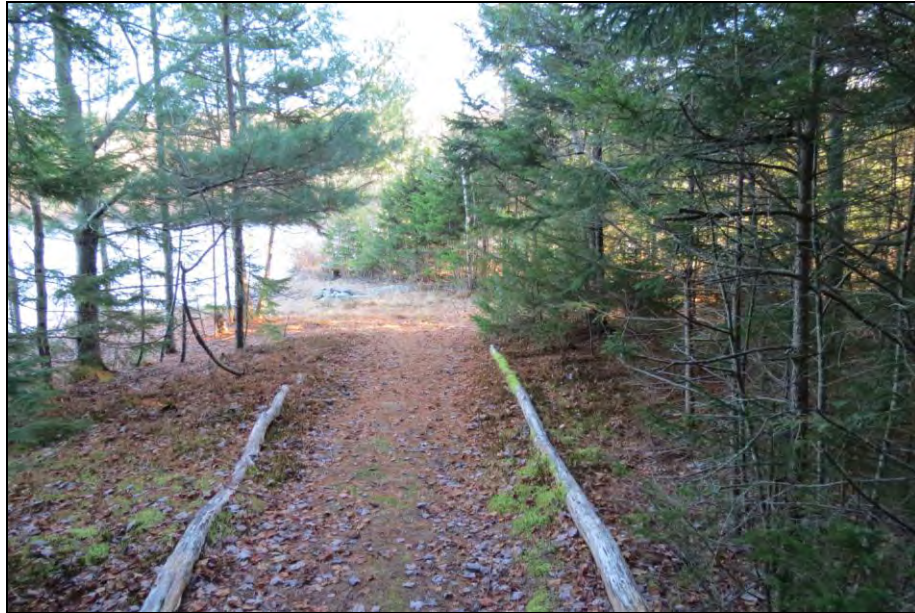
PLATE 12: Potential Impact Area B-2 showing marked trail/path. Facing east. December 5, 2014.

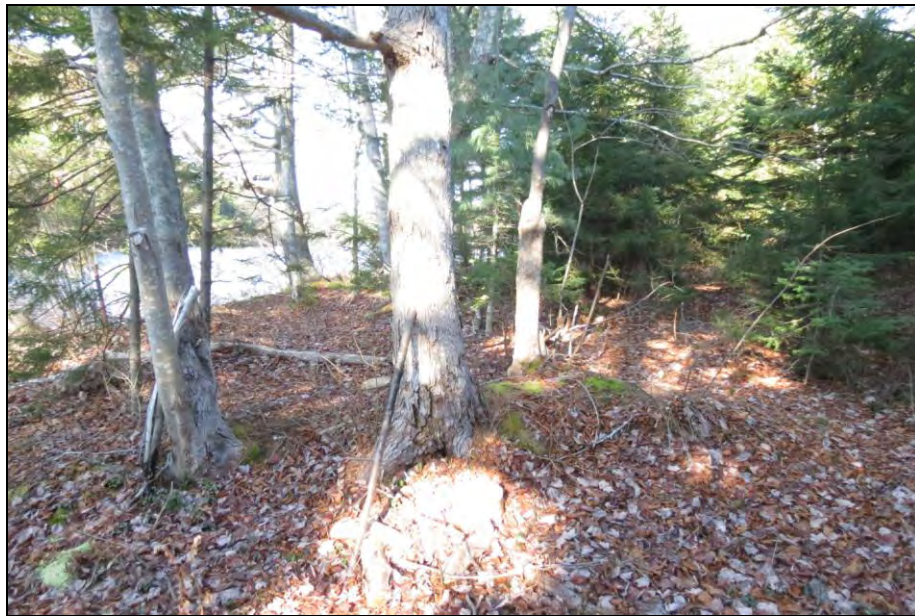
Description: Potential Impact Area C-1 is a medium-sized, flat area situated on the left bank of Lake Major. The area is located along the road/trail that runs parallel to Lake Major and just north of a large rock barricade keeping ATVs off the trail. The area measures approximately 30 metres north-south by 40 metres east-west (**Plate 13**). The area is considered suitable for Precontact habitation due to its flat and dry nature.

Potential: The area is considered to have high potential for encountering Precontact archaeological resources.

PLATE 13: Potential Impact Area C-1. Facing north. December 5, 2014.

Recommendation: The area should be subjected to a program of shovel testing.

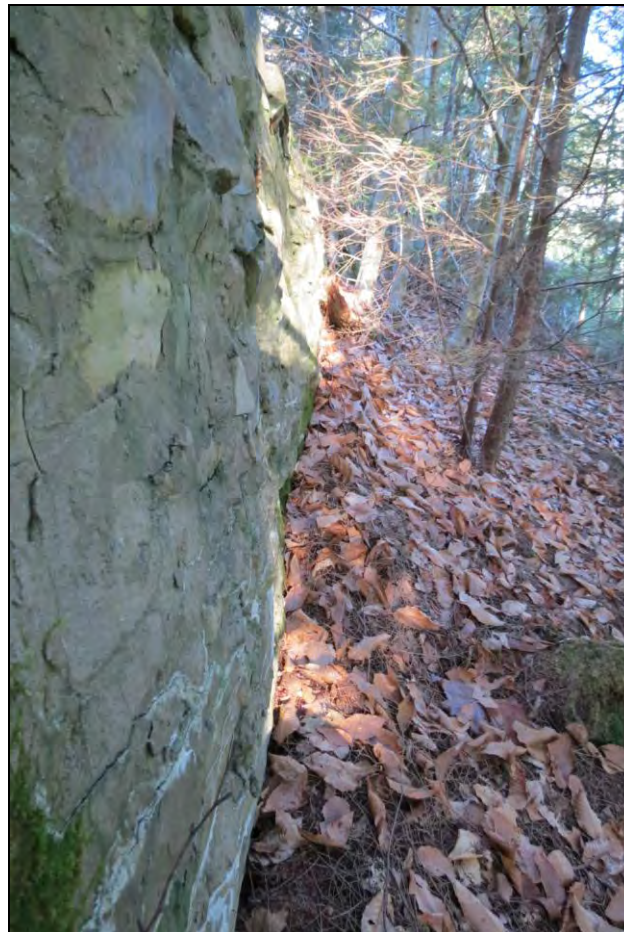
Description: Potential Impact Area C-2 is a very small terrace area situated on the right bank of Lake Major. The area contains a 1970s/80s cottage foundation as well as a stone and concrete landscaping retaining wall (**Plate 14**). The area of elevated potential is located just east of this wall and measures approximately 15 metres north-south and 20 metres east-west (**Plate 15**). Although the area was possibly disturbed due to modern construction, the terrace is high, flat and dry and is thus still considered suitable for Precontact habitation.

Potential: The area is considered to have moderate potential for encountering Precontact archaeological resources.

PLATE 14: Retaining wall located on Potential Impact Area C-2. Facing north. December 5, 2014.

Recommendation: The area should be subjected to a program of shovel testing.

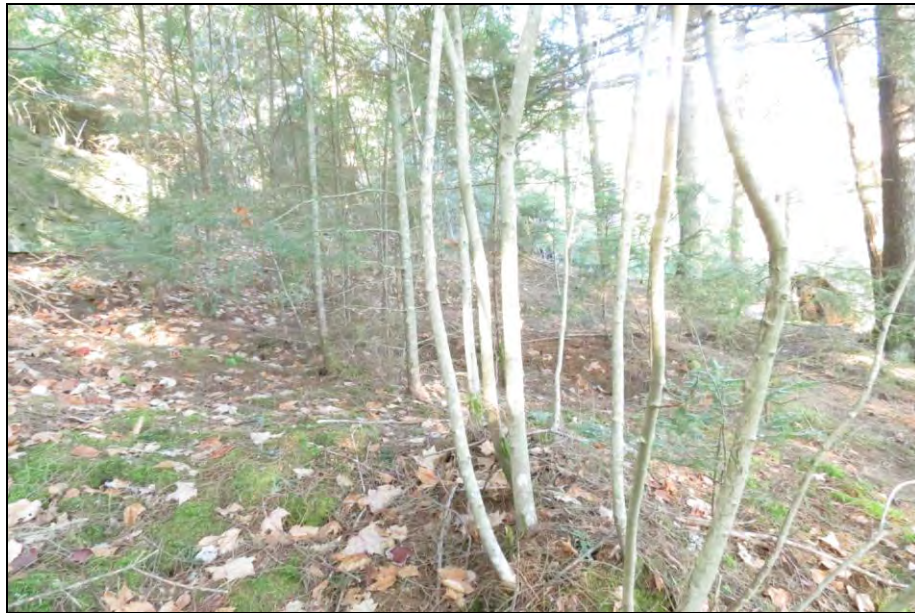
PLATE 15: Potential Impact Area C-2 with retaining wall on far left. Facing north. December 5, 2014.

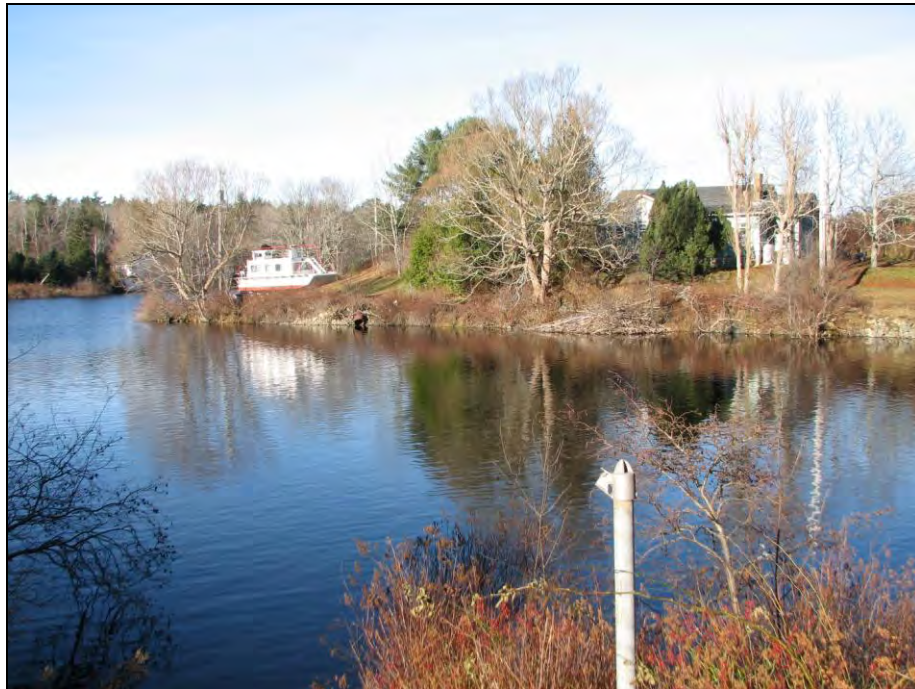
Description: Potential impact area 'g' is a flat area of manicured lawn on the left bank of Lake Major. The area consists of a manicured lawn and gravel driveway of an existing house/cottage on the property as well as a portion of ploughed agricultural field (**Plates 16-18**). The area of elevated potential includes all areas of relatively flat dry land on the property.

Potential: The area is considered to have high potential for encountering Precontact and/or historic archaeological resources.

PLATE 16: Potential Impact Area F-1 across water. Facing north. December 5, 2014.

Recommendation: The area should be subjected to a program of shovel testing.

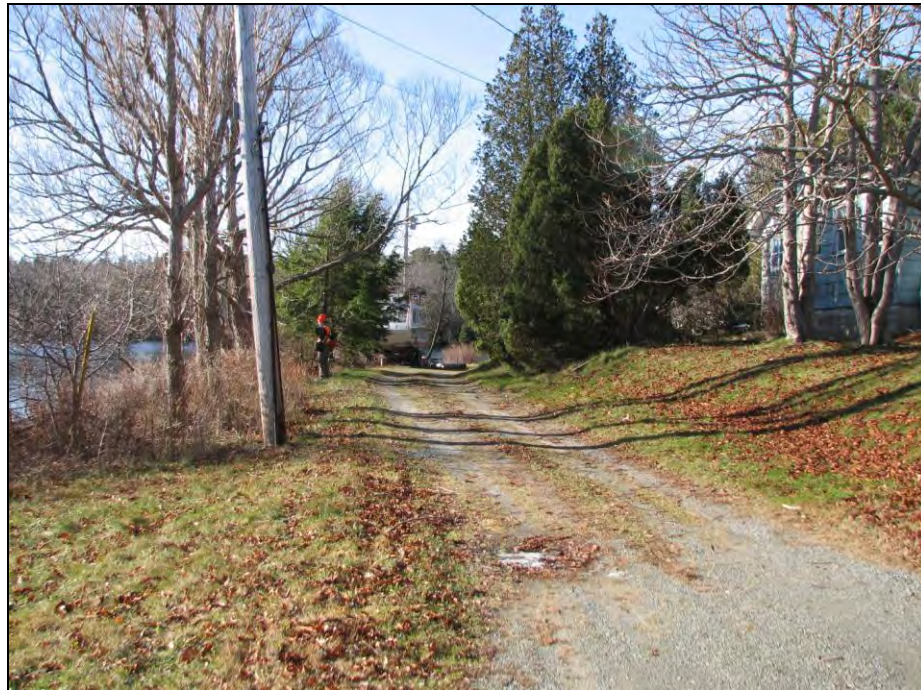
PLATE 17: Manicured lawn and gravel driveway on Potential Impact Area F-1. Facing west. December 5, 2014.

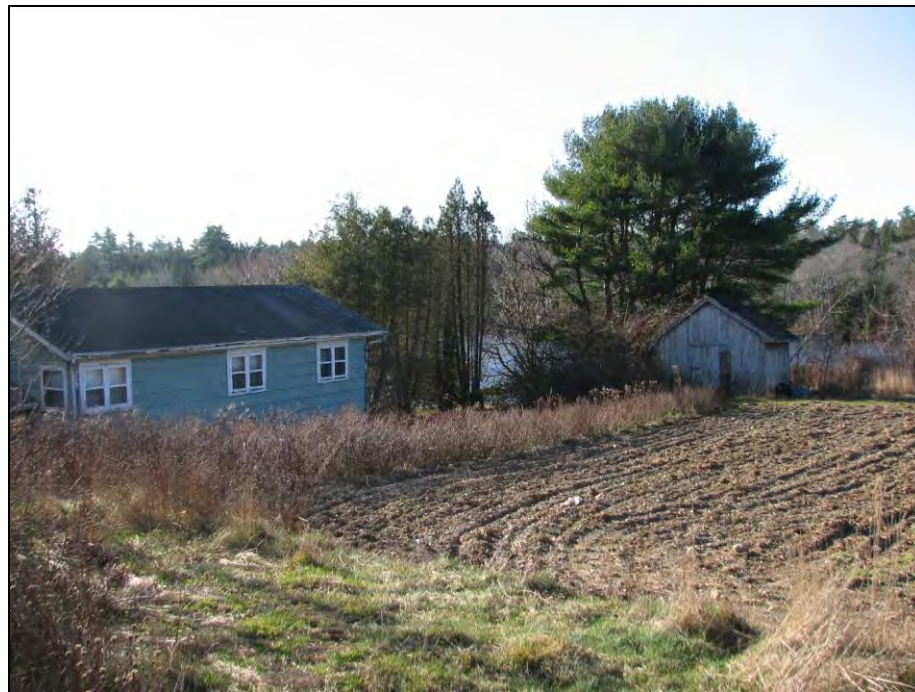
PLATE 18: Ploughed agricultural field on Potential Impact Area F-1. Facing southwest. December 5, 2014.

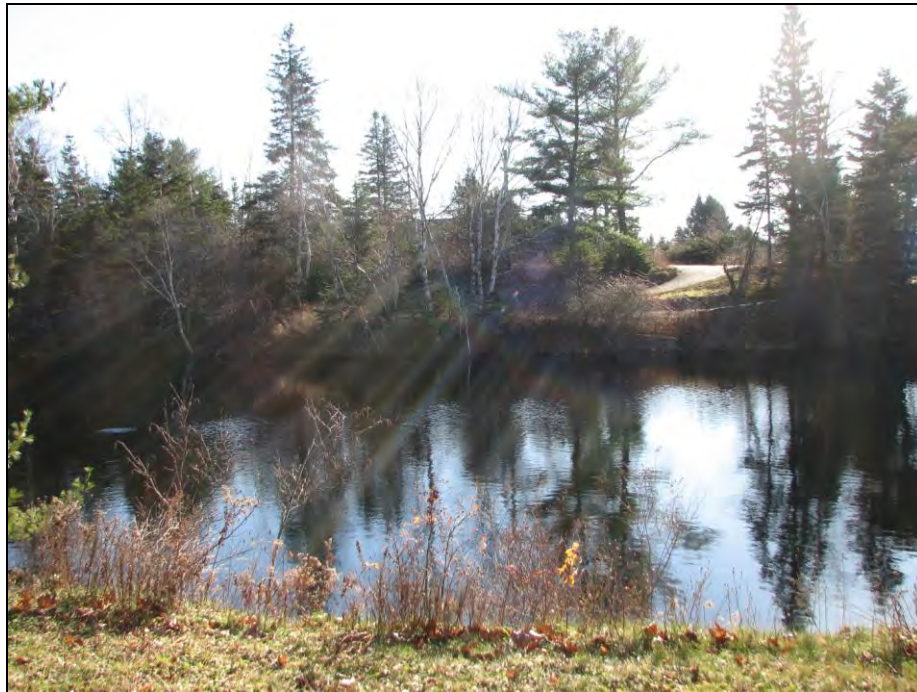
Description: Potential Impact Area F-2 is a flat area of manicured lawn on the left bank of Lake Major. The area consists of manicured lawn and gardens as well as both gravel and asphalt driveways of an existing house/cottage on the property (**Plates 19-21**). The area of elevated potential includes all areas of relatively flat dry land on the property.

Potential: The area is considered to have high potential for encountering Precontact and/or historic archaeological resources.

PLATE 19: Potential Impact Area F-2 across the water. Facing south. December 5, 2014.

Recommendation: The area should be subjected to a program of shovel testing.

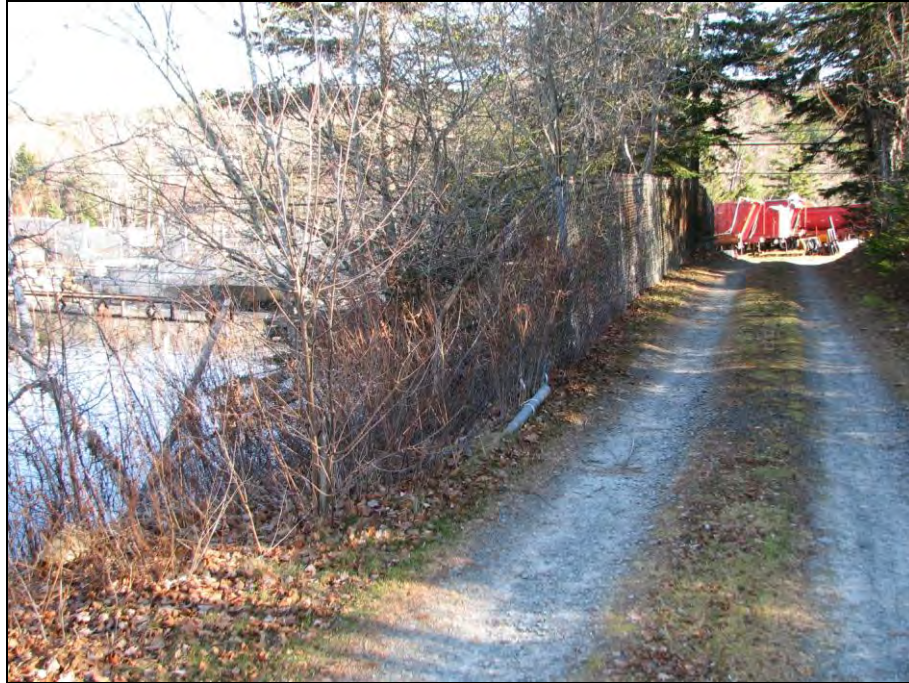
PLATE 20: Gravel driveway on Potential Impact Area F-2. Facing east. December 5, 2014.

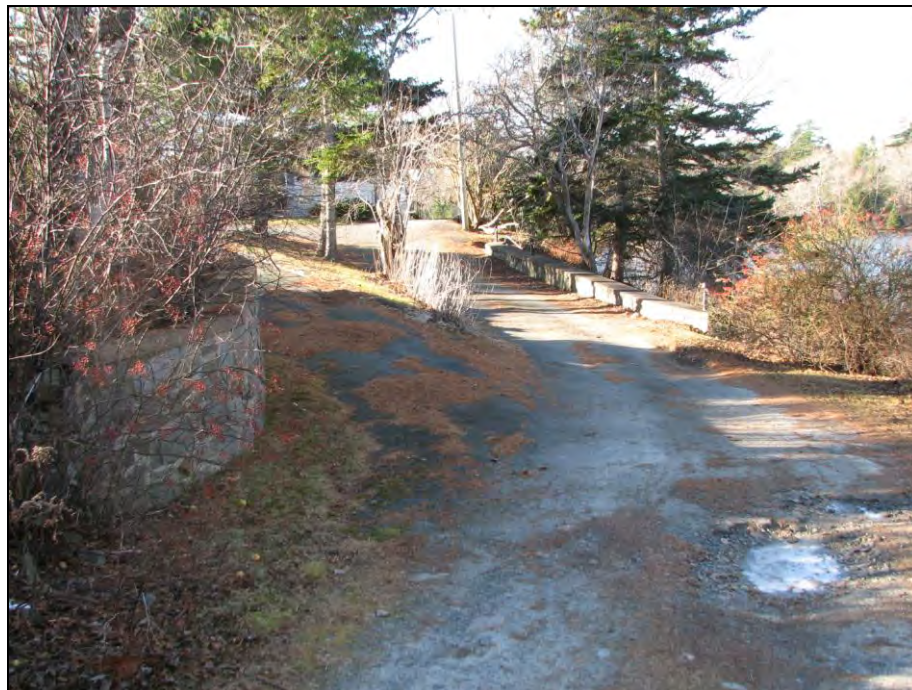
PLATE 21: Manicured lawn, gravel driveway and asphalt driveway on Potential Impact Area F-2. Facing west. December 5, 2014.
