Fish Habitat Assessment Survey in Moose River in the Vicinity of the Proposed Pit Expansion

To:	Jim Millard Atlantic Mining NS Corporation 900-1959 Upper Water St, Halifax, NS B3J 3N2	From:	Tim Vickers, Mary Murdoch Stantec Consulting Ltd. 845 Prospect St. Fredericton, NB E3B 2T7
File:	121619250	Date:	August 31, 2020

This memo addresses items 7 and 8 relating to fish habitat downstream of SW-2.

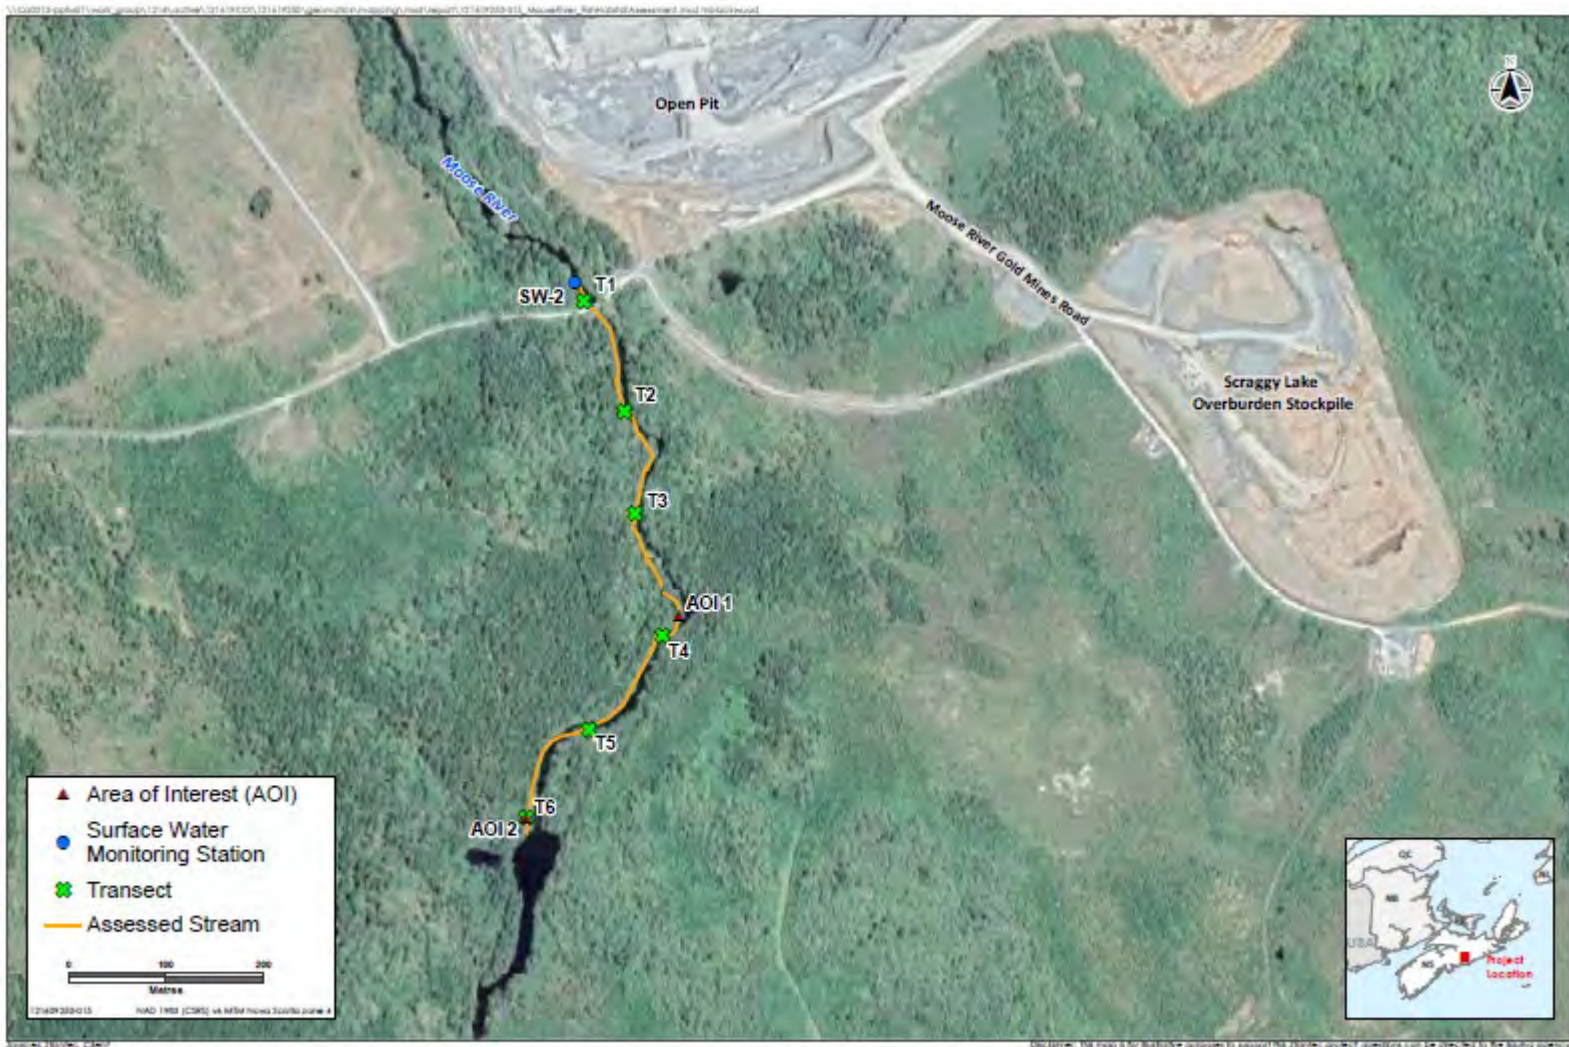
**Figure 1, Fish Habitat Assessment,
Moose River, NS**

On July 30, 2020, a fish habitat survey was conducted in Moose River by a Stantec aquatic biologist. A segment approximately 650 m long was surveyed, beginning at surface water monitoring station SW-2 and proceeding downstream (Figure 1). As requested by DFO, the fish habitat assessment methodology was provided to and approved by Christopher Burbidge of DFO on July 29, 2020. The assessment included collection of the following habitat information: channel width, channel depth, bank height, substrate composition, gradient, bank cover, bank slope, stream cover, habitat type (e.g., pool, riffle, run), vegetation. Habitat information was collected at six georeferenced transect locations and photos were taken as per request 8 above.

Generally, Moose River is a low gradient stream characterized by small boulder, cobble, and large gravel substrate, which indicates that it has undergone periods of high flow. Six stream transects (T1 to T6) were assessed for aquatic habitat, beginning at SW-2 and ending approximately 650 m downstream. Locations are shown on Figure 1 (Attachment A). The surveyed area consisted of both swift-flowing and slow-moving sections and the gradient shift over the course of the survey area ranged from 2.0 to 2.5%. Except for some areas on the banks, the riverbed in the survey area contains very little fine material (i.e., sand and fines).

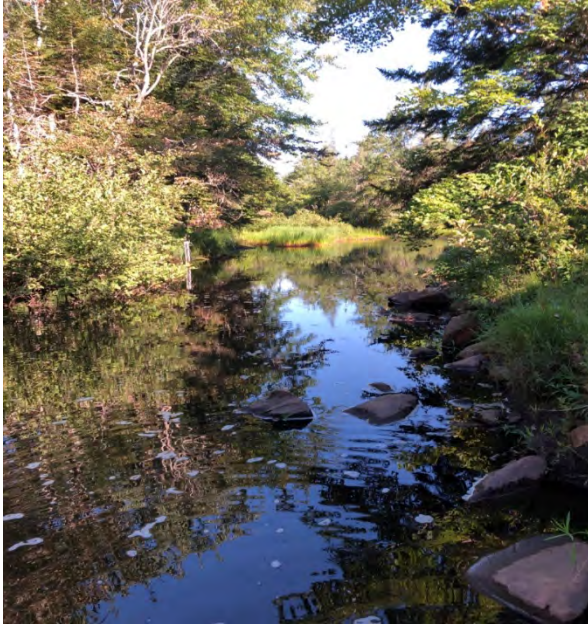
Photo 1. View upstream of transect T1 (Latitude: 44.979863, Longitude: -62.944511) approximately 10 m upstream from SW-2.

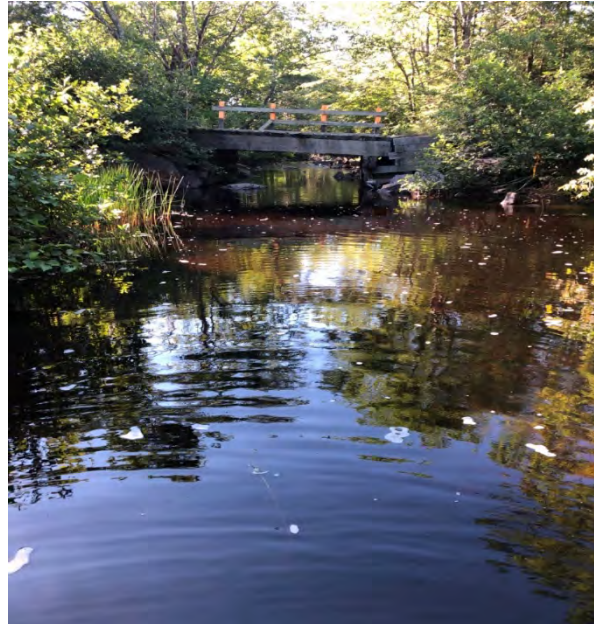
Photo 2. View downstream of transect T1 (Latitude: 44.979863, Longitude: -62.944511) approximately 10 m upstream from SW-2.

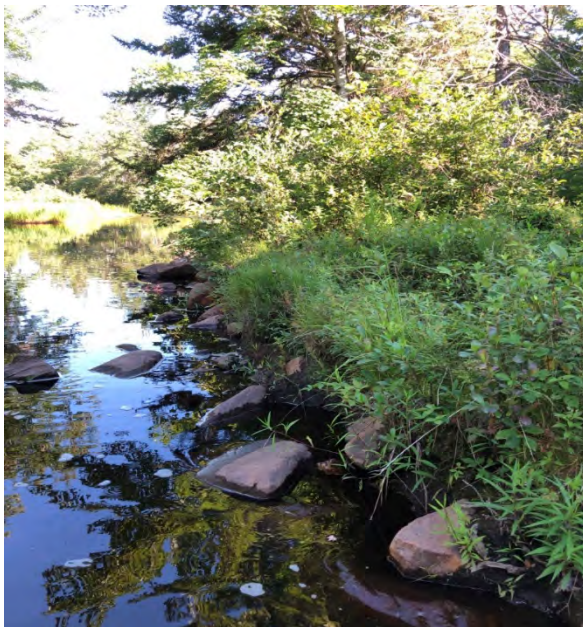
Photo 3. View of the left bank of transect T1 (Latitude: 44.979863, Longitude: -62.944511) approximately 10 m upstream from SW-2.

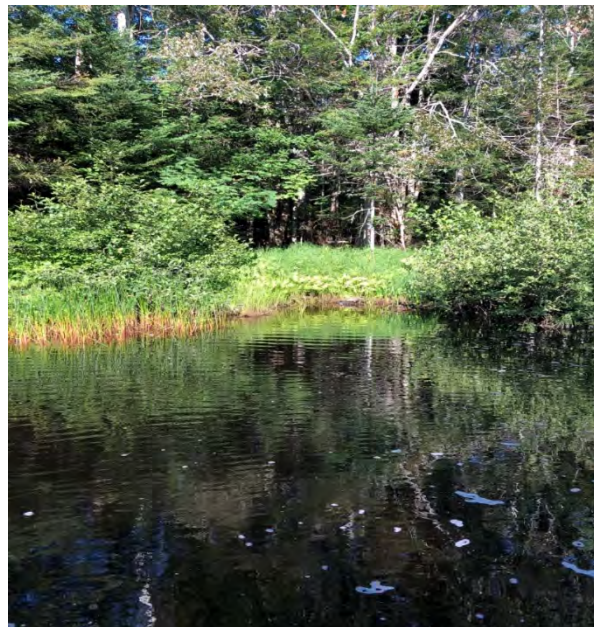
Photo 4. View of the right bank of transect T1 (Latitude: 44.979863, Longitude: -62.944511) approximately 10 m upstream from SW-2.

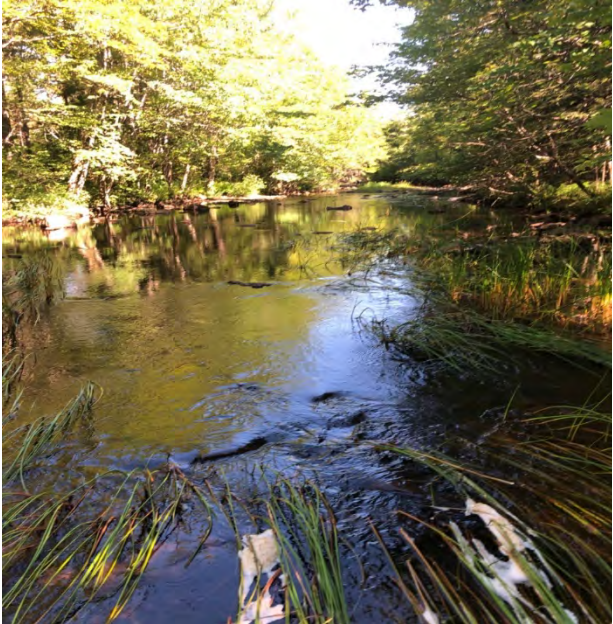
Substrate data were collected at transects T2 to T6 and these locations were dominated by small boulder (~20%), cobble (~30%) and large gravel (~20%). Banks were generally stable and riparian vegetation was dominated by deciduous trees (~40%). Average total instream and overhead cover in the survey area was ~15%. Rooted aquatic vegetation within the transects was dominated by emergent vegetation (~20%) (Attachment B, Photos 5, 8, 14, 20, 25, 26).

Photo 5. View upstream of transect 2 (T2)
(Latitude: 44.97903, Longitude: -62.944)
approximately 125 m downstream from SW-2.

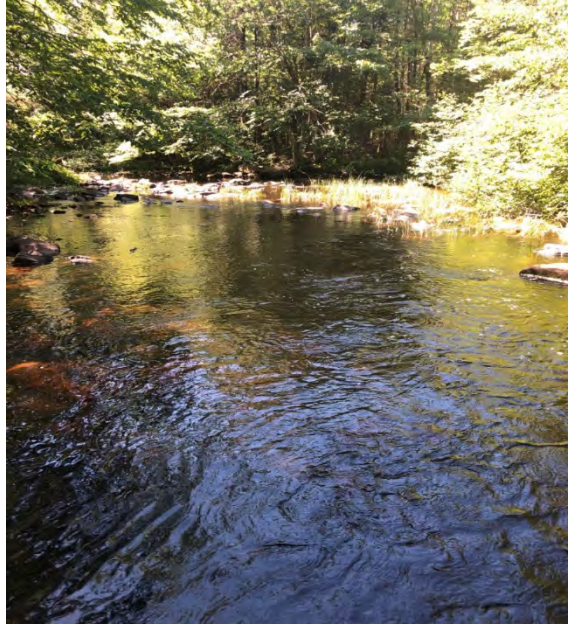
Photo 6. View downstream of transect 2 (T2)
(Latitude: 44.97903, Longitude: -62.944)
approximately 125 m downstream from SW-2.

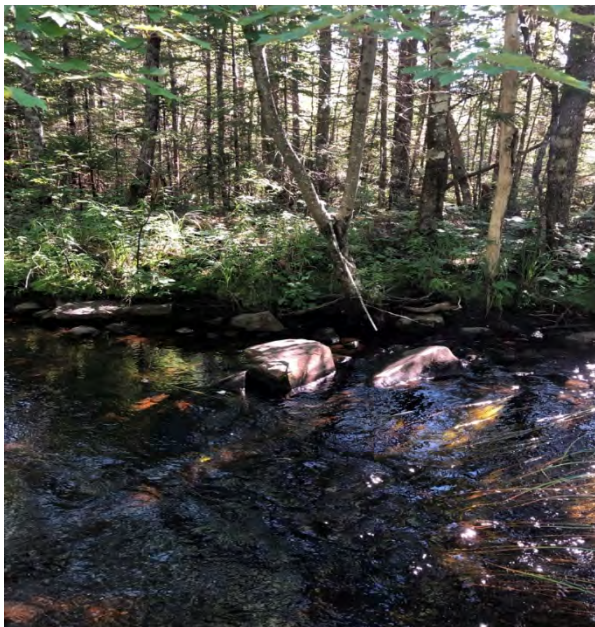
Photo 7. View of the left bank of transect T2
(Latitude: 44.97903, Longitude: -62.944)
approximately 125 m downstream from SW-2.

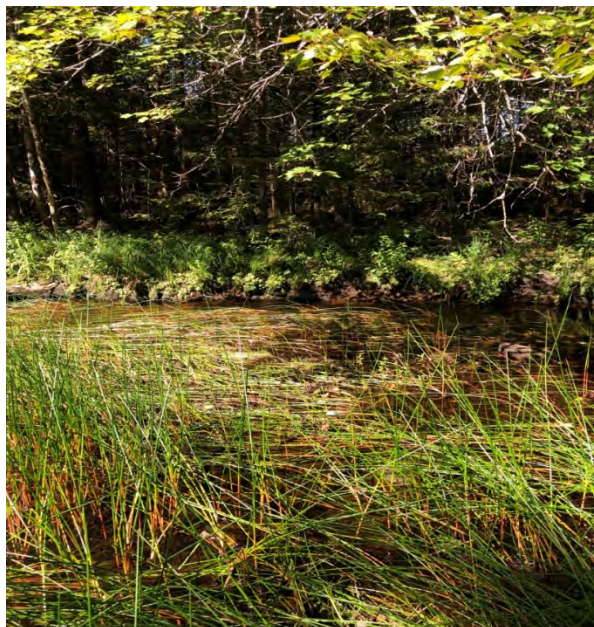
Photo 8. View of the right bank of transect T2
(Latitude: 44.97903, Longitude: -62.9440)
approximately 125 m downstream from SW-2.

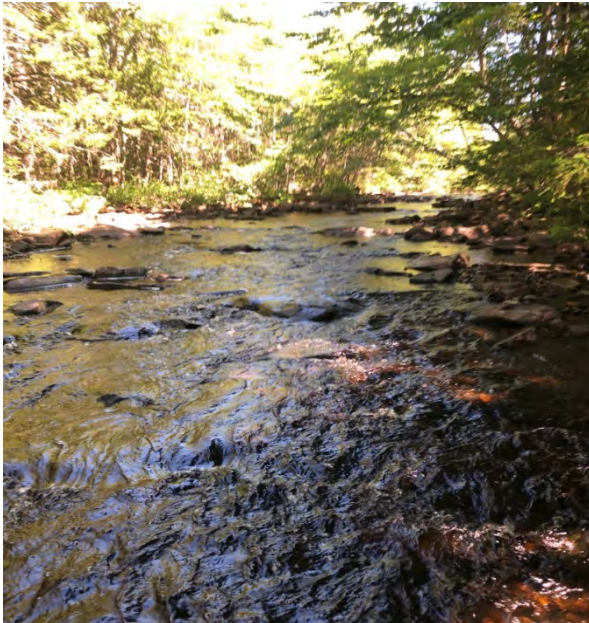
Photo 9. View upstream of transect T3 (Latitude: 44.97822, Longitude: -62.9436) approximately 245 m downstream from SW-2.

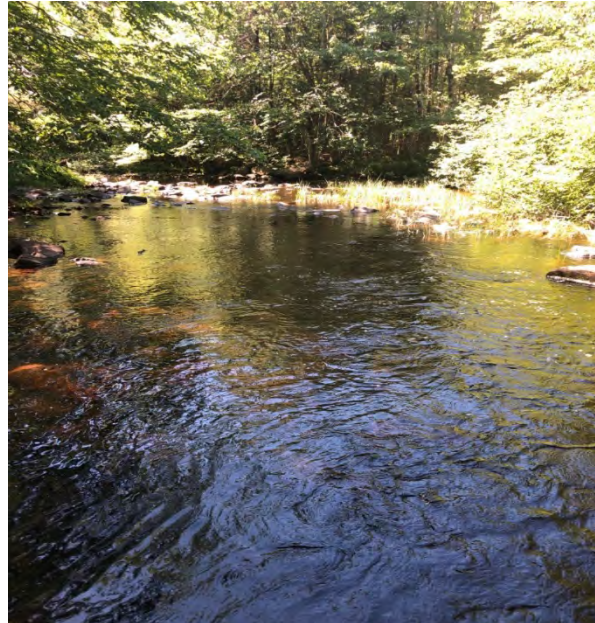
Photo 10. View downstream of transect T3 (Latitude: 44.97822, Longitude: -62.9436) approximately 245 m downstream from SW-2.

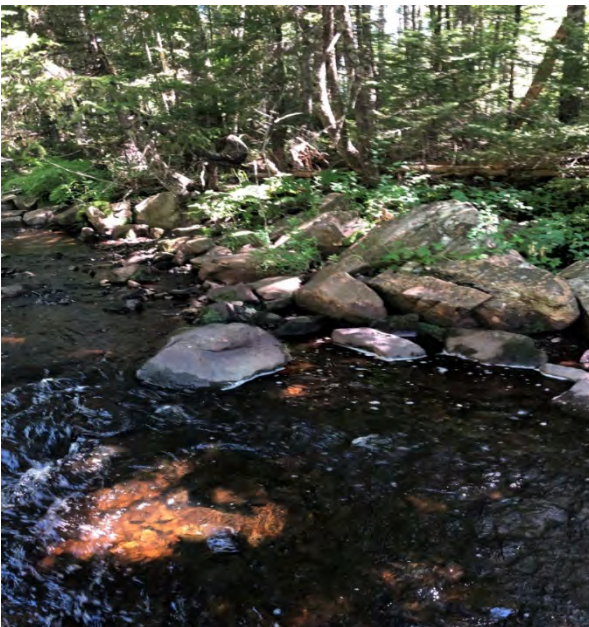
Photo 11. View of the left bank of transect T3 (Latitude: 44.97822, Longitude: -62.9436) approximately 245 m downstream from SW-2.

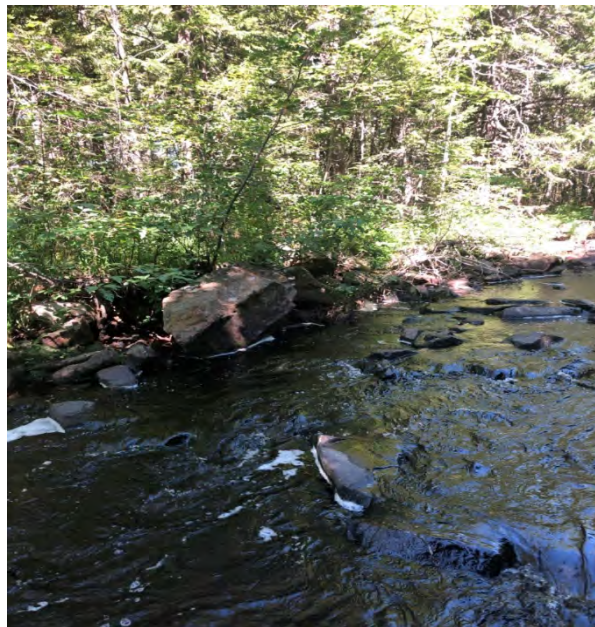
Photo 12. View of the right bank of transect T3 (Latitude: 44.97822, Longitude: -62.9436) approximately 245 m downstream from SW-2.

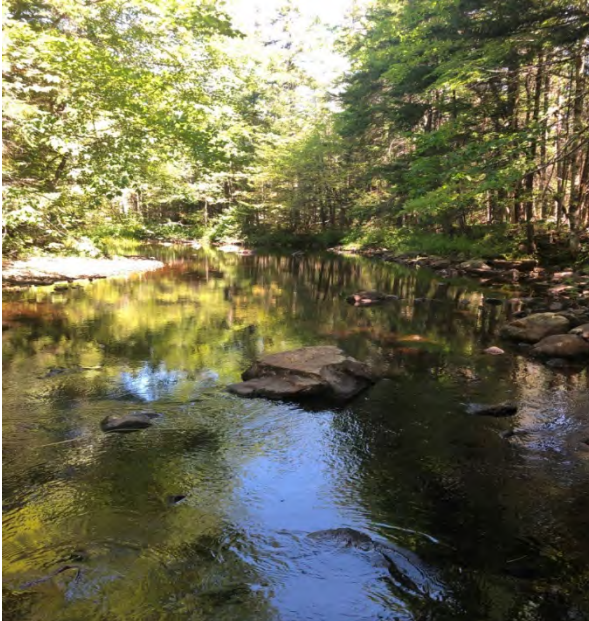
Photo 13. View upstream of transect T4 (Latitude: 44.97685, Longitude: -62.9432) approximately 395 m downstream from SW-2.

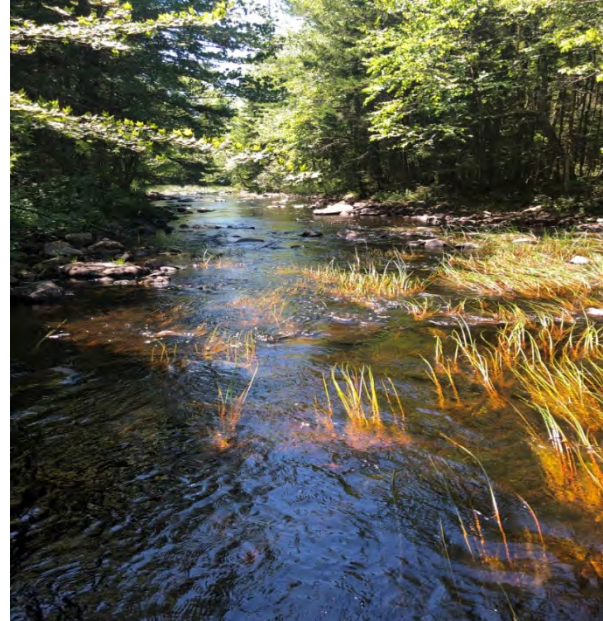
Photo 14. View downstream of transect T4 (Latitude: 44.97685, Longitude: -62.9432) approximately 395 m downstream from SW-2.

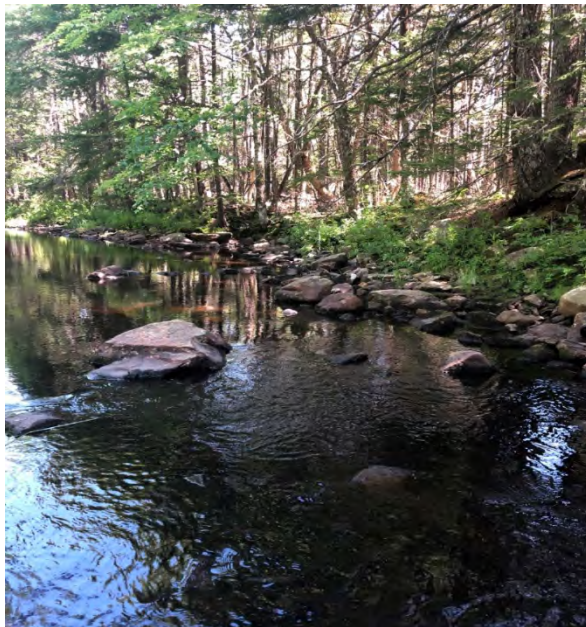
Photo 15. View of the left bank of transect T4 (Latitude: 44.97685, Longitude: -62.9432) approximately 395 m downstream from SW-2.

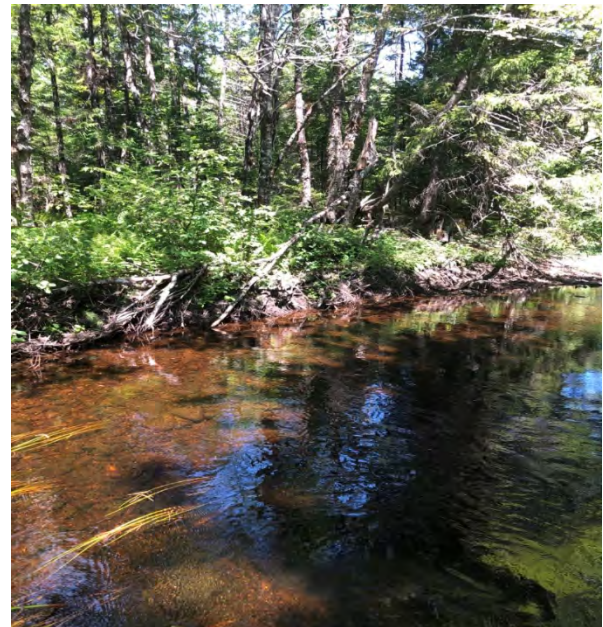
Photo 16. View of the right bank of transect T4 (Latitude: 44.97685, Longitude: -62.9432) approximately 395 m downstream from SW-2.

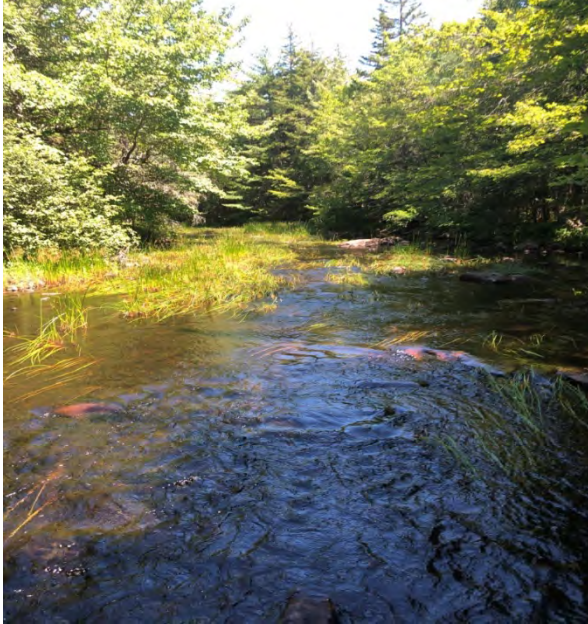
Photo 17. View upstream of transect T5 (Latitude: 44.97668, Longitude: -62.9435) approximately 520 m downstream from SW-2.

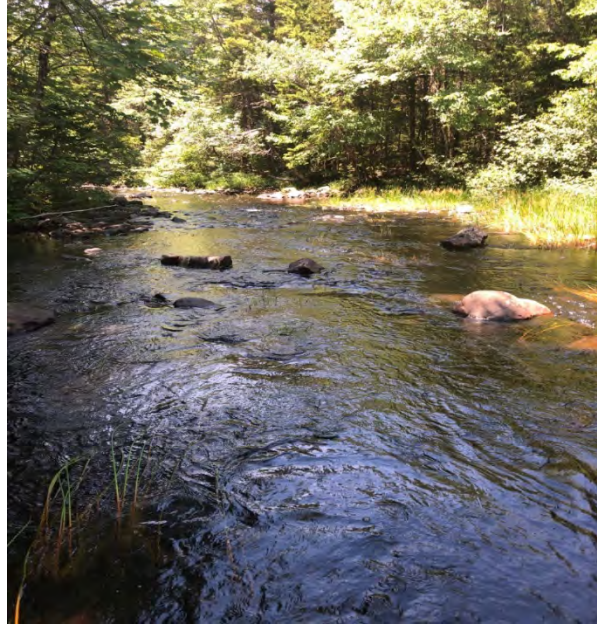
Photo 18. View downstream of transect T5 (Latitude: 44.97668, Longitude: -62.9435) approximately 520 m downstream from SW-2.

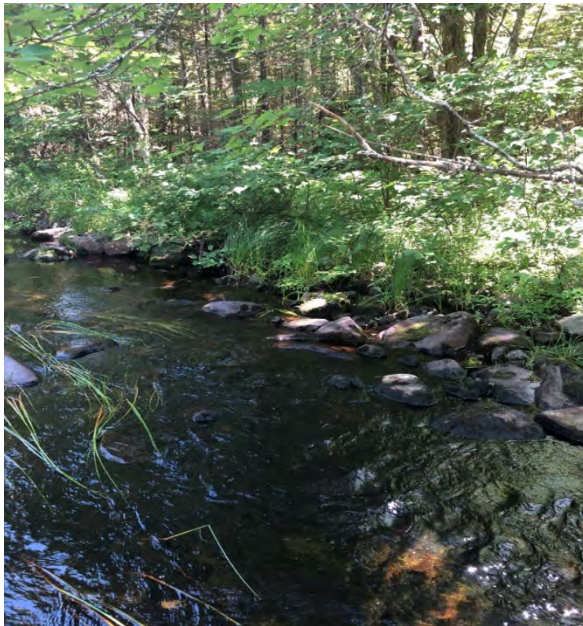
Photo 19. View of the left bank of transect T5 (Latitude: 44.97668, Longitude: -62.9435) approximately 520 m downstream from SW-2.

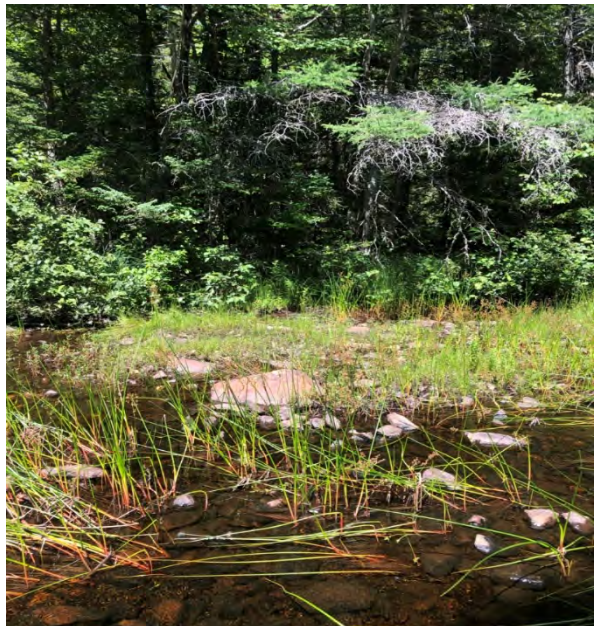
Photo 20. View of the right bank of transect T5 (Latitude: 44.97668, Longitude: -62.9435) approximately 520 m downstream from SW-2.

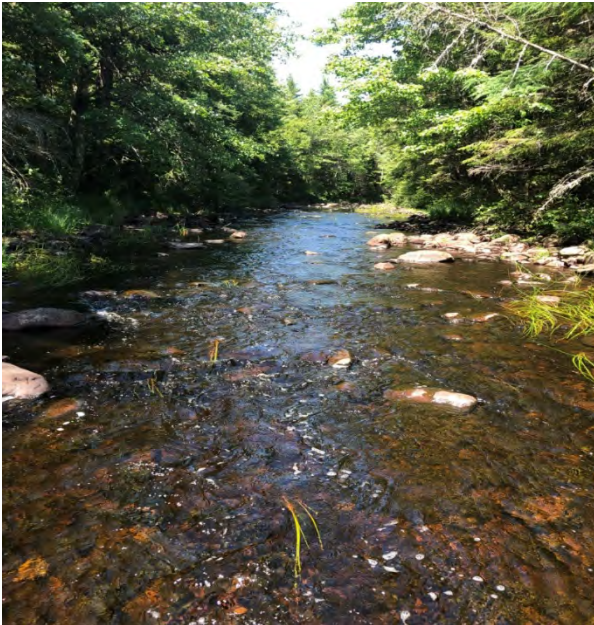
Photo 21. View upstream of transect T6 (Latitude: 44.97576, Longitude: -62.9445) approximately 650 m downstream from SW-2.

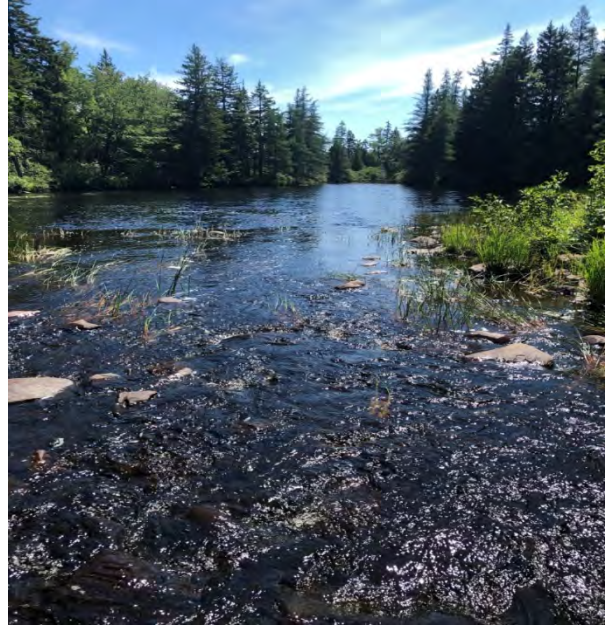
Two AOI were identified in the survey area that were generally shallow across the river bed. AOI 1 was located approximately 40 m upstream of transect T4 and AOI 2 was 2-3 m upstream of transect T6 at the end of the survey area where Moose River widens into a ponded area. Depth profiles for AOI 1 and AOI 2 are shown graphically in Figure X.X and data are provided in Appendix C. Given that adult and juvenile brook trout (*Salvelinus fontinalis*), juvenile landlocked Atlantic salmon (*Salmo salar*), American eel (*Anguilla rostrata*), and cyprinids including white sucker (*Catostomus commersonii*) have been previously reported to be within Moose River (CRA 2007), a minimum water depth of 5 cm would be required to allow upstream and downstream movements of these fish species and life stages. There was also an abundance of in-stream aquatic vegetation at these AOI which could become dense and further impede fish passage if water levels dropped to less than 5 cm. The maximum water depths in the AOIs at the time of the survey were 17 cm for AOI 1 and 9 cm for AOI 2 (19 cm).

Photo 22. View downstream of transect T6 (Latitude: 44.97576, Longitude: -62.9445) to AOI 2 approximately 650 m downstream from SW-2.

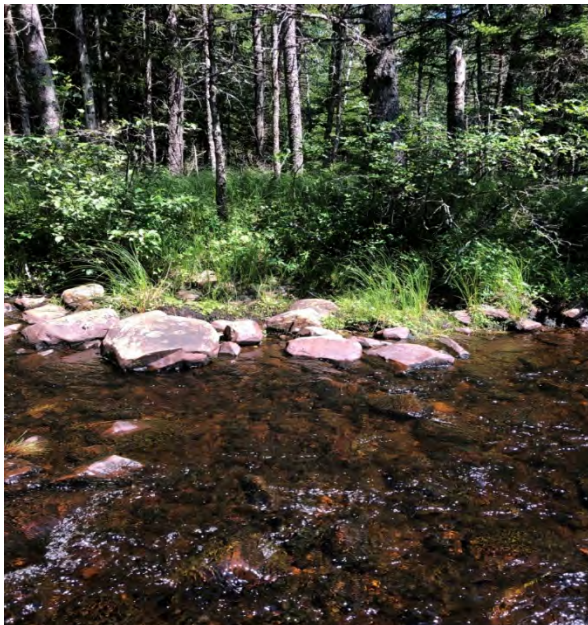
Photo 23. View of the left bank of transect T6 (Latitude: 44.97576, Longitude: -62.9445) approximately 650 m downstream from SW-2.

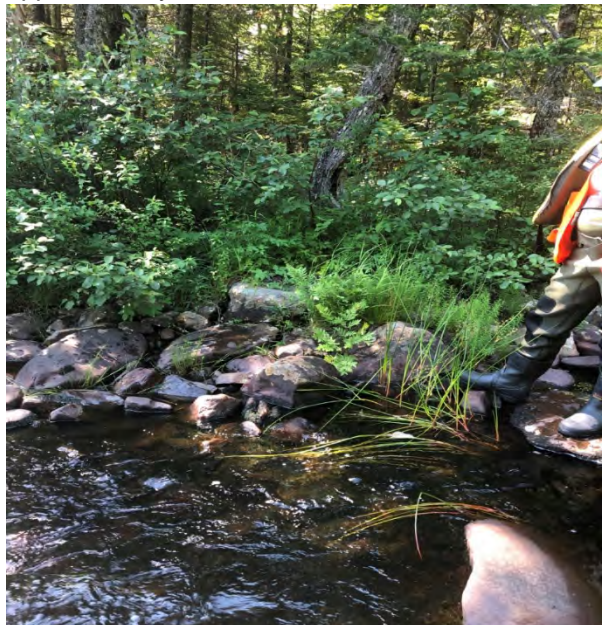
Photo 24. View of the right bank of transect T6 (Latitude: 44.97576, Longitude: -62.9445) approximately 650 m downstream from SW-2.

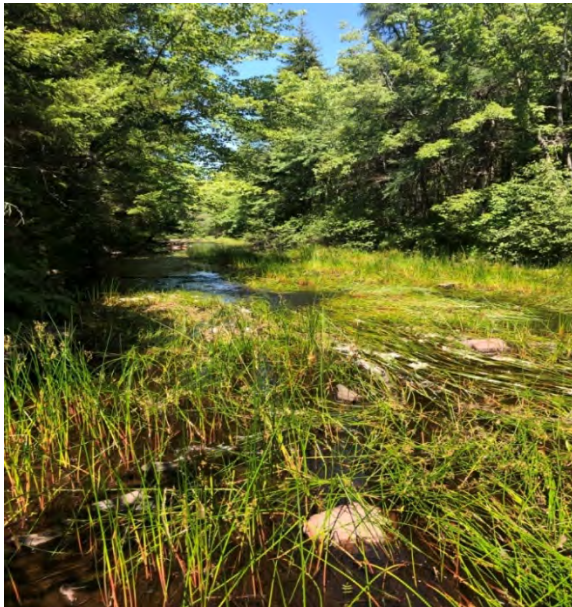
Photo 25. View upstream of potential AOI 1 (Latitude: 44.97707, Longitude: -62.9434) approximately 40 m upstream from T4.

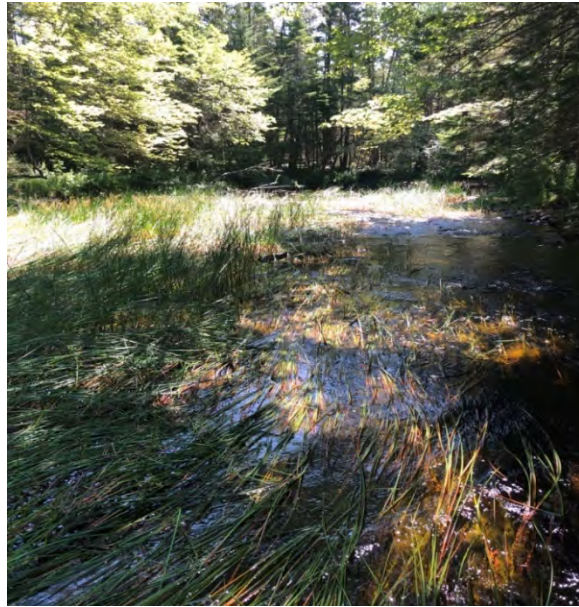
Photo 26. View downstream of potential AOI 1 (Latitude: 44.97707, Longitude: -62.9434) approximately 40 m upstream from T4.

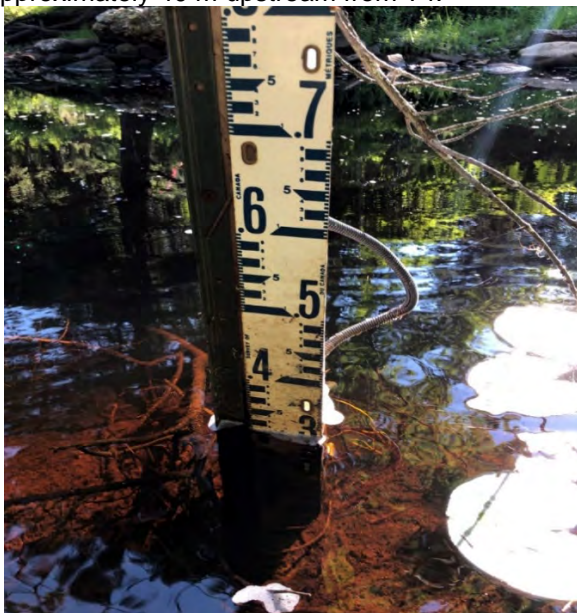
Photo 27. View of the staff gauge in Moose River located at SW-2. Gauge units are equivalent to 1/10th of a meter, therefore '4' on the staff gauge indicates 0.4 m water depth; gauge shows 0.315 m water depth.
