Watercourse and Fish Habitat Appendix 2021-2022

Westchester Wind Project

Watercourse and Fish Habitat Appendix: 2021-2022 Assessment for the Westchester Wind Project

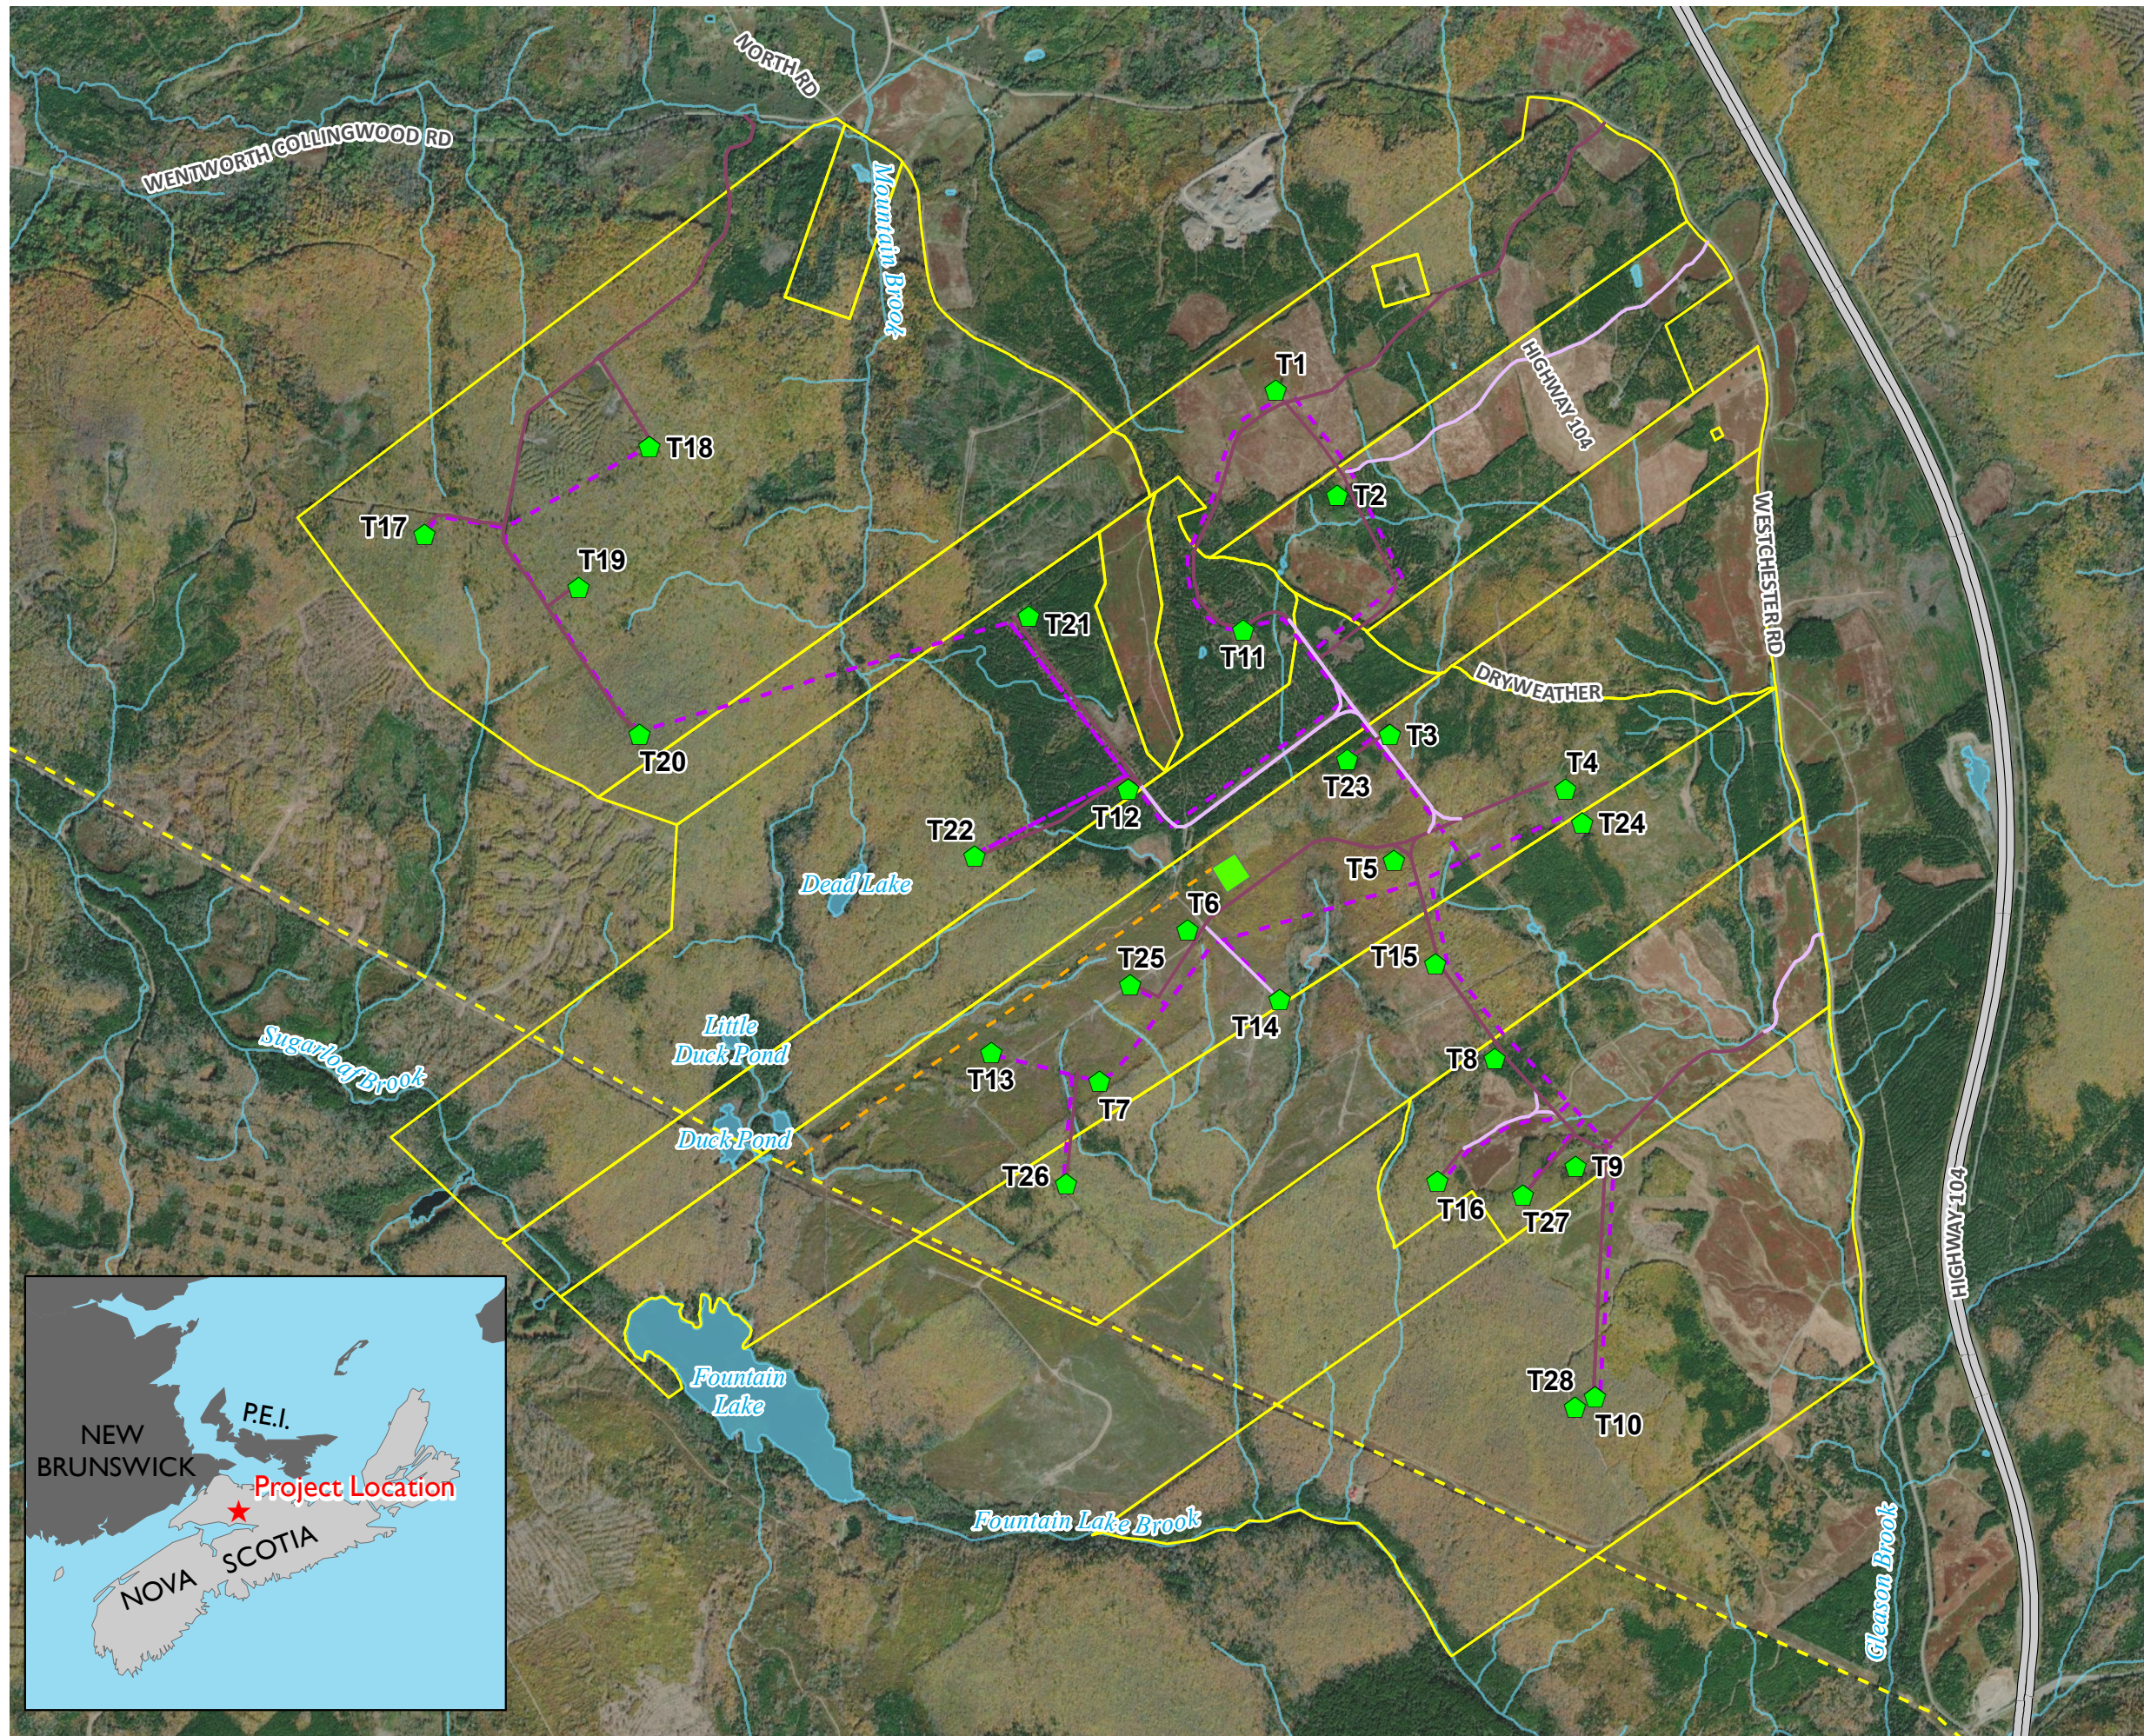
FIGURE 1

PROJECT LOCATION AND SITE LAYOUT

The Project is located on Westchester Mountain in Cumberland County, Nova Scotia. The Project is proposed to have an installed capacity of up to 50 MW, amounting to up to 12 wind turbine generators and associated infrastructure, including an electrical substation, collector lines, and overhead transmission line (Figure 1).

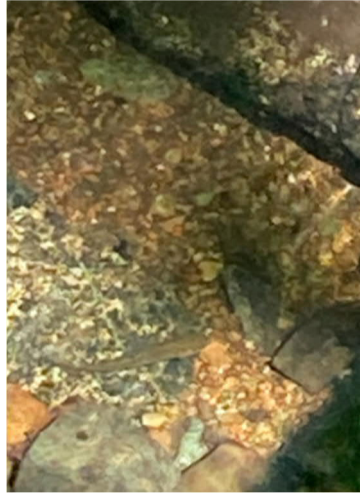
Brook Trout Observed in WC1-2022 July 26, 2022

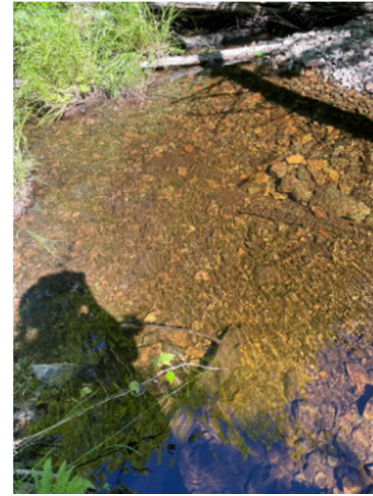
T4 July 13, 2022 – Small minnow observed Downstream

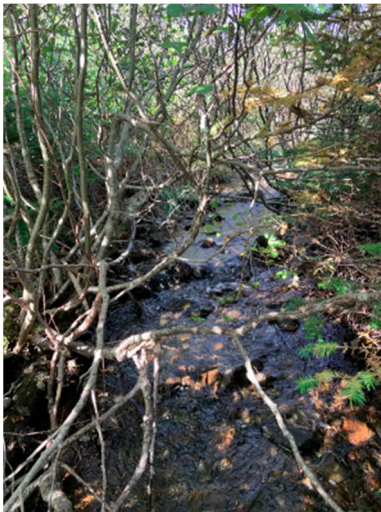
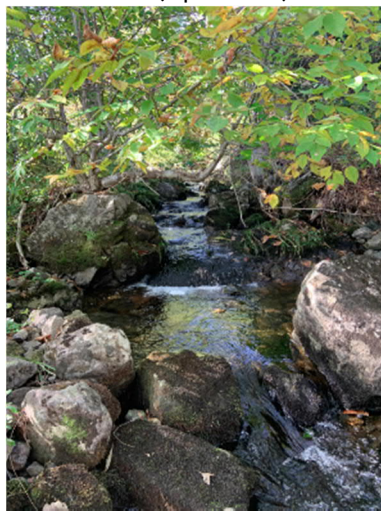
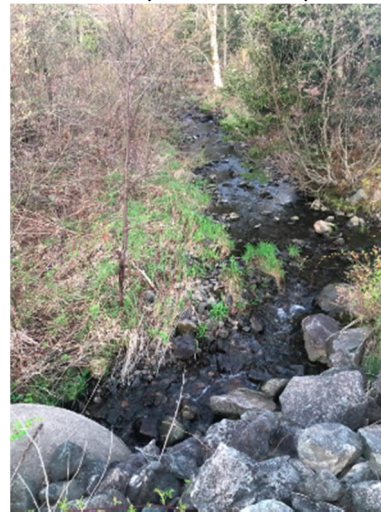
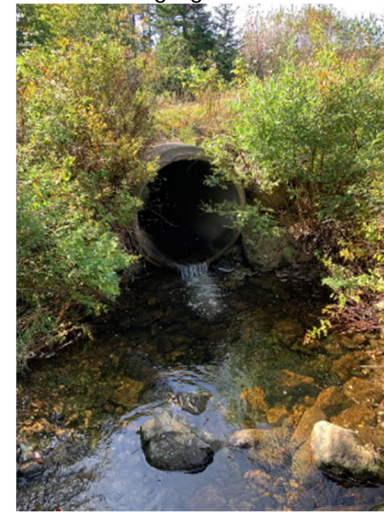
WC9-2021

Flow towards Gleason via a hanging culvert.
