## 5.0 Existing Environment

### 5.1 OVERVIEW OF PROJECT AREA

ALTON NATURAL GAS PIPELINE PROJECT

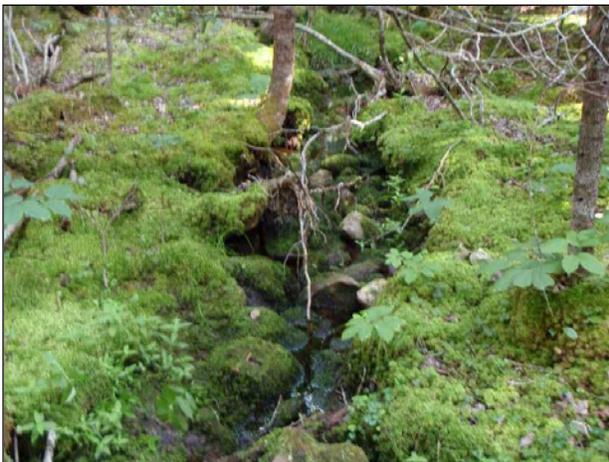
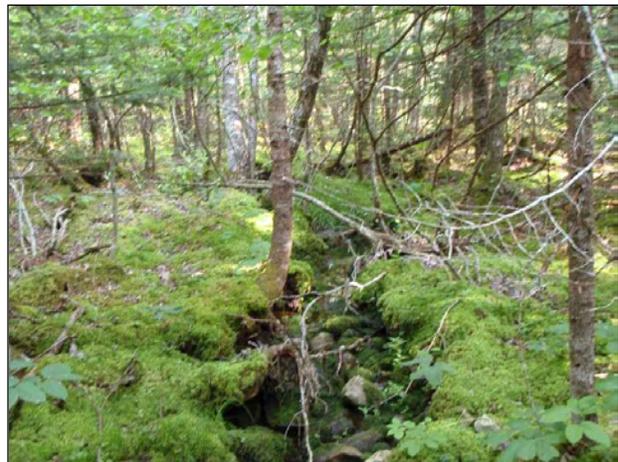
**PHOTOS 1 & 2**      **GL-1 crossing location**

Located 30 m to the east of the well site, GL-1 is an unnamed 1<sup>st</sup> order stream that contributes to the Stewiacke River approximately 2.25 km south-southeast. The headwaters for this watercourse likely originate a short distance above the crossing as the channel dissipates into subsurface flow 60 m upstream from the gas line crossing. Wetted width and depth increase into the downstream section, indicating an influx of water from drainage or spring seeps. While flow was indeterminate during the time of survey, higher flow periods were evident from the absence of leaf litter along the edges of the channel, this is most likely due to spring meltwater as no vegetation was uprooted along the channel edge. The substrate was predominately sand/gravel with the presence of boulders. Along the entire length of the survey area mosses and algae were present on the rocky substrate; the abundance of moss indicates low flow during the majority of the year. Canopy cover is between 25-50% and consists of coniferous forest which extends more than 100 m from the right bank and ends at clearing for the well site 30 m from the left bank. A couple of patches of vegetation are present between the center line and upstream transect which may limit the passage of large bodied fish. Discharge during the assessment period was non-detectable.

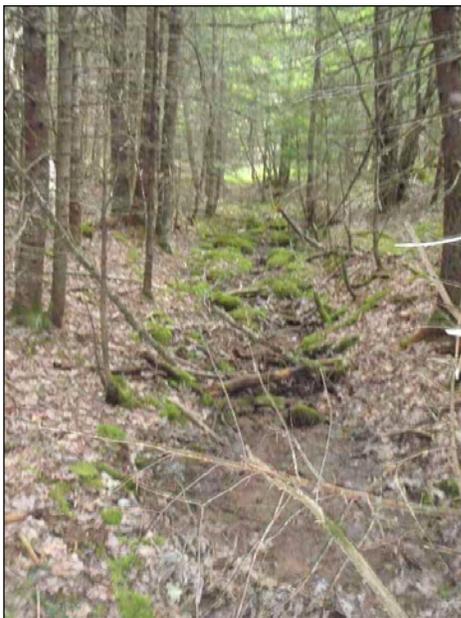
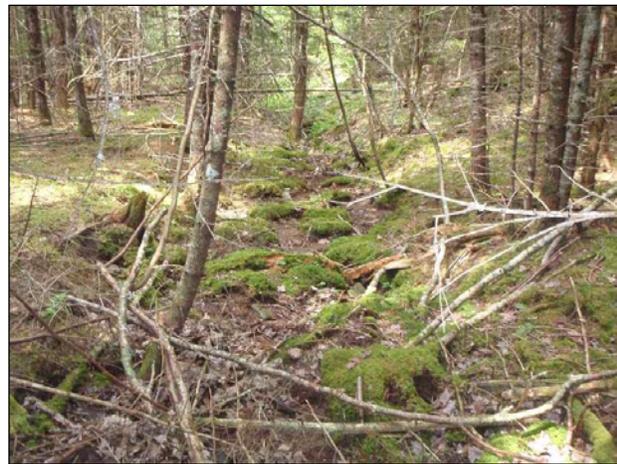
**PHOTOS 3 & 4      GL-5 crossing location**

The crossing at GL-5, was determined to not be a watercourse as the depression showed evidence of ephemeral flows during the spring freshet and contained no water during the survey. The bed of the depression contained large amounts of leaf litter and detritus similar to the surrounding forest floor. The depression was 1.90 m at the CL; continuing “upstream” the depression disperses and becomes undefined. Discharge during the assessment period was non-detectable, as no water was contained within the channel.

A fishing survey was not carried out in GL-5, as no suitable fish habitat was observed.

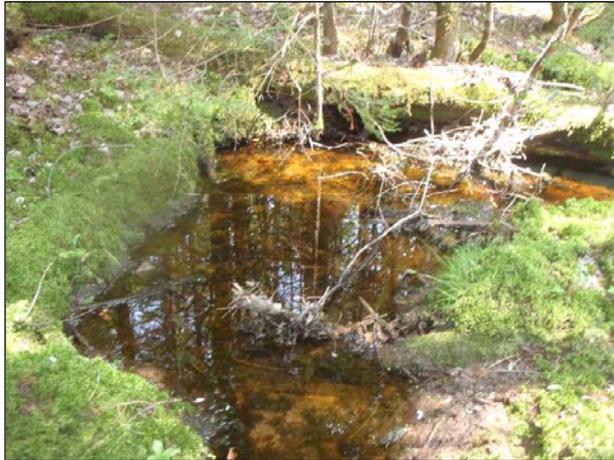
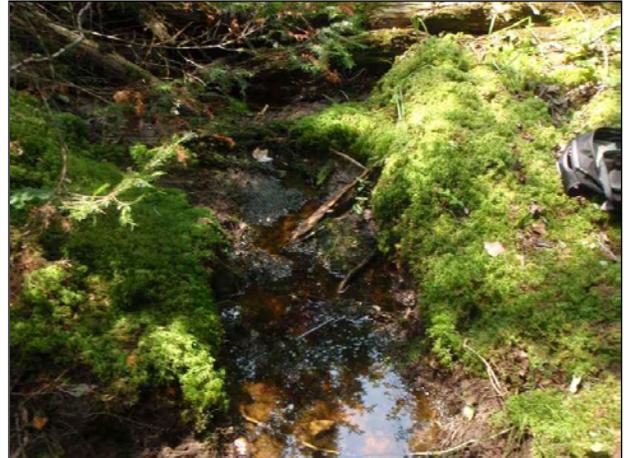
**PHOTOS 5 & 6**      **GL-6 crossing location**

The crossing at GL-6 is the first crossing south of the Stewiacke River, this watercourse ranged in width from 0.66 m -0.77 m with bankfull widths reaching 1.98 m. The water was tea-stained and no flow was observed during the assessment. The substrate ranged from cobble to boulder at the crossing location and upstream with heavy sedimentation observed at the downstream transects. Algal slimes and crusts were present on the majority of the rocky substrate. The sedimentation likely was caused through the erosion of streambanks as no additional sources of sediment were observed. The riparian zone at ground level was covered in moss with the canopy formed of a thin coniferous forest which provided approximately 50% coverage. This forest was cleared starting at 10 m from the right bank and 30 m from the left. The moss

encroached into the channel along with terrestrial grasses along drier reaches. Discharge during the assessment period was non-detectable.

A fishing survey was not carried out in GL-6, as no suitable fish habitat was observed.

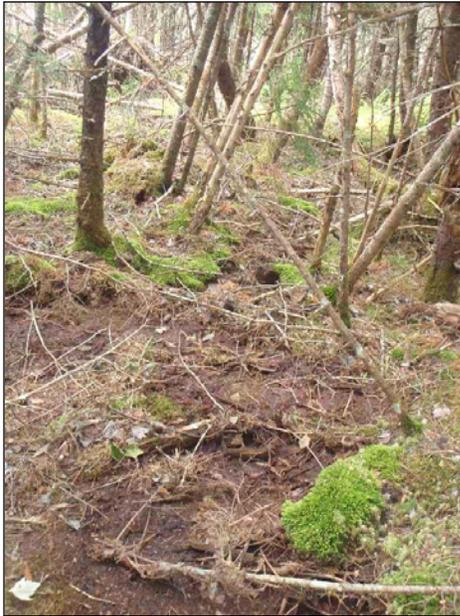
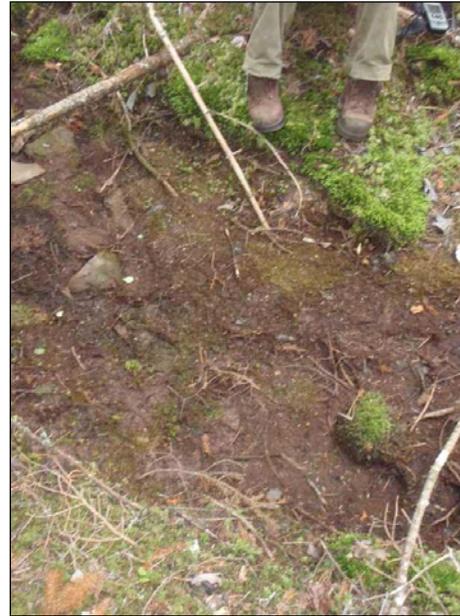
**PHOTOS 7 & 8      GL-7 crossing location**

The crossing at GL-7 is located approximately 800 m southeast of the intersection of the gas line and Cloverdale road. The channel width varies from 0.95 -1.22 m. At the time of the survey the only portion which contained water was upstream of the crossing location and consisted of intermittent pooling throughout the 100 m upstream transect, the slope is very gentle which decreases water velocities. Numerous deadfalls crossed the watercourse, including conifers whose roots had been exposed from the erosion of stream banks. Downstream from the crossing location there is increased bank erosion which in turn results in sedimentation in the still waters following bends in the channel. The channel ends with a large berm impounding the channel. The berm is located adjacent to a logging road and prevents the channel from flowing into the ditch alongside the road. The channel follows along the edge of the berm for a short distance approximately 10 m before dispersing. Substrate along the channel is composed of silt and small pebbles; deposition of silt is heavy often covering up to  $\frac{3}{4}$  of the rocky substrate. Upstream where the slope decreases ponding is present with moss growing within the channel. The left and right banks were mainly coniferous forest with de-forested areas up to 10 m from each bank. The trees remaining along the riparian zone provide 25-50% coverage for the channel. Discharge during the assessment period was non-detectable as no water was contained within the channel.

A fishing survey was not carried out in GL-7, as no suitable fish habitat was observed.

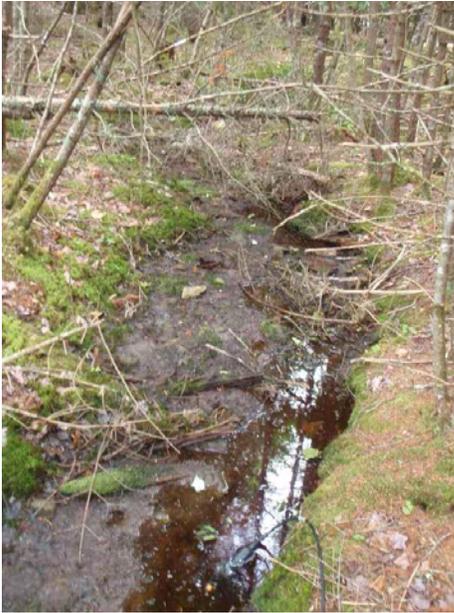
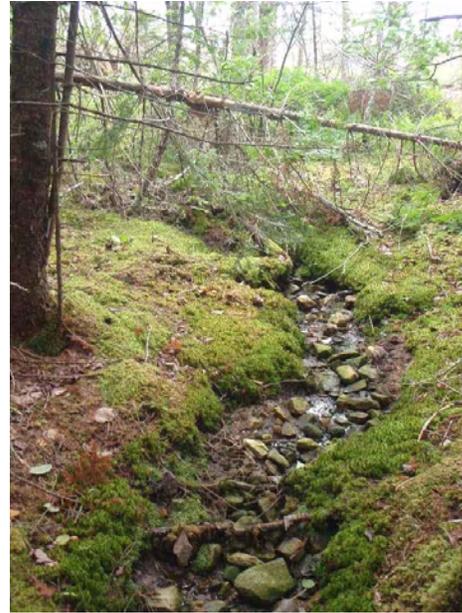
**PHOTOS 9 & 10**      **GL-8 crossing location**

Crossing GL- 8 was determined on site to not be a watercourse. There was pooling at the crossing location with the average water depth 6.0 cm; a potential wetland begins 10 m upstream from the crossing location and expands in width upstream. Downstream the channel becomes dry approximately 30 m from the crossing location. Along the entire surveyed length of the GL-8 deadfalls have fallen across channel; in one section the flow was completely blocked. The dry channel bed widens downstream from the crossing location and becomes deeply entrenched. The substrate is predominately silt, with sand or pebbles with the pebbles deeply embedded in the silt. At certain locations in the channel bed moss and algae has grown over the substrate. The riparian zone surrounding the channel is mainly coniferous forest and open to clearcuts. The coniferous forest provides 50-75% coverage for the channel. GL-8 had no visible flow during the assessment, but detritus was removed from the center of the channel due to rain events of the previous day. Discharge during the assessment period was non-detectable as no water was contained within the channel.

A fishing survey was not carried out in GL-8, as no suitable fish habitat was observed.
