# APPENDIX D

## TERRESTRIAL SURVEY RESULTS

GOLDBORO  
LNG

## **Habitat, Wetland and Rare Lichen Survey, September 24-28<sup>th</sup>, 2012: Methods, Results and Photographs**

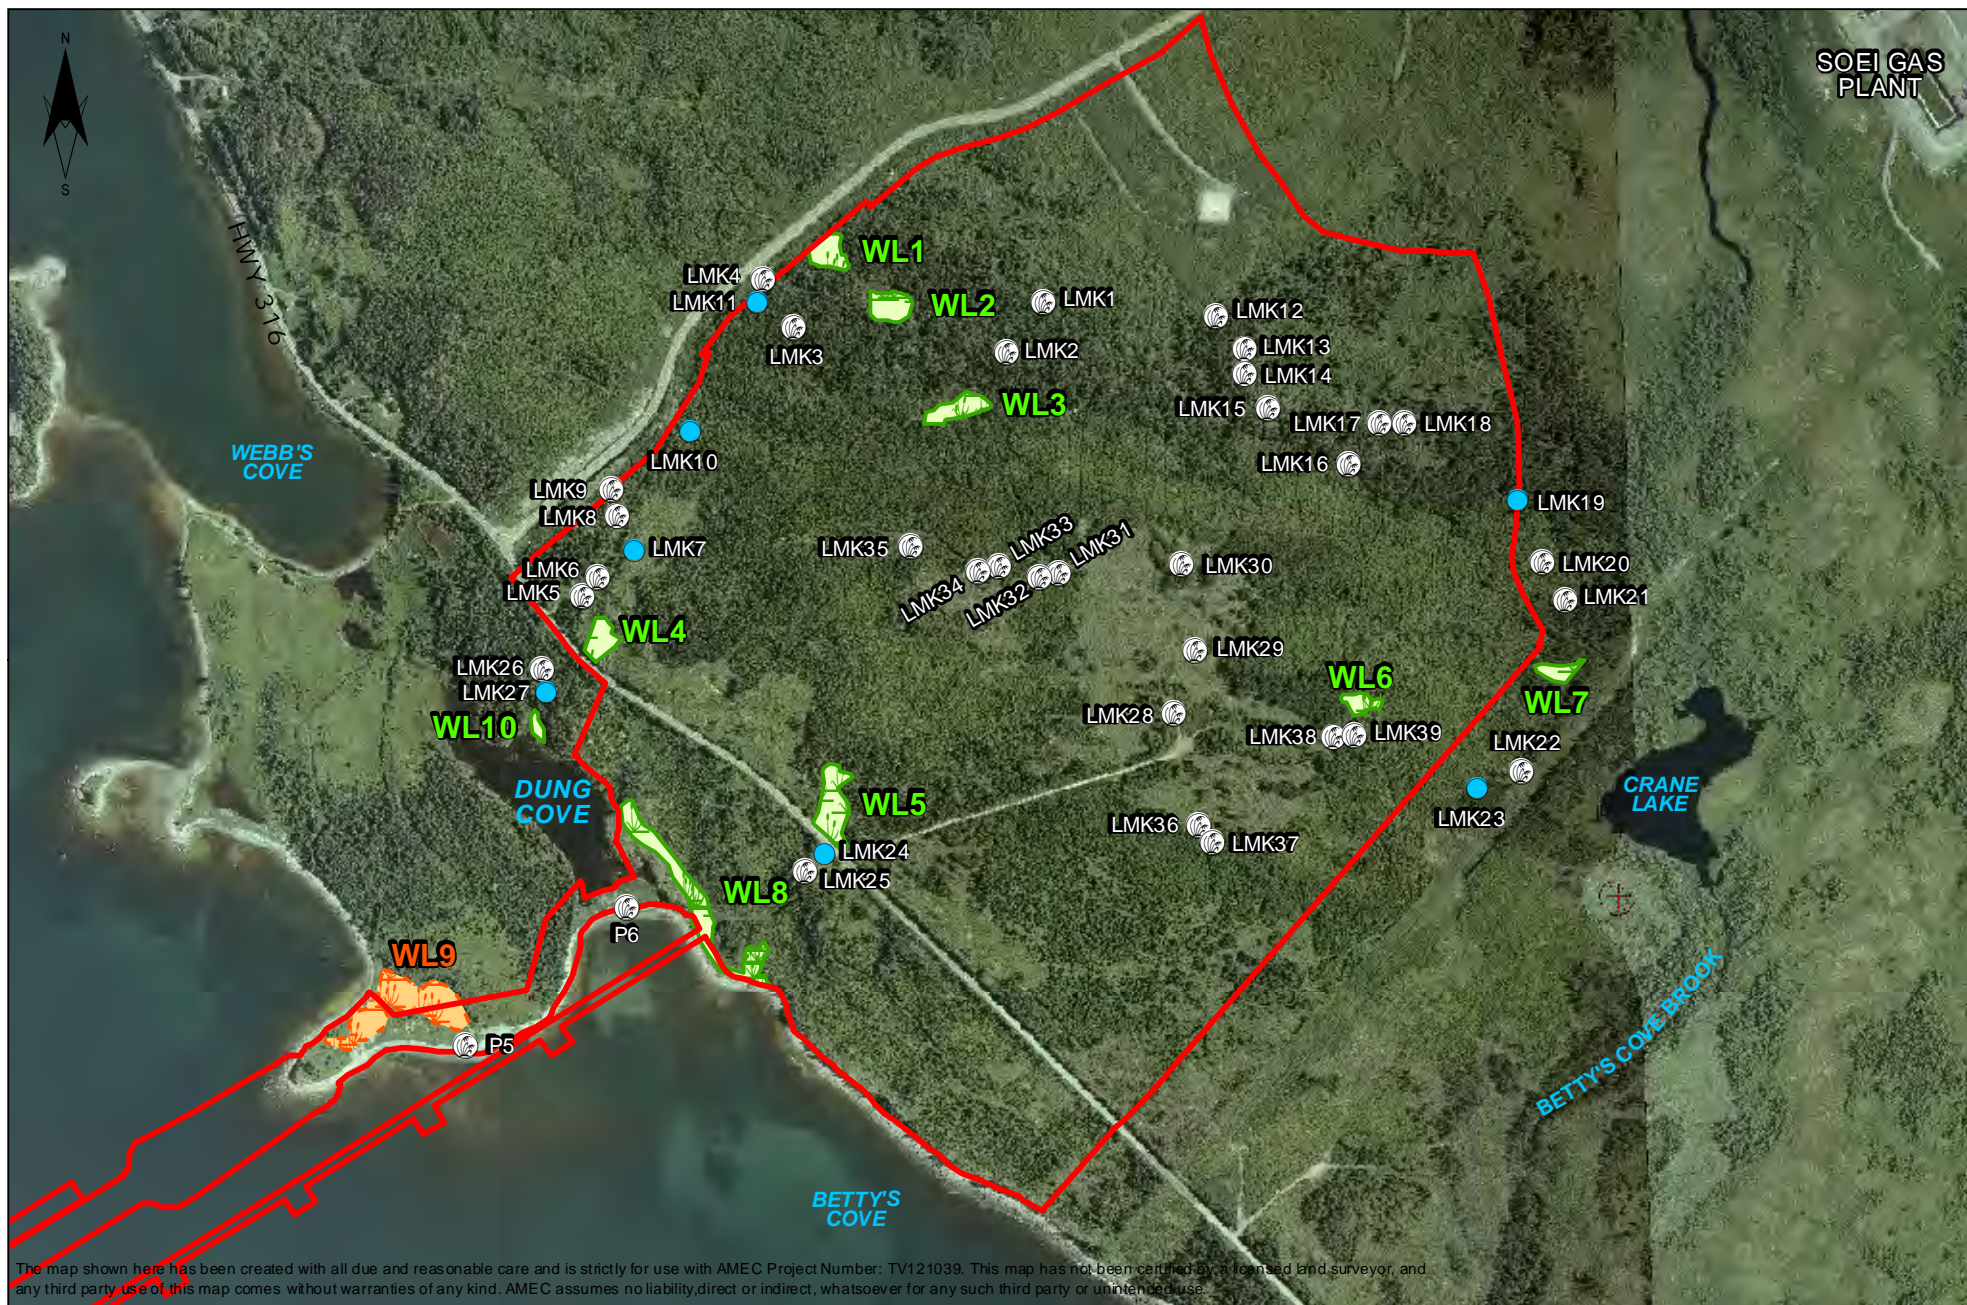
100 50 0 100 200 Metres	PROJECT: <b>GOLDBORO LNG</b>	DWN BY: TM	DATE: May 2013
	DATUM: NAD 83		CHK'D BY: MS	REV. NO:
	PROJECTION: UTM 20 North	TITLE: <b>WETLAND, HABITAT AND LICHEN SURVEY SEPTEMBER 2012</b>	SCALE: 1:10,000	FIGURE NO: 1
	PROJECT NO: TV121039

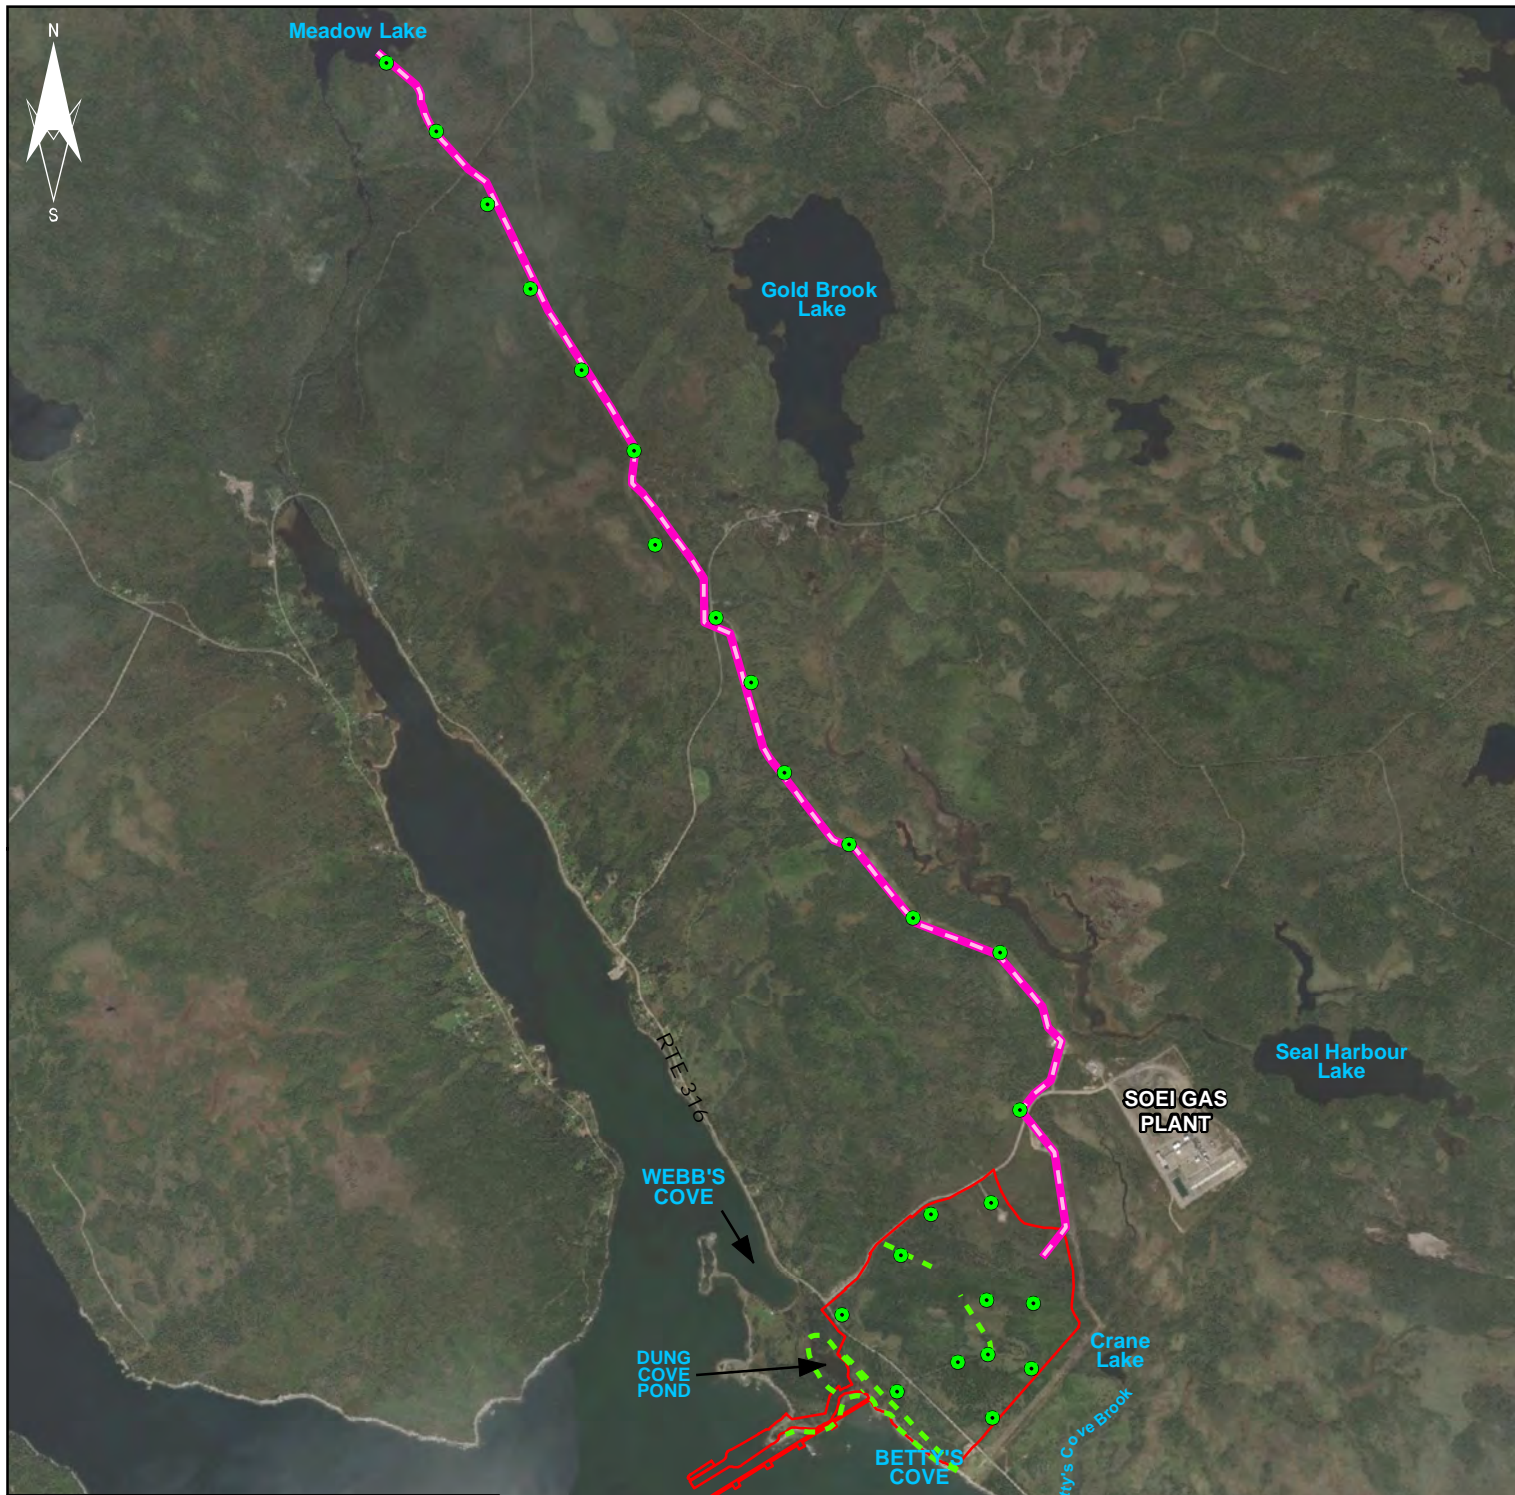
- 2013 Point Count Survey Locations
- Water Supply Pipeline
- - - Bird Survey Transect
- 20130515\_New\_Footprint

Survey locations are depicted in Figure 1. Only one avian SAR, the Olive-sided Flycatcher, was observed during the surveys: two individuals were heard near the intersection of the pipeline ROW with Goldbrook Road.

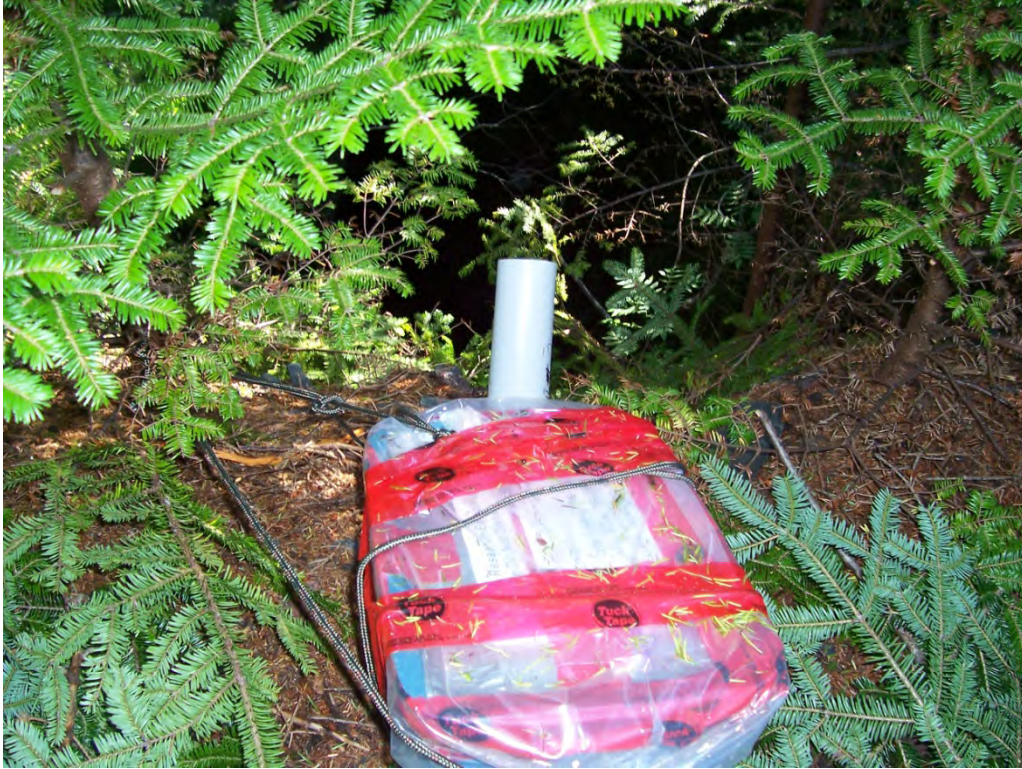
**Photo D6-1: Anabat SD2 unit deployed near AMO, before concealment in brush**

Table D6-1: Summary of Anabat SD2 and Roost Logger data recorded at AMO ISH-05-026 from Aug 27 to September 16, 2013

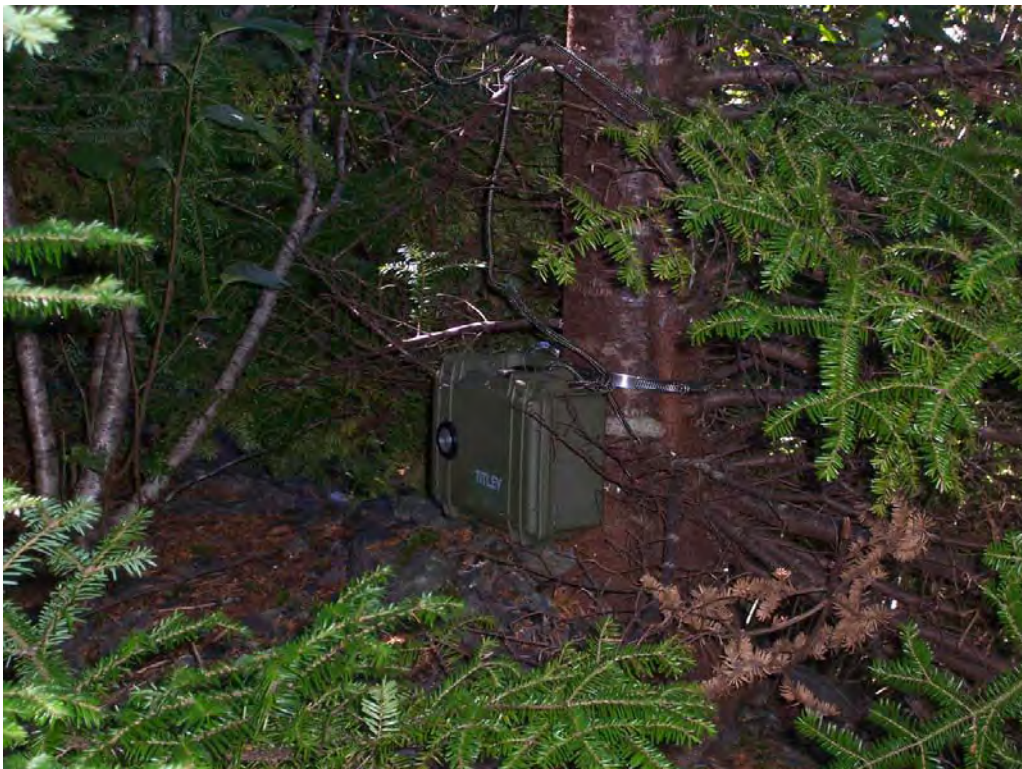
**Photo D6-2: Anabat Roost Logger deployed at entrance to AMO**
