NOVA SCOTIA TRANSPORTATION AND INFRASTRUCTURE
RENEWAL

Environmental Assessment Final – Highway 107 Burnside to Bedford

Final Report

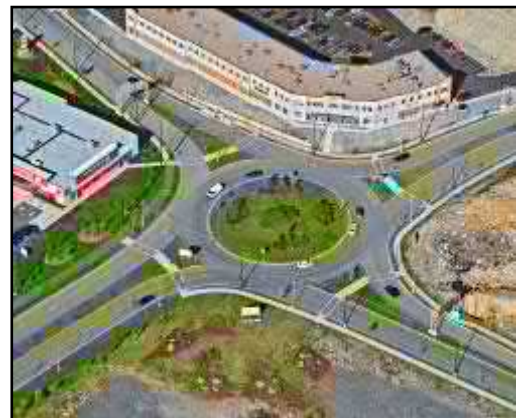
Photo 1 Typical Roundabout (Photo provided by NSTIR)

Figure 1-1 identifies proposed structure locations. Modern multilane roundabouts (R1 to R11) will follow NSTIR design standards. **Photo 1** shows a typical roundabout similar to those proposed for this Project.

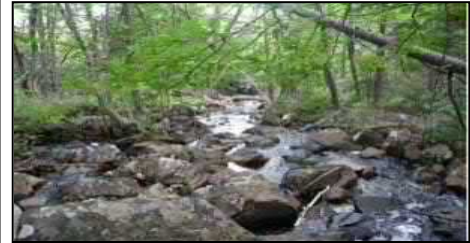
Photo 4 WC-04 Wrights, Wiggins Brook

The crossing of Wrights/Wiggins Brook (water crossing - WC-04) between Enchanted Lake and Flat Lake in Burnside will be constructed as a concrete culvert (approximately 1800 mm diameter) with fish passage features (baffles) designed through discussion with the Department of Fisheries and Oceans Canada (DFO). This crossing location will be re-aligned to allow construction “off-line” and will include a plunge pool and baffle installation.
