**RE: Amendment of Industrial Approval No. 2001-019700
Quarry - Panuke Road
Municipal Enterprises Limited**

Construction and operation of a Quarry, and associated works, at or near Panuke Road, Three Mile Plains, Hants County in the Province of Nova Scotia.

Project: Municipal Enterprises Limited
Quarry
Panuke Road
Three Mile Plains, Hants County

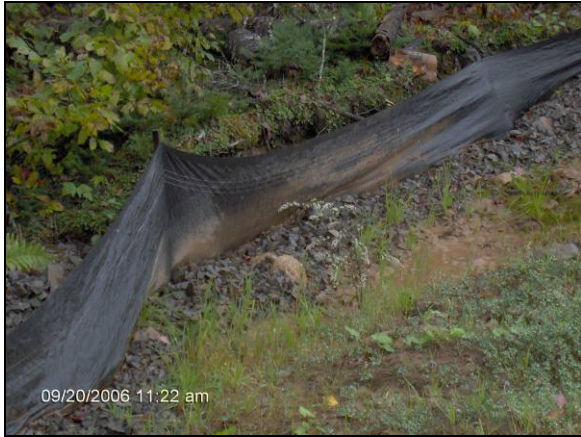
Photo 1. Silt control screens erected around the SW perimeter of the quarry

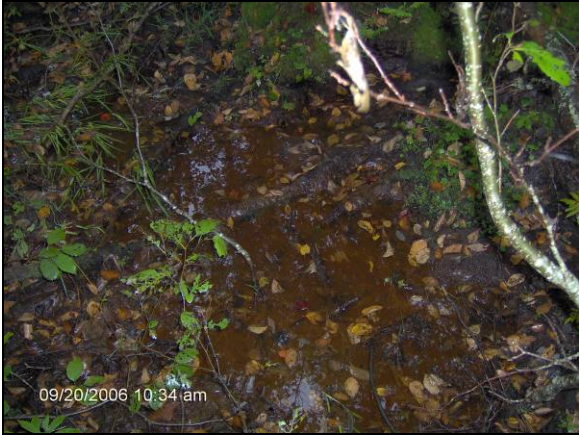
Photo 2. View facing up stream at the start of the survey, Site 1.

Site 1, UTM Grid (20414186, 4976004): The stream at this location had a dry width of 2.8 m and a wet width of 1.2 m. The flow rate was $<0.1 \text{ m}\cdot\text{s}^{-1}$ and the maximum water depth was 10 cm. Substrates consisted of leaf detritus, orange flocculent material and fine sediments, which were up to 5 cm deep, overlaying well embedded angular rocks and cobbles. There were no obvious signs of anthropogenic impacts. Both banks consisted of rocks which were covered with sphagnum moss and ferns. The banks were 30-40 cm high and offered no overhangs. There was 70% overhead canopy cover from mixed deciduous trees. The stream at this location also supported abundant aquatic vegetation and frogs.

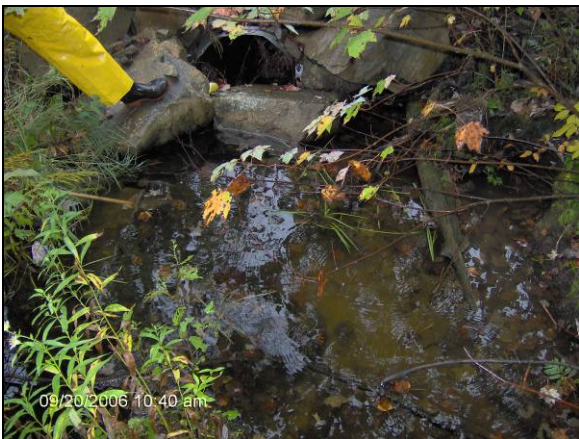
Photo 3. The first culvert and aquatic plants showing direction of brook flow, Site 2.

Site 2, UTM Grid (20414141, 4976037): The stream at this location had a dry width of 3.0 m and a wet width of 2.8 m, passing through a 60 cm culvert underneath a forest track road. At this location, the stream consisted of a shallow pool with low flow where the maximum water depth was 25 cm. Substrates consisted of decaying leaves, detritus, and soft sediments overlaying well embedded angular rocks and cobbles. There were no obvious signs of anthropogenic impacts. Both banks consisted of rocks which were covered with sphagnum moss and ferns. The banks were 40 cm high and had slight undercutting. There was between 50-70% overhead canopy cover from mixed deciduous trees. Water striders were present at this site.

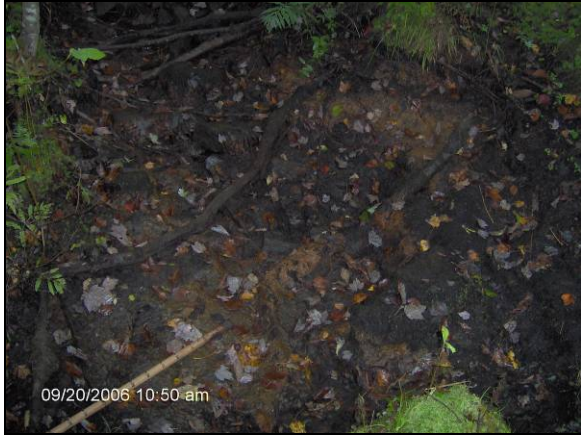
Photo 4. Dry stream bed, which would normally be a pool, Site 3.

Site 3, UTM Grid (20414105, 4976063): The dry stream bed at this location had a maximum width of 3.0 m, which would normally be a pool. Substrates consisted of decaying leaves, detritus, and soft sediments which were up to 5 cm deep and covered by dried orange flocculent material. These sediments were overlaying well embedded angular cobbles. There were no obvious signs of anthropogenic impacts. Both banks consisted of rocks which were covered with sphagnum moss and ferns. There was between 90-95% overhead canopy cover from mixed deciduous and coniferous trees at this site.

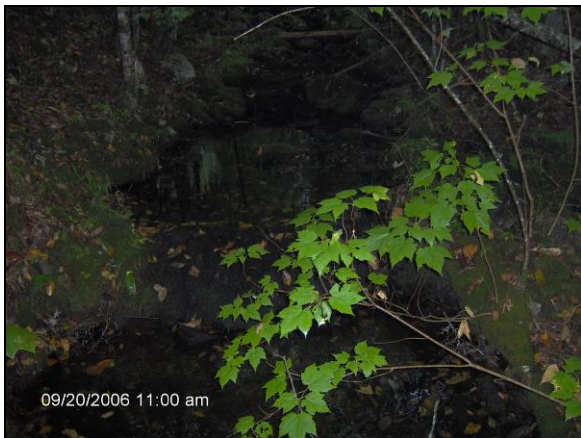
Photo 5. Had the stream not been dry a series of cascades would exist, Site 4.

Site 4, UTM Grid (20414061, 4976072): At this location, the partially dry stream bed exhibits several isolated pools of water with almost no flow. Had the stream been running there would be a series of cascades and runs. The stream had a dry width of 2.6 m, a wet width of 2.5 m and a maximum water depth of 50 cm in the deepest pool. Substrates consisted of decaying leaves, detritus, and soft sediments overlaying well embedded angular cobbles. Both banks consisted of rocks which were covered with sphagnum moss and ferns. There was 100% overhead canopy cover from mixed deciduous and coniferous trees. Along this 18 m section there would be a series of cascades and runs with a 7.5% slope as the stream descends 1.35 m.

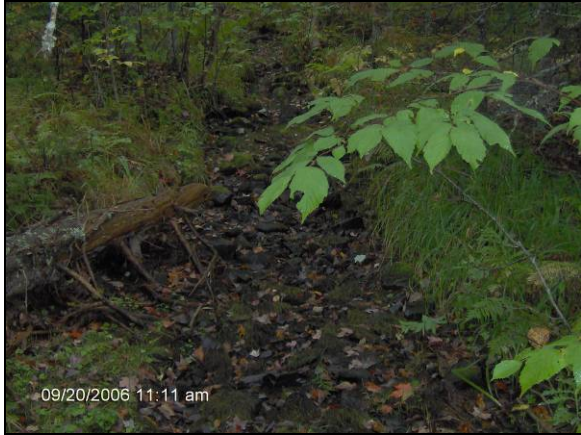
Photo 6. Dried stream bed covered with leaf detritus and dried aquatic vegetation, Site 5.

Site 5, UTM Grid (20414026, 4976119): At this location, the dry stream bed exhibits a 20 m straight run with a 5.6% slope. The stream would have a dry width of 2.6 m. Substrates consist of dried aquatic vegetation overlaying well embedded angular cobbles and gravel. Banks consist of rocks covered with sphagnum moss and ferns. There was 100% overhead canopy cover from mixed deciduous and coniferous trees. At this site, the quarry was only 40-50 m NE from the stream.

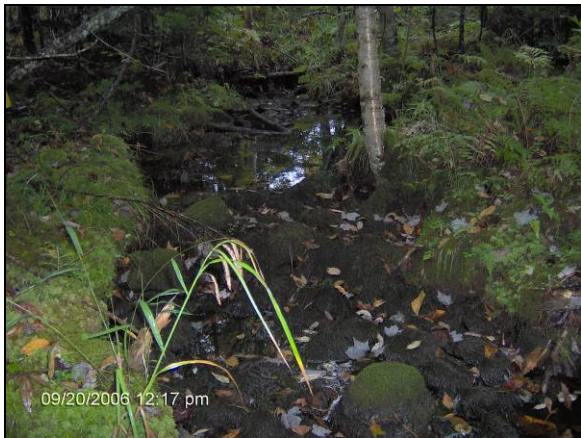
Photo 7. Partially filled stream bed with large embedded weed covered boulders, Site 6.

Site 6, UTM Grid (20413996, 4976159): Under normal conditions the stream at this location would have riffles along this section, but now exhibits almost no flow. The stream had a width of 2.1 m and a maximum water depth of 22 cm in the deepest of 3 isolated shallow pools. Substrates consisted of decaying leaves, detritus, and soft silty sediments overlaying well embedded angular cobbles. Both banks consisted of rocks which were covered with sphagnum moss, and tree roots offering a small amount of overhang. There was 90% overhead canopy cover from mixed deciduous and coniferous trees. Along this section there was <5% slope.

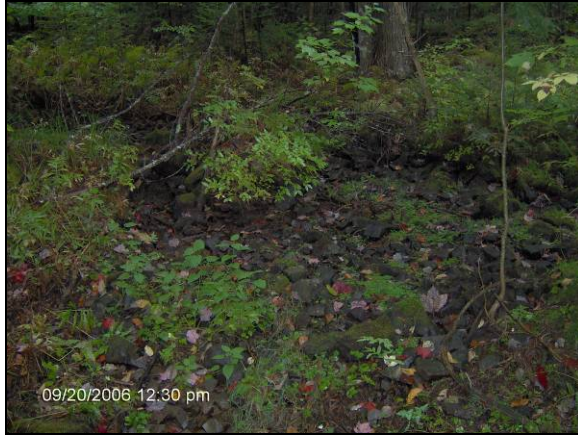
Photo 8. Dry stream bed, Site 7.

Site 7, UTM Grid (20413938, 4976193): Under normal conditions, the stream at this site would have riffles along this section, but is now completely dry; with a maximum width of 5.5 m. Substrates consisted of embedded angular cobbles and gravel. Both banks consisted of rocks, which were covered with sphagnum moss and tree roots up to 40 cm high offering no overhang. There was 70% overhead canopy cover from mixed deciduous and coniferous trees. Along this section there was 7% slope and remnants of flood debris, such as tree branches and logs.

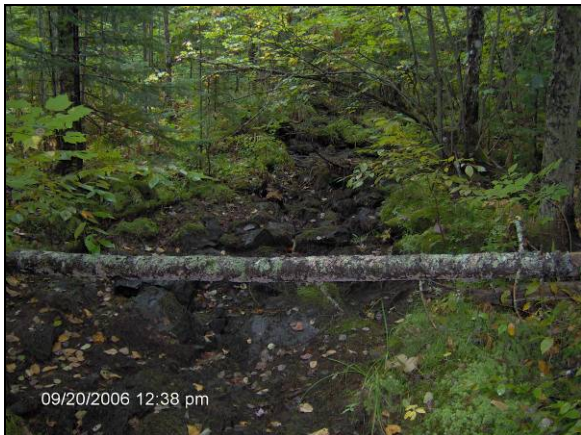
Photo 9. Dried stream bed showing flood debris, Site 8.

Site 8, UTM Grid (20413915, 4976240): Under normal conditions the stream at this site would have runs and riffles along this section, but is now completely dry, with a maximum width of 3.0 m. Substrates consisted of embedded angular rocks and cobbles covered by moist aquatic vegetation. Both banks consisted of rocks, which were covered with sphagnum moss and tree roots up to 30 cm high offering no overhang. There was 90% overhead canopy cover from mixed deciduous and coniferous trees. Along this section there was more evidence of flood debris such as tree branches and logs.

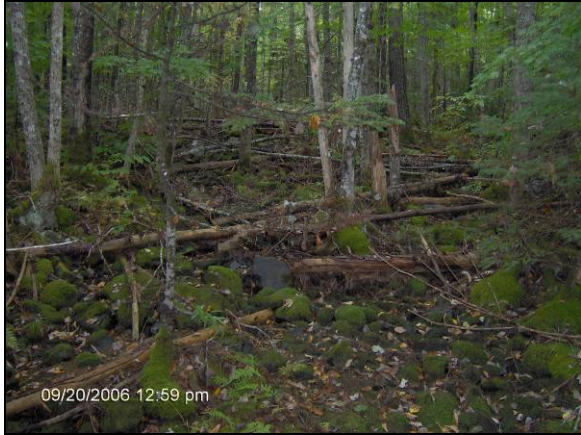
Photo 10. Poorly defined dried stream bed, Site 9.

Site 9, UTM Grid (20413937, 4976313): The stream here was again dry, but under normal conditions would have three poorly defined channels along this section. Combined, the three channels would have a maximum width of 20 m. Substrates consisted of embedded angular rocks and cobbles covered by aquatic vegetation. Banks are poorly defined at this site, but consist of rocks which were covered with sphagnum and other unidentified mosses, offering no overhang. There was 90% overhead canopy cover from mixed deciduous and coniferous trees. Along this section there was a steeper 15% slope and more evidence of flood debris, such as tree branches and logs.

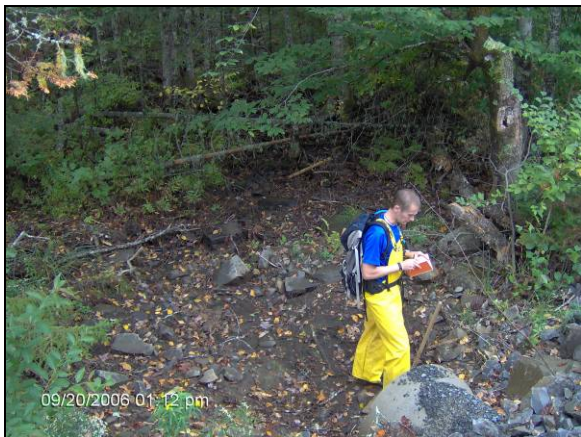
Photo 11. Second culvert with dried stream bed, Site 10.

Site 10, UTM Grid (20413954, 4976418): The stream at this location had a maximum width of 5.5 m and passed through a 60 cm culvert underneath a forest track road. Substrates consisted of decaying leaves, detritus, and soft sediments overlaying well embedded angular cobbles and gravel, along with some boulders. Both banks consisted of rocks which were covered with sphagnum moss and roots. There was 50% overhead canopy cover from mixed deciduous trees. Along this section there was a 4% slope and more evidence of flood debris, such as tree branches and logs.

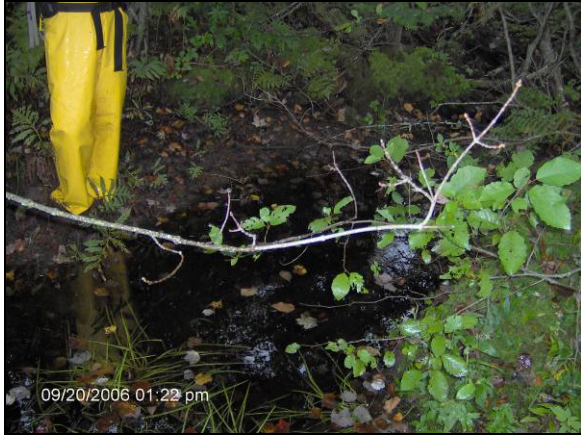
Photo 12. Stagnant pool with no flow, Site 11.

Site 11, UTM Grid (20413985, 4976470): The stream at this location had a dry width of 2.4 m and a wet width of 1.4 m. There was a stagnant pool with virtually no flow rate and maximum water depth was 30 cm. This pool was preceded by a wide ill-defined stream bed. Substrates consisted of leaf detritus, and fine soft sediments, which were up to 20 cm deep. Banks were covered with sphagnum moss and ferns up to 30-40 cm high, offering small overhangs. There was 80-90% overhead canopy cover from mixed deciduous trees. Along this section there was <4% slope and the stream also supported water striders.

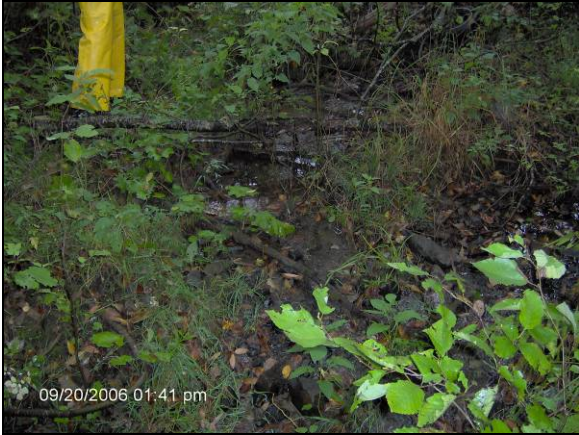
Photo 14. Tributary stream entering dried stream bed, Site 13.

Site 13, UTM Grid (20414041, 4976573): This is a tributary stream which enters the dry stream bed. The tributary has a flow rate of $0.2 \text{ m}\cdot\text{s}^{-1}$ and originates from ground water out of rocks behind the quarry. The tributary has a wet width of 85 cm and a maximum water depth of 5 cm. Substrates consisted of leaf detritus, and fine soft sediments covering embedded angular cobbles and gravel. Banks were covered with sphagnum moss and ferns up to 30-40 cm high, offering small overhangs. There was 50-60% overhead canopy cover from mixed deciduous trees at this location.

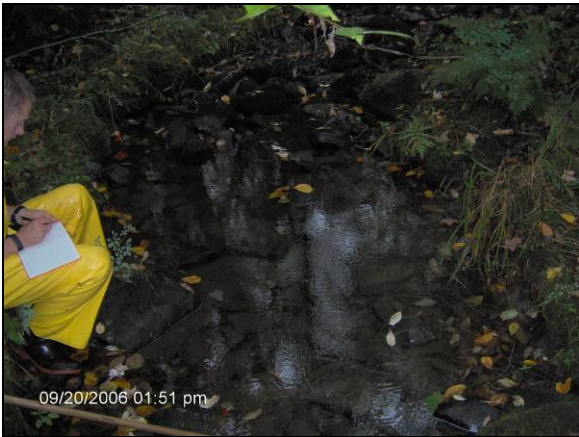
Photo 15. Small pool containing unidentified fish, Site 14.

Site 14, UTM Grid (20414046, 4976618): This section of the stream becomes a small pool with a maximum water depth of 25 cm and a width of 1.0 m. Substrates consisted of leaf detritus, and fine soft sediments covering embedded angular cobbles with almost no slope. Banks were covered with sphagnum moss and ferns up to 40 cm high offering small overhangs, where unidentified fish (2-3 cm long) were seen. There were also lots of water striders at this site. There was 70-90% overhead canopy cover from mixed deciduous trees.

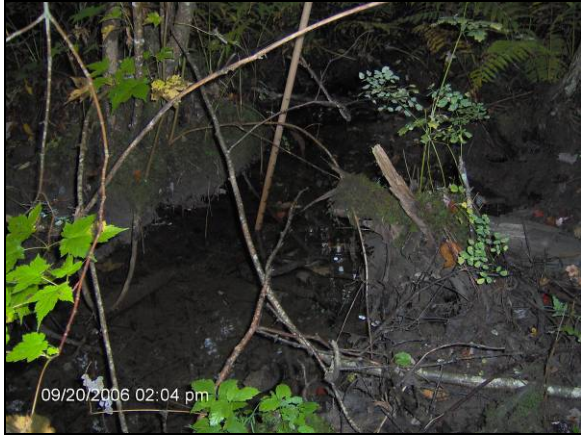
Photo 16. Stream containing unidentified fish, Site 15.

Site 15, UTM Grid (20414073, 4976677): This section of the stream becomes more defined with a slow run with low flow, maximum water depth of 30 cm and width of 1.0 m. Substrates consisted of leaf detritus, and fine soft sediments, with a depth of 10 cm. No cobbles were seen here. Banks were covered with sphagnum moss and ferns up to 40 cm high, offering multiple overhangs, where unidentified fish (3-4 cm long) were seen. There were also lots of water striders at this site. There was 90% overhead canopy cover from mixed deciduous and coniferous trees.

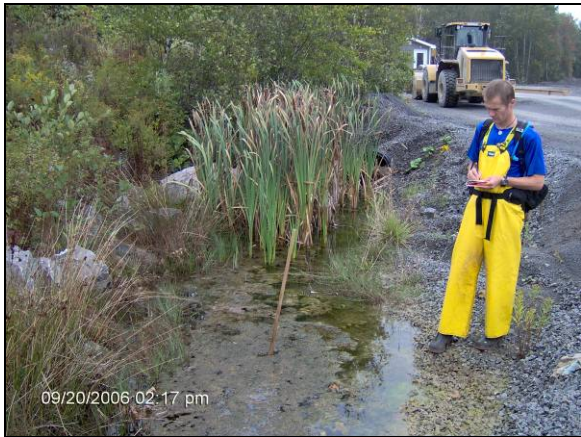
Photo 17. Small pool within the quarry supporting juvenile fish, Site 16.

Site 16, UTM Grid (20414049, 4976493): At this location there is a small pool (10 x 1.5 m) in the western corner of the quarry, choking with weed and surrounded by cat tails. The maximum water depth was 40 cm with soft quarry silts up to 10 cm deep. This pool contains >20 unidentified fish. The out flow of the pool passes through a culvert and forms the tributary stream at site 13.

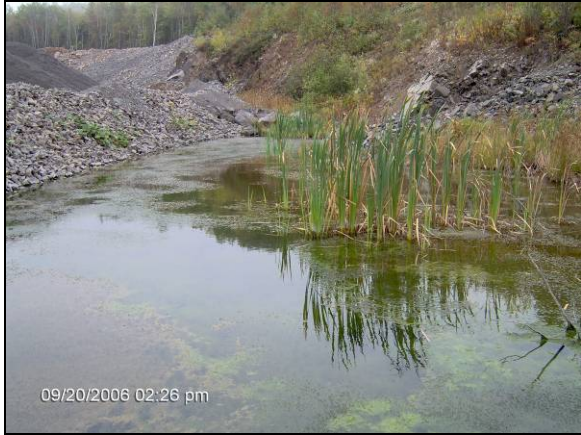
Photo 18. Large pool within the quarry supporting juvenile fish, Site 17.

Site 17, UTM Grid (20414061, 4976072): At this site there is a large pool in the western corner of the quarry, containing weed and surrounded by cat tails. The maximum water depth was 35 cm with soft quarry silts up to 10 cm deep. This pool contains >50 unidentified fish. The out flow of the pool passes through a culvert which feeds into the small pool and ultimately forms the tributary stream at site 13.
