**Flat Lake, Highway 103,  
HADD Compensation Project  
(DFO HADD Authorization 03-G8-068):  
2009 Vegetation Monitoring:  
September 11, 2009 (Year 4)**

Diane LaRue, Vegetation Consultant,  
Environmental Services, NSTIR

September 2009

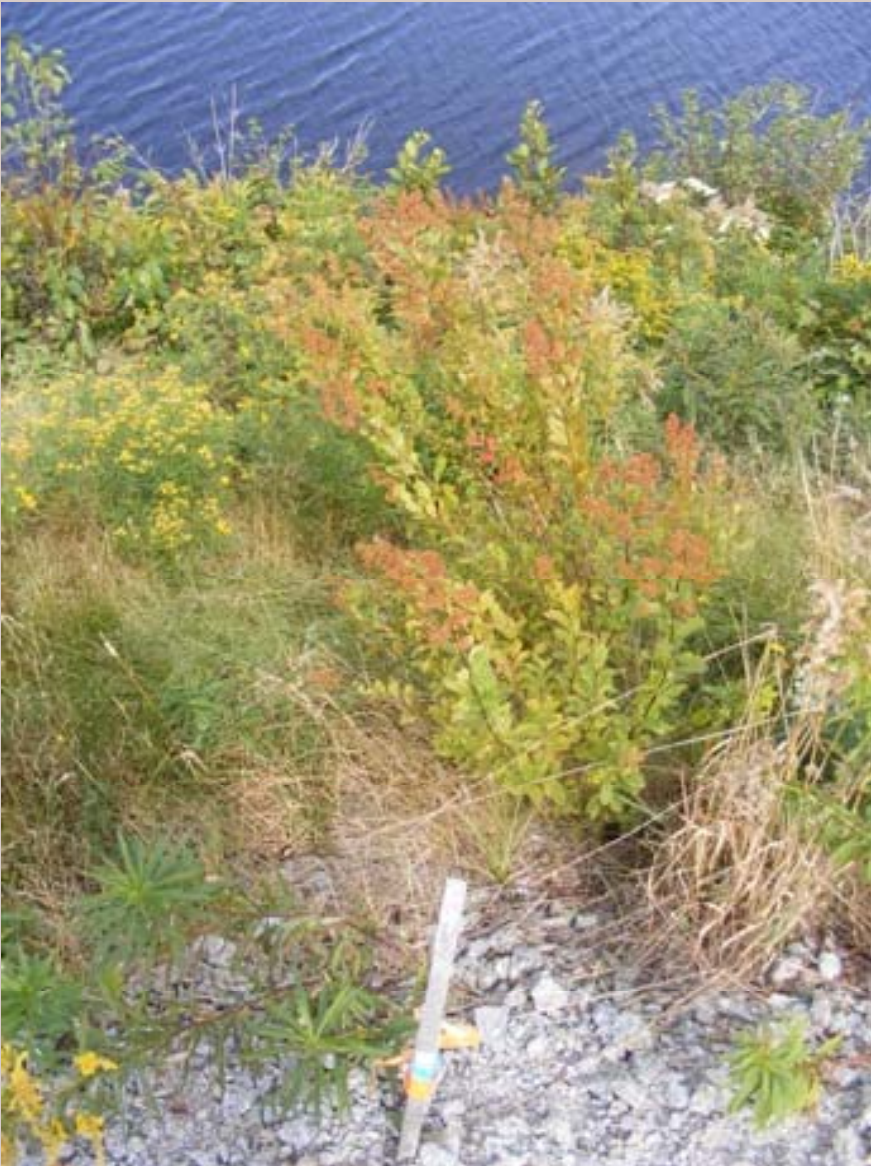
# Stake 1: 100% Cover

- 30% turf species
- 70% wildflowers including:
  - Goldenrods
  - Evening Primrose
  - Pearly Everlasting

Sweetfern  
coming in.

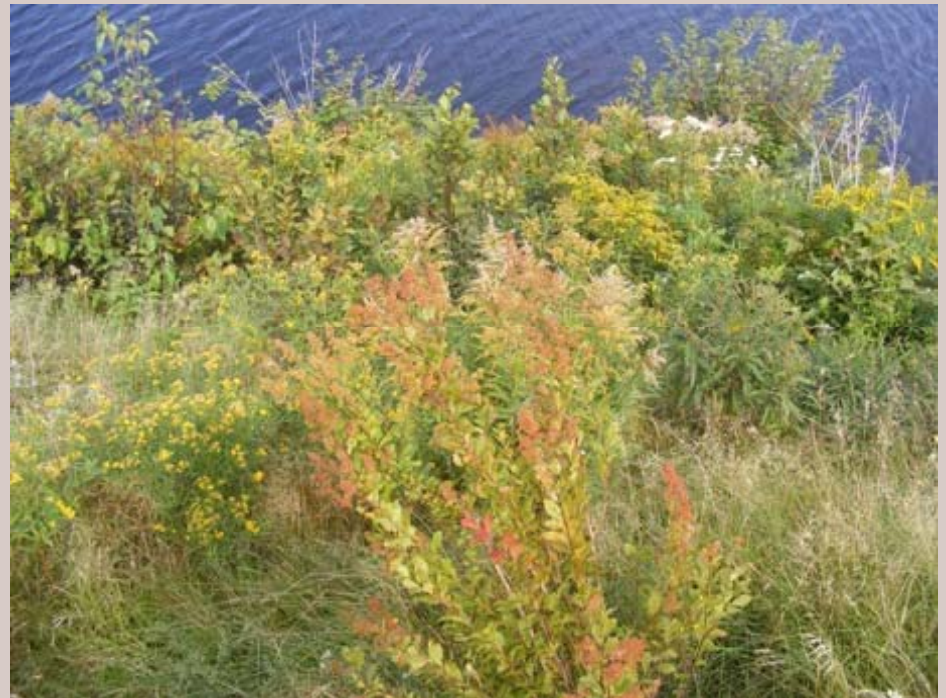
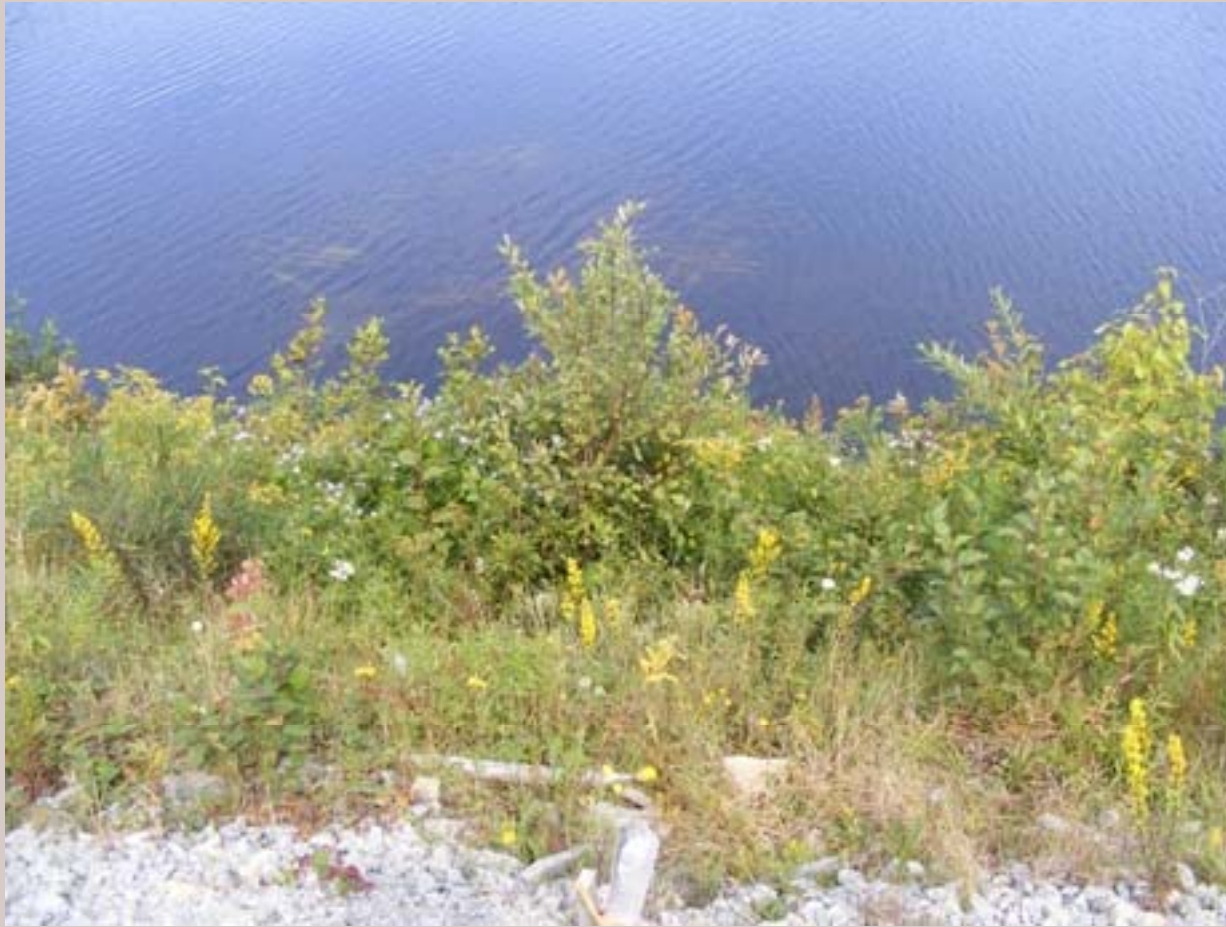
## Stake 2: 100% Cover

- 30% Grass and Wildflowers (e.g. Goldenrods, Asters)
- 70% Trees and Shrubs, including:
  - Meadowsweet
  - Alder
  - Blackberry
  - Bush Honeysuckle
  - Red Maple
  - Sweetfern
  - Wild Rose
  - Birch.

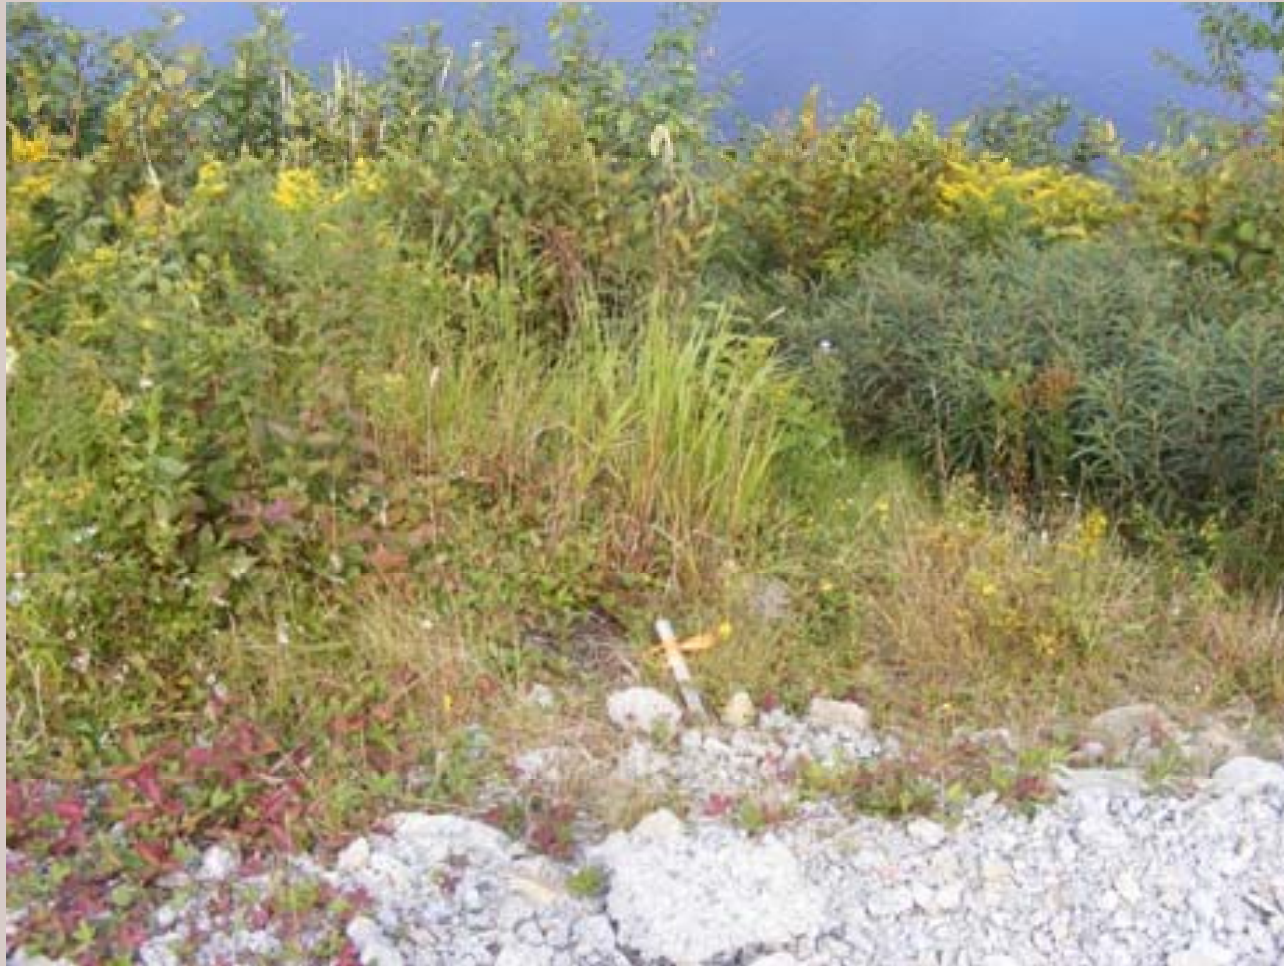
## Stake 4: 100% Cover

- 10% Grasses and Wildflowers (e.g. Goldenrods, Asters)
- 90% Shrubs and Trees, including:
  - Birch
  - Sweetfern
  - Bush Honeysuckle
  - Alders
  - Raspberry
  - Wild Cherry
  - Meadowsweet
  - Wild Strawberry.

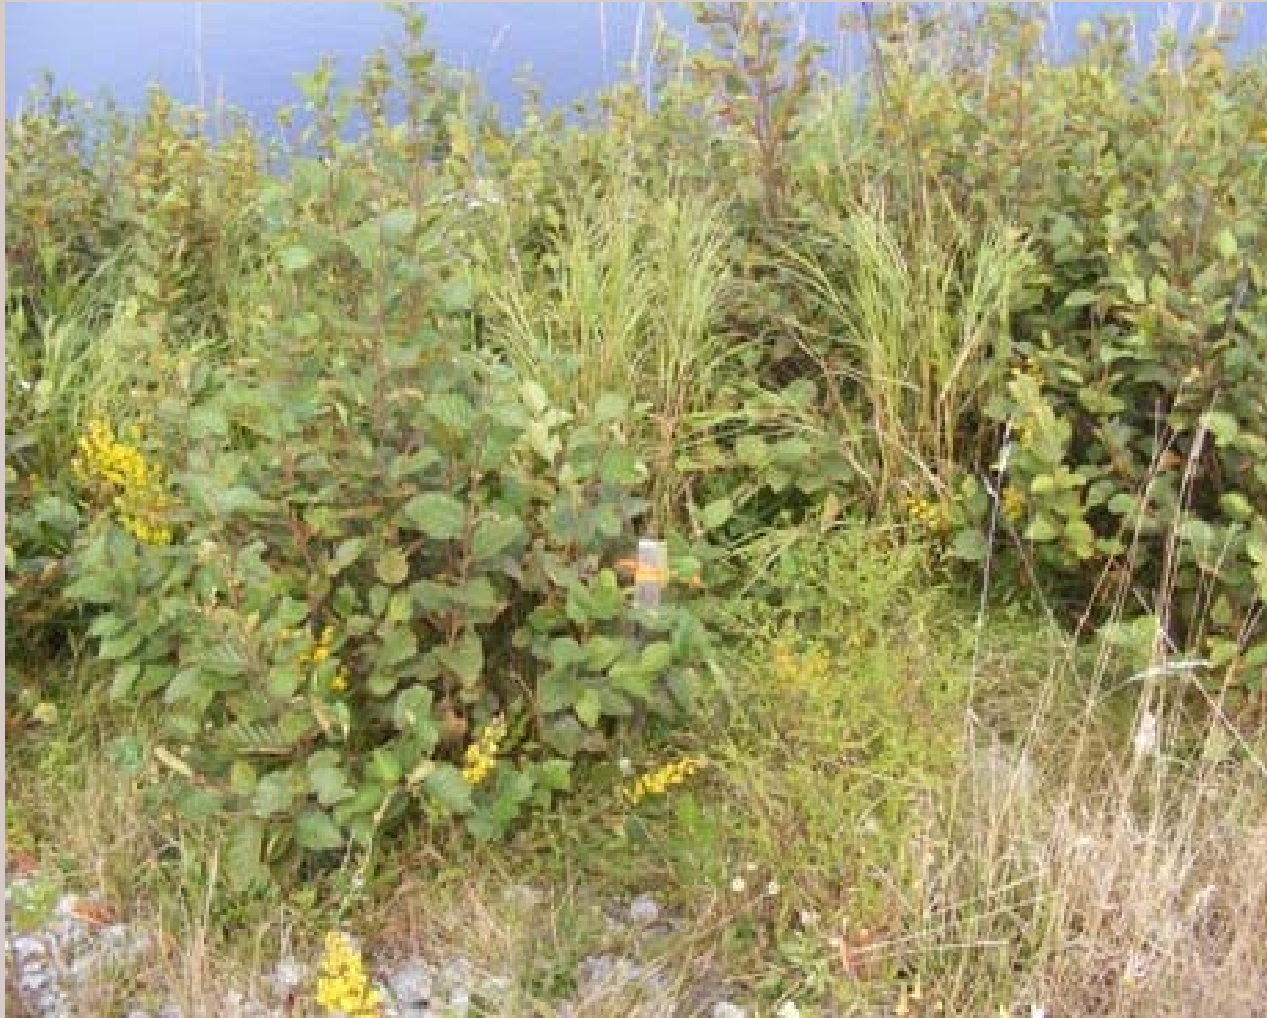
## Stake 5: 100% Cover

- 5% Grasses and Wildflowers
- 95% Shrubs and Trees, including:
  - 60% Alder
  - Meadowsweet
  - Willow
  - Blackberry
  - Bush Honeysuckle
  - Raspberry.

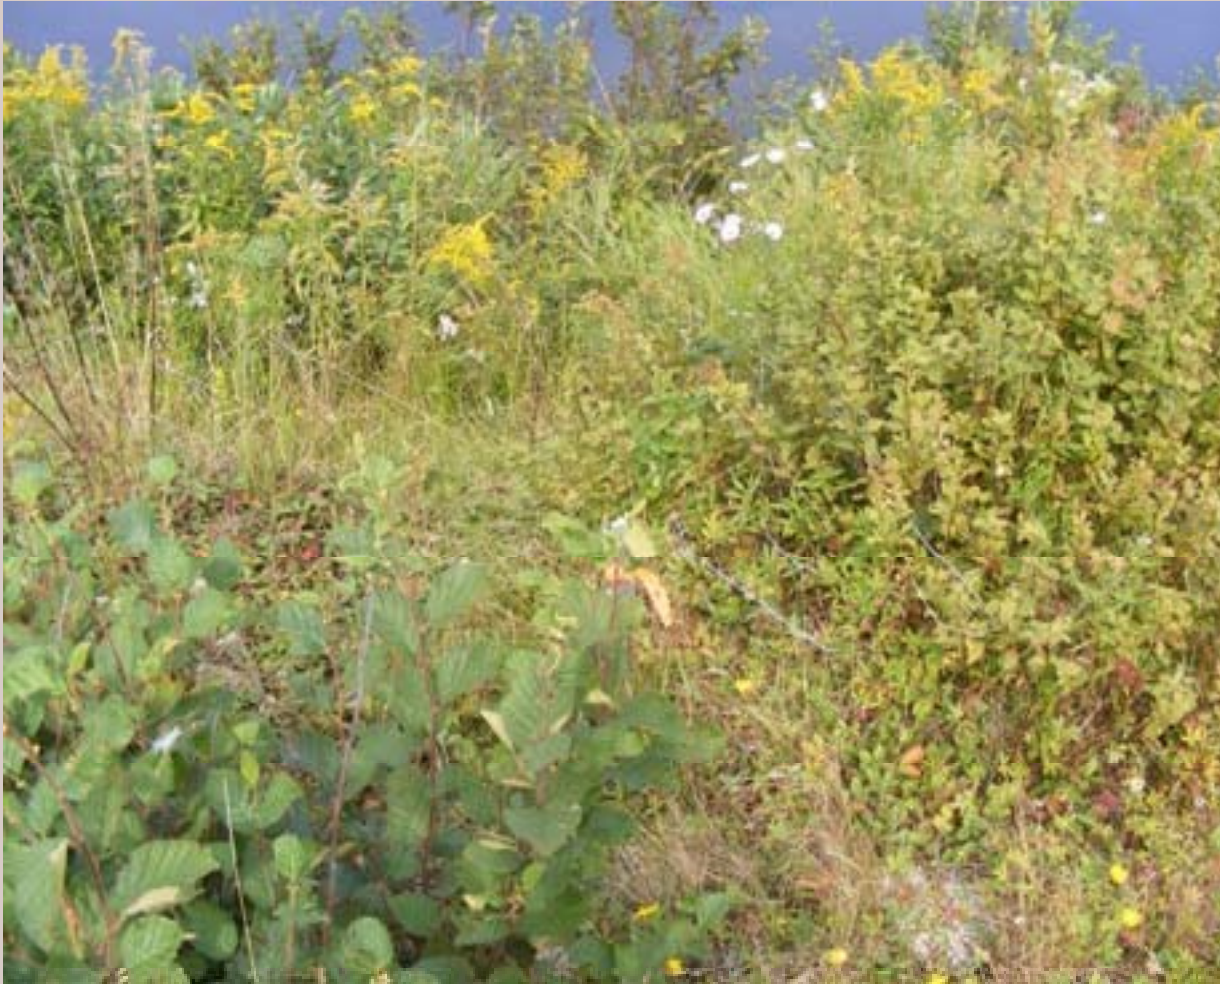
# Stake 6: 100% Cover

- 10% Grass
- 20% Wildflowers, including:
  - 3 spp. of Goldenrods
  - Aster spp.
  - Pearly Everlasting
- 70% Shrubs and Trees, including:
  - Meadowsweet
  - Alder
  - Black Huckleberry
  - Black Chokeberry
  - Bracken Fern.

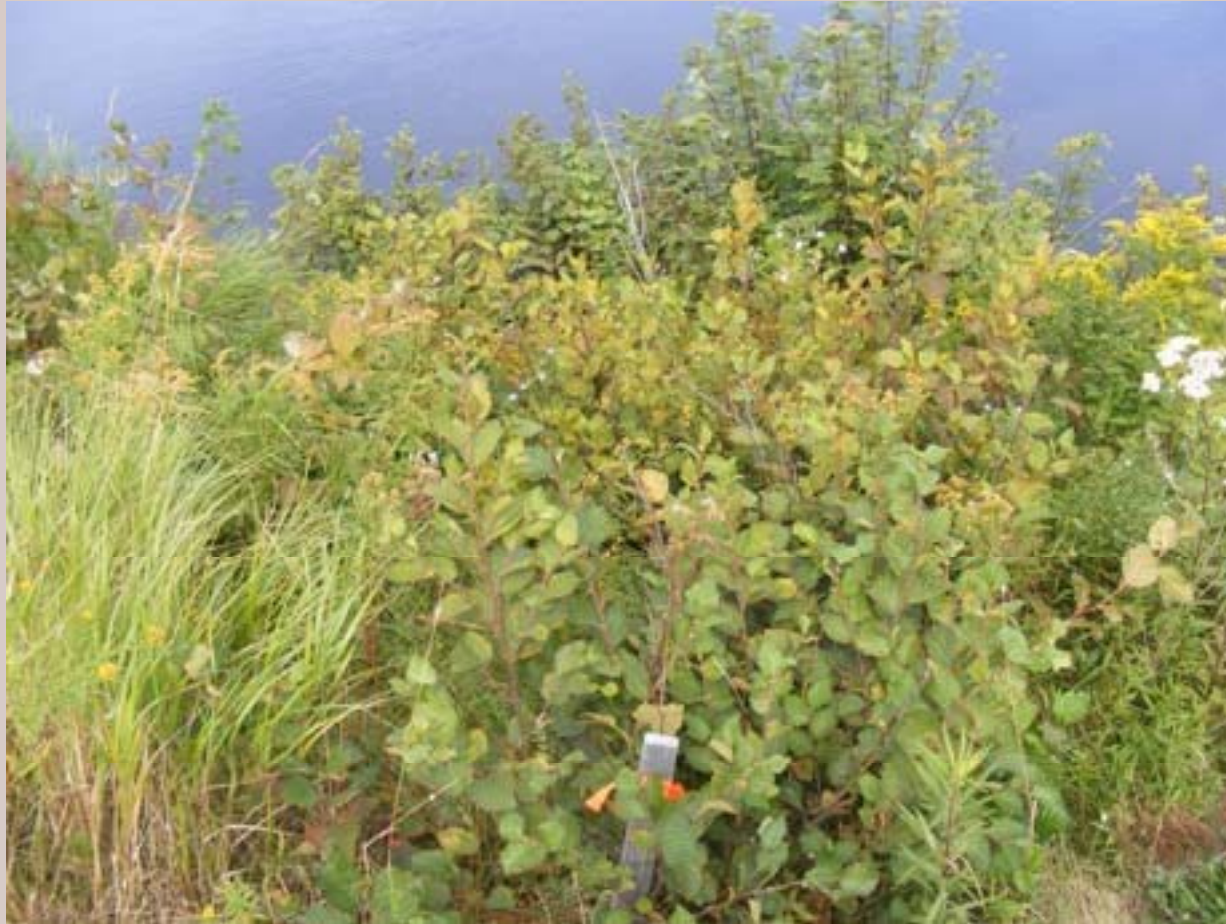
# Stake 7: 100% Cover

- 5% Grass
- 10% Wildflowers, including:
  - Goldenrod spp.
  - Pearly Everlasting
  - Aster spp.
- 85% Shrubs and Trees, including:
  - Wild Raisin
  - Raspberry
  - Alder
  - Red Maple
  - Birch
  - Bush Honeysuckle
  - Pin Cherry
  - Blackberry.

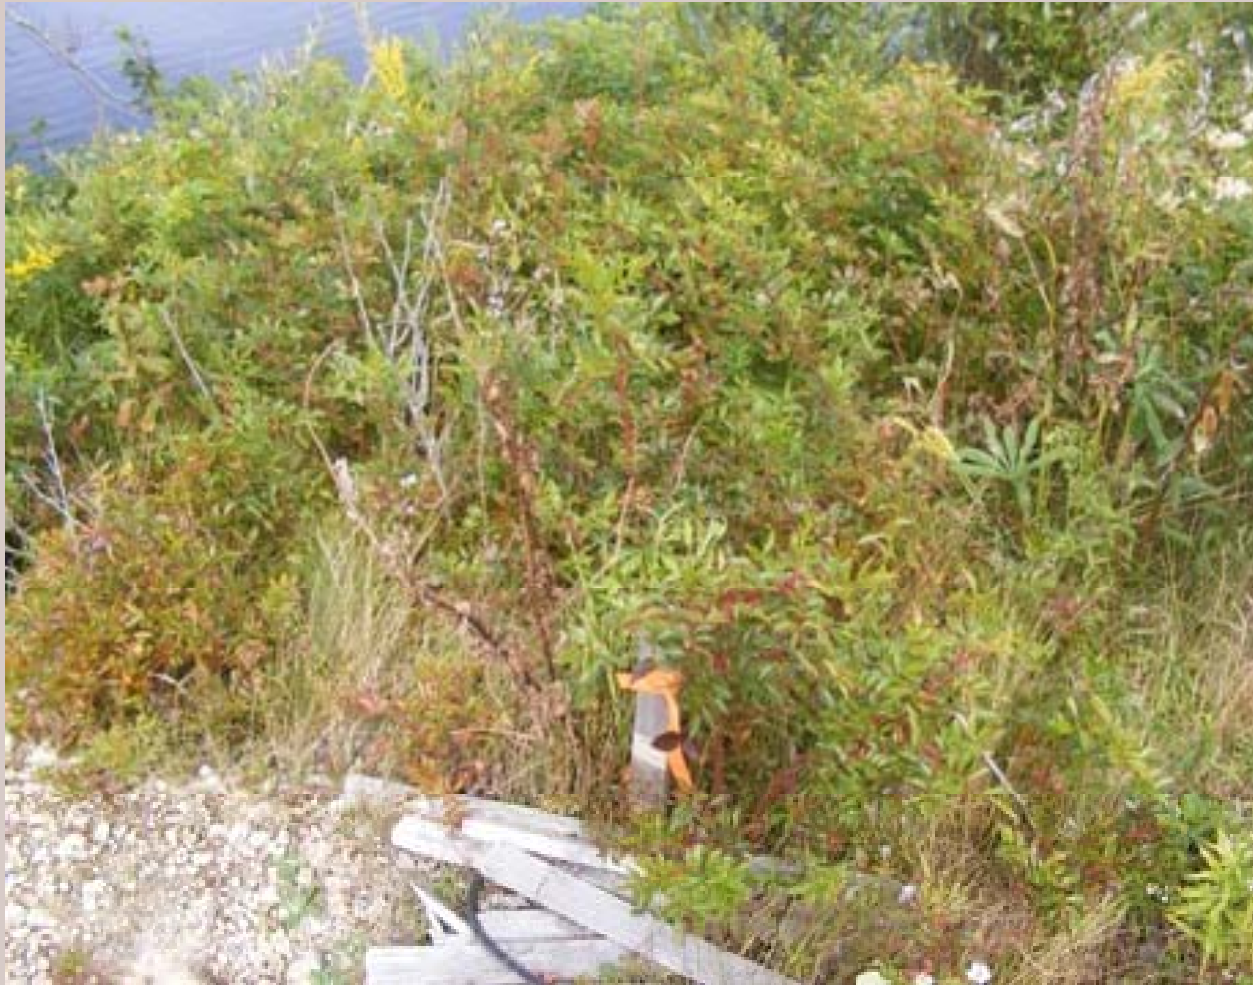
# Stake 8: 100% Cover

- 5% Grasses and Wildflowers, including:
  - Goldenrod spp.
  - Aster spp.
  - Narrow Leaf Goldenrod
- 95% Shrubs and Trees, including:
  - Mostly Wild Rose
  - Bracken Fern
  - Black Huckleberry
  - Pine – to right
  - Birch
  - Raspberry
  - Sweetfern
  - Pin Cherry
  - Meadowsweet.

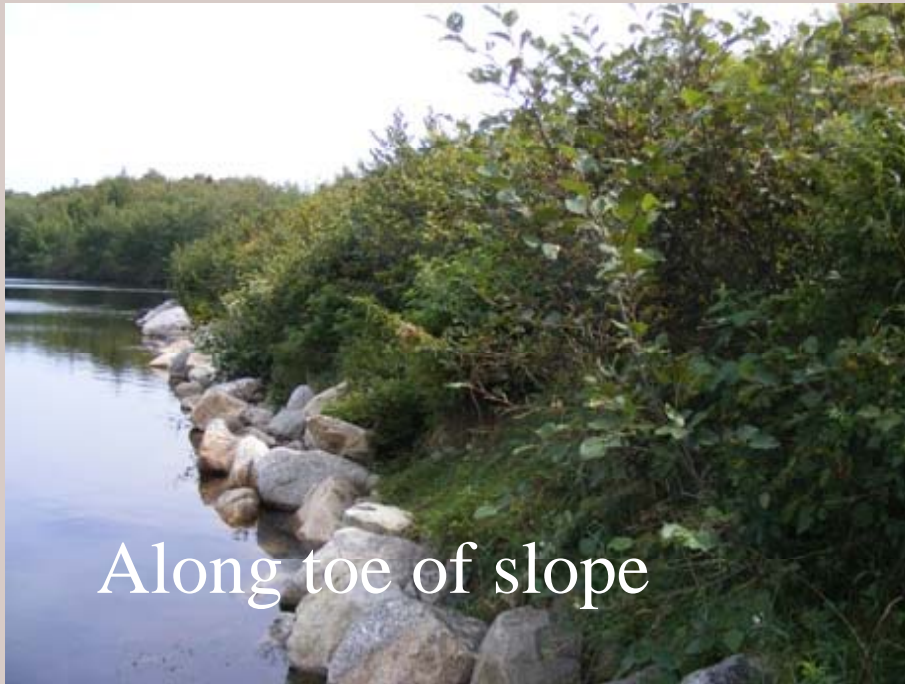
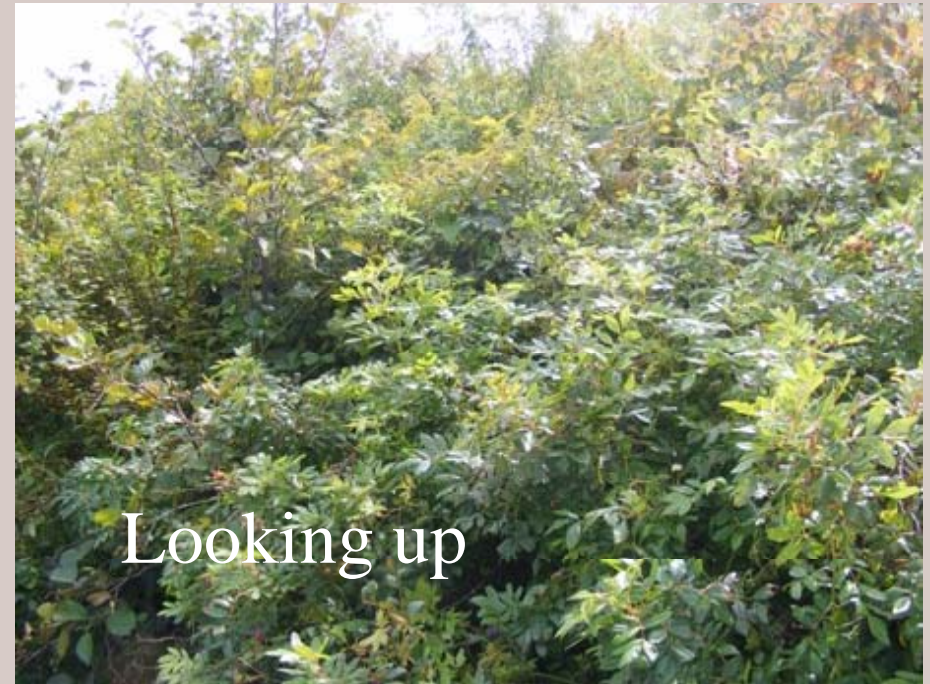
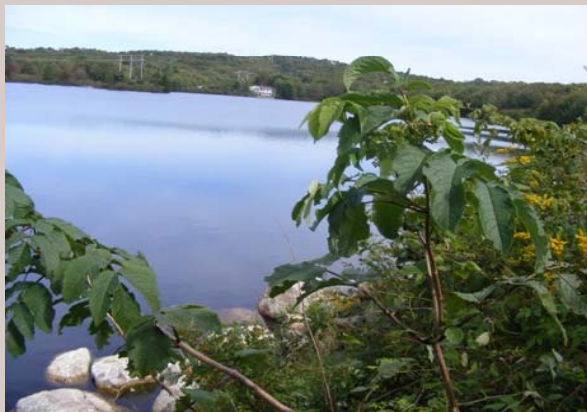
# From Toe of Slope at Stake 8

Red Elderberry at toe of slope

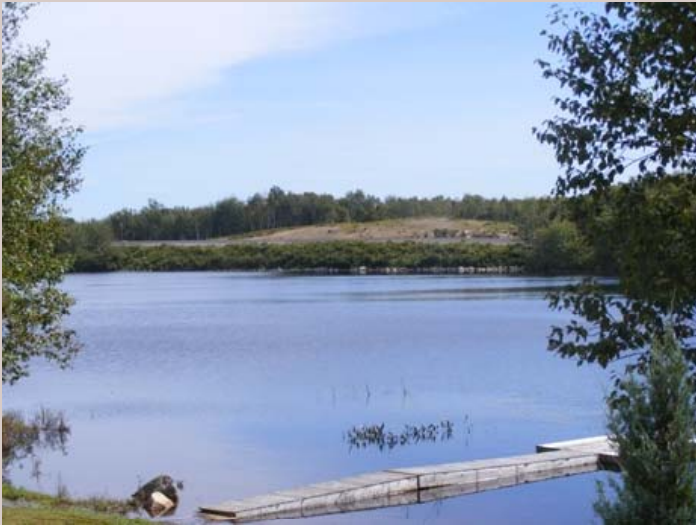
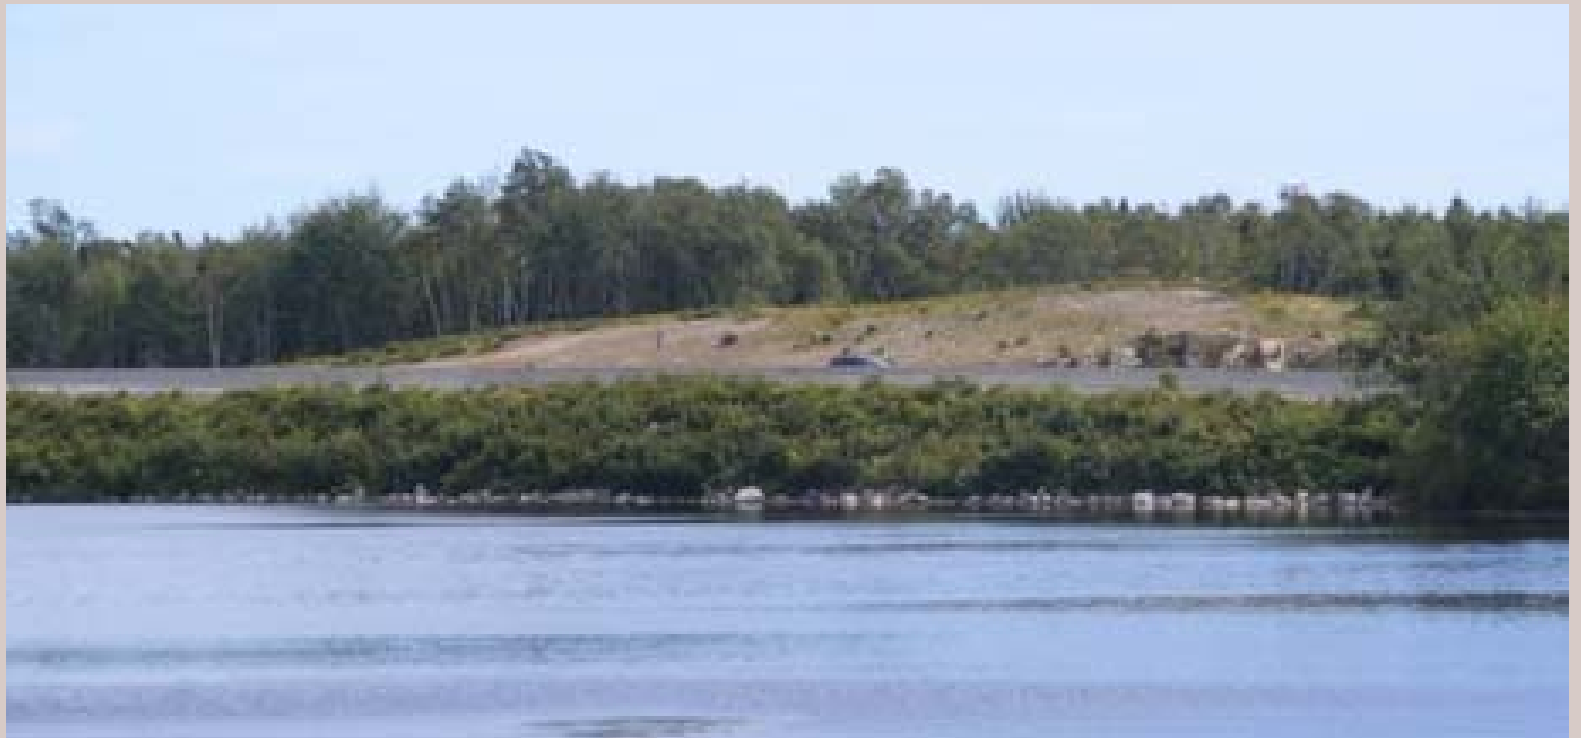
# View of Slope from Across Lake

- **Slope Vegetation is Successfully Protecting Lake From Surface Soil Erosion**
  - No indication of soil loss to lake or slope failure.
- **100% Vegetation Cover**
  - Grass has been replaced by native wildflowers and increasingly by shrubs and trees.
- **Vegetation and Soil (from Grubbings) is Successfully Allowing Native Trees and Shrubs to Establish.**
- **Native Species and Ecosystem are Successfully Re-establishing From Transplanted Clumps**
  - Native species have survived and are spreading; and
  - Riparian and forest habitats are re-establishing.
