**Cranberry Lake, Highway 103,  
HADD Compensation Project  
(DFO HADD Authorization 03-W8-303):  
2009 Vegetation Monitoring:  
September 14, 2009  
Year 5, Final**

Diane LaRue, Vegetation Consultant  
Environmental Services, NSTIR  
October 2009

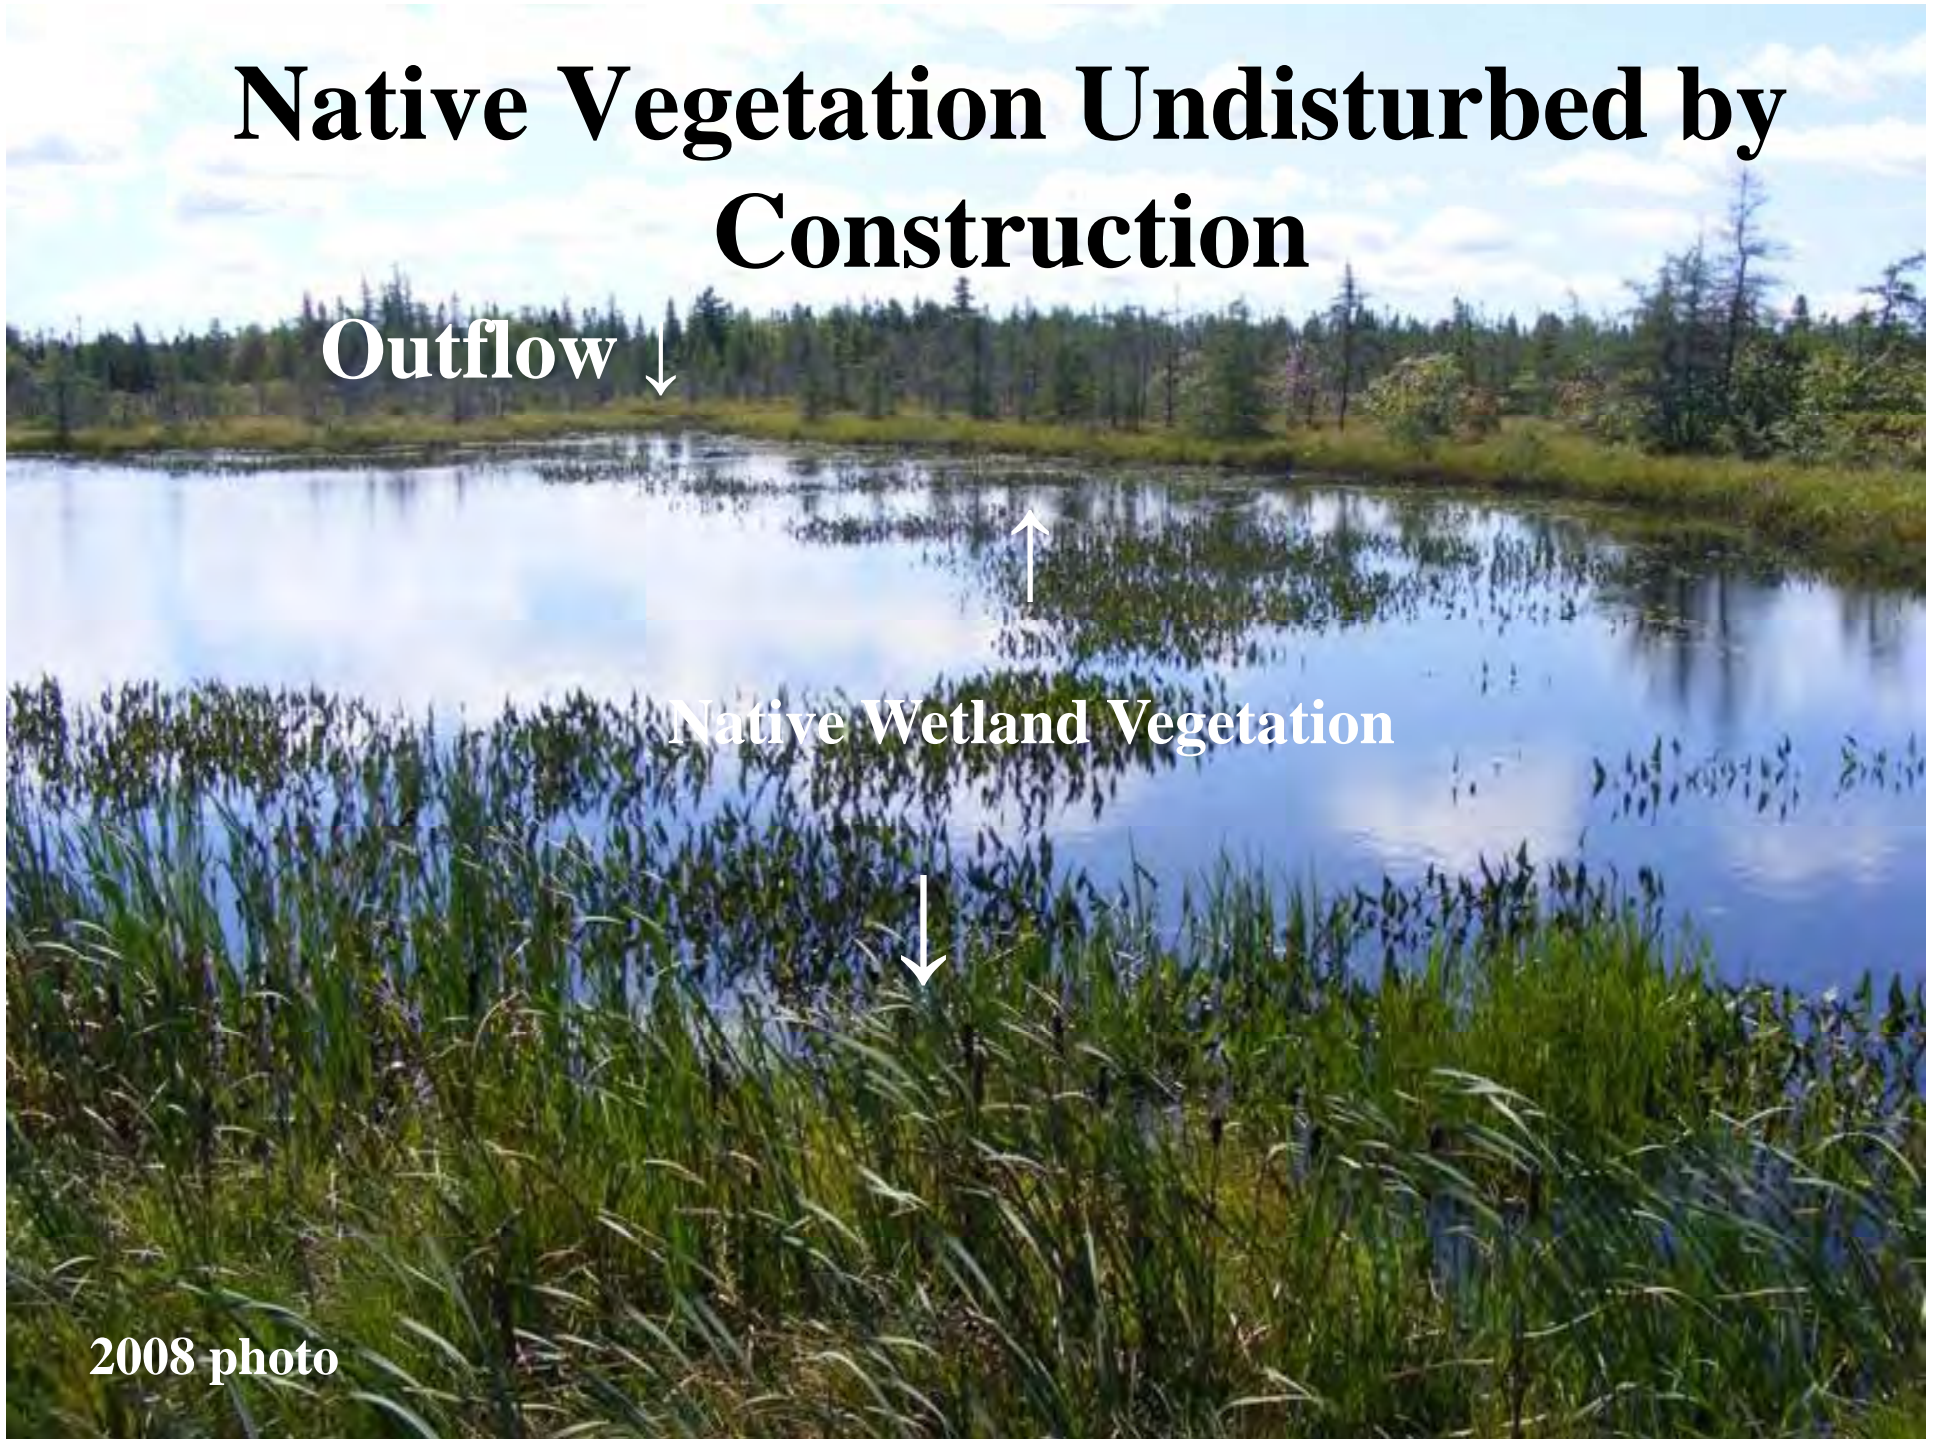
2008 photo

# Native Vegetation Undisturbed by Construction

Outflow ↓

↑  
Native Wetland Vegetation

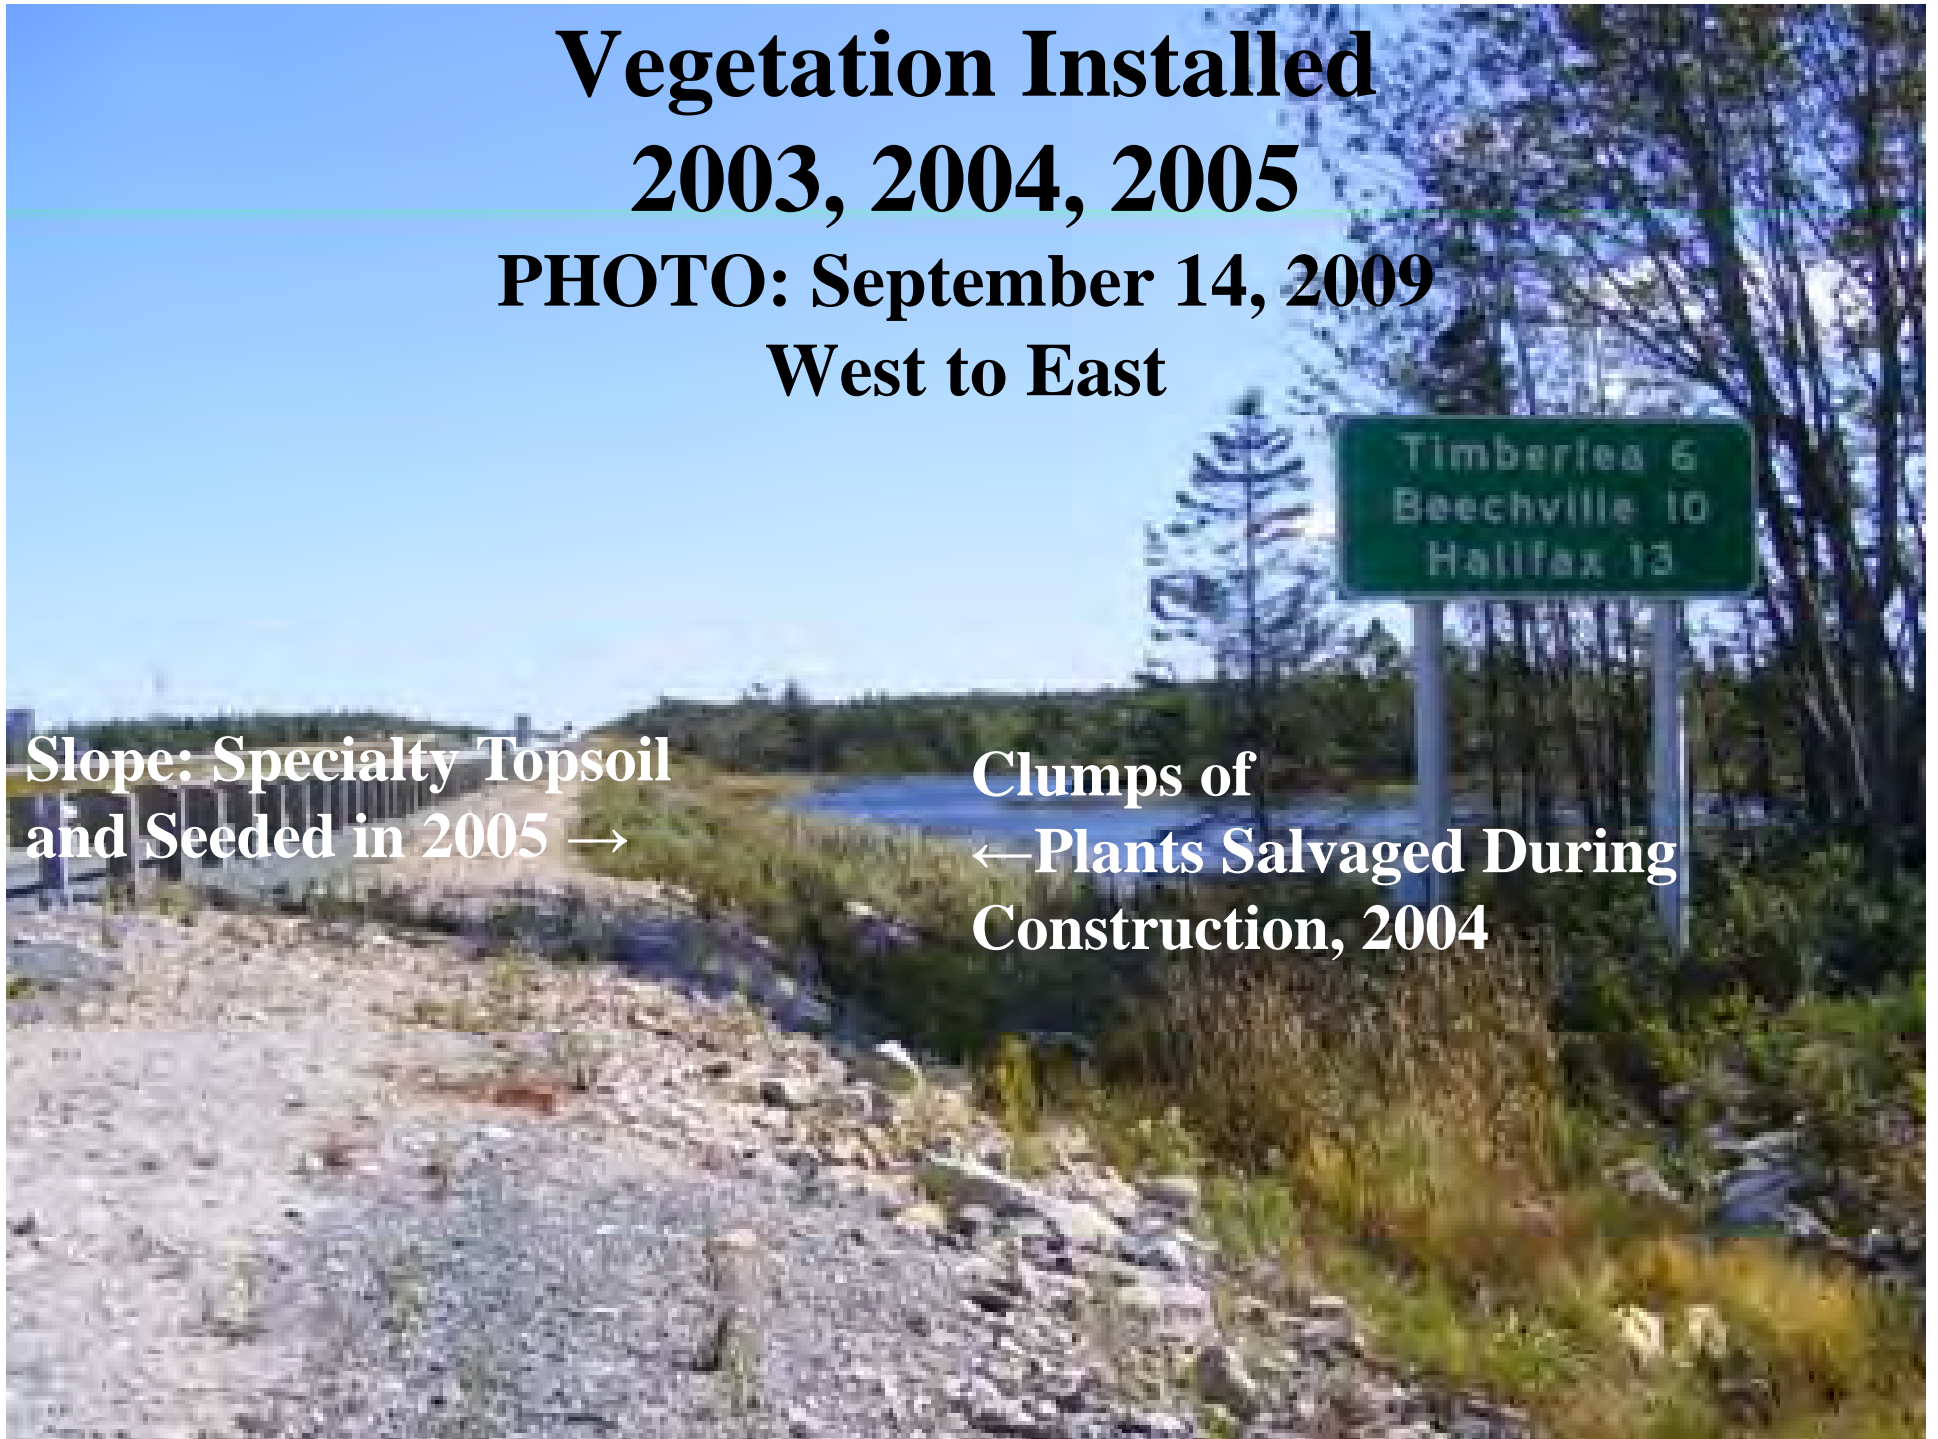
PHOTO: September 14, 2009  
West to East

# Vegetation Installed 2003, 2004, 2005

Slope: Specialty Topsoil  
and Seeded in 2005 →

← Clumps of  
Plants Salvaged During  
Construction, 2004

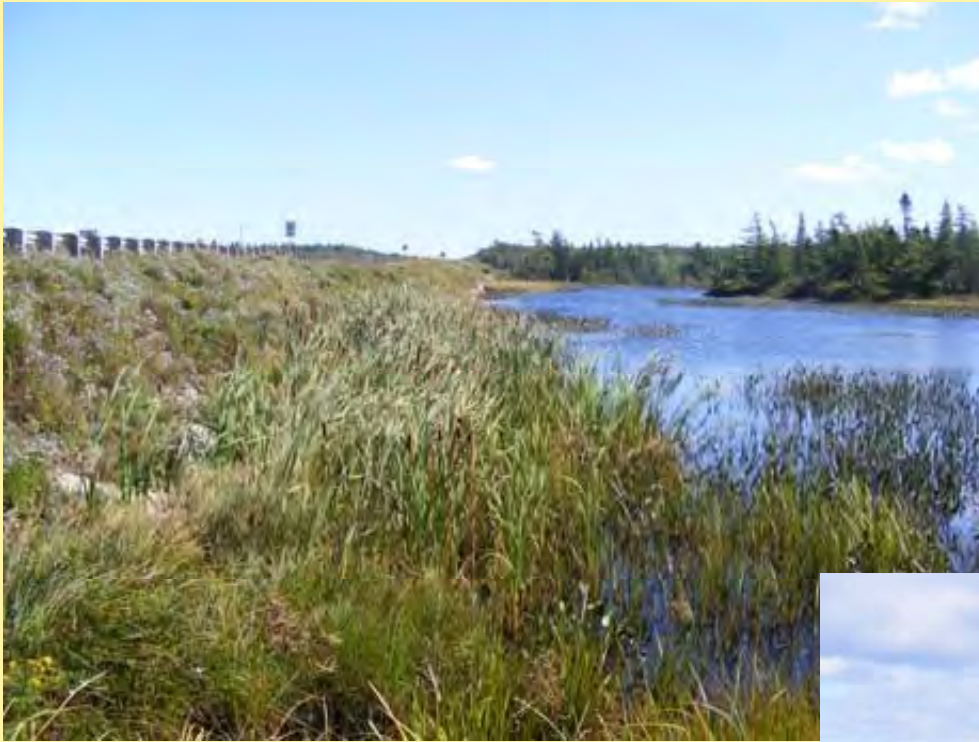
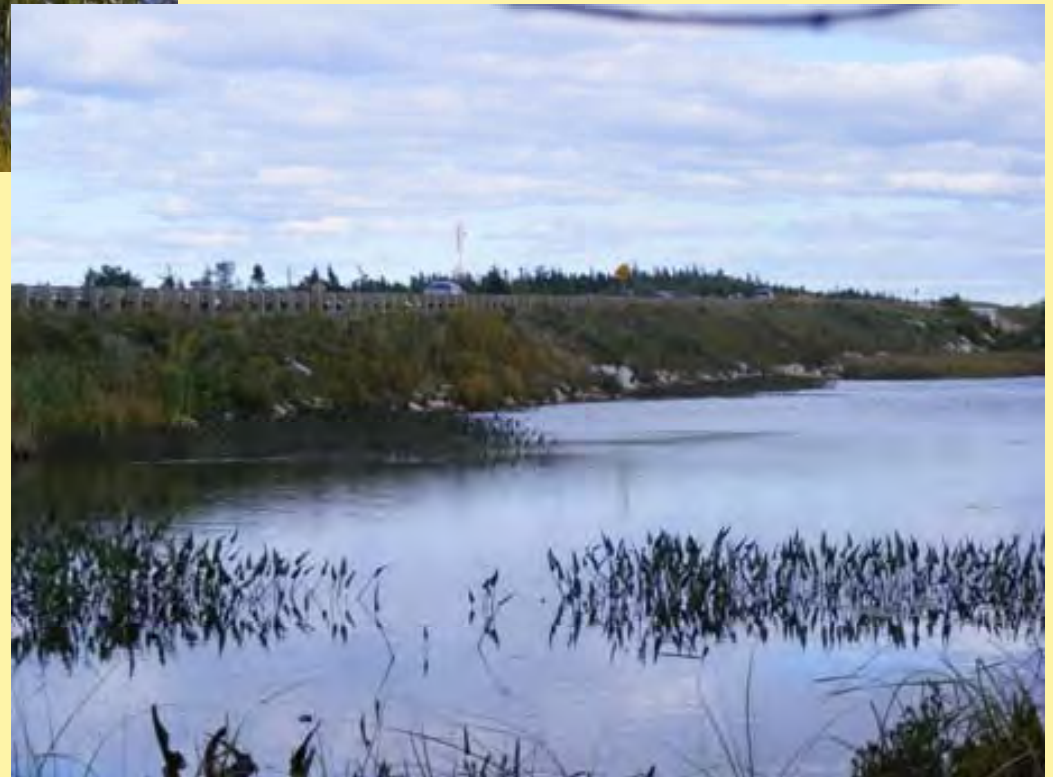
# West to East Views of Monitored Slope and Shoreline

**Slope is now (2009)  
vegetated in native  
wildflowers and  
introduced ‘weed’  
species**

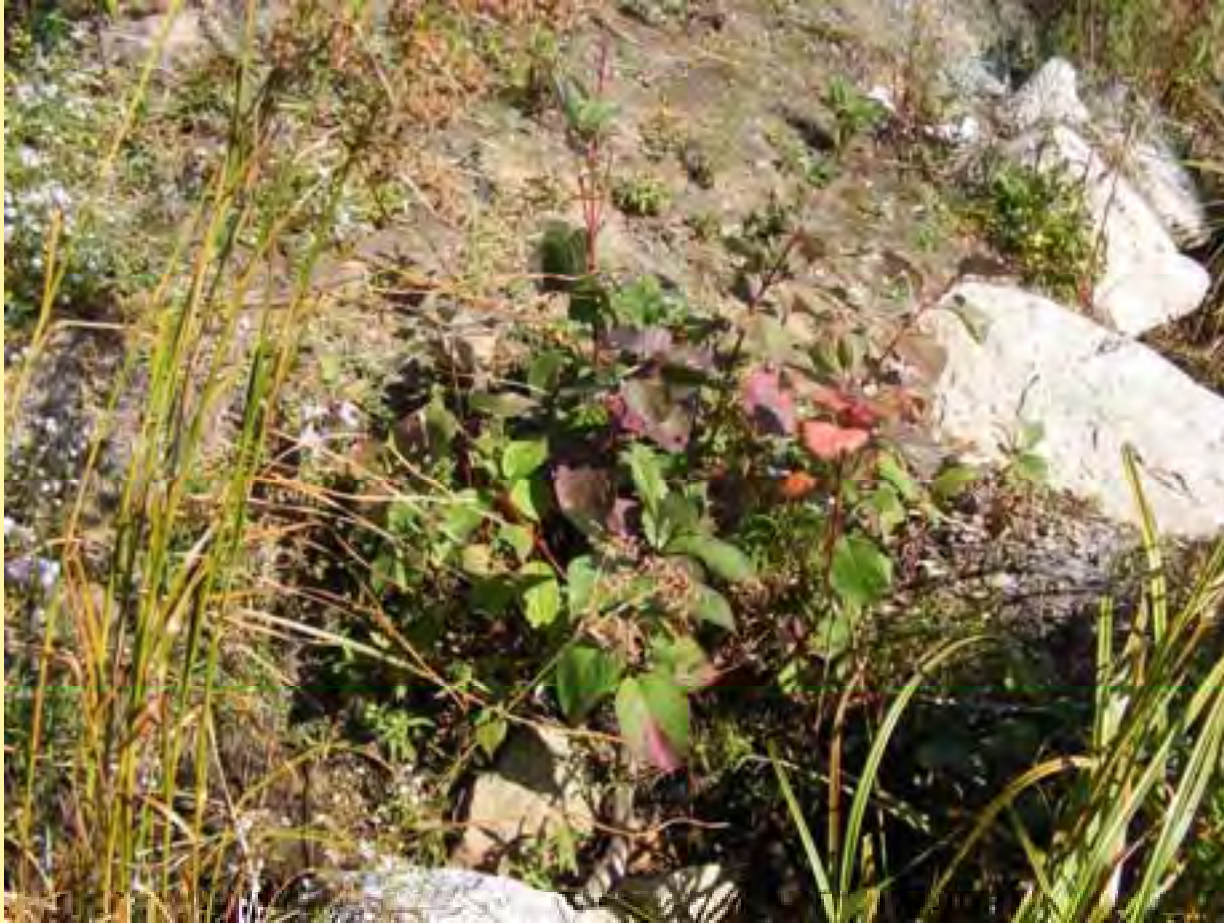
# West of Station + 680; West End of Lake

- Native Red Osier Dogwood successfully established.
- Installed Fall 2005 from pre-rooted mat.

- There is no sign of erosion or loss of soil from the slope to the lake; and
- **RECOMMEND:** Introduce native tree species e.g., Spruce, at the west end in particular, to help protect lake water from roadside spray.

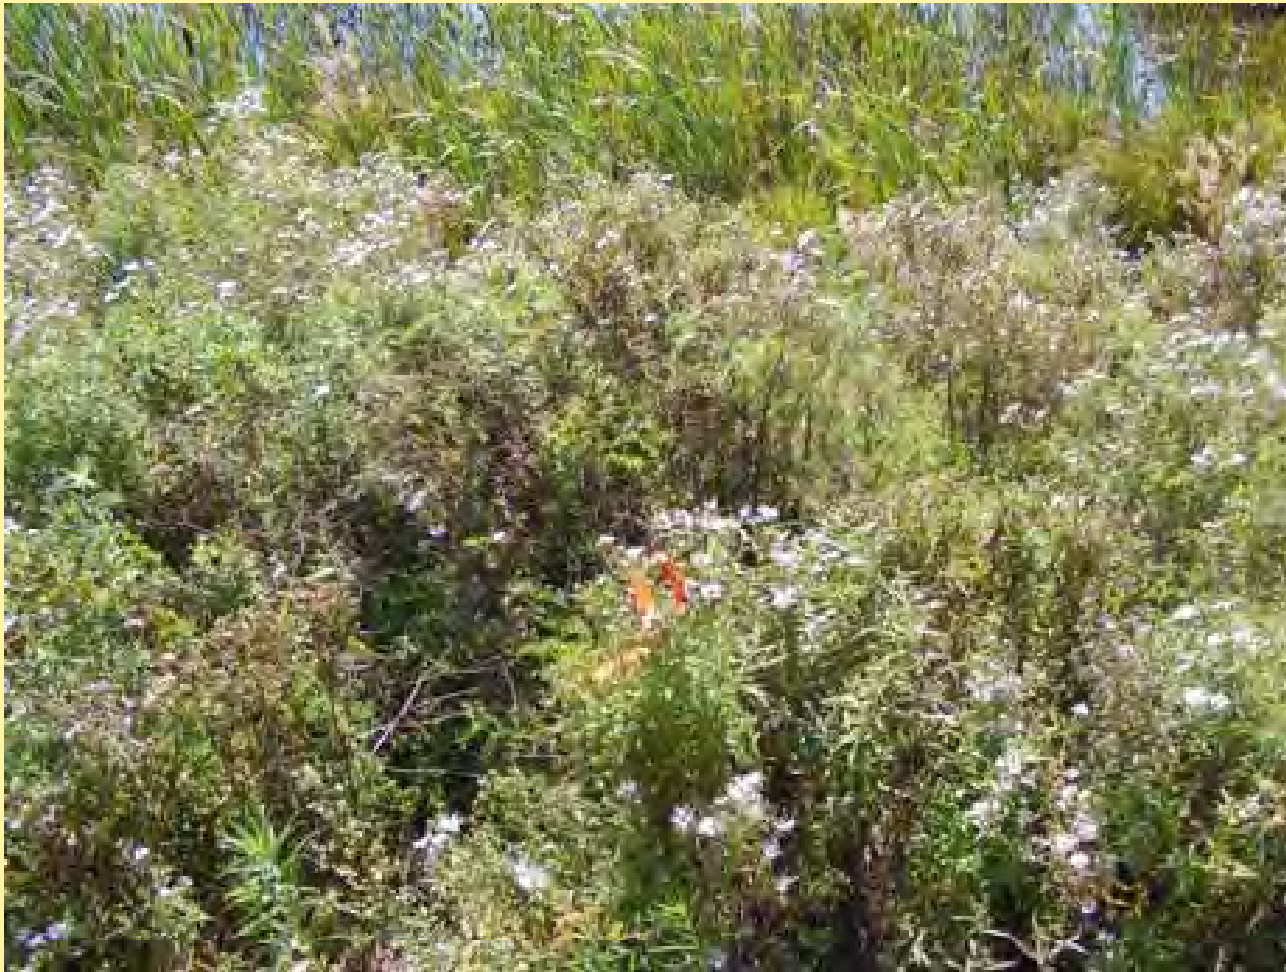
# Station + 680

Slope: 90% cover

- Grasses gone
- Wildflowers (Asters, Goldenrods)
- Introduced 'weed' species.

Bottom:

- Mostly Cattails, some grasses, some Sweet Gale.

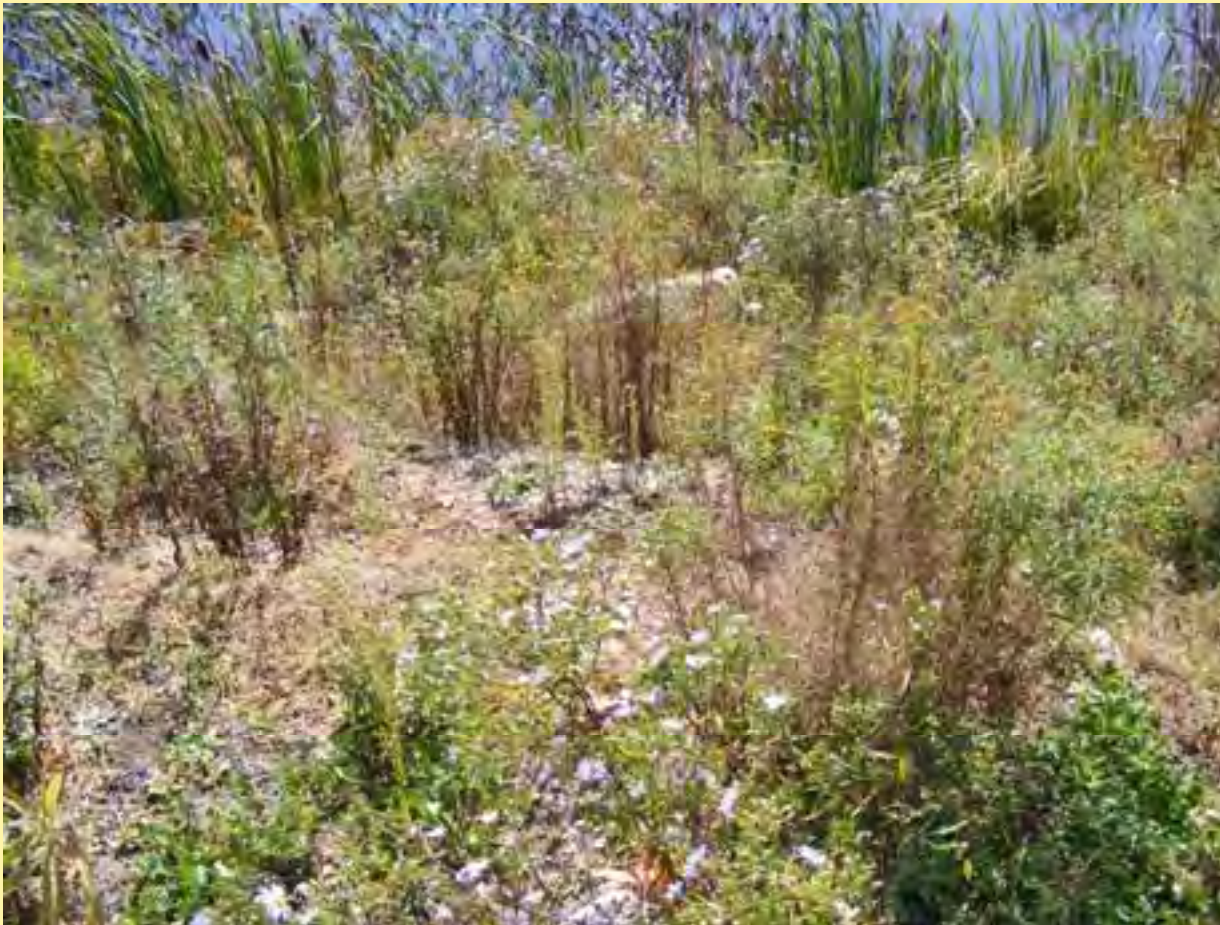
# Station + 660

- Slope 90% cover
  - Grasses gone
  - 90% native Asters
  - 10% introduced 'weed' species.
- 
- **Bottom:**
  - Cattails mostly in mud at bottom
  - Some Sweet Gale
  - Some grasses.

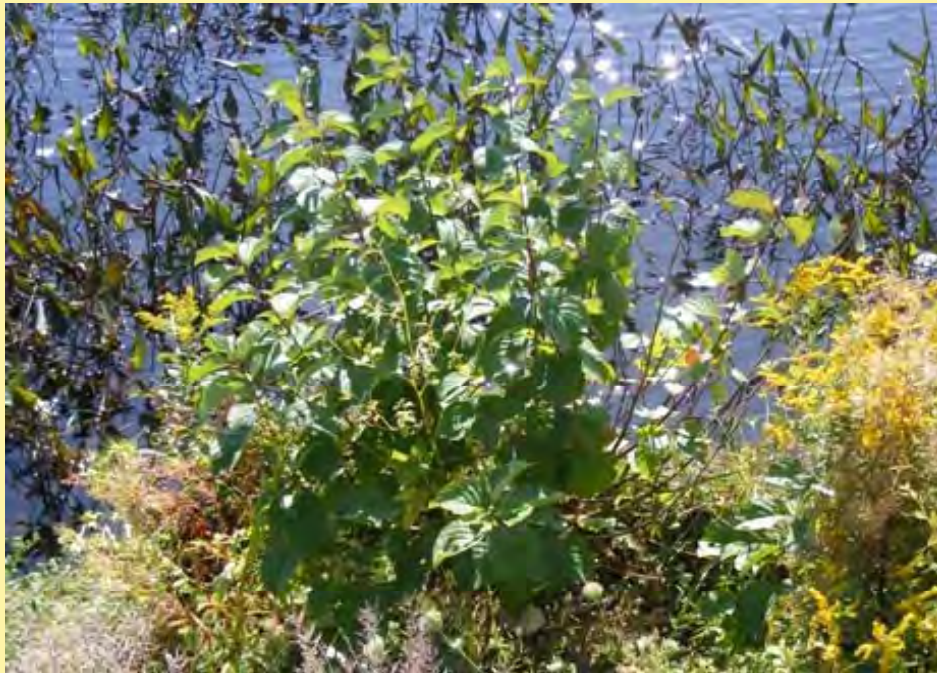
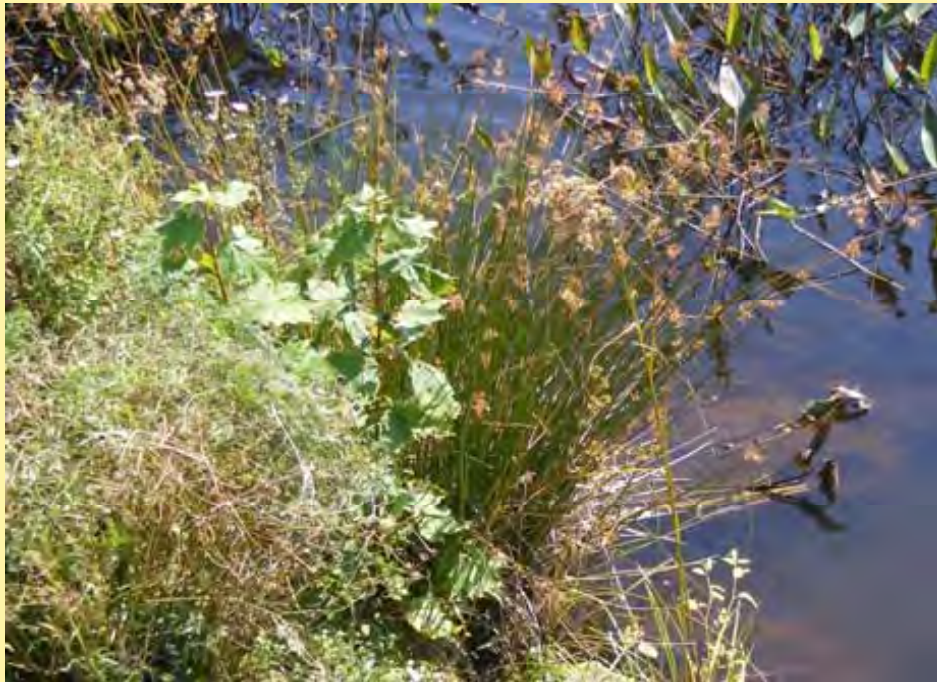
# Between + 640 and + 620

- Red Osier Dogwood successfully established from dormant stake
- Red Maple growing from transplant salvaged from wetland number 2
- Mullein noted in 2008 is gone.

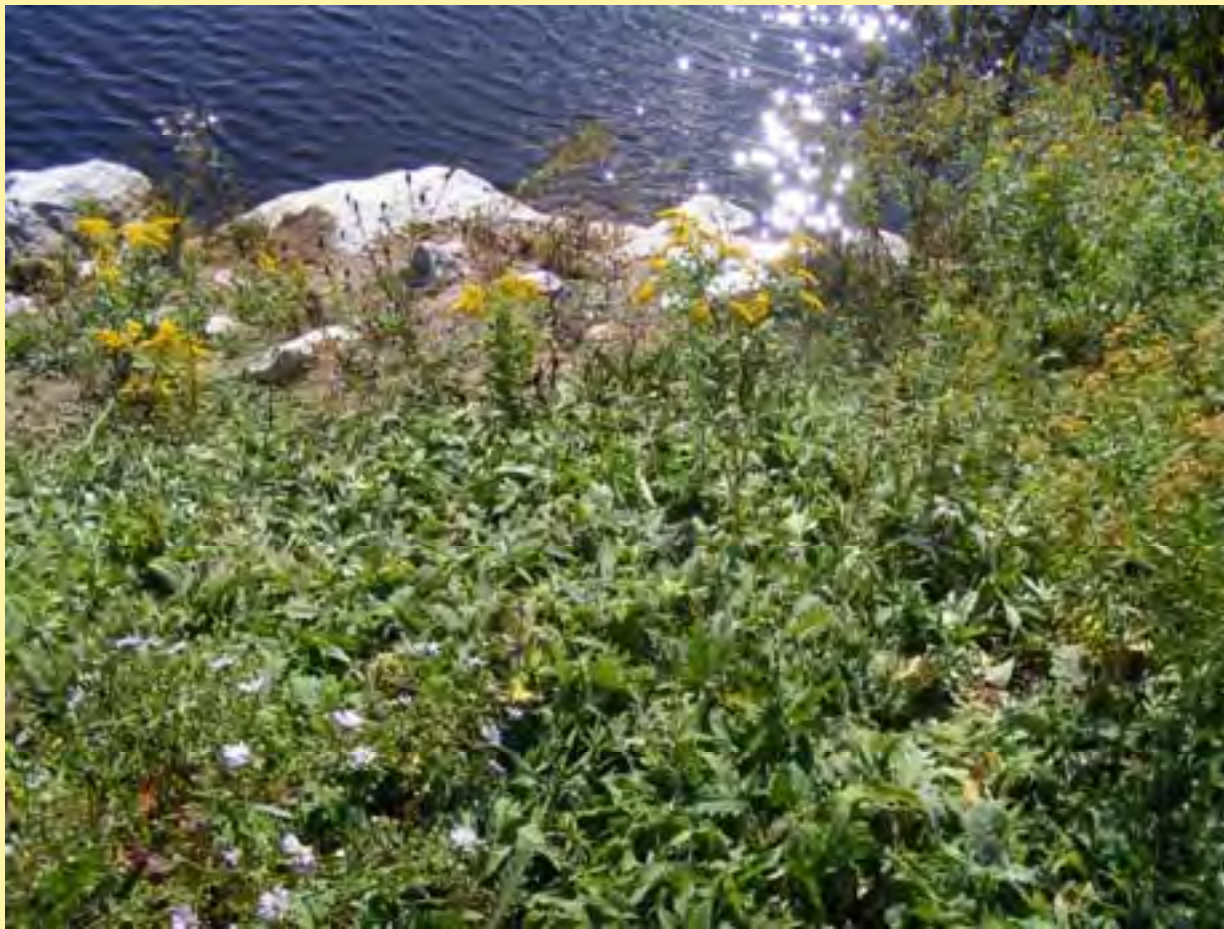
# Station + 620

- Slope 90% cover
  - No grass
  - Mostly introduced 'weed' species (Thistle, Knapweeds)
  - Native wildflowers (Goldenrod spp., Aster).
- Meadowsweet to left established from original clump transplant.

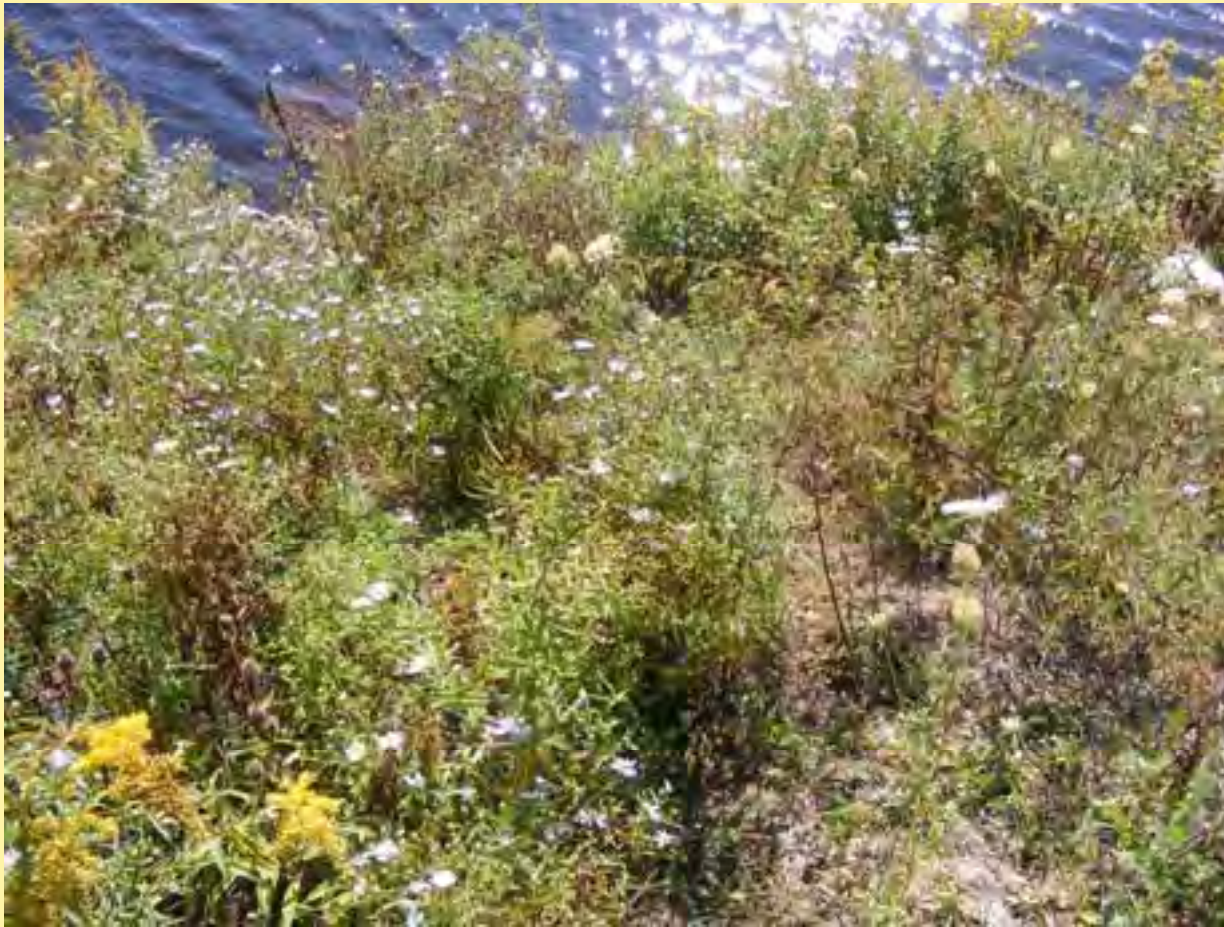
# Station + 600

- Slope 95% cover
  - No grass
  - Introduced ‘weeds’ and native wildflowers (Aster, Goldenrod).
- Bottom:
  - Goldenrods, Aster, Wild Carrot
  - Meadowsweet
  - Soft Rush.

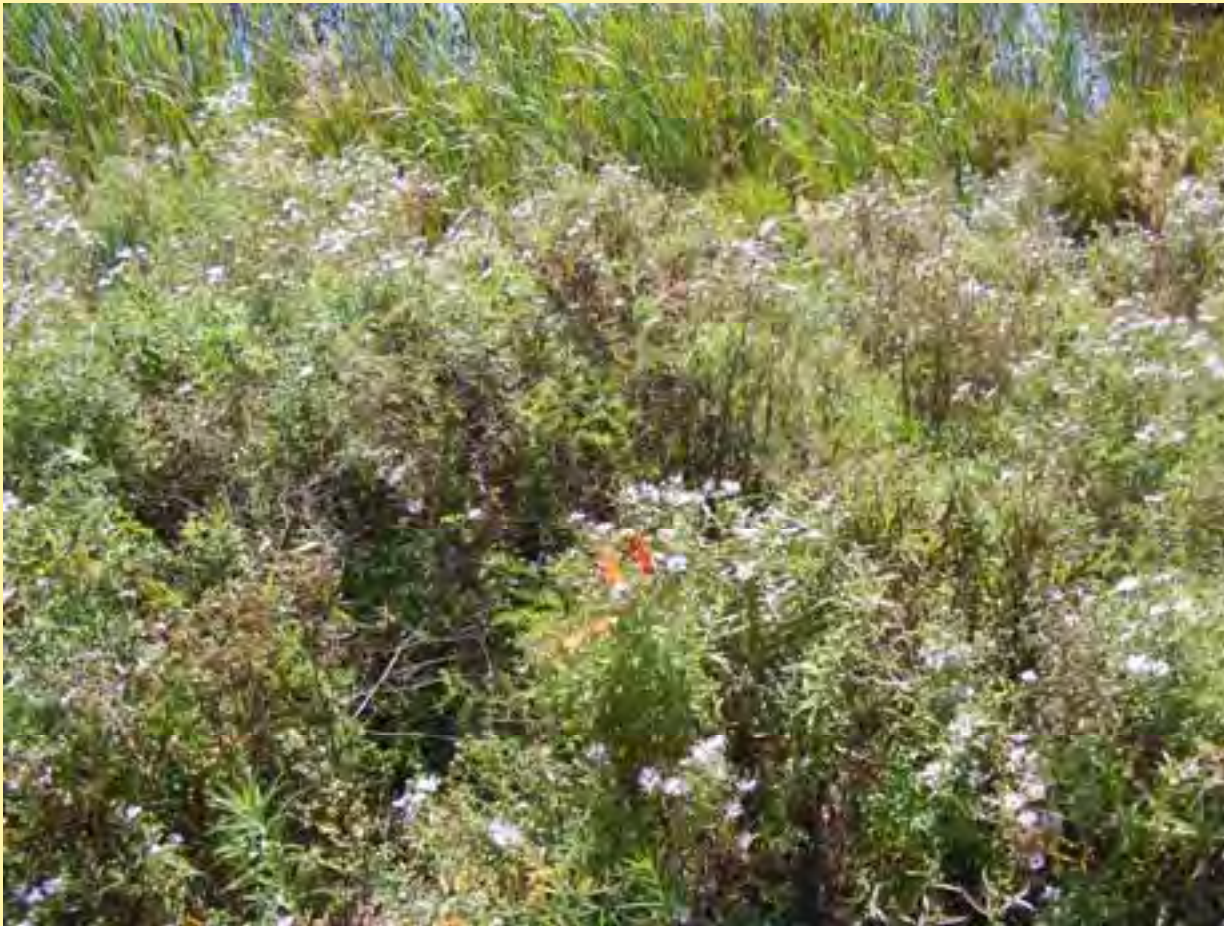
# Station + 580

- Slope 90% cover
  - No grass
  - Mostly Aster
  - And some introduced ‘weed’ species.
- Transplanted clump at shoreline of native Black Chokeberry, Leatherleaf, Cranberry, Sweet Gale and unidentified shrub.
- Also, Aster, Jewelweed, and Knapweed.

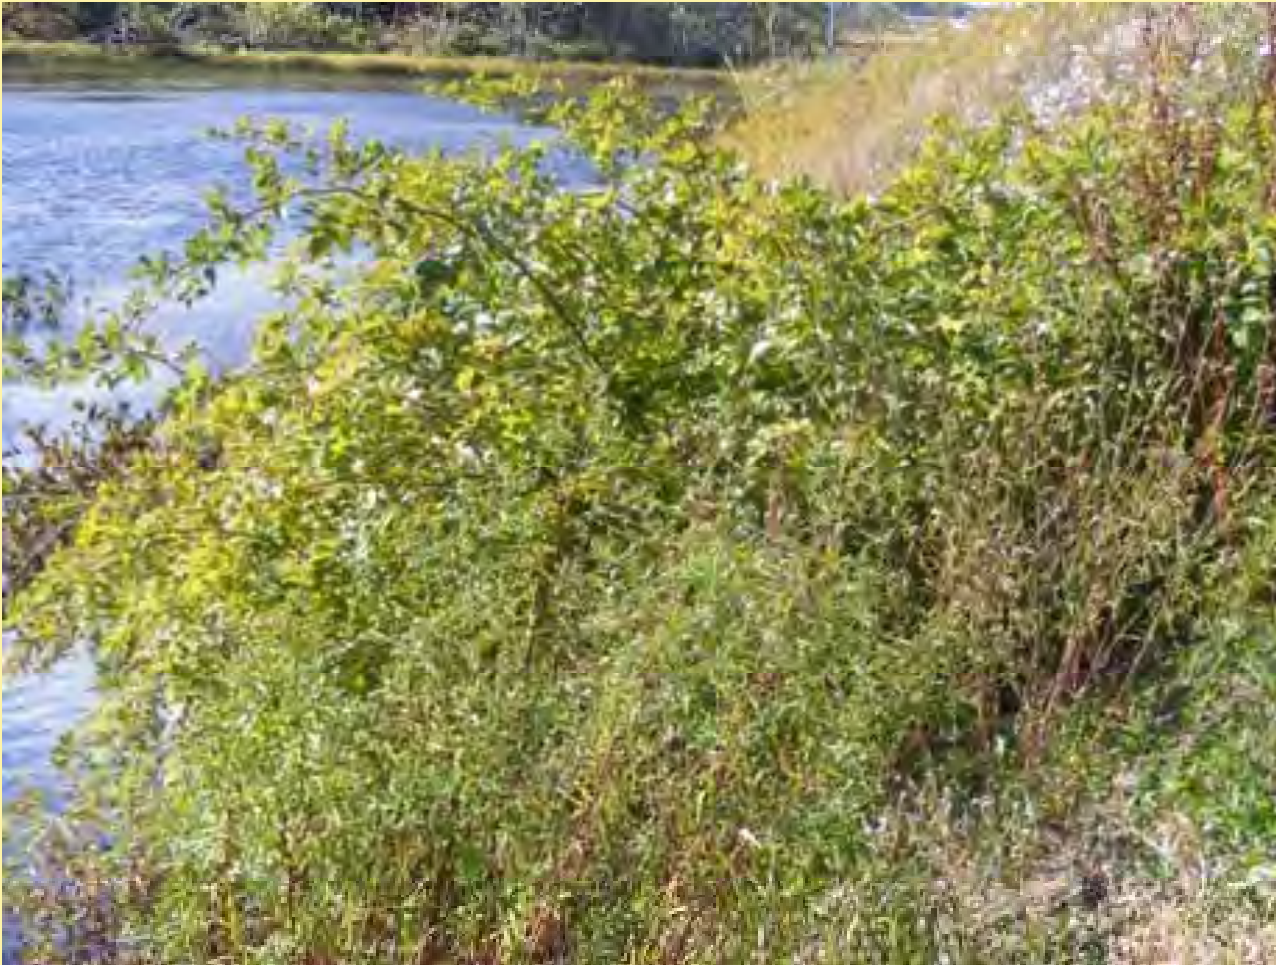
# Between Stations + 580 and 560

- Large Multiflora Rose from clump transplanted during construction
- NOTE: may now be considered an invasive shrub.

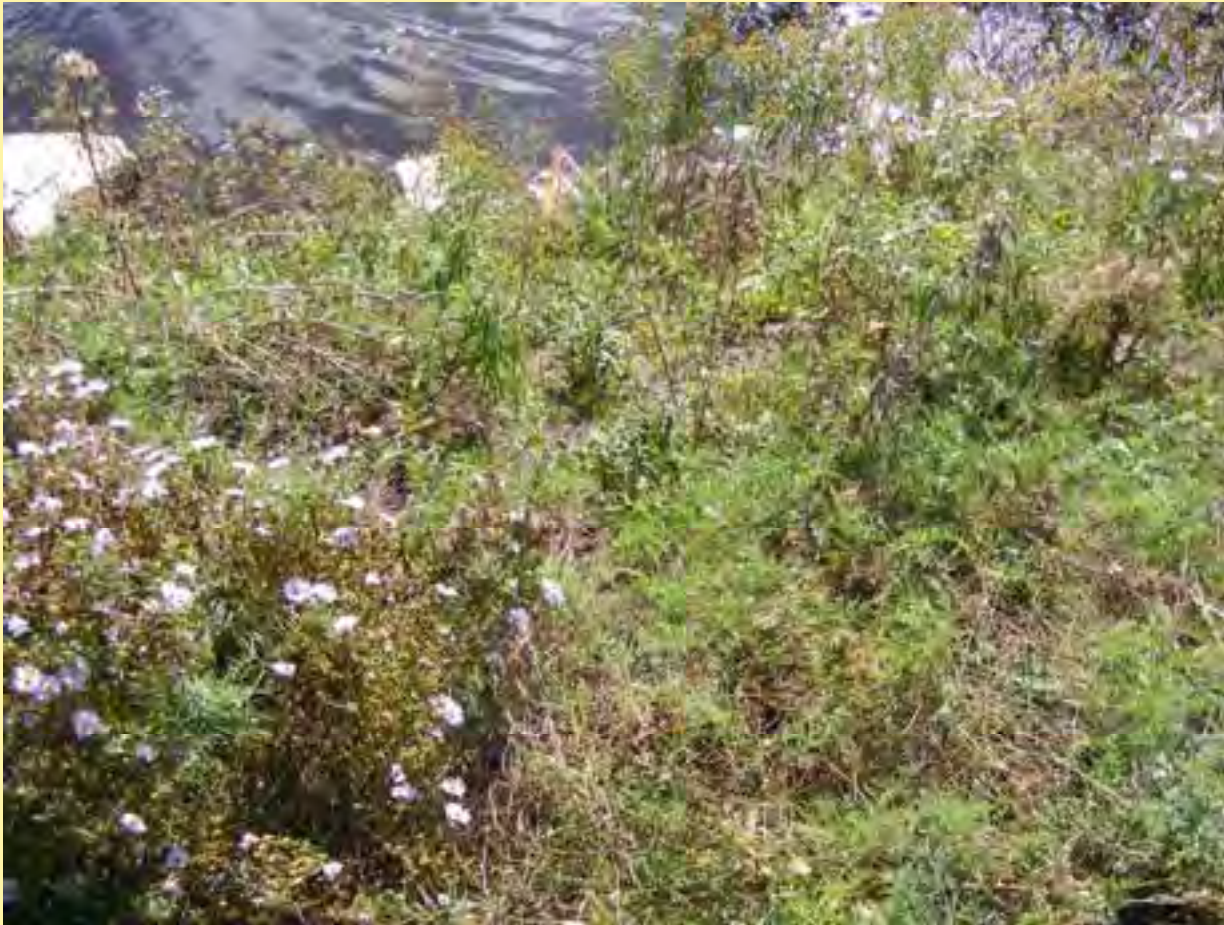
# Station + 560

- Slope 95% cover
  - Sparse grass
  - Mostly introduced ‘weed’ species (Thistle, Vetch)
  - Native wildflowers (Goldenrod spp., Aster)
  - Sparse Clover.

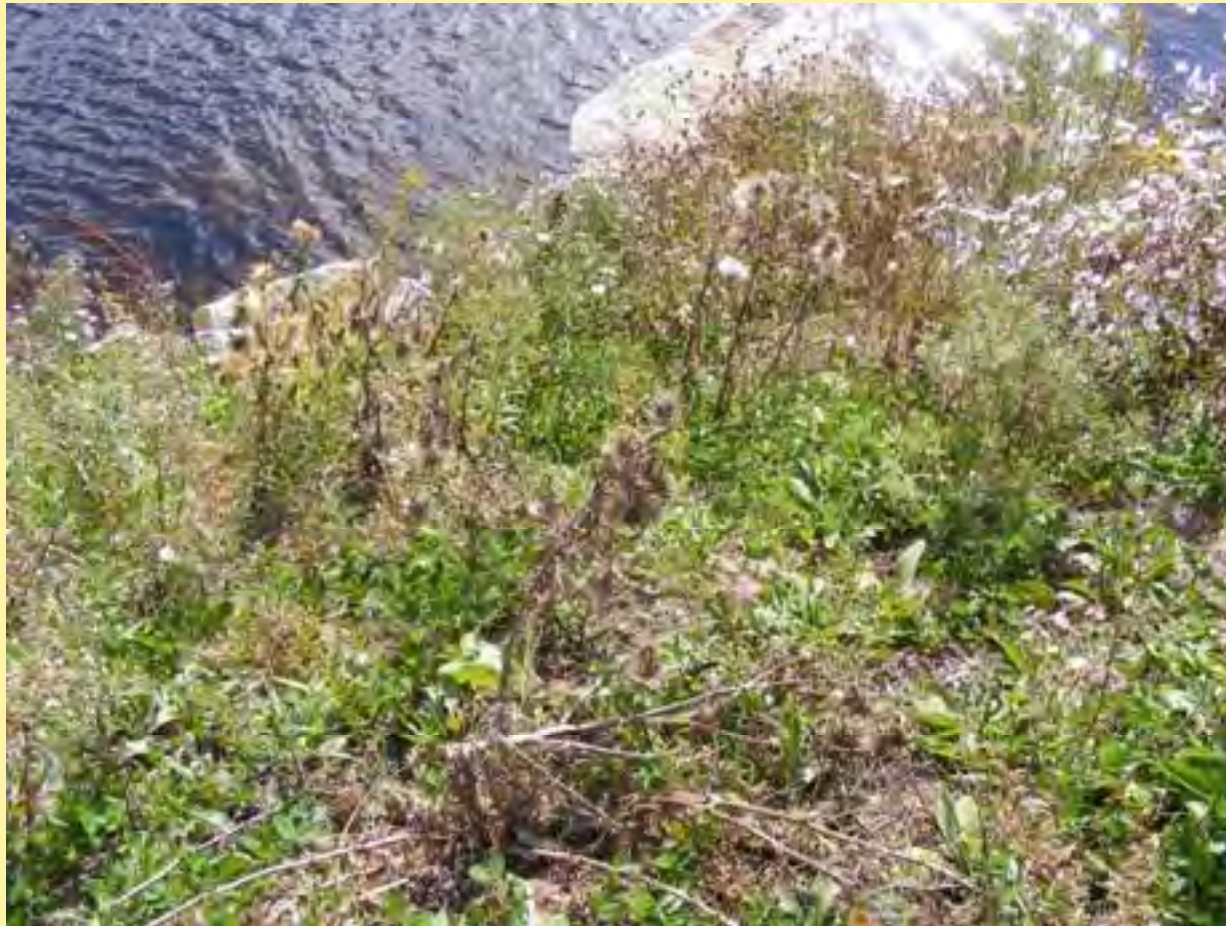
# Station + 540

- Slope 90% cover
  - Sparse grass
  - Mostly Thistle and other introduced 'weed' species
  - Some Goldenrod, Aster, Horseweed.
- Several stems installed near here - None alive
- Bottom:
  - Soft Rush.

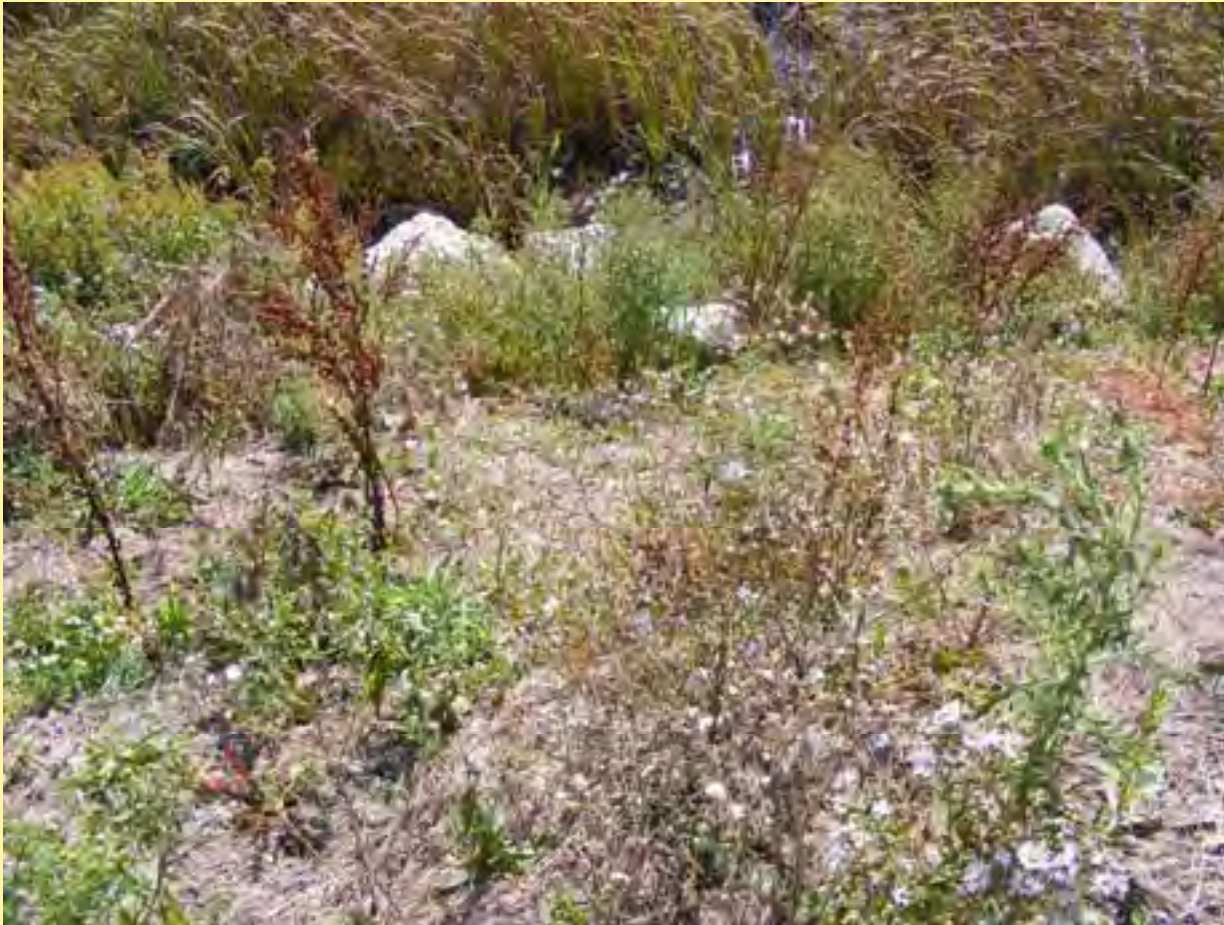
# Station + 520

- Slope 90% cover
  - Sparse grass
  - Clover
  - Introduced ‘weeds’ (Thistle, Wild Carrot, Dock, Mullein seedlings, knapweed)
  - Horseweed
  - Native Goldenrods, Aster.

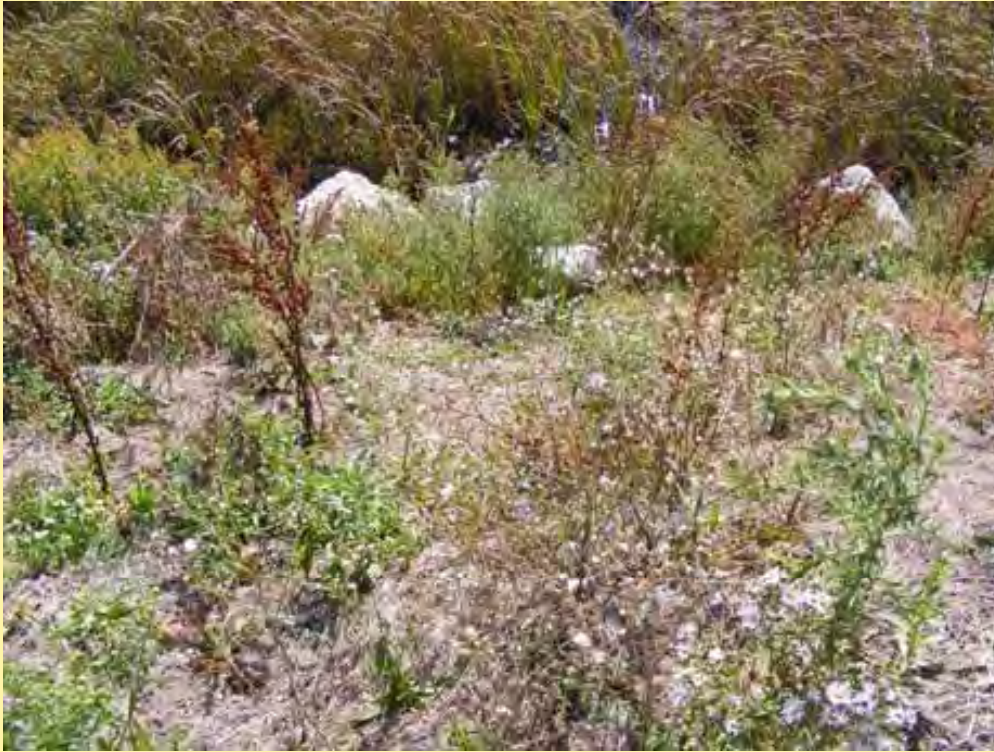
# Station + 500

- Slope: 50 % ‘cover is dead grass’
  - Introduced ‘weeds’ (Dock, Knapweed, Thistle)
  - Native wildflowers (Aster, Goldenrod)
  - Raspberry.
- Bottom:
  - 60% Cattail
  - 20% grasses
  - 20% native shrubs (Leatherleaf, Sweet Gale).
