**Cranberry Lake, Highway 103,  
HADD Compensation Project  
(DFO HADD Authorization 03-W8-303):  
2009 Vegetation Monitoring:  
September 14, 2009  
Year 5, Final**

Diane LaRue, Vegetation Consultant  
Environmental Services, NSTIR  
October 2009

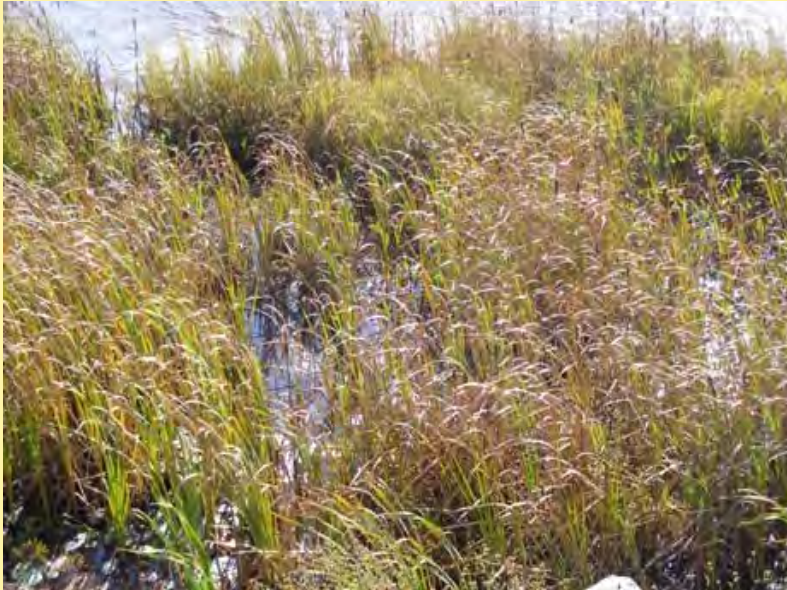
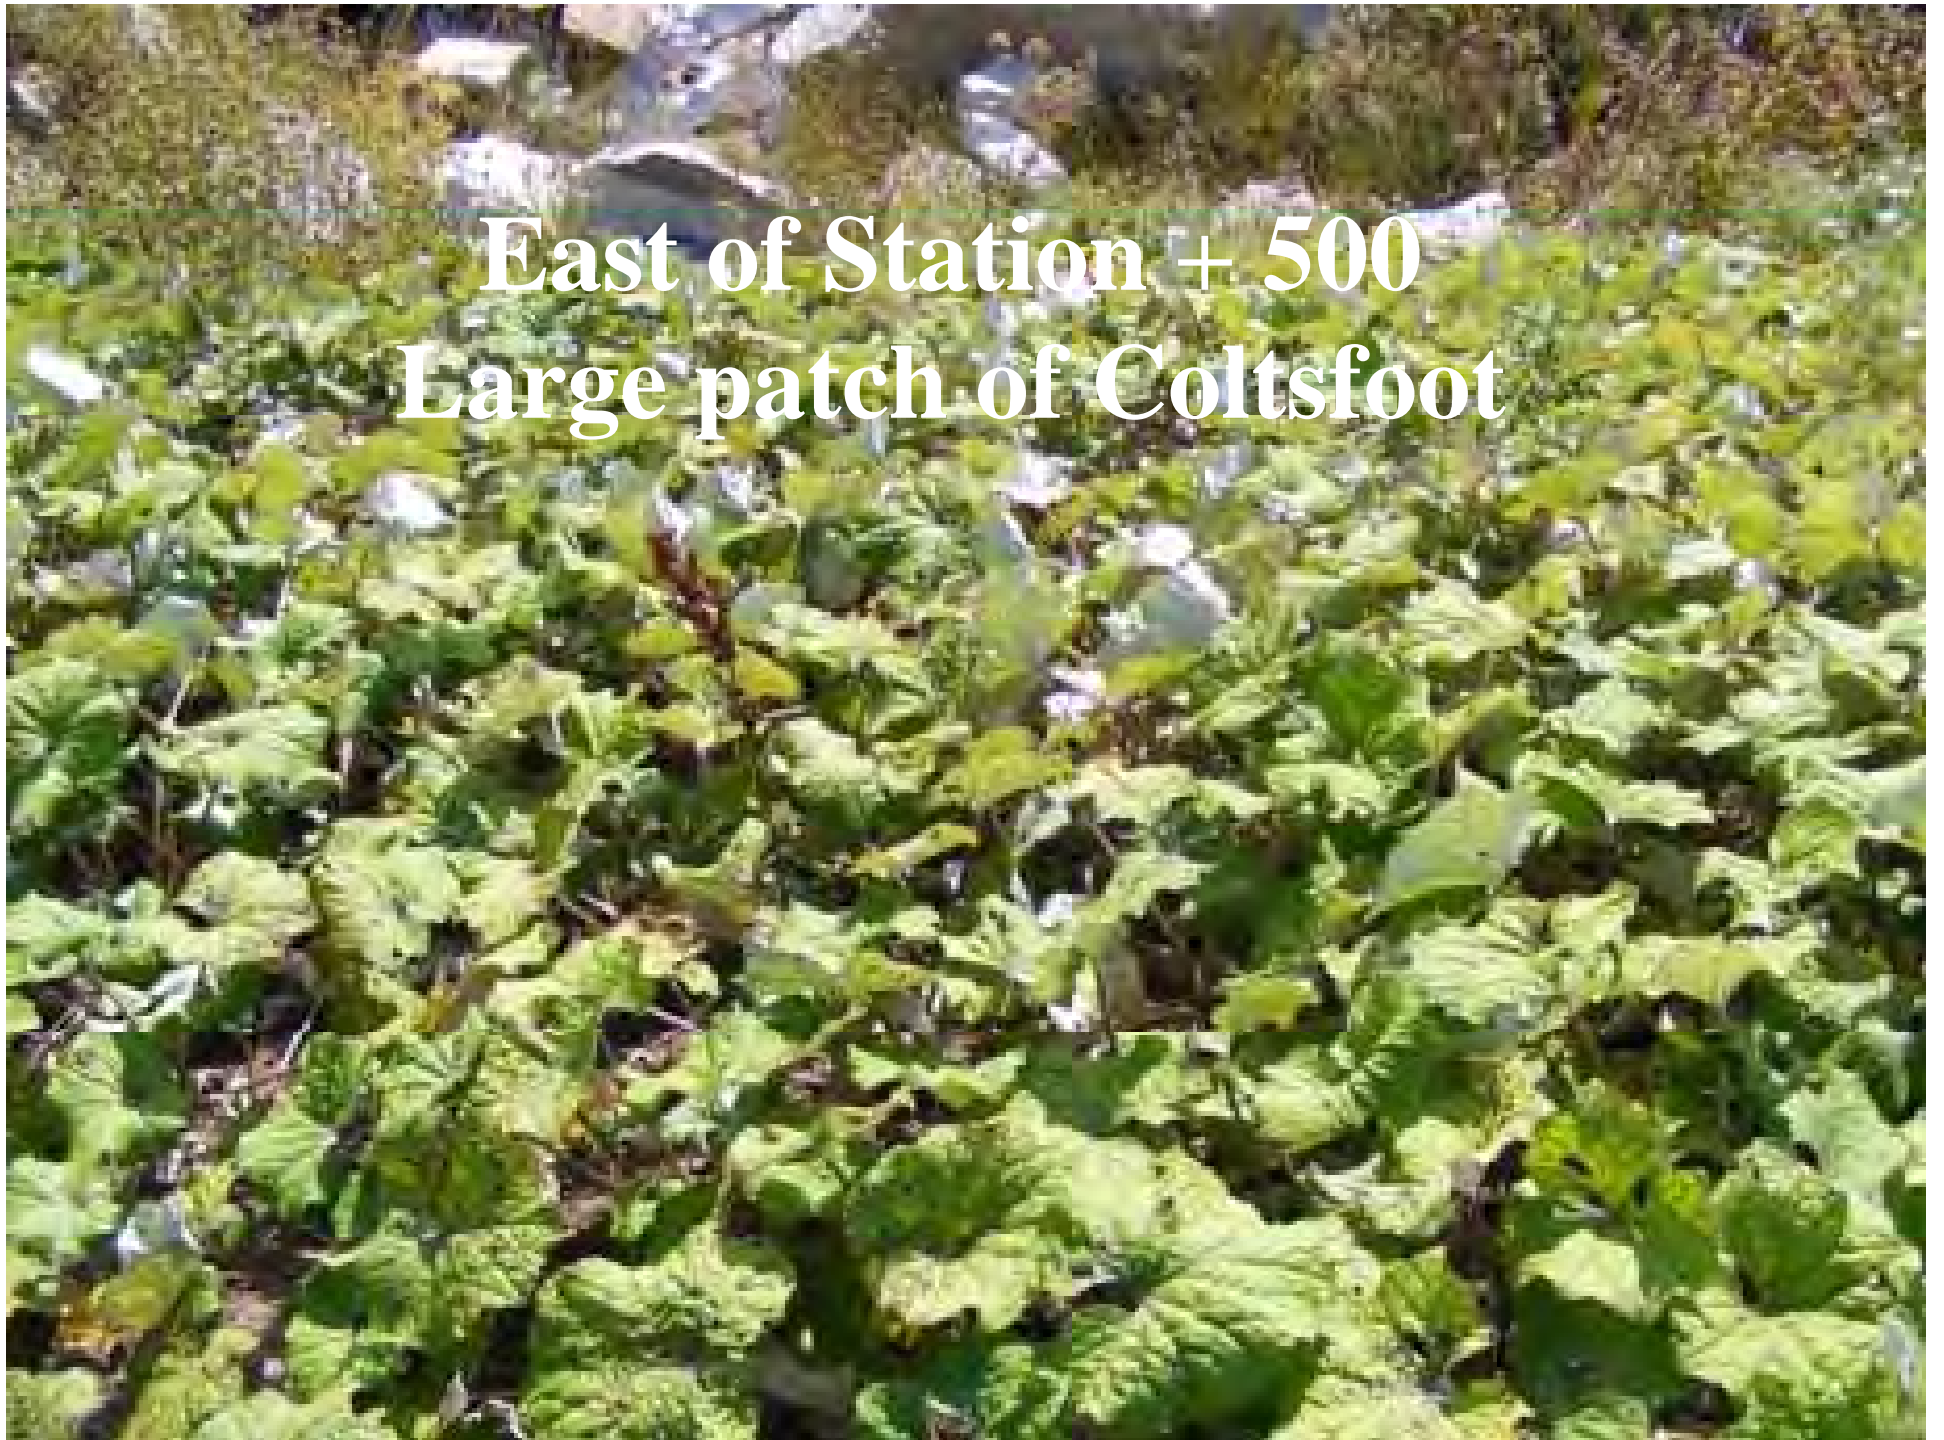
**East of Station + 500**  
**Large patch of Coltsfoot**

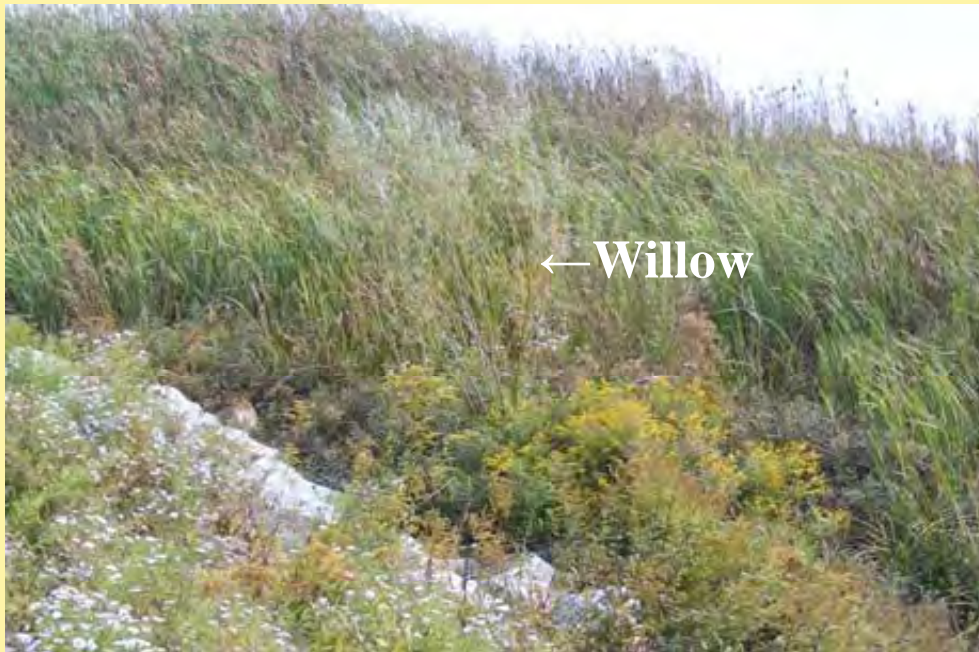
# Between Stations +480 and + 500

- Willows established from dormant stakes
- Shore clumps established from vegetation salvaged during construction.

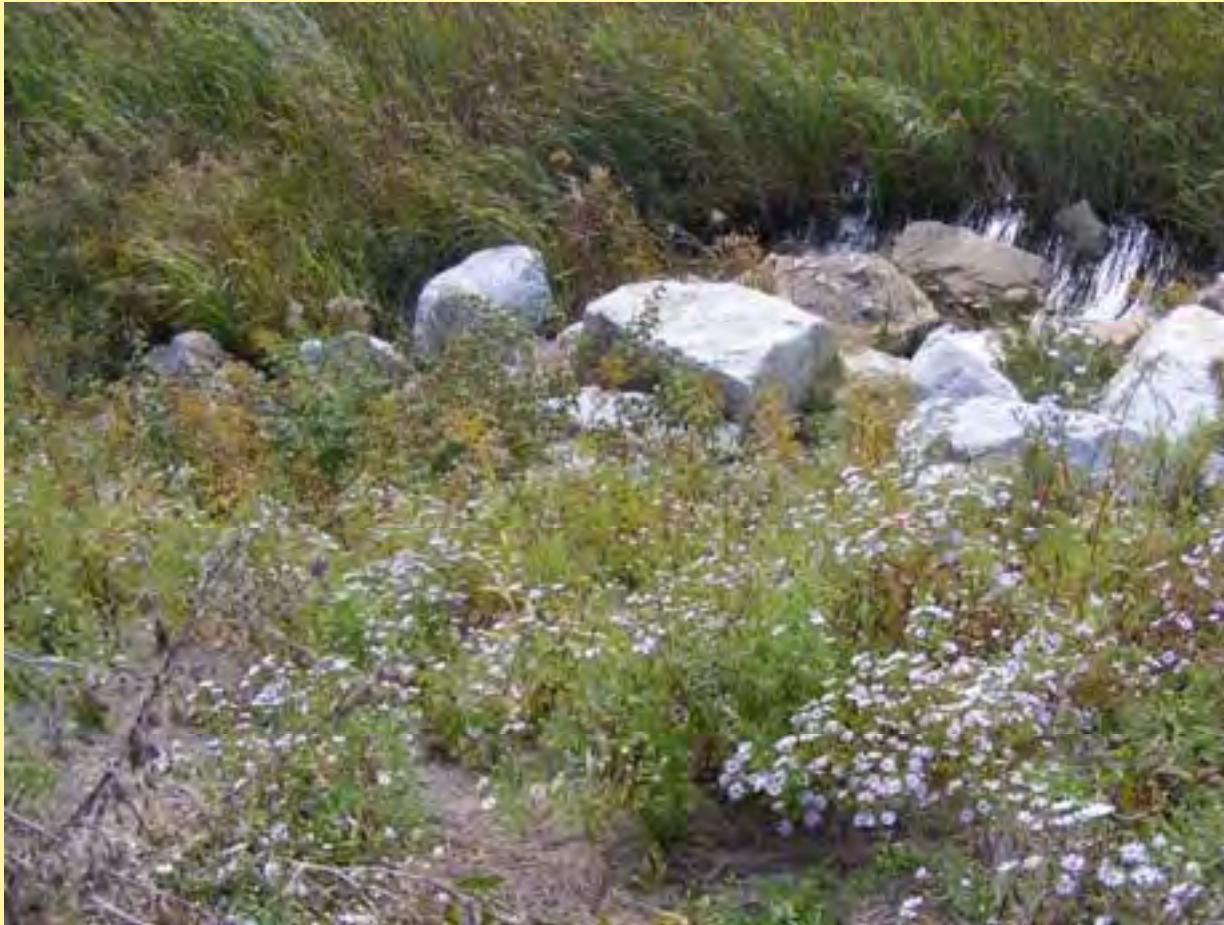
# Station + 480

- Slope: 80% live cover (20% dead grass)
  - Mostly Aster with occasional Goldenrod
  - Occasional introduced ‘weed’ species (Thistle)
  - Raspberry
- Shore (transplanted at construction):
  - Mostly Cattail (90%)
  - Sweet Gale, Leather-leaf, Bulrush, Soft Rush.

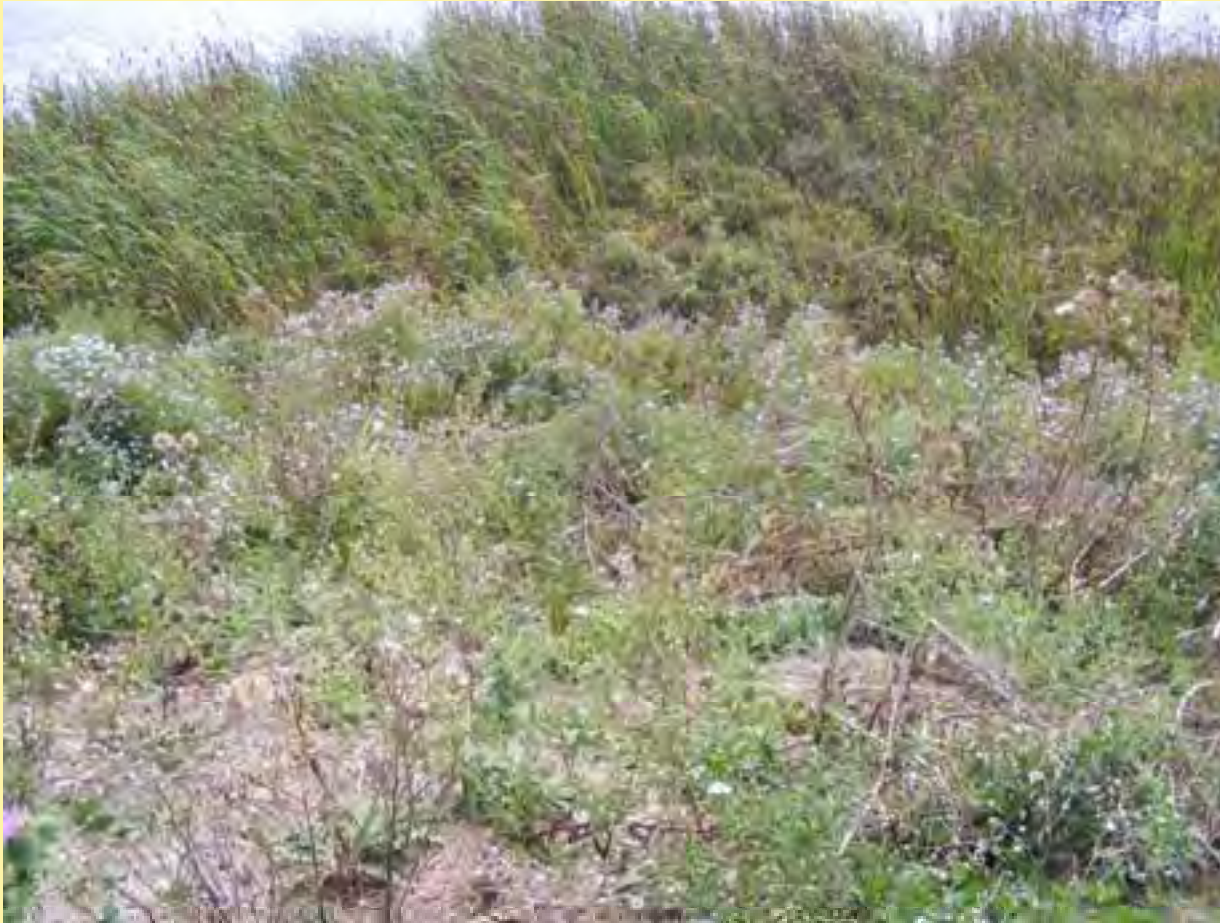
# Station + 460

- Slope: 80% live cover (20% dead grass)
  - No grass observed
  - Introduced ‘weed’ species (Thistle, Groundsel, Dock)
  - Native Asters
  - Raspberry.
- Shore Mostly Cattail
  - Also Sweet Gale, Bulrush, Aster, and Soft Rush.

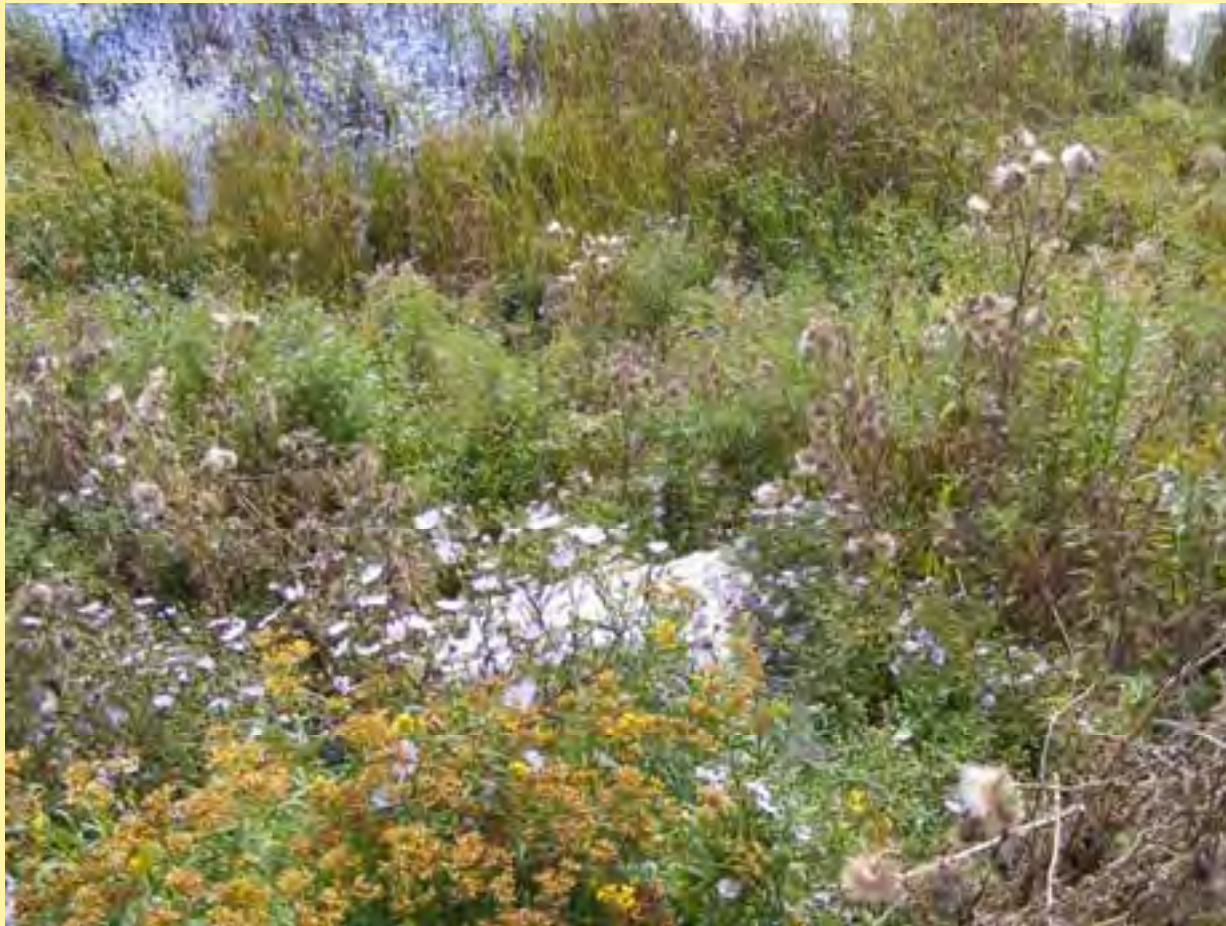
# Station + 440

- Slope 100% cover
  - Sparse grass
  - Introduced ‘weeds’ (Thistles)
  - Native wildflowers (Aster, Narrow Leaf Goldenrod)
  - To left, several Mullein seedlings.
- Shore:
  - Mostly Cattail
  - Bulrush
  - Sweet gale
  - Water Lily in water.

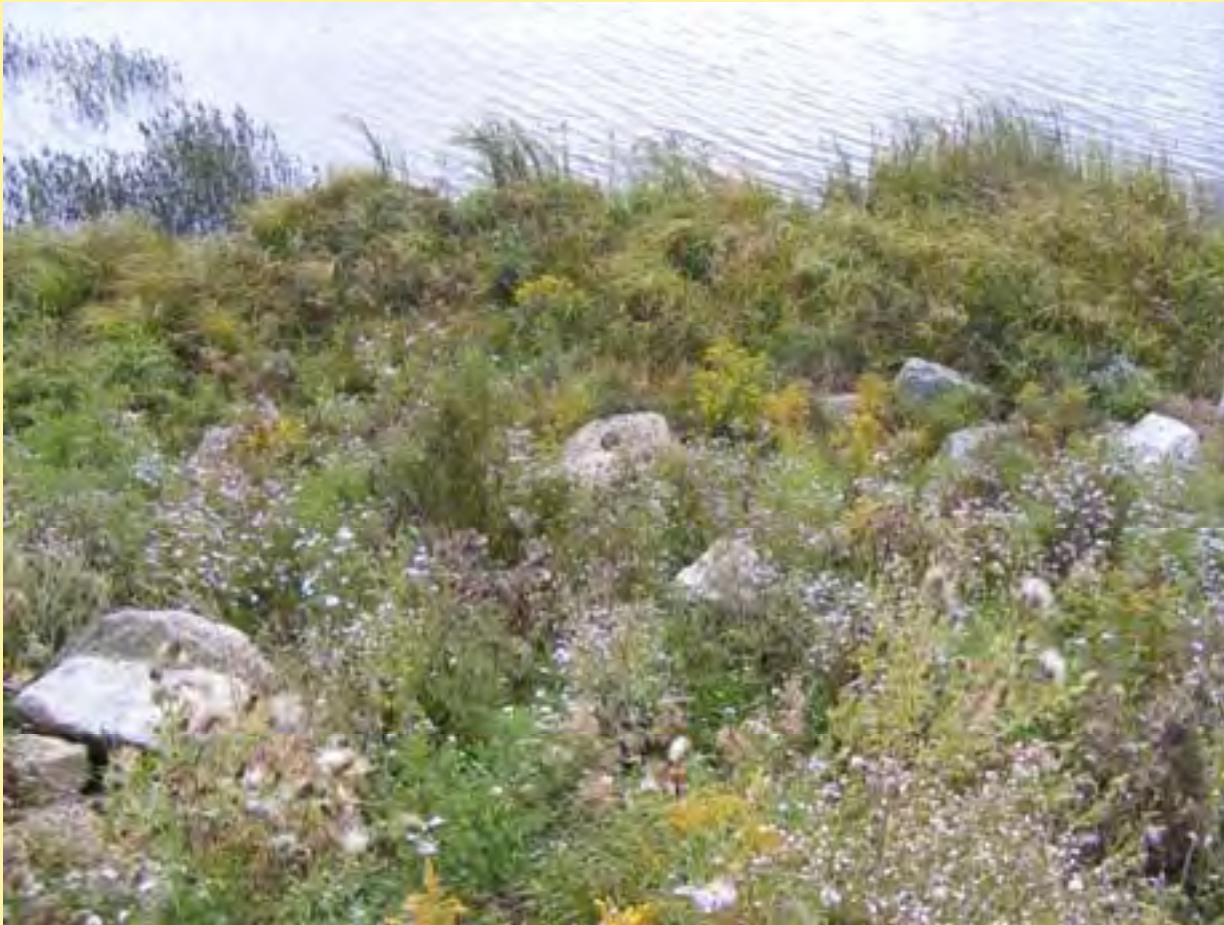
# Station + 420

- Slope 90% cover
  - Sparse grass
  - Introduced ‘weeds’ (Thistle, Sweetclover – 1<sup>st</sup>, 2<sup>nd</sup> year plants, Groundsel)
  - Native wildflowers (Goldenrod, Aster).
- Shore
  - Some Cattail at water’s edge
  - Grasses, Goldenrods, Bulrushes
  - Maple, natural regeneration.

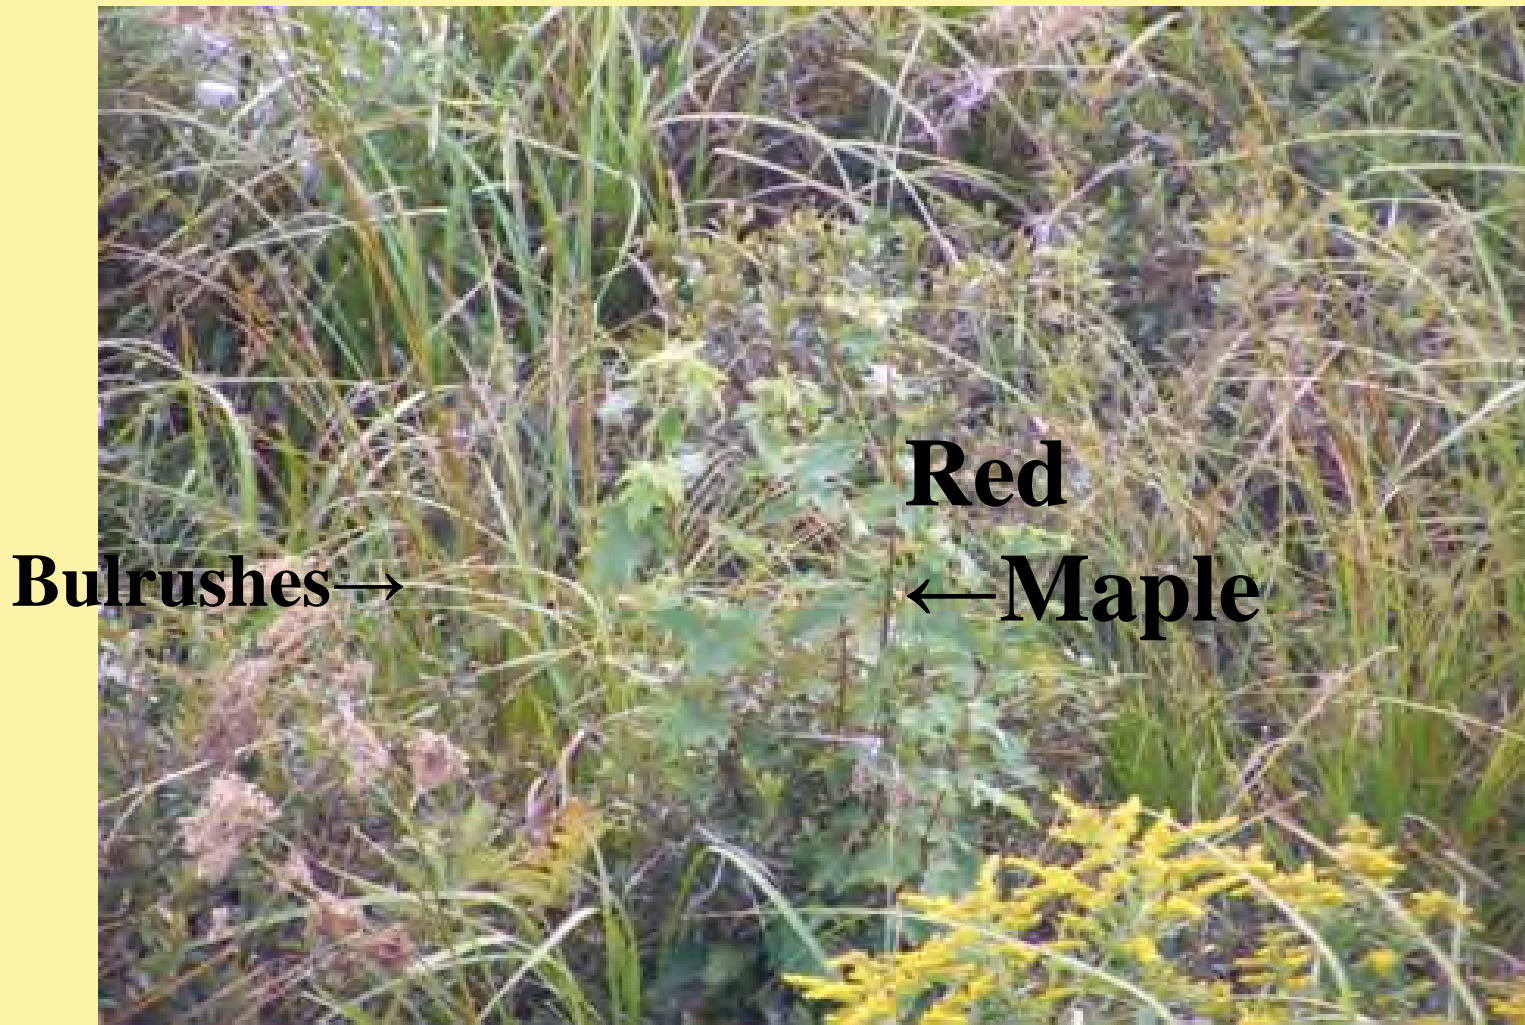
# Station + 420

- Young Red Maple, naturally regenerating

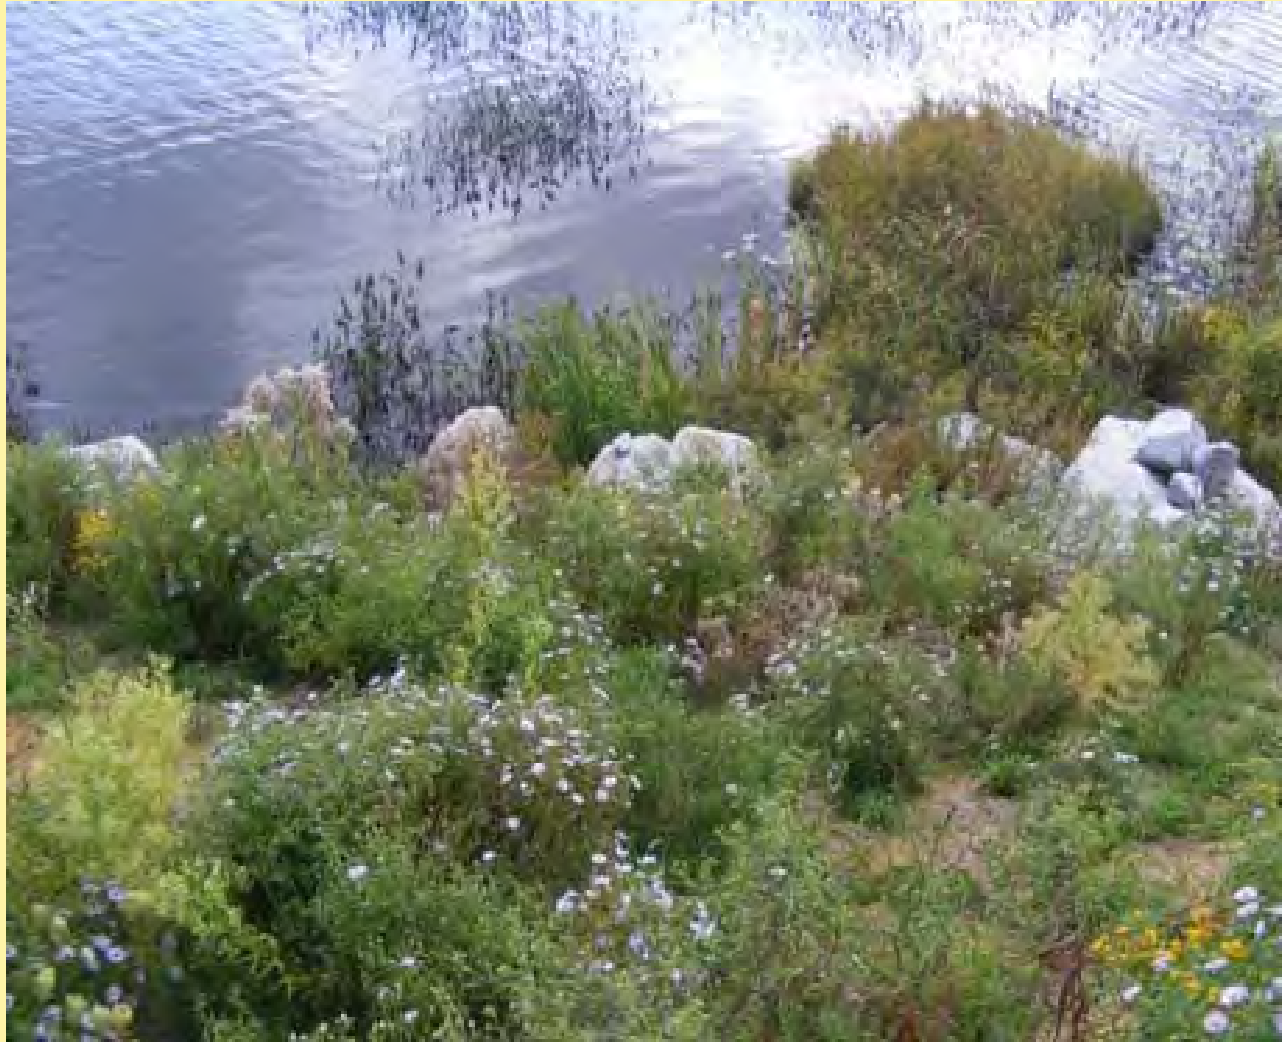
# Station + 400

- Slope 100% cover
  - No bare soil
  - Sparse grass and Clover
  - Chickweed (live and dead)
  - Other introduced 'weed' species (Wild carrot, Groundsel)
  - Native Goldenrods and Asters
  - Horseweed.
- Shore
  - Cattails
  - Meadow-sweet
  - Bulrush, grasses
  - Sweet Gale
  - Pickerel Weed, Water Lily.

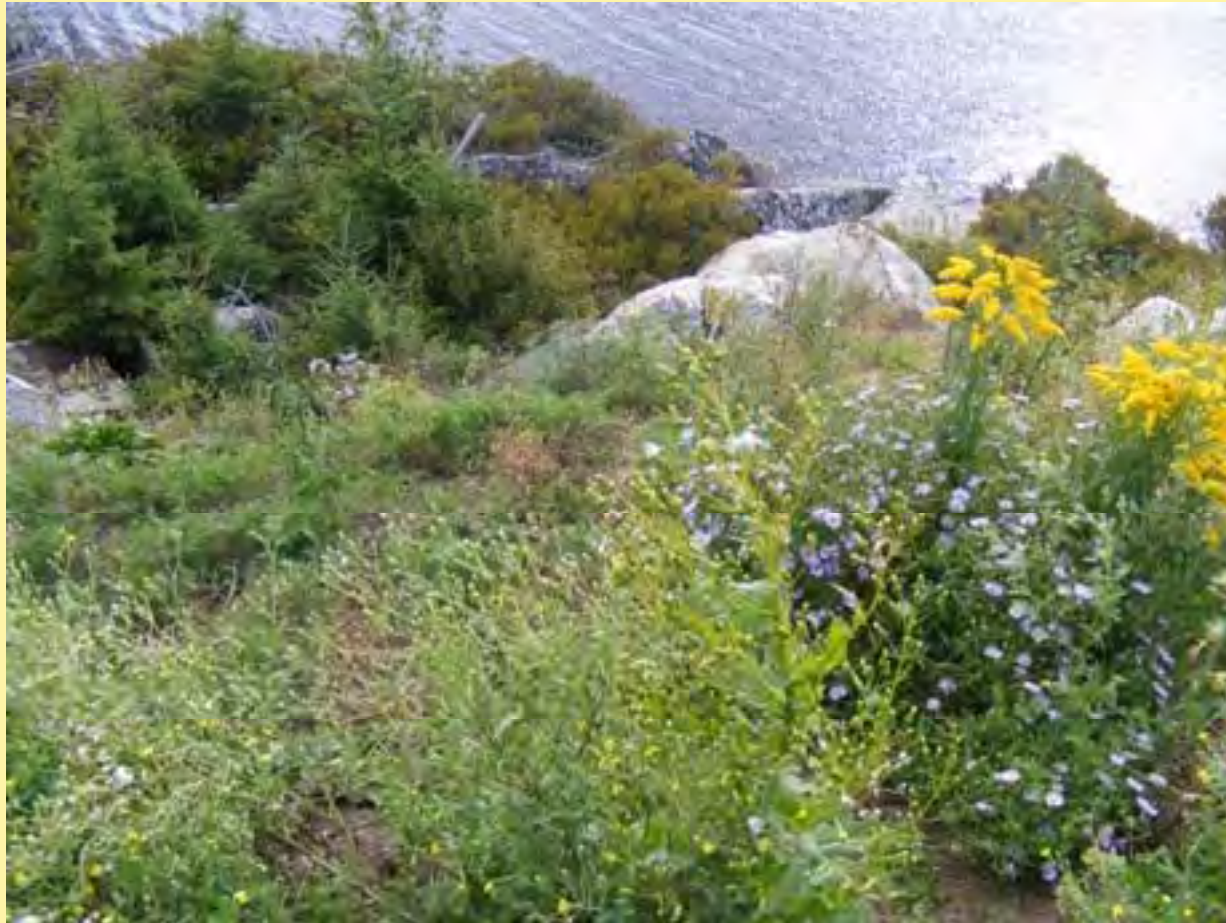
# Station + 380

- Slope: 80%  
Live Cover
  - Sparse grass
  - Introduced ‘weeds’ (Groundsel, Vetch)
  - Clover
  - Native Asters, Goldenrod.

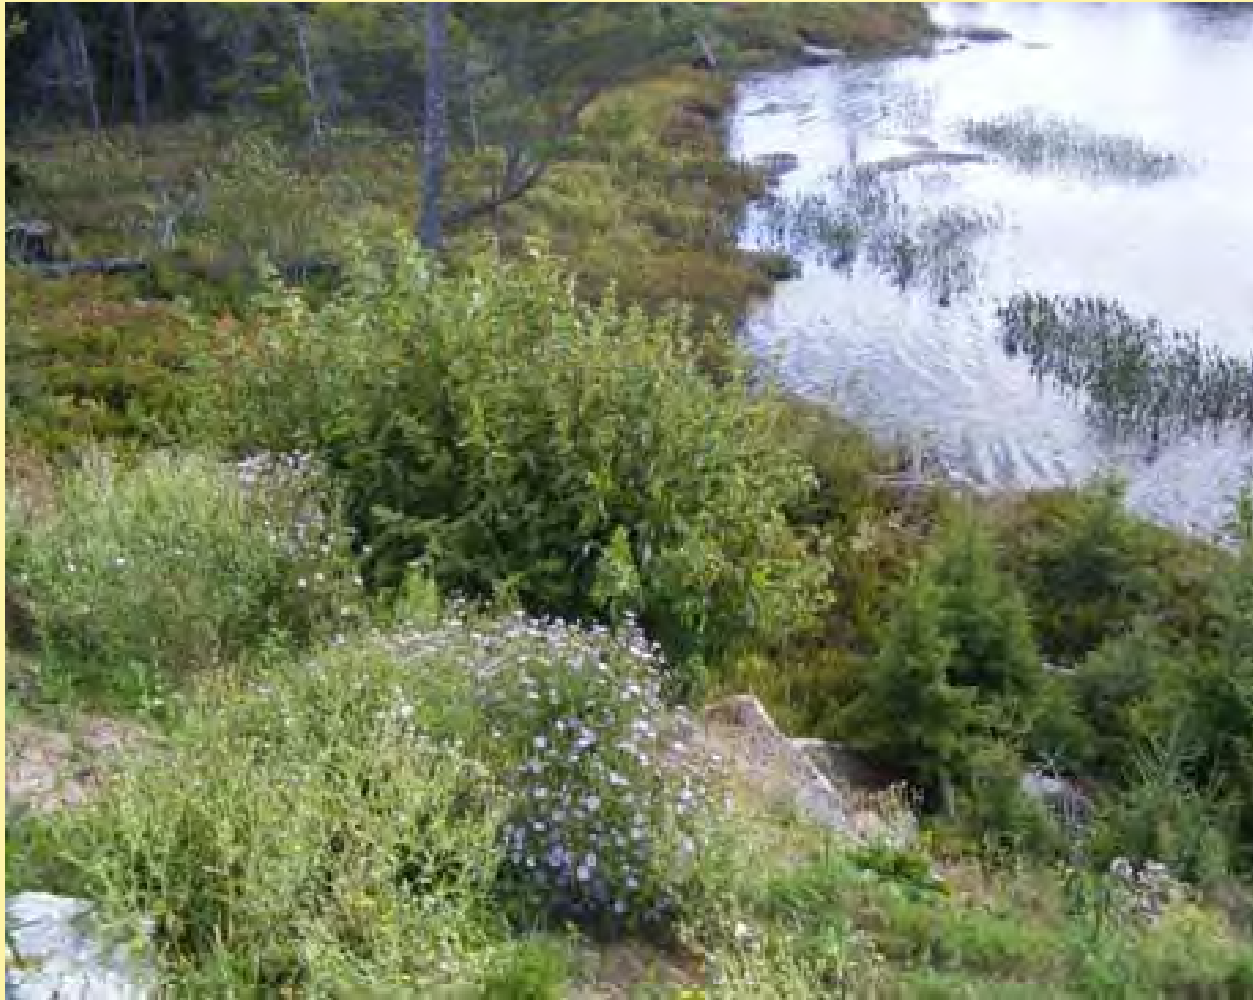
# Station + 380

- Bottom of slope:
  - 100% cover of recovering native forest vegetation in undisturbed area.

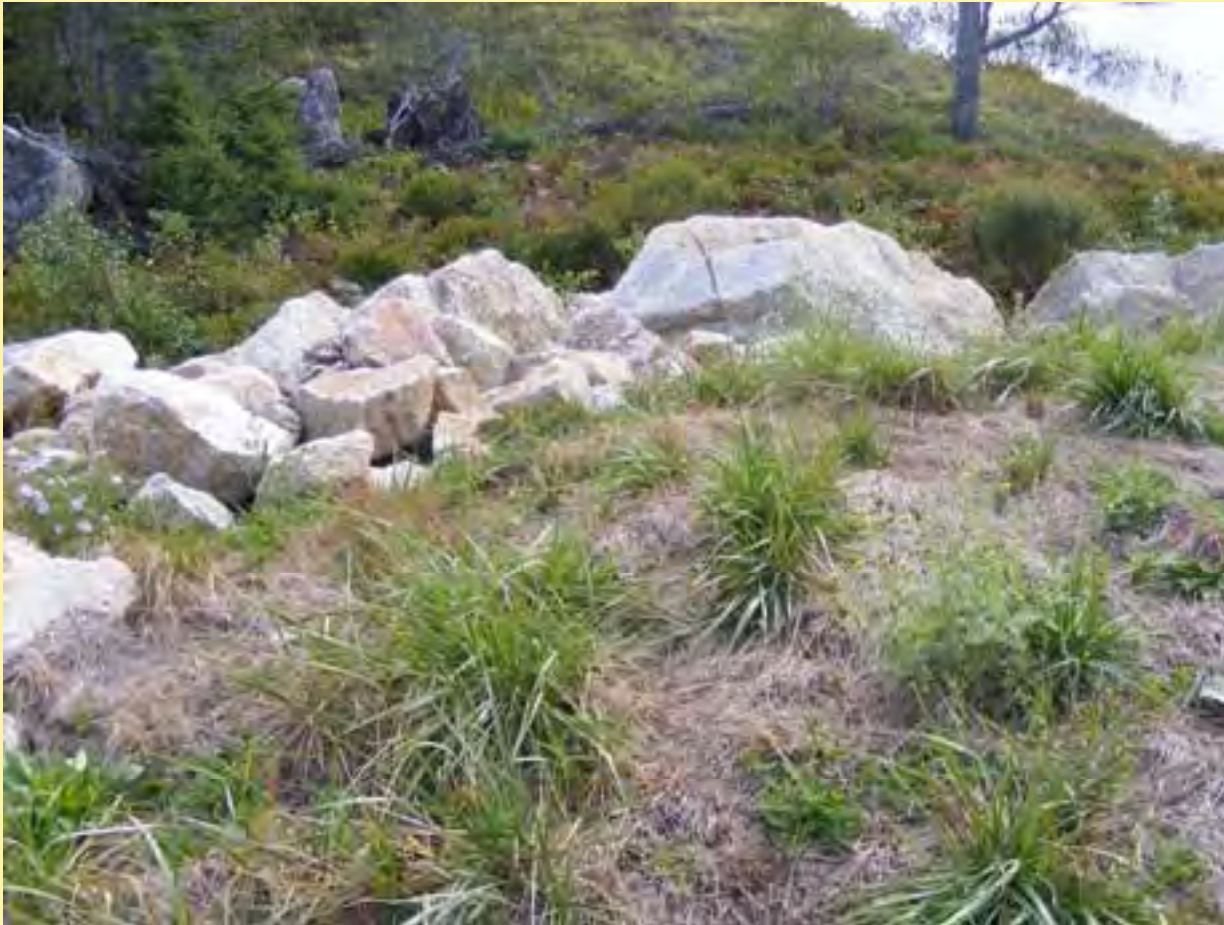
# Station + 360

- Slope: 100% cover
  - 50% live (clumps of grass, Groundsel, occasional Clover, occasional Asters).
- Bottom: 100% cover
  - Recovering forest vegetation.

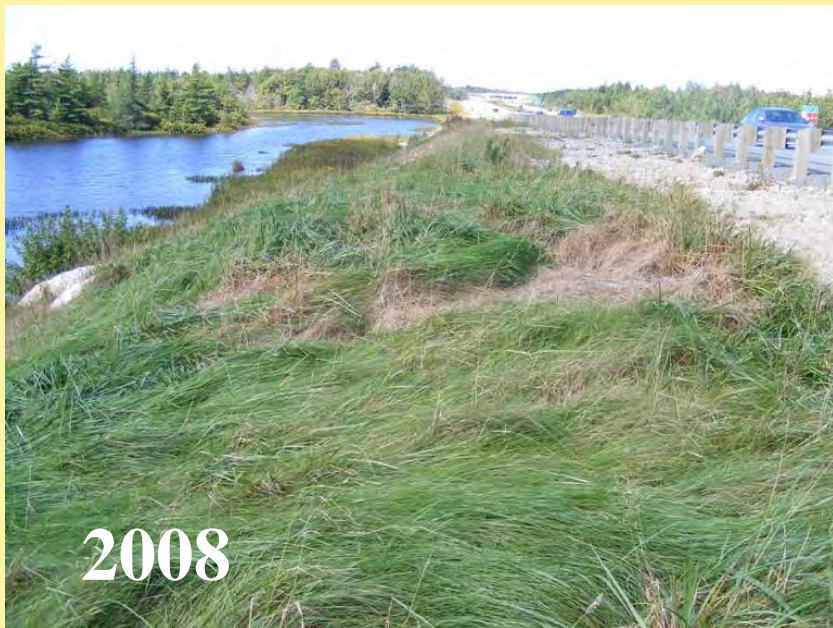
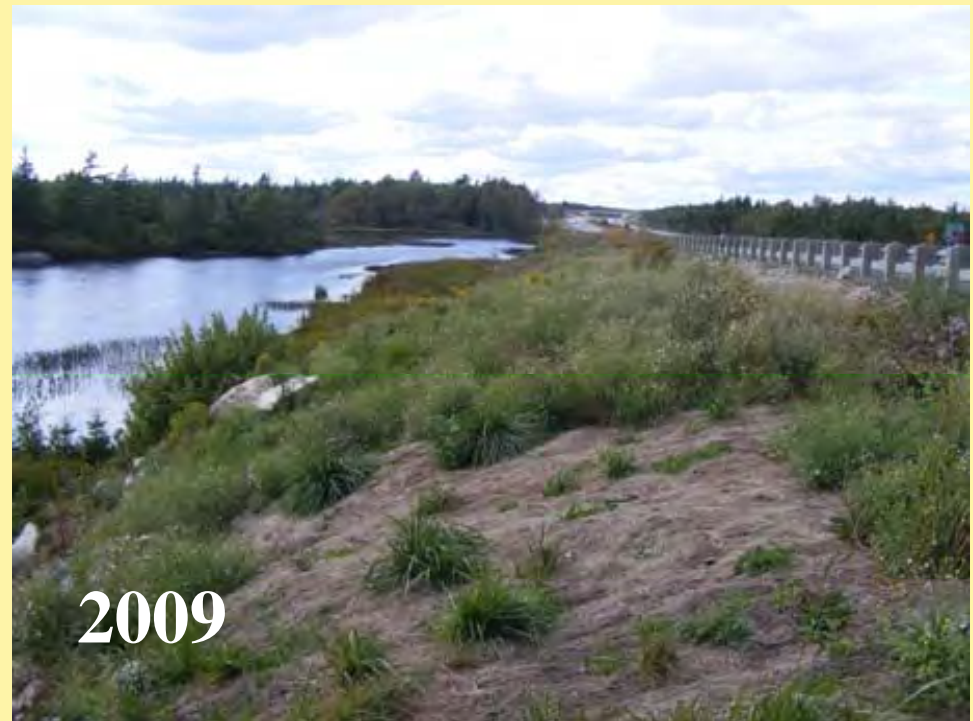
# East to West 2008 and 2009

- Grass dying out
- Replaced with introduced 'weed' species and native wildflowers.

**Both photos taken in mid-September**

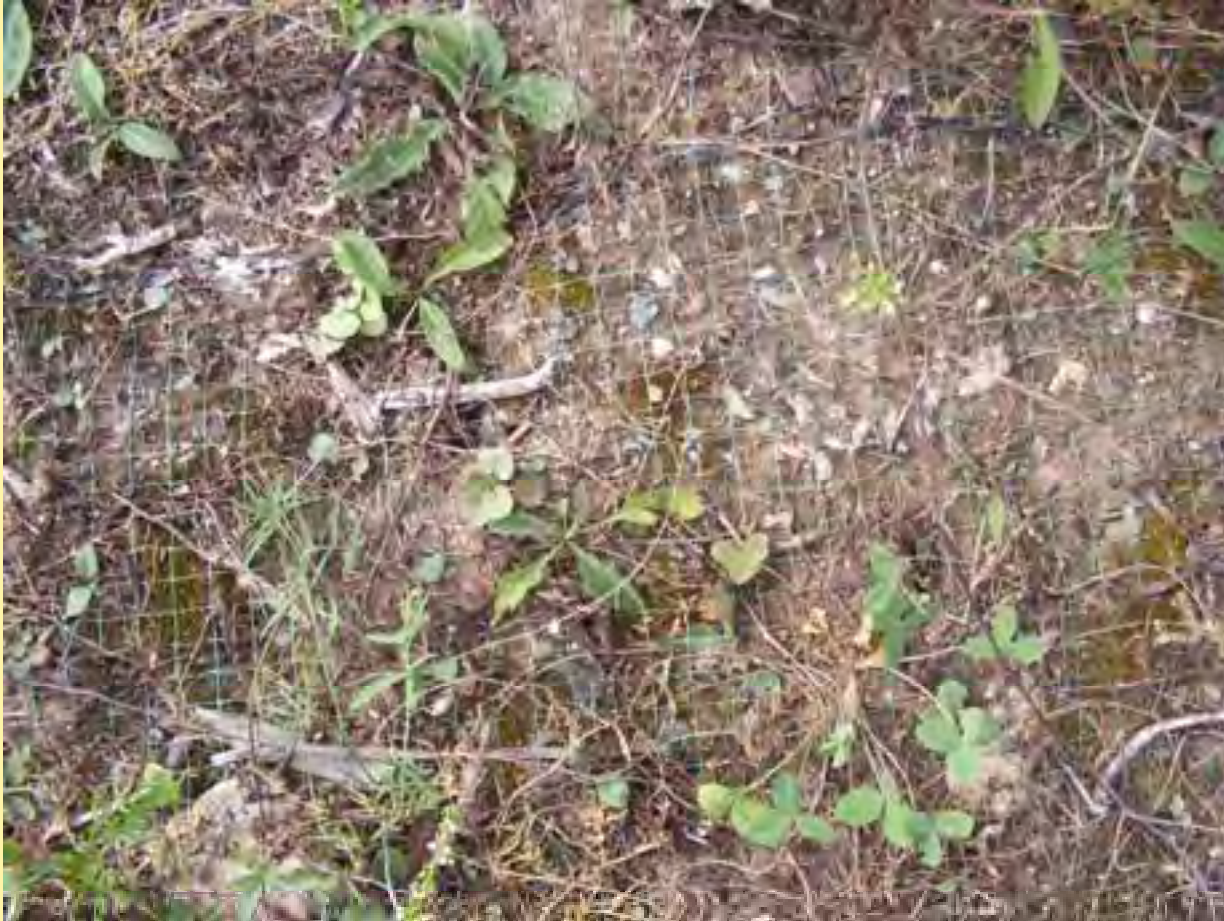
# Erosion Control Netting

- Still strong and intact
- Sparse vegetation in some areas
- Moss providing some cover
- Some bare soil.
