As-Built Report for the Cranberry Lake, Highway 103, HADD Compensation Project: Shoreline and Slope Vegetation in 2004 and 2005

Diane LaRue, Vegetation Consultant
Environmental Services, TPW,
November 2005

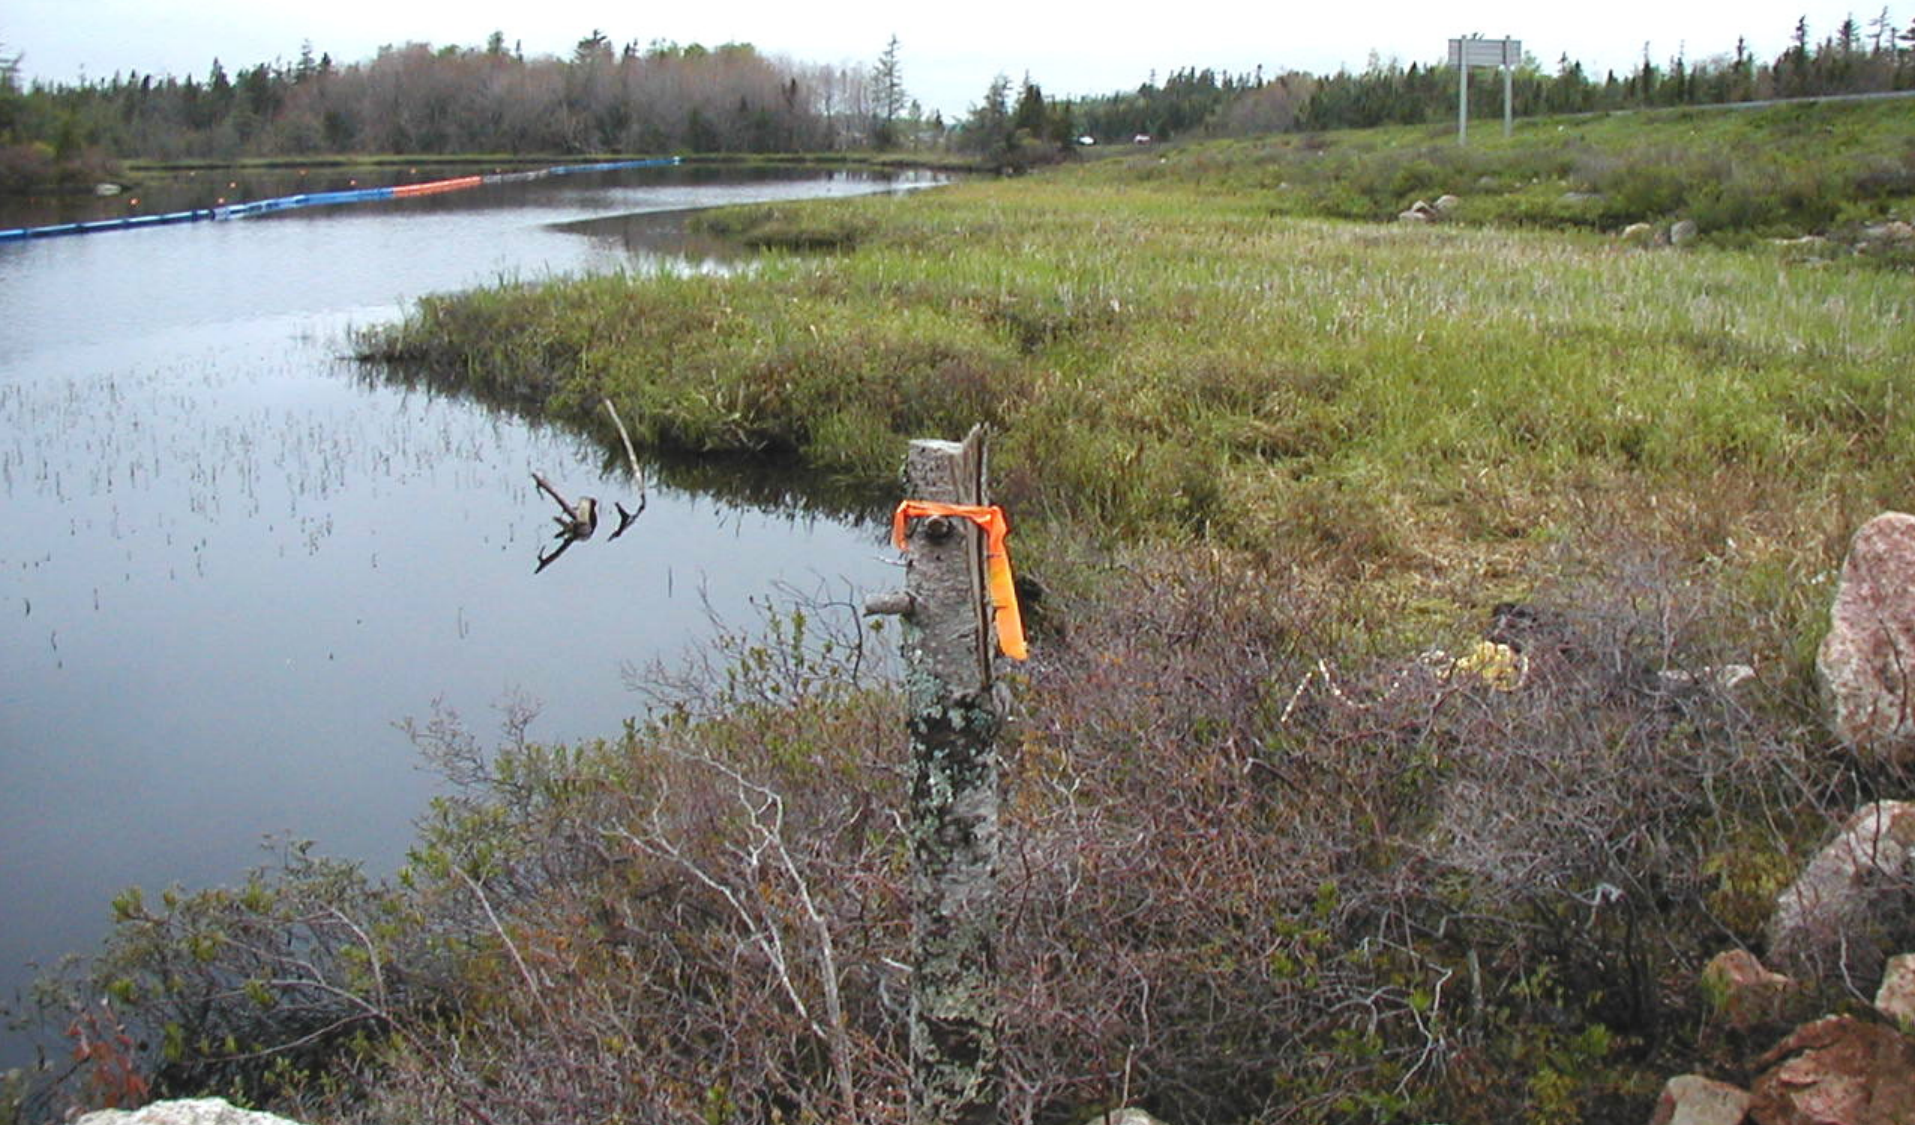
Pre-Construction – June 2004

Original shoreline with stake marking future shoulder

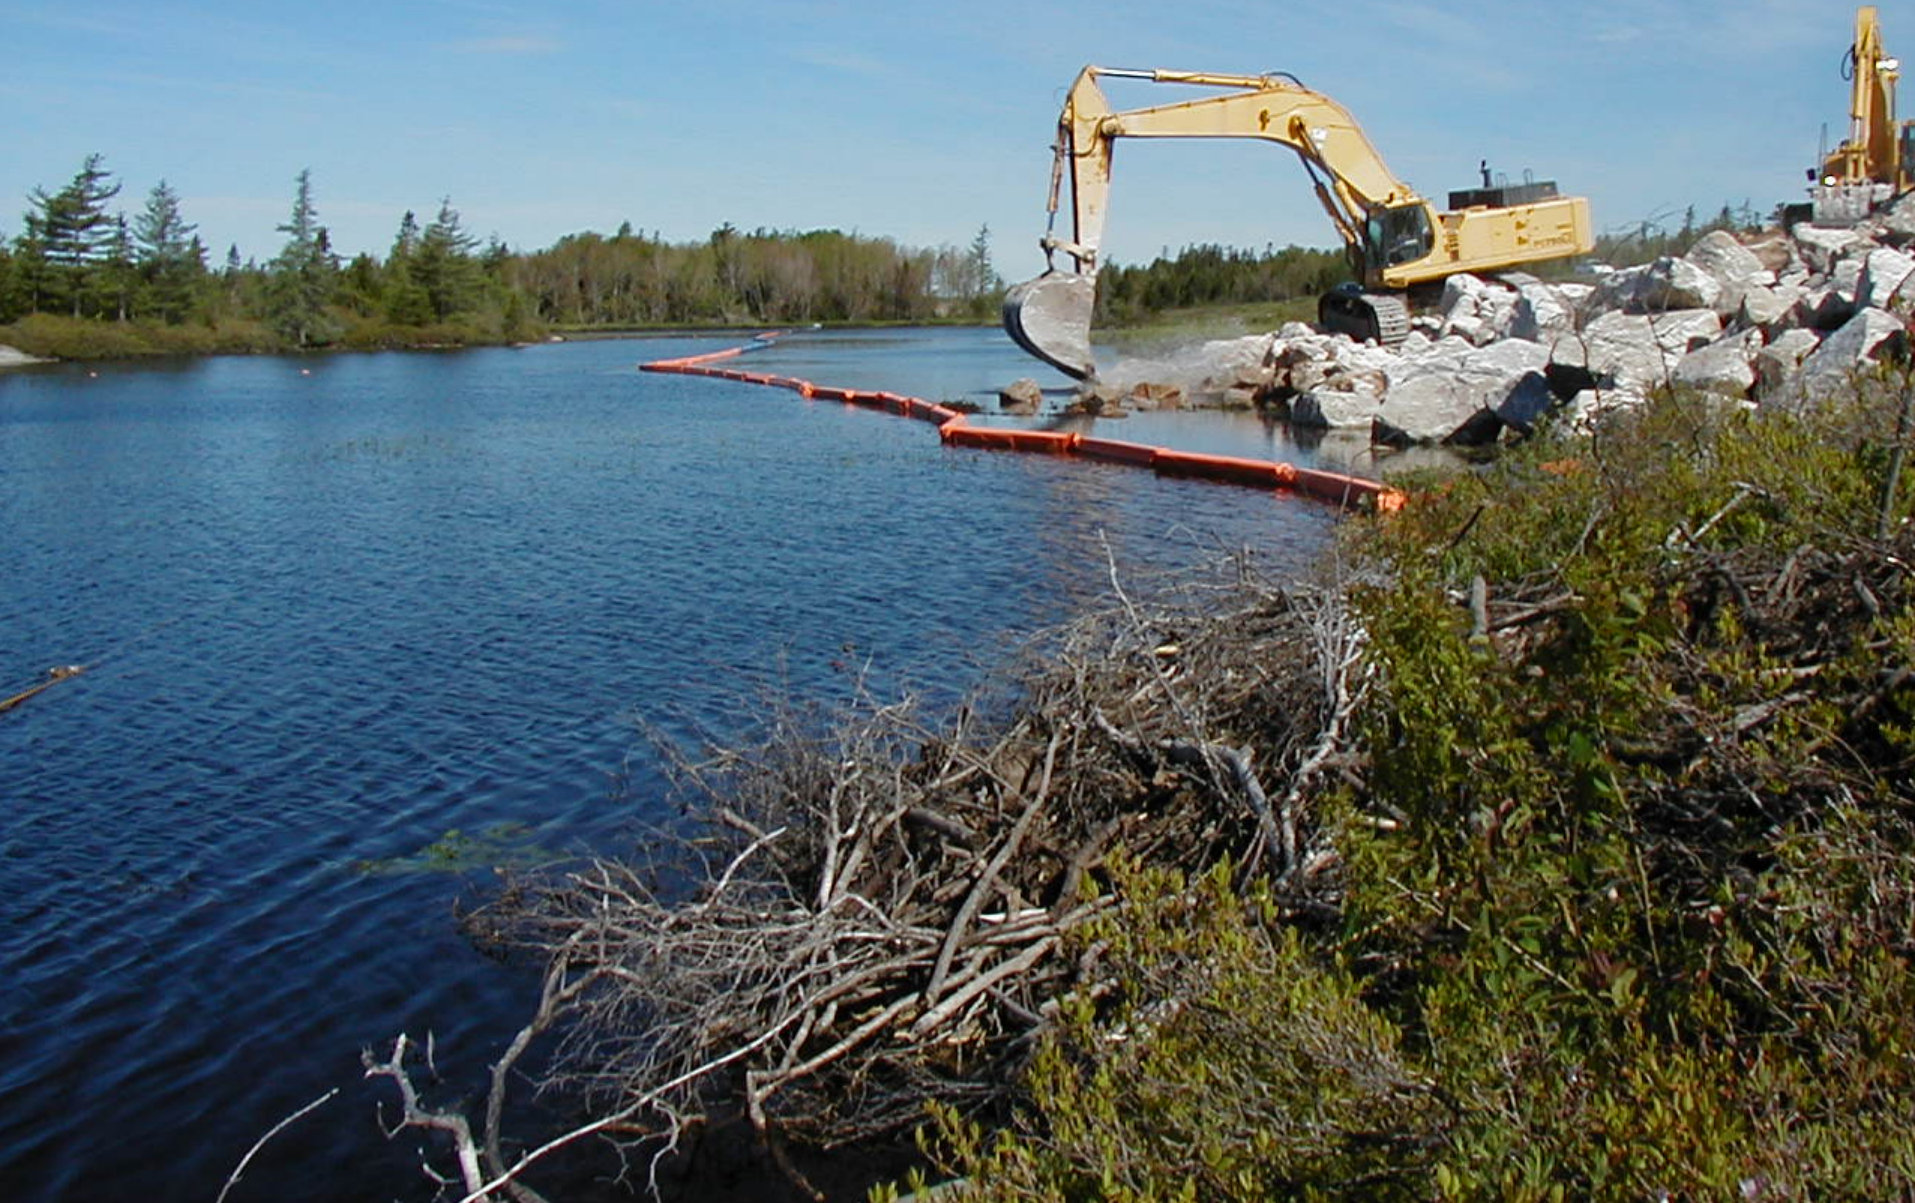
Preparing Sill for Vegetation Clumps

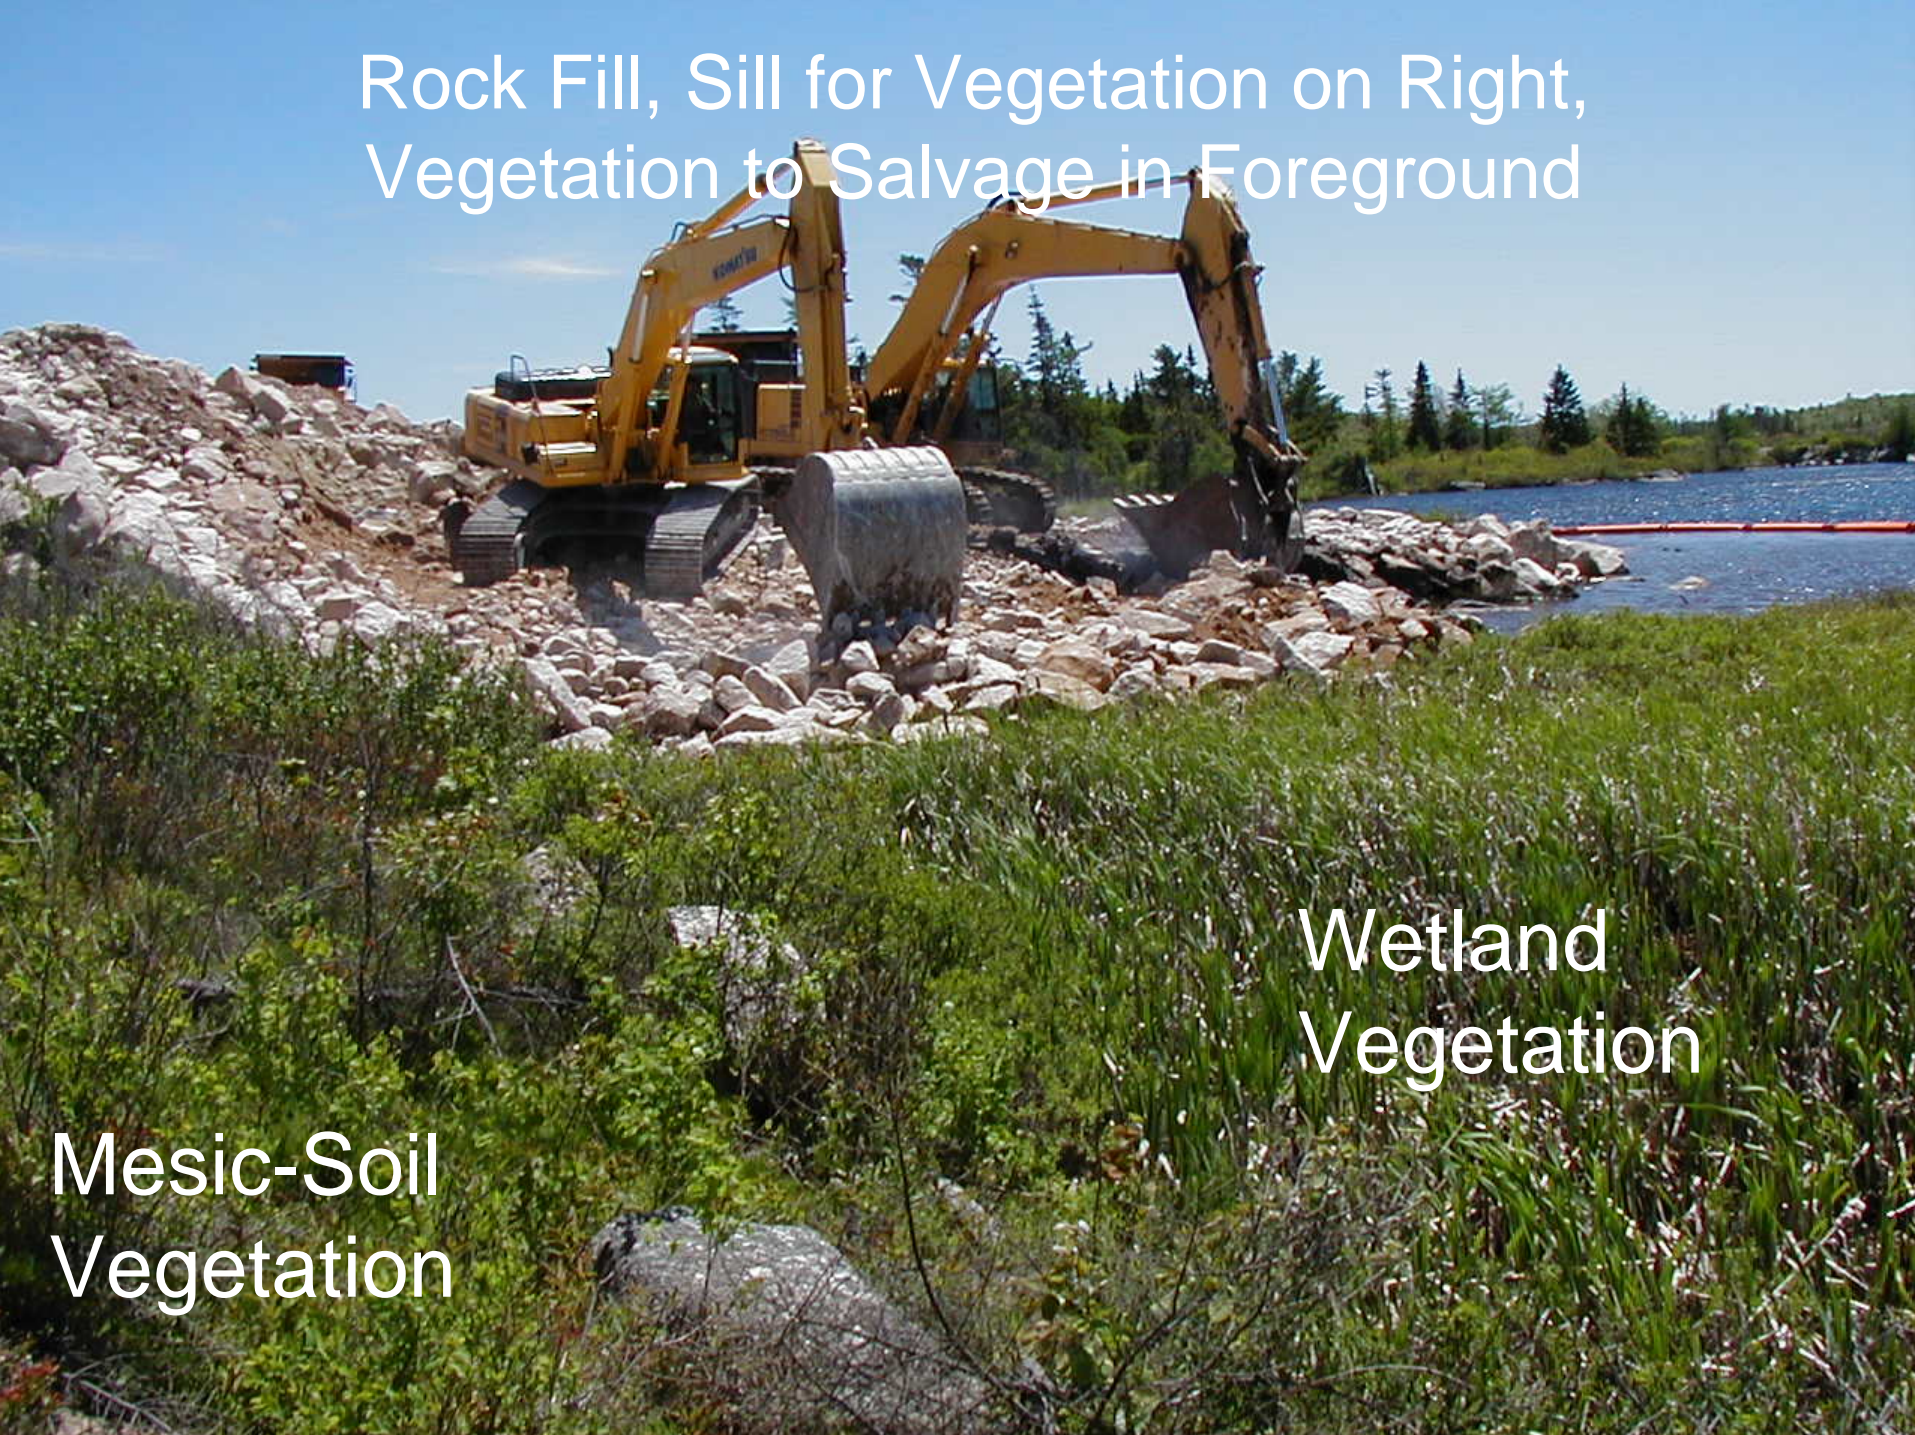
Rock Fill, Sill for Vegetation on Right,
Vegetation to Salvage in Foreground

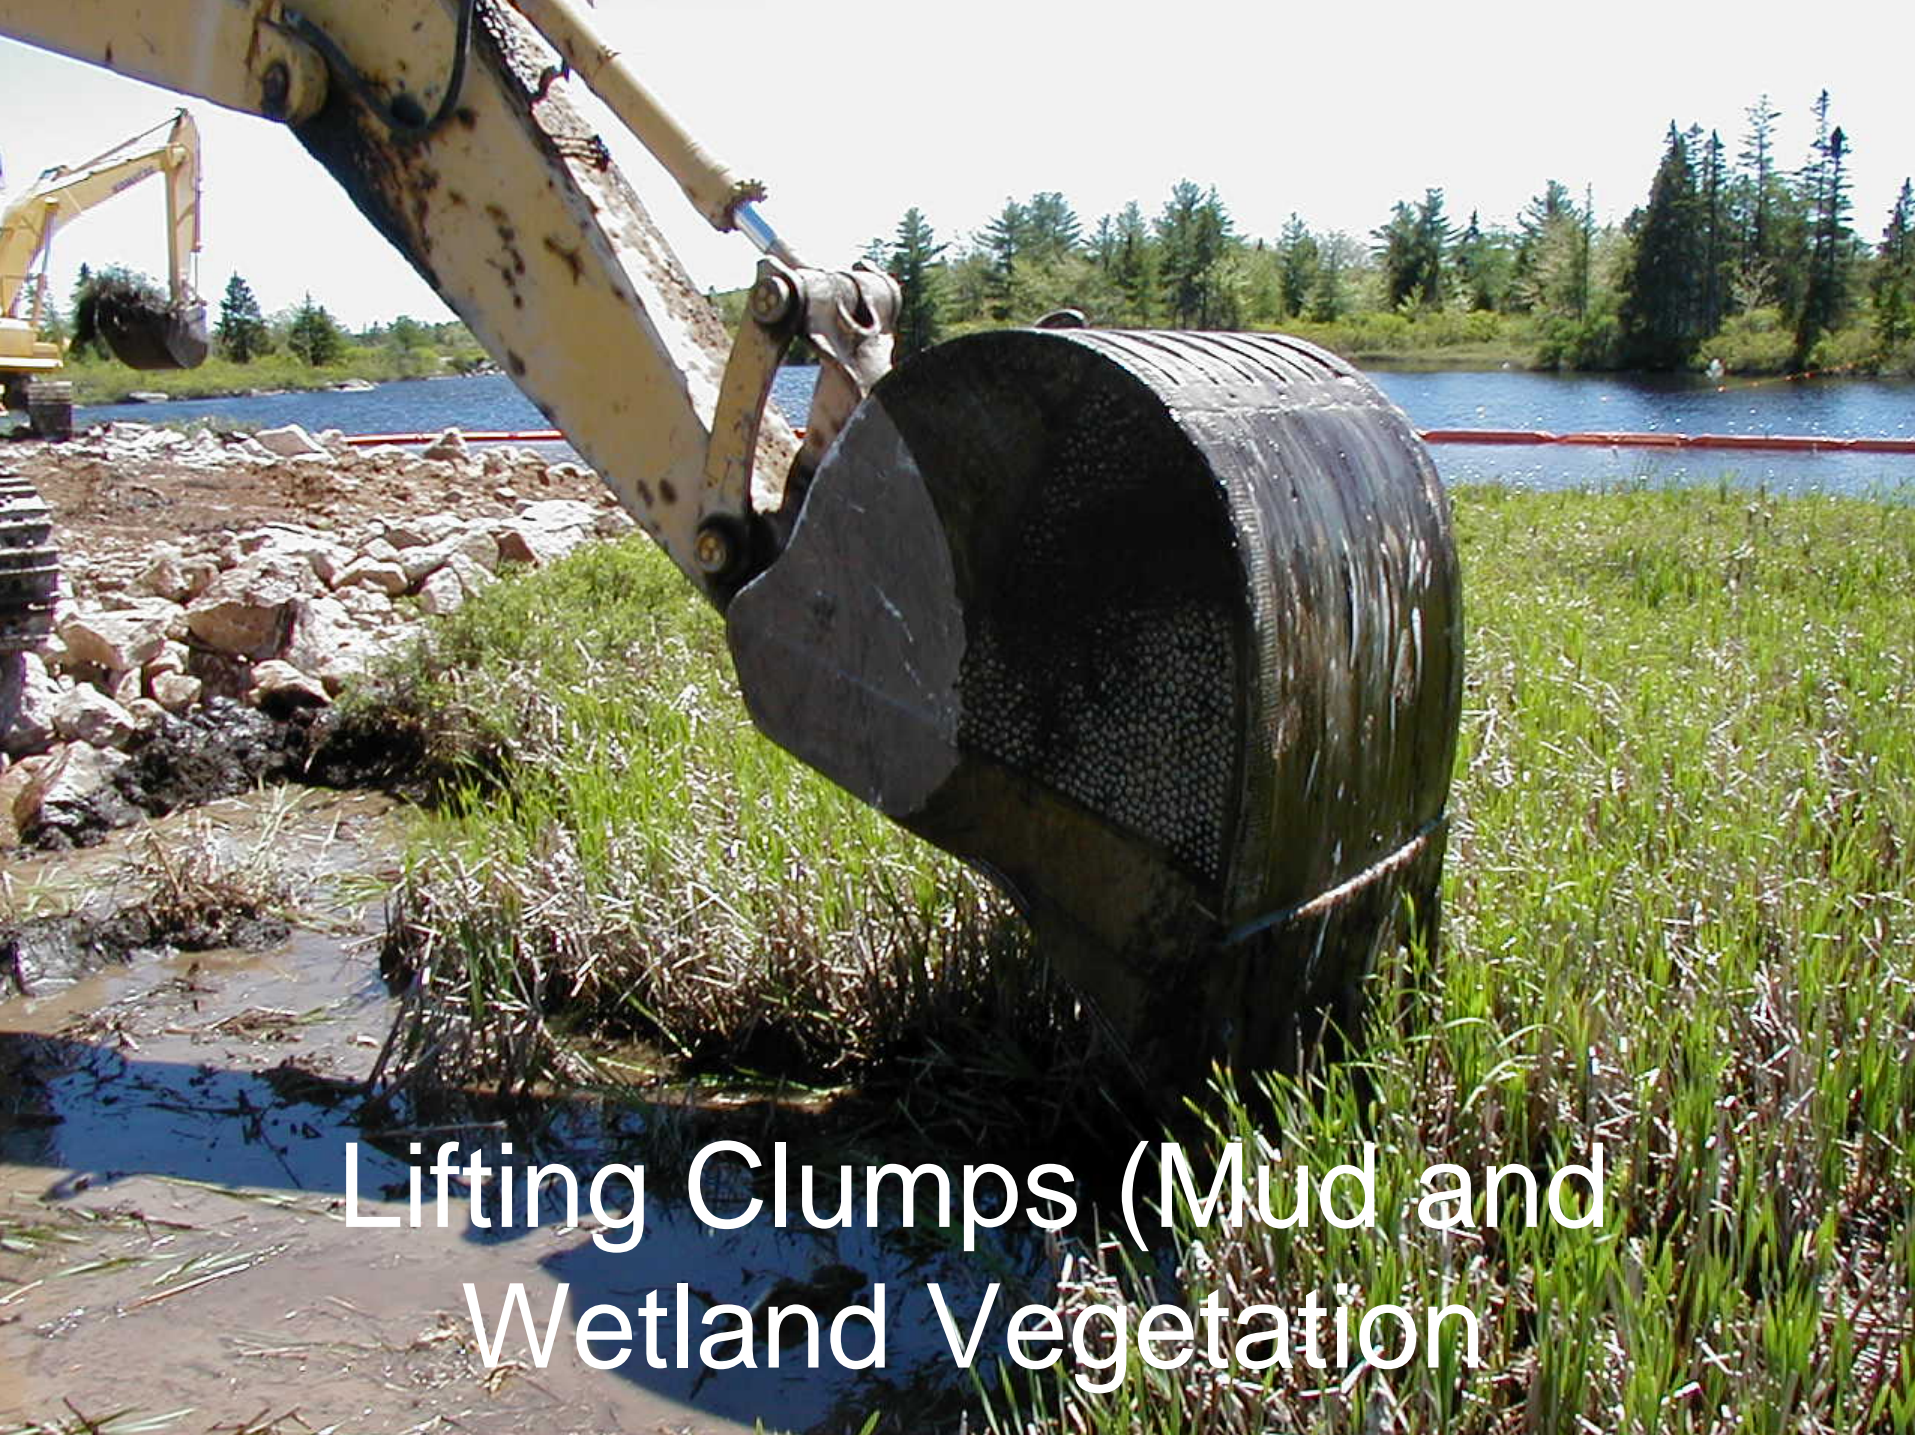
Wetland
Vegetation

Mesic-Soil
Vegetation

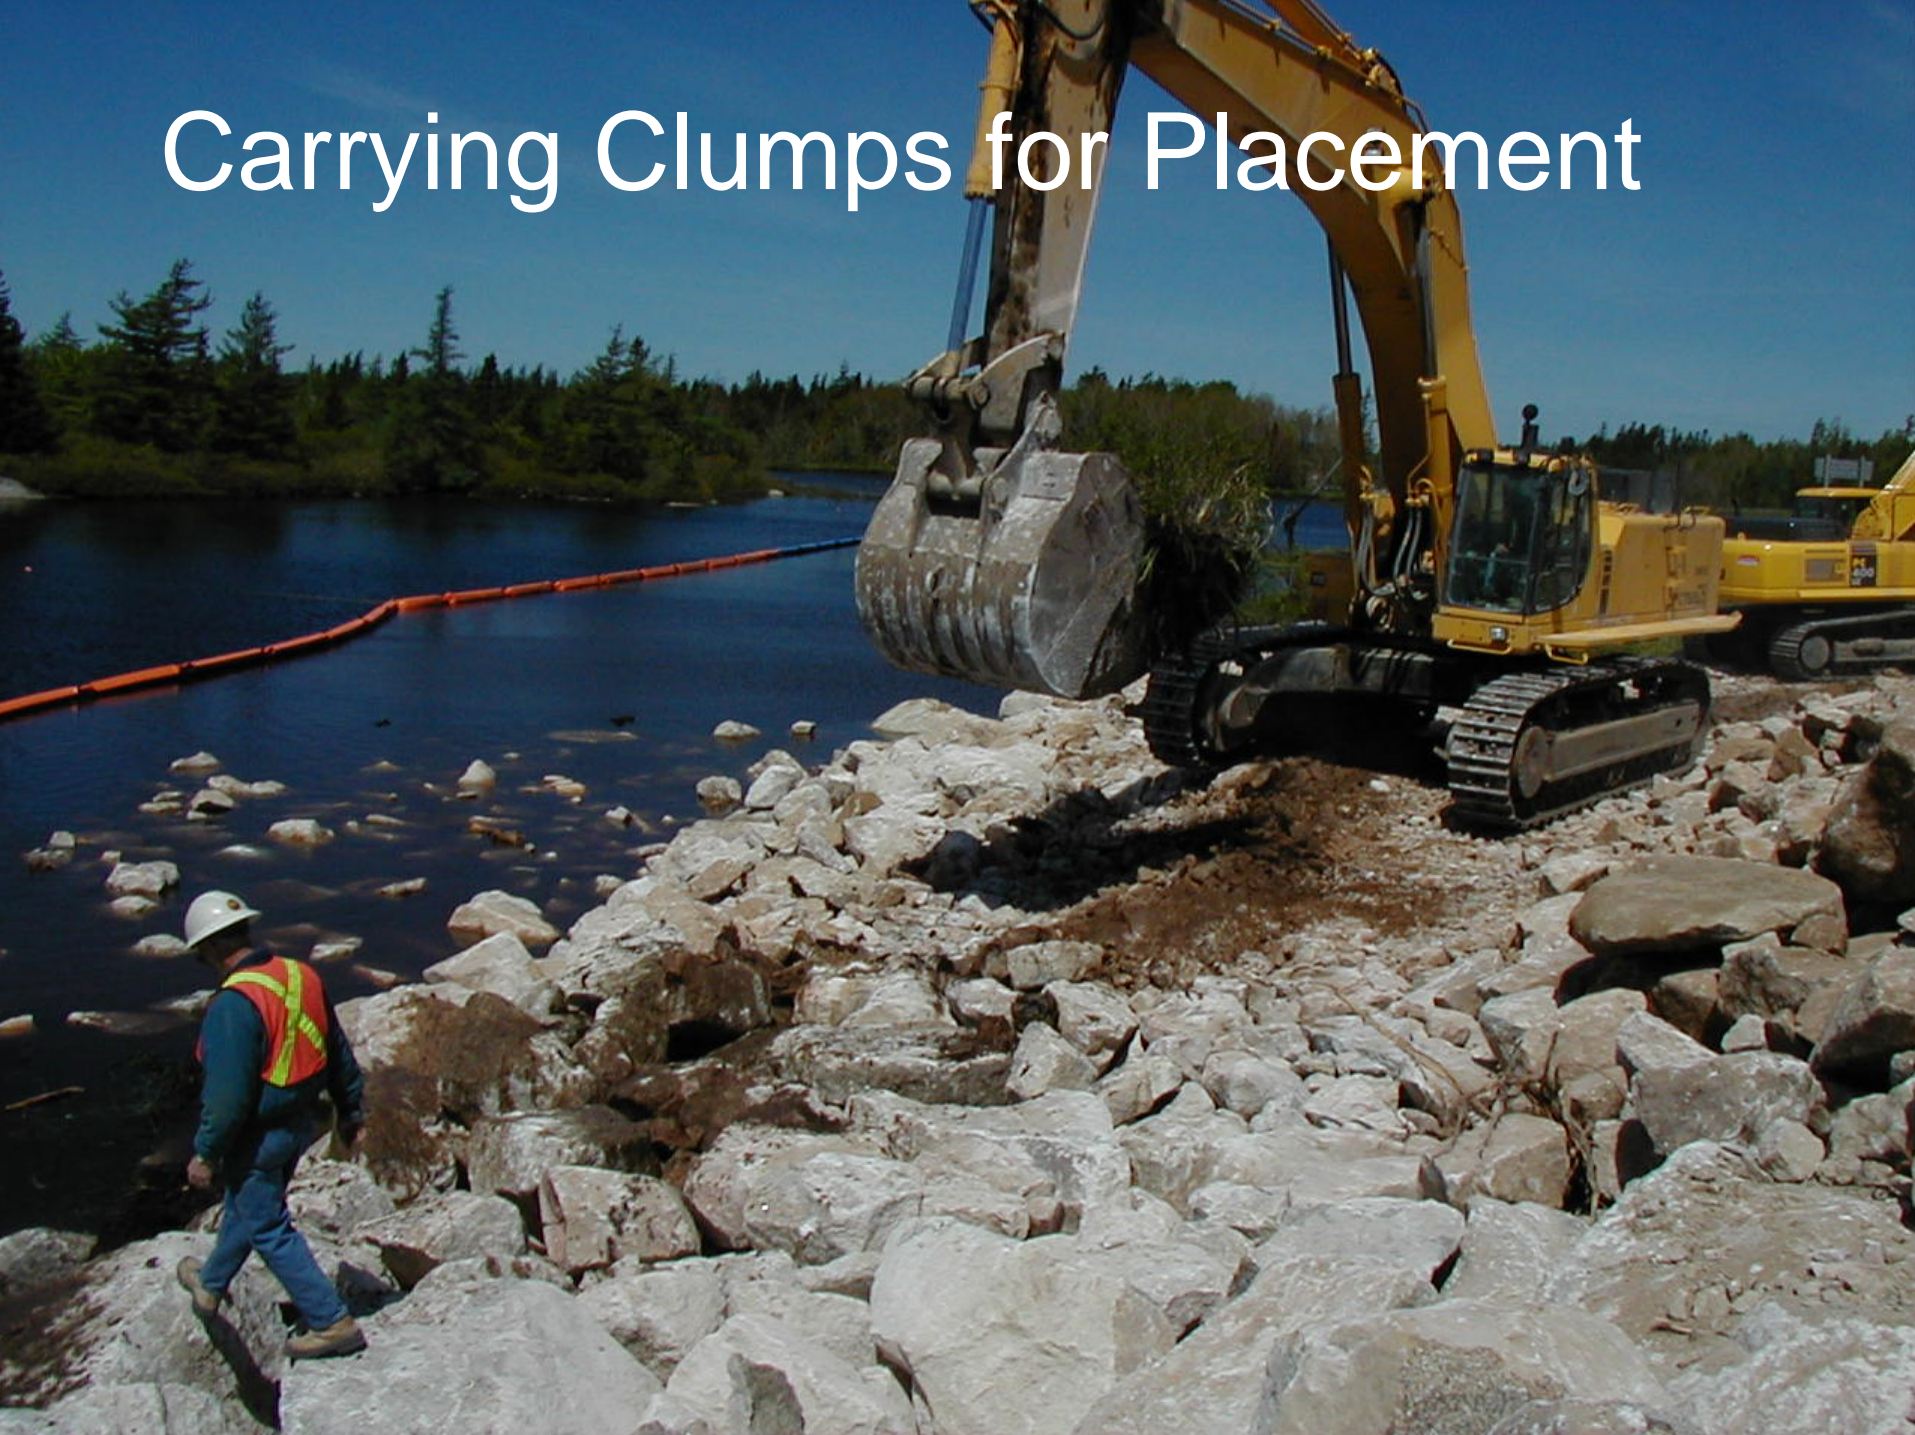
Lifting Clumps (Mud and
Wetland Vegetation)

Carrying Clumps for Placement

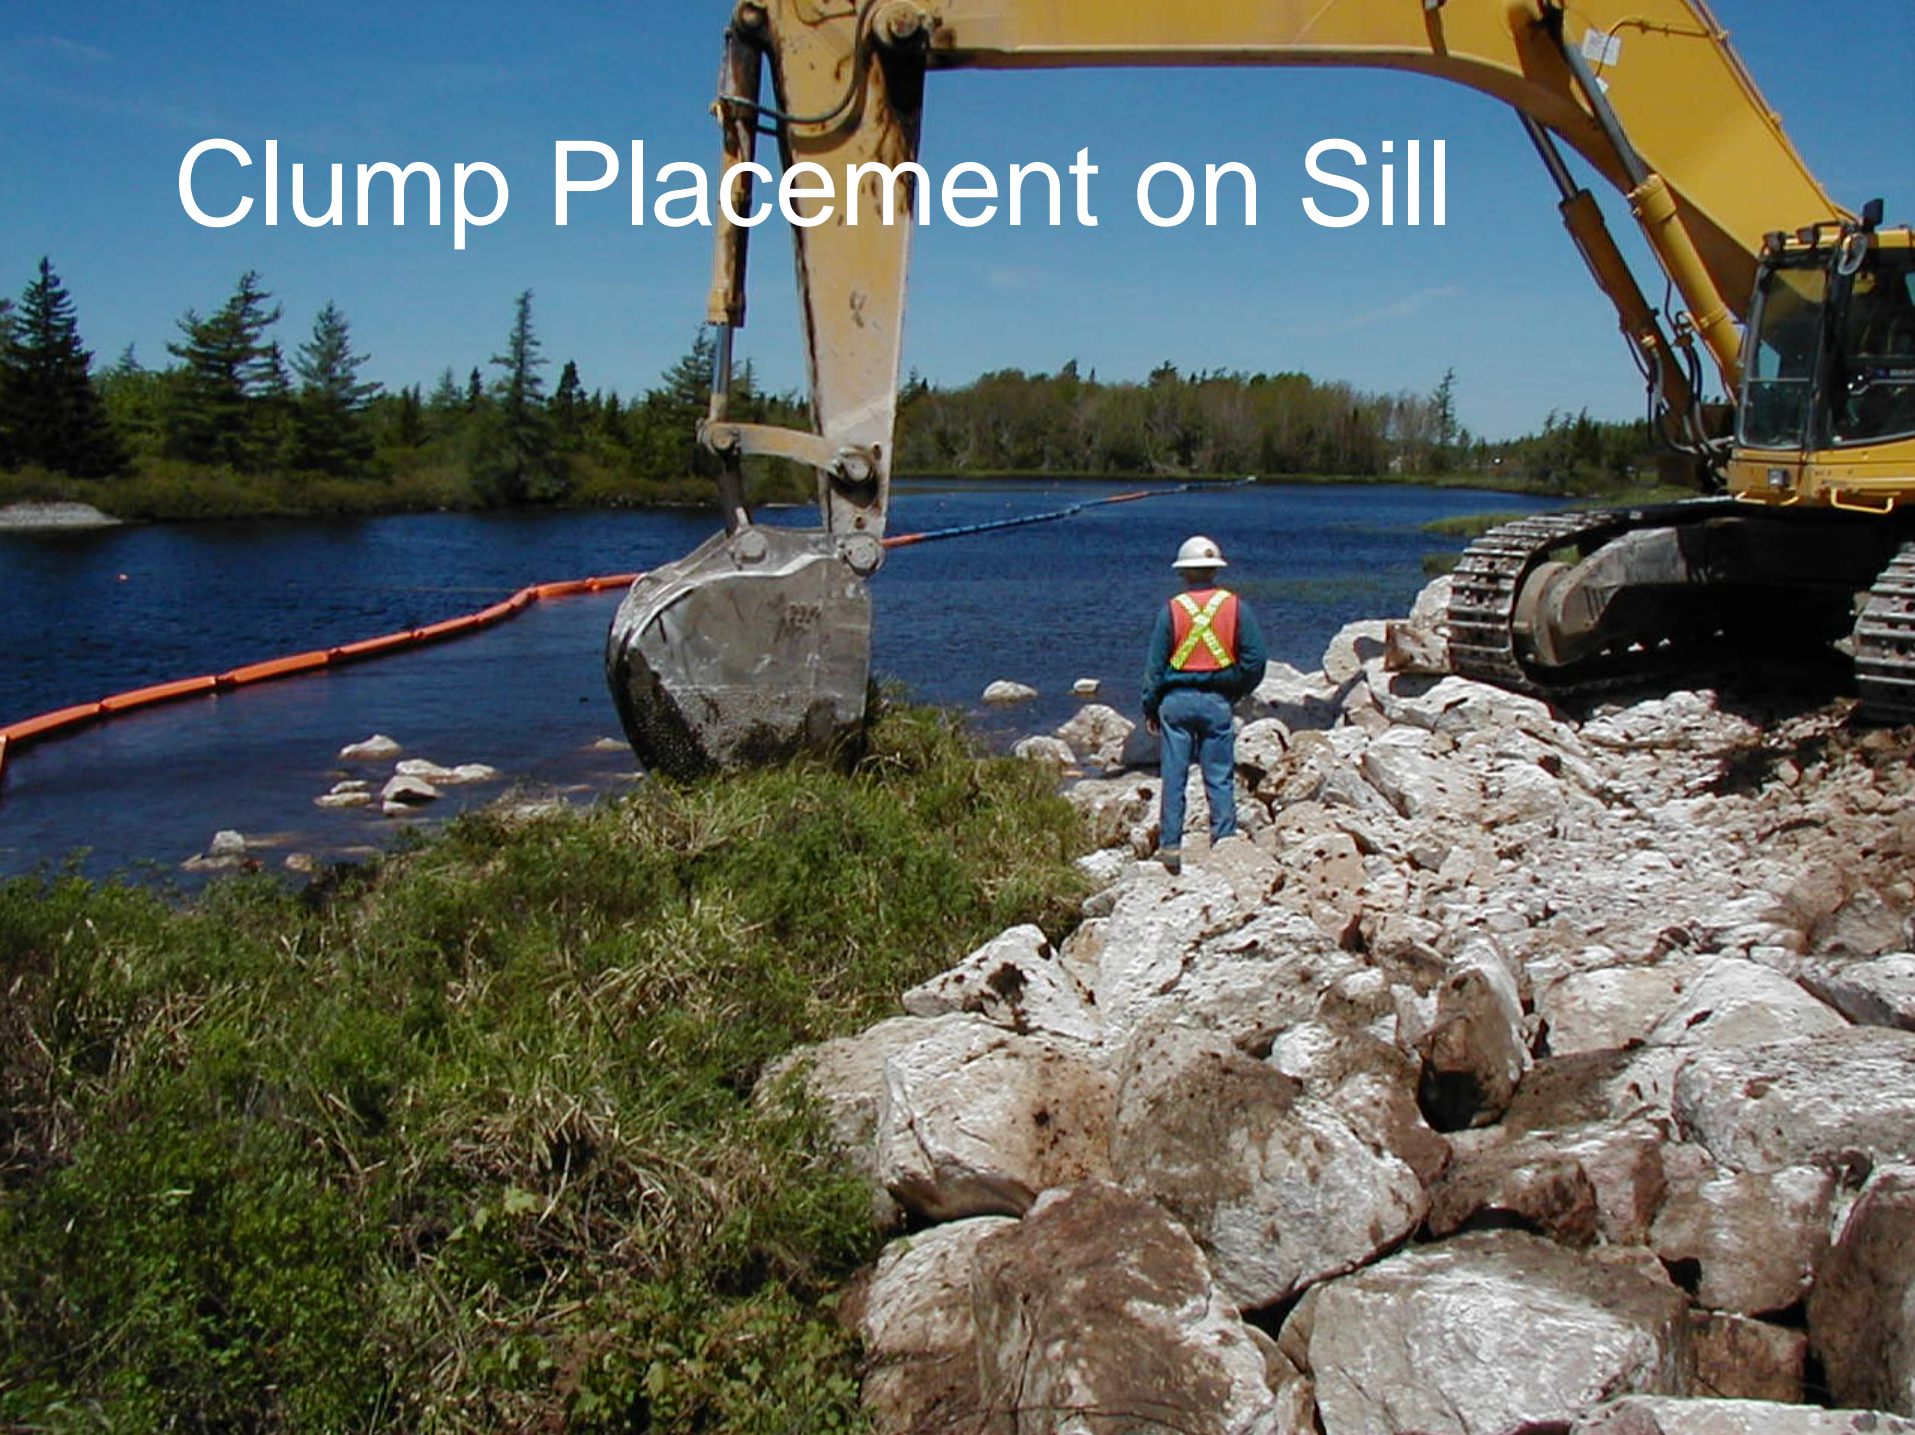
Clump Placement on Sill

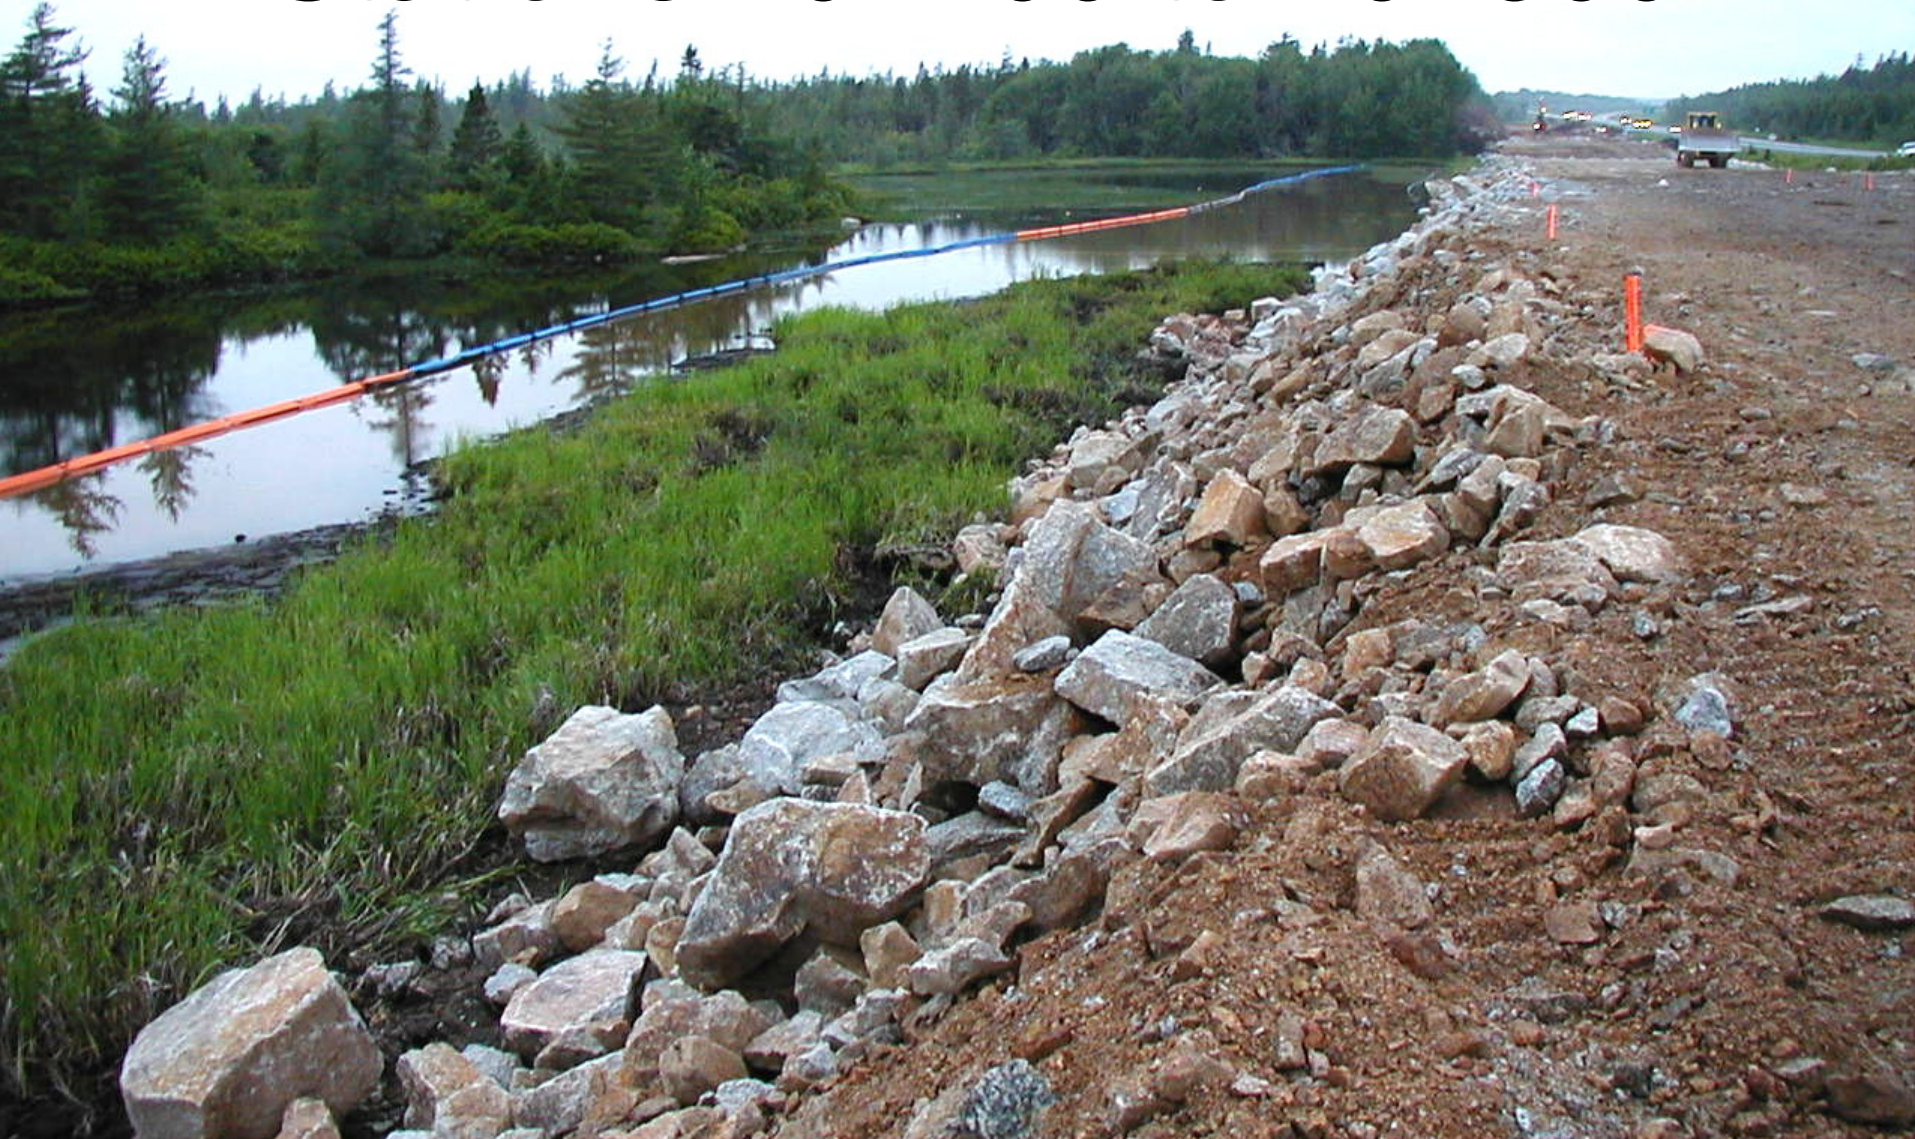
New Shoreline, East End: Stations 10+400 to 10+500

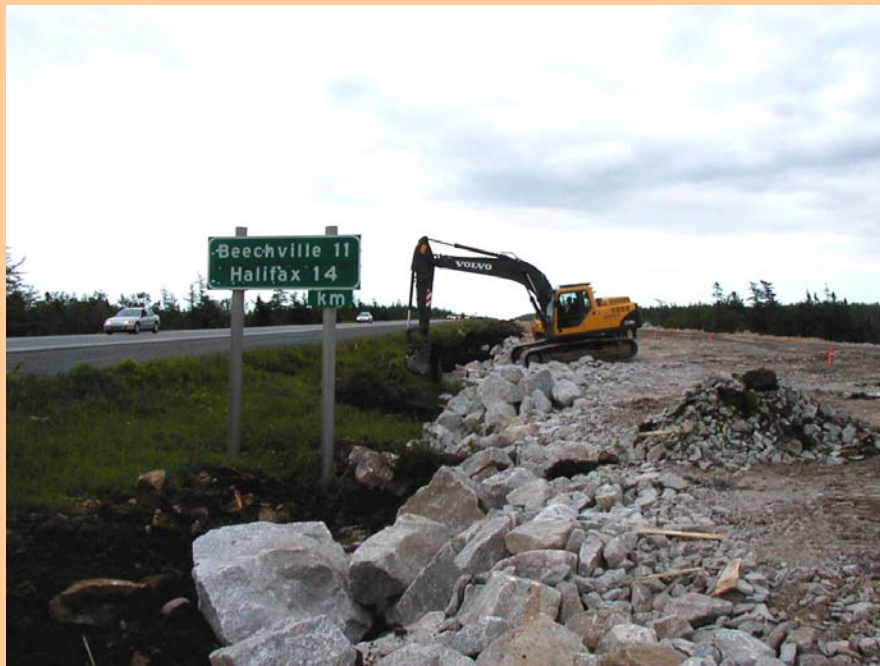
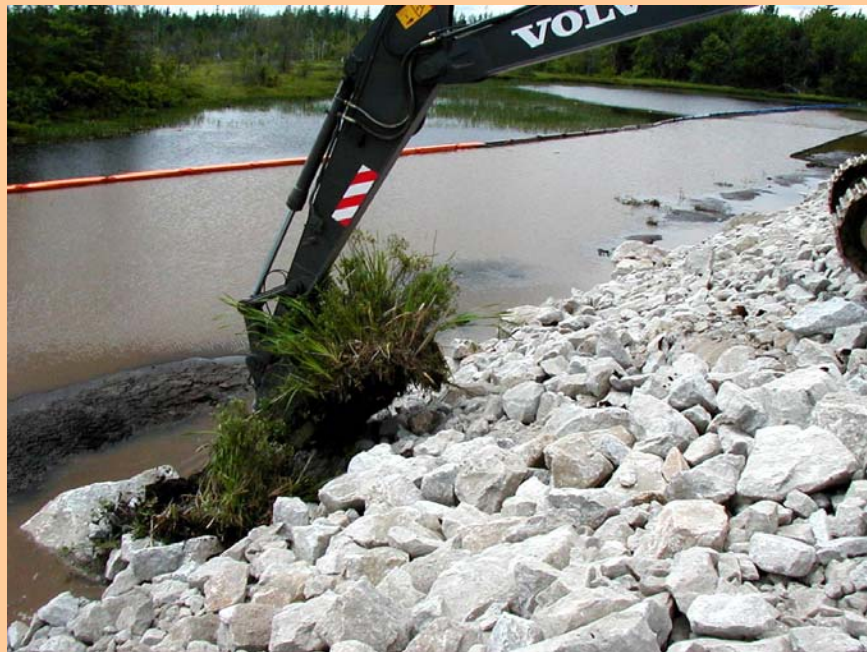
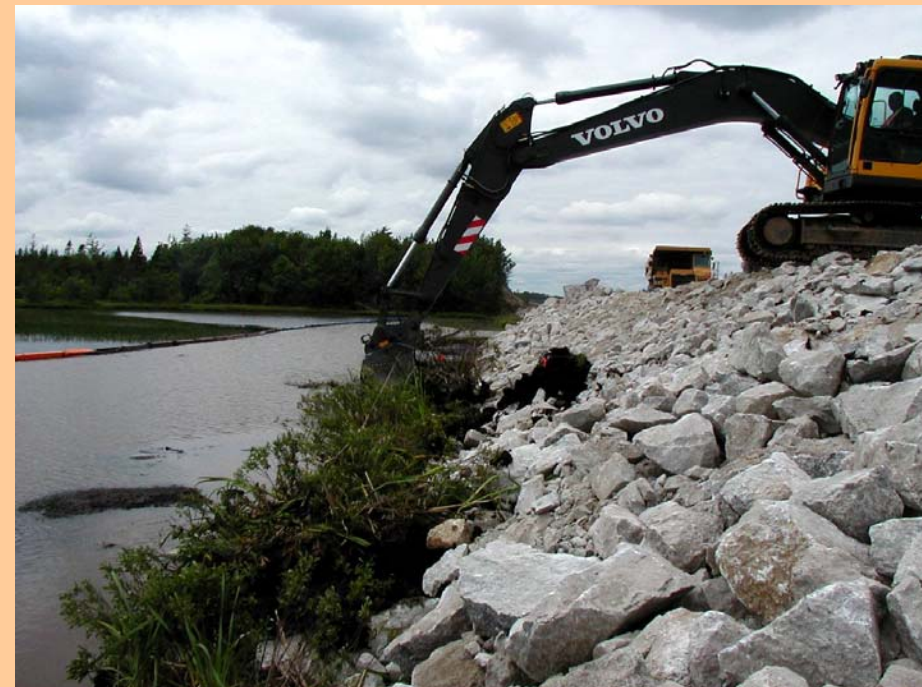
Lifting of Salvaged Clumps and Placement on Top of Rock Shoreline

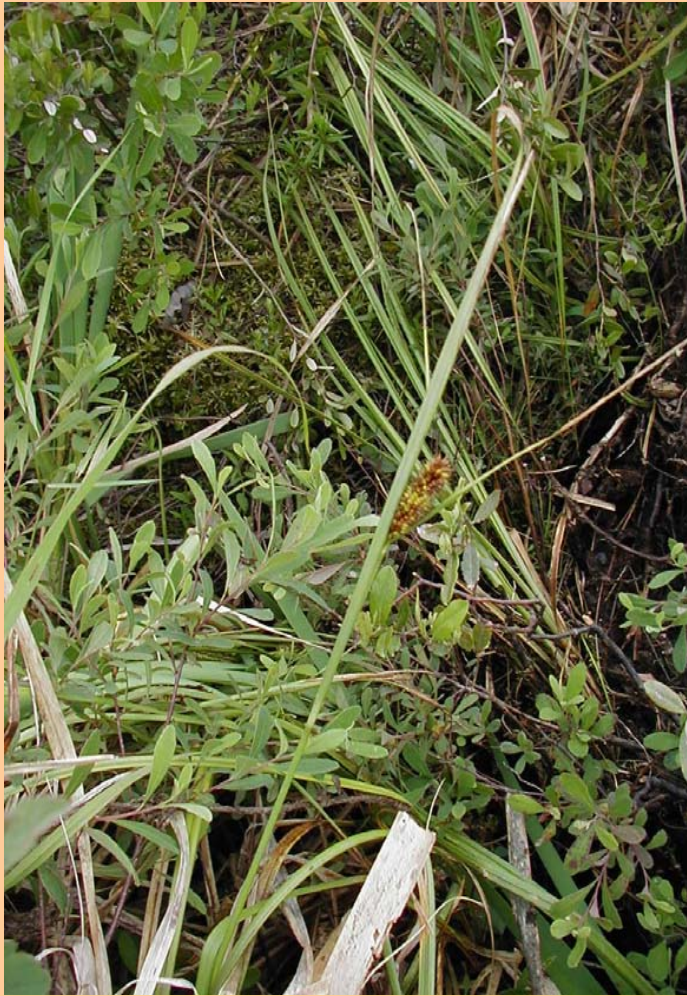
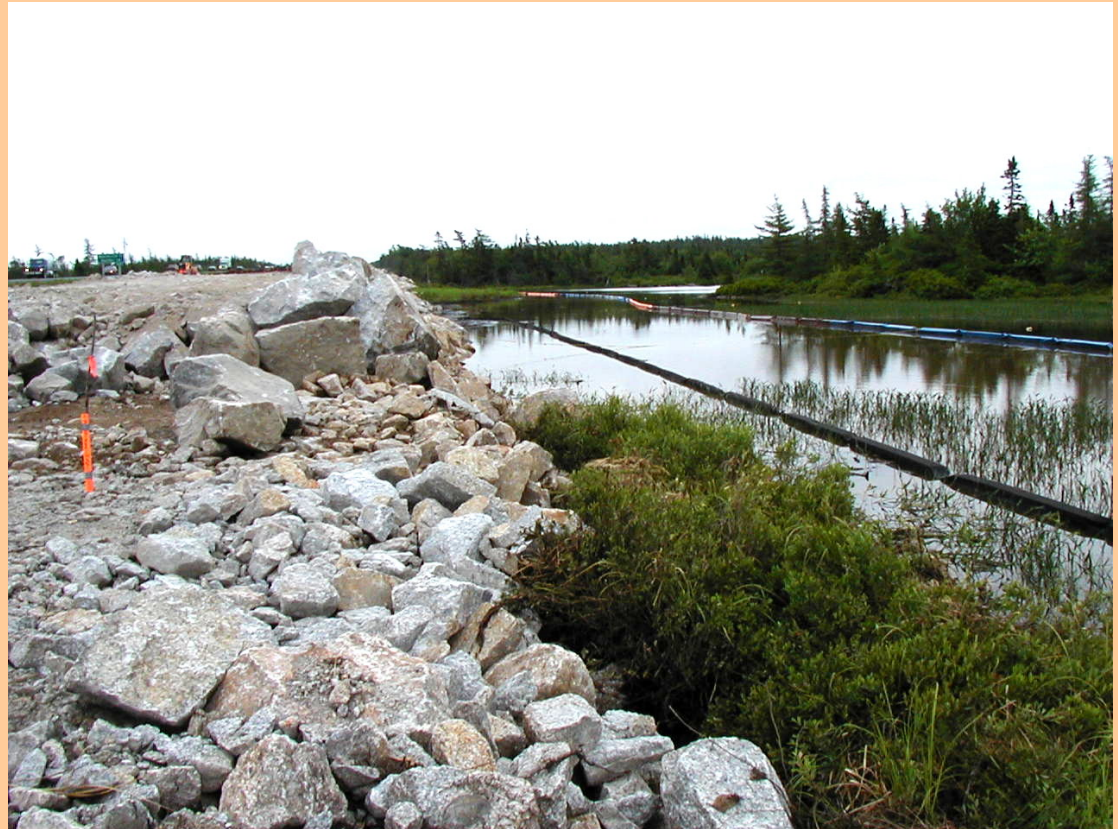
Transplanted Wetland Clumps: Stations 10+630 to 10+680
