As-Built Report for the Cranberry Lake, Highway 103, HADD Compensation Project: Shoreline and Slope Vegetation in 2004 and 2005

Diane LaRue, Vegetation Consultant
Environmental Services, TPW,
November 2005

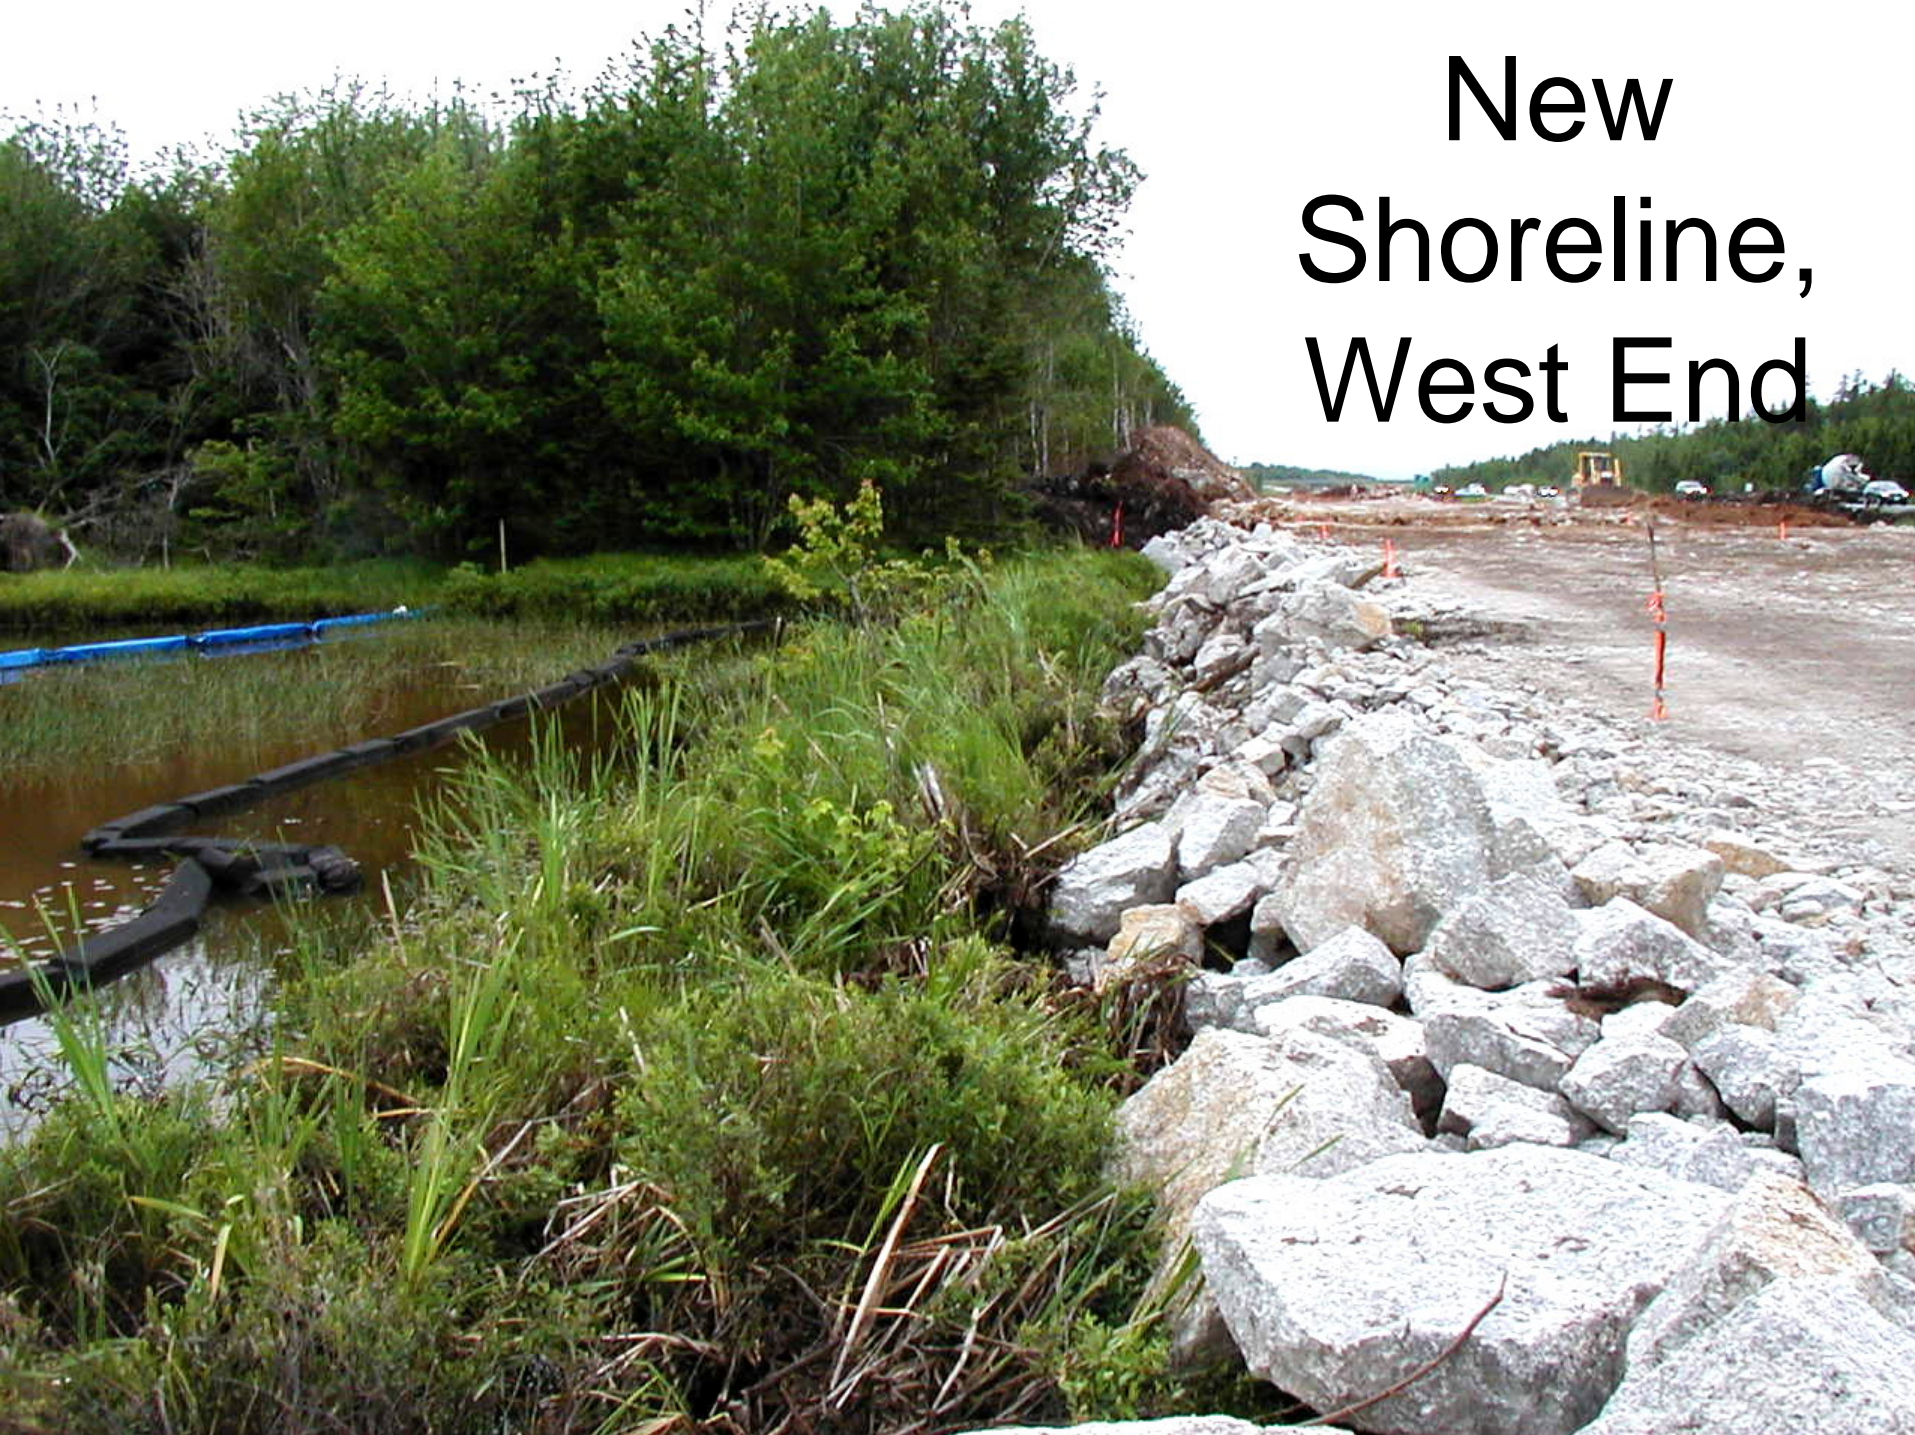
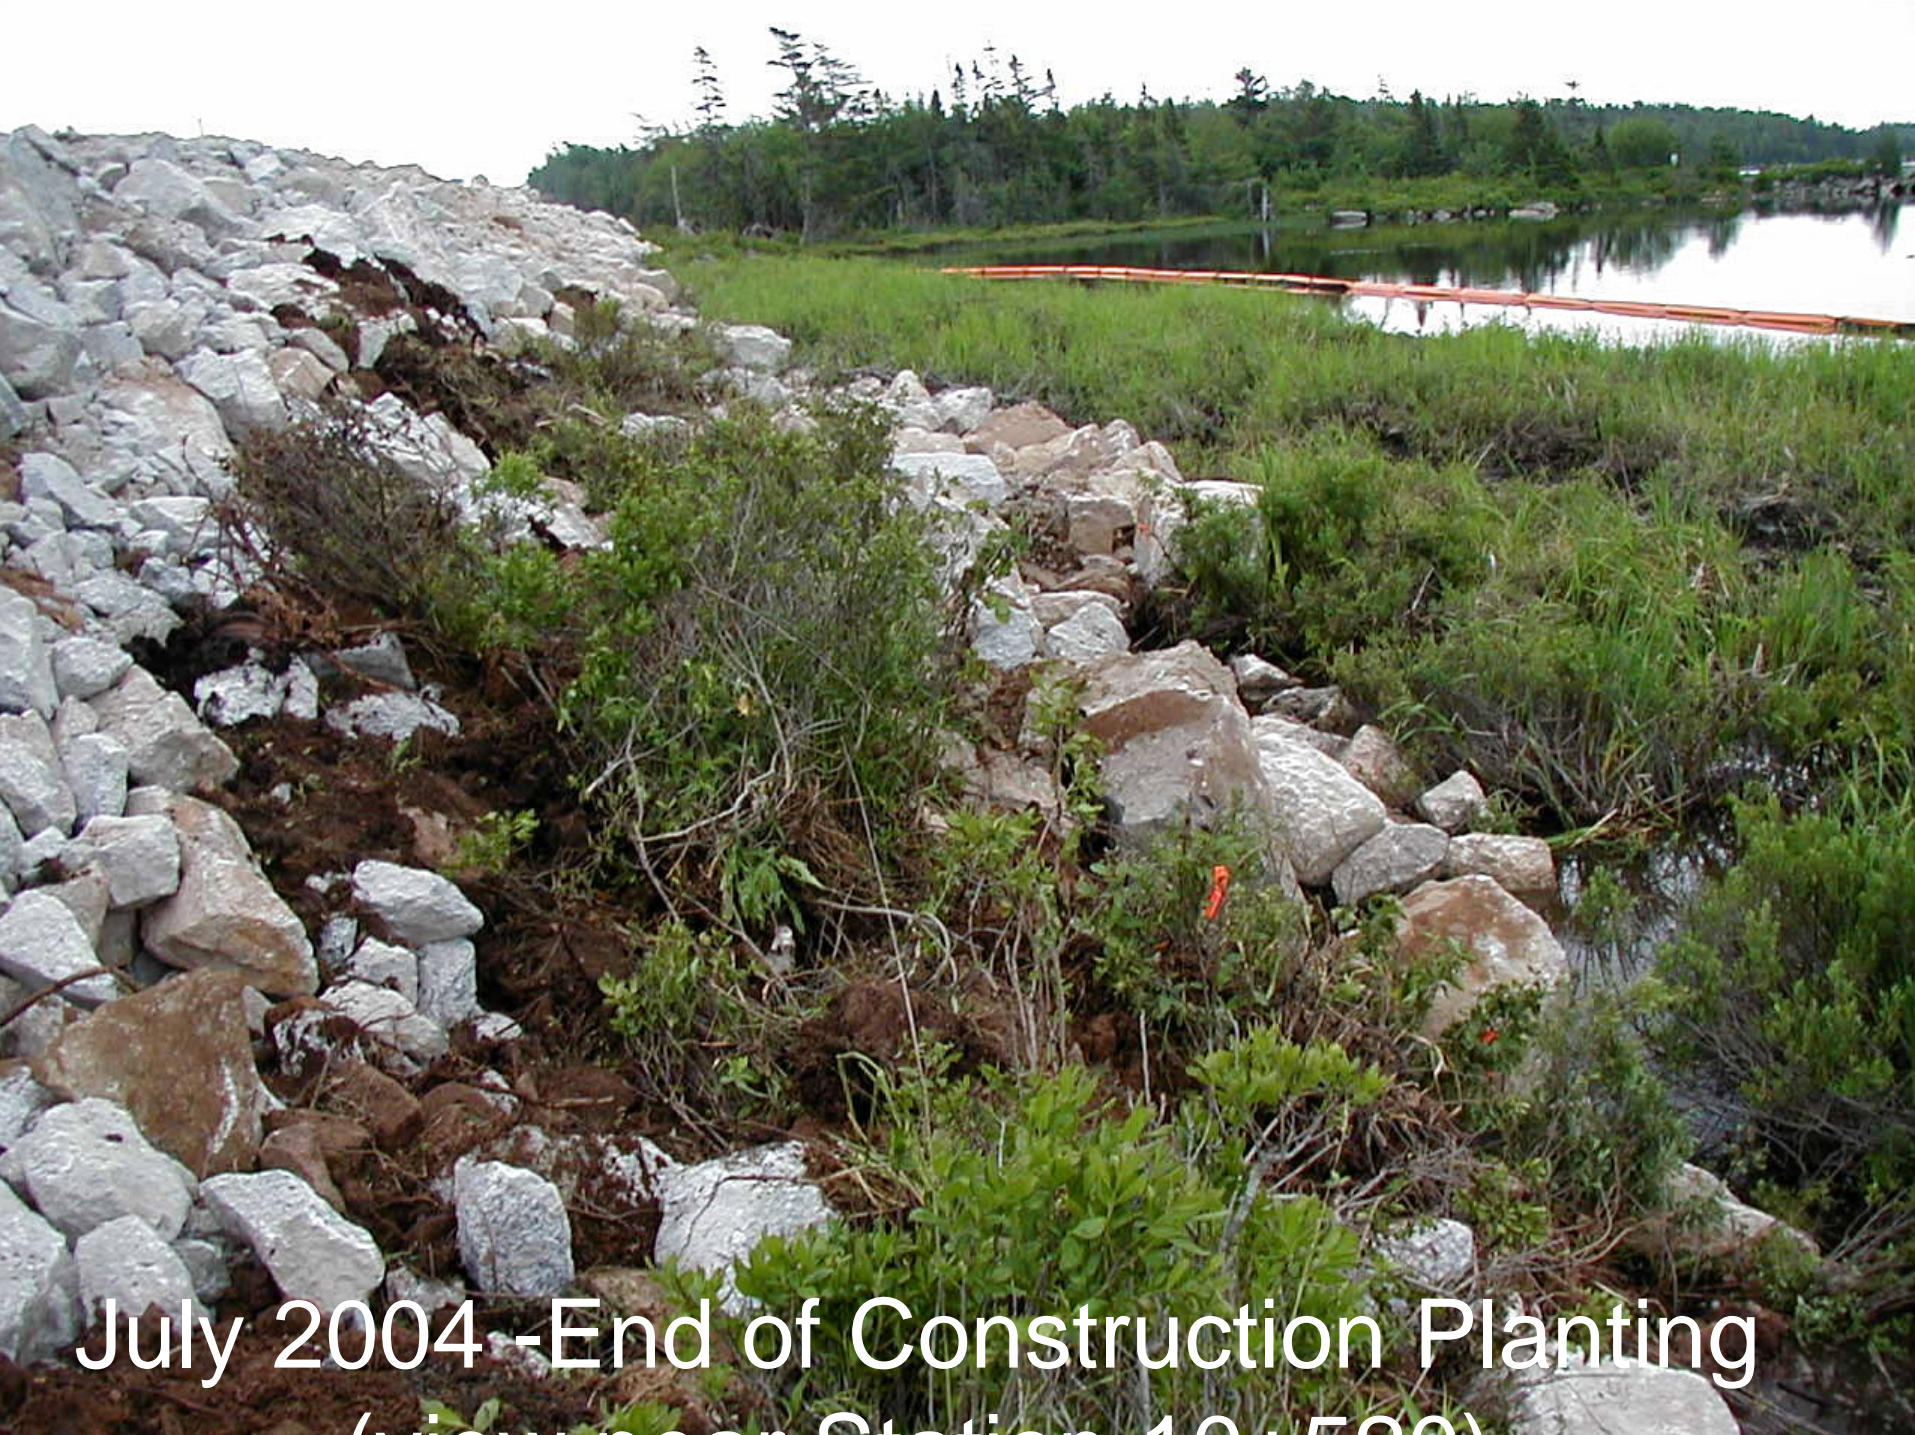
New Shoreline, West End

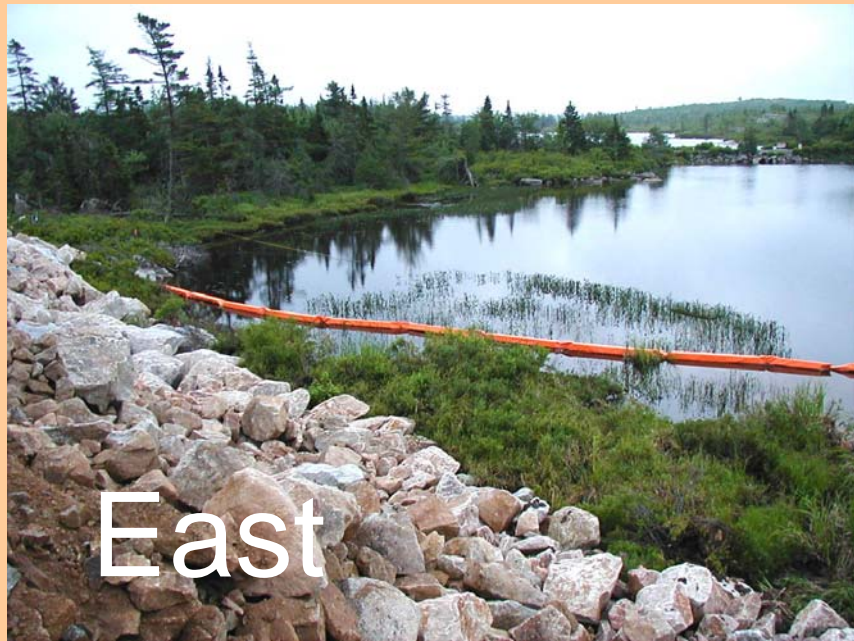
July 2004 -End of Construction Planting
(view near Station 10+500)

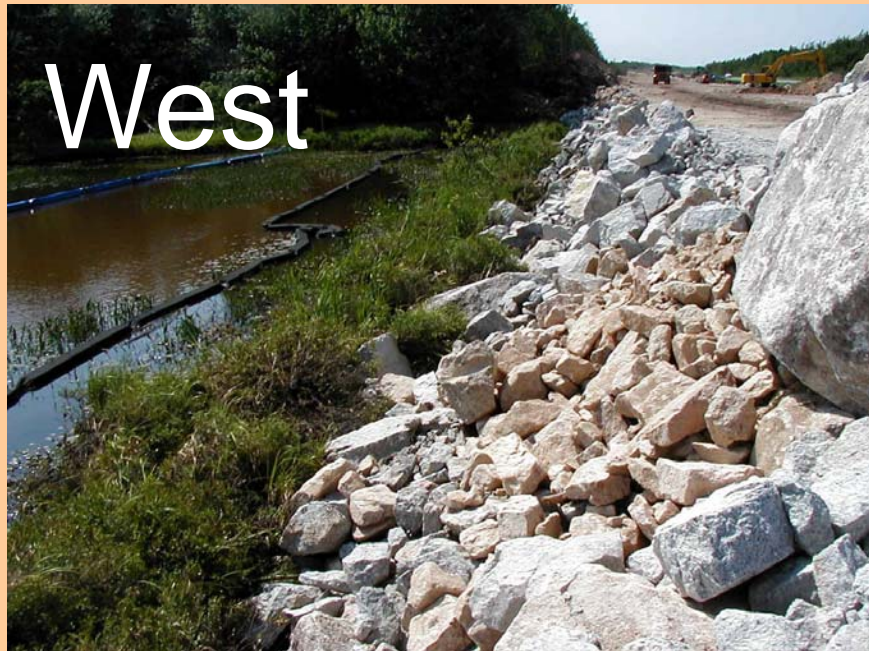
Fall 2004
East:
New Shoreline of
Dense Wetland
Vegetation on Mud

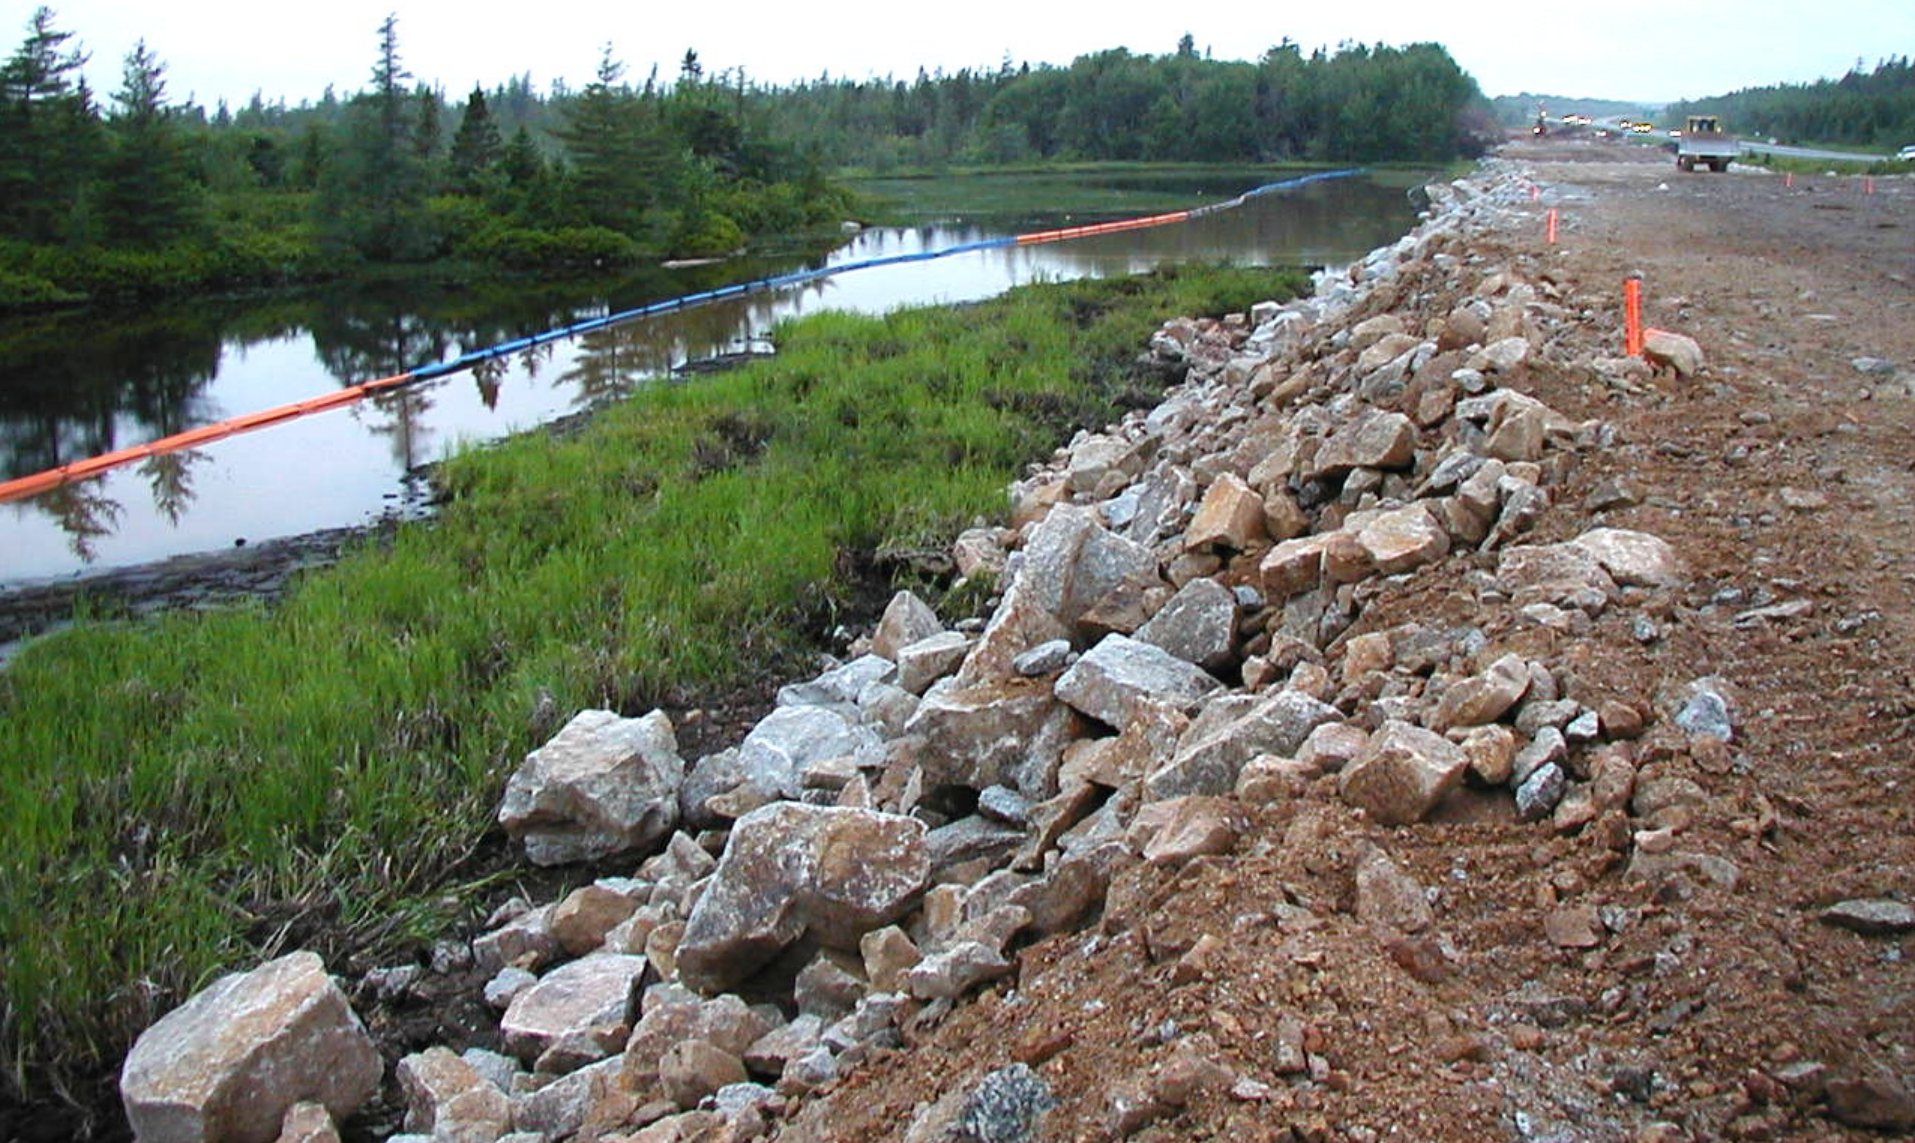
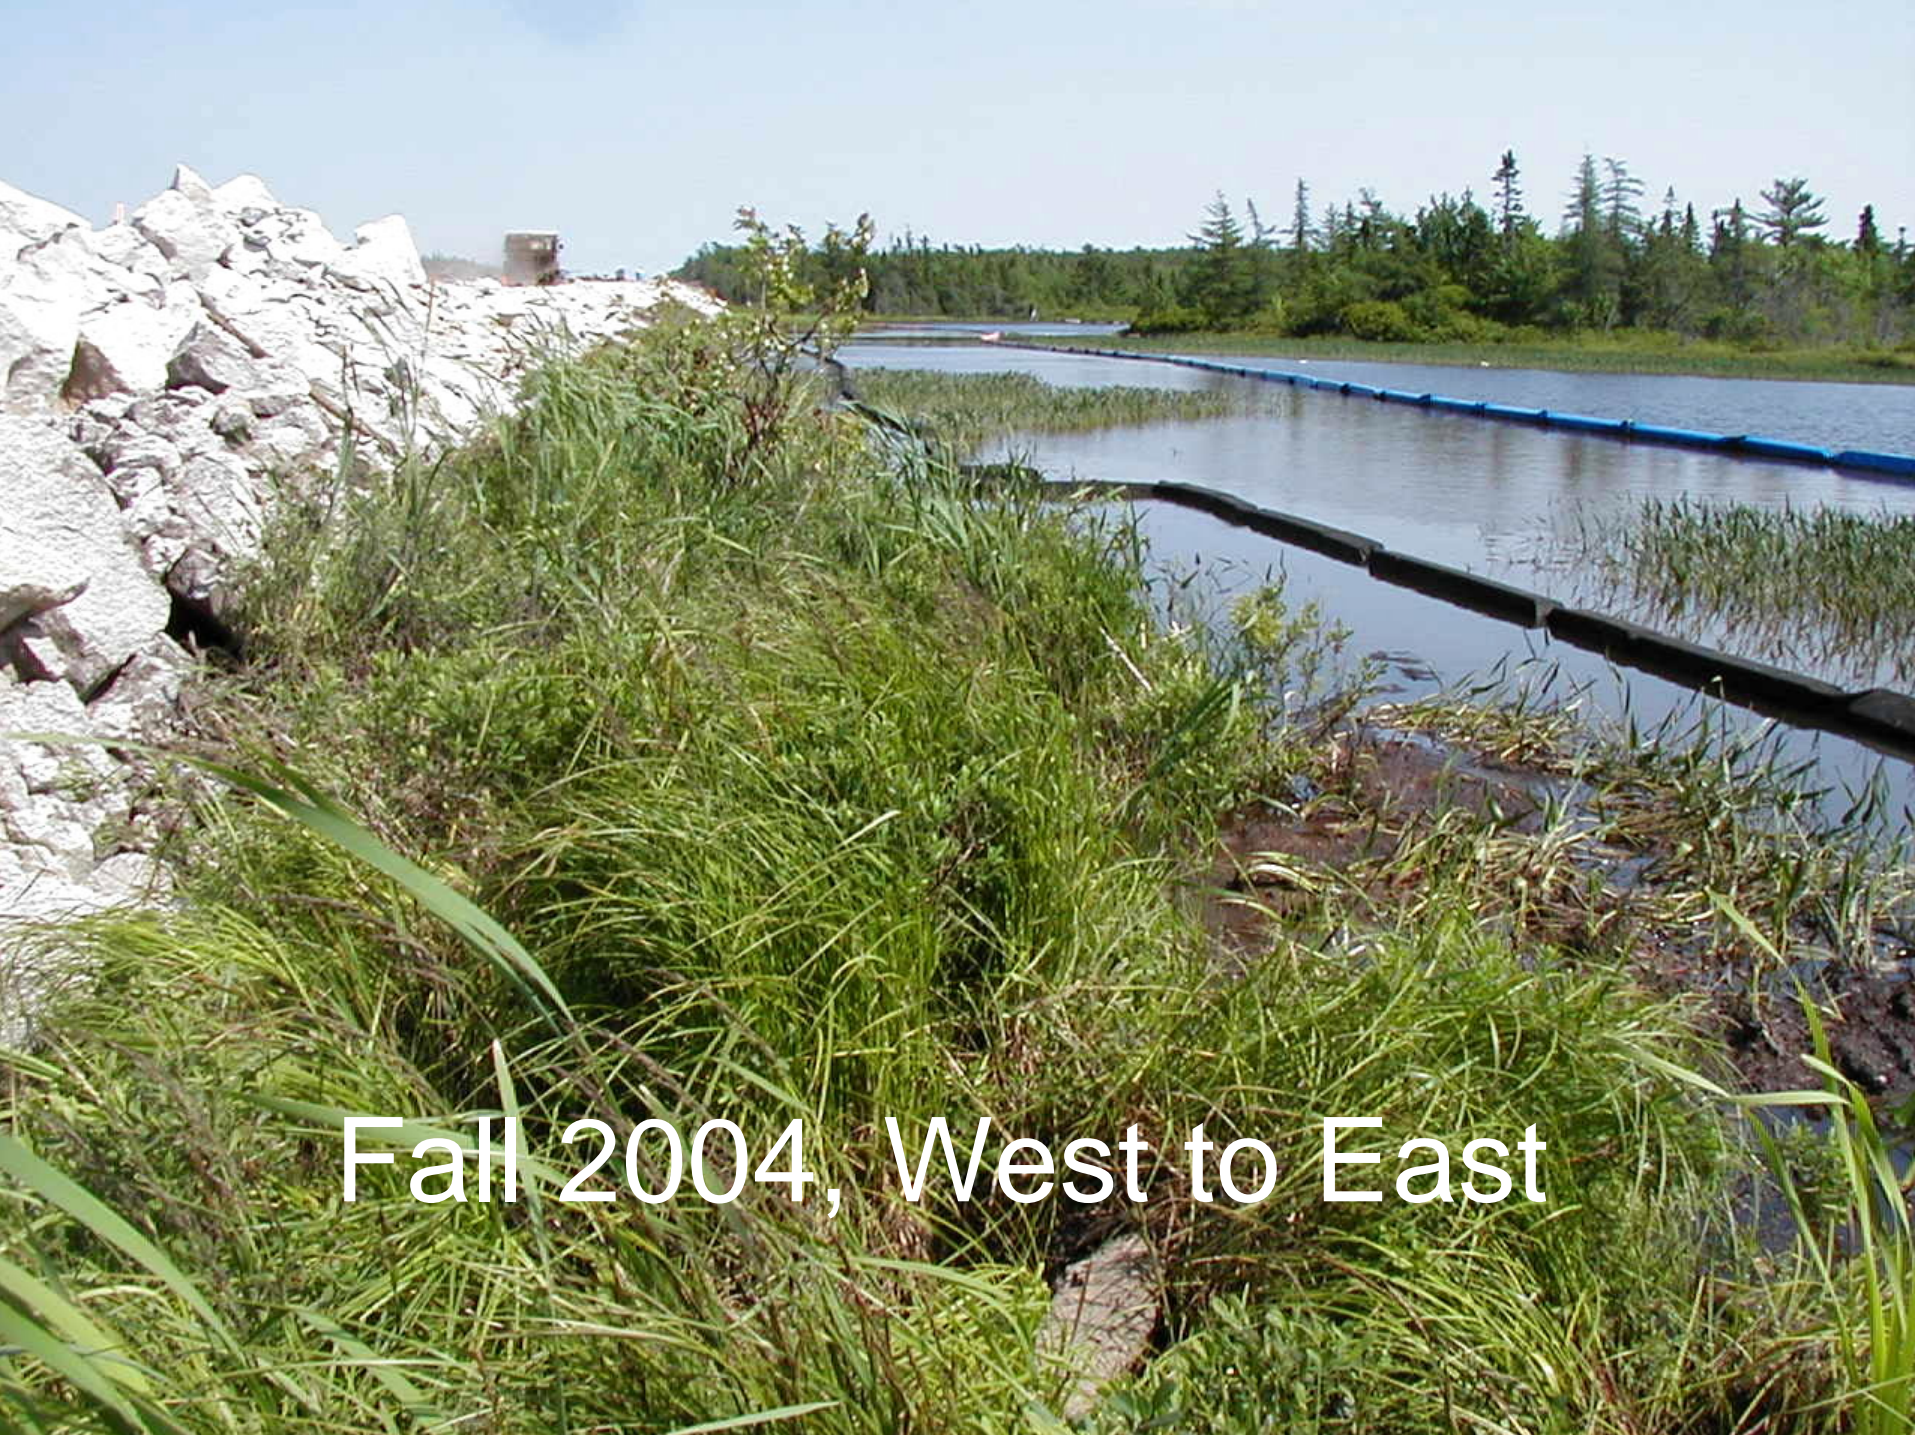
West:
New Shoreline of
Dense Wetland
Vegetation on Mud and
Mesic-Soil Species on
Rock

Fall 2004 East to West

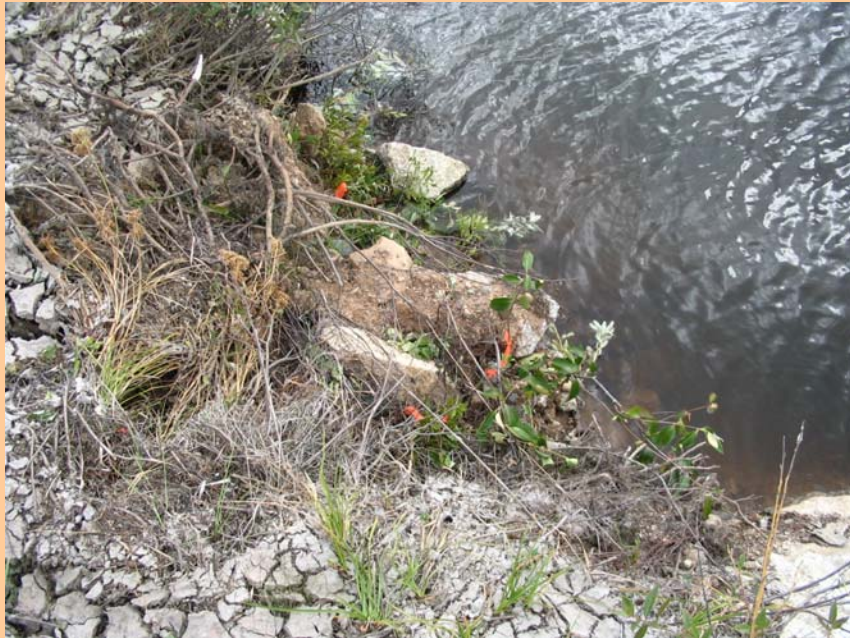
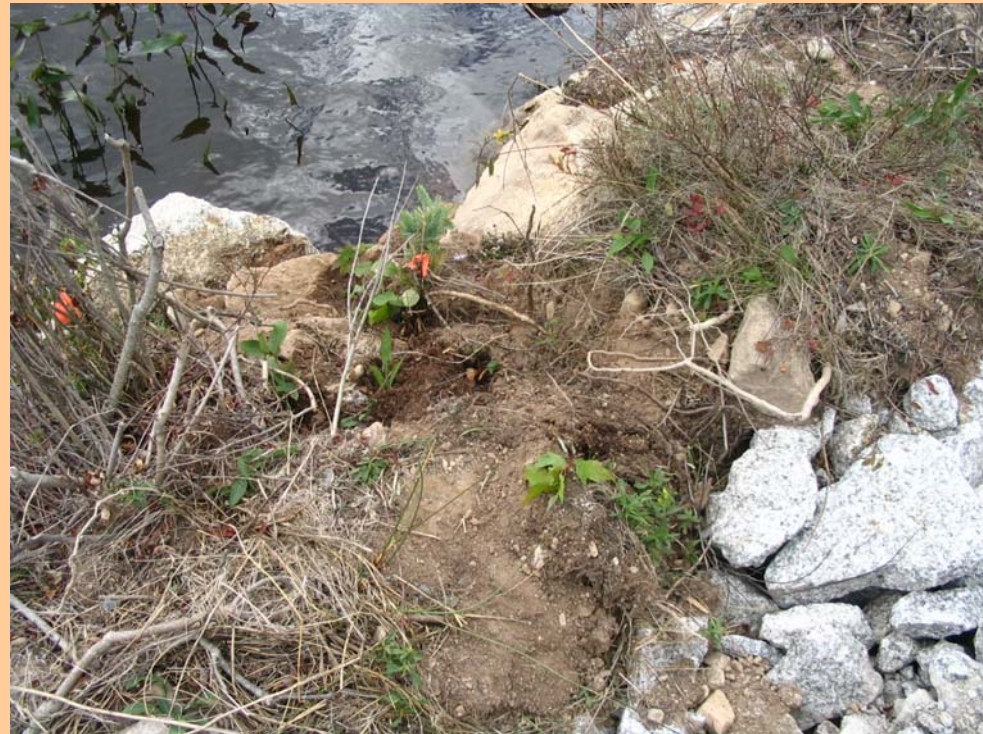
Fall 2004, Individual Plantings Near Station 10+620 (plants from Wetland #2)

Several individual transplants of native vegetation were also salvaged from 'Wetland #2' (originally located approximately 3 km west of Cranberry Lake at Watercourse H; this wetland was subsequently in-filled in October 2004). The transplants were placed on or near the shore towards the west end of the Cranberry Lake slope (near Station 10+620). Major species included Spruce, Fir, Larch, Maple and Wild Raisin. Each transplant was marked with orange survey ribbon.

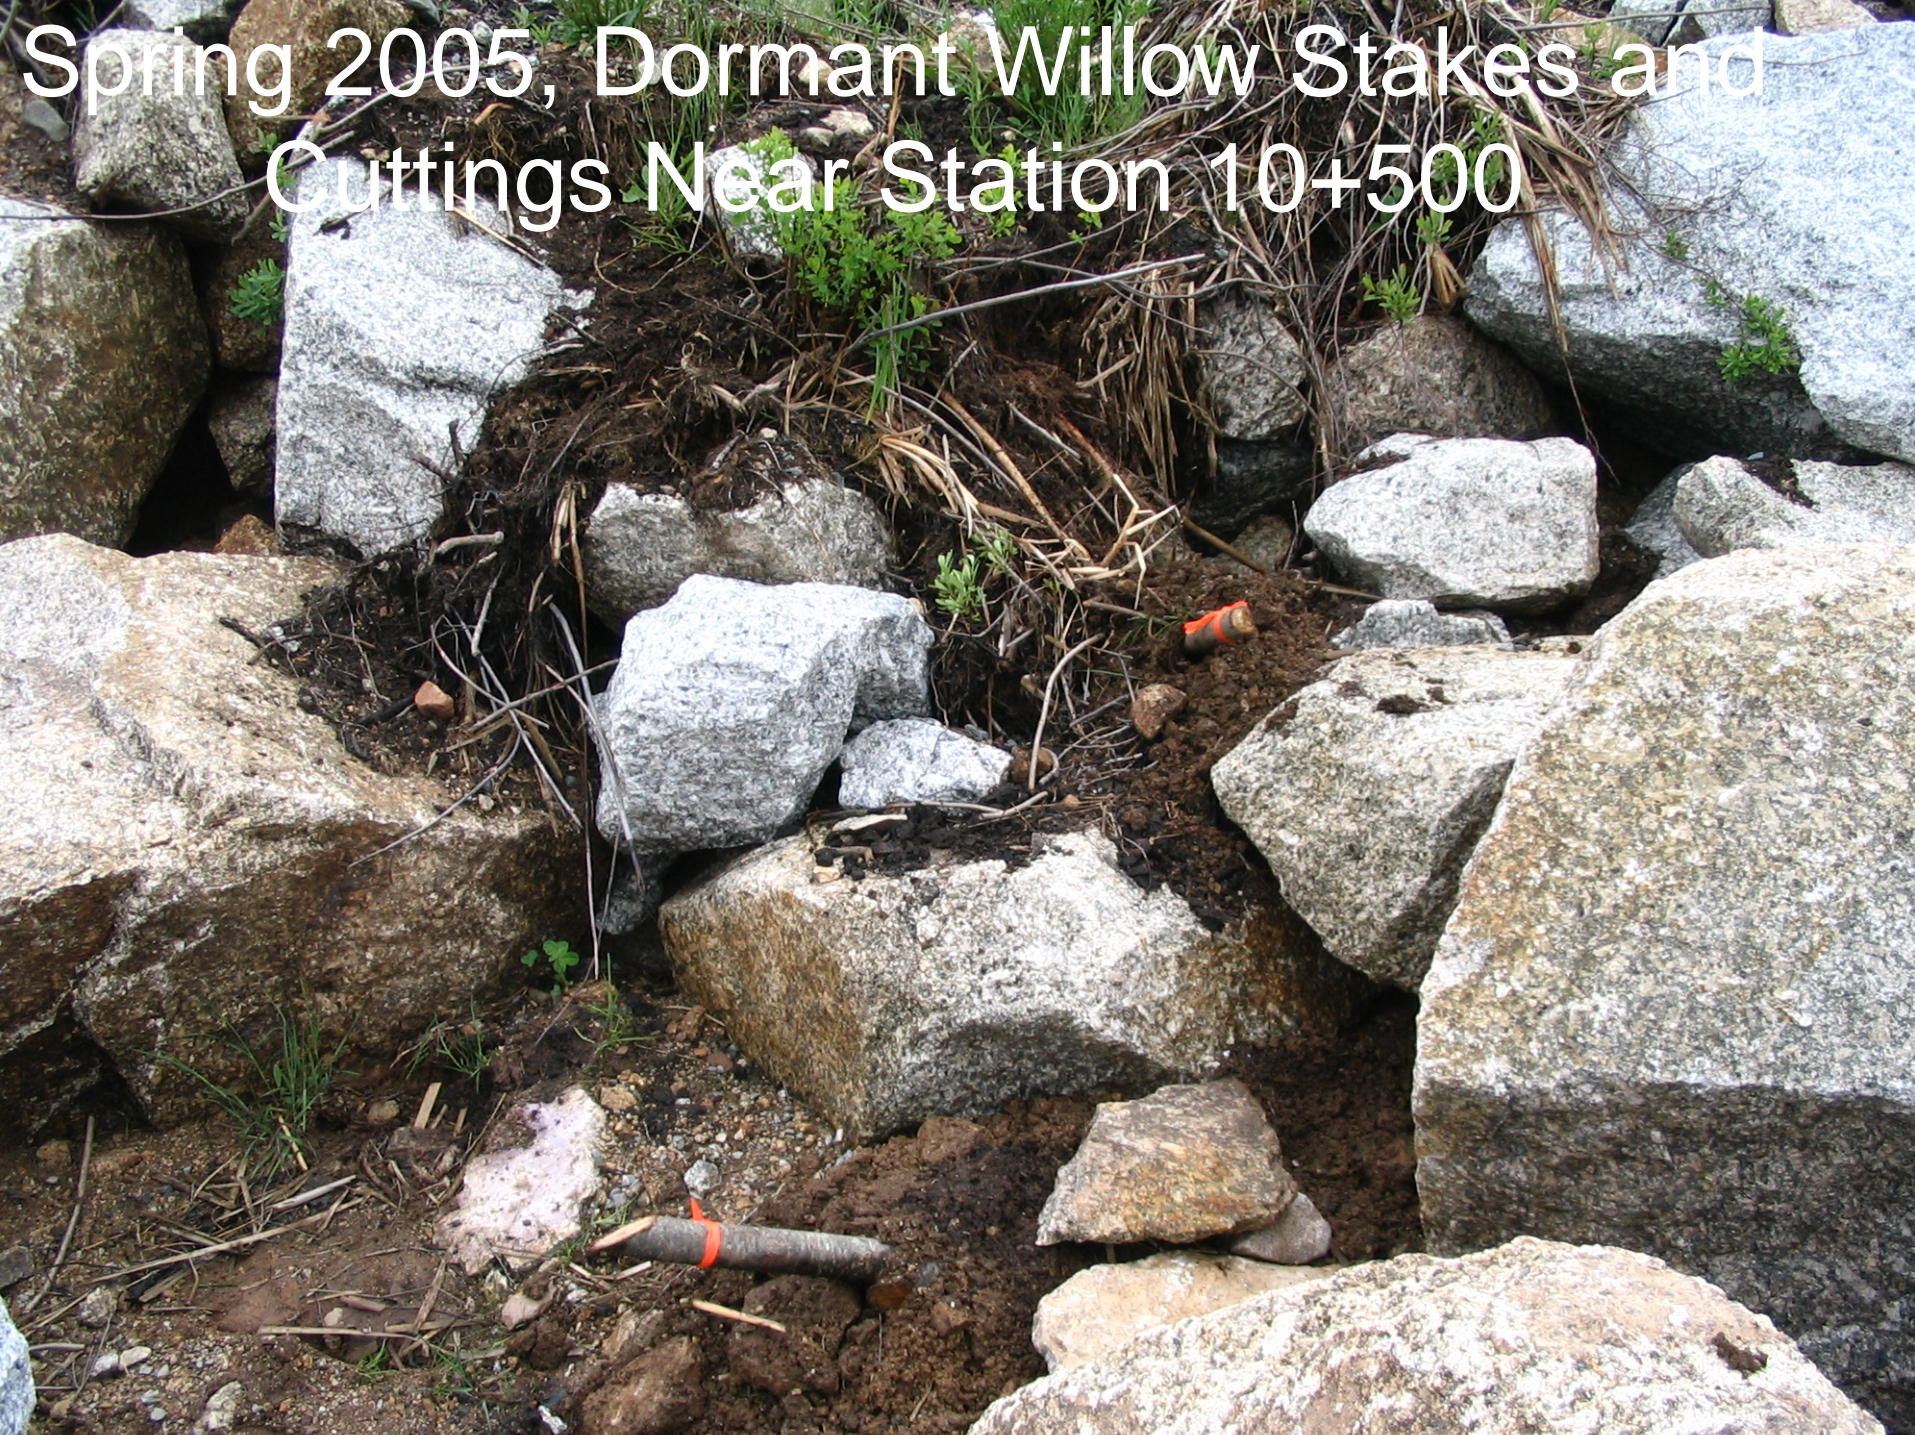
Spring 2005, Dormant Willow Stakes and Cuttings Near Station 10+500

In the spring of 2005, several dormant stakes of Willow (*Salix* spp.) and Red Osier Dogwood (*Cornus sericea*) were installed towards the western end of the slope. The Willow cuttings were installed in a sandy substrate between the water and the rock slope (near Station 10+500), and in the salvaged soil clumps near Station 10+540. The Red Osier Dogwood were planted in the salvaged soil (between Stations 10+620 and 660).

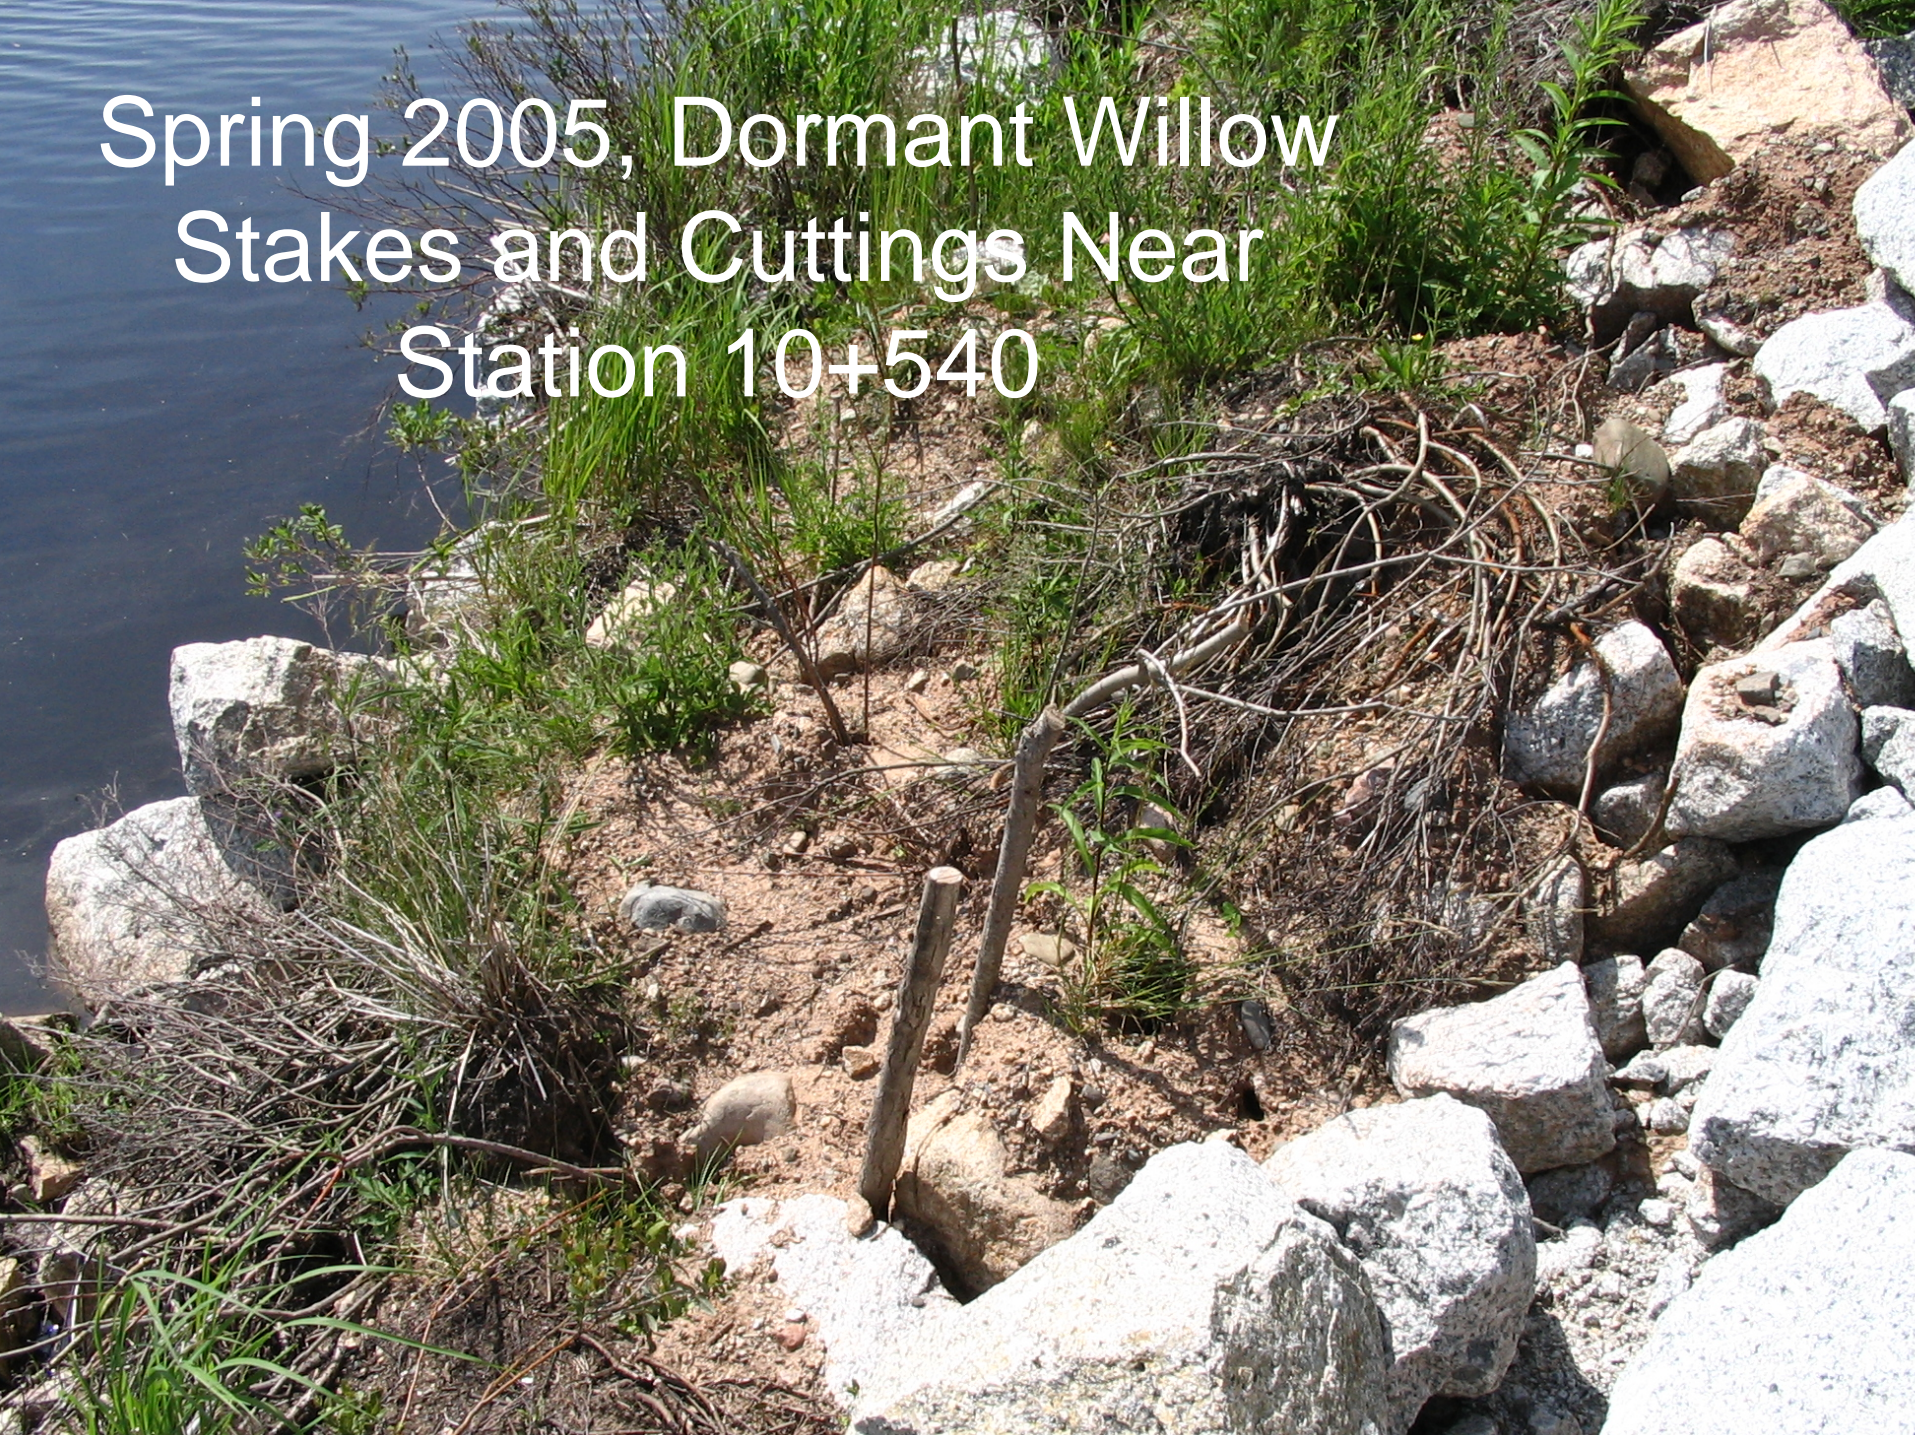
Spring 2005, Dormant Willow
Stakes and Cuttings Near
Station 10+540

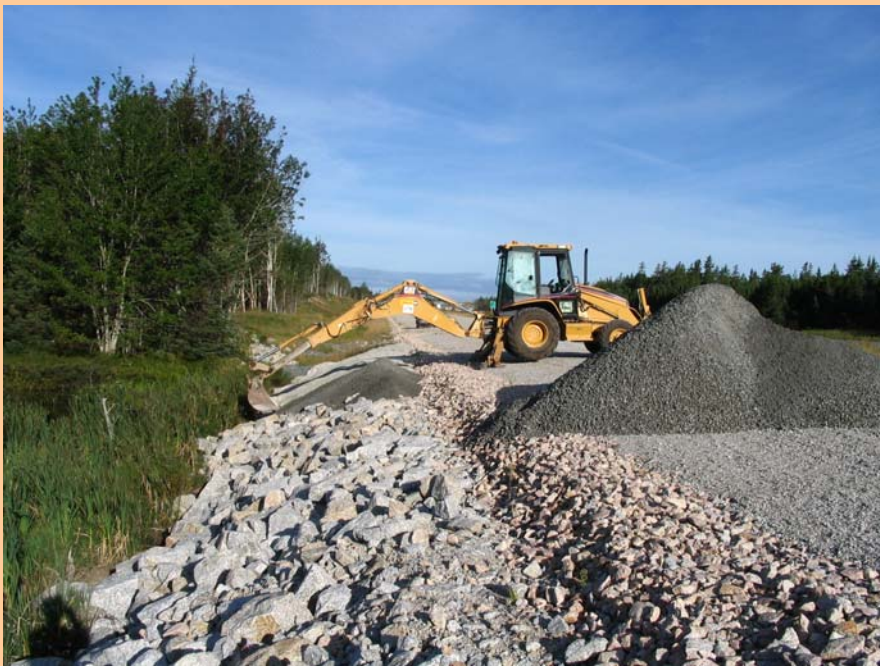
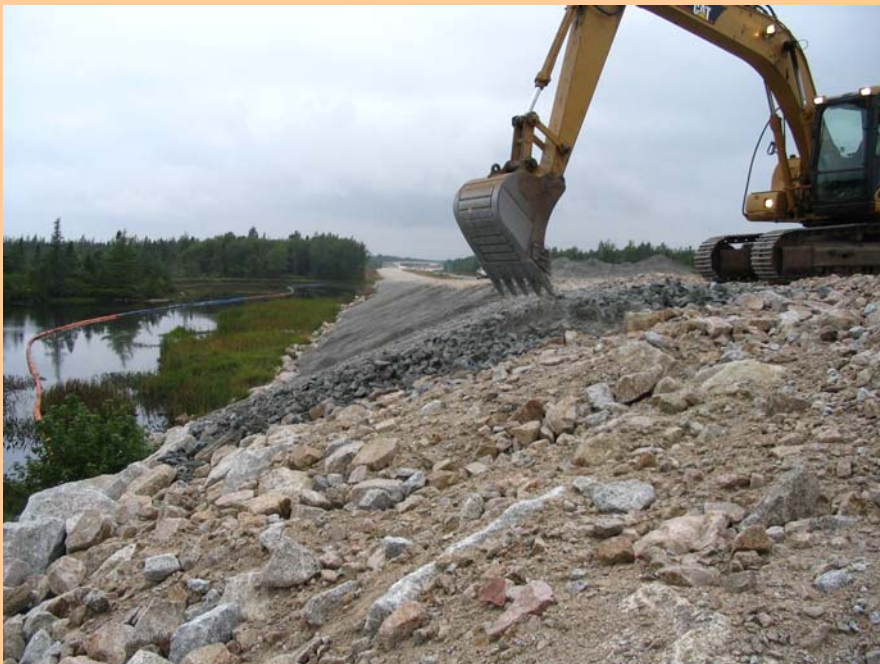
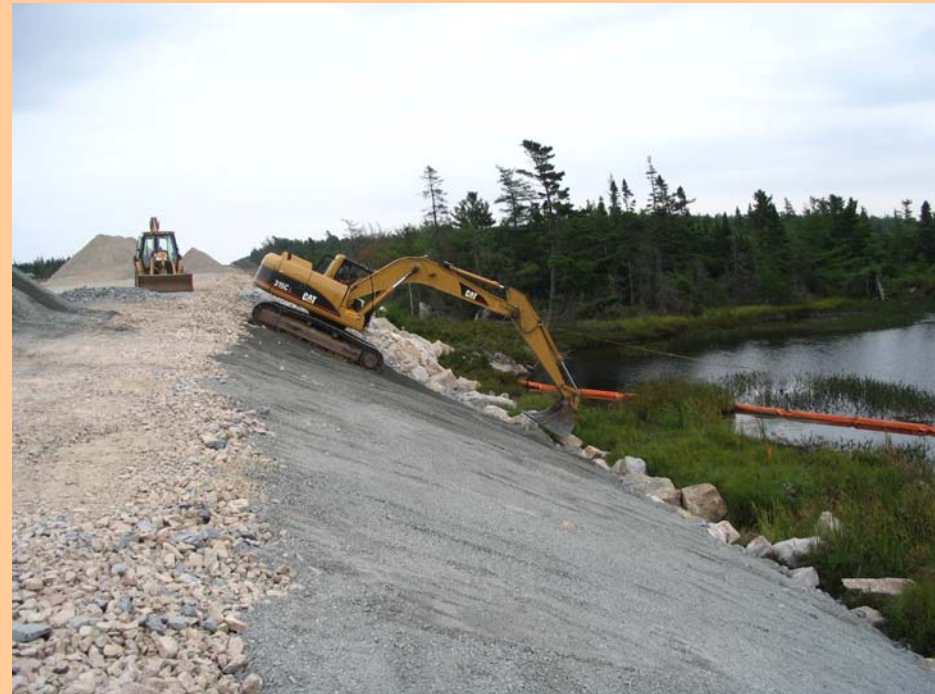
September 2005 - Slope Vegetation: Gravel Fill Prior to Topsoil/Compost

In September of 2005, the rock slope supporting the new lanes above the new lake shore was prepared for the establishment of seeded vegetation by filling the spaces at the western end with gravel, and the eastern end with surge rock, then gravel. The surface was then covered with about 20 cm of topsoil with compost on top and mixed in with the top centimeters of topsoil. The slope was hydroseeded with the 'Nova Scotia Highway Mix' and immediately covered with erosion control blanket (September 20). Periodic observations following the seeding led to a few repairs of rilling that appeared after heavy rains. By mid-November, the grass cover was well established, with no bare soil exposed.

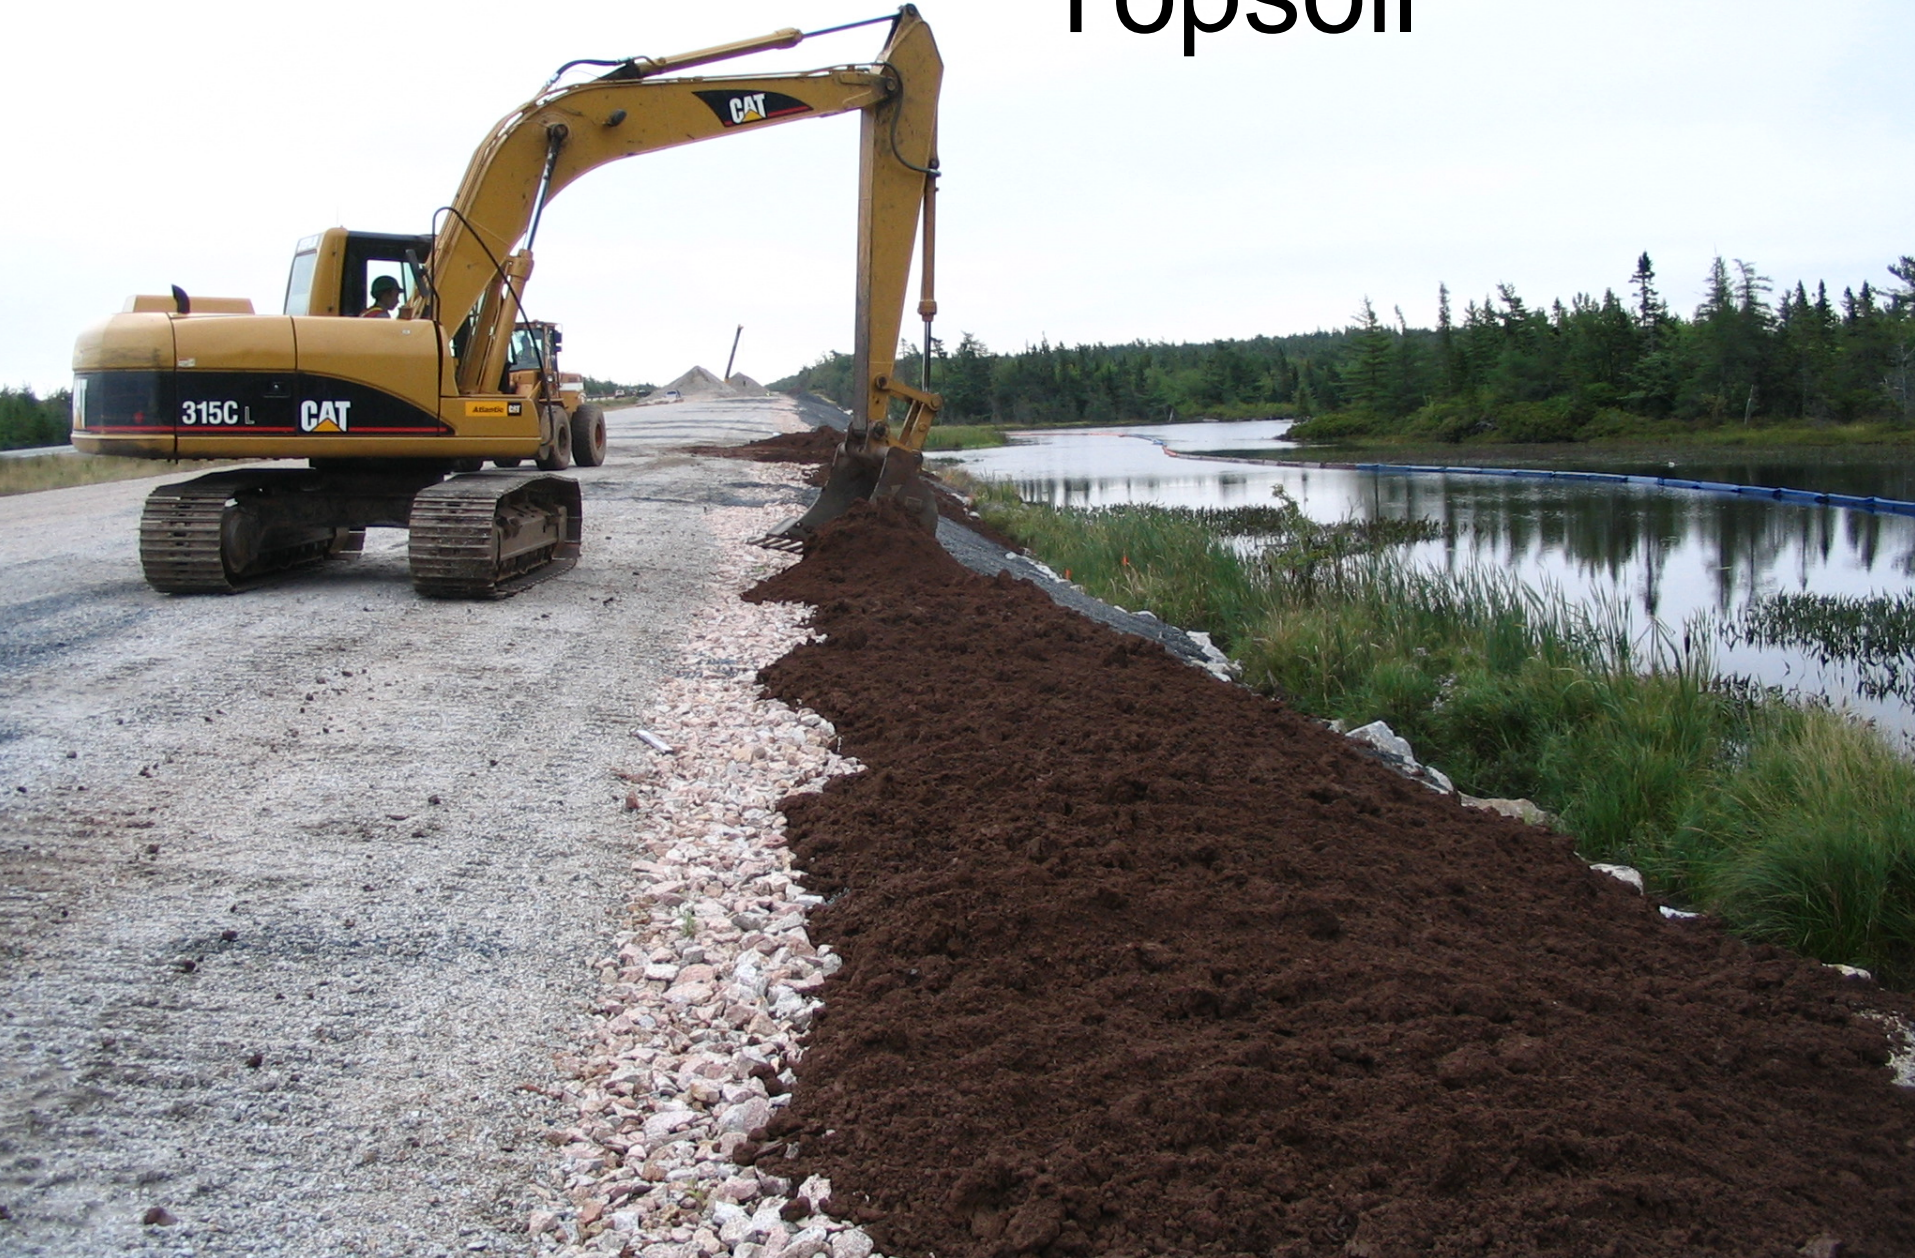
Topsoil
