As-Built Report for the Cranberry Lake, Highway 103, HADD Compensation Project: Shoreline and Slope Vegetation in 2004 and 2005

Diane LaRue, Vegetation Consultant
Environmental Services, TPW,
November 2005

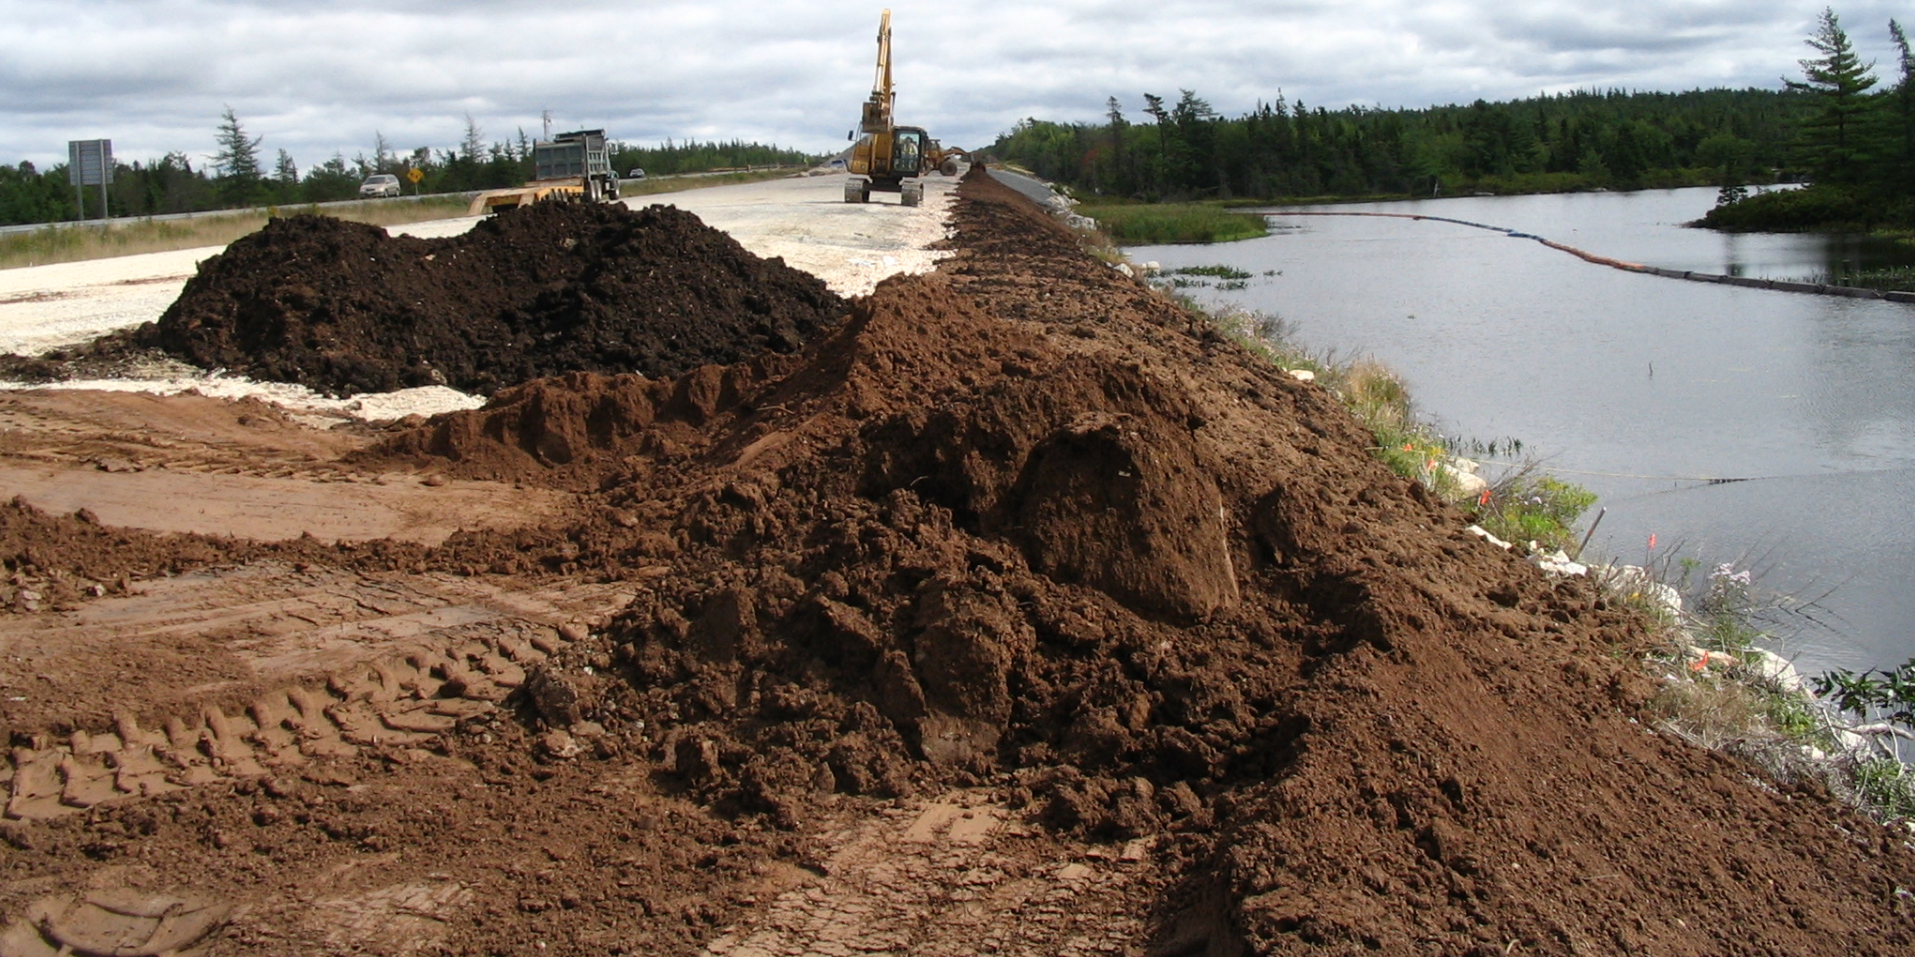
Adding Compost

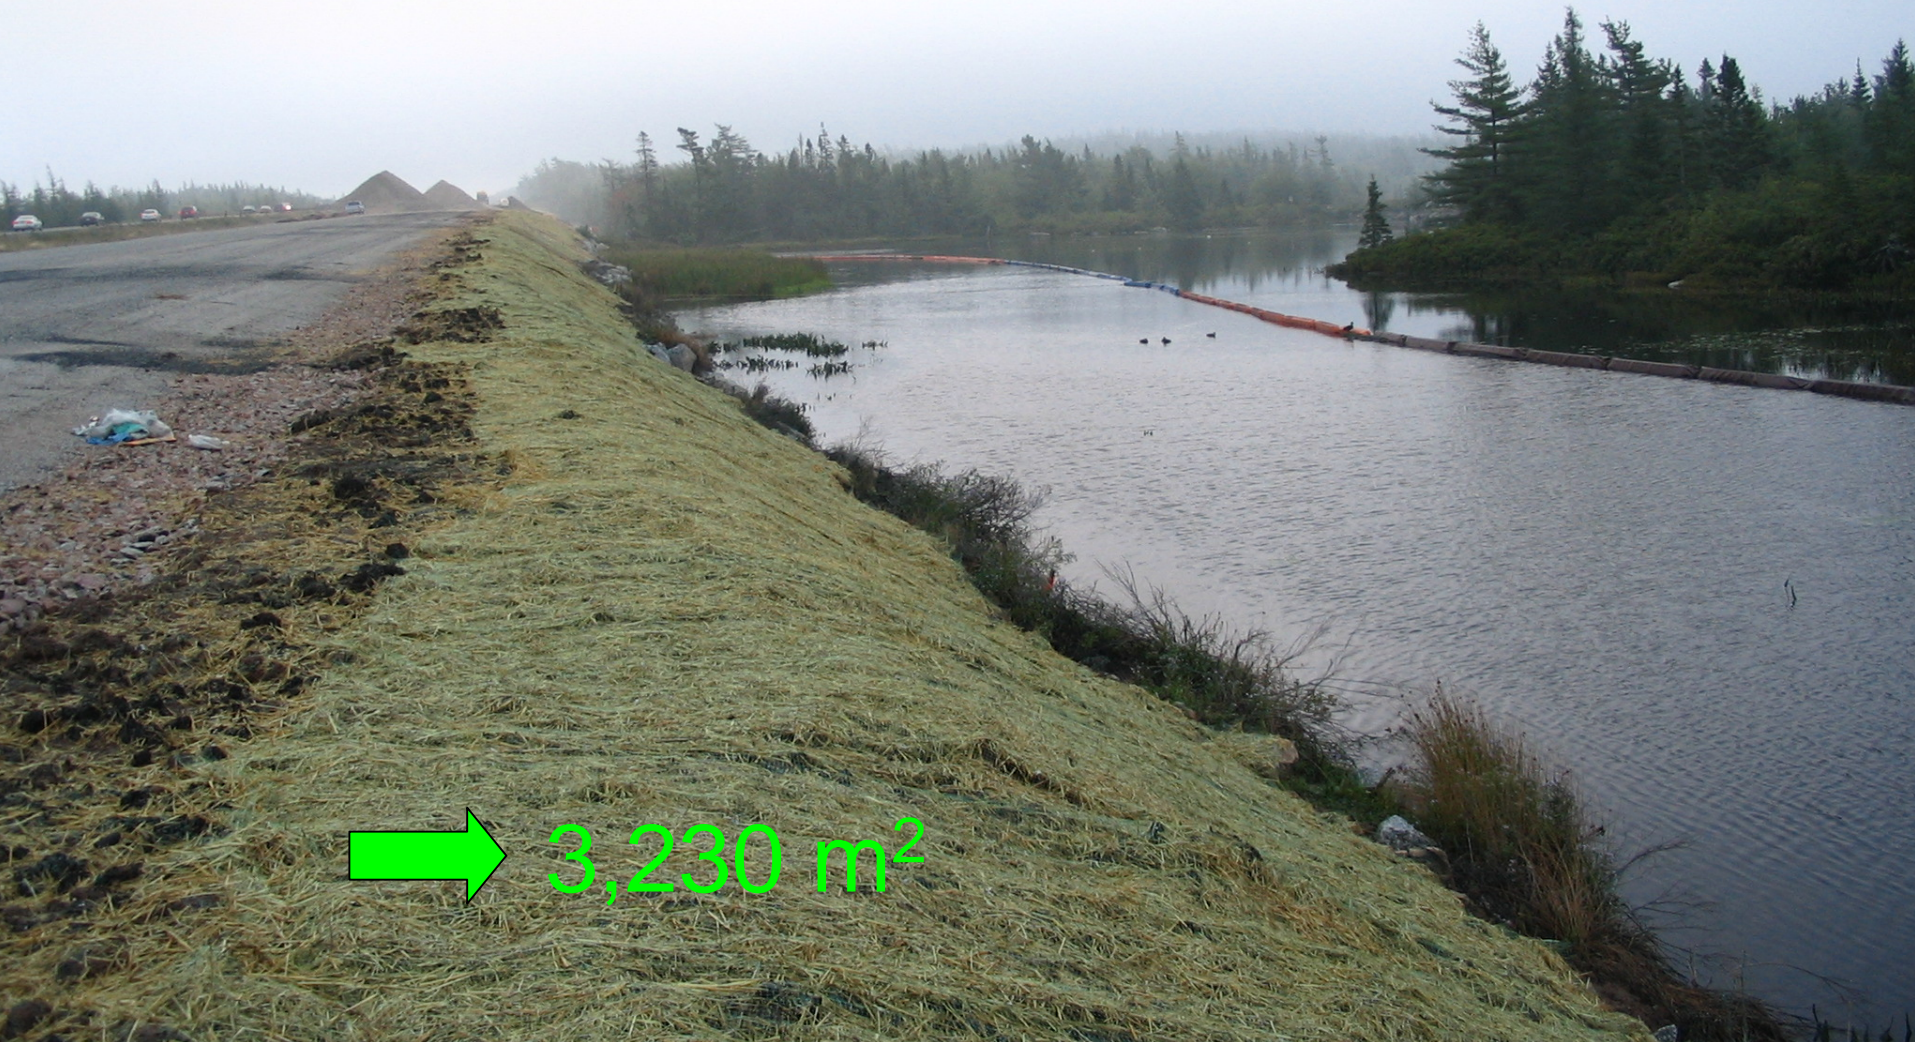
Finished September 21, 2005

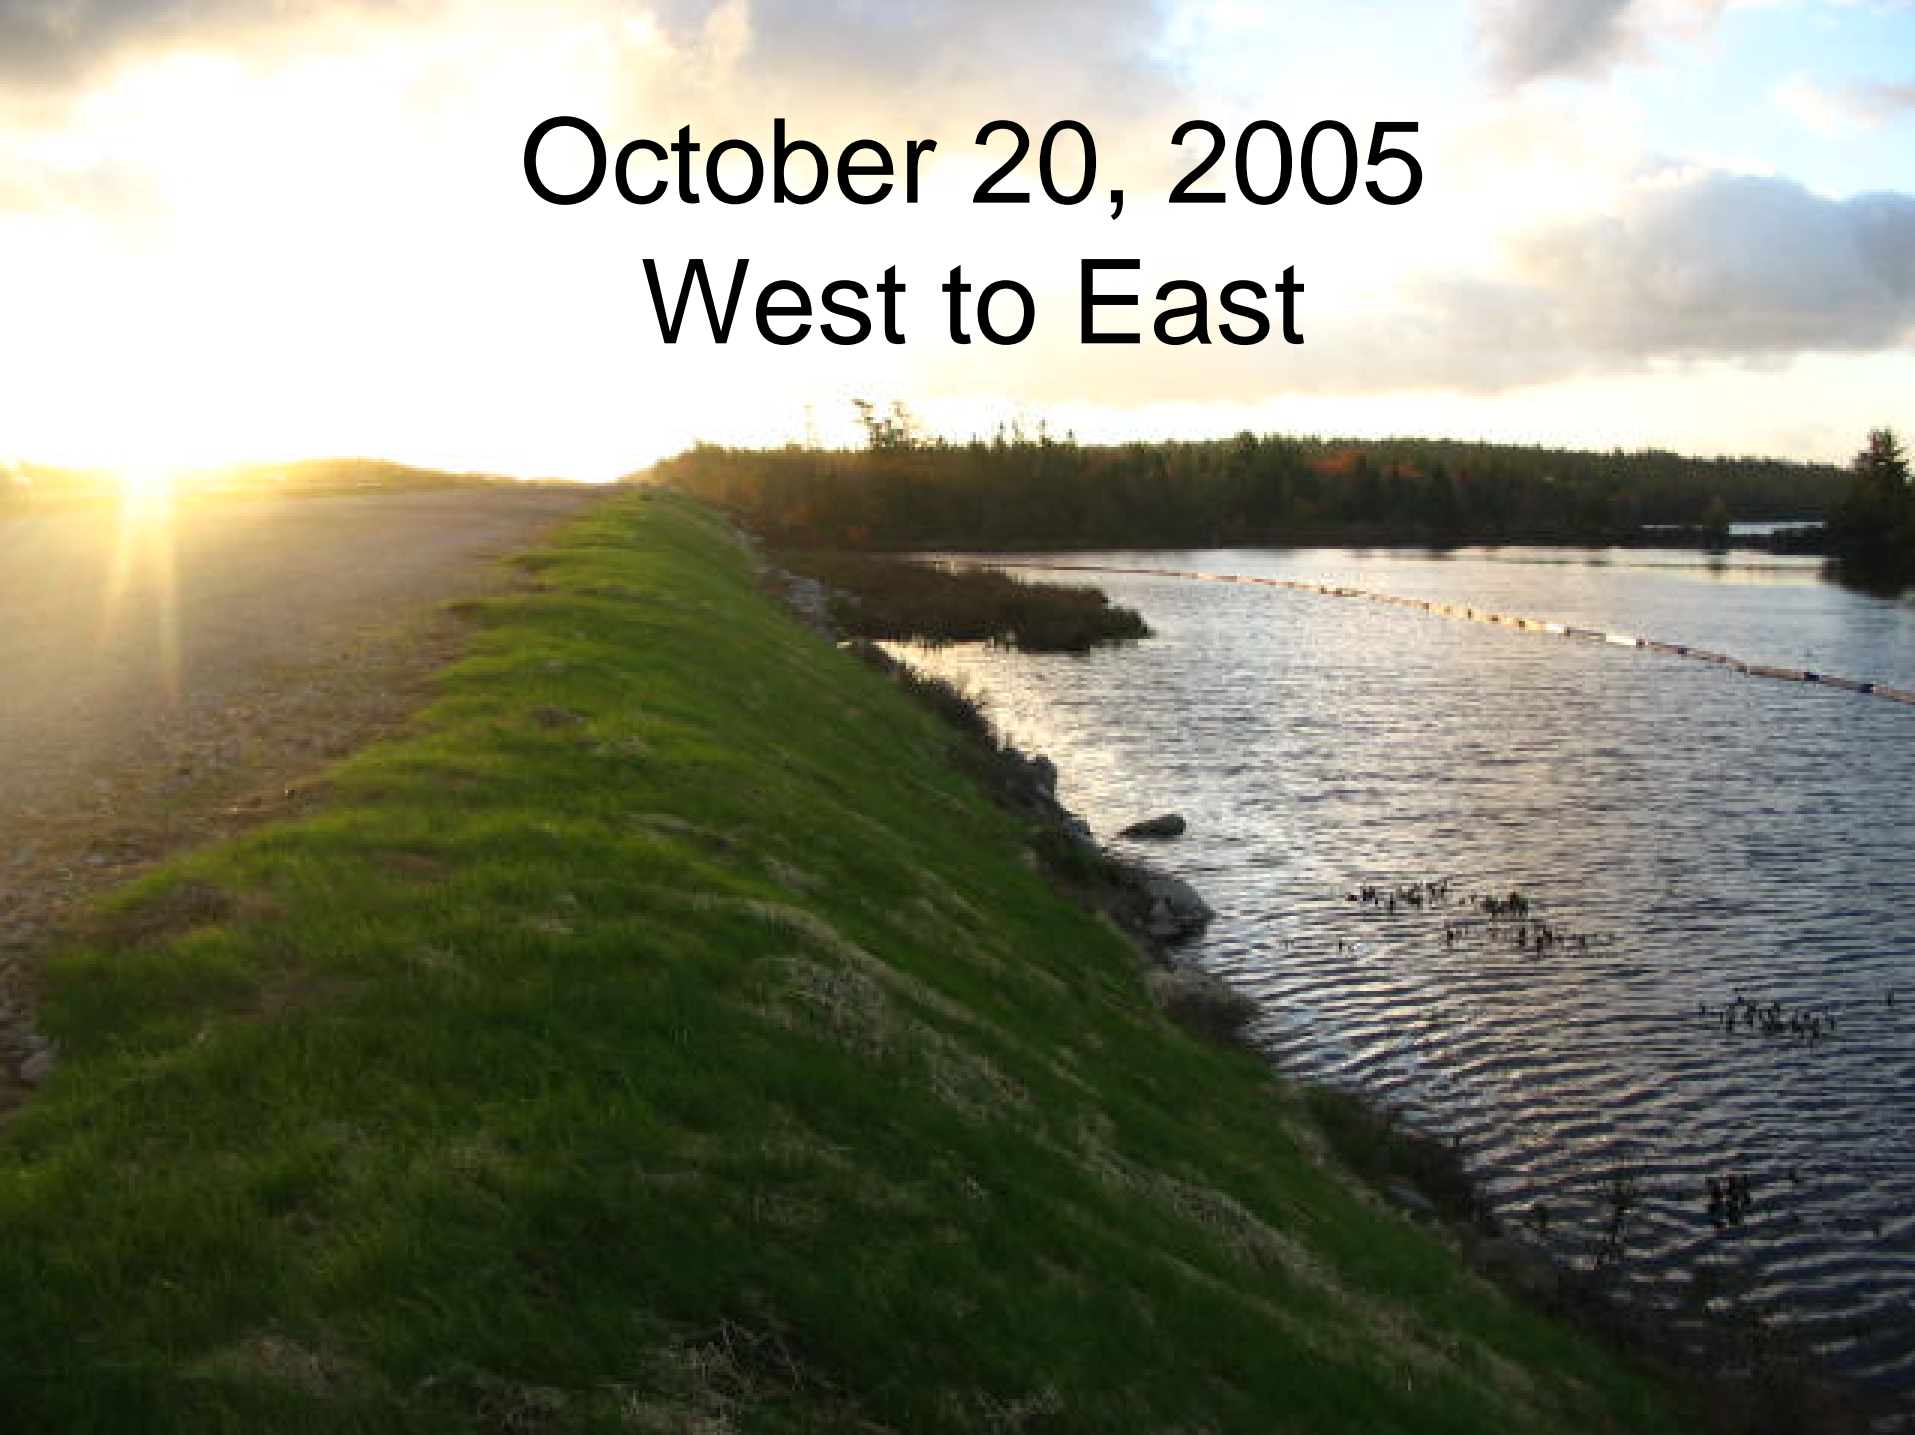
October 20, 2005
West to East
