HABITAT COMPENSATION AND MITIGATION ACTIVITIES FITZGERALD LAKE BROOK 2002 - 2003

The construction activities, including culvert installation, on the Antigonish/Guysborough Road at Fitzgerald Lake Brook required the realignment of a natural stream corridor which involved destruction of fish habitat. Several mitigation and fish habitat compensation measures were required as part of the HADD Application/EIS, January 2002.

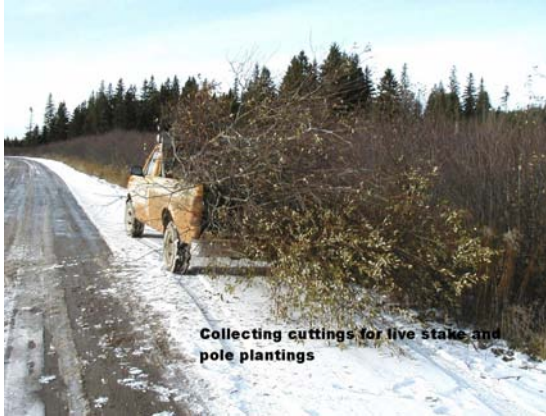
Collecting cuttings for live stake and pole plantings

November 4-5, 2002: Cutting, preparation and installation of dormant stakes and poles of Willows (*Salix spp.*), Alder (*Alnus spp.*), and Wild Raisin (*Viburnum nudum*).

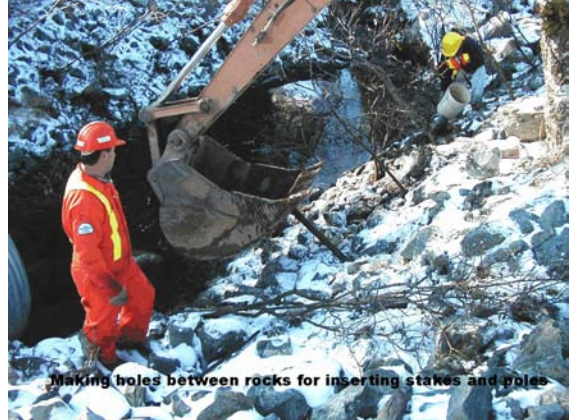
Making holes between rocks for inserting stakes and poles

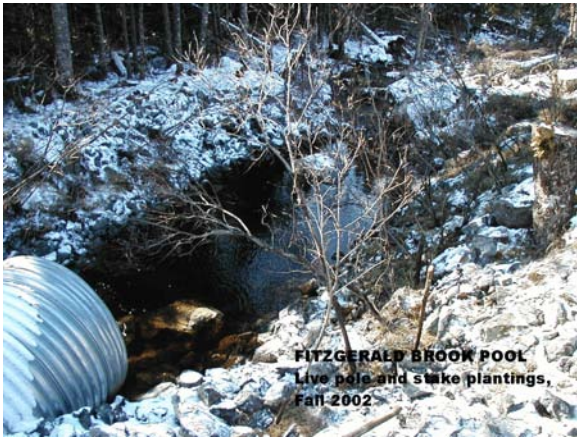
**FITZGERALD BROOK POOL
Live pole and stake plantings,
Fall 2002**

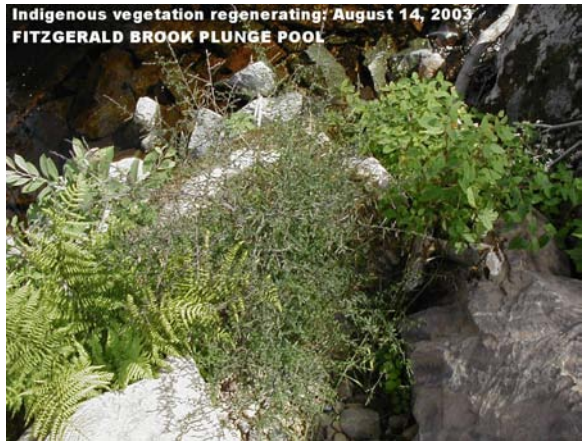
**Indigenous vegetation regenerating: August 14, 2003
FITZGERALD BROOK PLUNGE POOL**

Natural regeneration is taking place in native soils adjacent to plunge pool: Mountain Ash, Spruce, Maple, Wild Raisin, ferns, Joe Pye Weed, Asters, Turtlehead

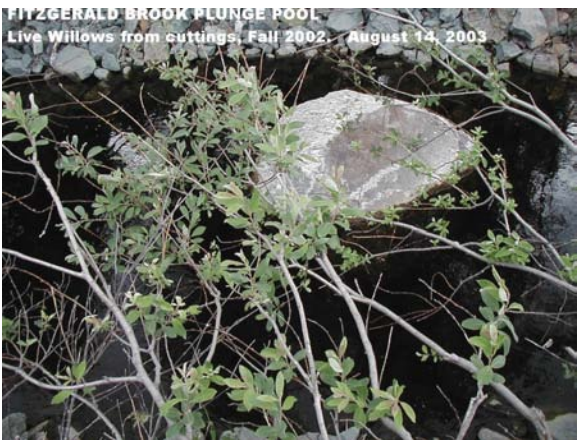
**FITZGERALD BROOK PLUNGE POOL
Live Willows from cuttings, Fall 2002, August 14, 2003**

Survival of Cuttings - Leafed out and thriving (August 14, 2003)

Facing Downstream	Species	< 2 m Alive	> 2 m Alive	Total Alive	% Survival
Left Side	Willows	6	5	11 from 25	44%
	Alder		0		0
	Wild Raisin		0		0
Right Side	Willows	4	4	8 from 20	40%
	Alder		0	0	0
	Wild Raisin		0	0	0

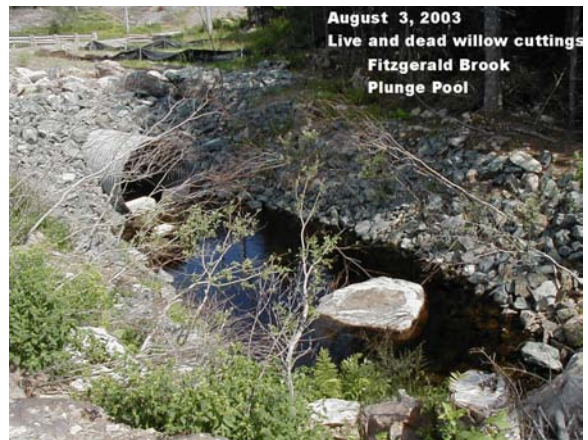
**August 3, 2003
Live and dead willow cuttings
Fitzgerald Brook
Plunge Pool**

Due to complete lack of survival of Alder and Wild Raisin, these will be replaced (in the same holes) in the fall of 2003 with additional cuttings of willows. Cuttings from locally available Red Osier Dogwood, Meadowsweet and Black Elderberry will also be planted.

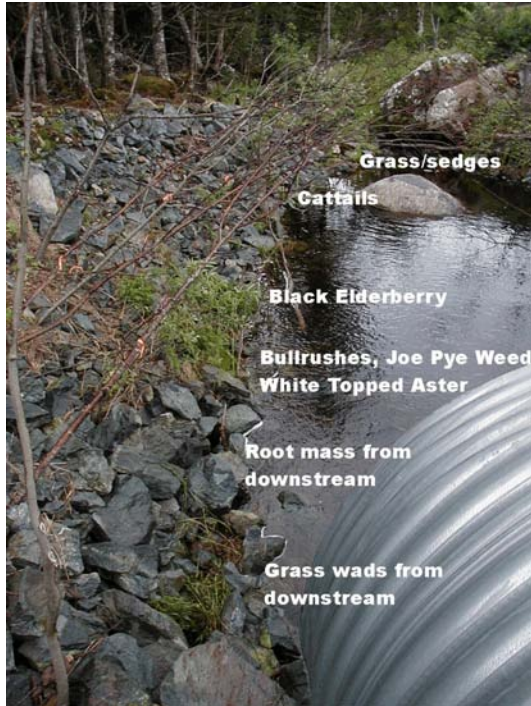
Left side of plunge pool, facing downstream

10 - 12 clumps of material (soil and rooted plants) planted on each side of pool along water line. Standing in water at edge of pool, rocks pulled away at water's edge until felt soil. Plant clumps dropped in, covered with old hay from the site, and protected with smaller rocks which were used to weigh down the soil clumps.

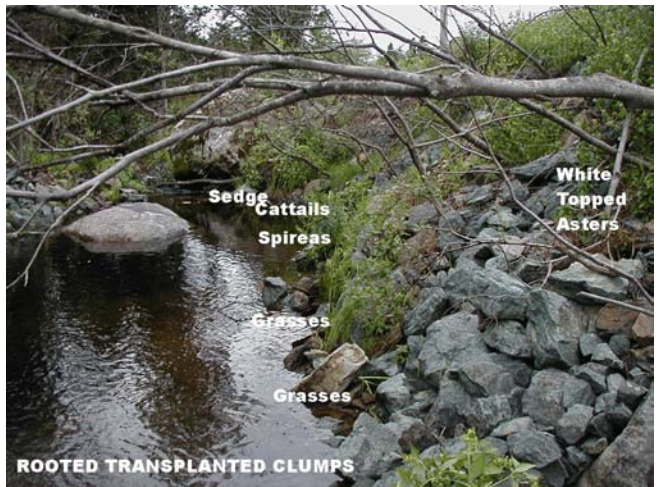
Right side of plunge pool, facing downstream

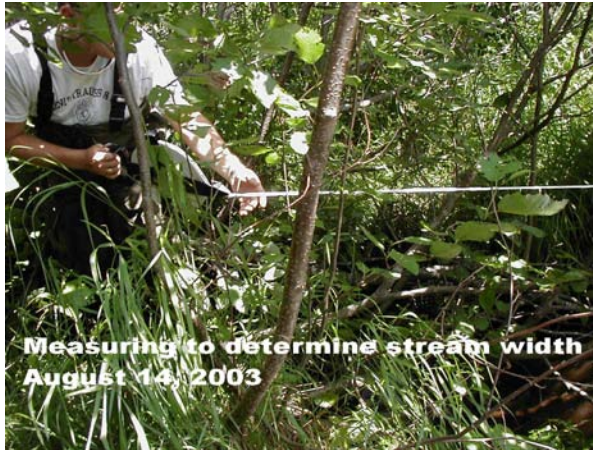
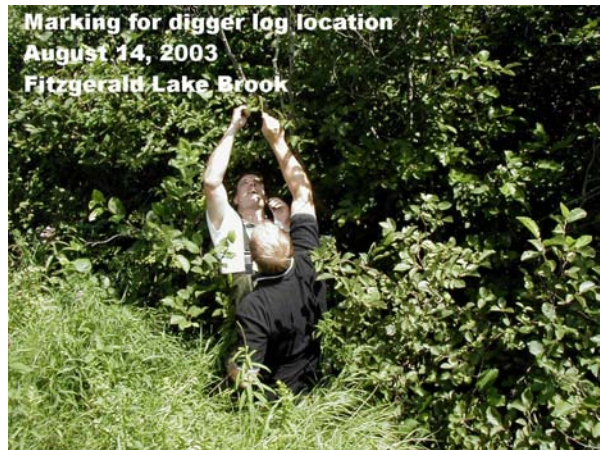
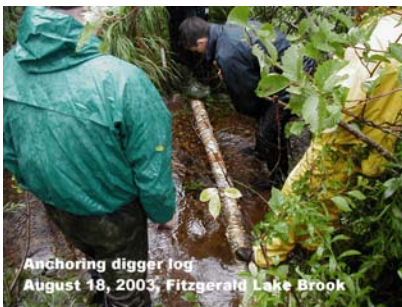
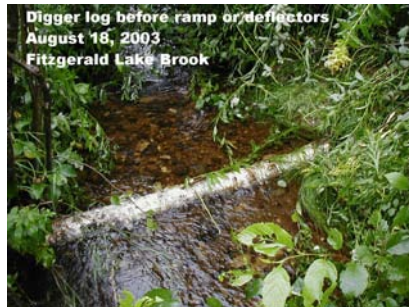
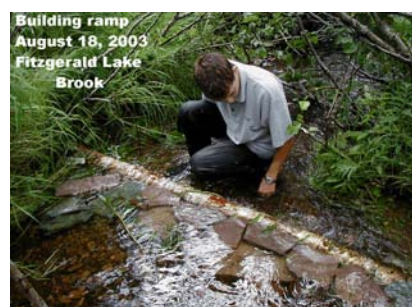
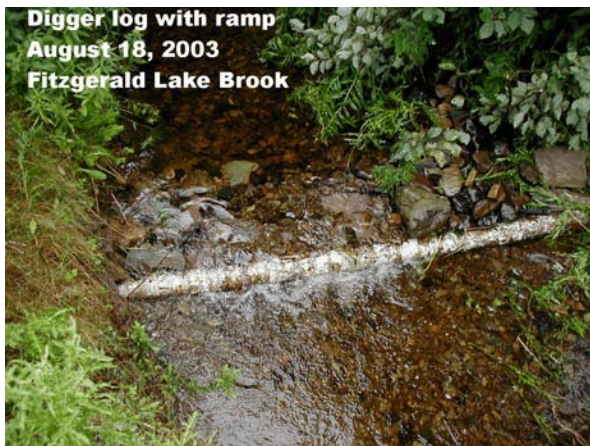
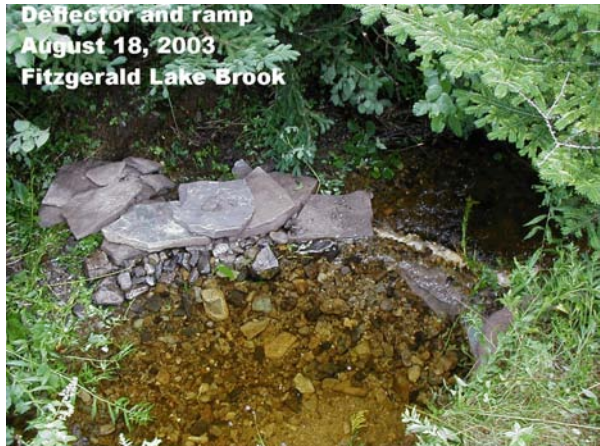
**DOWNSTREAM ESTABLISHMENT OF RIFFLE/POOL HABITAT
AUGUST 14 AND AUGUST 18-19, 2003**

Fifteen (15) structures installed in Fitzgerald Lake Brook for enhancement of fish habitat as part of HADD. TPW crew under supervision of DFO. August 18 and 19, 2003.

August 14, 2003: Site visit with DFO. DFO specialist measured and marked locations for installation of digger logs (rather than rock sills). Work arranged for August 18.

August 18 and 19, 2003: 15 digger logs with deflectors and ramps installed under direction of DFO specialist.
