**Flat Lake, Highway 103,  
HADD Compensation Project  
(DFO HADD Authorization 03-G8-068):  
2010 Vegetation Monitoring –  
Year 5 Final**

Diane LaRue, Vegetation Consultant  
Environmental Services, NSTIR  
Monitored September 2, 2010

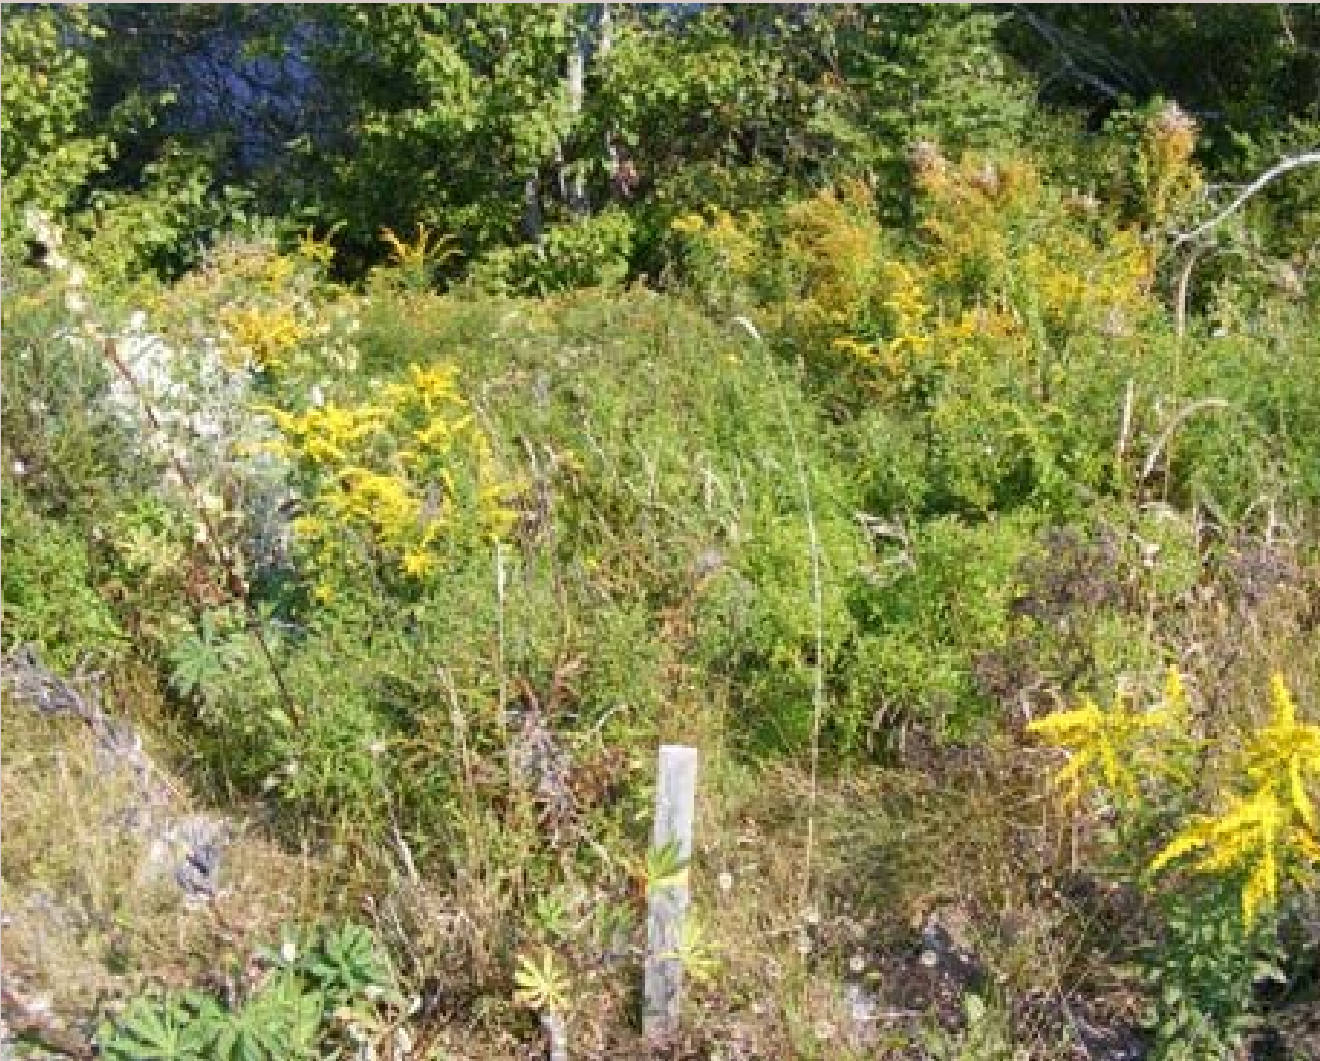
# Stake 1:

100% Cover

- 5% Grass species
- 90% Wildflowers including:
  - Goldenrod spp.
  - Evening primrose
  - Pearly everlasting
- 5% Sweetfern; Trees along shore were left during construction
- Lupines at shoulder

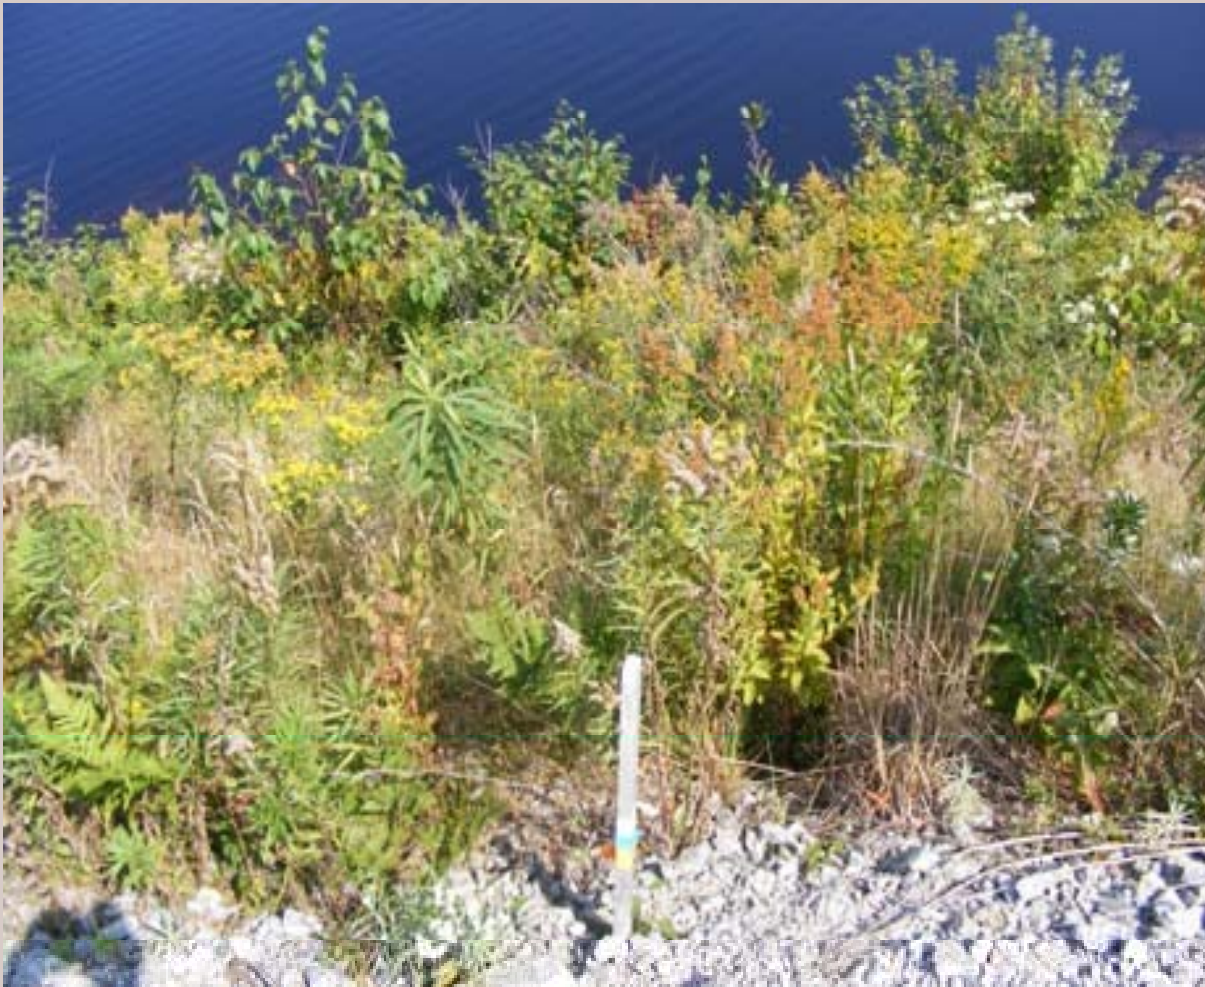
# Stake 2:

100% Cover

- 20% Grasses
- 40% Wildflowers and Ferns, including
  - Goldenrod spp.
  - White asters
  - Bracken fern
- 40% Trees and Shrubs, including
  - Meadowsweet
  - Alder
  - Pin cherry
  - Bush honeysuckle
  - Red maple
  - Sweetfern
  - Birch
  - Willow

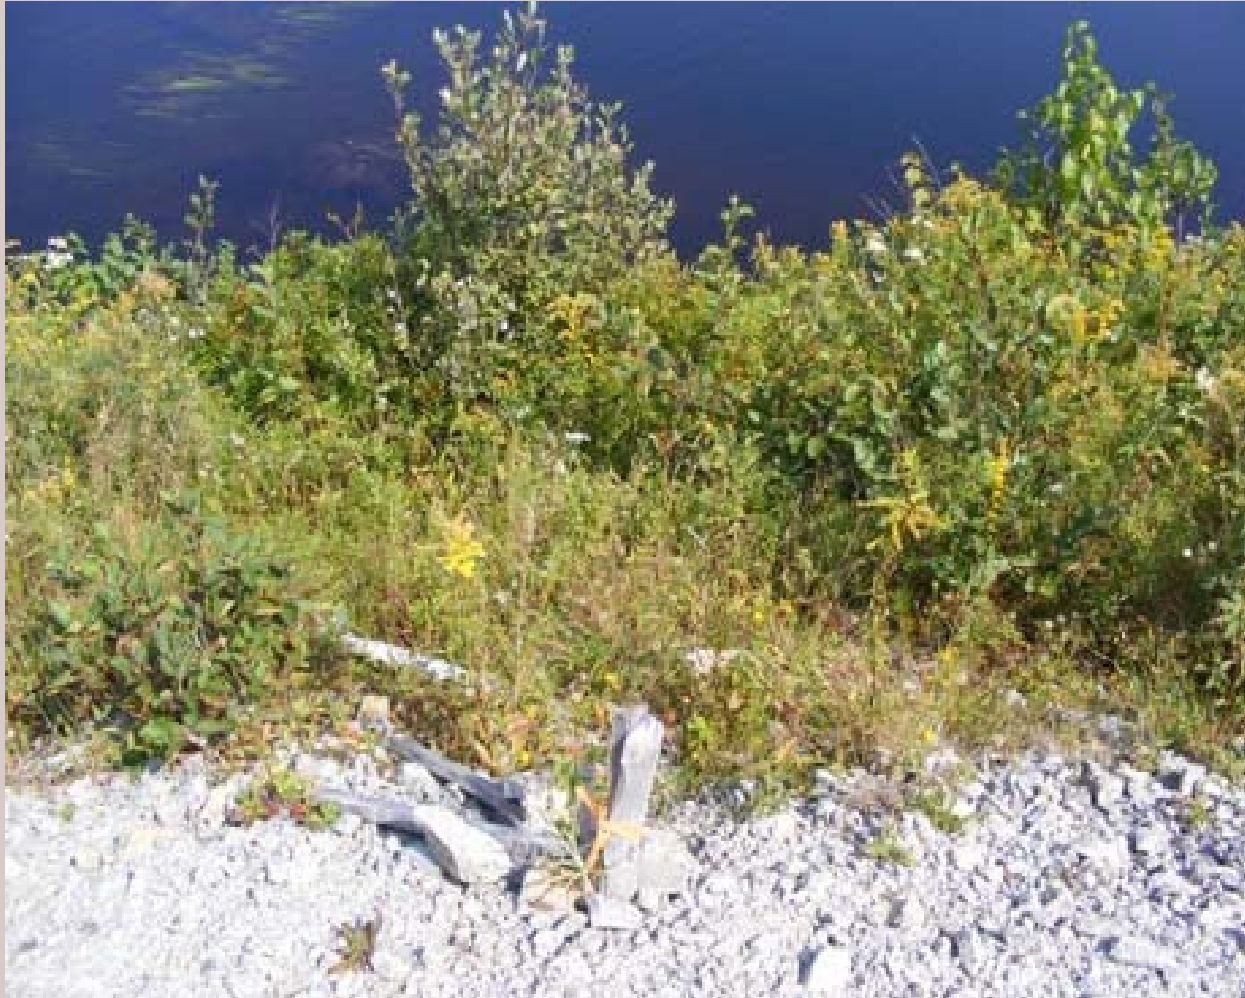
# Stake 3: 100% Cover

- 5% Grasses
- 35% Wildflowers including
  - Goldenrod spp.
  - Aster spp.
  - Pearly everlasting
- 60% Shrubs and Trees, including
  - Birch
  - Sweetfern
  - Raspberry
  - Wild rose
  - Red maple
  - Willow
  - Alder
  - Pin cherry
  - Bush honeysuckle
  - Poplar

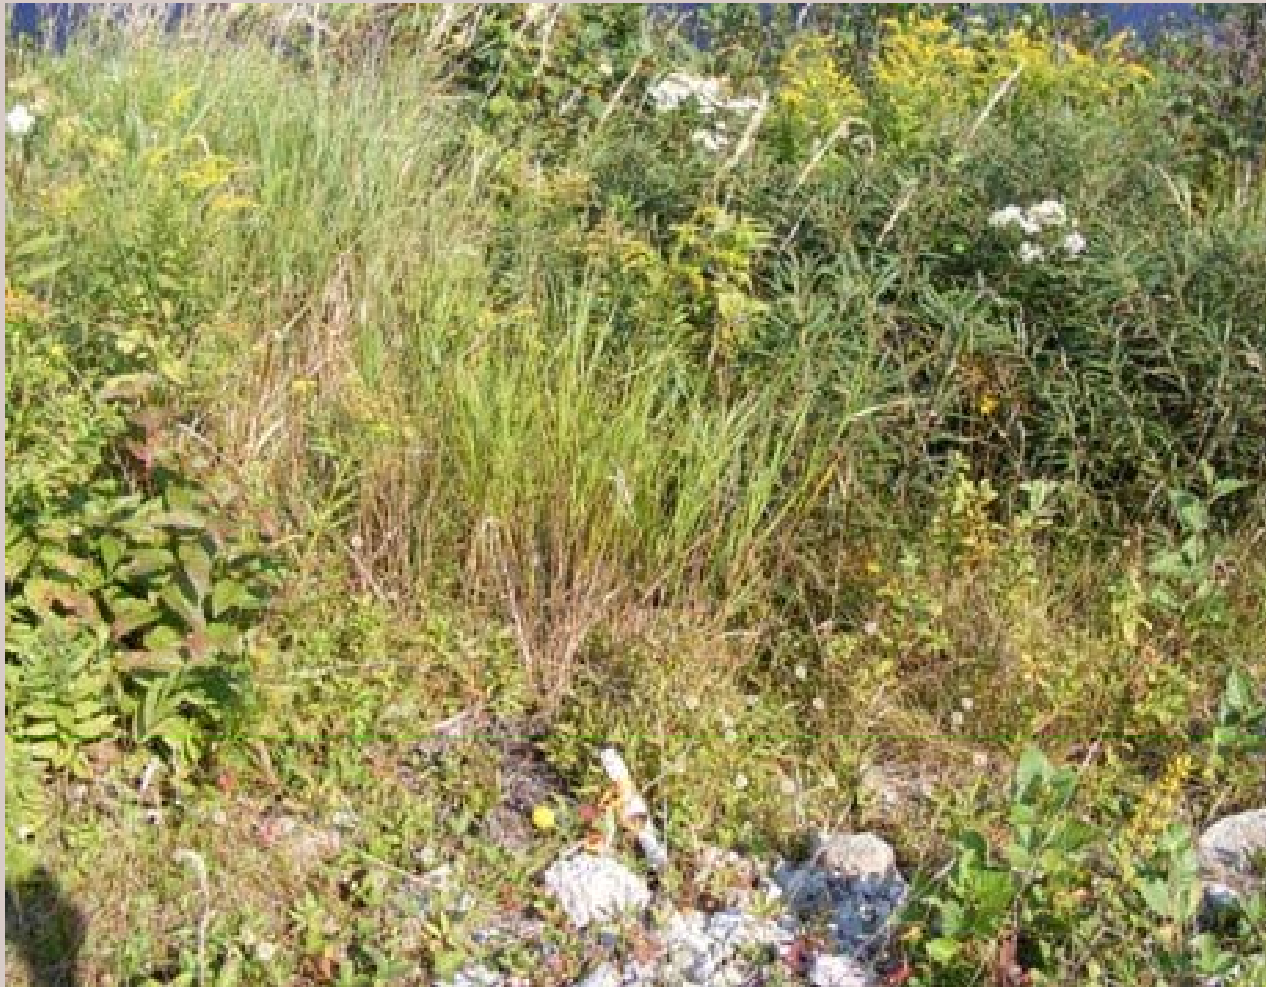
# Stake 4:

100% Cover

- 10% Grasses and Wildflowers (e.g. Goldenrods, Asters)
- 90% Shrubs and Trees, including
  - Birch
  - Sweetfern
  - Bush honeysuckle
  - Alders
  - Raspberry
  - Pin cherry
  - Meadowsweet
  - Wild strawberry

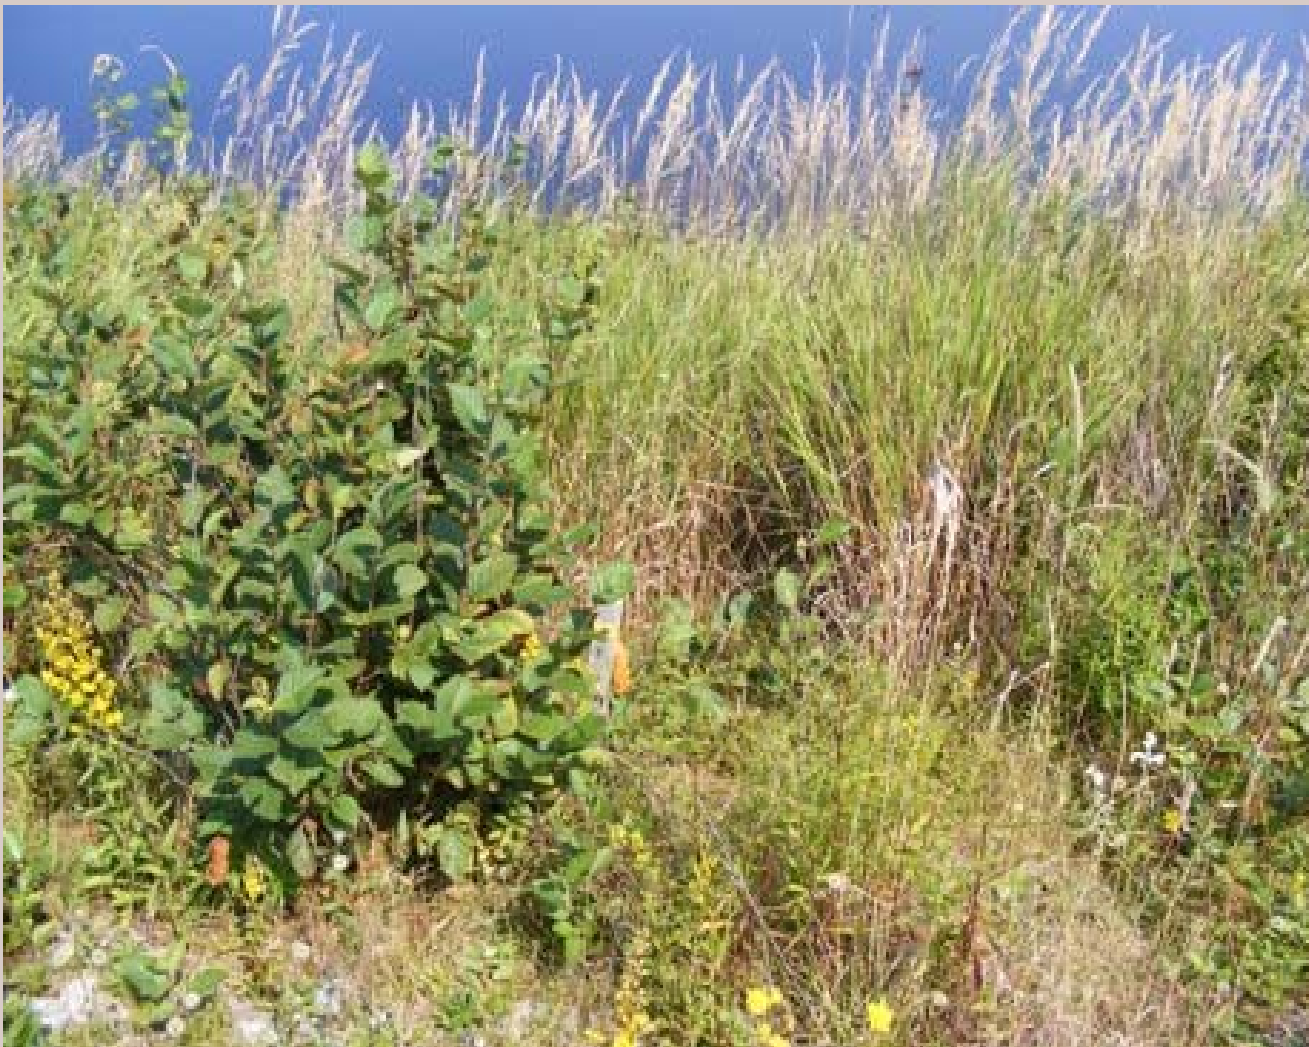
# Stake 5:

100% Cover

- 10% Grasses and Wildflowers, including
  - Goldenrod spp.
  - Aster spp.
  - Pearly everlasting
- 90% Shrubs and Trees, including
  - Alder
  - Meadowsweet
  - Willow
  - Raspberry
- Shoulder: Wild strawberry and Coltsfoot

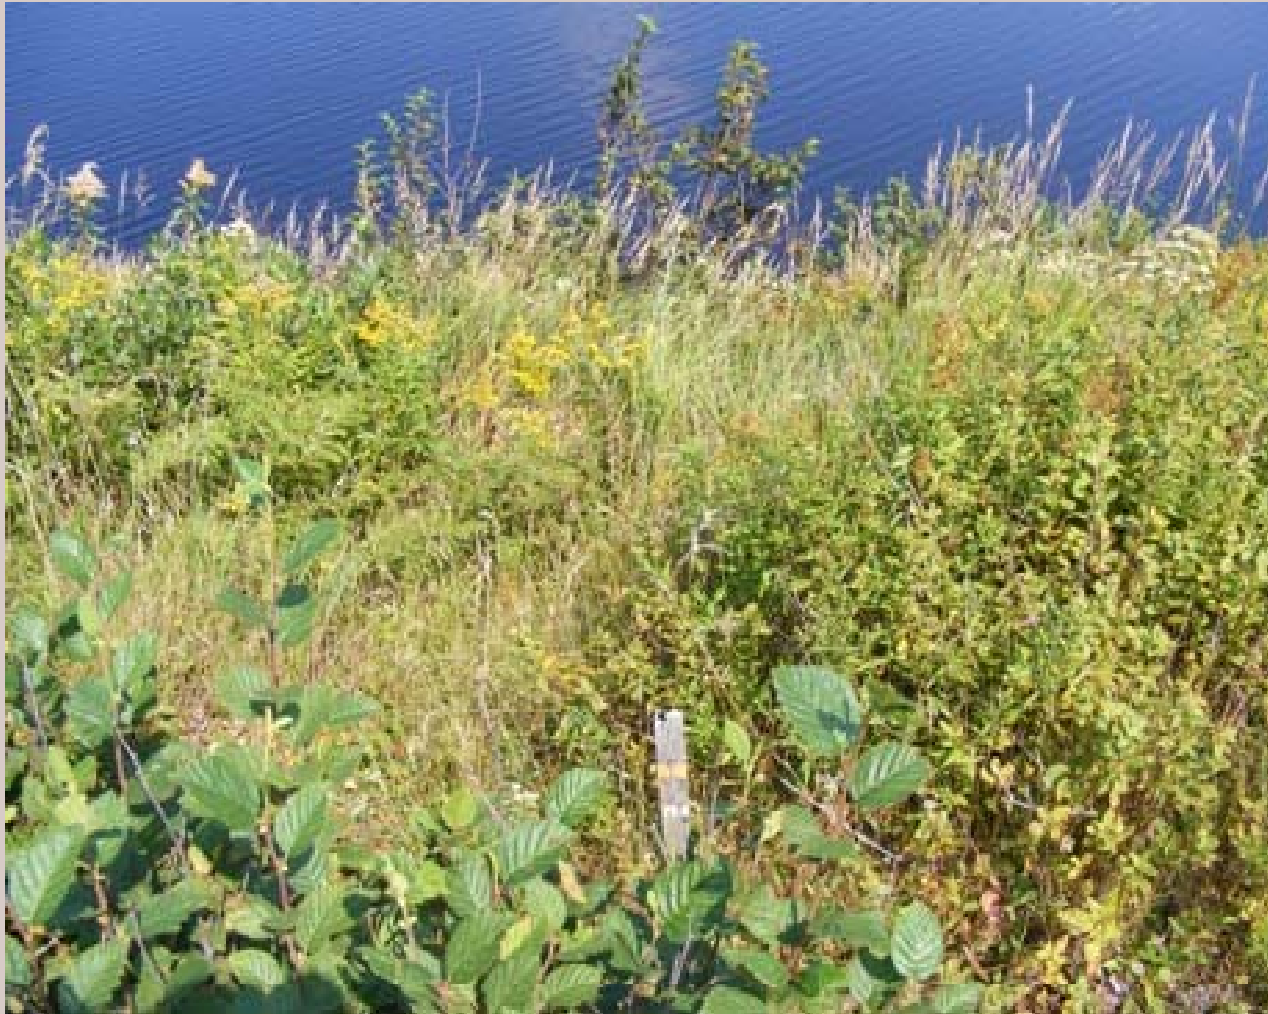
# Stake 6: 100% Cover

- 15% Grass
- 15% Wildflowers and Ferns including:
  - Goldenrod spp.
  - Aster spp.
  - Pearly everlasting
  - Bracken fern
- 70% Shrubs and Trees, including:
  - Meadowsweet
  - Alder
  - Black huckleberry
  - Black chokeberry
  - Pin cherry
  - Blackberry
  - Wild strawberry

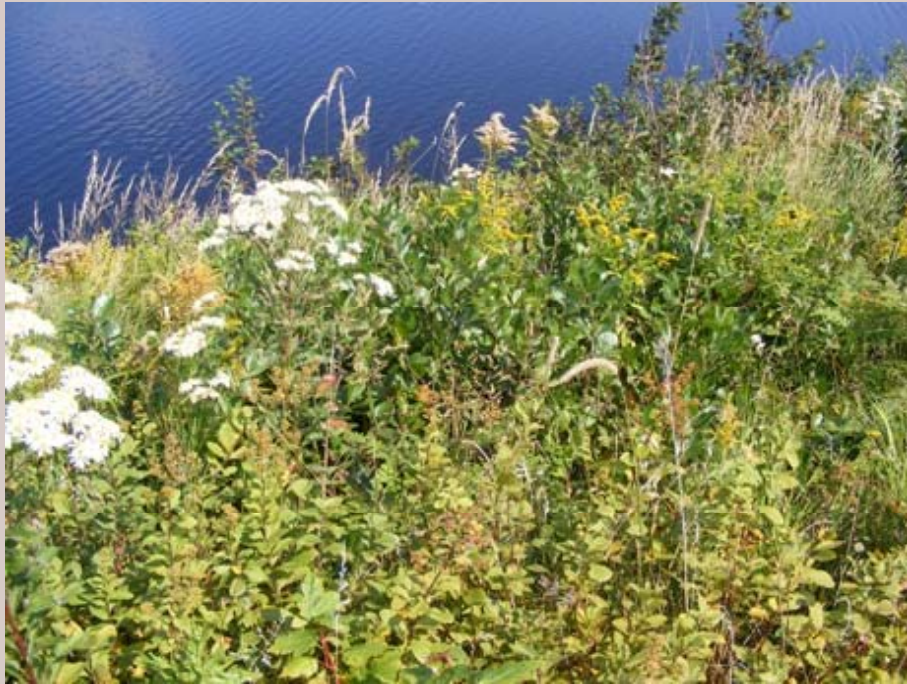
# Stake 6: Examples of Plant Community

- Meadowsweet
- White topped aster
- Goldenrods
- Red maple

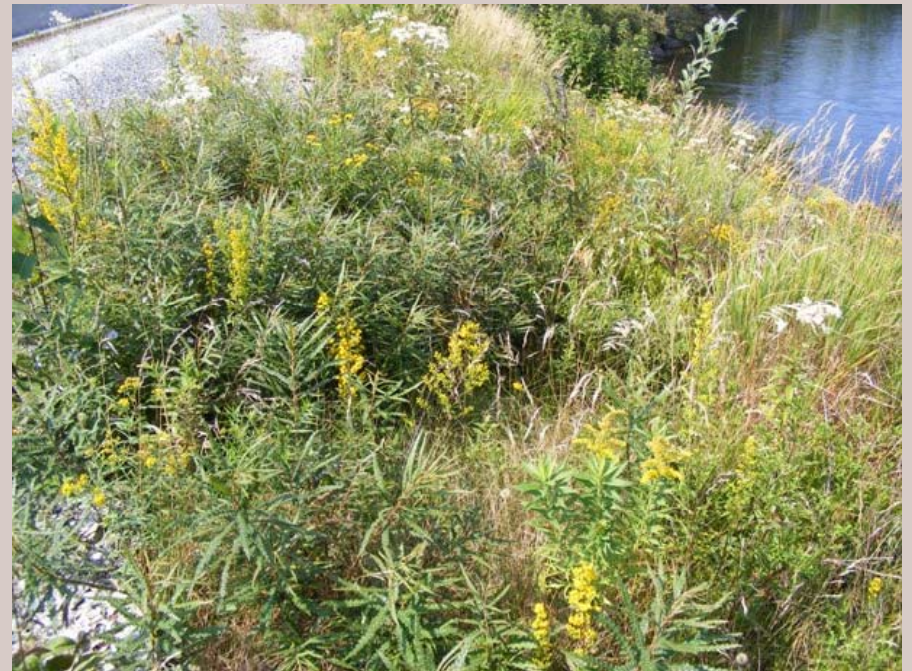
- Goldenrods
- Sweetfern
- Grasses

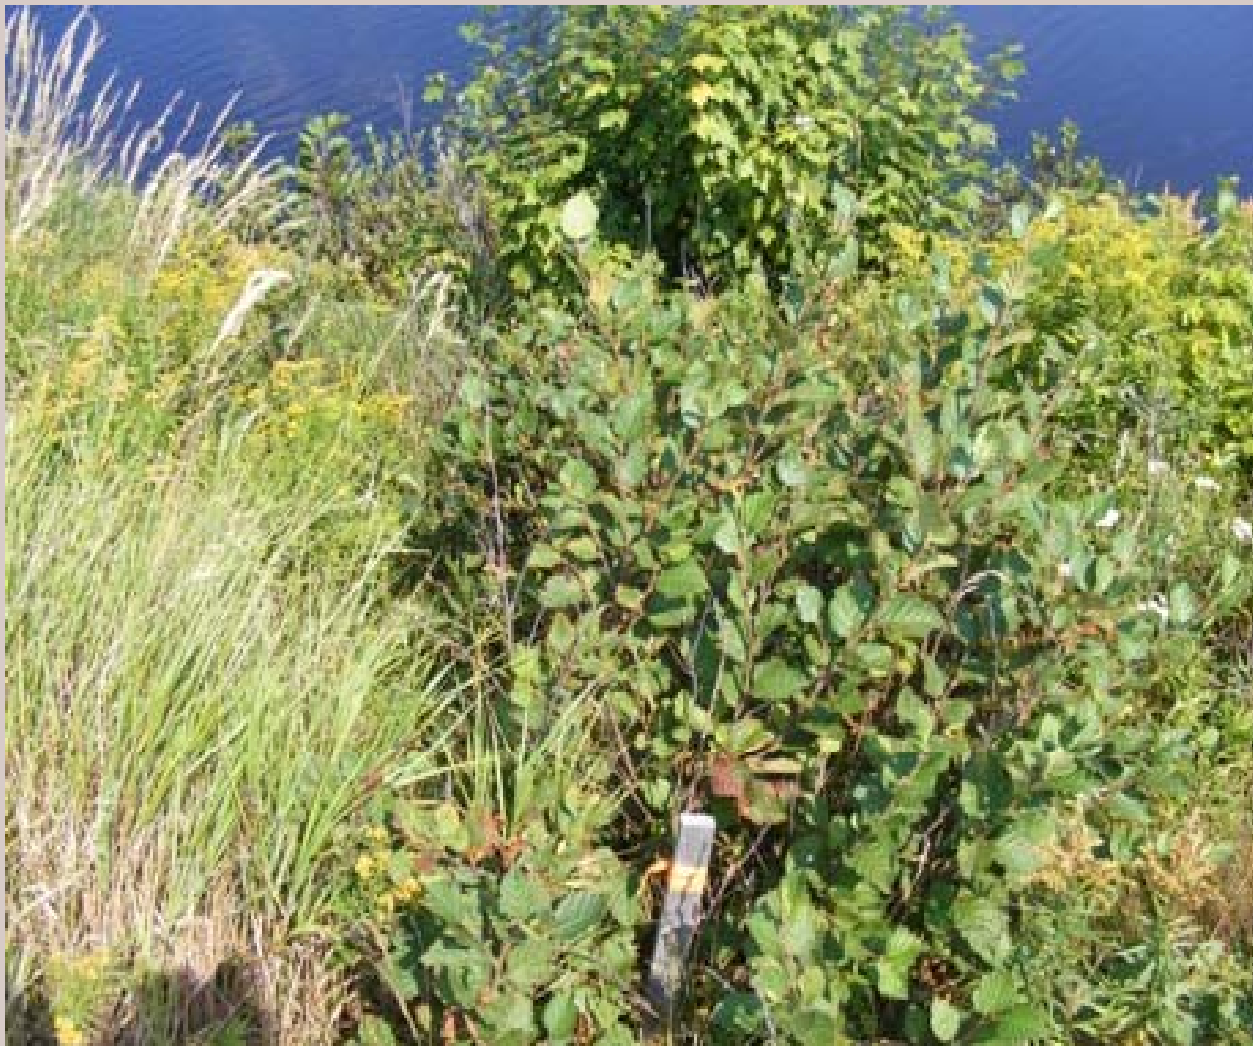
# Stake 7:

100% Cover

- 10% Grasses
- 10% Wildflowers and Ferns, including:
  - Goldenrod spp.
  - Pearly everlasting
  - Aster spp.
  - Bracken fern
- 80% Shrubs and Trees, including:
  - Wild raisin
  - Raspberry
  - Alder
  - Red maple
  - Birch
  - Bush honeysuckle
  - Pin cherry
  - Blackberry
  - Willow

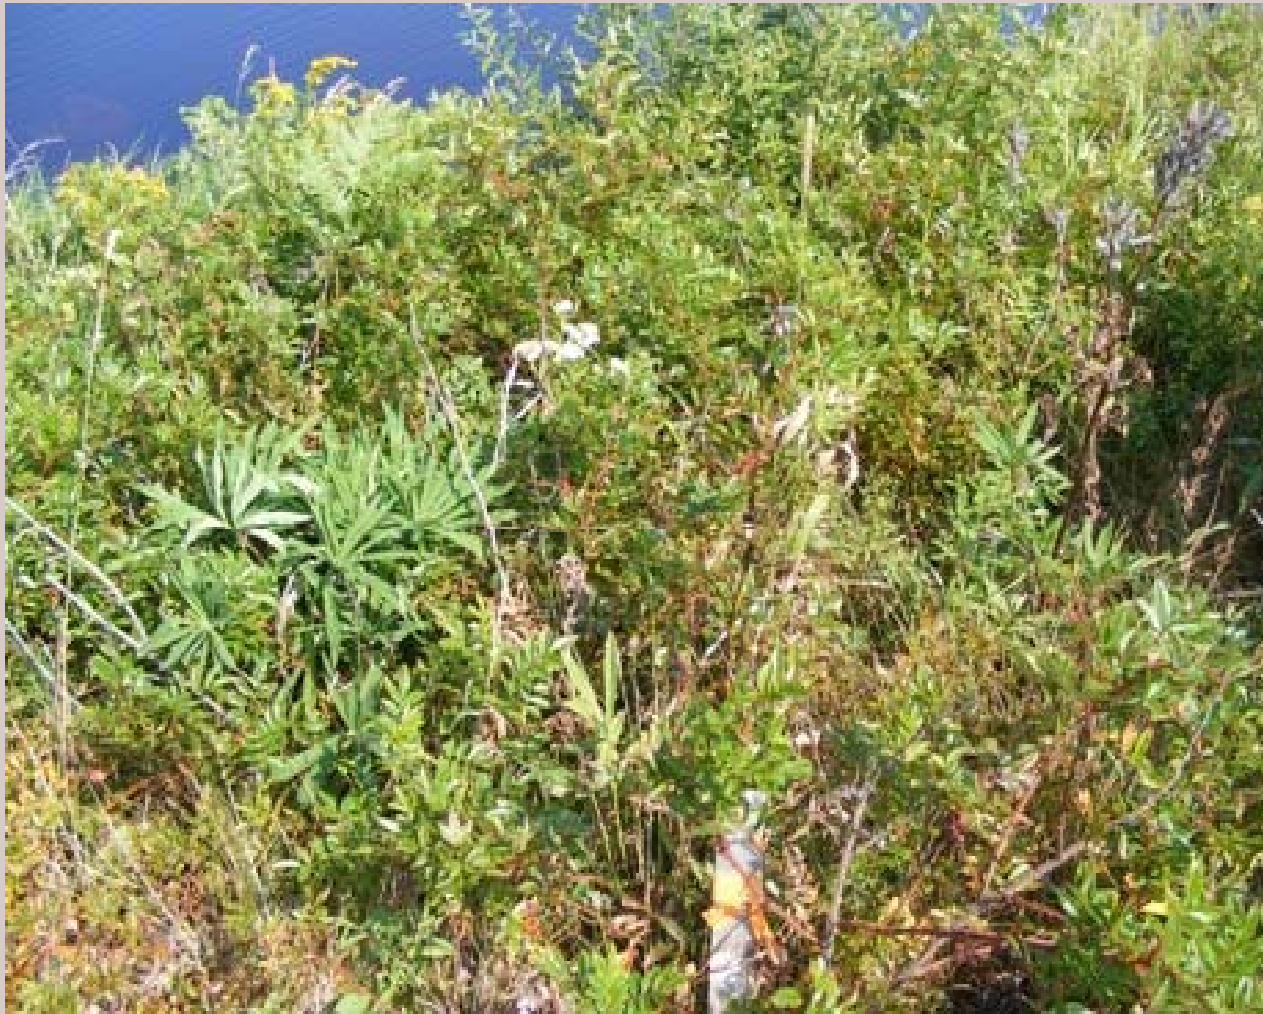
# Stake 8:

100% Cover

- 5% Grasses, Ferns and Wildflowers, including:
  - Goldenrod spp.
  - Aster spp.
  - Bracken fern
- 95% Shrubs and Trees, including:
  - Wild rose
  - Wild raisin
  - Black huckleberry
  - Birch
  - Raspberry
  - Sweetfern
  - Pin cherry
  - Meadowsweet
  - Alder at shoulder

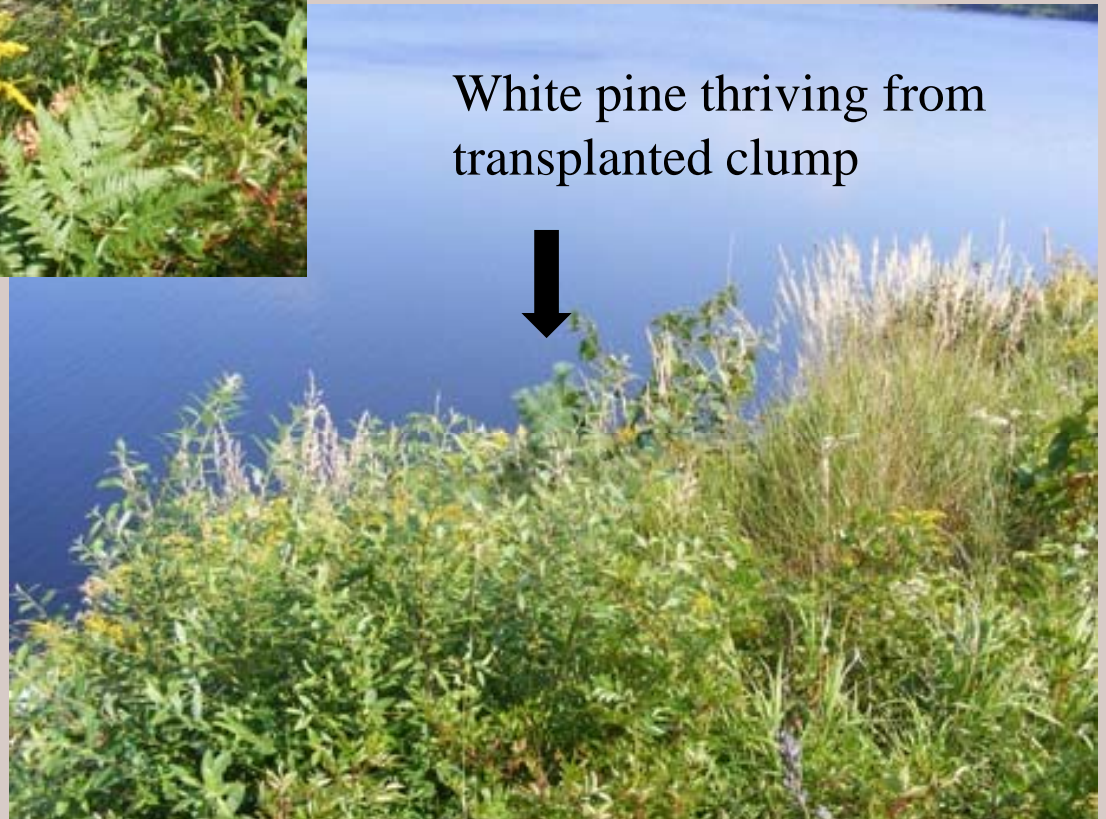
White pine thriving from  
transplanted clump

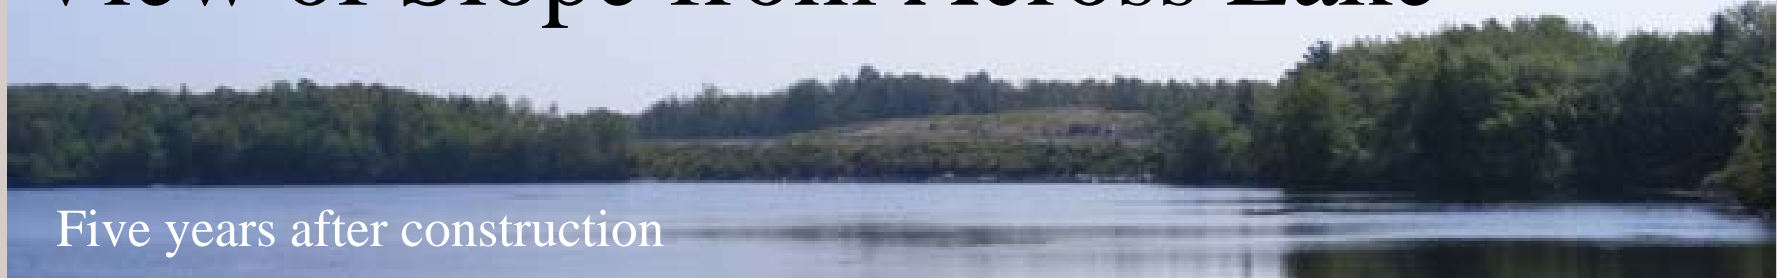
# View of Slope from Across Lake

Five years after construction

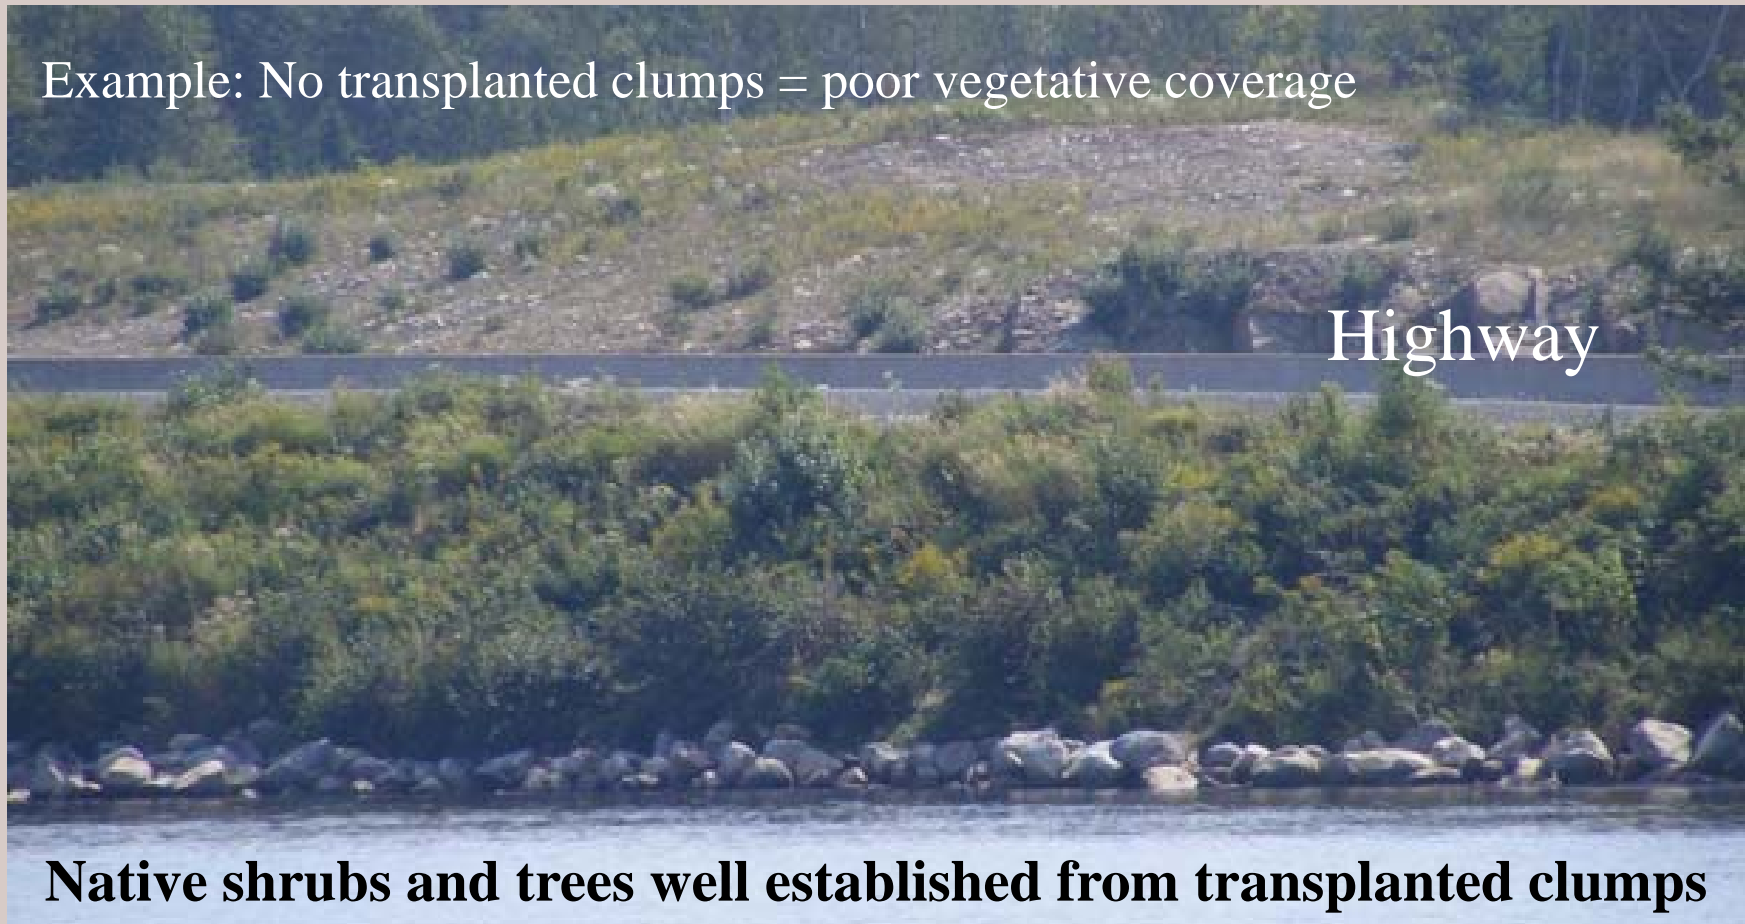
Example: No transplanted clumps = poor vegetative coverage

**Native shrubs and trees well established from transplanted clumps**
