A Report for:
Nova Scotia Department of
Transportation and Infrastructure Renewal

Post-Restoration Monitoring (Year 4) of the Cogmagun River Salt Marsh Restoration Project

CBWES Inc.

March 2014
Publication No. 39

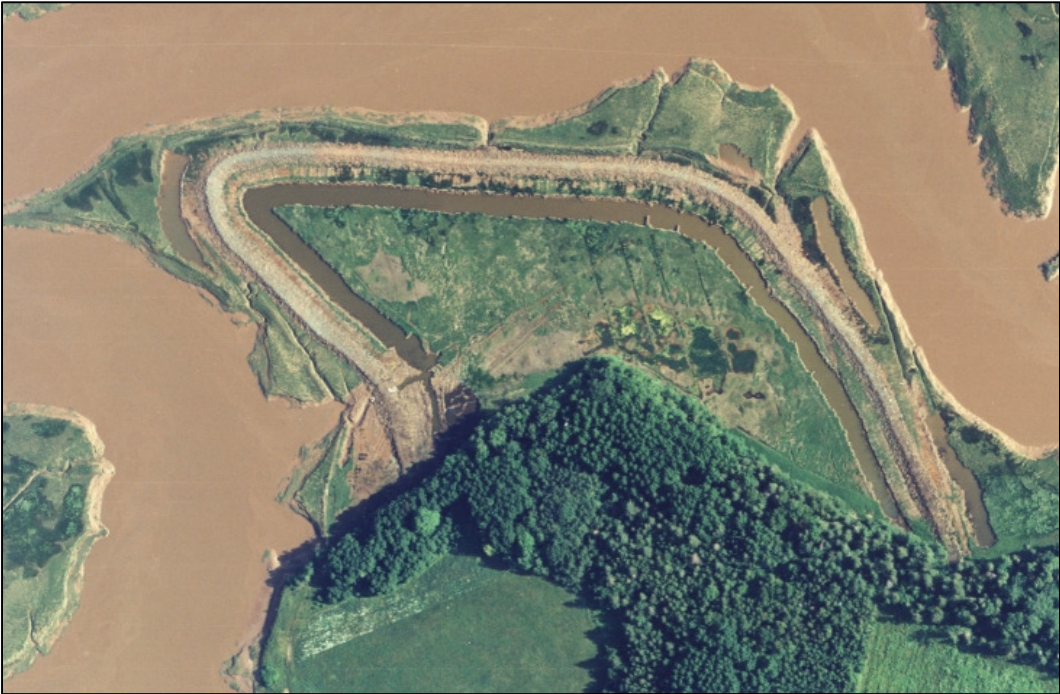
Figure 3 COG following the construction of the dyke and conversion to freshwater impoundment. 1992 aerial photograph.

The Cogmagun River restoration site (COG) is a 6.9 ha (69,000 m²; 17 acres) tidal wetland along the Cogmagun River in Hants County, NS. In 1991, DUC constructed a protective dyke and water control structure converting 4.8 ha of the site into a freshwater pond (impoundment) for waterfowl and wildlife (Figure 1 to Figure 3). The site was put forth as a potential salt marsh restoration/compensation project in 2009 through a partnership between NSTIR, DUC, Red Fox Farm, and CBWES.

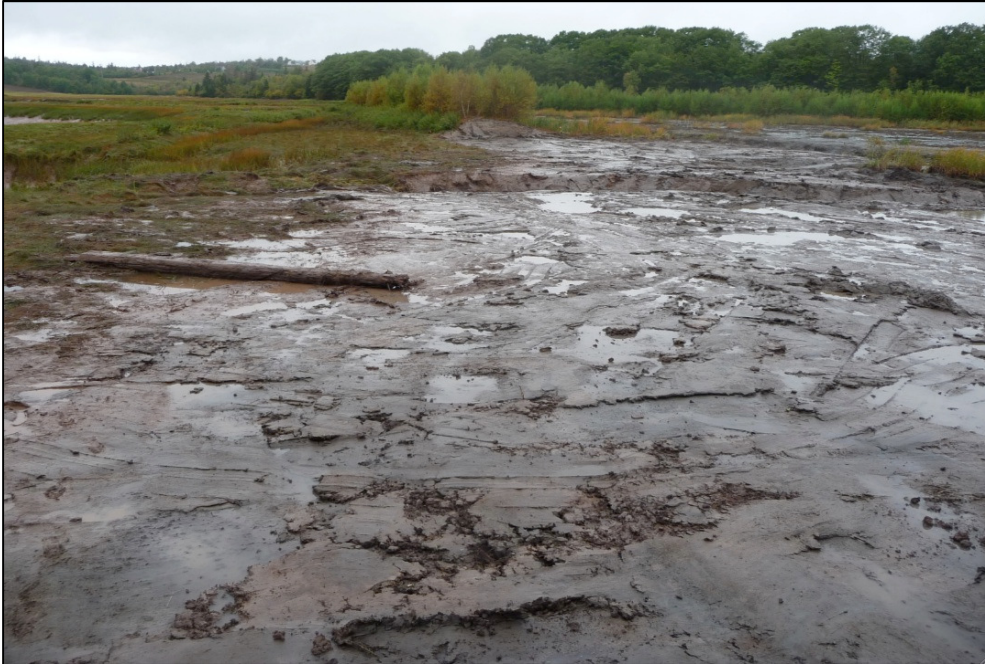
Figure 5 Completed breach (60 m) and tide channel. Photograph by T. Bowron, 24 September 2009.

Restoration took place on 22-23 September 2009 and consisted of the excavation of a 60 m breach along the downstream portion (western) of the dyke (Figure 4), the removal of the water control structure and the incorporation of the resulting hole into a tidal creek connecting the existing channel (borrow pit) within the site to the one in the fringe marsh (Figure 5 and Figure 6). Detailed information on the restoration design and construction phases of the project is provided in Bowron et al. (2010).

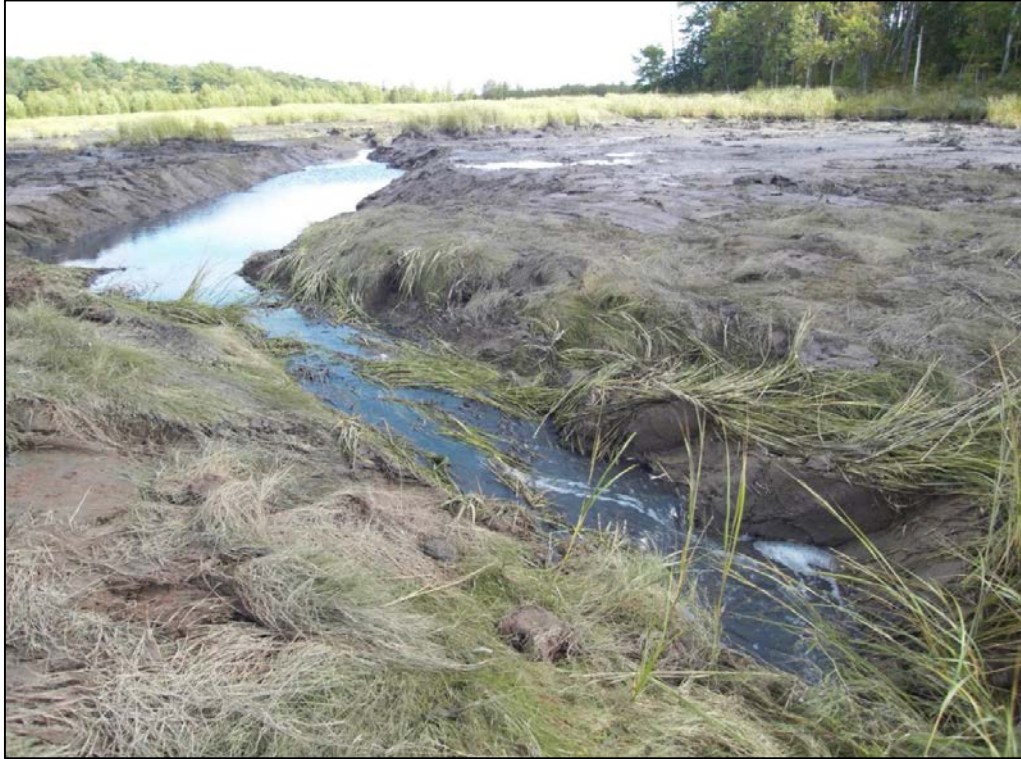
Figure 6 Tidal channel following completion of restoration work (looking from mouth of channel towards interior of the restoration site). Photograph by J. Graham, 23 September 2009.

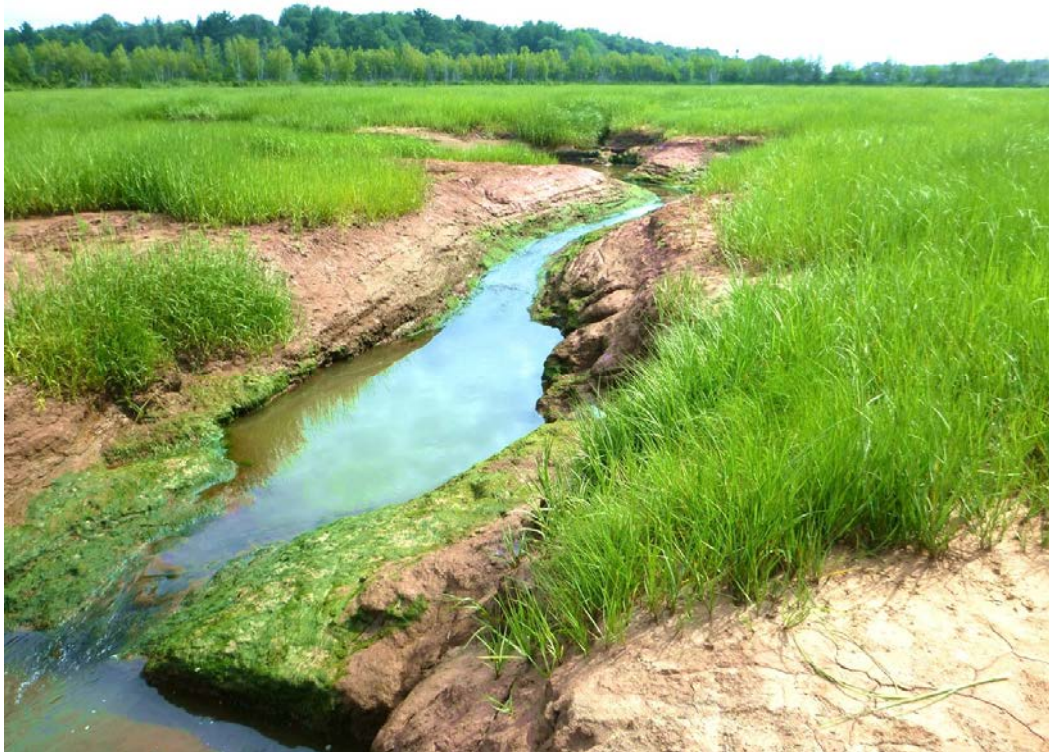
Figure 7 Tidal channel four years after restoration (mouth of channel looking towards interior of restoration site). Photograph by T. Bowron, 16 July 2013.

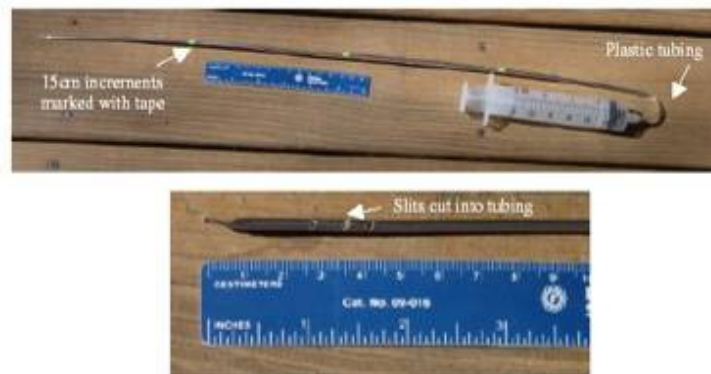
Figure 10 Photograph of a soil probe (sipper) used to take interstitial pore water samples to measure pore water salinity (Roman et al. 2001).

during the 2009 and 2010 monitoring years using a soil probe (sipper; Figure 10). The sipper was constructed according to the design specifications outlined in Roman et al. (2001). Samples were taken by sequentially inserting the sipper into the soil to the target depth and drawing out a water sample. Due to the high sediment concentration of water samples collected by the sipper, samples were bottled and returned to the lab and allowed time for the sediment to settle out before a refractometer (nearest 2 ppt) reading was taken. In order to ensure consistent and accurate readings, the sipper sampling method was replaced by a FieldScout EC 110 Meter⁸ in 2011. During the 2011 field season, data was collected using both methods for two consecutive sampling events (“double read”) in order to ensure consistency and minimize sampling error. Only the FieldScout was used during the 2013 field season. When using the FieldScout, measurements were taken *in situ*, and readings recorded in the field.

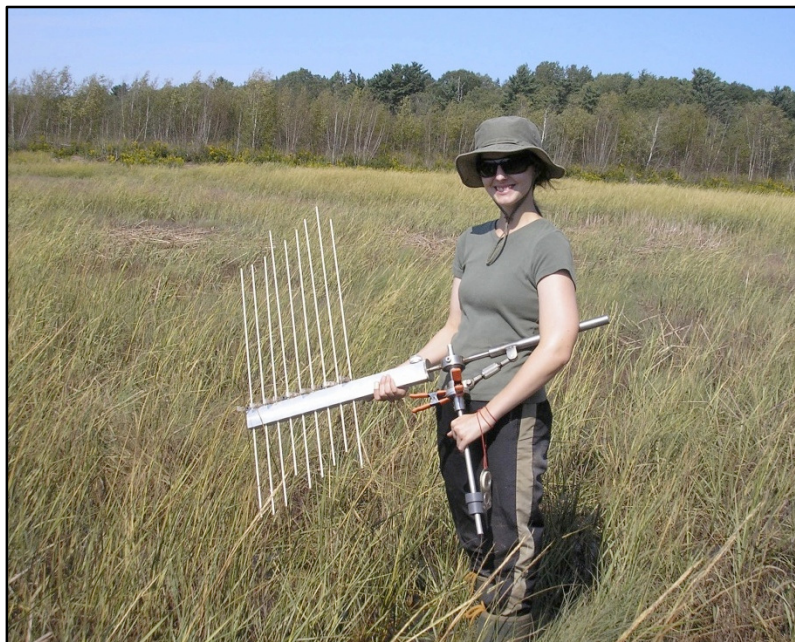
Figure 12 The nine measure pins of the RSET. Photograph by CBWES Inc.

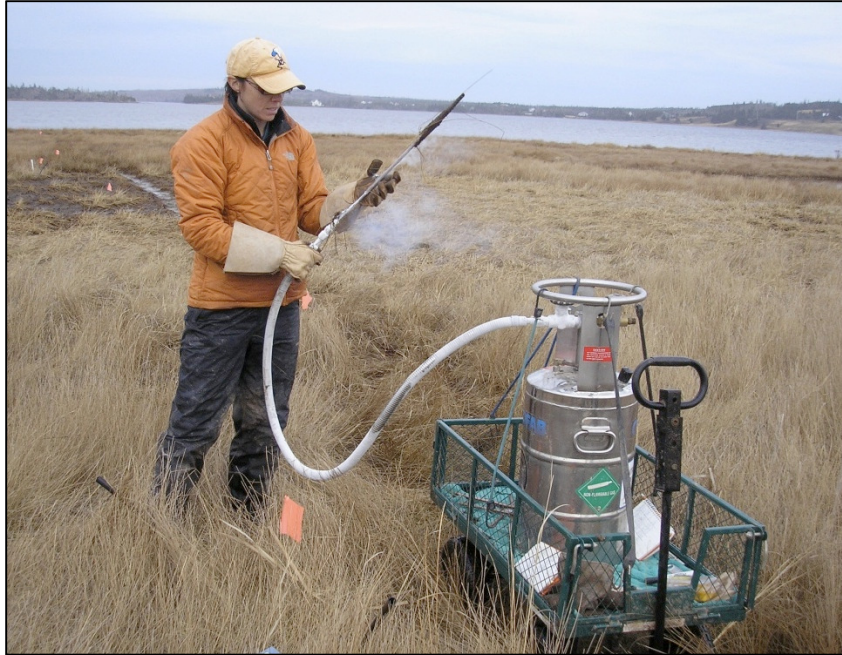
Figure 13 Marker horizon sampling with the cryogenic corer (with stainless steel tubing and copper “bullet”) at Lawrencetown Lake Reference Site. Photograph taken by B. Lemieux, December 2011.

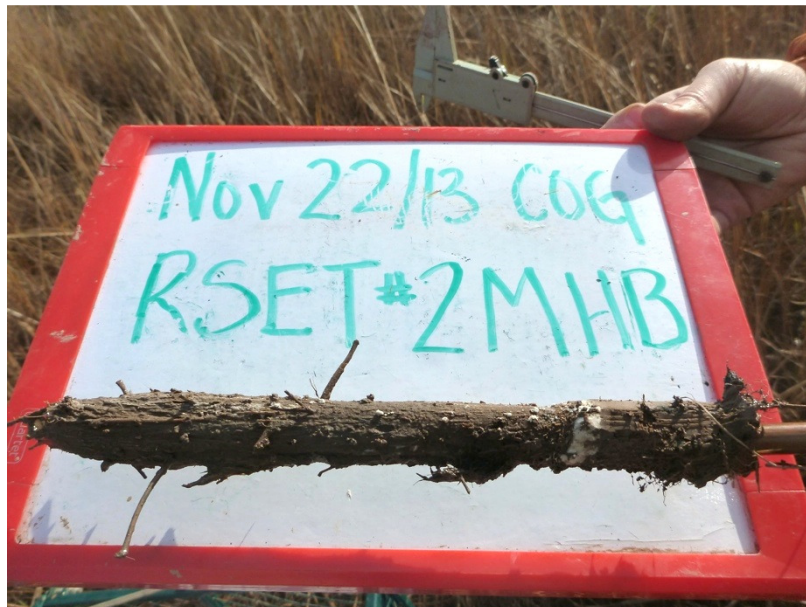
Figure 14 Core or "marsh-cicle" on bullet used for marker horizon calculations. The white band is the feldspar “horizon” and the top of core (marsh surface) is to the right. Photograph by CBWES Inc.

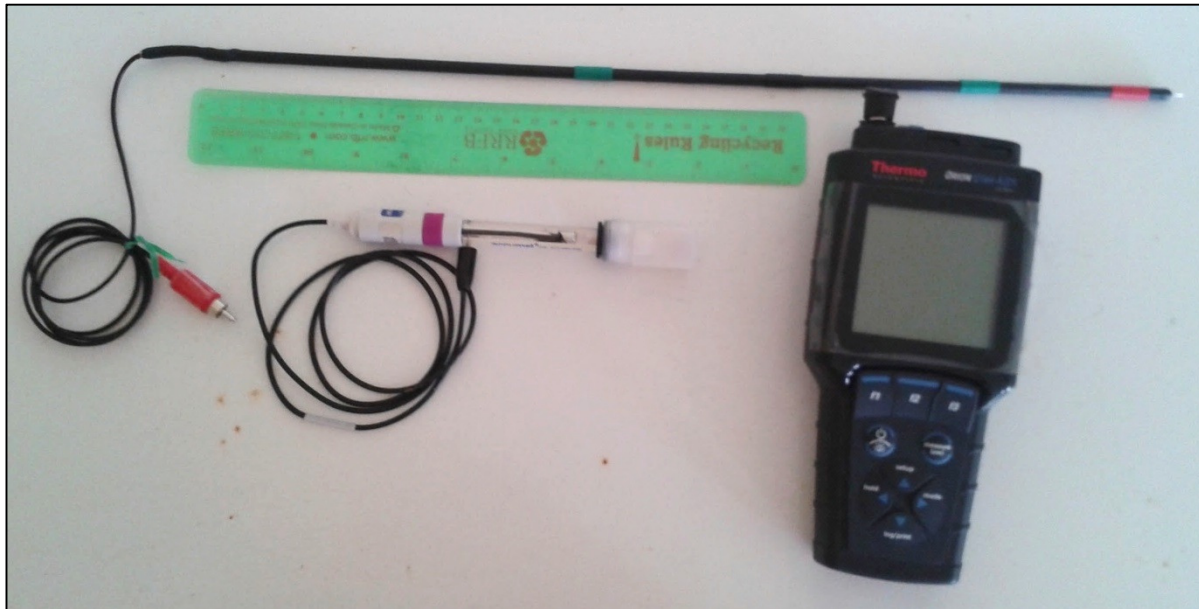
Figure 15 Constructed platinum electrodes (top), accumet calomel reference electrode (bottom) and Thermo Scientific Orion Star A221 Milivolt Meter (Photo: C. Skinner 2013).

Redox potential was measured at both sites on 23 August 2014 and 27 September 2014 using a series of platinum electrodes, an accumet calomel reference electrode and Thermo Scientific Orion Star A221 Milivolt Meter⁹ (Figure 15). Platinum electrodes (probes) were constructed based on the design by Vepraskas and Cox (2002). Probes were calibrated in a mixture of quinhydrone and pH 4.00 buffer before use in the field to ensure accurate readings. Sampling locations (6 per site) were matched with sediment sample locations (Figure 8; Figure 9). A shallow and a deep measurement were taken at each sampling location using two probes inserted into the marsh sediment 2 cm and 20 cm respectively. Probes were deployed 30 minutes before readings were taken to allow the probes to equilibrate. The reference electrode was inserted into the soil close to the probes at the time of measurement. Measurements from the two probes were taken by individually connecting the probe to the Meter and waiting for the Meter to stabilize (max five minutes). Redox potential was determined by adding +244 mV to each field measurement to account for the potential of the reference electrode.

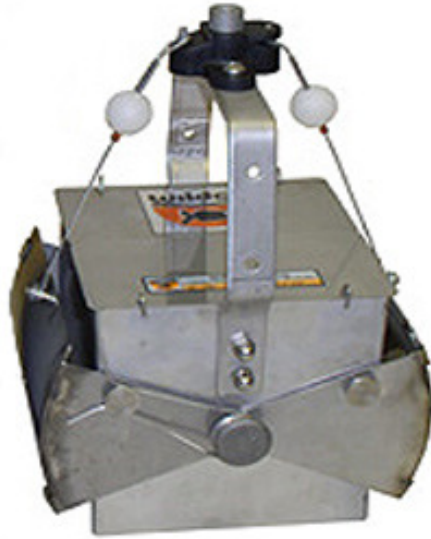
Figure 16 Ekman Dredge.

Benthic invertebrate samples were taken on 11 September 2013 using a standard 6" x 6" Ekman Dredge (15 cm x 15 cm; 0.023 m² sediment sample) (Figure 16). Samples were analyzed for biological species composition and abundance. Four samples from the main channel, pannes, creeks and ditches were taken at each site (Figure 8; Figure 9). Each sample was individually bagged, labeled and placed in a cooler containing ice for transport to the laboratory facilities at EnviroSphere Consultants Ltd. in Windsor, NS where the samples were sorted and analyzed for species composition and abundance.

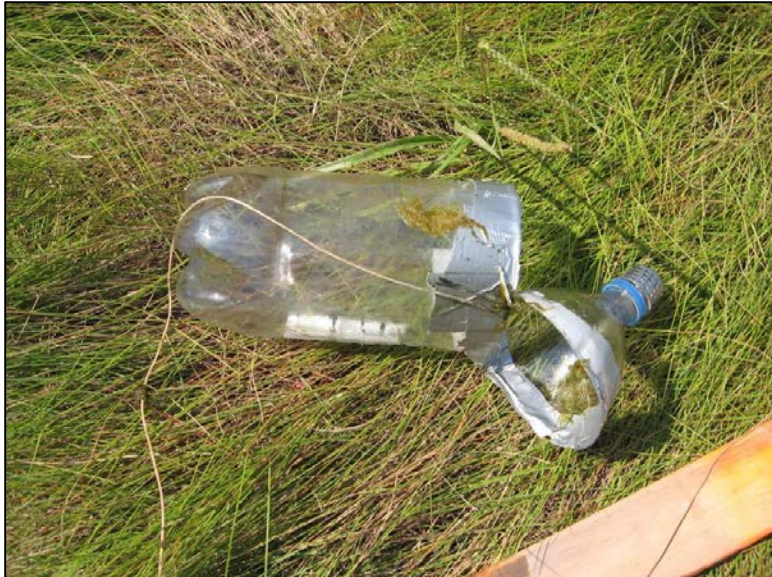
Figure 17 Disassembled Invertebrate Activity Trap. Photograph by T. Bowron 2007.

Aquatic invertebrates within the water column of select pannes within and outside (fringe marsh) COG were sampled using Aquatic Invertebrate Activity Traps (IAT) (Figure 17). IAT were submerged and anchored within the water column of the panne being sampled and allowed to passively sample over a single tide cycle (approximately 24 hour period). Four samples were taken on 16 July and 22 August 2013. Traps were set on the dates indicated and then retrieved the following day. No samples were taken at COG-R due to a lack of suitable habitat conditions (no pannes or standing water). Samples were emptied into a 0.5 mm sieve and all captured materials and organisms field-preserved in 70% isopropyl alcohol for transport to the lab for processing.

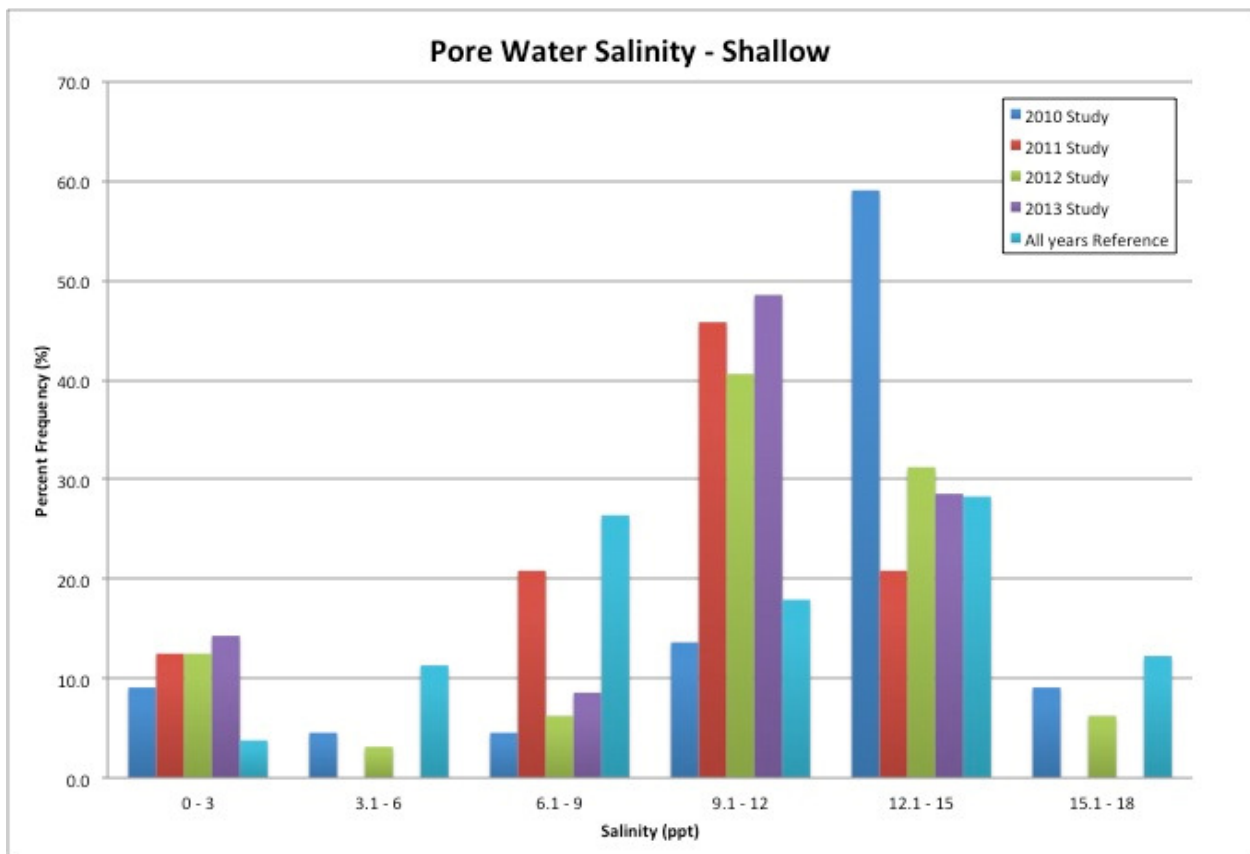
Figure 22 Frequency of pore water salinity values for shallow (15 cm) samples at COG and COG-R.

At the restoration site, both shallow and deep salinity readings showed a shift in salinity distributions following restoration. Pre-restoration salinities were lower than those observed at the reference site, with the higher salinity classes missing from the distribution (Figure 22; Figure 23). The year following restoration (2010), pore water salinity levels were higher than pre or reference condition, and had more readings occurring in the higher salinity classes than in subsequent years. This was likely reflective of the hypersaline conditions at the site due to the lack of vegetative cover (e.g., exposed marsh surface/mudflat) and the high influx of new estuarine sediments (see Sediment Accretion and Elevation). The post-restoration Year 2 (2011) and Year 3 (2012) salinity level distribution at COG more closely matched that of the reference condition. By Year 4 (2013), no significant difference was detected between salinity levels at the two sites.

The similarity in salinity levels between the two sites (no statistically significant differences) since the second year post-restoration (2011) and the similar spatial and temporal trends, would suggest that conditions at the restoration site are stabilizing and reaching parity with the reference condition.

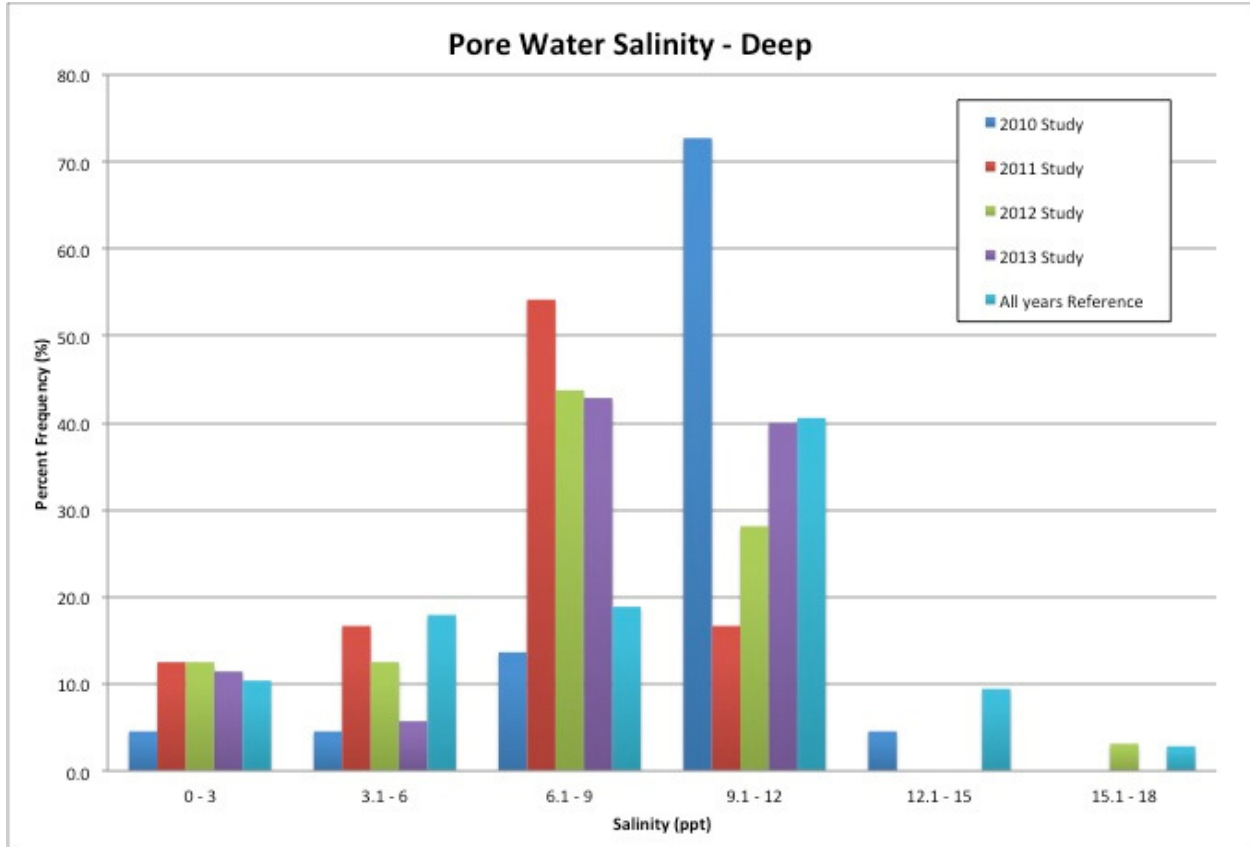
Figure 23 Frequency of pore water salinity values for deep (45 cm) samples at COG and COG-R.

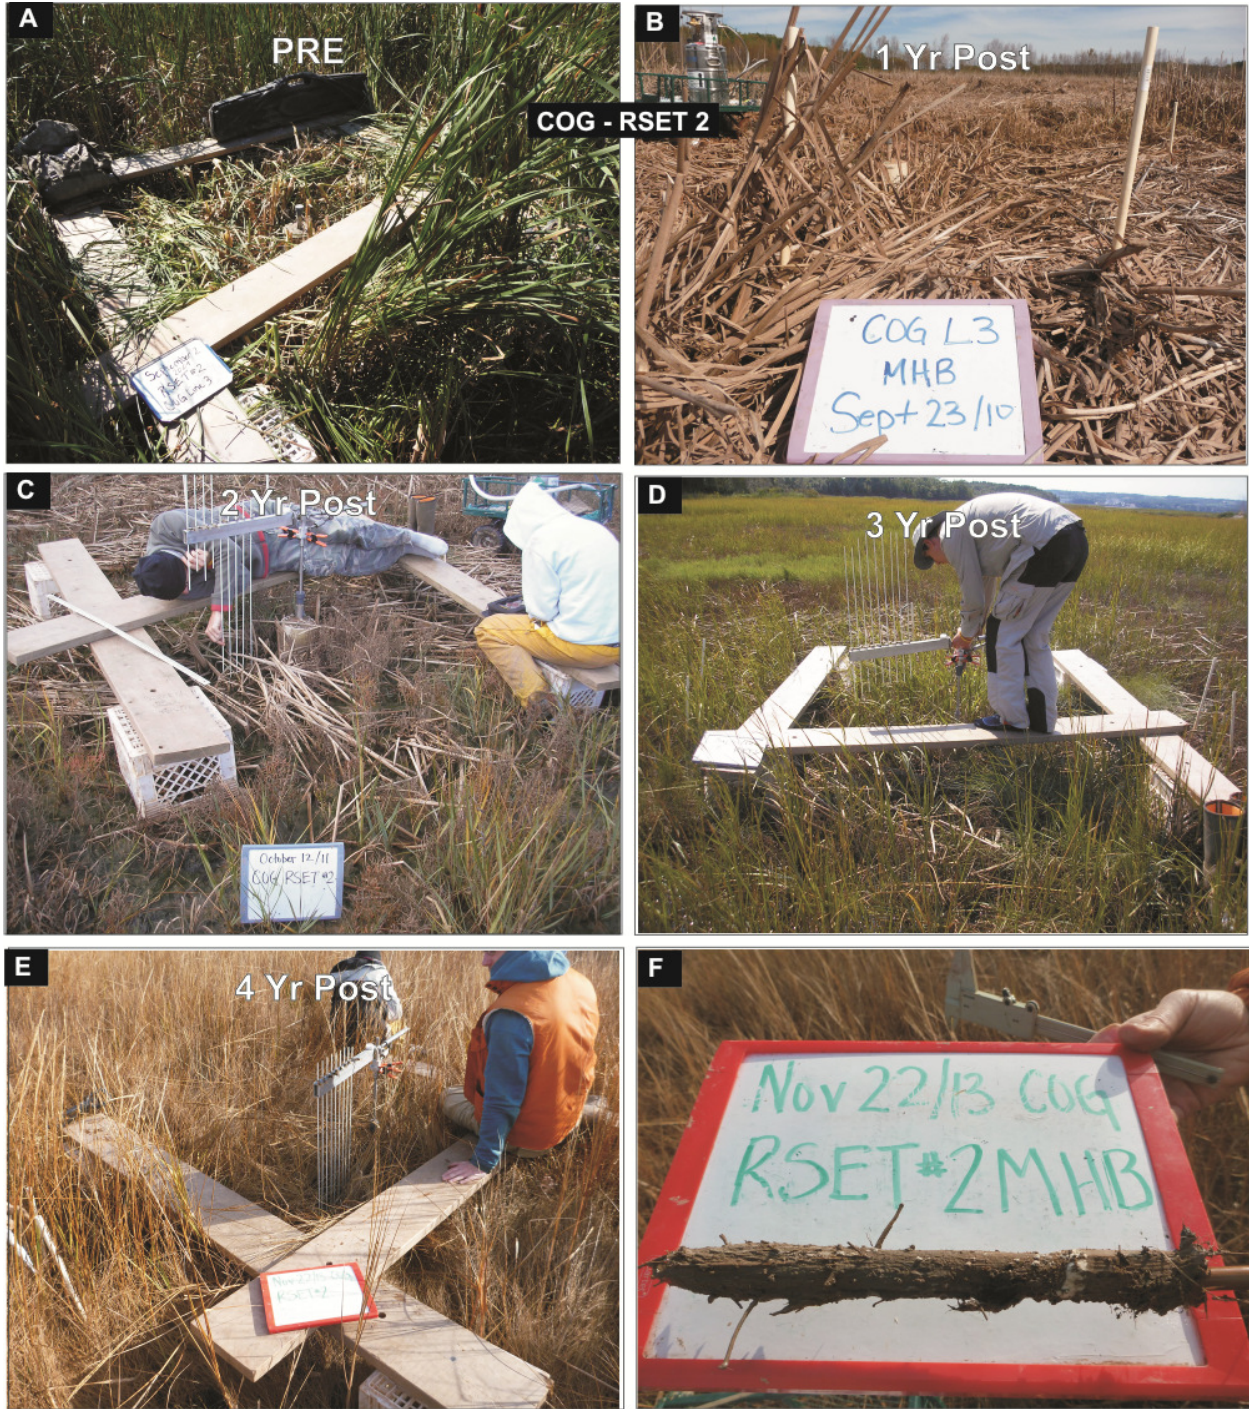
Figure 25 RSET-02 at COG a) Pre (19 August 2009), b) Year 1 Post (23 September 2010), c) Year 2 Post (12 October 2011), d) Year 3 post (20 August 2012) and e) Year 4 post (22 November 2013). Photo (f) shows an example of a marker horizon core. Photographs taken by CBWES Inc..

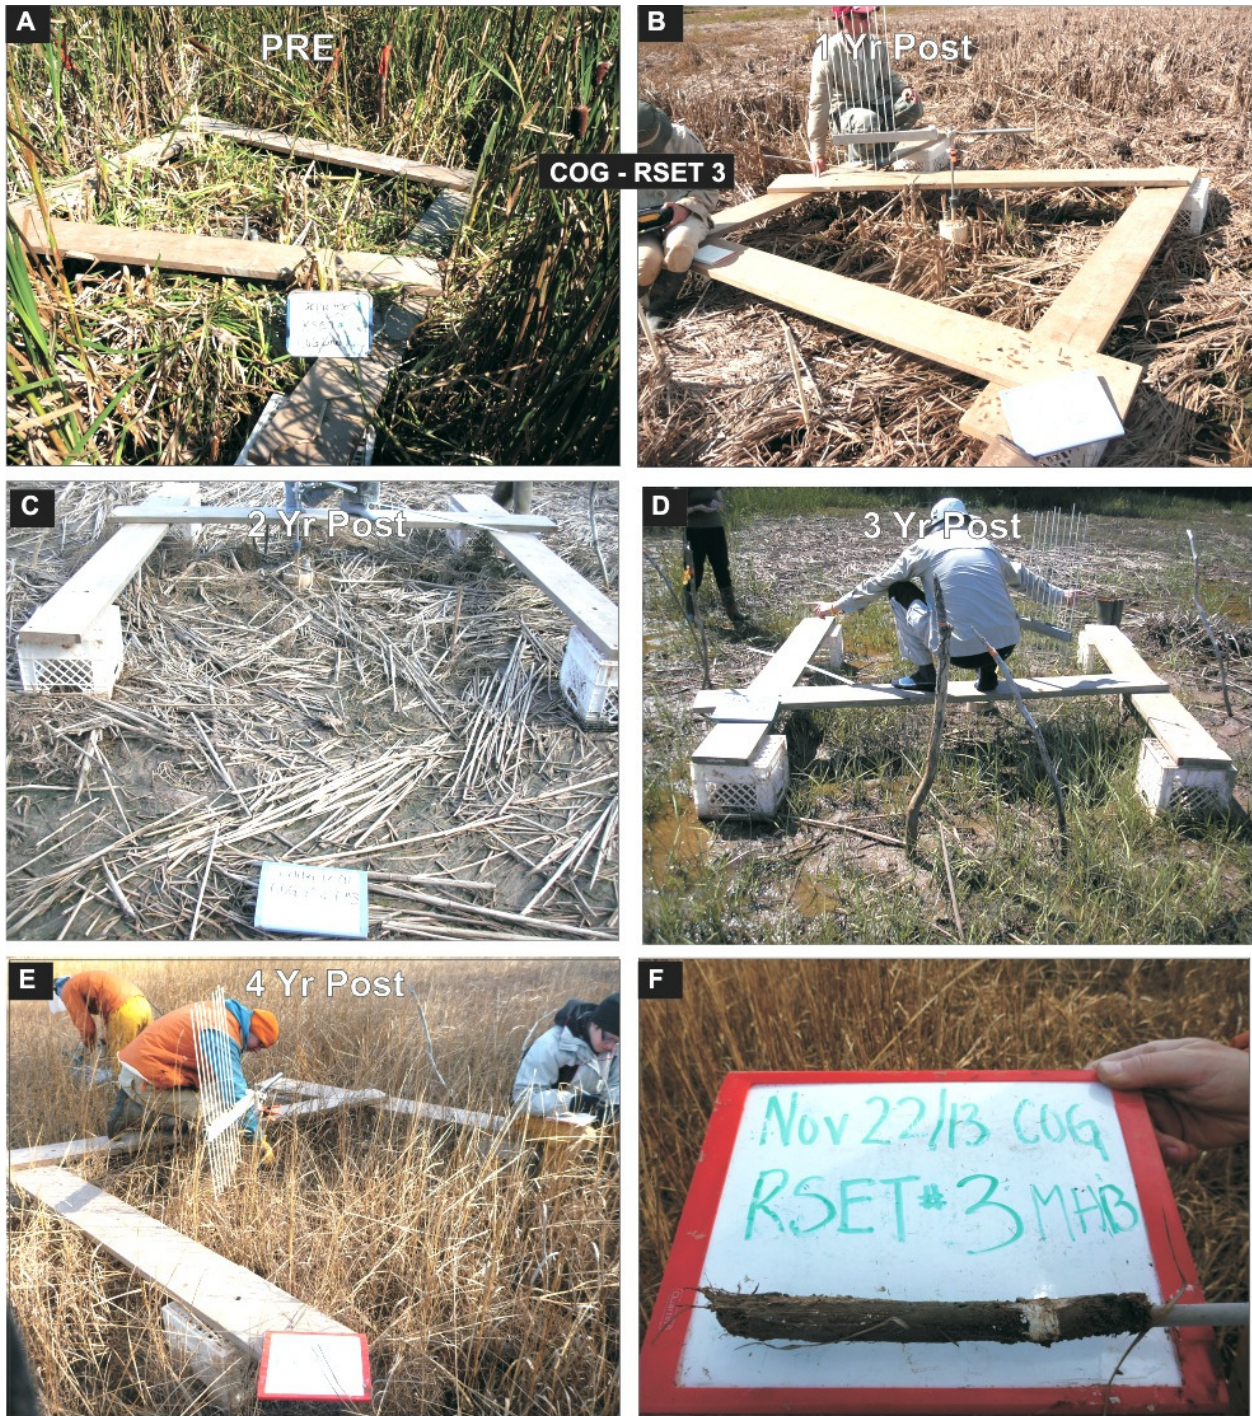
Figure 26 RSET-03 at COG a) Pre (19 August 2009), b) Year 1 Post (23 September 2010), c) Year 2 Post (12 October 2011), d) Year 3 post (20 August 2012) and e) Yr 4 post (Nov 22, 2013). Photo (f) shows an example of a marker horizon core. Photographs taken by CBWES Inc..

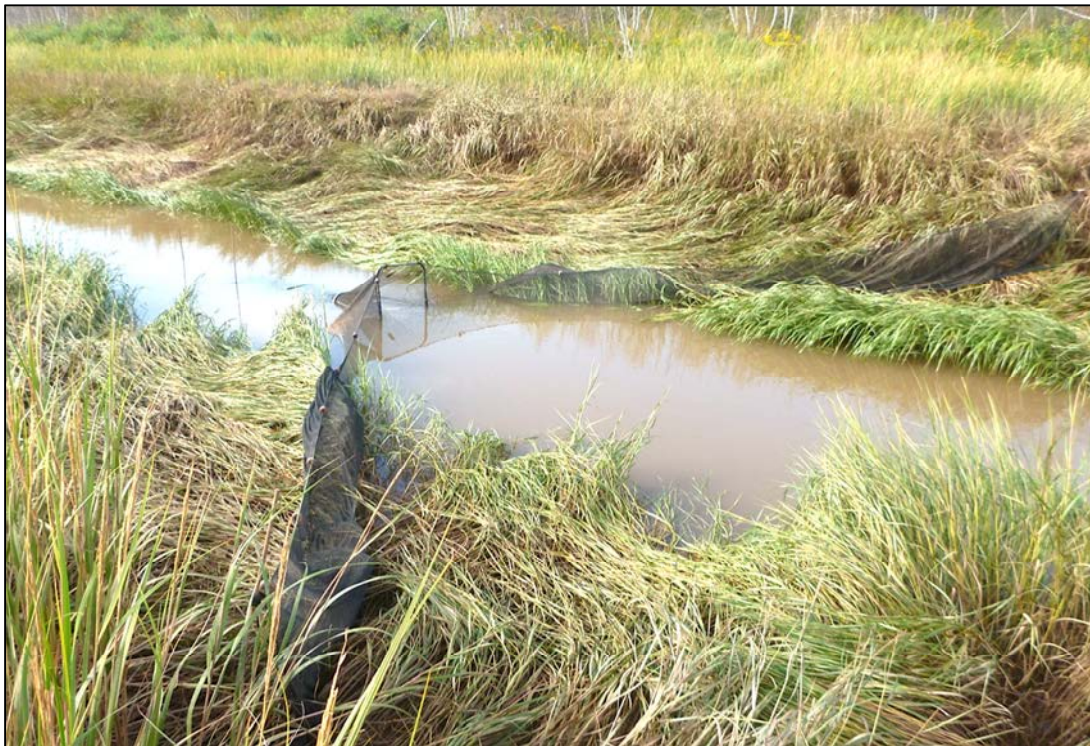
Figure 37 Fyke net set within the borrow pit at COG. Photograph by T. Bowron, 27 September 2013.

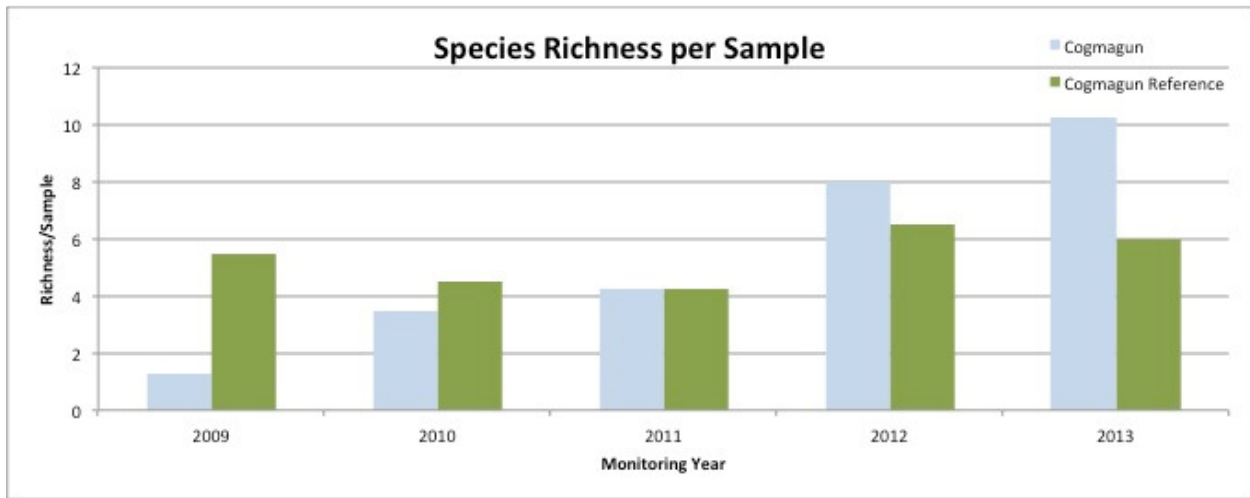
Figure 38 Benthic invertebrate species richness for all years at COG and COG-R.

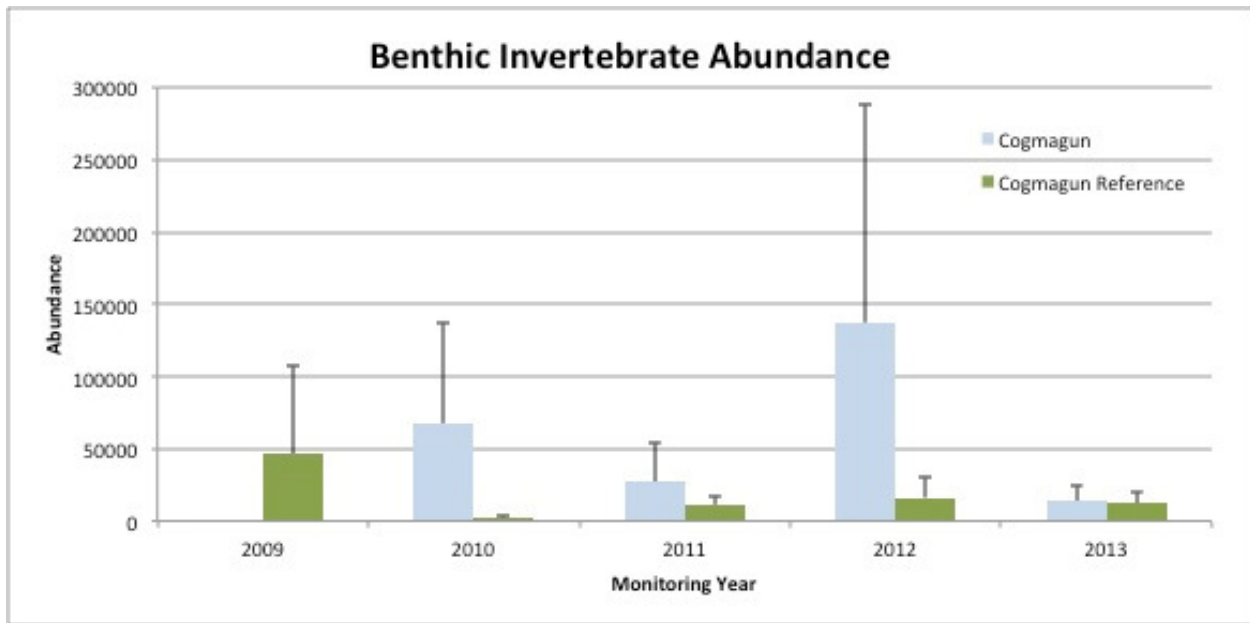
Figure 39 Benthic invertebrate species abundance for all years at COG and COG-R.

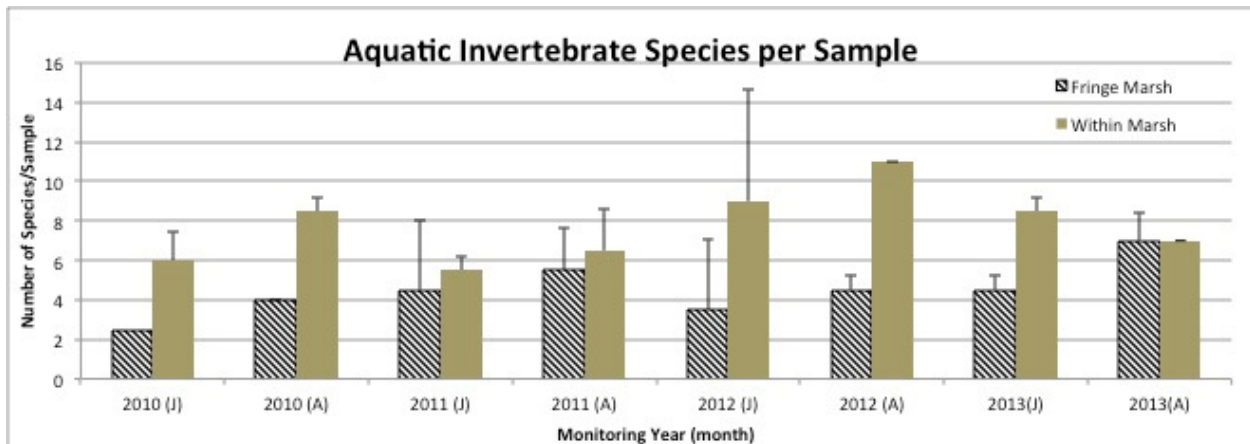
Figure 40 Aquatic invertebrate diversity for all years for samples from the fringe and within the restoration site.

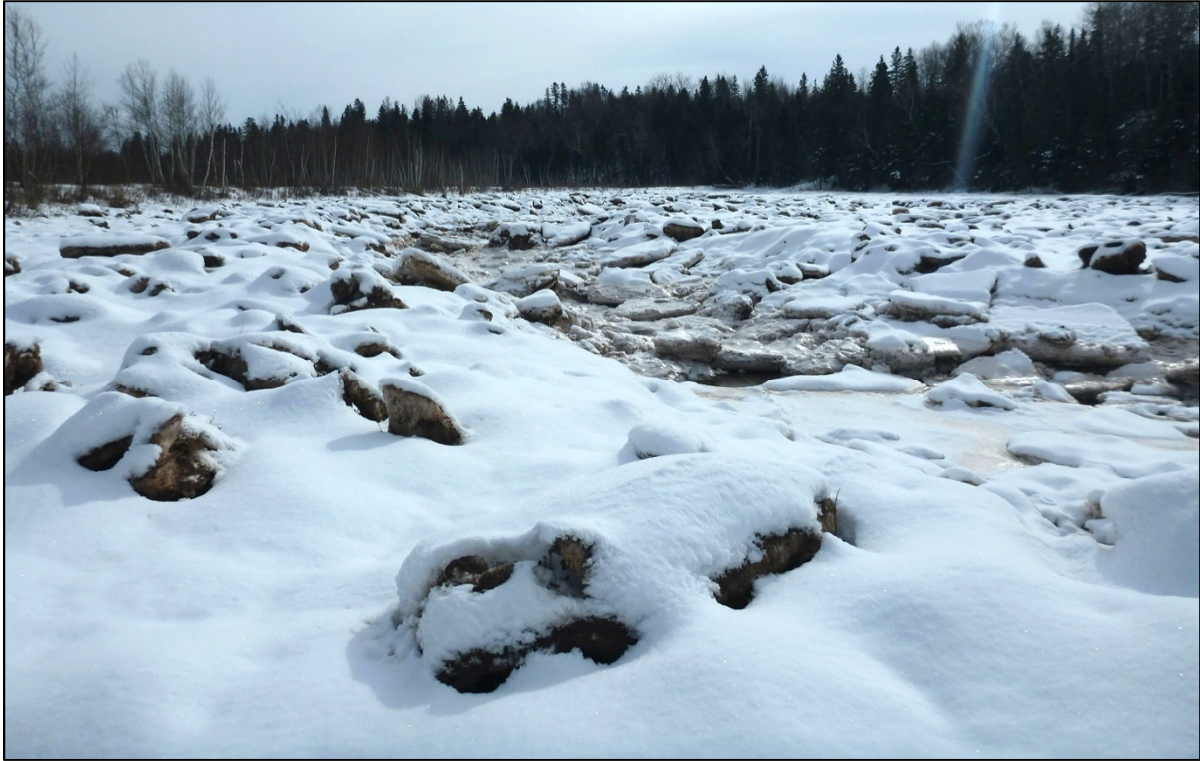
Figure 42 Sea ice on the marsh surface at COG. Photograph by T. Bowron 21 February 2014.

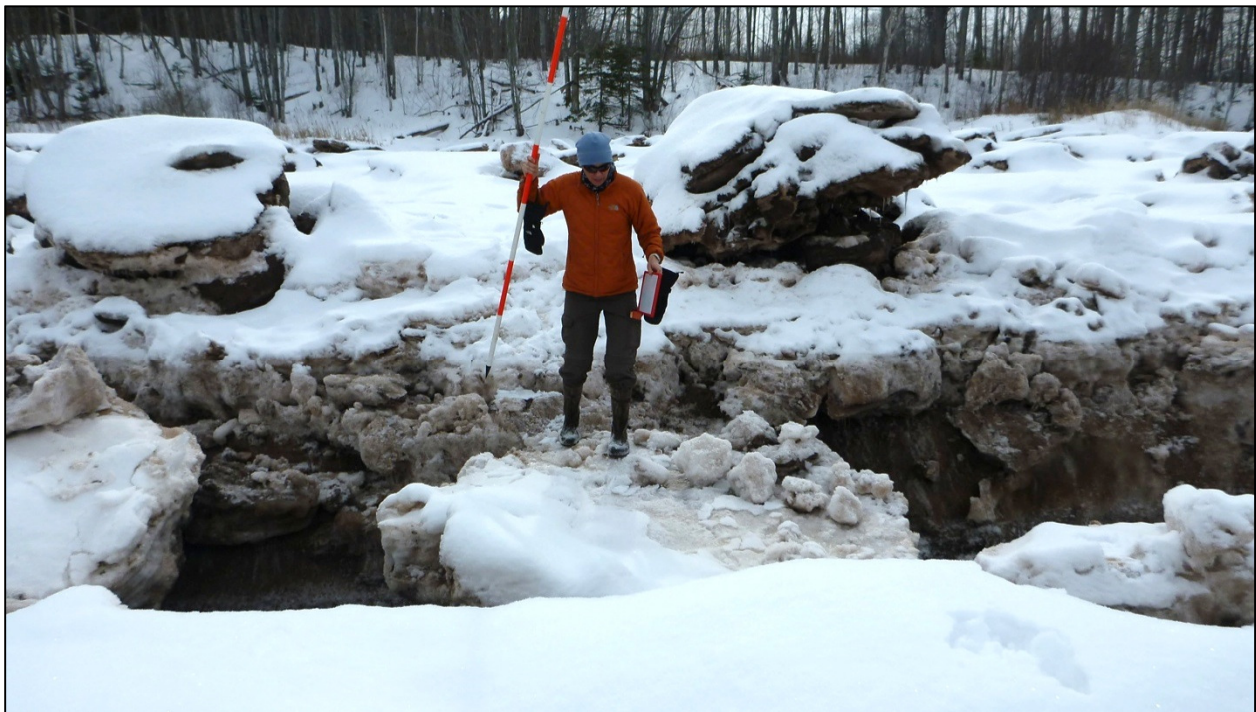
Figure 43 Sediment rich ice blocks in the borrow pit channel and marsh surface at COG. Photograph by T. Bowron 21 February 2014.

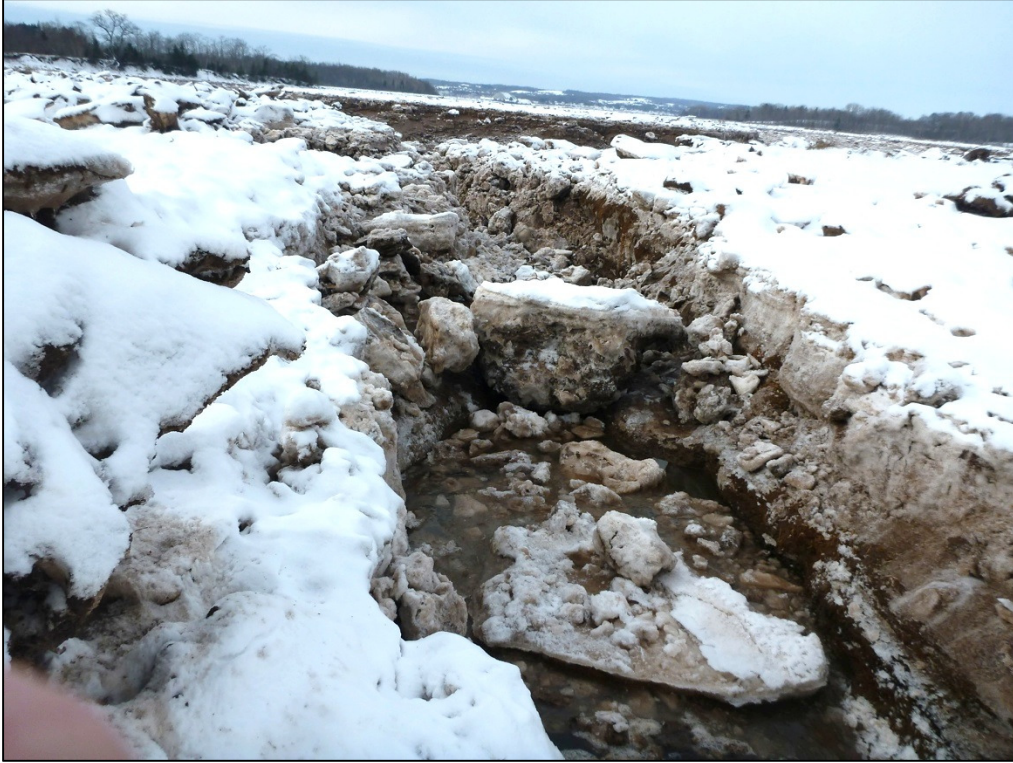
Figure 44 Fast and sea ice within the constructed tidal channel. Photograph by T. Bowron 21 February 2014.

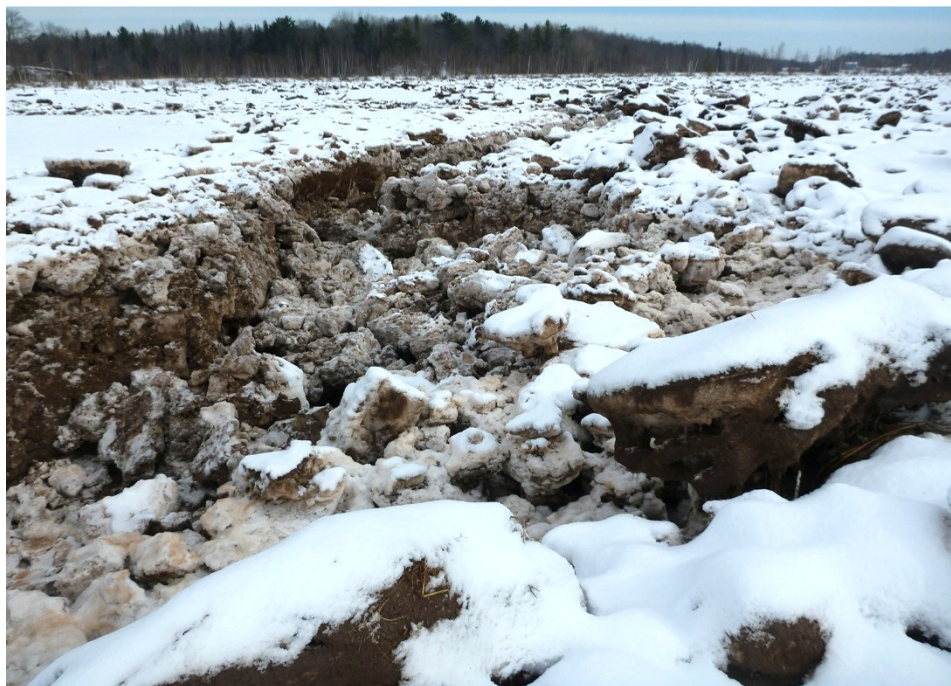
Figure 4 Channel and dyke breach. Photograph from the fringe marsh near the mouth of the channel looking towards restoration site.

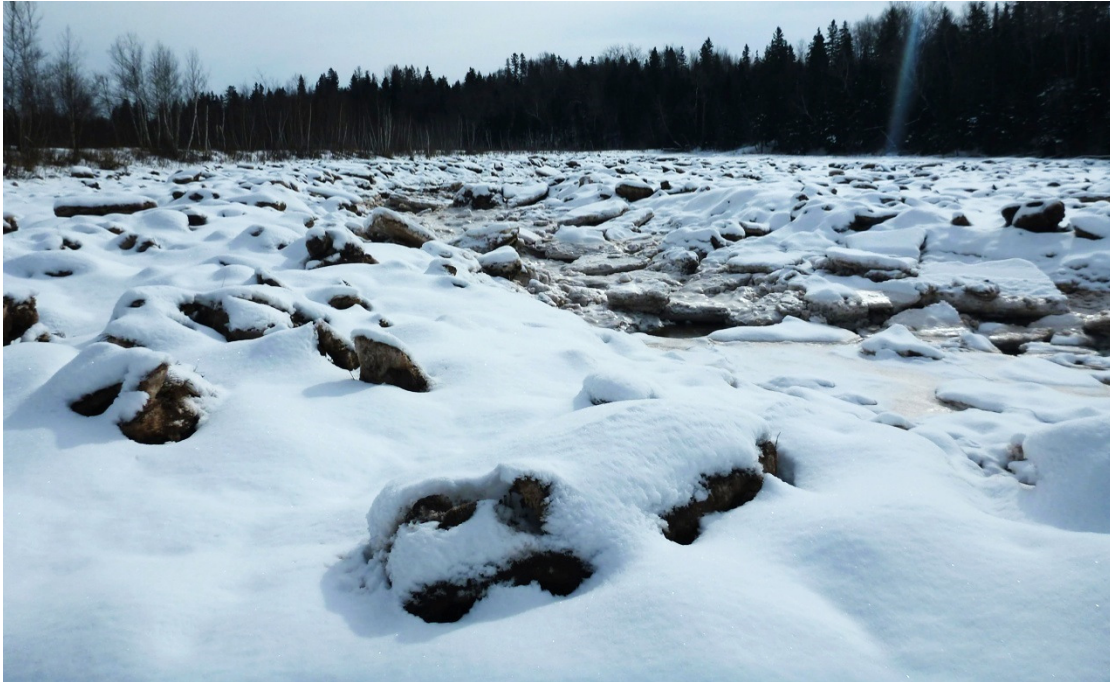
Figure 5 Borrow pit near transect five. Photograph from the corner of the borrow pit looking towards the upland.
