A Report for:  
Nova Scotia Department of  
Transportation and Infrastructure Renewal

## Pre-Restoration Monitoring (Baseline) of the Morris Island Salt Marsh Restoration Project

March 2014  
Publication No. 40

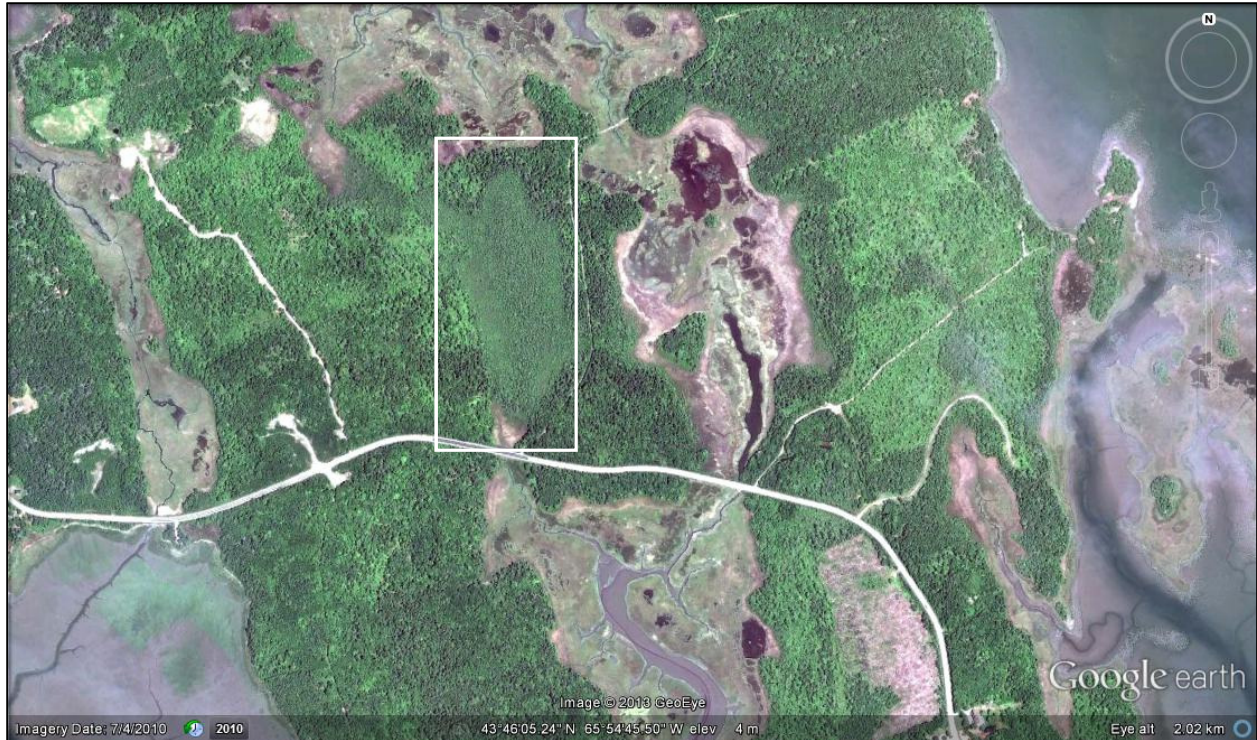
**Figure 3 Google Earth image showing adjacent habitat to the Morris Island Restoration Site (white box) including downstream salt marsh and channels.**

The Morris Island Restoration Site (hereafter referred to as “MI”) is a coastal wetland complex (tidal, brackish, treed swamp, bog) approximately 8 ha (19.8 acre; 8,000 m<sup>2</sup>) in size on Morris Island, Yarmouth County, Nova Scotia (NS) (Figure 1 to Figure 3). The site was historically part of the broader Tusket River Estuary, but its’ hydrological connection was significantly reduced by the construction of a causeway-culvert structure across the lower portion of the site. This structure altered the natural hydrological regime of the site causing a reduction in area of tidally influenced wetland within the site. The subsequent failure (collapse) of the culvert further reduced tidal influence and led to an almost complete loss of tidal wetland conditions.

The elevation of the current road surface (causeway) is 3.9 to 4.0 m. The dirt road adjacent to the site ranges in elevation from 3.0 m (near the front of the site) to 4.0 m (back). Elevations at the back end (upstream end) of the site were approximately 2.1 m, while elevations of the tidal wetland beyond the site (north) were between 1.8 and 1.9 m. A natural berm (~3.5 to 4.0 m) separates the back portion of the restoration site from the tidal wetland to the north (Figure 3).

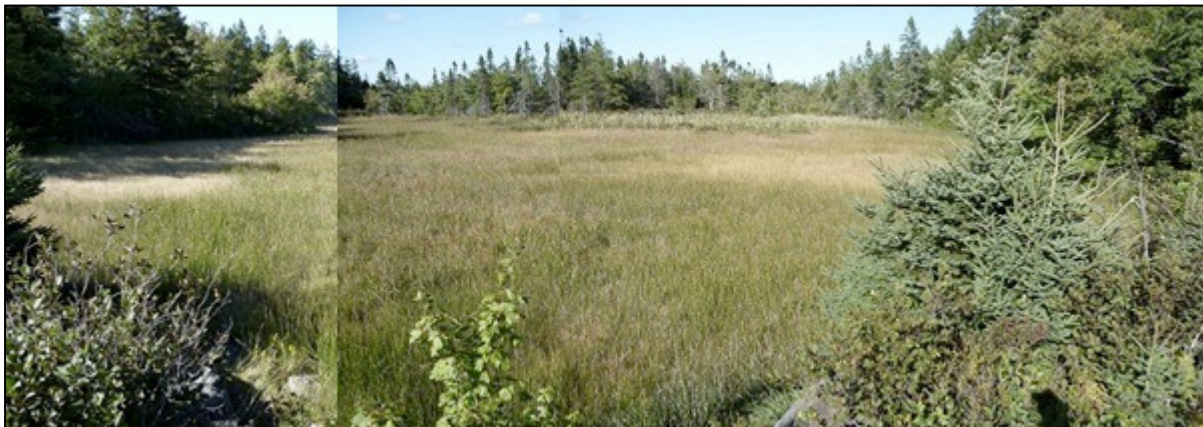
**Figure 4 Morris Island Restoration Site from the road (16 September 2012).**

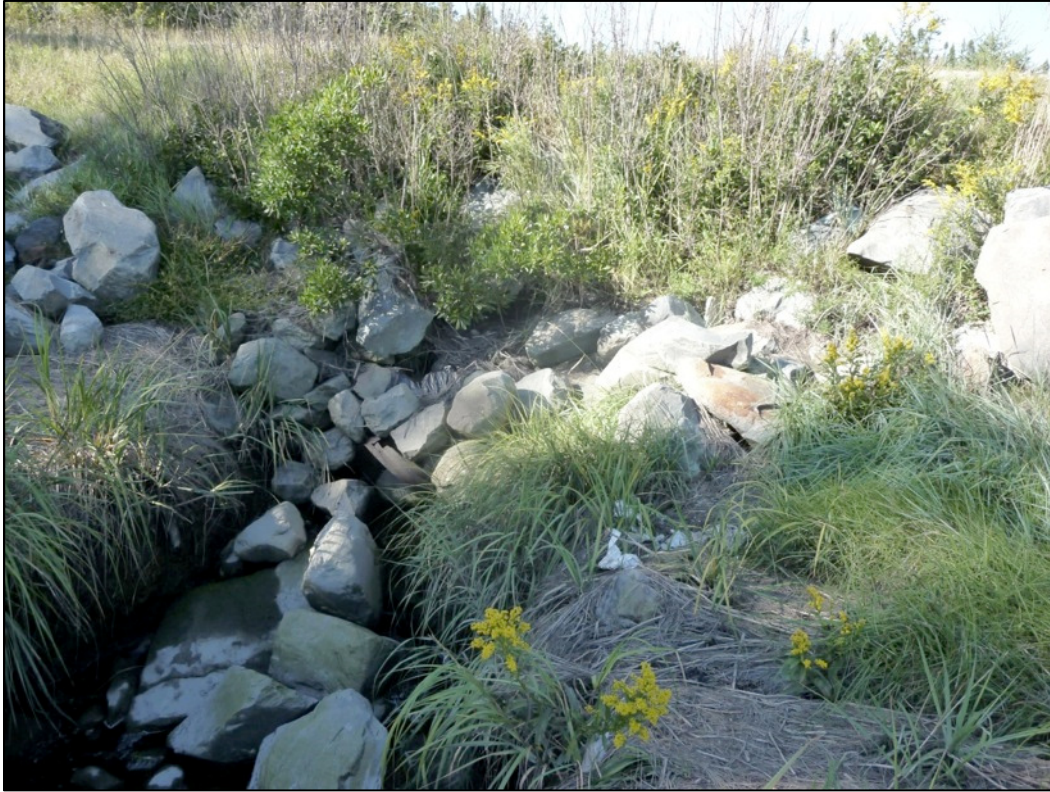
**Figure 6 Downstream end of culvert (16 September 2012).**

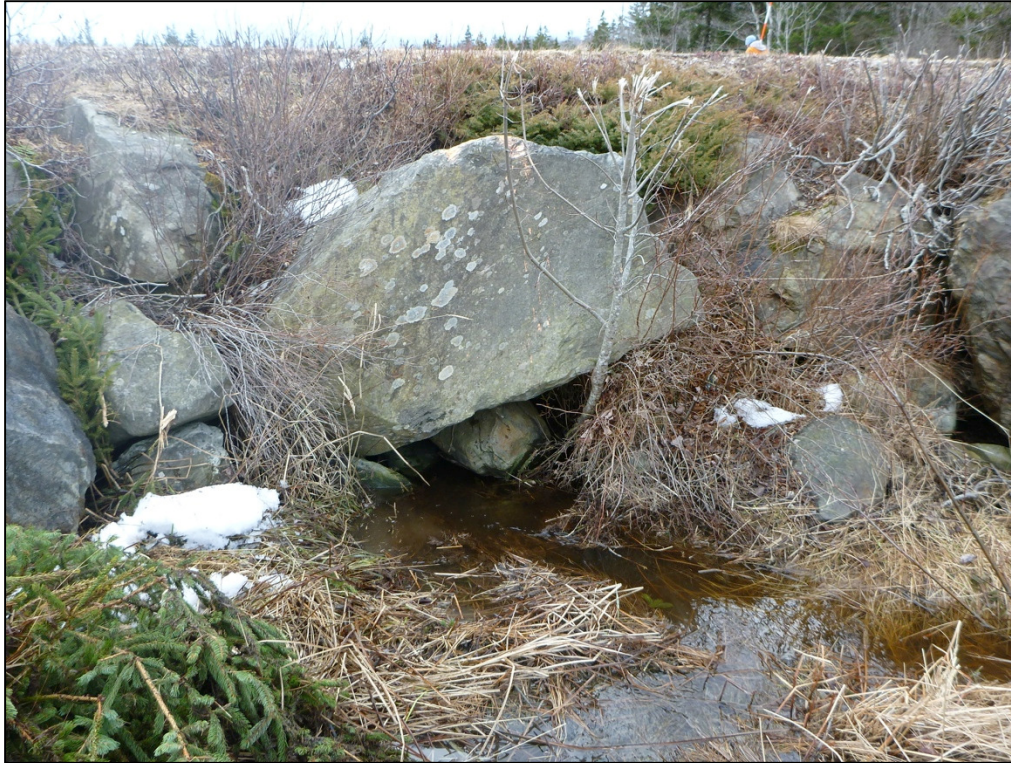
**Figure 7 Culvert upstream: partial blockage by armour stone (24 February 2014).**

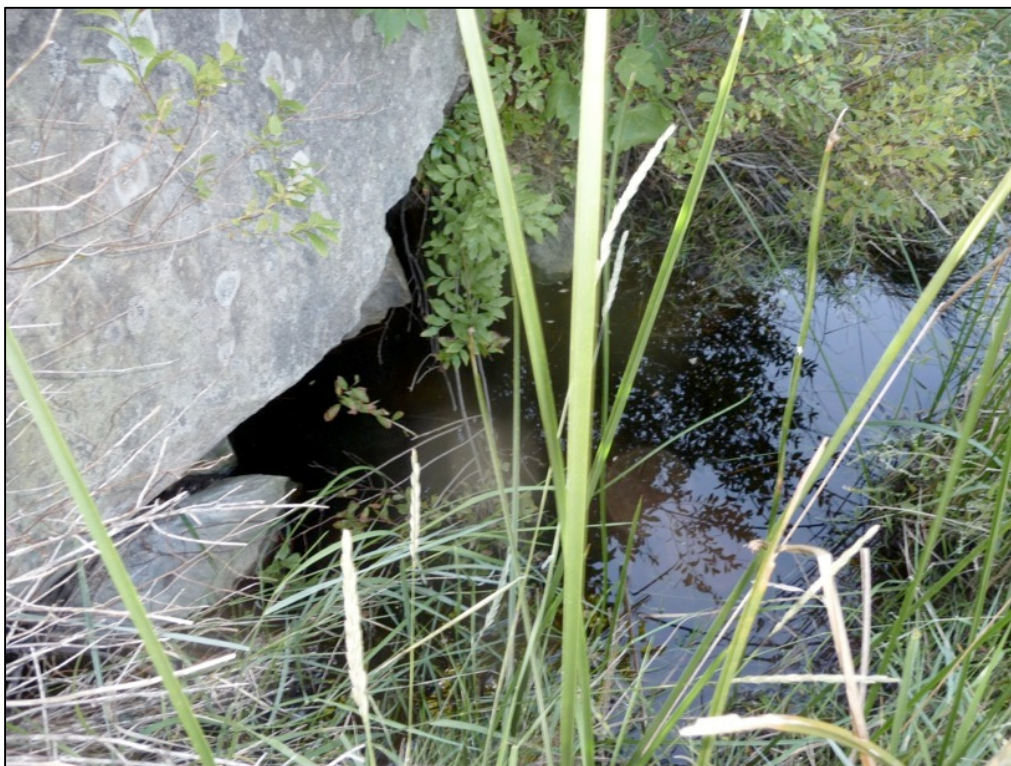
Route 308 crosses the tidal wetland habitat as a two-lane, rock-filled causeway-culvert structure (Figure 9). The existing culvert is an aluminum structure that is approximately 16.15 m long, with inverts sitting at 1.521 m CGVD28 upstream and 1.836 m downstream (Figure 6 to Figure 8). This culvert has been in decline (collapse, slumping), although some tidal influence still occurs on the higher high tide events enabling the persistence of several halophytes and brackish species immediately upstream of the culvert (e.g. *Spartina patens* (Salt meadow cord grass), *Limonium nashii* (Sea lavender), *Juncus gerardii* (Black grass), *Scirpus americanus* (Three-square bulrush), spike rushes, *Juncus balticus* (Baltic Rush), *Elymus* sp. and *Typha* sp.) (Figure 4). Much of the restoration site is dominated by bog vegetation (*Vaccinium* (Cranberry), *Chamaedaphne calyculata* (Leatherleaf), *Sarracenia purpurea* (Pitcher-plant) and sedges), which transitions to mixed scrub-shrub and bog habitat. During heavy rainfall events the site is unable to drain water efficiently, causing considerable ponding upstream. Subsequently the soils upstream are waterlogged and could be classified as organogenic, or derived from organic substances. The channel directly upstream of the culvert is undefined (Figure 8).

**Figure 8 Culvert upstream and the undefined channel (16 September 2012).**

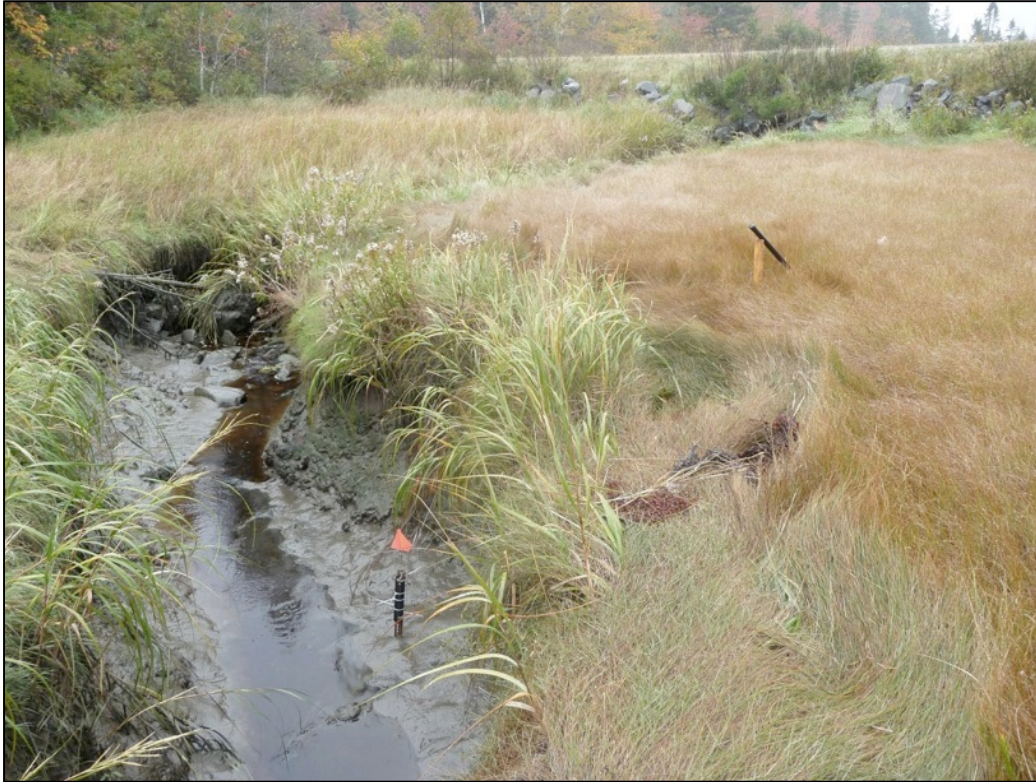
**Figure 9** Downstream location of Levellogger showing causeway (Route 308) crossing (12 October 2012).

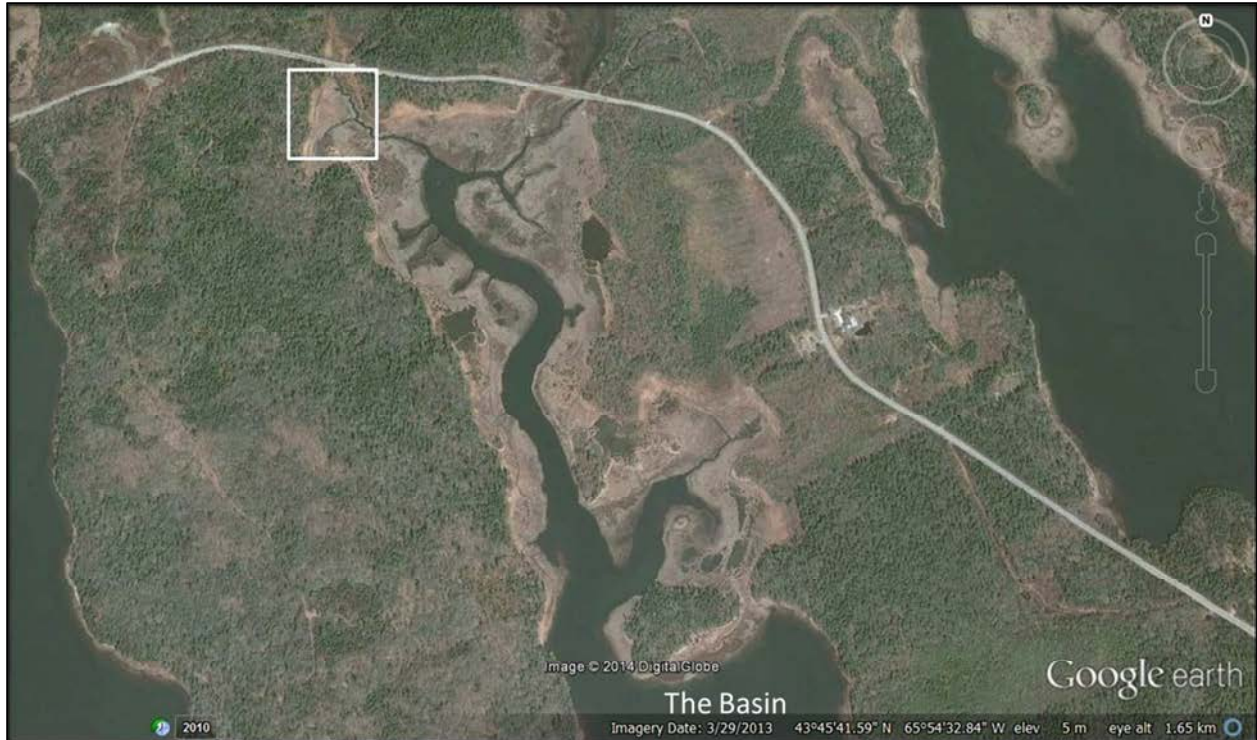
**Figure 10 Google Earth image showing downstream habitat to the Morris Island Reference Site (white box).**

The reference site (MIR) for the monitoring program is located immediately downstream of MI, on the opposite side of the Route 308 causeway (Figure 10 and Figure 11). The area of downstream marsh used as the reference site is similar in spatial extent (1.9 ha) as the restoration site. The causeway, and therefore upper boundary of MIR, is approximately one kilometer from the head of the marsh channel where it meets “The Basin” (Figure 10). MIR exhibits the typical salt marsh habitat zonation pattern, well developed tidal creek, a minimal panne system, and host of plant species common to tidal wetlands along the Atlantic coast.

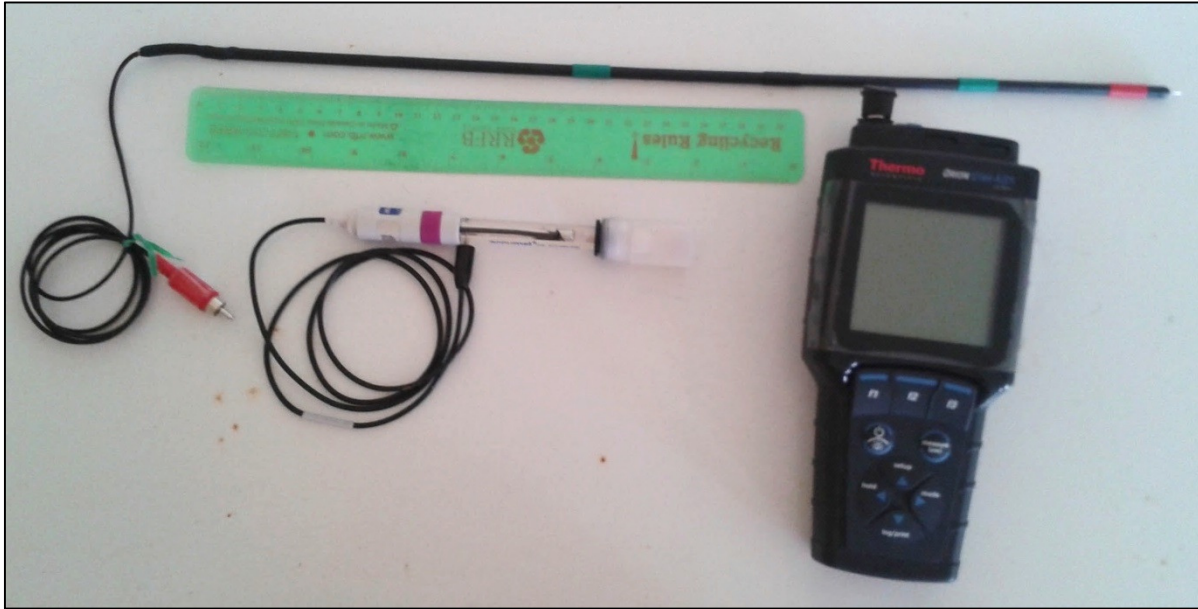
Redox potential was measured at both sites on 29 August 2014 using a series of platinum electrodes, an accument calomel reference electrode and Thermo Scientific Orion Star A221 Milivolt Meter<sup>7</sup> (Figure 14). Platinum electrodes (probes) were constructed based on the design by Vepraskas and Cox (2002). Probes were calibrated in a mixture of quinhydrone and pH 4.00 buffer before use in the field to ensure accurate readings. Sampling locations (six per site) were matched with sediment sample locations (Figure 12). A shallow and a deep measurement were taken at each sampling location using two probes inserted into the marsh sediment 2 cm and 20 cm respectively. Probes were deployed 30 minutes before readings were taken to allow the probes to equilibrate. The reference electrode was inserted into the soil close to the probes at the time of measurement. Measurements from the two probes were taken by individually connecting the probe to the Meter and waiting for the Meter to stabilize (max five minutes). Redox potential was determined by adding +244 mV to each field measurement to account for the potential of the reference electrode.

**Figure 14** Constructed platinum electrodes (top), accumet calomel reference electrode (bottom) and Thermo Scientific Orion Star A221 Milivolt Meter. Photograph by C. Skinner 2013).

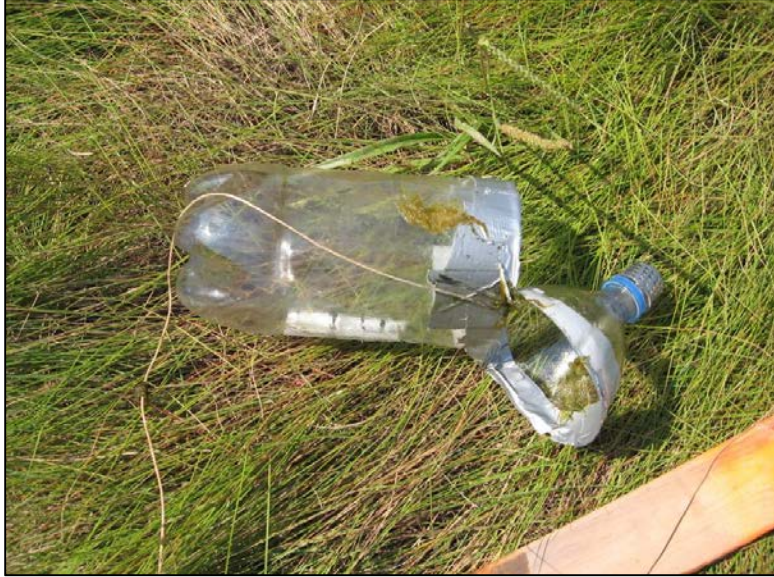
Aquatic invertebrates within the water column of select pannes/ponds within MI and MIR were sampled using Aquatic Invertebrate Activity Traps (IAT) (Figure 15). IAT were submerged and anchored within the water column of the panne or pond being sampled and allowed to passively sample over a single tide cycle (approximately 24 hour period). Four samples were taken on 30 July and 29 August 2013. Traps were set on the dates indicated and then retrieved the following day. Samples were emptied into a 0.5 mm sieve and all captured materials and organisms field-preserved in 70% isopropyl alcohol for transport to the laboratory facilities at EnviroSphere Consultants Ltd. in Windsor, NS where the samples were sorted and analyzed for species composition and abundance. An ANOVA analysis was conducted comparing the effect of time (sample month) over site.

**Figure 15 Disassembled Invertebrate Activity Trap. Photograph by T. Bowron 2007.**

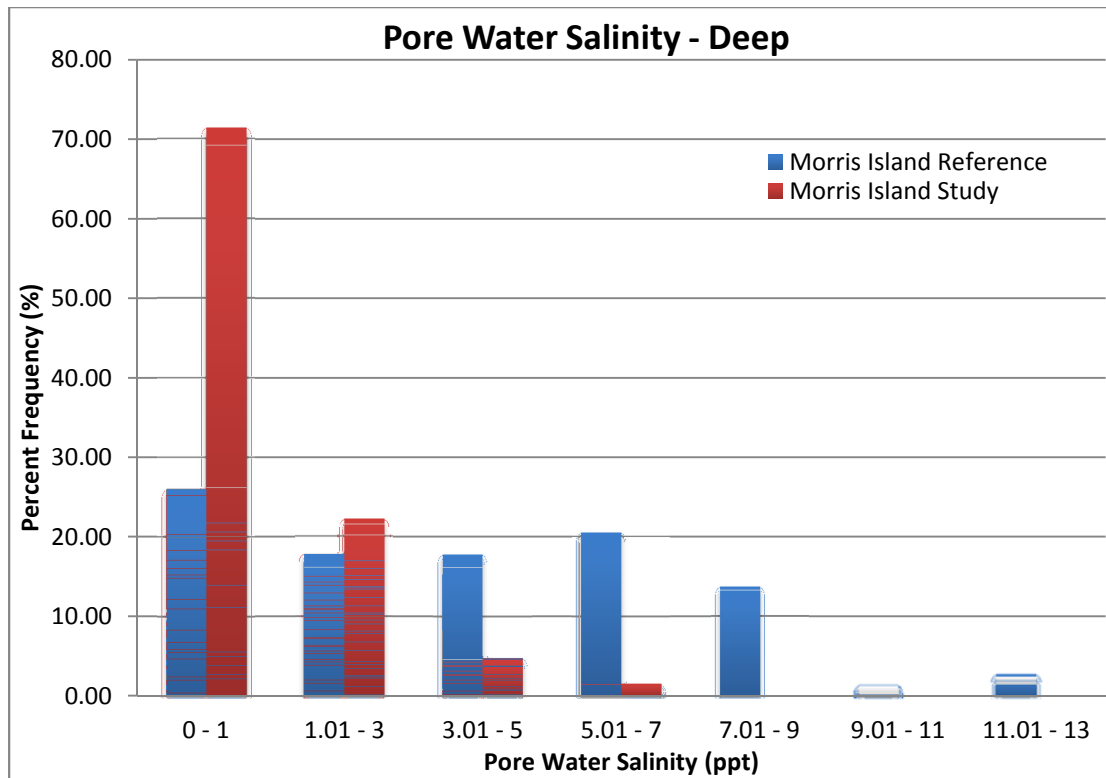
Figure 23 Salinity level frequencies for deep readings at MI and MIR.

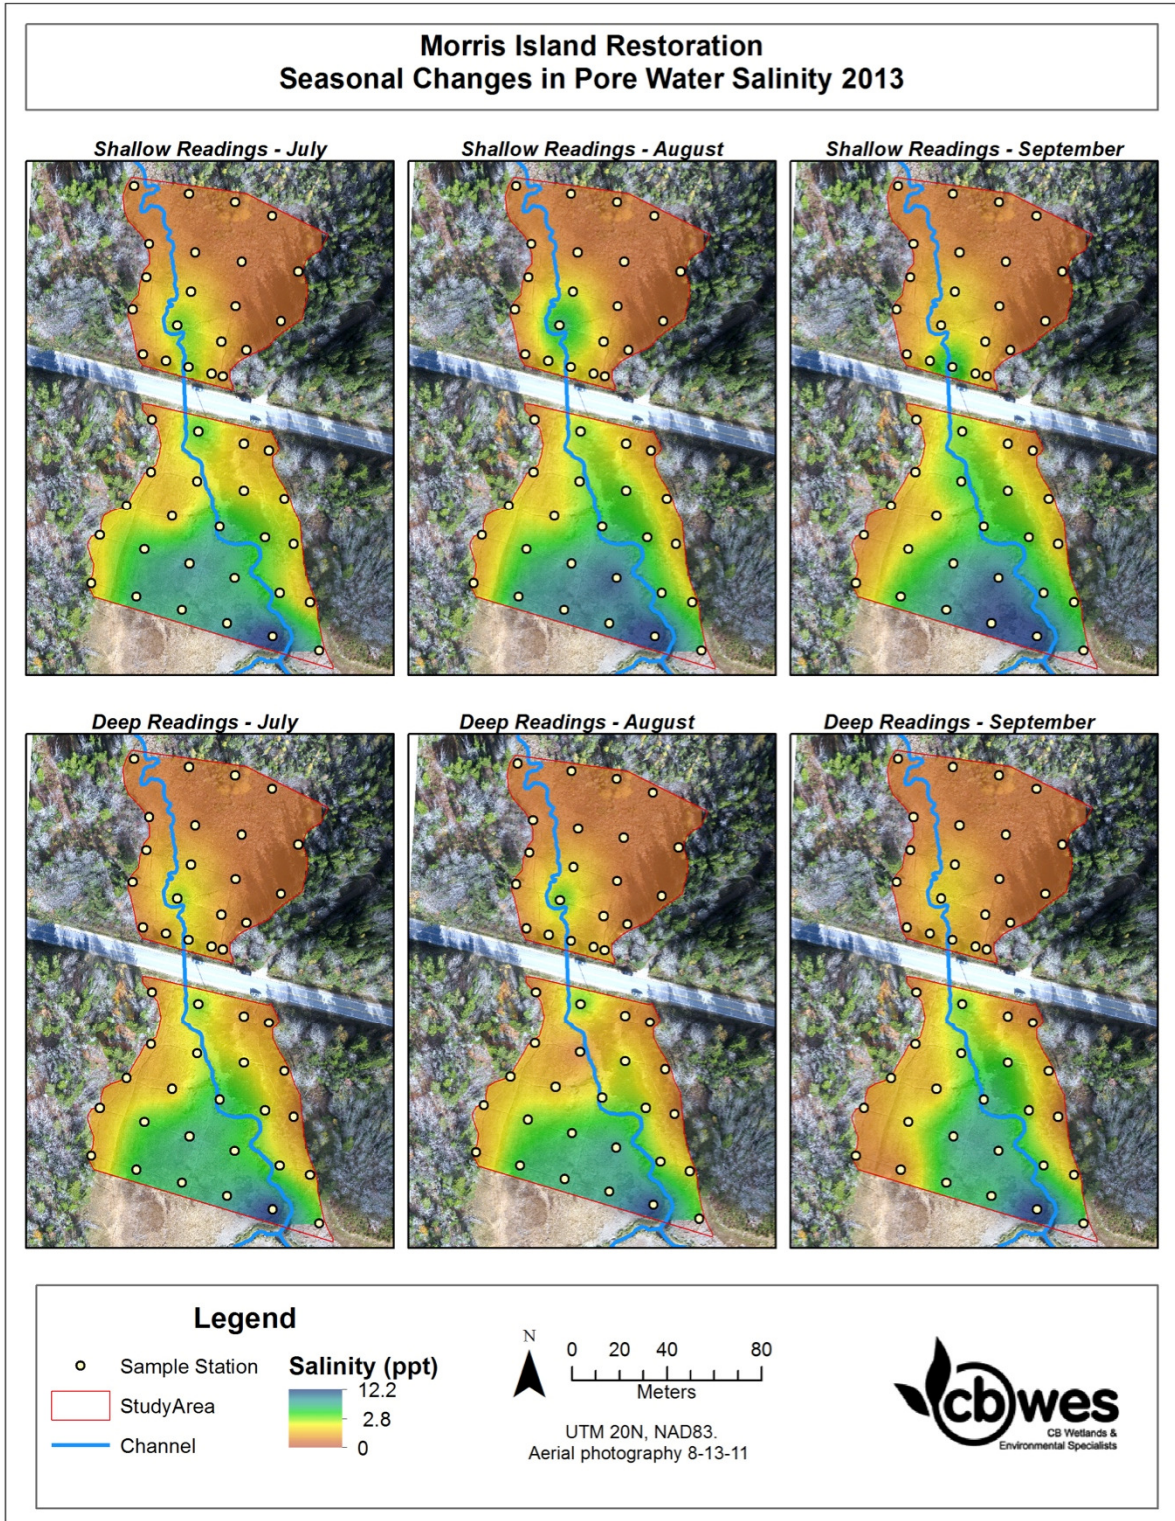
Figure 24 Seasonal changes in pore water salinity, 2013.

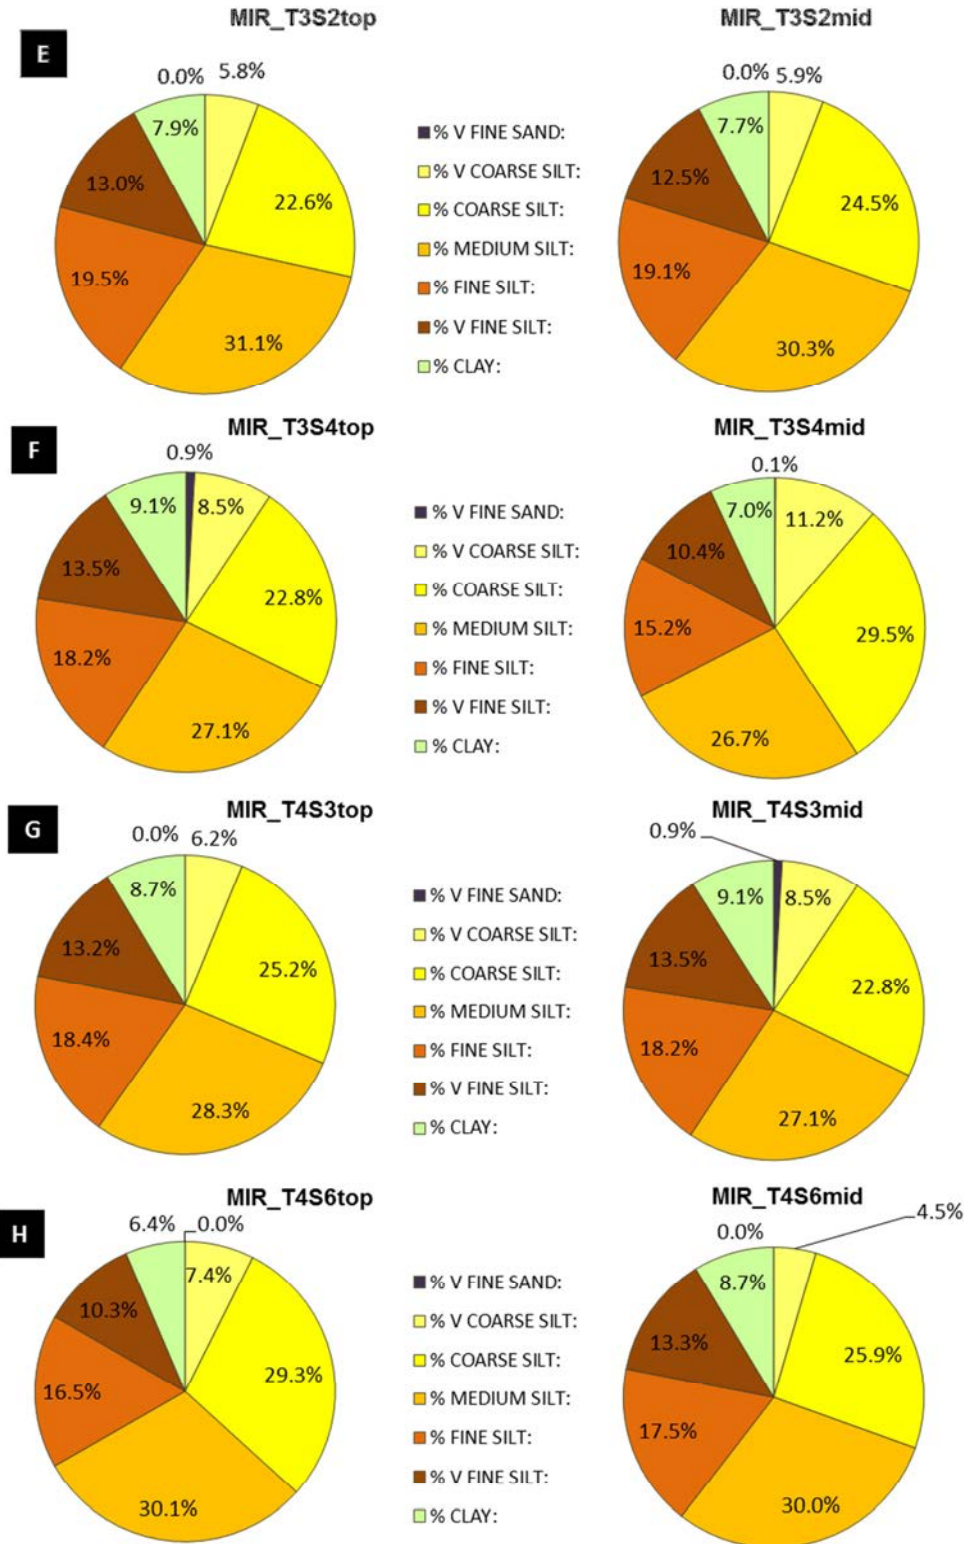
Figure 30 Distribution of grain size classes within the top 2 cm and mid section of surface cores collected from MIR site at e) MIR\_T3S2, f) MIR\_T3S4, g) MIR\_T4S3, h) MIR\_T4S6.

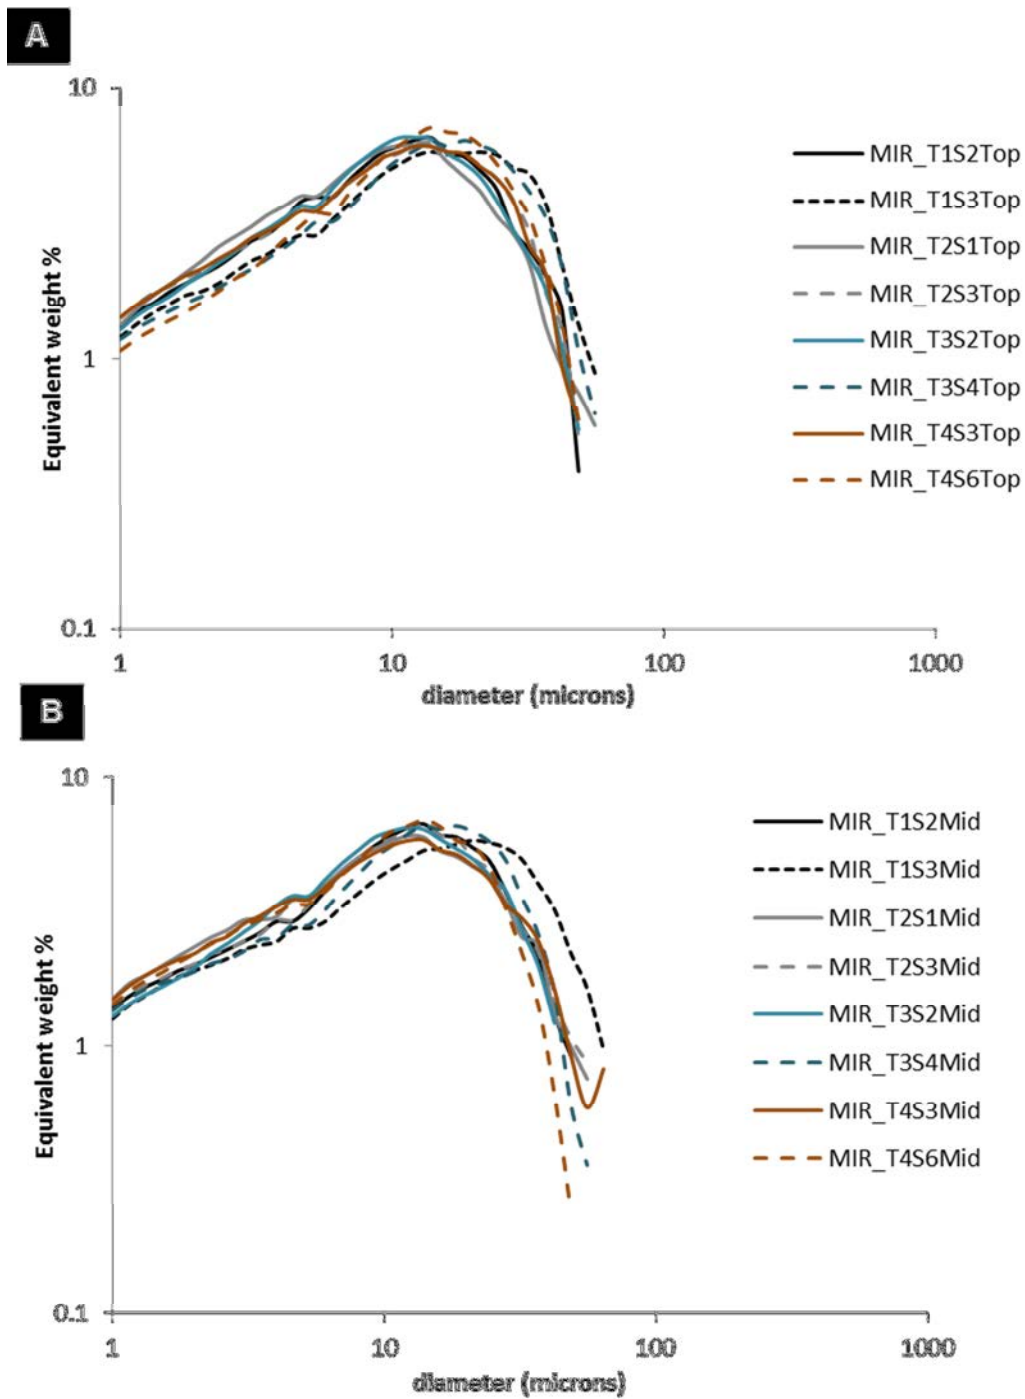
Figure 32 Comparison of the detailed grain size spectra for top 2 cm and mid section of core samples collected in 2013 at MIR site processed with the Coulter Multisizer 3.

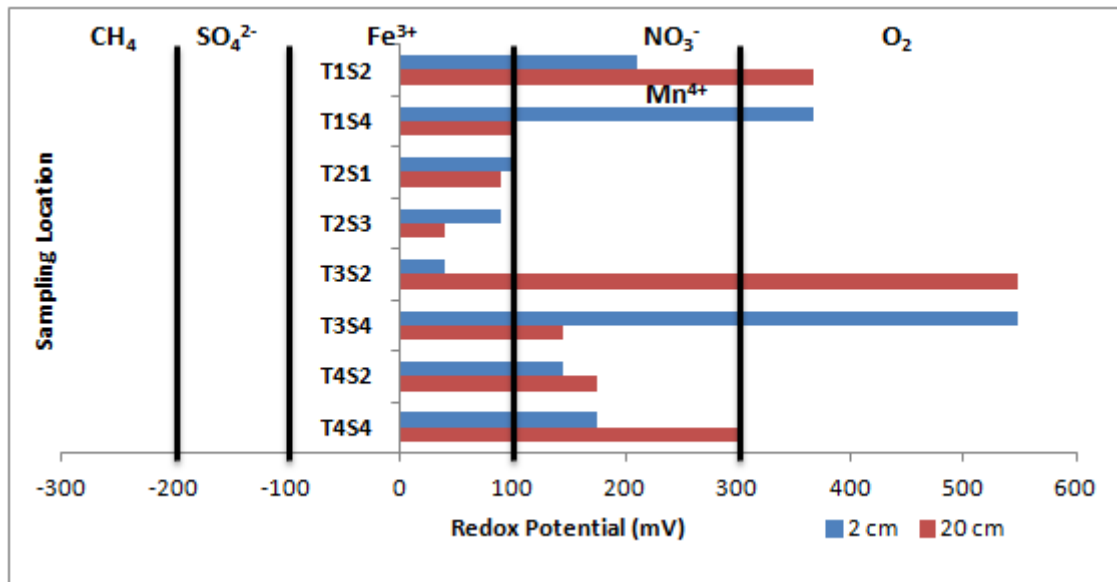
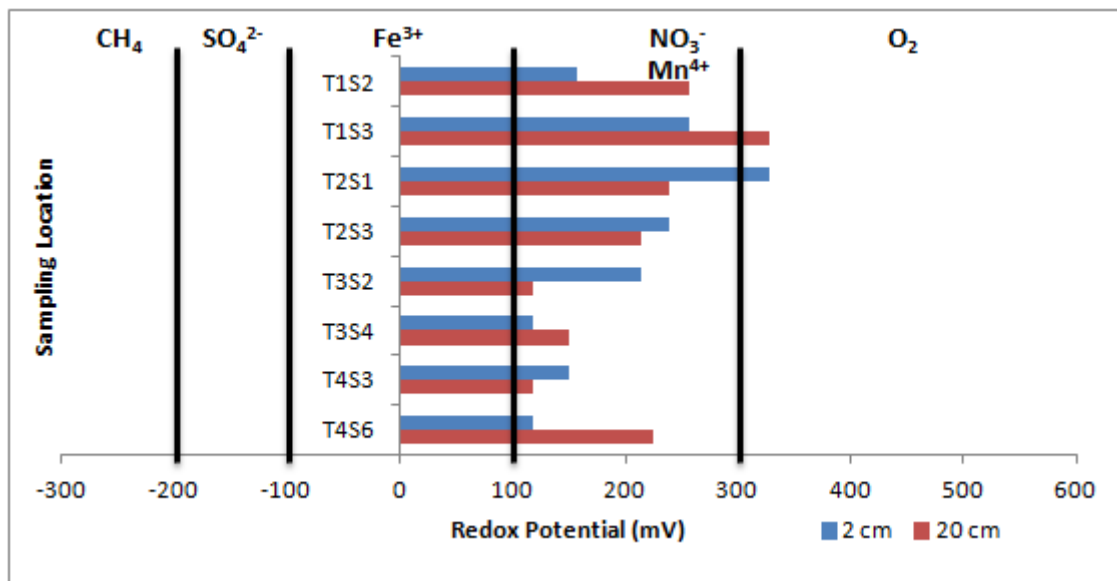
Overall, the sites were experiencing similar dominant reduction reactions creating similar stress on the vegetation. Vegetation on the restoration site is comprised of wetland species (brackish and freshwater species compared to halophyte species at the reference) that are adapted to this kind of soil condition and stress. However, once restoration of tidal water occurs, the new hydrological regime will cause significant changes in soil conditions (water content, salinity, chemistry), which will in turn drive change in vegetation community structure.

Figure 33 Mean redox potential values in relation to dominant reduction oxidation reaction occurring at 2 cm and 20 cm depth segmented into ranges of redox potential for dominant reduction reactions; a) MI, and b) MIR.

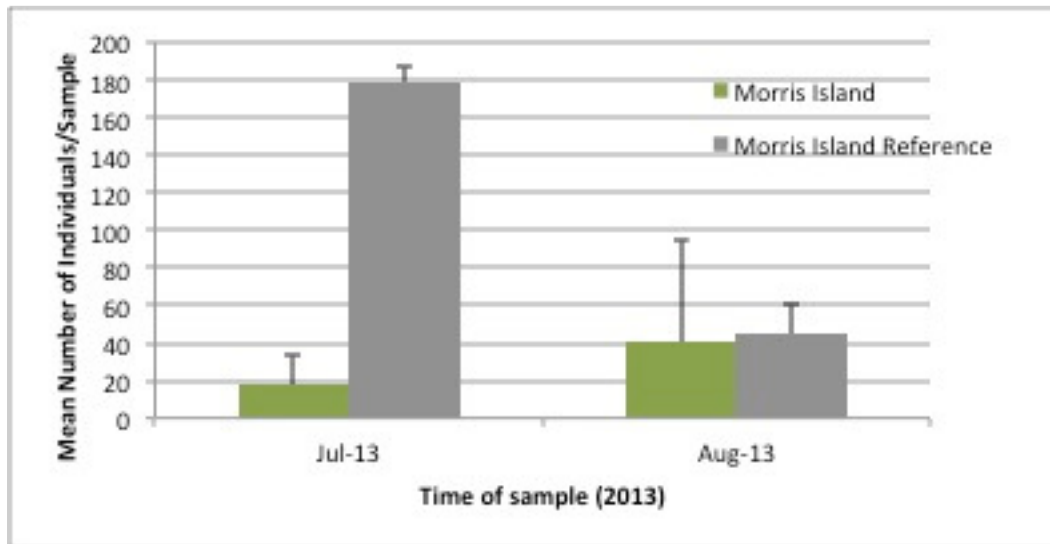
**Figure 36 Aquatic invertebrate mean abundance for MI(R), 2013.**

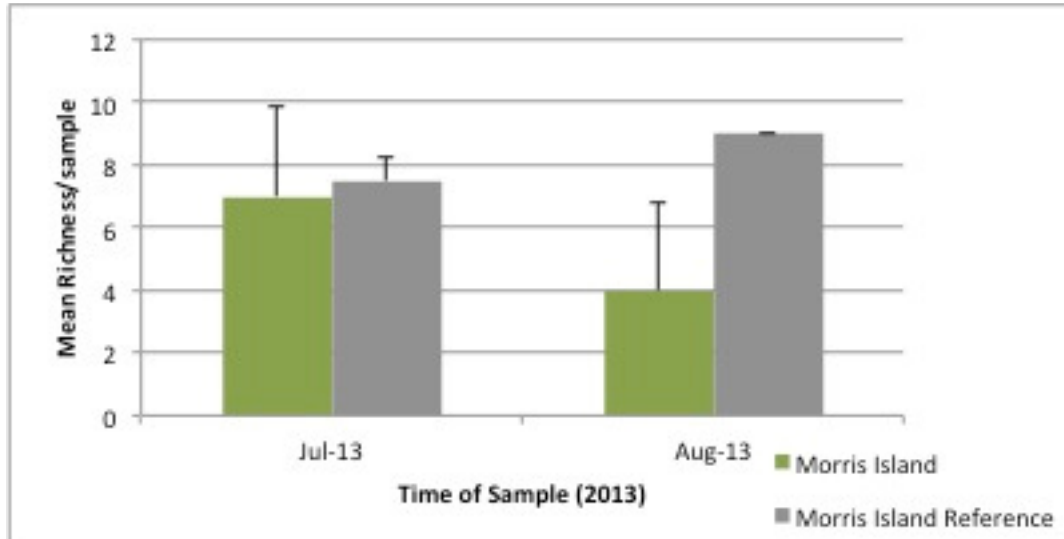
**Figure 37 Aquatic invertebrate diversity for MI(R), 2013.**

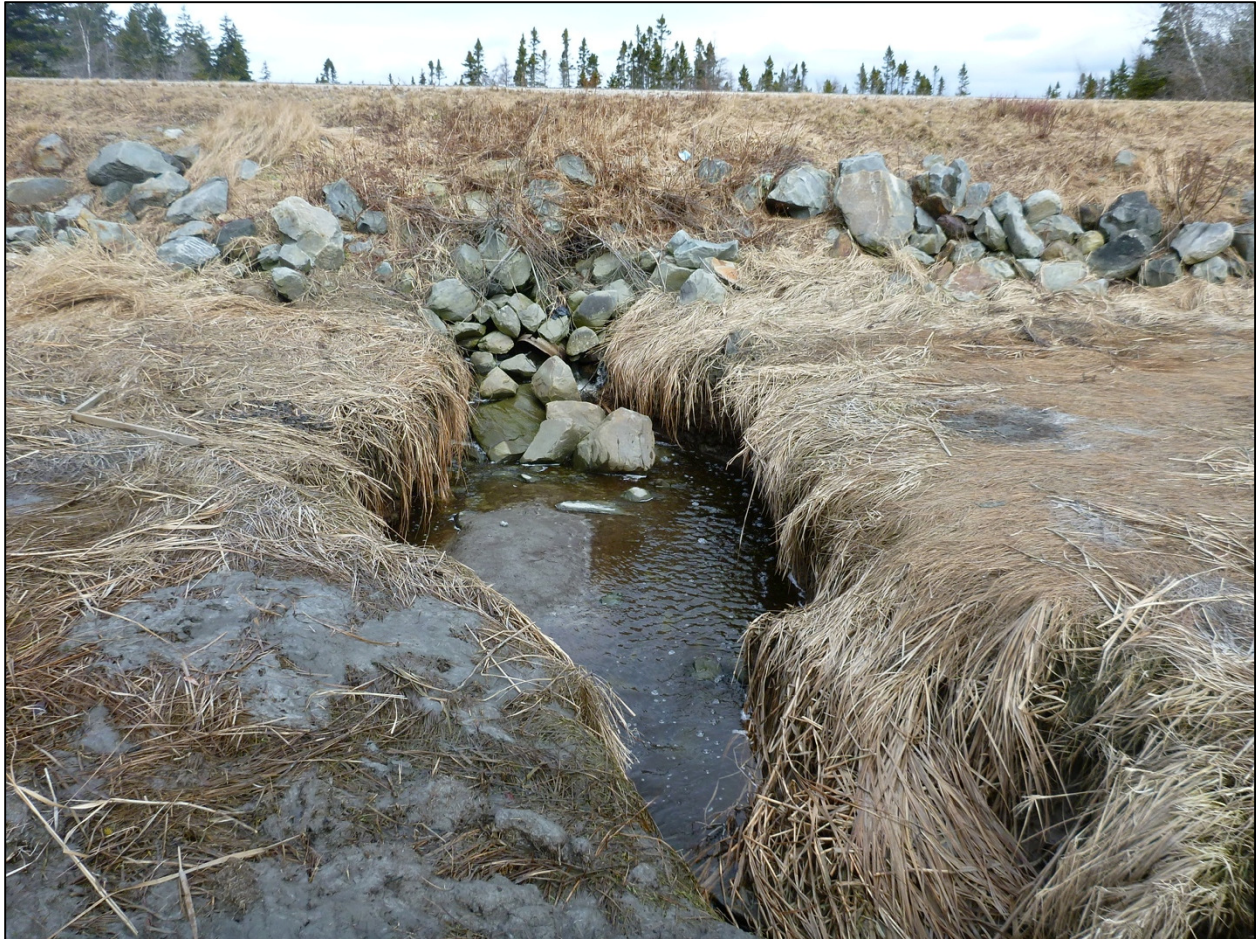
**Figure 38 Sediment deposits on the marsh surface of the reference site. 24 February 2014. Photograph by CBWES Inc.**

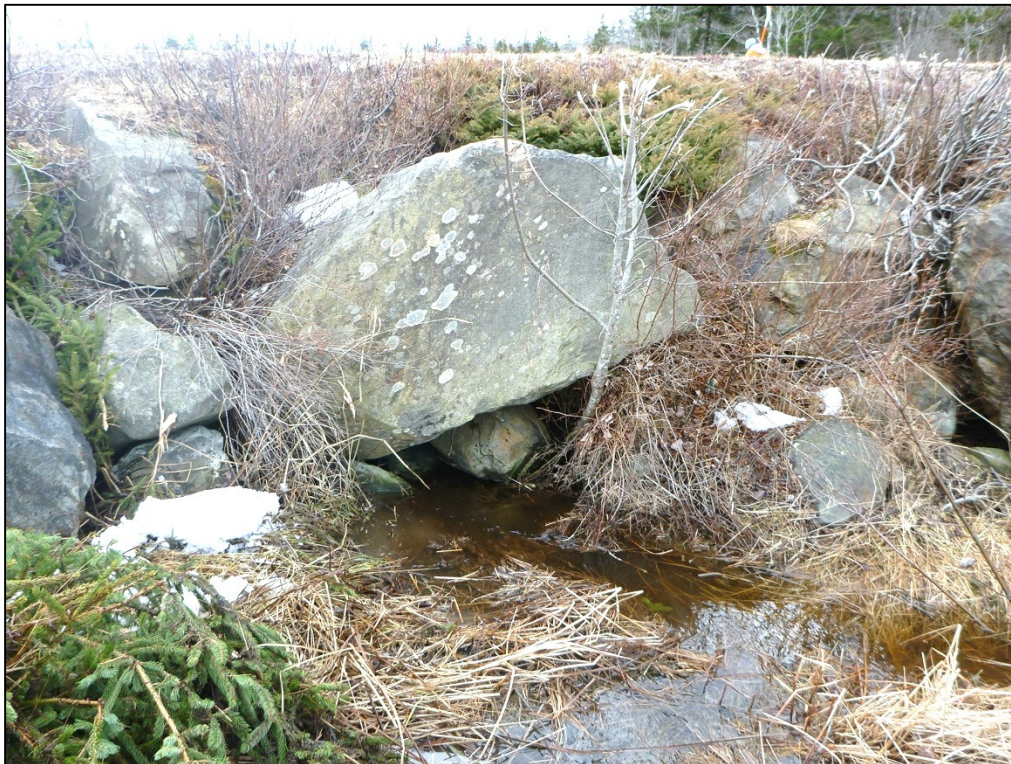
**Figure 4** Upstream end of the culvert

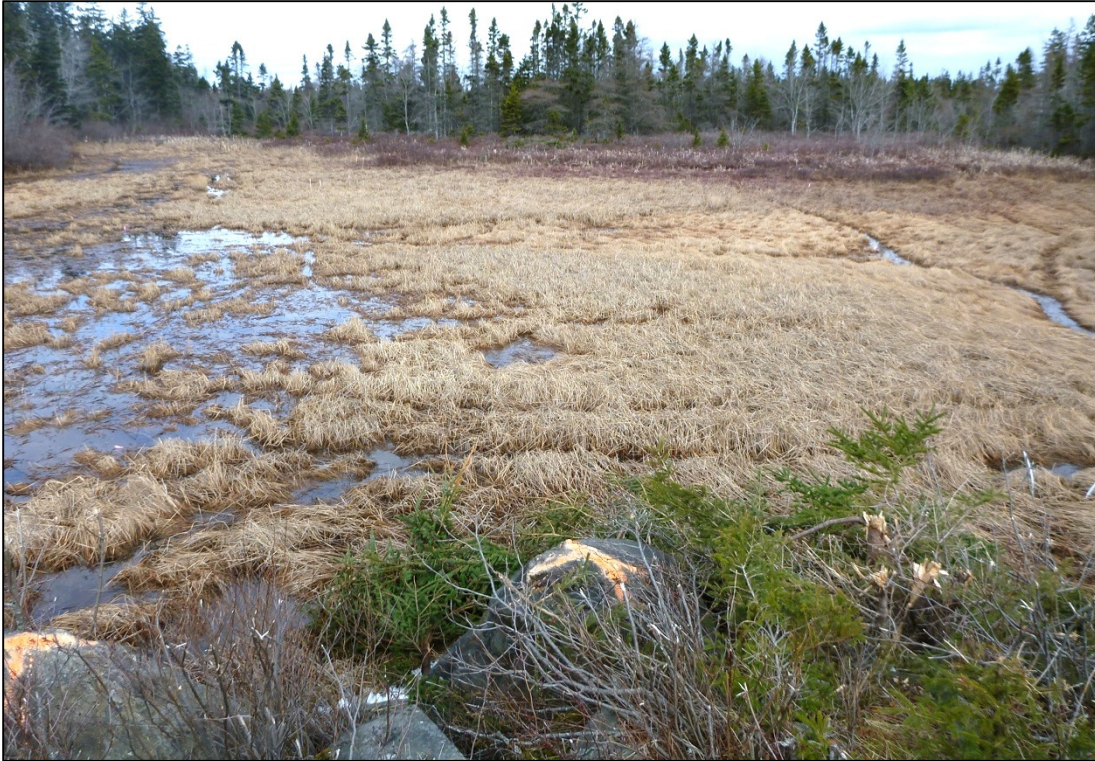
**Figure 5** Landscape photograph of MI taken from the causeway above the culvert looking (north) towards the back of the site. Note the amount of standing water on the site which was not present during the summer month.

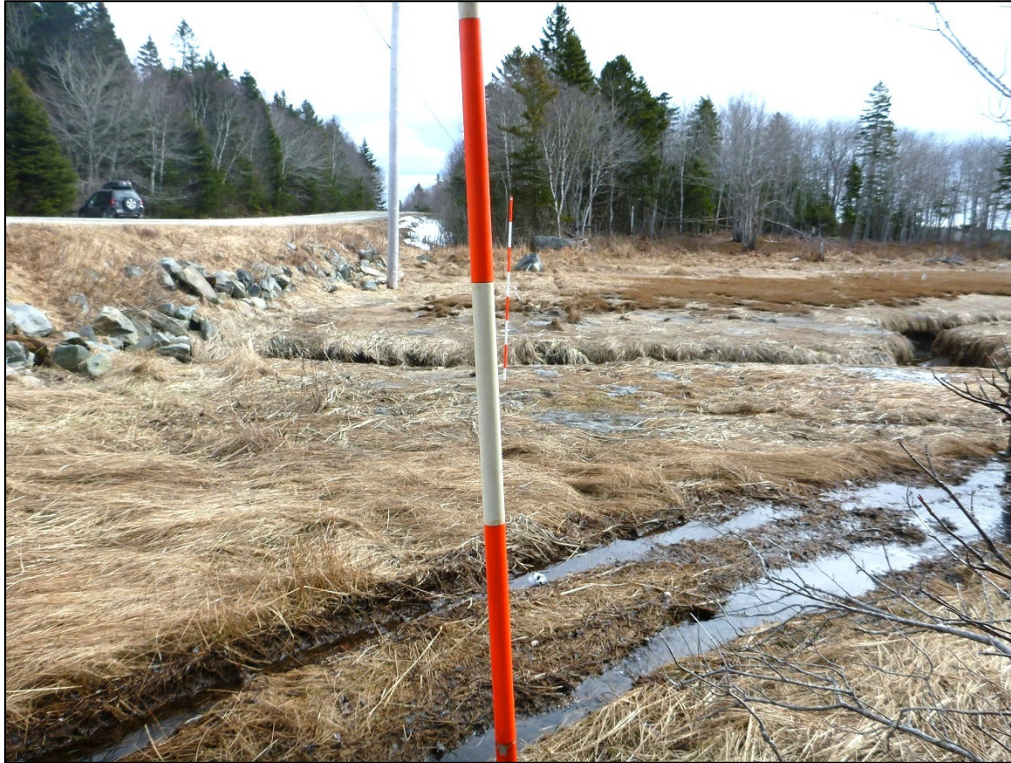
**Figure 6** Transect one. Note the ATV tracks in the foreground. Trail was not in use during summer months.

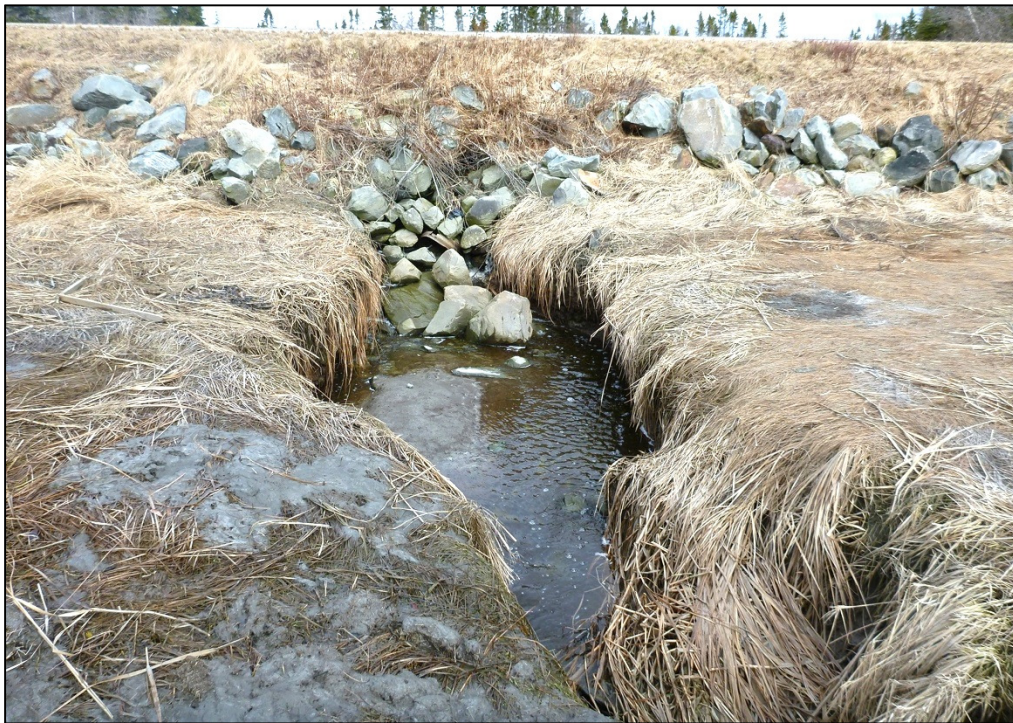
**Figure 9** Downstream end of the culvert and tidal channel.

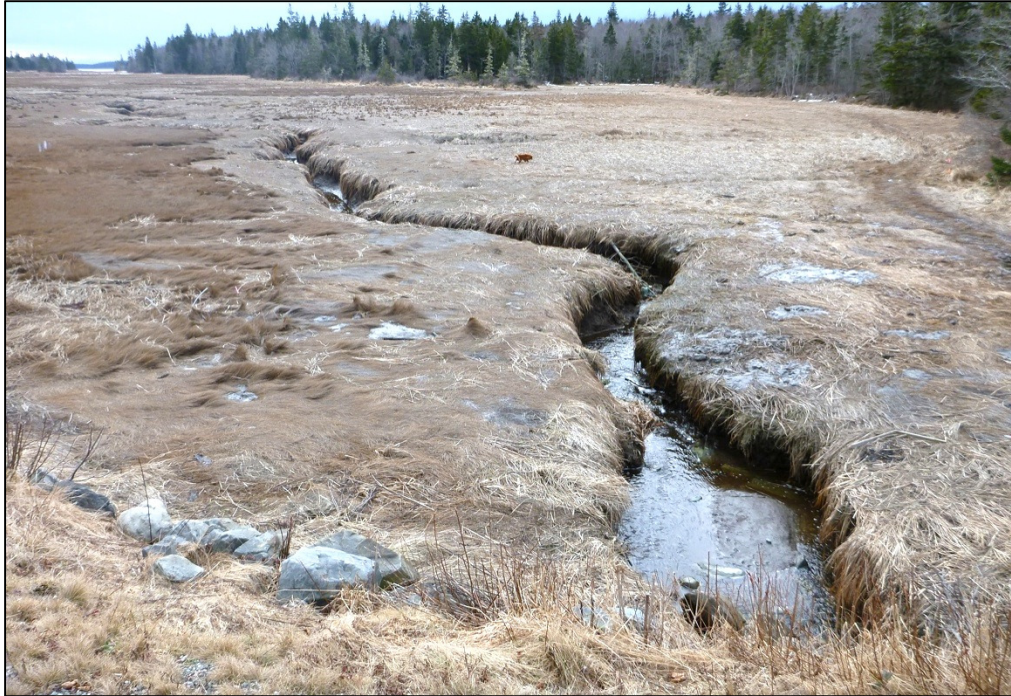
**Figure 10** Landscape photograph of reference site taken from the causeway above the culvert looking (south) downstream towards the mouth of the estuary.
