A Report for:
Nova Scotia Department of
Transportation and Infrastructure Renewal

Post-Restoration Monitoring (Year 4) of the St. Croix River High Salt Marsh & Tidal Wetland Restoration Project

CBWES Inc.

March 2014
Publication No. 38

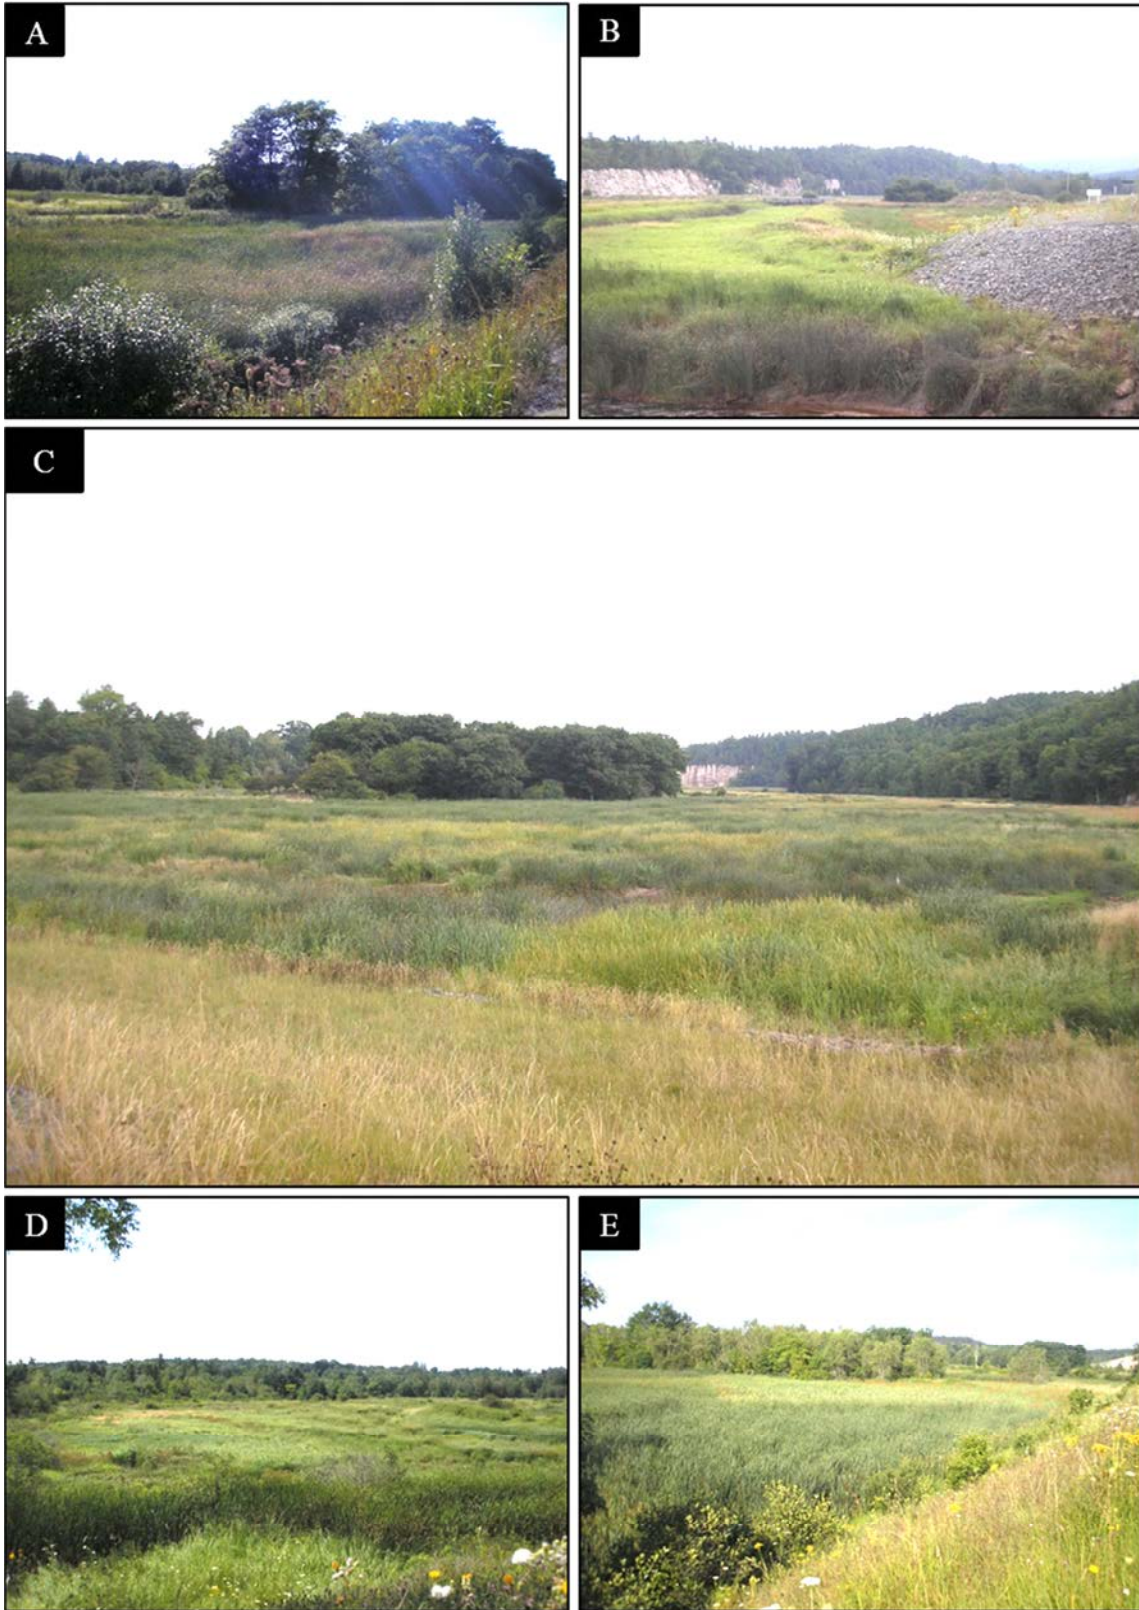
Figure 3 St. Croix Restoration sites: A) SCS; B) SCE; C) SCW; D) SCP front portion; and E) SCP back portion taken from eastern corner. Photographs taken by CBWES Inc., August 2012.

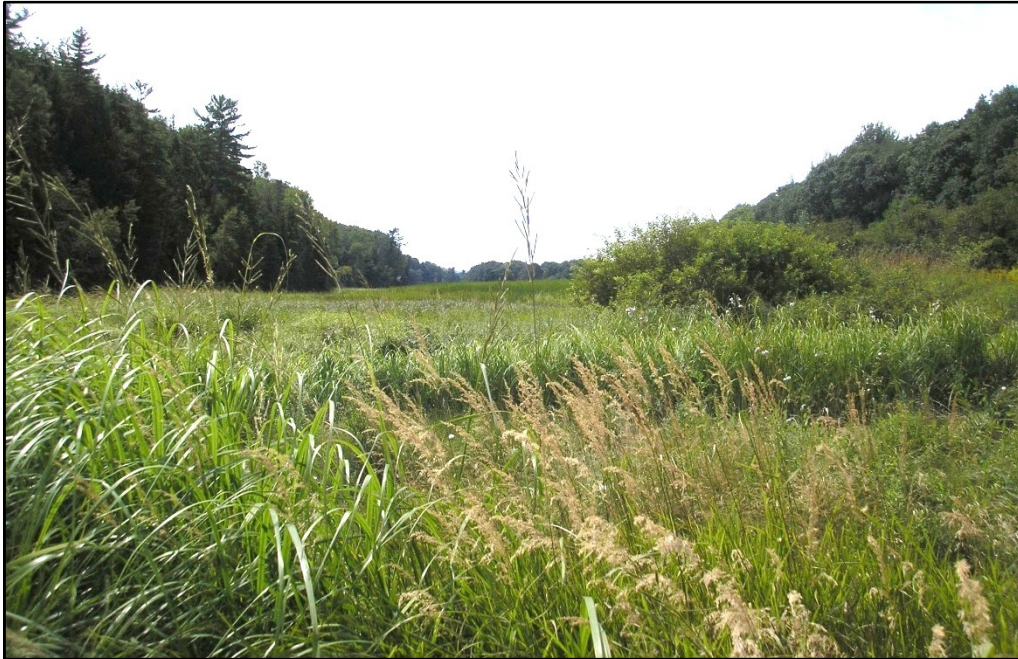
Figure 6 SCR facing downstream near Line 2, 15 August 2012. Photograph taken by N. Neatt.

A section of marsh along the north branch of the St. Croix (Herbert River) was identified as a suitable reference site for this project (Figure 6 and Figure 7). This site exhibited similar hydrological and sedimentological conditions as those present at the restoration sites. This reference site is one of the few remaining undyked sections along the tidal component of the St. Croix River system that was also readily accessible for study. The portion of the marsh that was used as the project reference site was 0.46 ha (4590.55 m²). In addition, the fringe marsh areas between the dykes and the main river channel at the restoration site (St. Croix River and Thumbhill Creek) were also used as reference for elevation, soils and vegetation. The reference site is characterized by a mixture of pasture weeds (*Centaurea nigrum*, *Cirsium arvense*, *Filipendula ulmaria*, *Equisetum* and *Solidago* sp.) in some areas with a mixture of species characterized by brackish marsh species (*Calystegia sepia*, *Spartina pectinata*, *Galium palustre*, *Agrostis stolonifera*) in others.

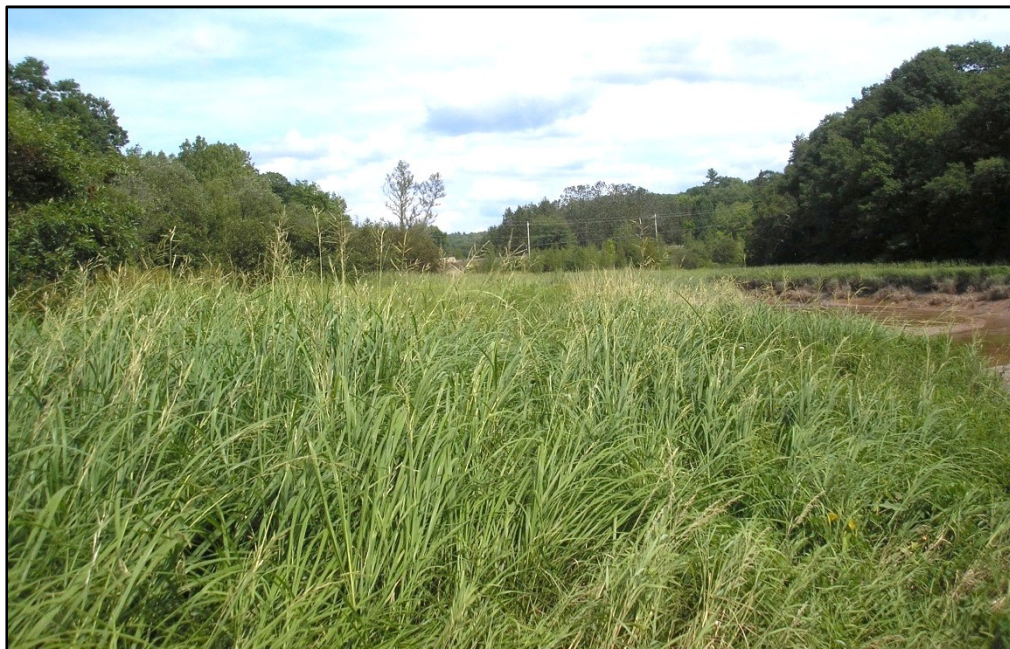
Figure 7 SCR facing upstream near Line 2, 15 August 2012. Photograph taken by N. Neatt.

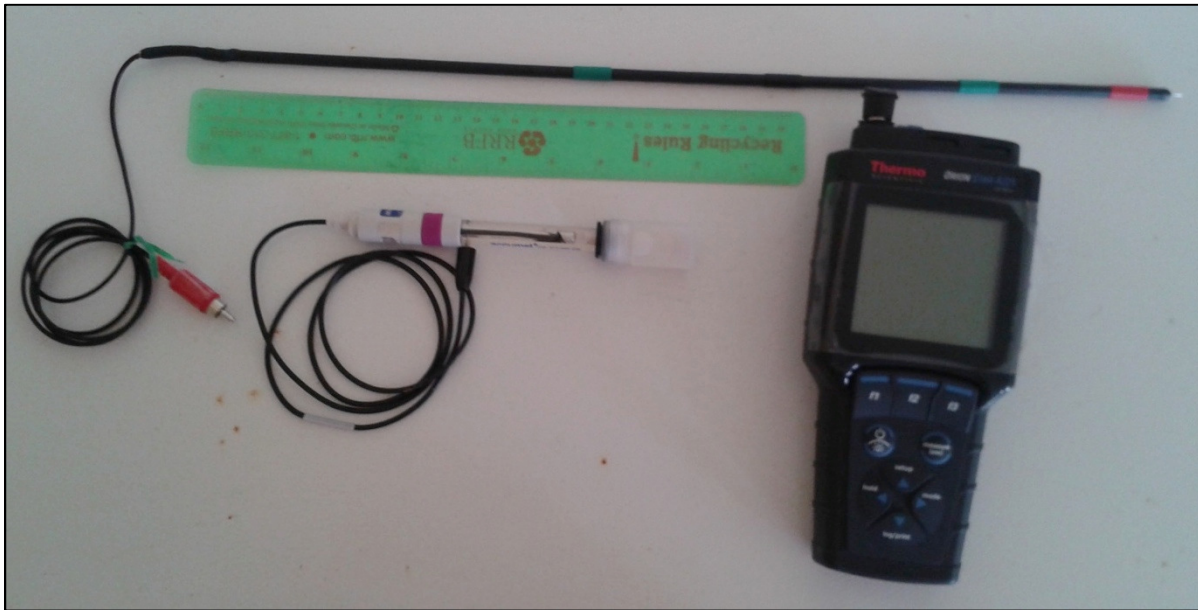
Redox potential was measured at both sites on 12 and 16 September 2014 using a series of platinum electrodes, an accumet calomel reference electrode and Thermo Scientific Orion Star A221 Millivolt Meter⁸ (Figure 11). Platinum electrodes (probes) were constructed based on the design by Vepraskas and Cox (2002). Probes were calibrated in a mixture of quinhydrone and pH 4.00 buffer before use in the field to ensure accurate readings. Sampling locations (SCW 8; SCP 5; SCE 3; SCR 6) were matched with sediment sample locations (Figure 8 and Figure 9). A shallow and a deep measurement were taken at each sampling location using two probes inserted into the marsh sediment 2 cm and 30 cm respectively. At SCR soil compaction at some sampling locations hindered probe insertion to 30 cm; therefore, the probes were inserted to 20 cm. Probes were deployed 30 minutes before readings were taken to allow the probes to equilibrate. The reference electrode was inserted into the soil close to the probes at the time of measurement. Measurements from the two probes were taken by individually connecting the probe to the Meter and waiting for the Meter to stabilize (max five minutes). Redox potential was determined by adding +244 mV to each field measurement to account for the potential of the reference electrode.

Figure 11 Constructed platinum electrodes (probes: top), accumet calomel reference electrode (bottom) and Thermo Scientific Orion Star A221 Millivolt Meter. Photograph taken by C. Skinner 2013.

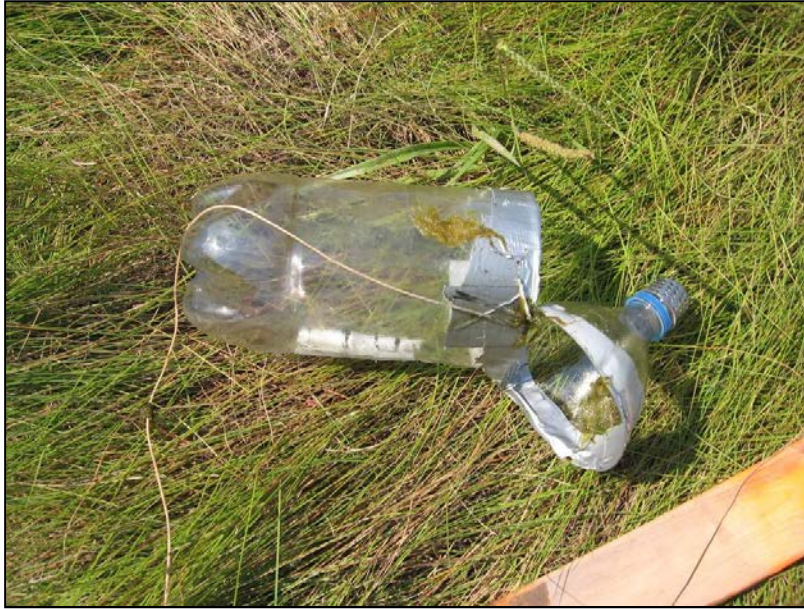
Figure 13 Disassembled Invertebrate Activity Trap (IAT). Photograph by T. Bowron 2007.

Sampling of other aquatic invertebrates within the water column of the pannes occurred at SCW and SCP. Two samples were taken at each site on 25 July and 14 August 2012 using Invertebrate Activity Traps (IAT; passive sampling). The IAT were left to sample a 24 hour period during a neap tide cycle. These traps were constructed from 2 L clear plastic bottles; the top portion was cut off, inverted and taped in place with duct-tape (Figure 13). The IAT were placed in four pannes (two at SCW and two at SCP), submerged and anchored to ensure the trap remained within the panne. The samples were emptied into a 0.5 mm sieve and the remaining materials and organisms were field preserved in 70% isopropyl alcohol. Envirosphere Consultants Ltd. then performed the species identification.

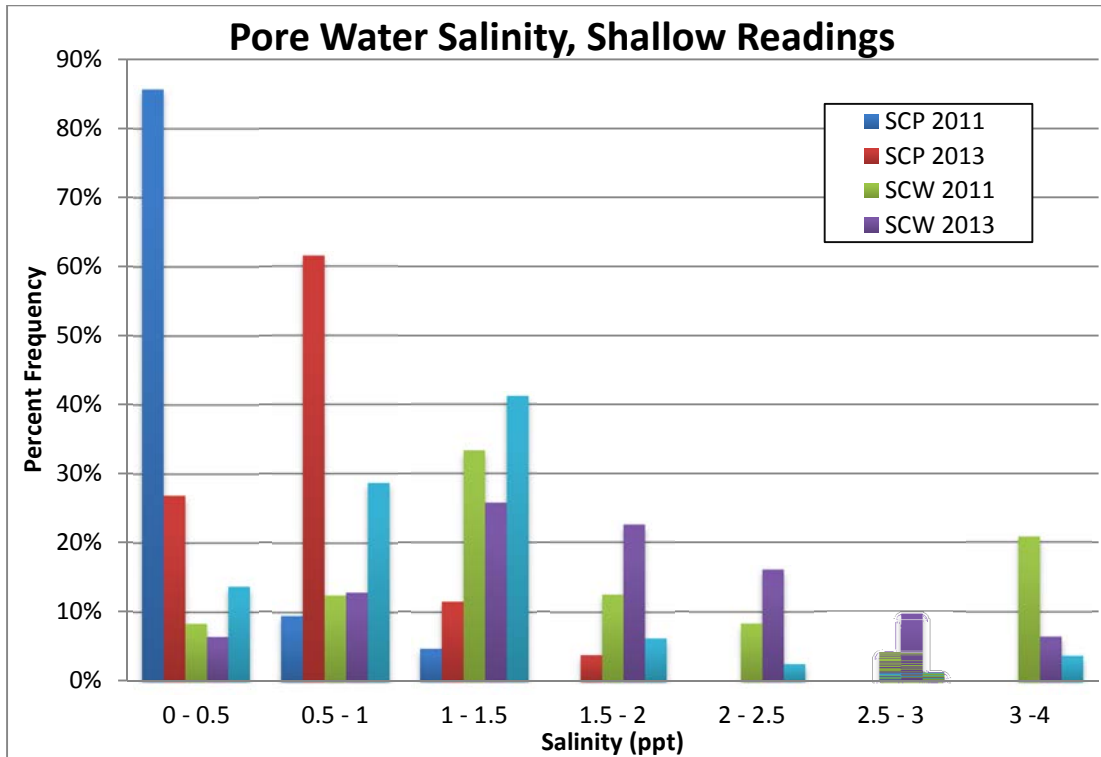
The salinity values at the SC restoration sites and SCR continue to be very low when compared to other dyke breach restoration projects and reference sites in the Bay of Fundy region. This was expected as the other sites are salt marsh systems and located well within the tidal prism of their respective systems, compared to SC which is at the upper limit of tidal influence. The other breach projects have salinity means of 8.8 ppt (Cogmagun: Bowron et al. 2014a) and 7.6 ppt (Walton: Neatt et al. 2013) with maximum readings of 14 – 17 ppt. Tidal water readings at Cogmagun (2013) and Walton (2012) during fish surveys revealed 26 ppt and 27 ppt respectively. The highest reading at SCW during fish surveys was 13.7 ppt with a reading of 15 ppt in the River (at Depth: Table 5). The lowest reading at SCW during fish surveys was 0.8 ppt and a reading of 2.6 ppt in the River (at Depth: Table 5). SCW and SCP were more brackish in comparison to other restoration project sites, with greater salinity readings at SCW compared to SCP most likely associated with its location in the River system. As discussed in *Section 4.3 Soils and Sediments*, the SC restoration sites are within the zone of the estuarine turbidity maximum (ETM) or the location of vertical mixing between fresh and salt water. SCW appears to be low enough in the system that it receives a greater amount of saline sediment from the River on high tides compared to SCP.

Figure 25 Frequencies for pore water salinity shallow readings at SCW, SCP and SCR for Year 2 (2011) and Year 4 post-restoration (2013).

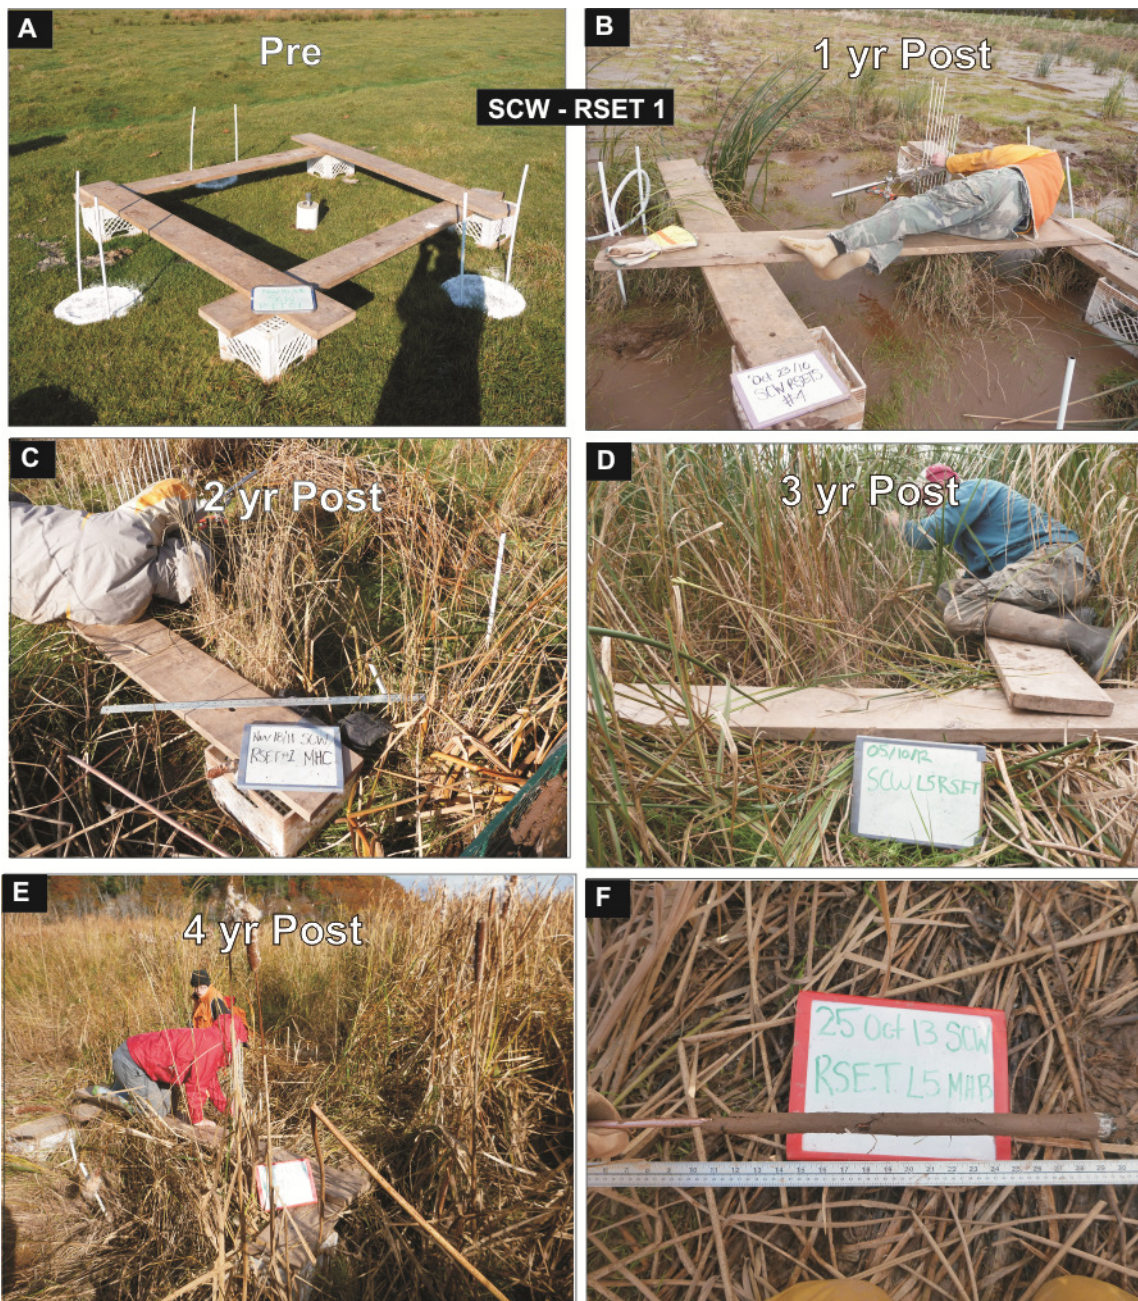
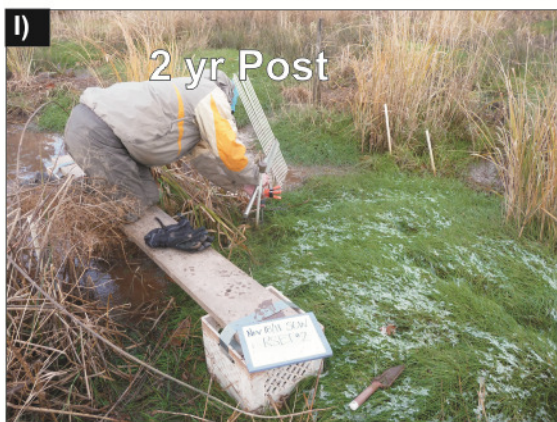
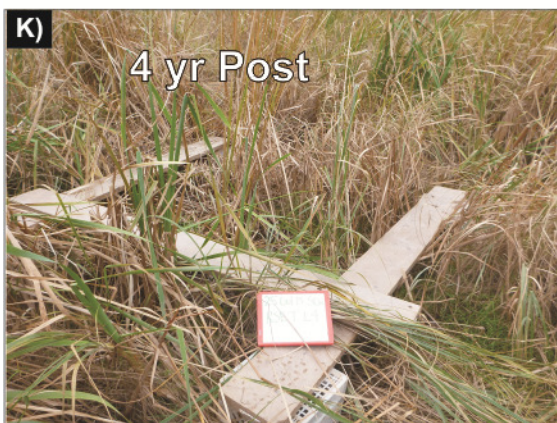
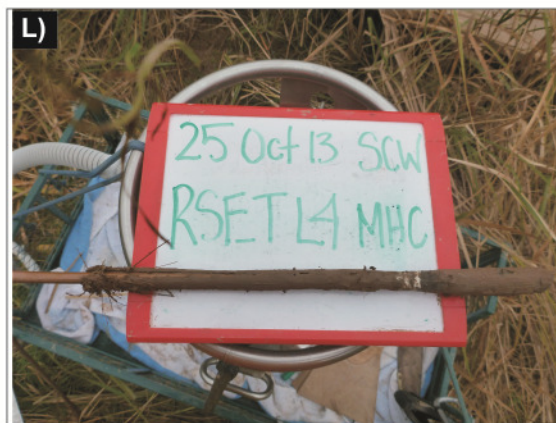
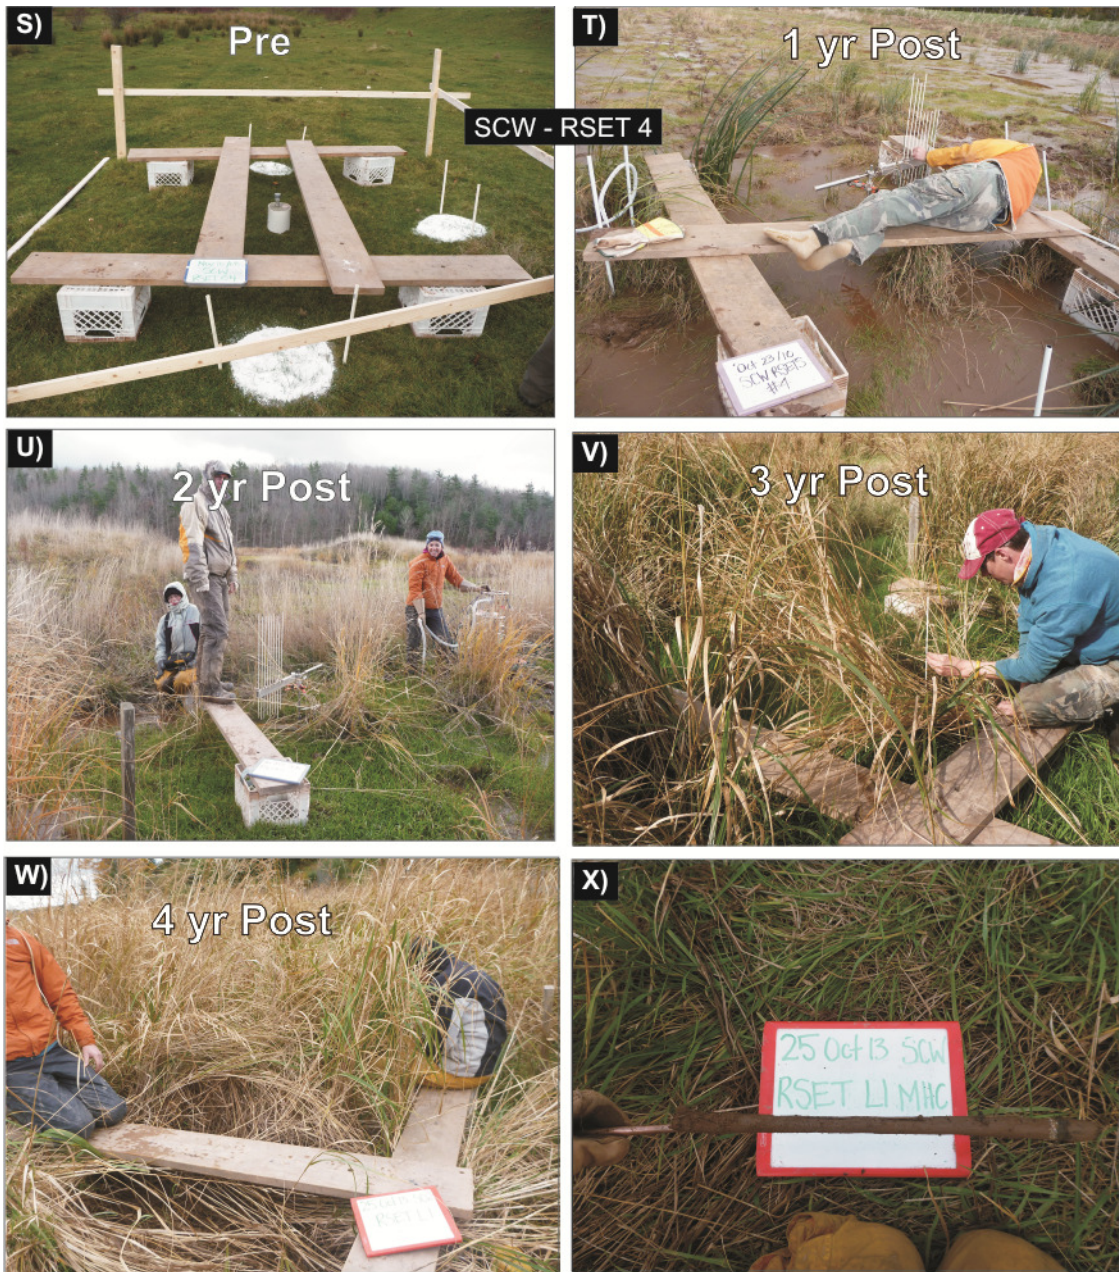
The decrease in the rate of change in surface elevation is directly associated with the redistribution of sediment within the system and the rising of the marsh surface within the tidal frame. As the surface rises within the tidal frame, it is inundated for shorter periods of time resulting in less sediment availability and inundation time. Figure 32 provides an overview of the impacts of sediment accretion facilitating vegetation growth around the excavated pond at SCW. In addition, deposited sediment can act as a disturbance agent that facilitates vegetative colonization by re-setting the ‘clock’ to zero (Figure 33). Refer to Lemieux, 2012 for a detailed discussion of the sequence of vegetative recovery within the St. Croix system and the role of sedimentation. The opening of a new area for tidal waters to occupy through dyke breaching, can also have an effect on the tidal prism of the area. The very low rates of sediment accretion at SCP yet markedly higher values at SCW in 2012 may potentially be explained by sediment being sequestered on the incoming tide at SCW and not be available to feed SCP. The higher rates at both sites during 2012-13 may be associated with increased tidal height, duration and frequency of inundation. However, without measures of suspended sediment concentration and tide records throughout the year at both sites this remains a hypothesis.

Figure 27 RSET stations at SCW pre- (2008), and year 1 (23 October 2010), year 2 (18 November 2011), year 3 (5 October 2012) and year 4 (23 October 2013) post-restoration. Photographs taken by CBWES Inc.

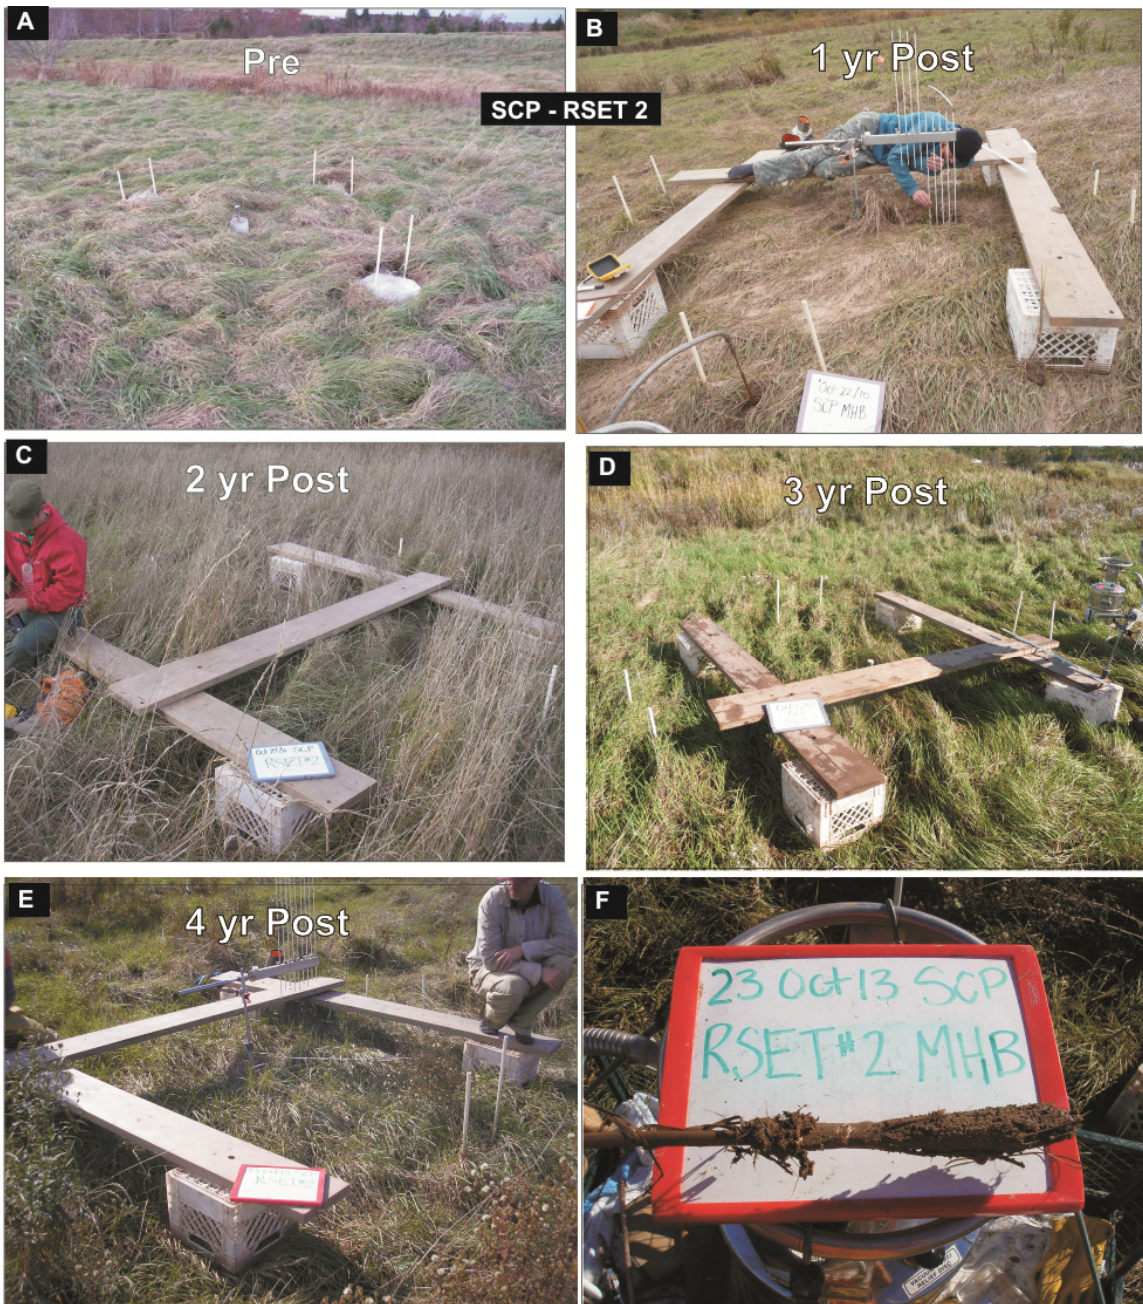
Figure 29 SCP_RSET-02 measurements pre-, and year 1 (22 October 2010), year 2 (24 October 2011), year 3 (1 October 2012) and year 4 (23 October 2013) post-restoration. Photographs taken by CBWES Inc.

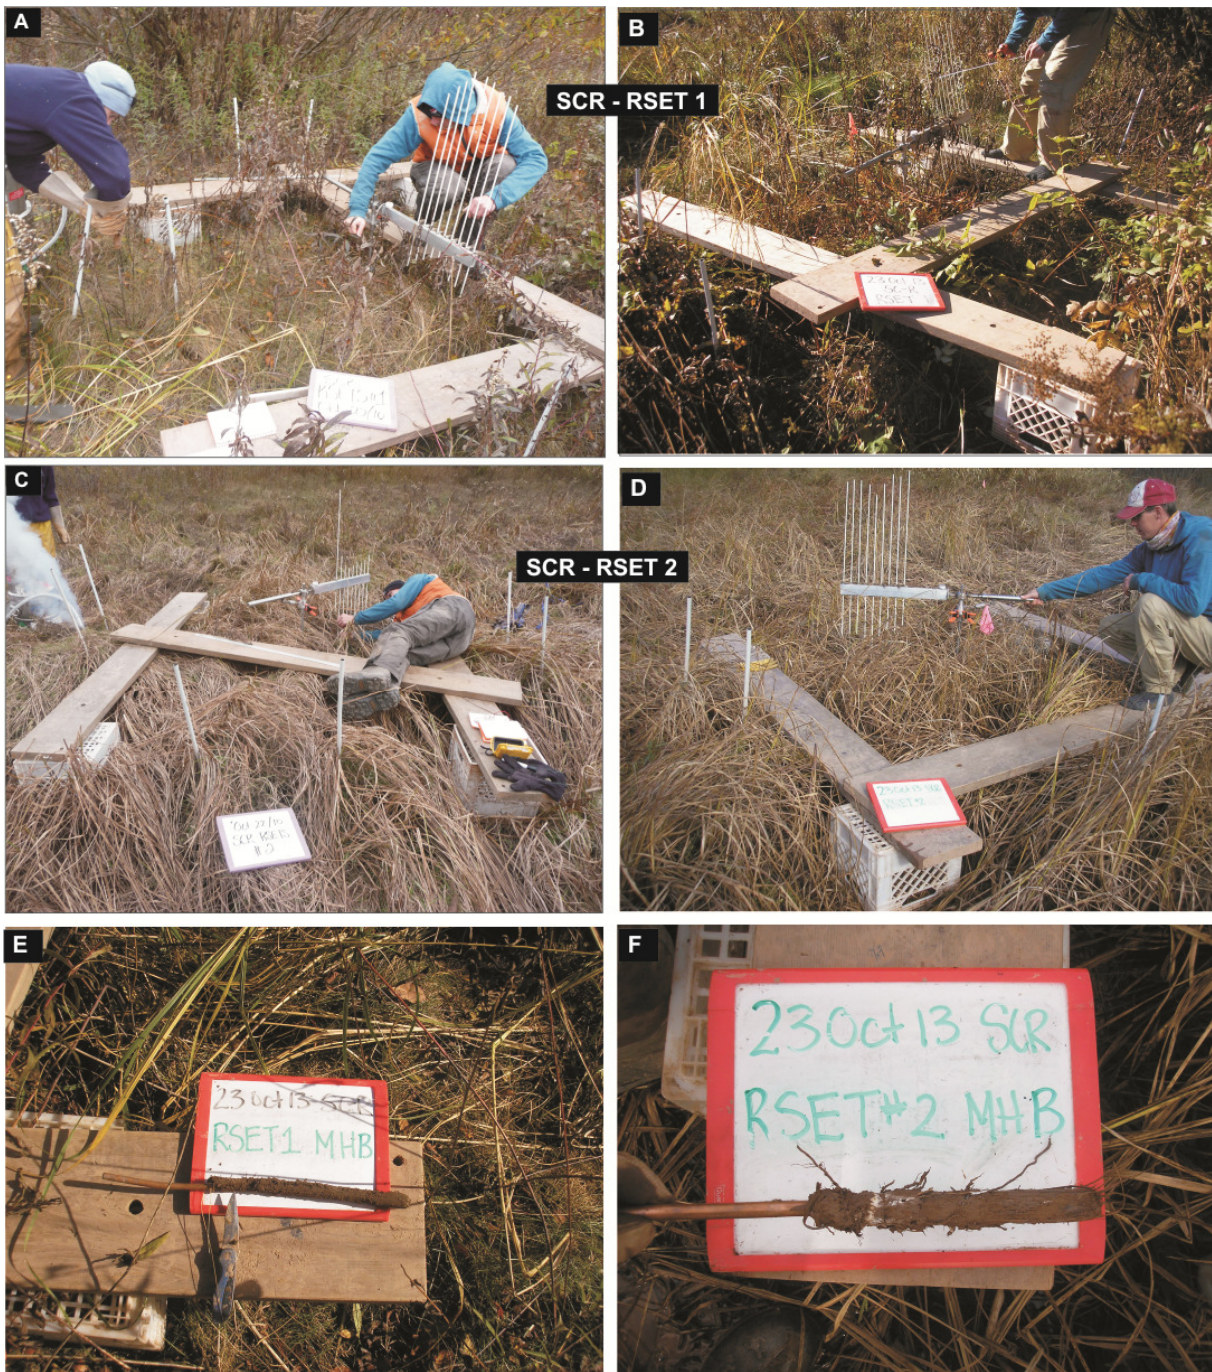
Figure 30 RSET and marker horizon measurements at SCR in 2009 and 2013. Photographs taken by CBWES Inc.

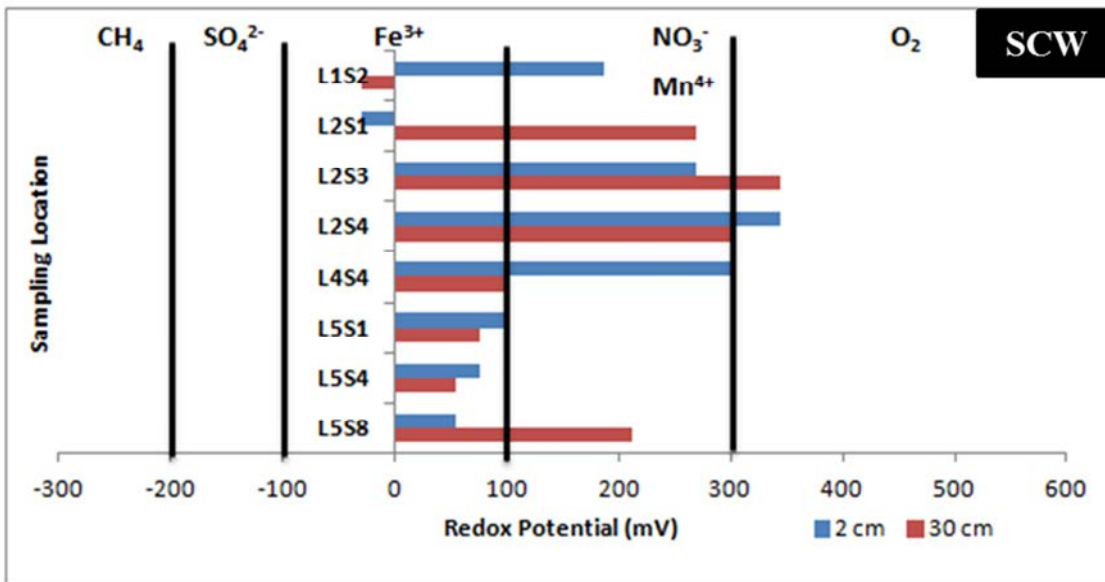
Overall, the values indicated moderate anaerobic stress on vegetation with the potential for moderate decomposition rates to occur within the soil under these anaerobic conditions. There is potential for sulfide, a known phytotoxin, to accumulate within the soil, as the soil is heterogeneous and multiple redox reactions occur at one time. However, sulfate reduction was not the dominant redox reaction being measured at any of the SC restoration sites; therefore, high levels of sulfide are not expected to accumulate. The areas that experienced oxygen reduction could allow for the oxidation of the reduced compounds (i.e. sulfide) and decrease the level within the soil. The values indicate appropriate drainage and lack of water logging at the sampling locations; therefore, the high anaerobic conditions needed for high sulfide levels to accumulate were not present at the time the readings were taken. An additional year of data collection should provide some insight into whether or not the SC restoration sites are trending towards conditions at the reference or if a greater anaerobic stress is expected in the future.

Figure 34 Mean redox potential values in relation to dominant reduction oxidation reaction occurring at 2 cm and 30 cm depth broken into ranges of dominant reduction reactions as specified by Reddy and DeLaune (2008) at SCR and the SC restoration sites.

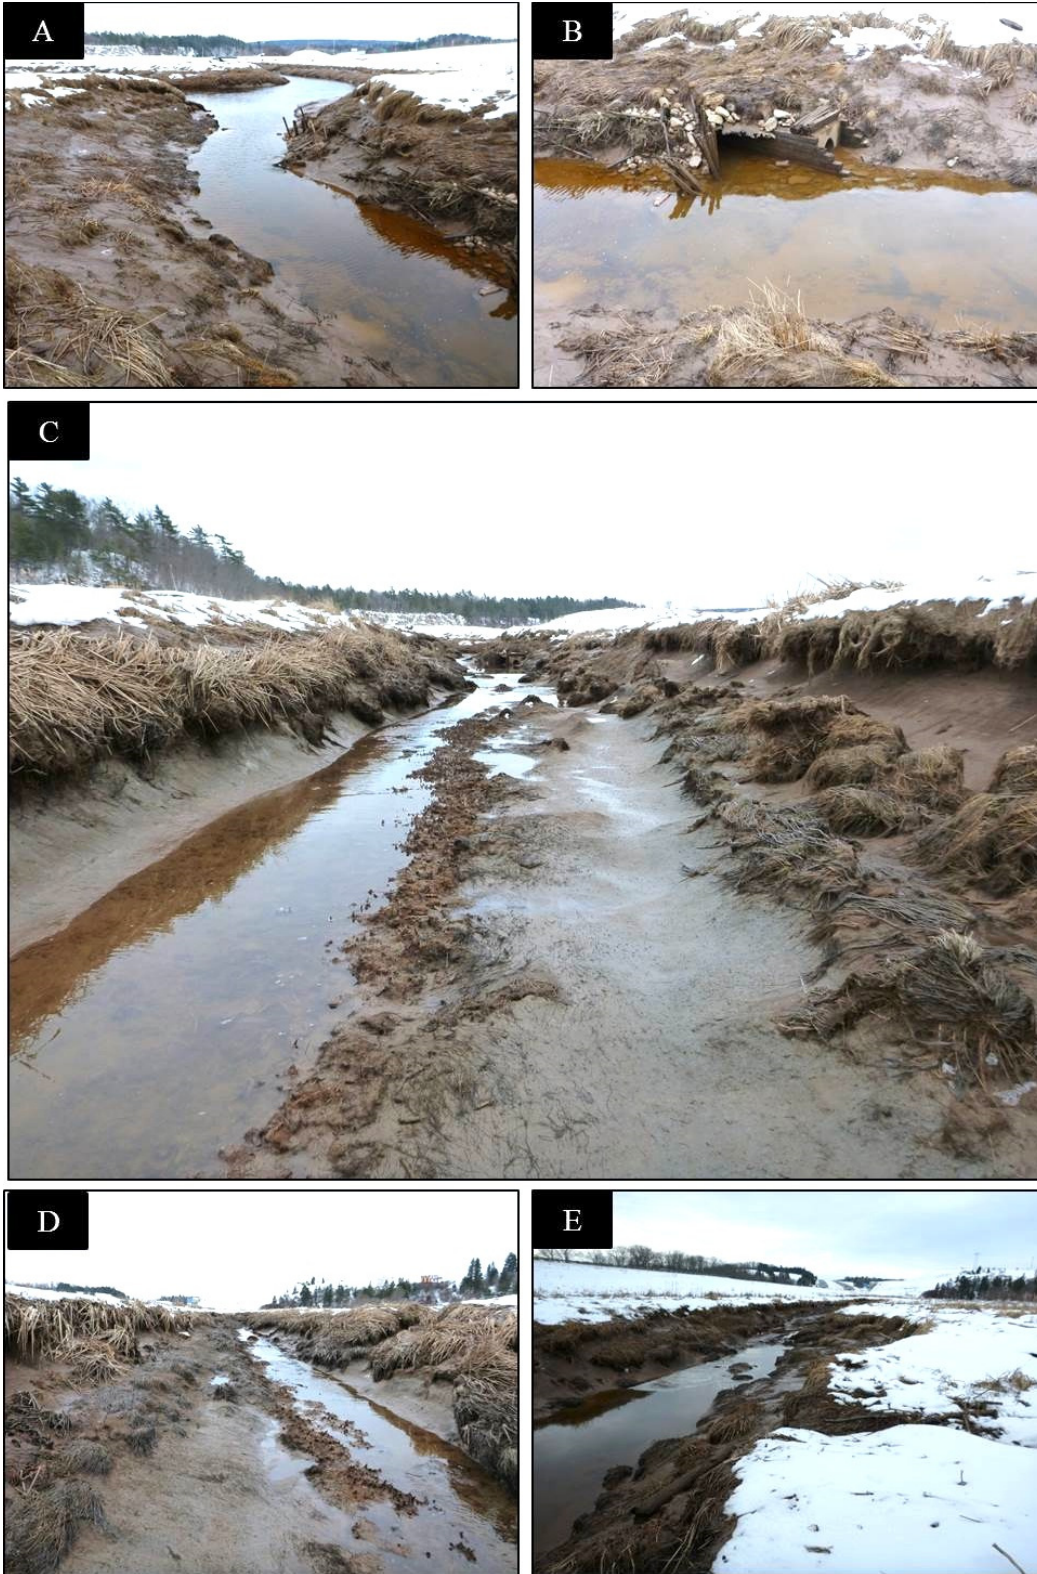
Figure 44 Main channel at SCW showing a) mouth of channel; b) old aboiteau structure; c) the scour and erosion along the right of the channel facing the River; and c) channel towards upstream; d) scour erosion and area where channel is now, continuing to erode back and deepen. Photographs by CBWES Inc., 21 February 2014.

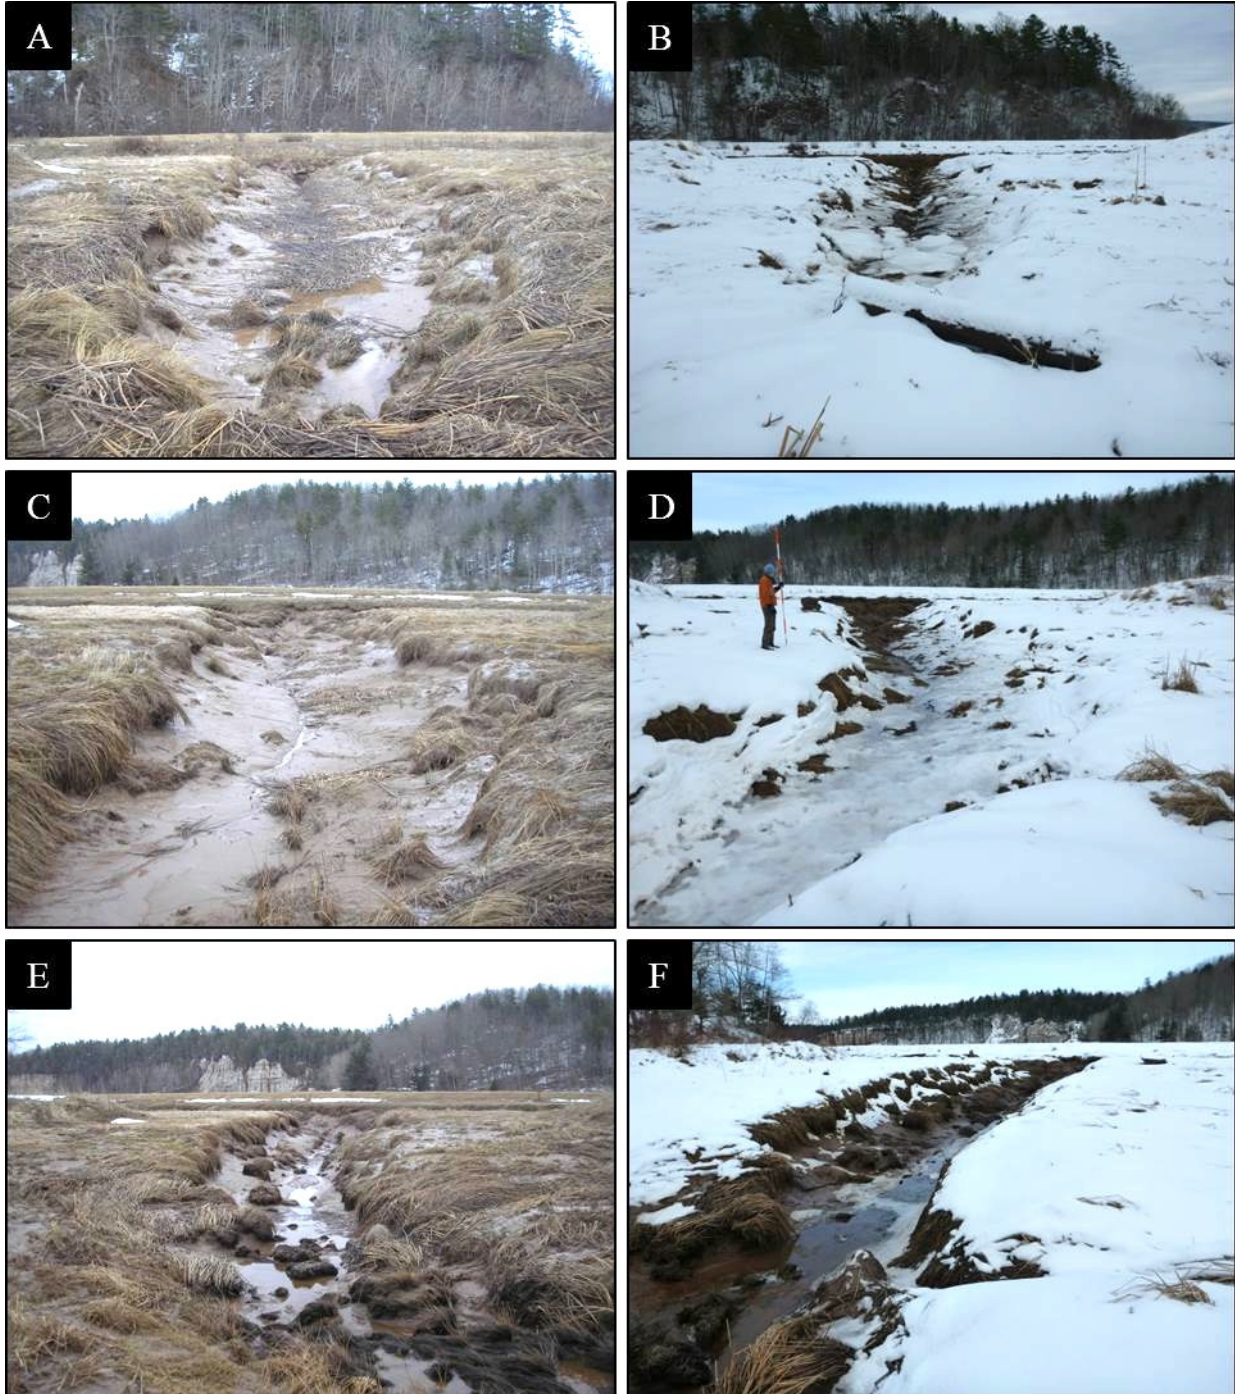
Figure 45 Channels at SCW in 2013 (left) and 2014 (right) starting with the creek closest to the aboiteau channel (A/B) and working to back of the site (E/F). Photographs by CBWES Inc., 21 February 2014.

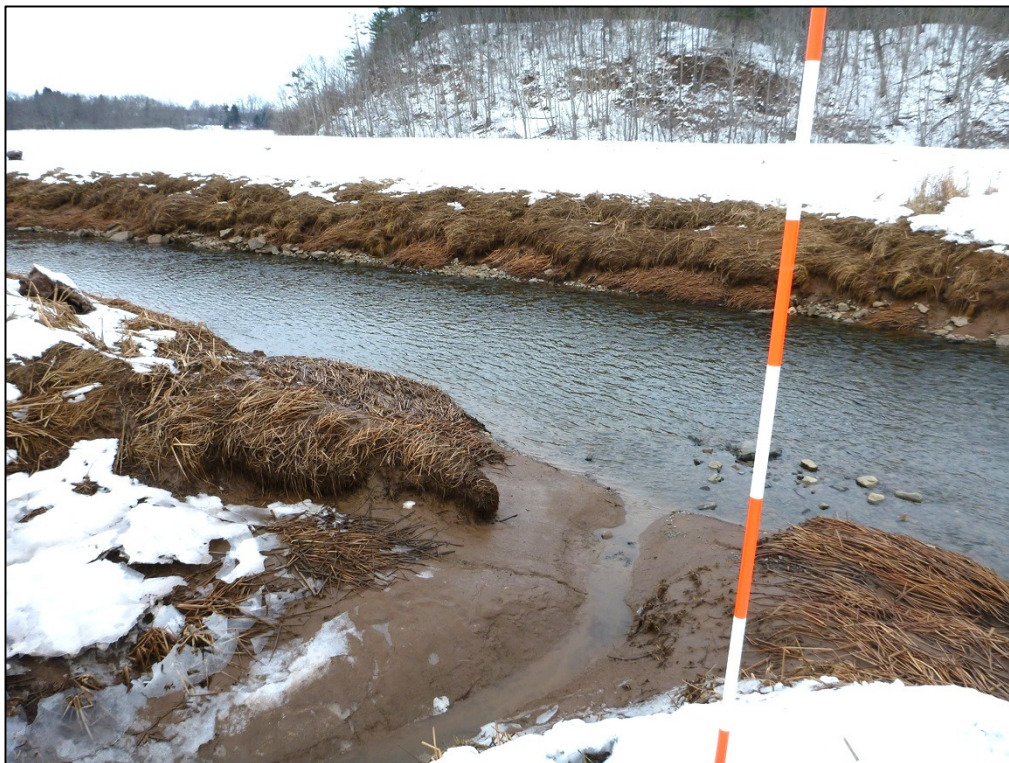
Figure 46 Mouth of excavated channel at SCE, 21 February 2014.

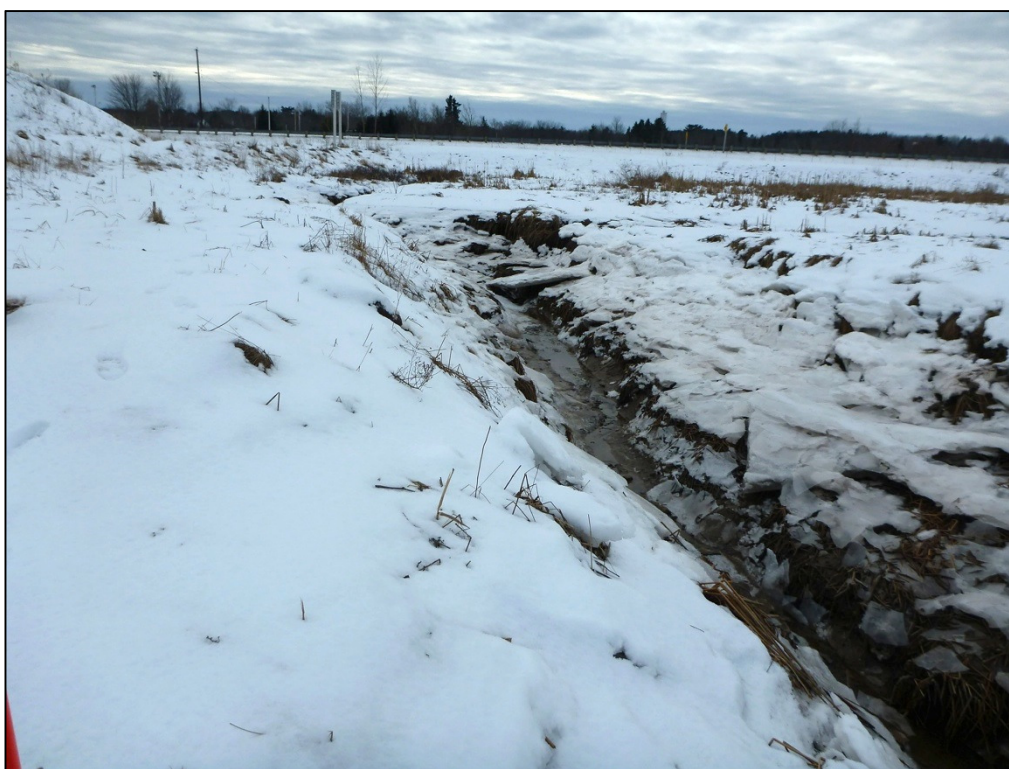
Figure 47 Excavated channel at SCE, 21 February 2014.

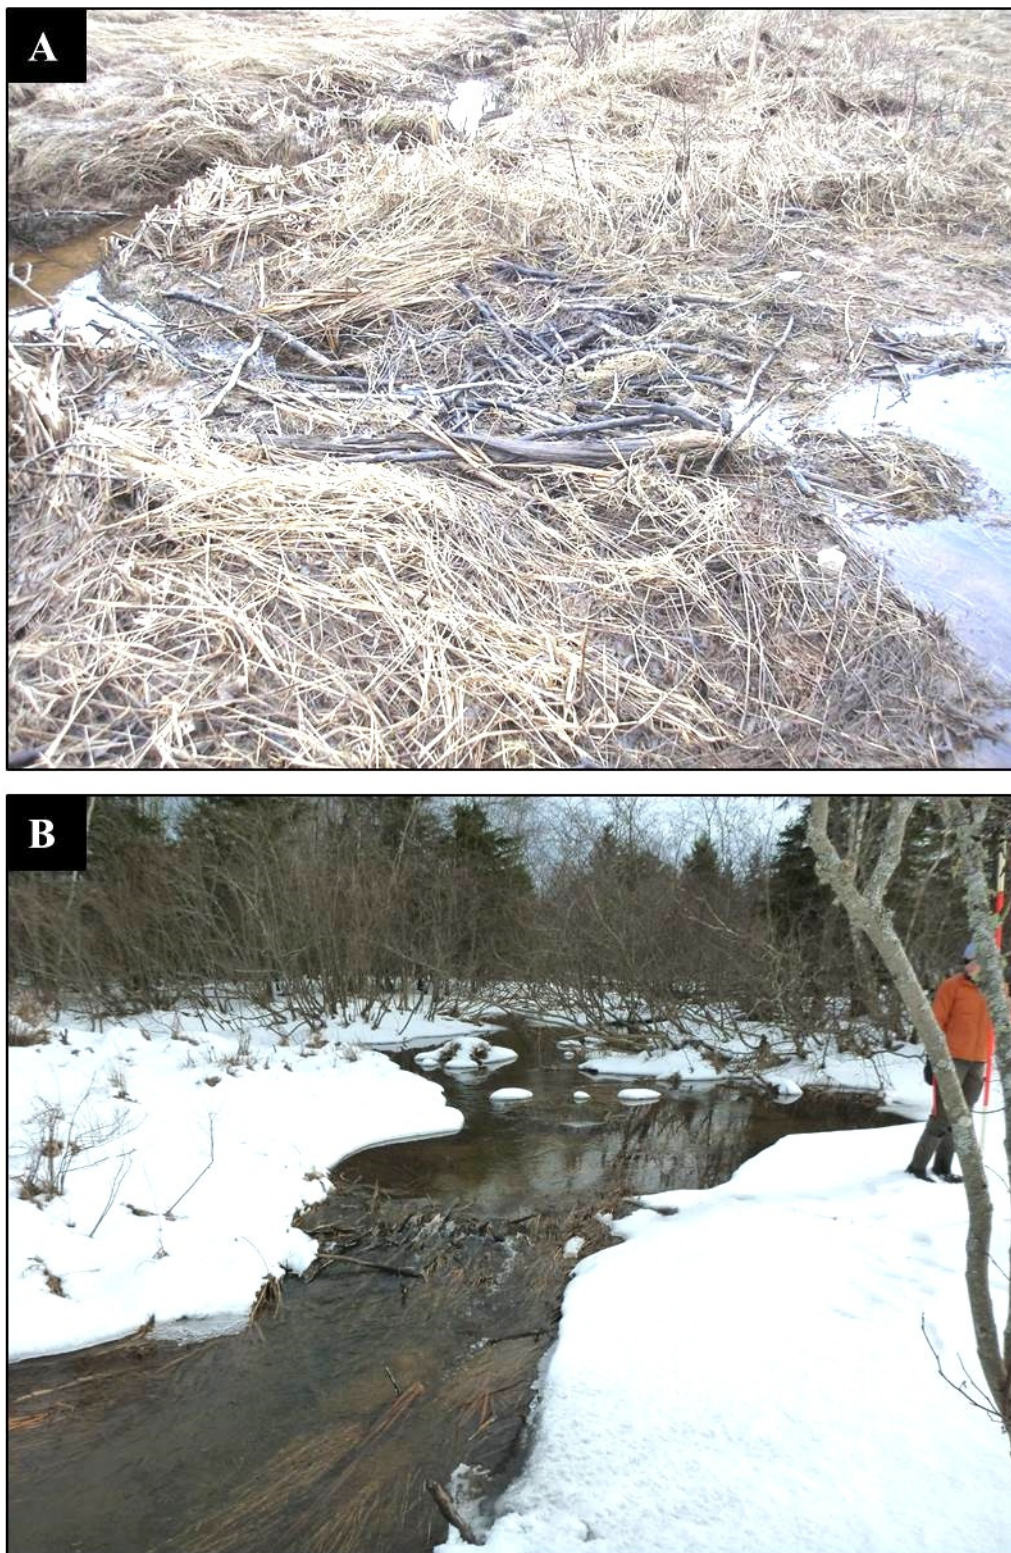
Figure 48 Small beaver dam at SCP that flooded the old access road and into the back portion of the site in A) 6 March 2013 and B) 21 February 2014.
