What Caused the STINK in Three Fathom Harbour in Summer 2015?

**Bob Pett, Ph.D., Environmental Analyst
September 30, 2015**

Wetland Restoration Project to Offset Wetland Loss at the New Lakeview Elementary School

Project Restores Tidal Flushing to the Causeway 'Pond'

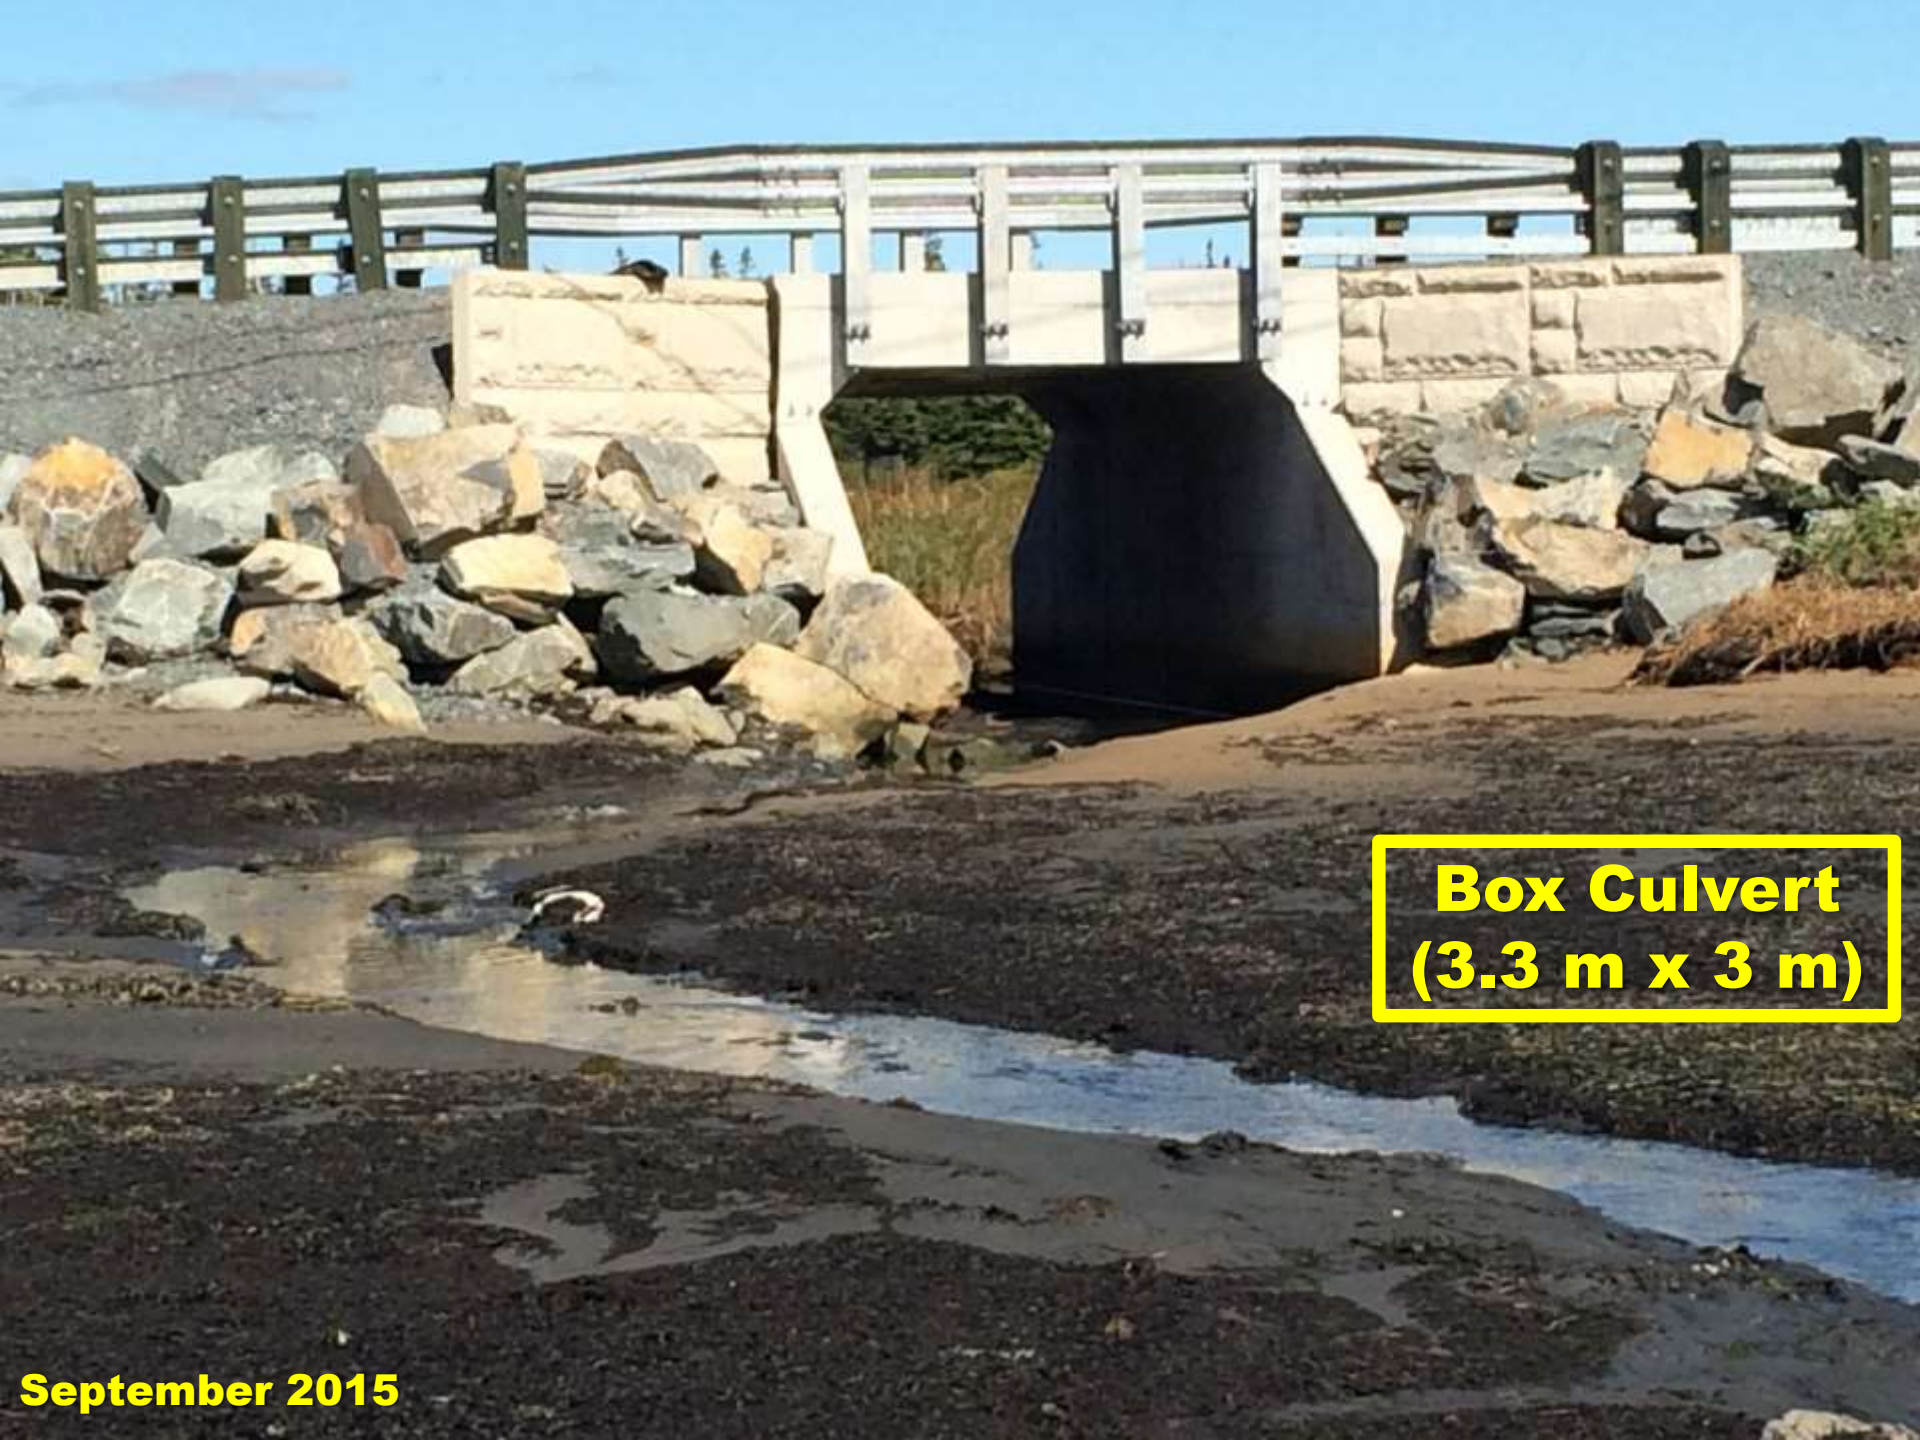
September 2010

**Buried Culvert
(0.82 m D)**

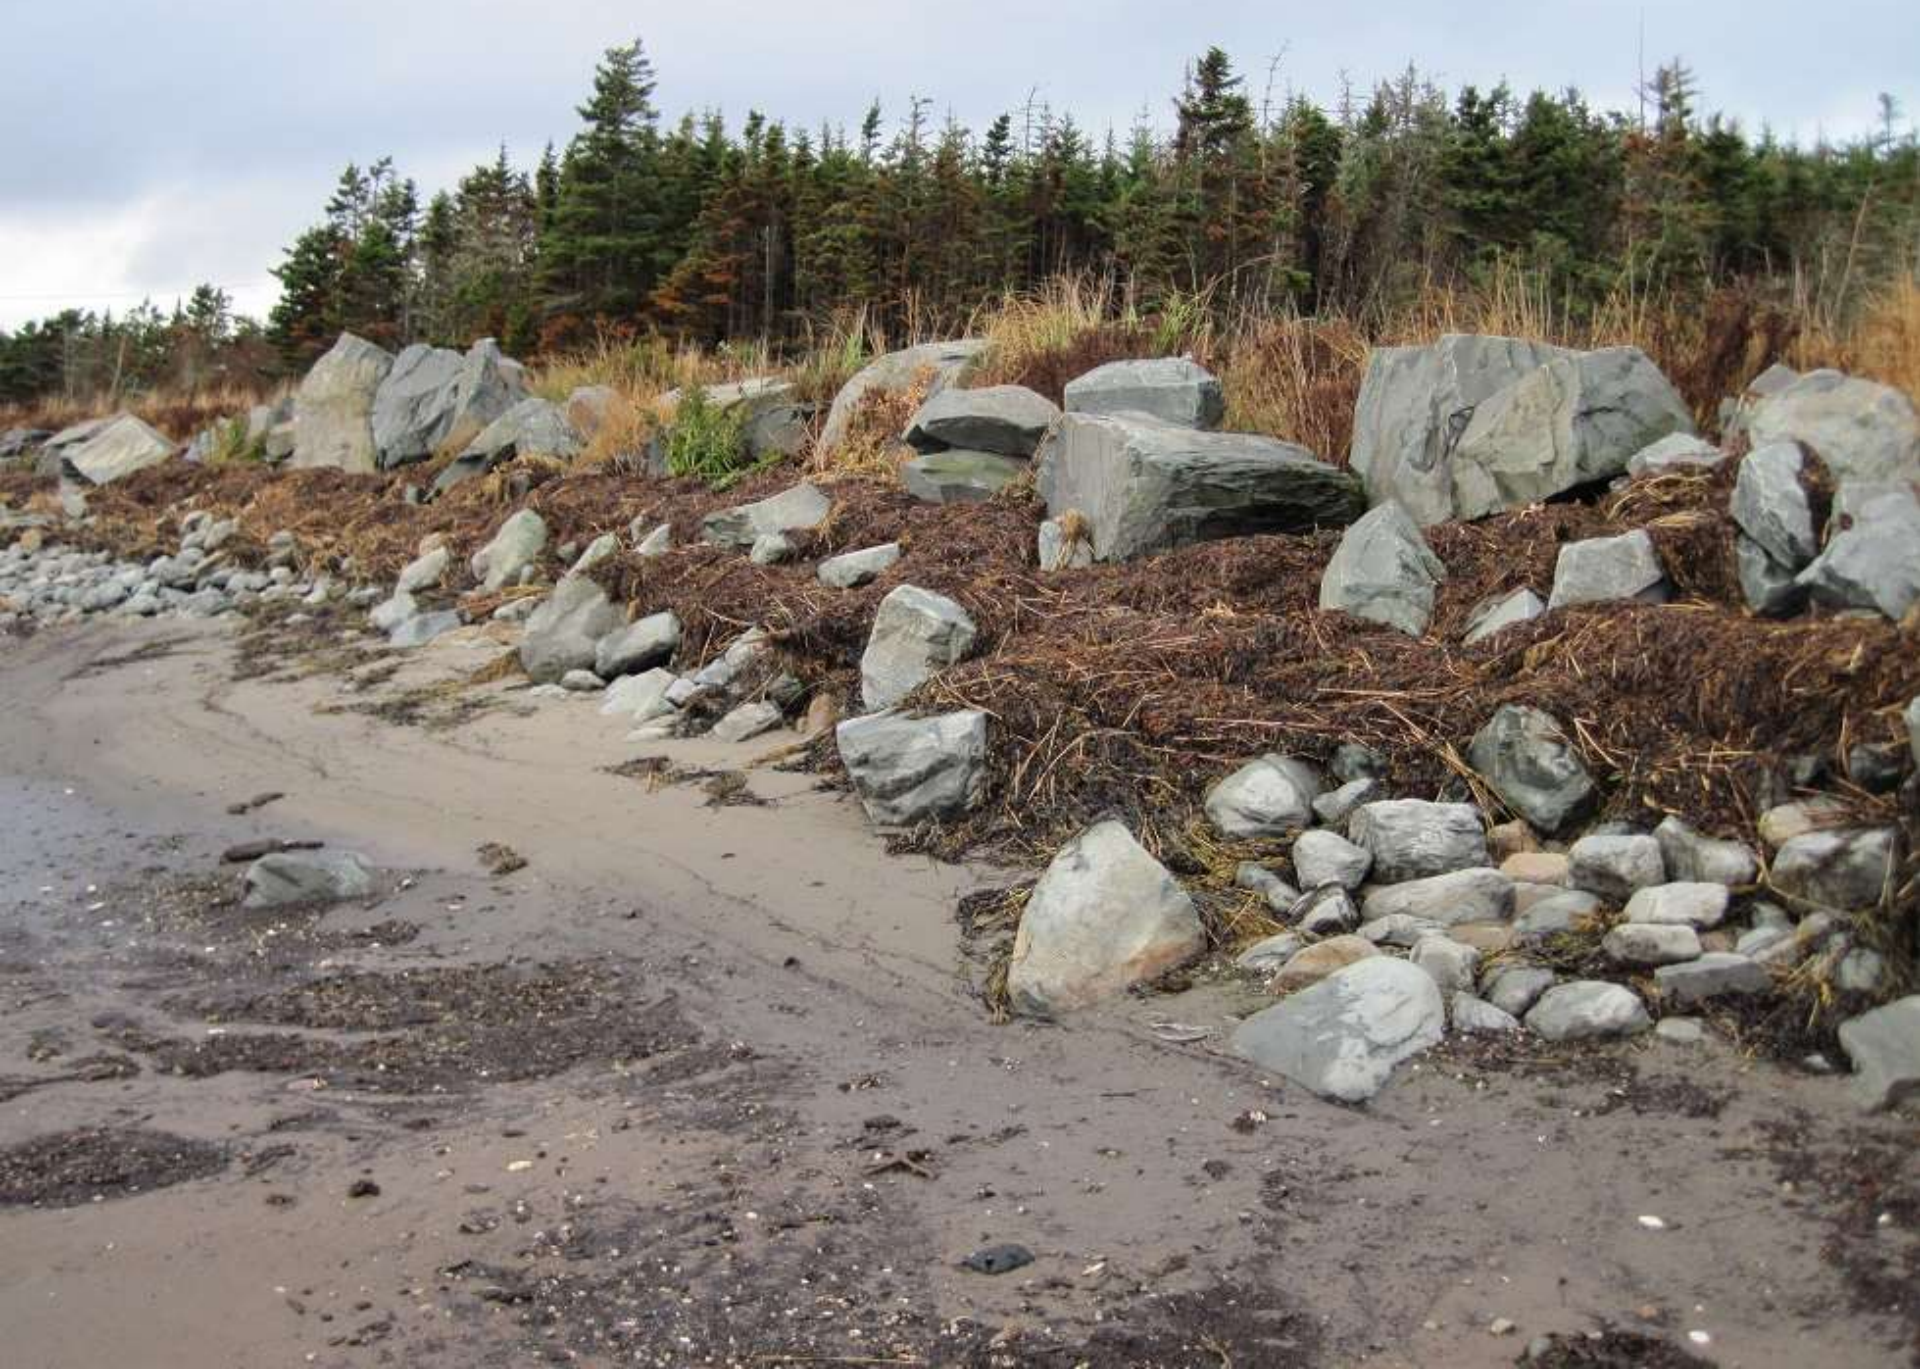
September 2010

**Very little seaweed
wrack on the beach
in September 2010**

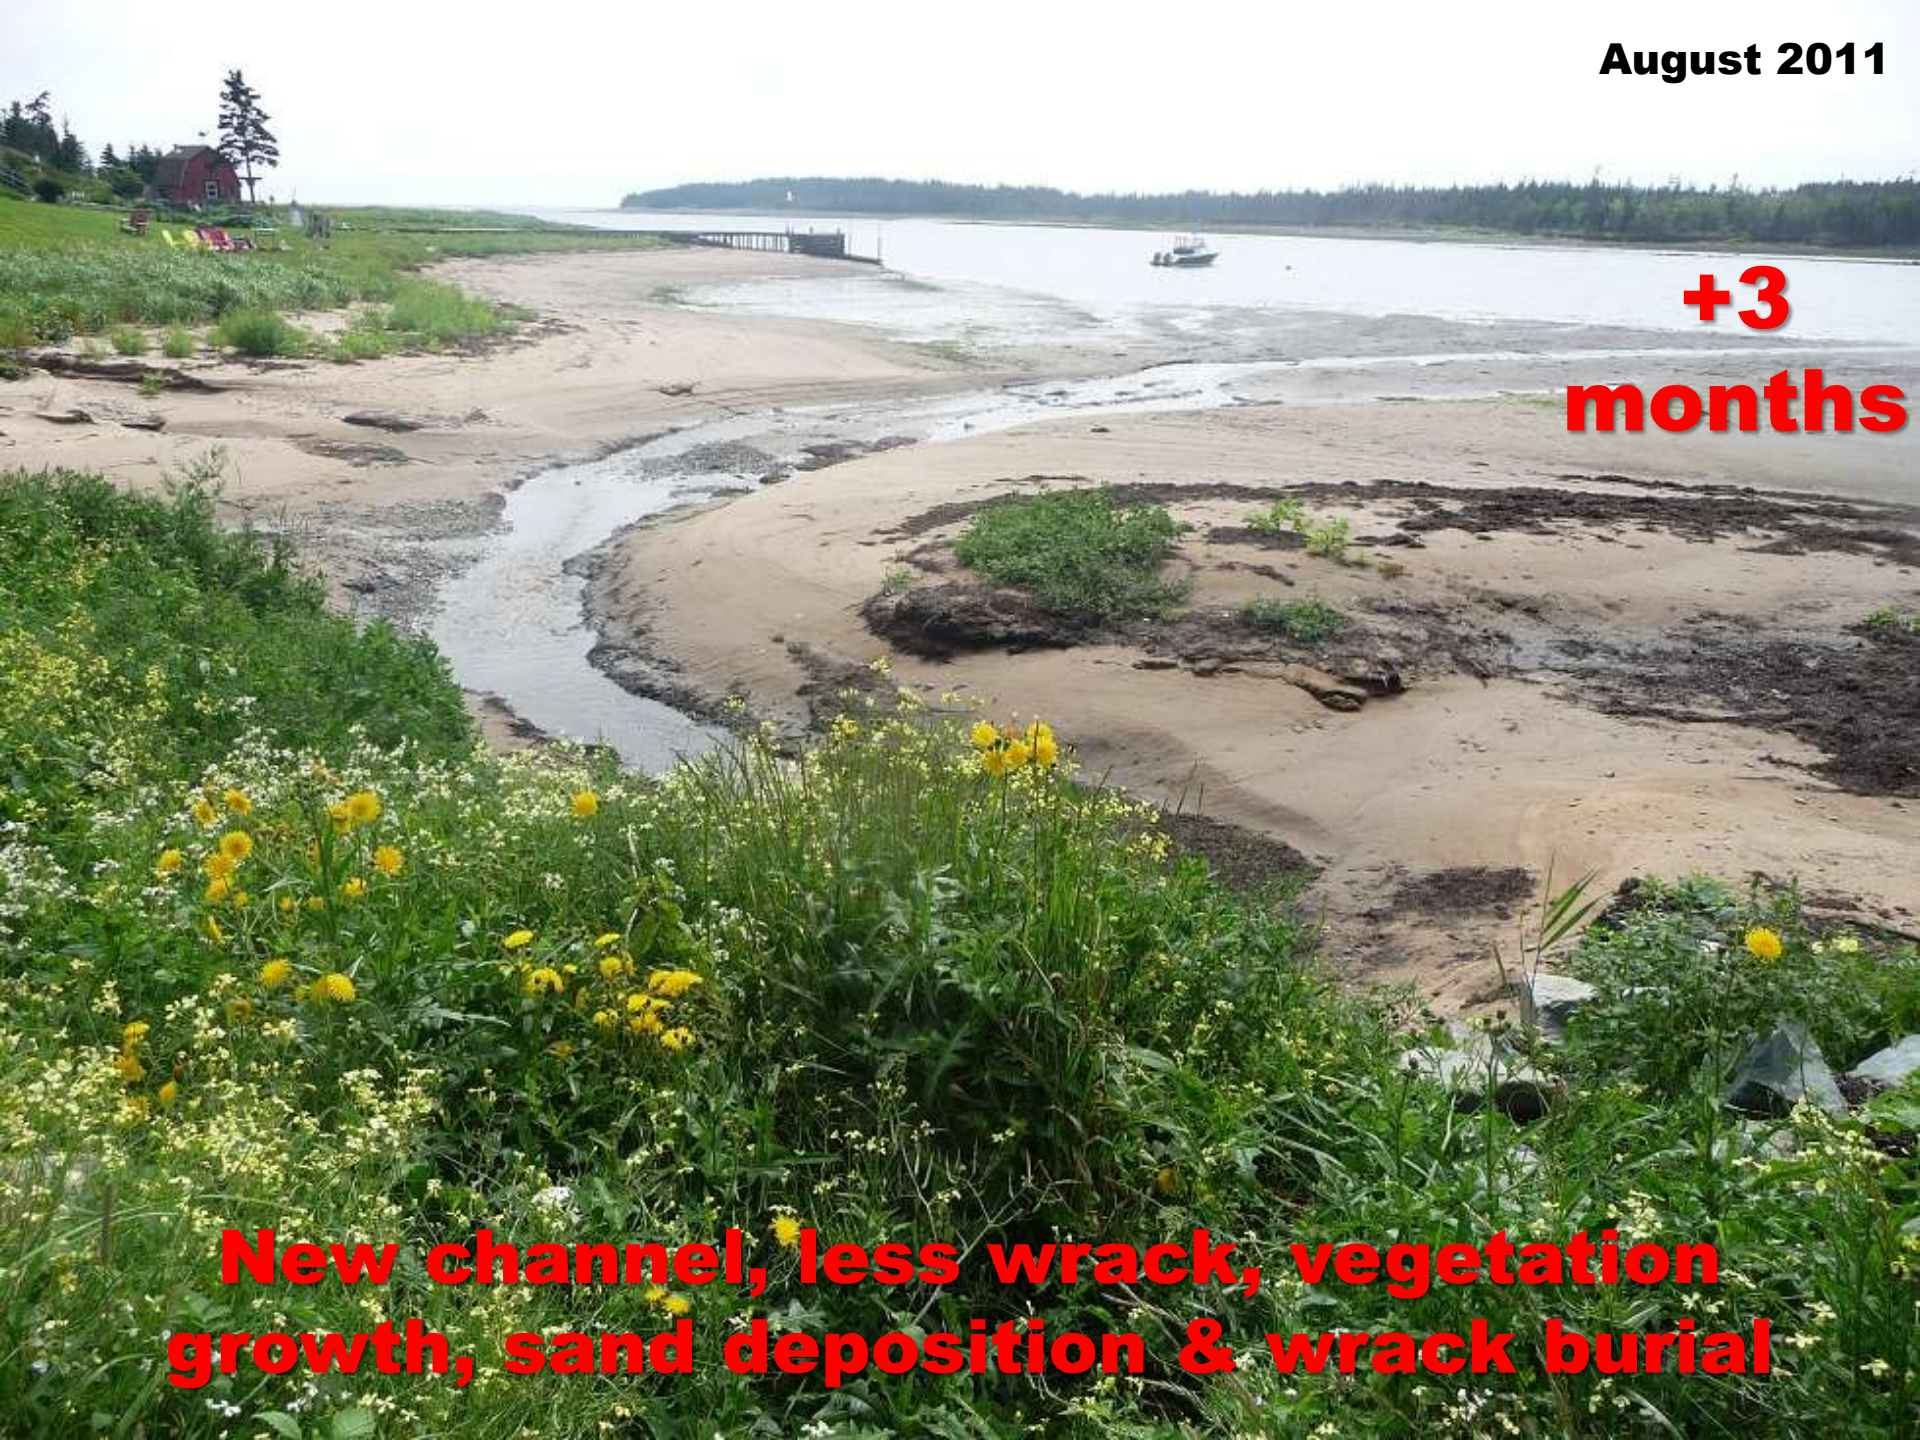
May 2011

**Considerable deposit
of seaweed wrack
after the winter**

**Recent rain storm
blew-out the culvert
and drained the pond**

**Rare
Event**

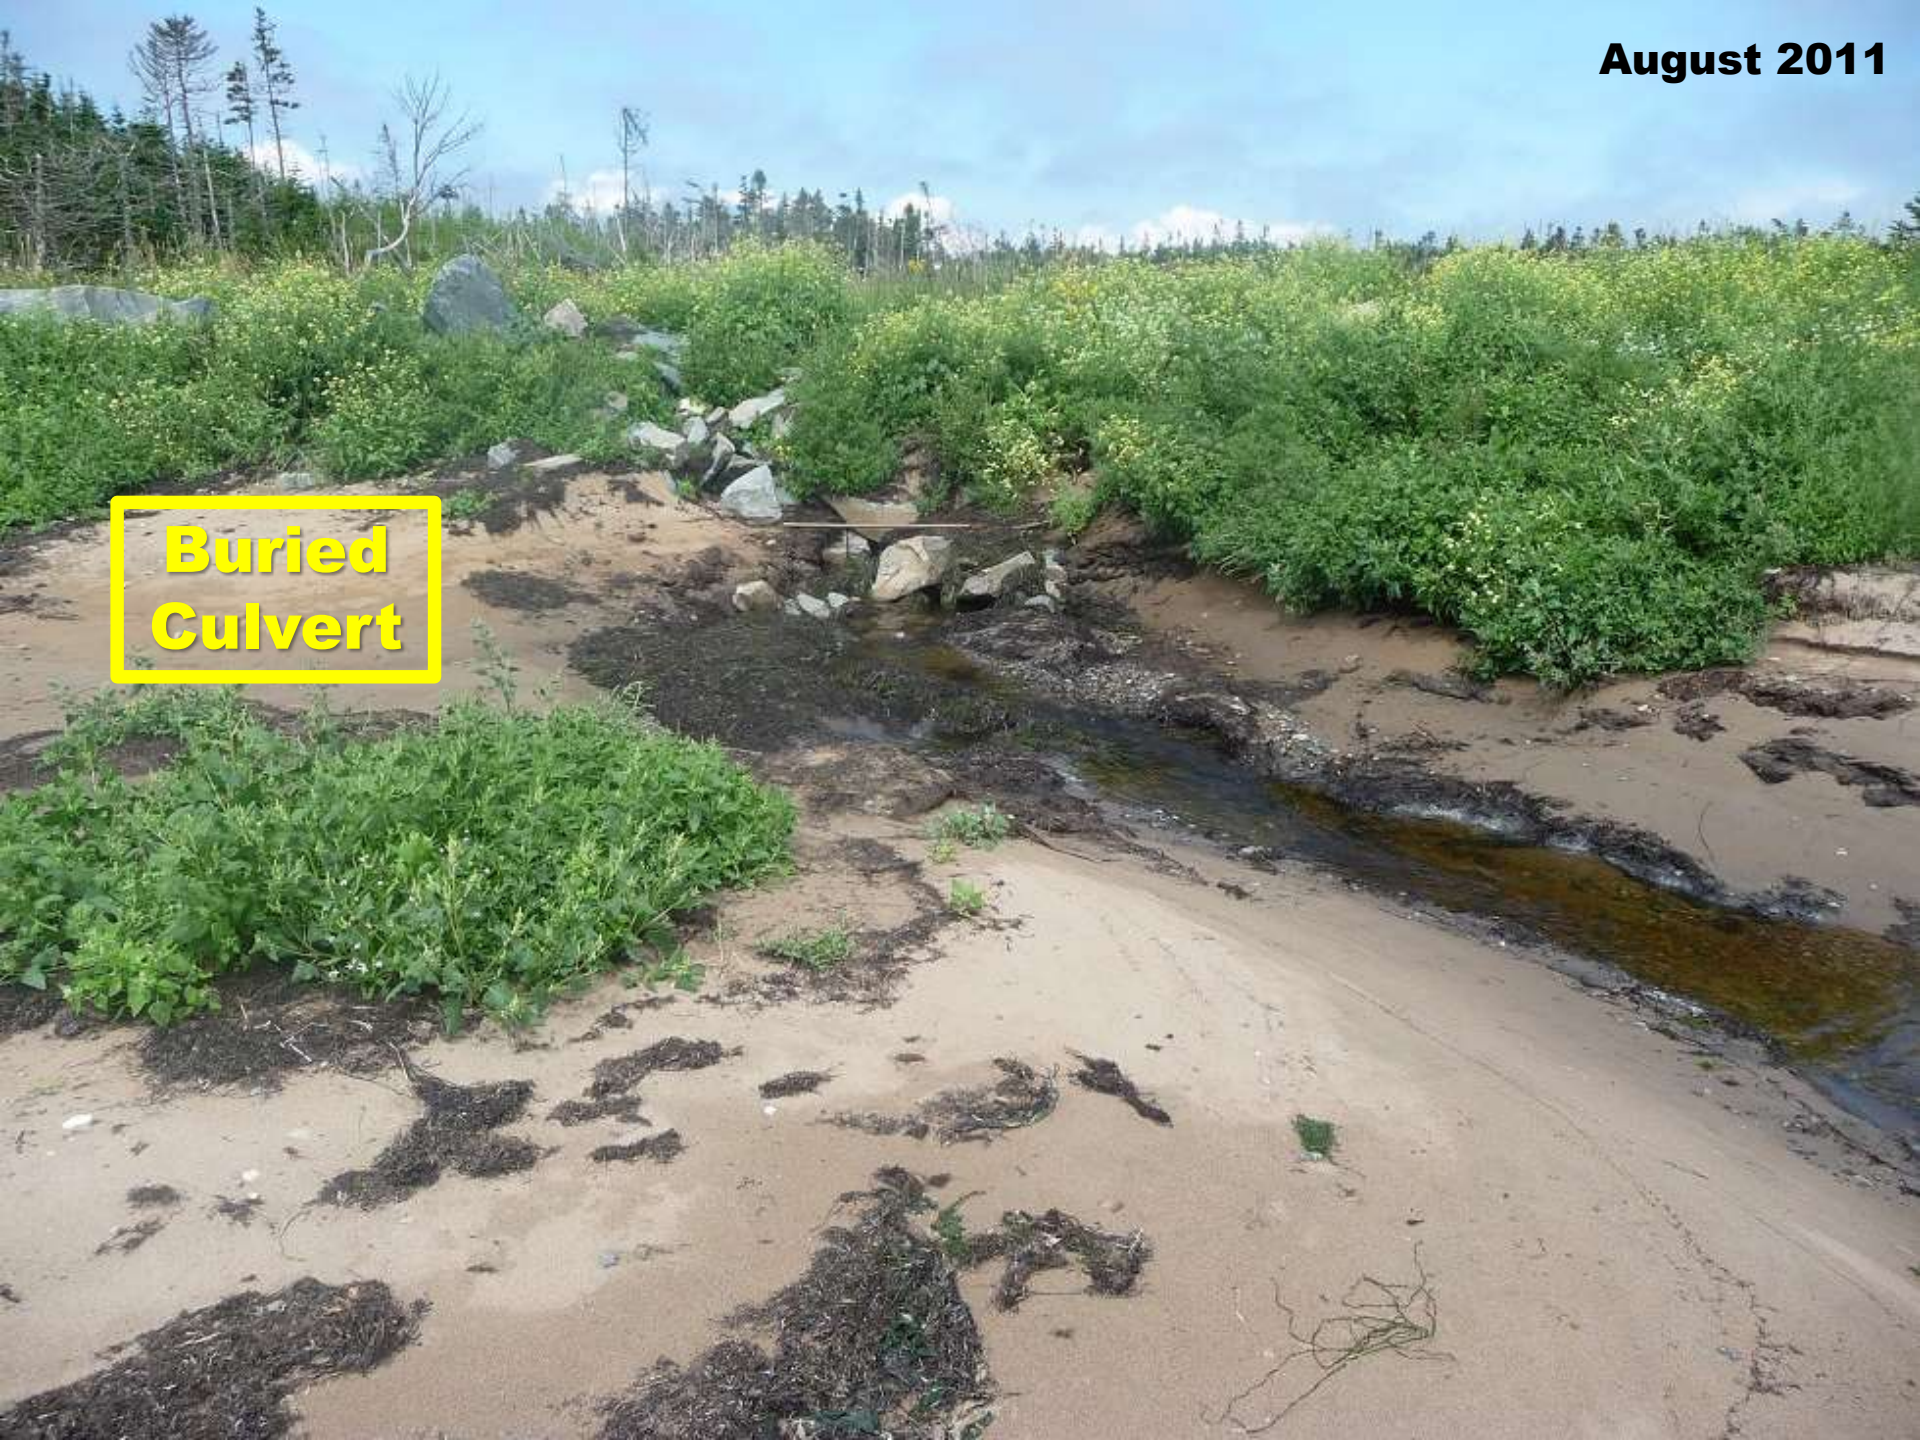
August 2011

**New channel, less wrack, vegetation
growth, sand deposition & wrack burial**

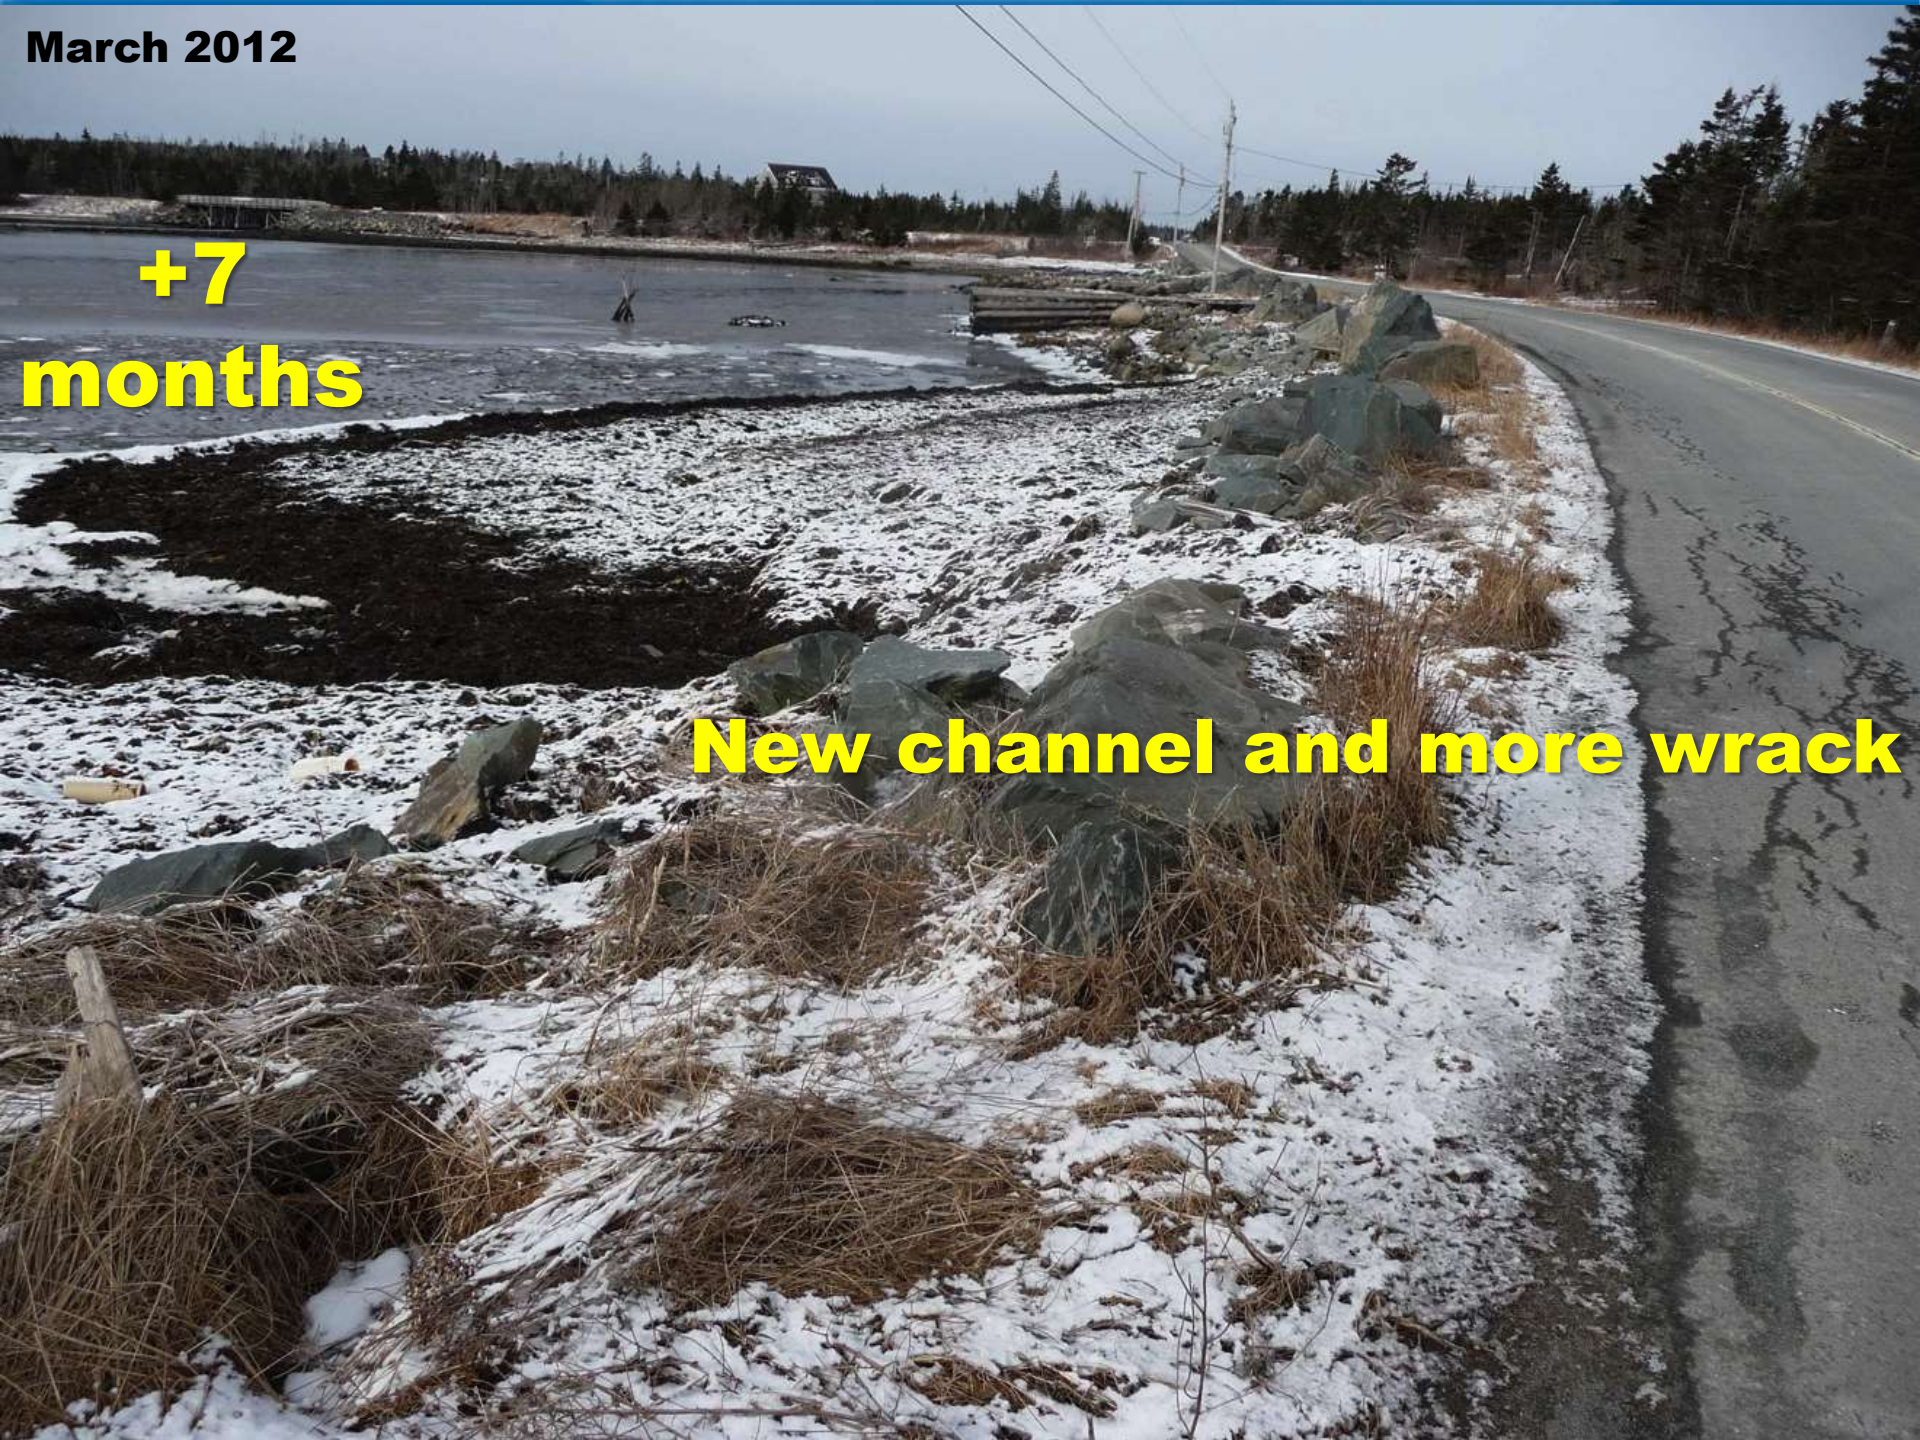
August 2011

**Buried
Culvert**

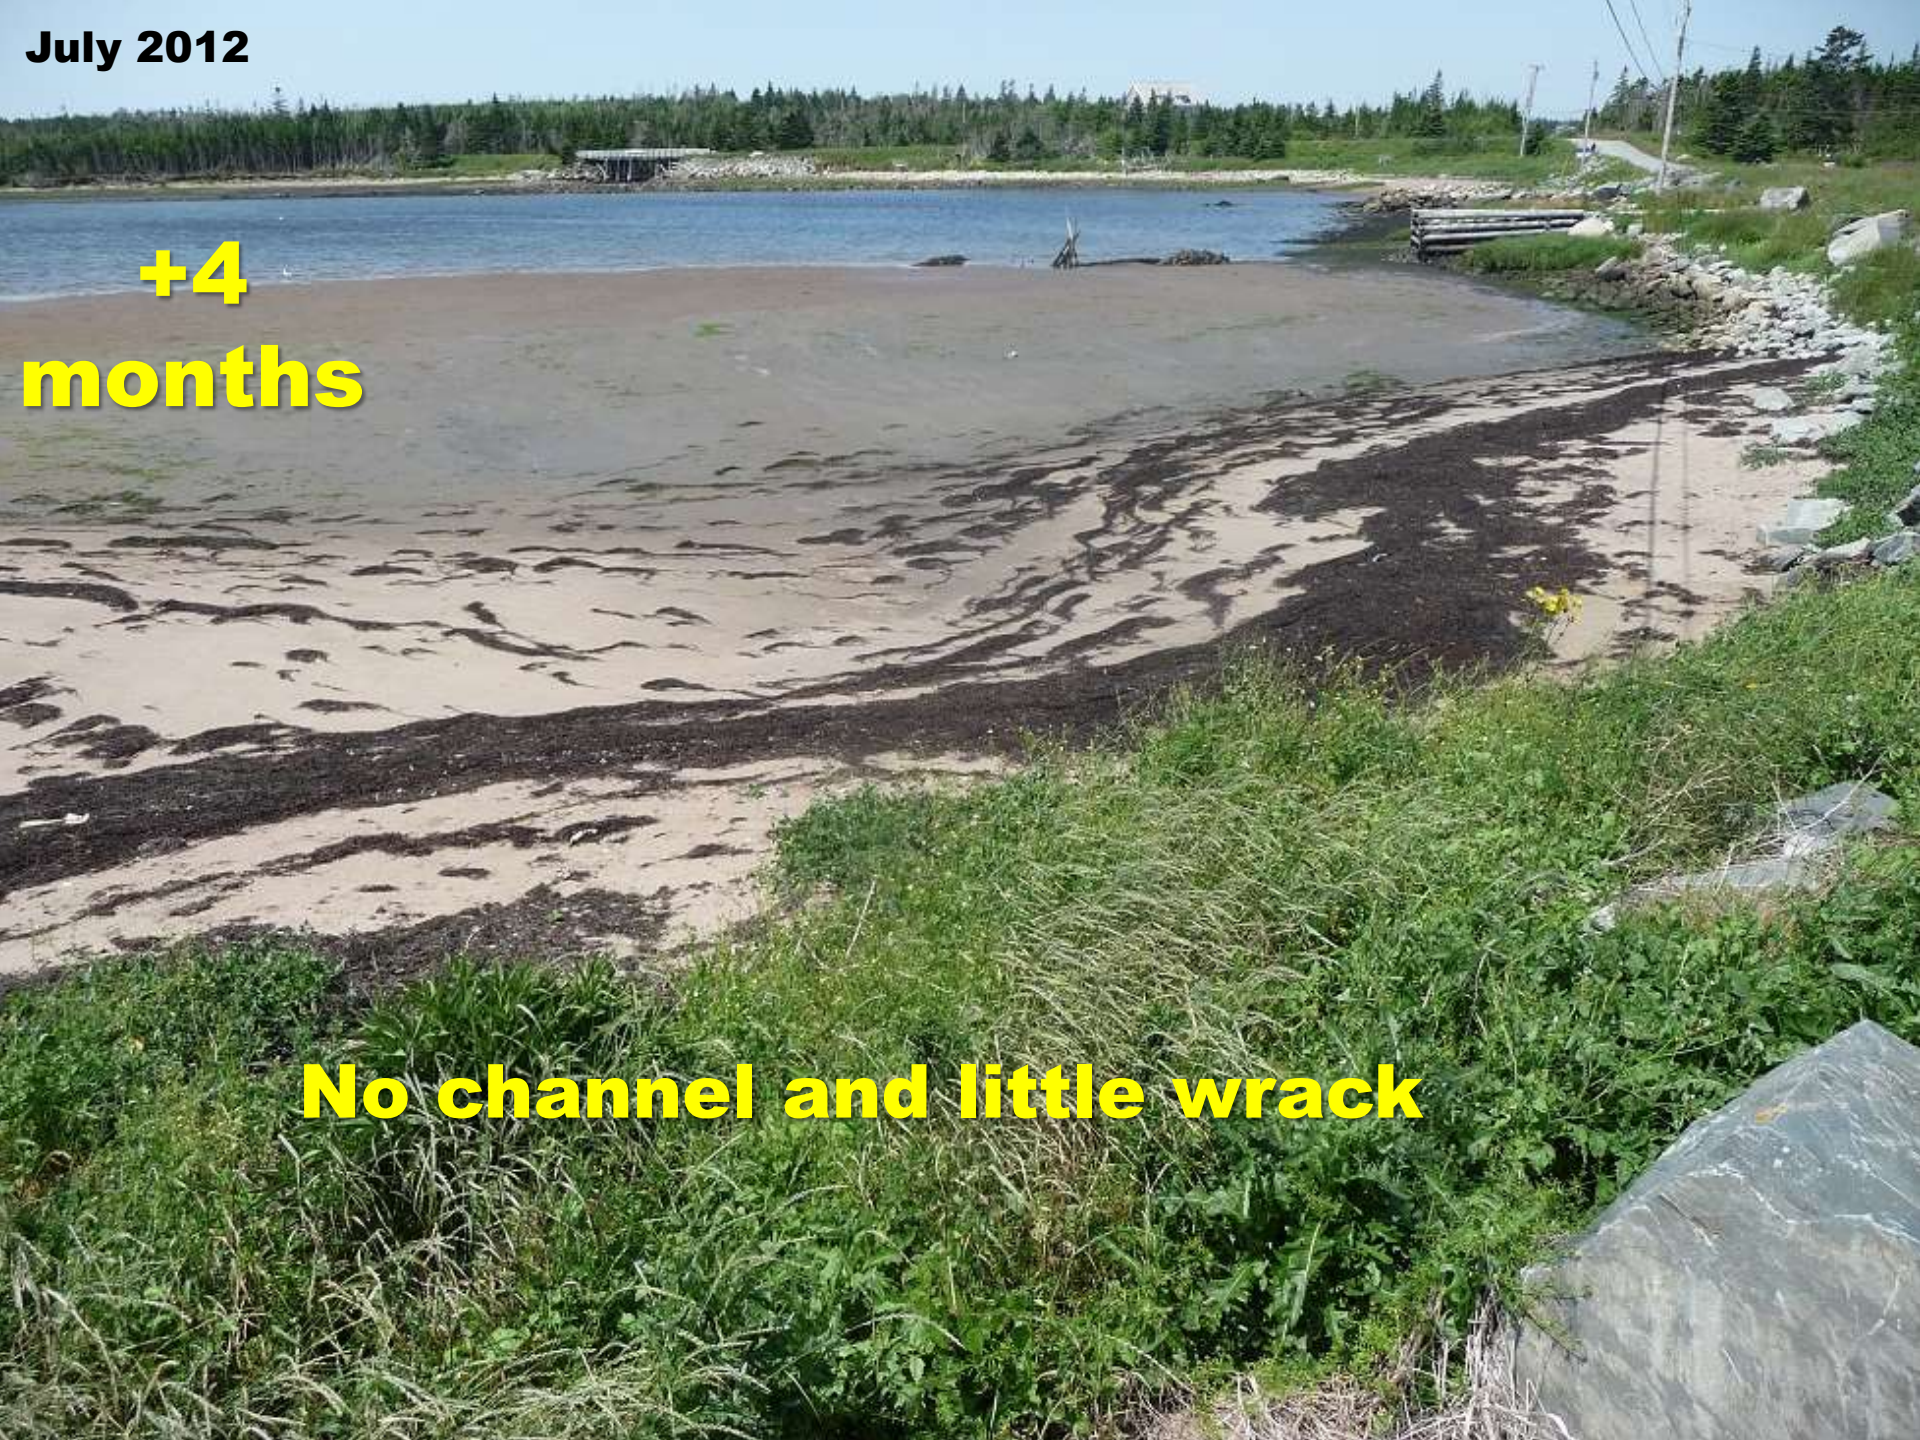
March 2012

New channel and more wrack

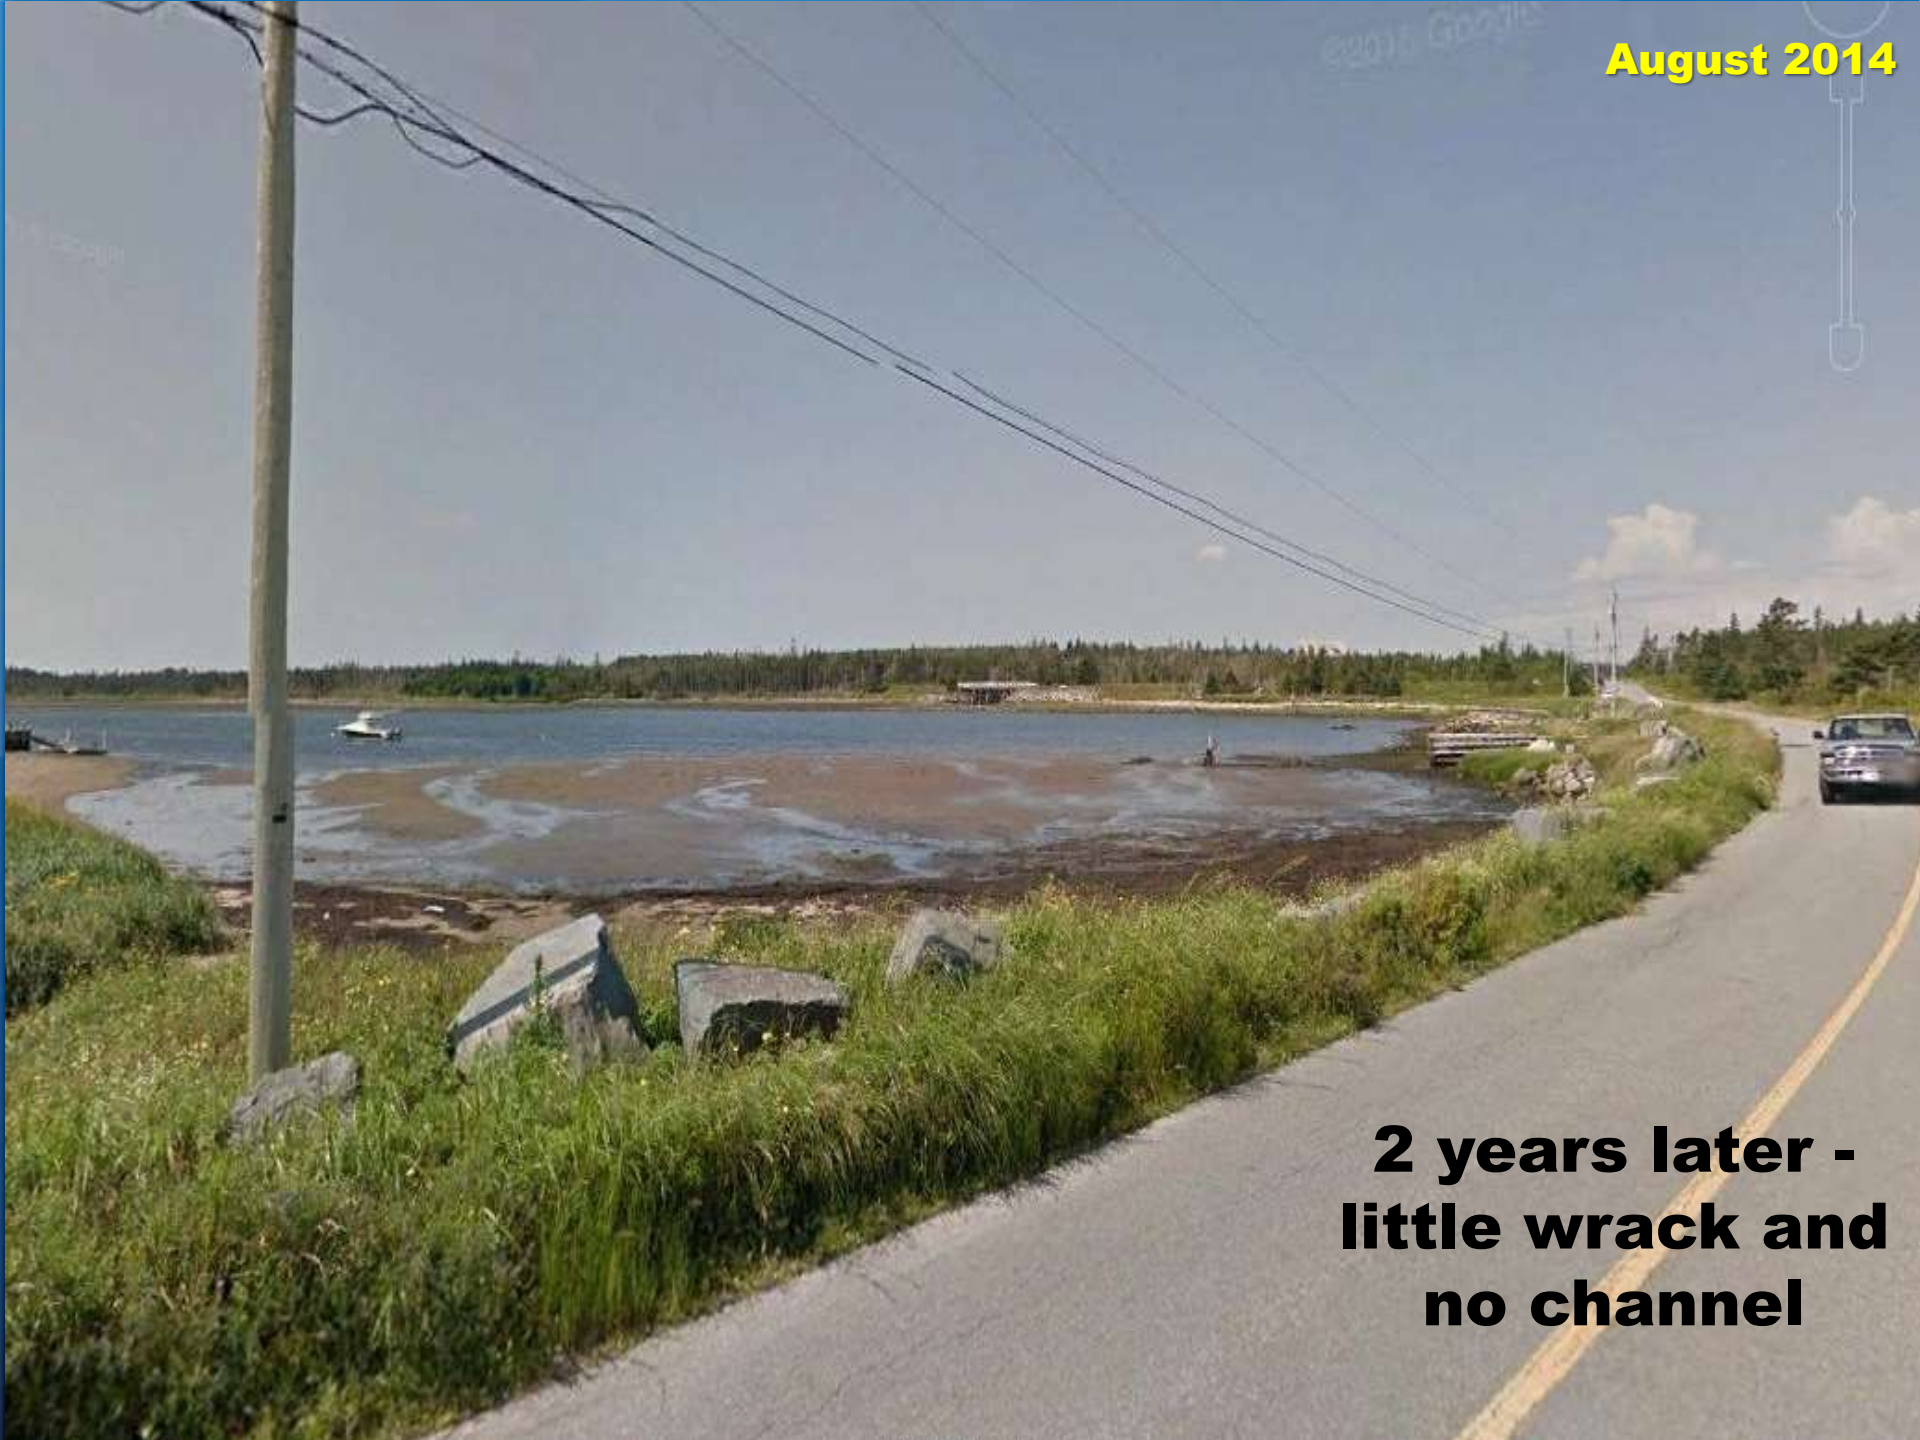
July 2012

No channel and little wrack

Appears to be a pattern of wrack deposition in fall and winter and clearing out (& burial) through the summer months.

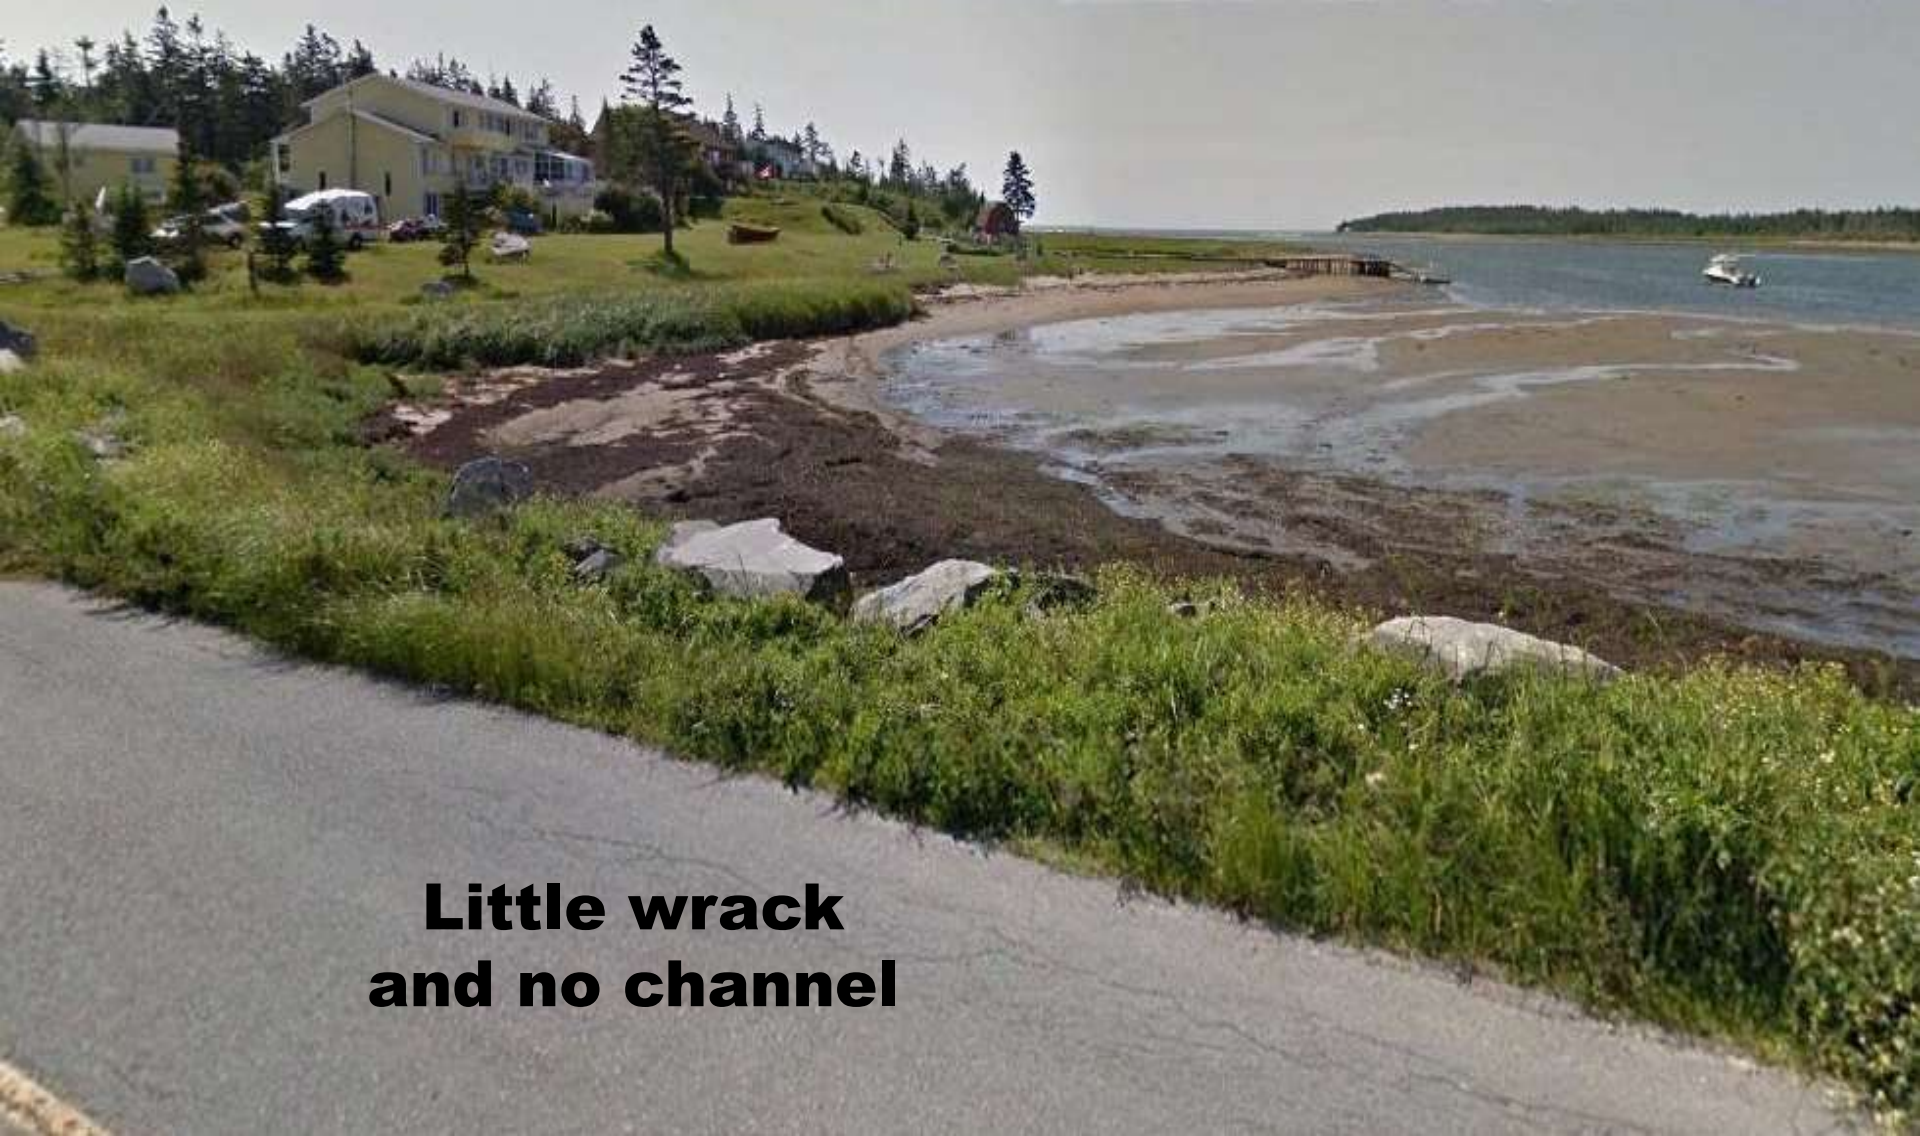
August 2014

**2 years later -
little wrack and
no channel**
