What Caused the STINK in Three Fathom Harbour in Summer 2015?

**Bob Pett, Ph.D., Environmental Analyst
September 30, 2015**

Wetland Restoration Project to Offset Wetland Loss at the New Lakeview Elementary School

Project Restores Tidal Flushing to the Causeway 'Pond'

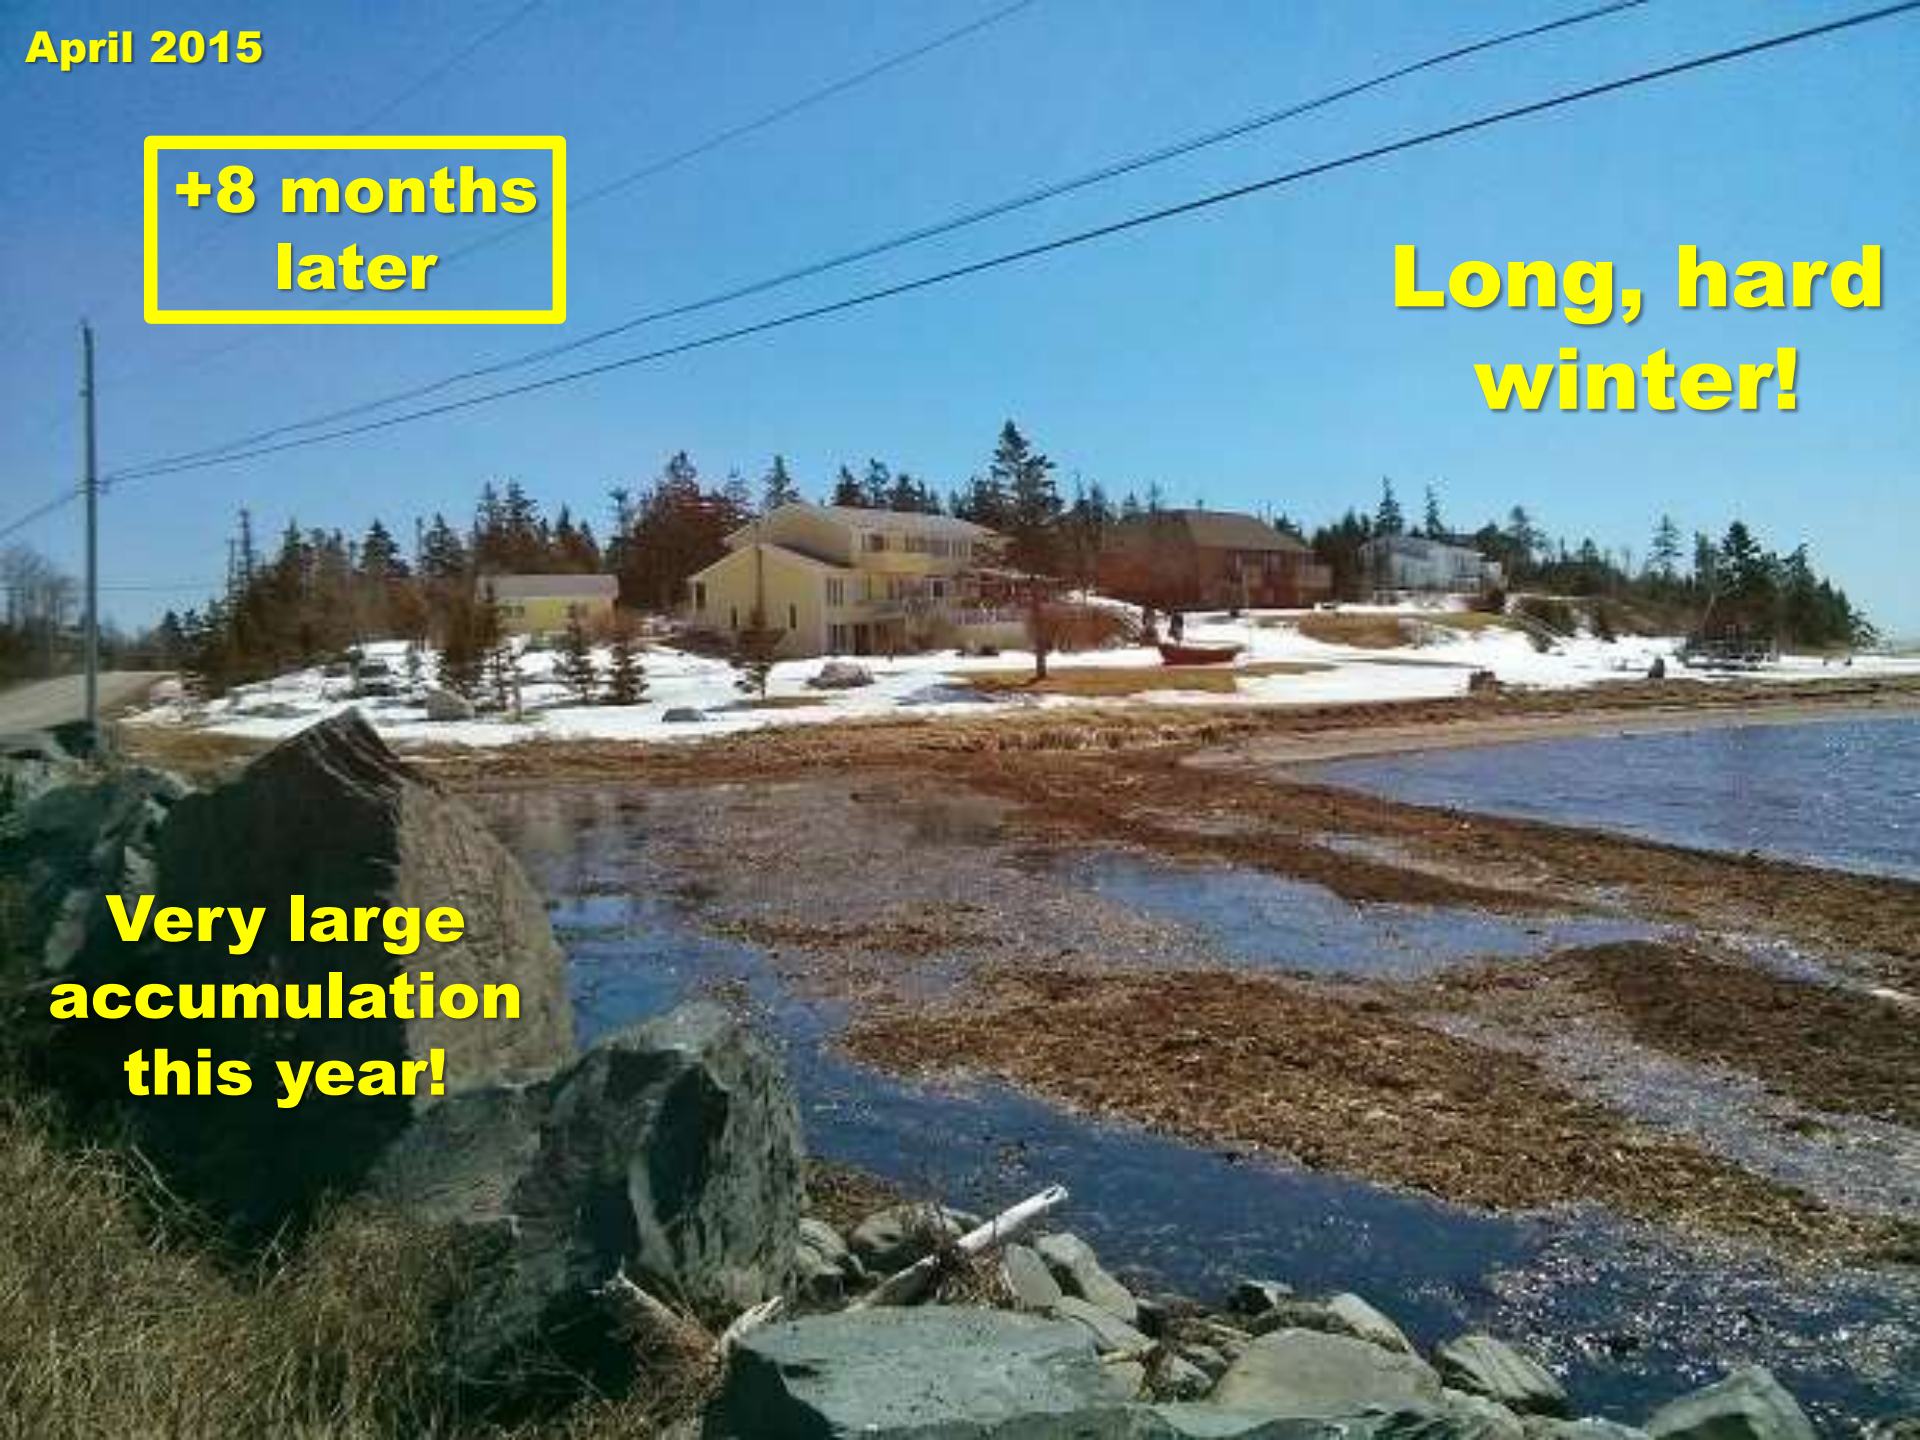
April 2015

**Little wrack
and no channel**

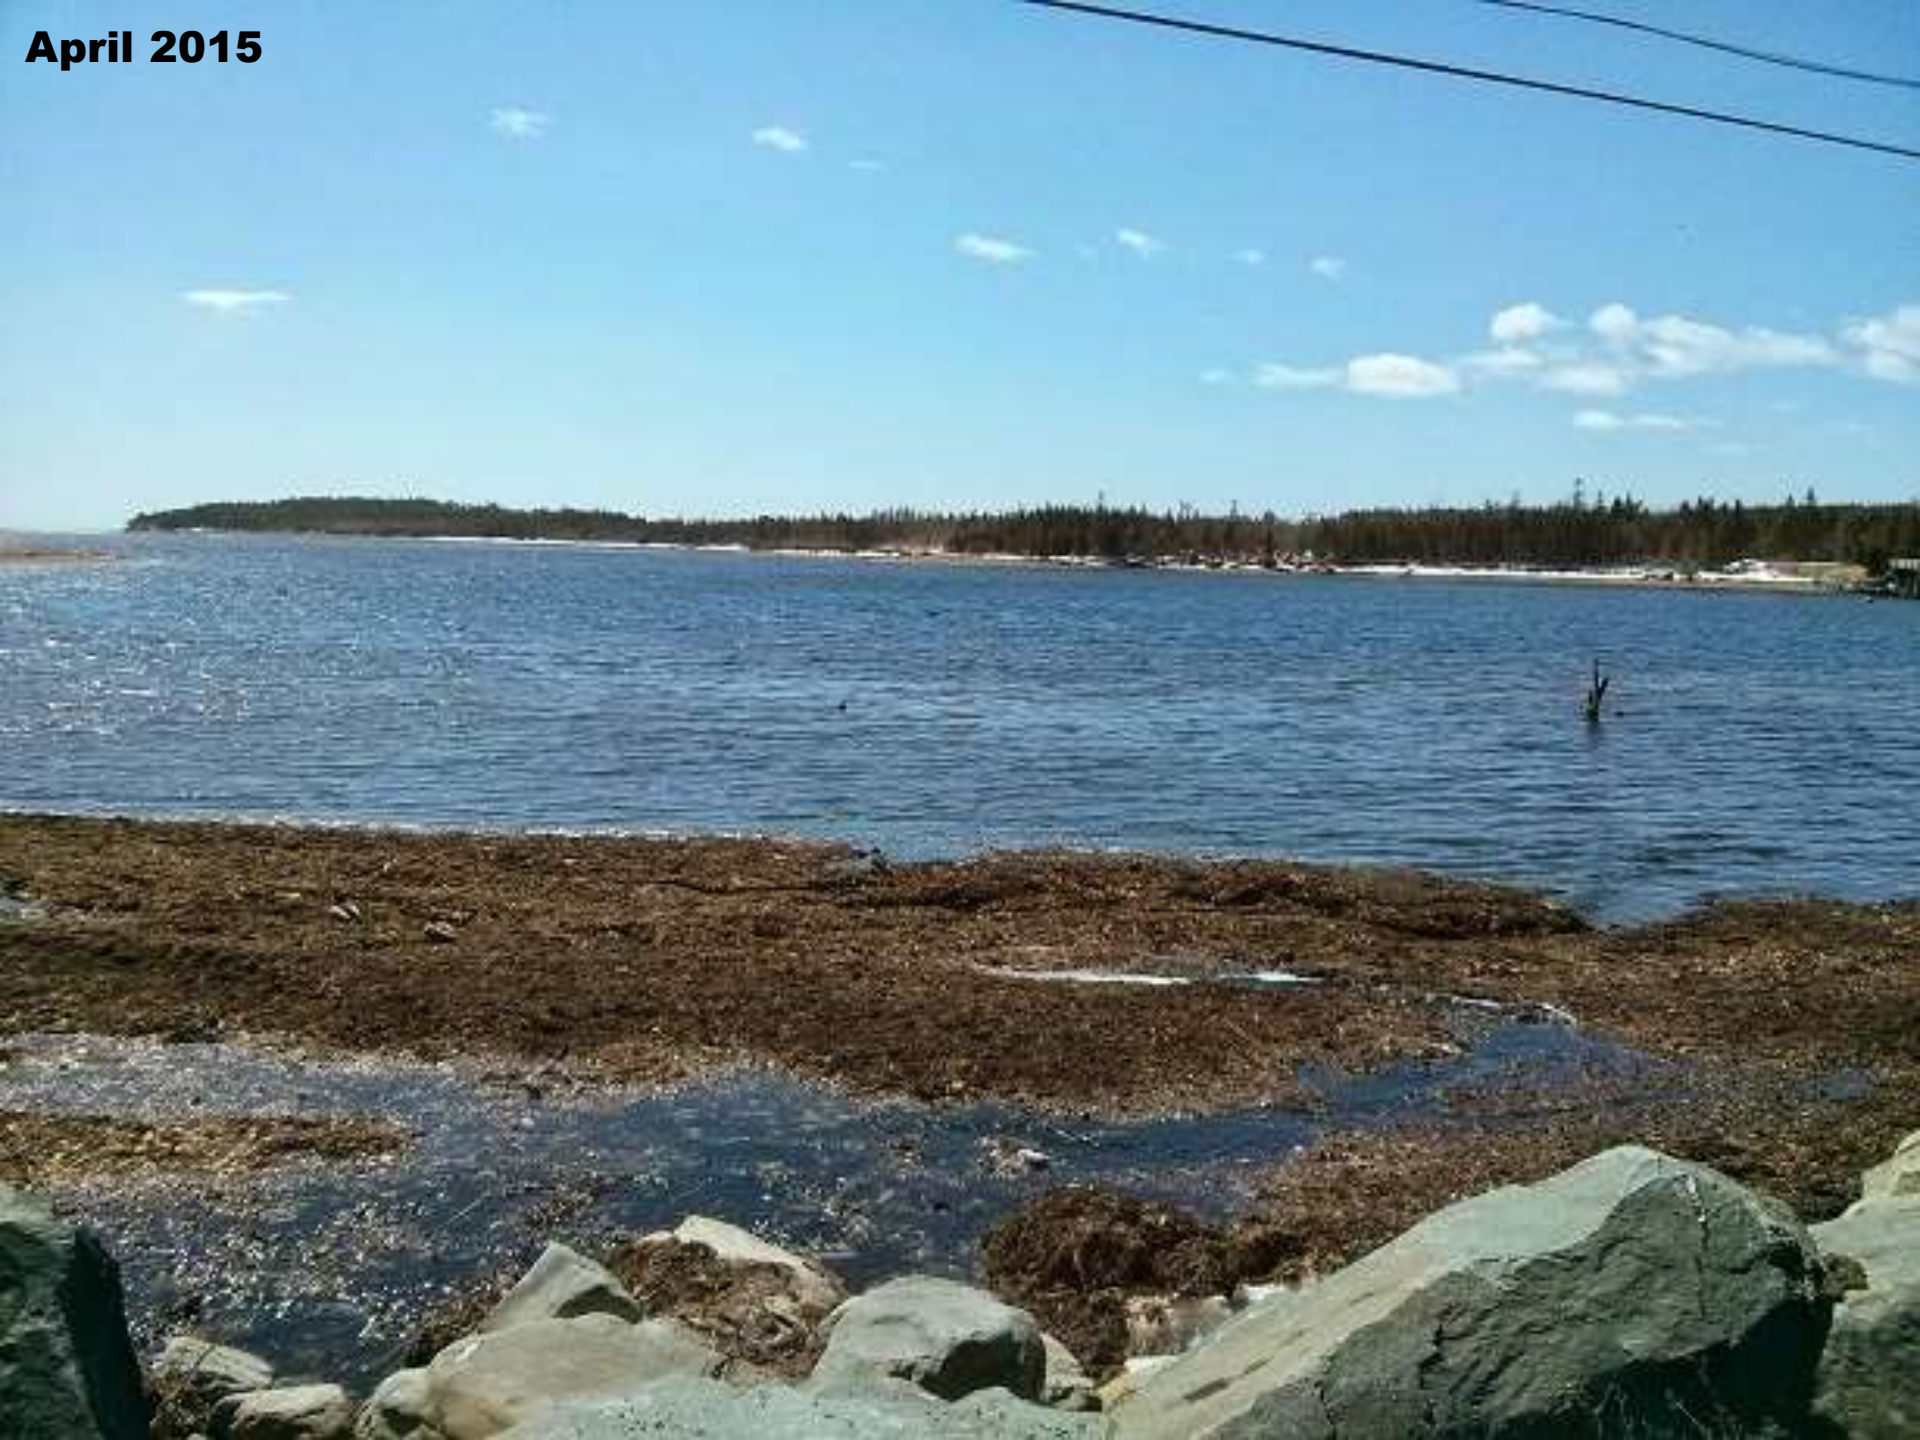
April 2015

**Long, hard
winter!**

**Very large
accumulation
this year!**

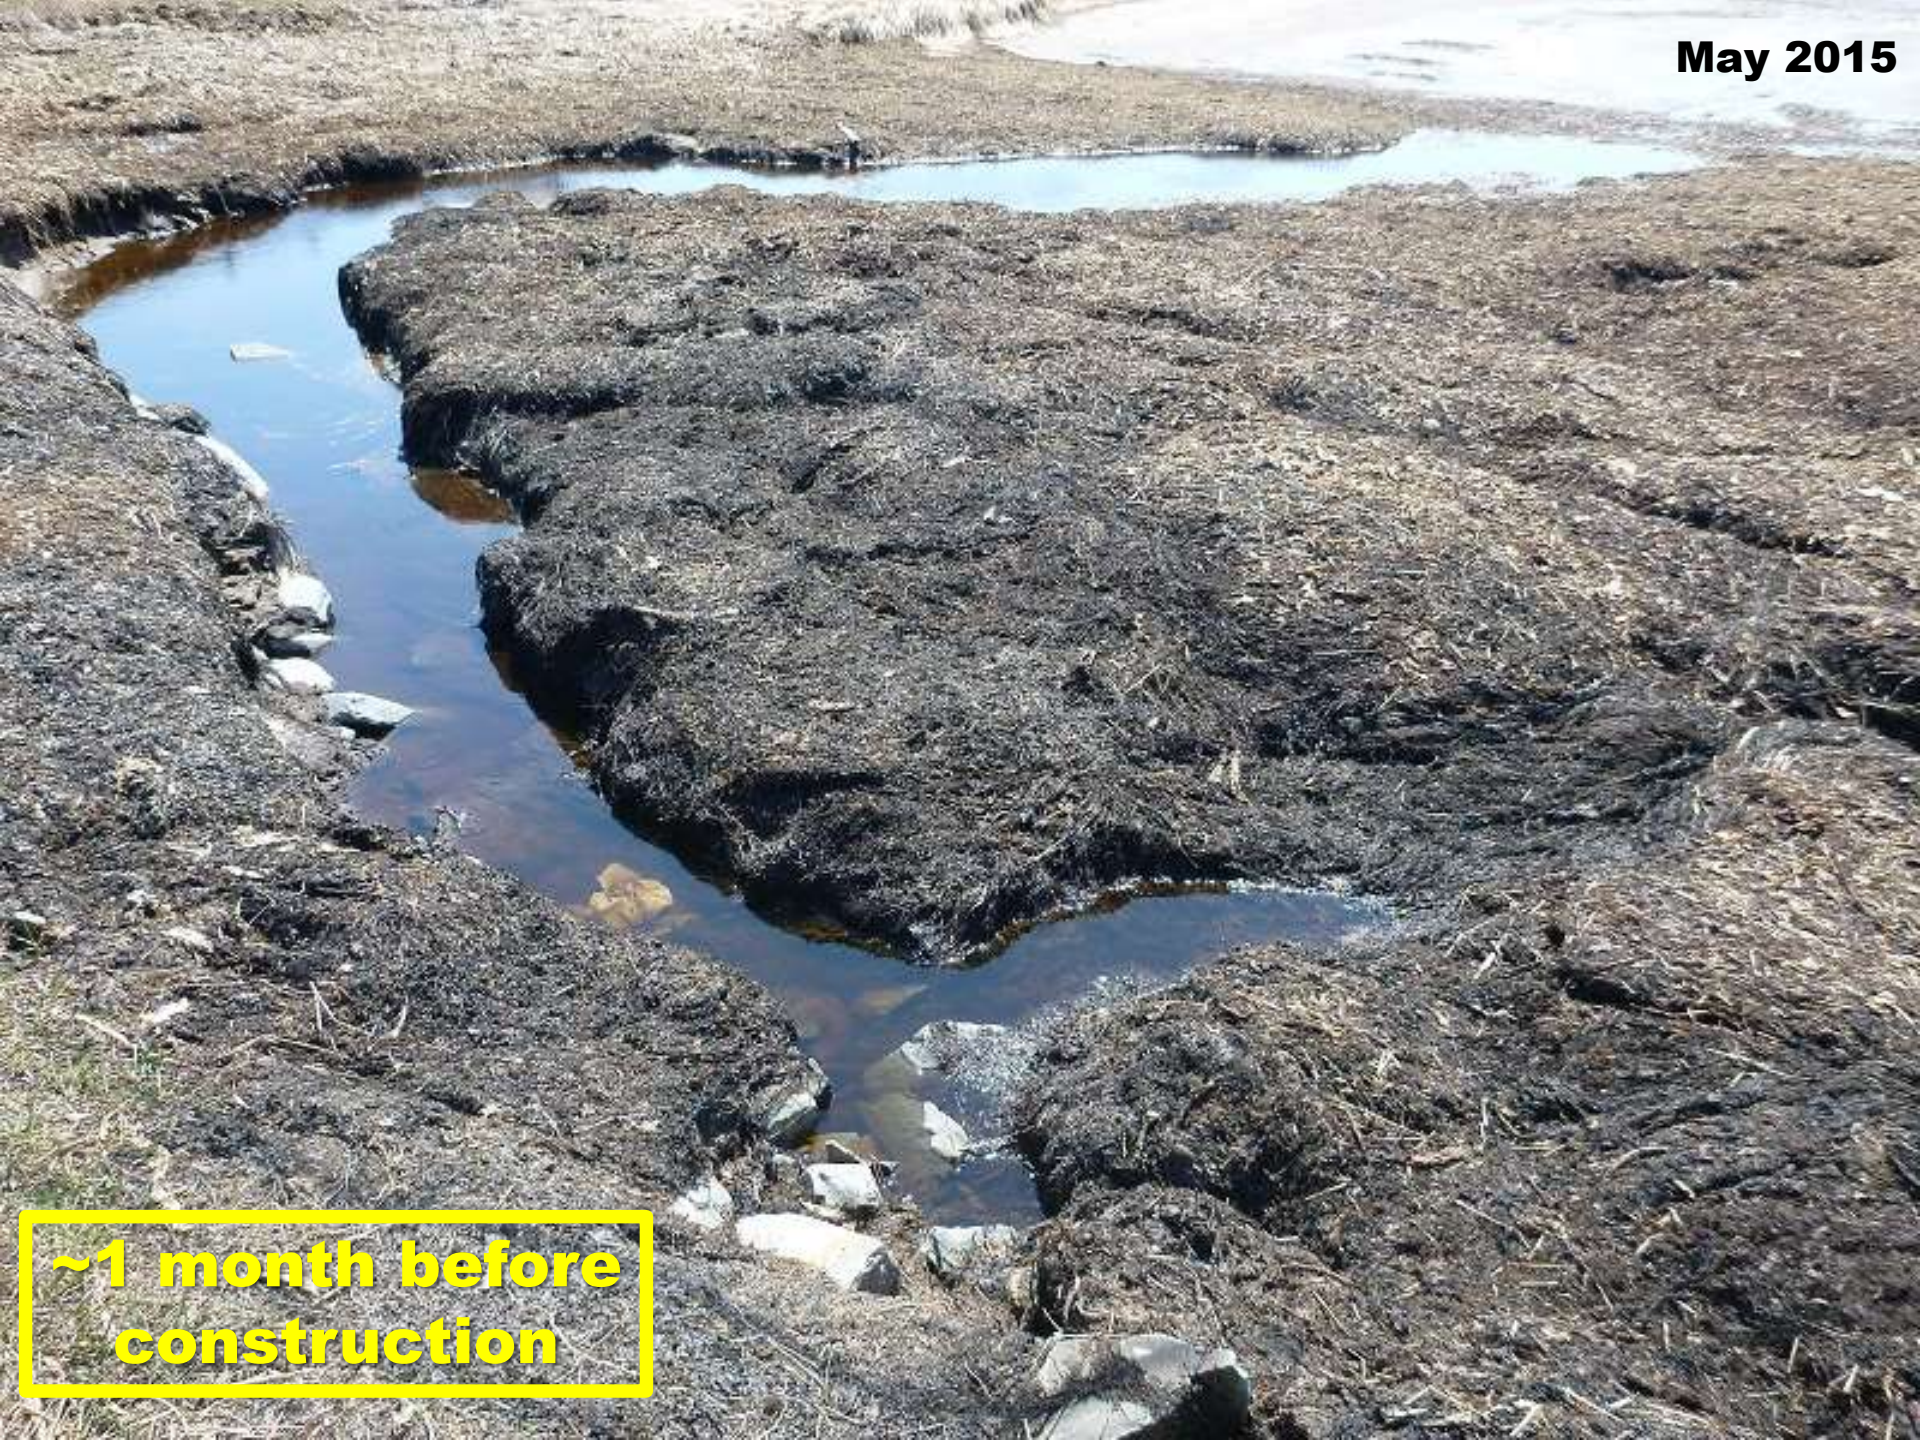
May 2015

**~1 month before
construction**

When excavation started in early June, there were thick deposits of seaweed wrack. These deposits were still present at the end of construction in early July.

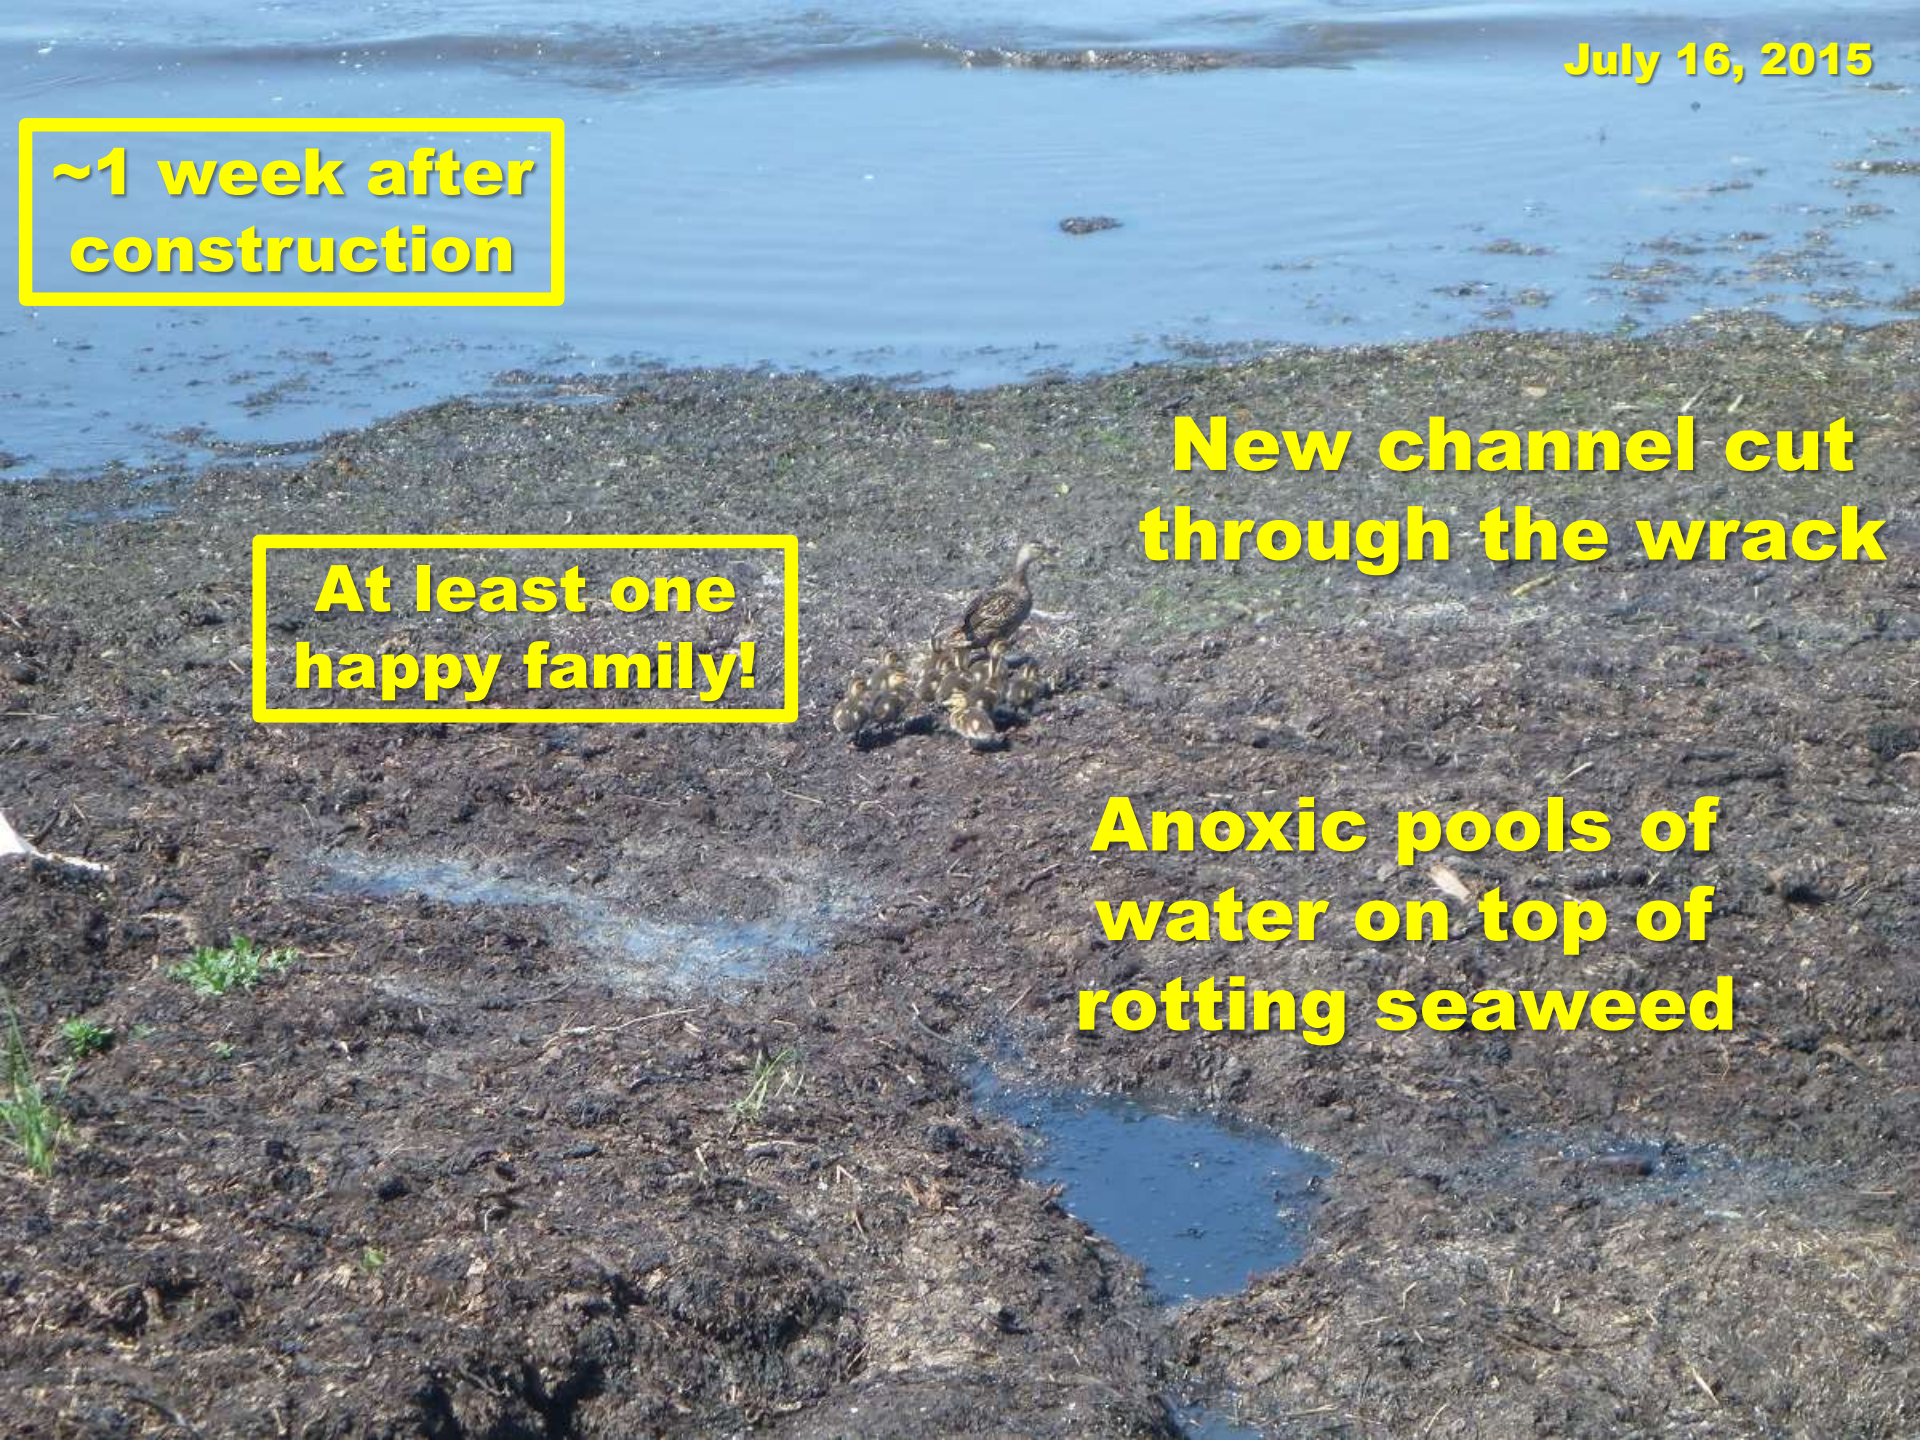
July 16, 2015

Digging into the thick layer of wrack, followed by new channel formation by ebbing waters during a warm and humid period, exposed rotten seaweed (wrack) to oxygen and released noxious gases (e.g., hydrogen sulfide).

Decomposition accelerated along with a STINK!

**~1 week after
construction**

**New channel cut
through the wrack**

**Anoxic pools of
water on top of
rotting seaweed**

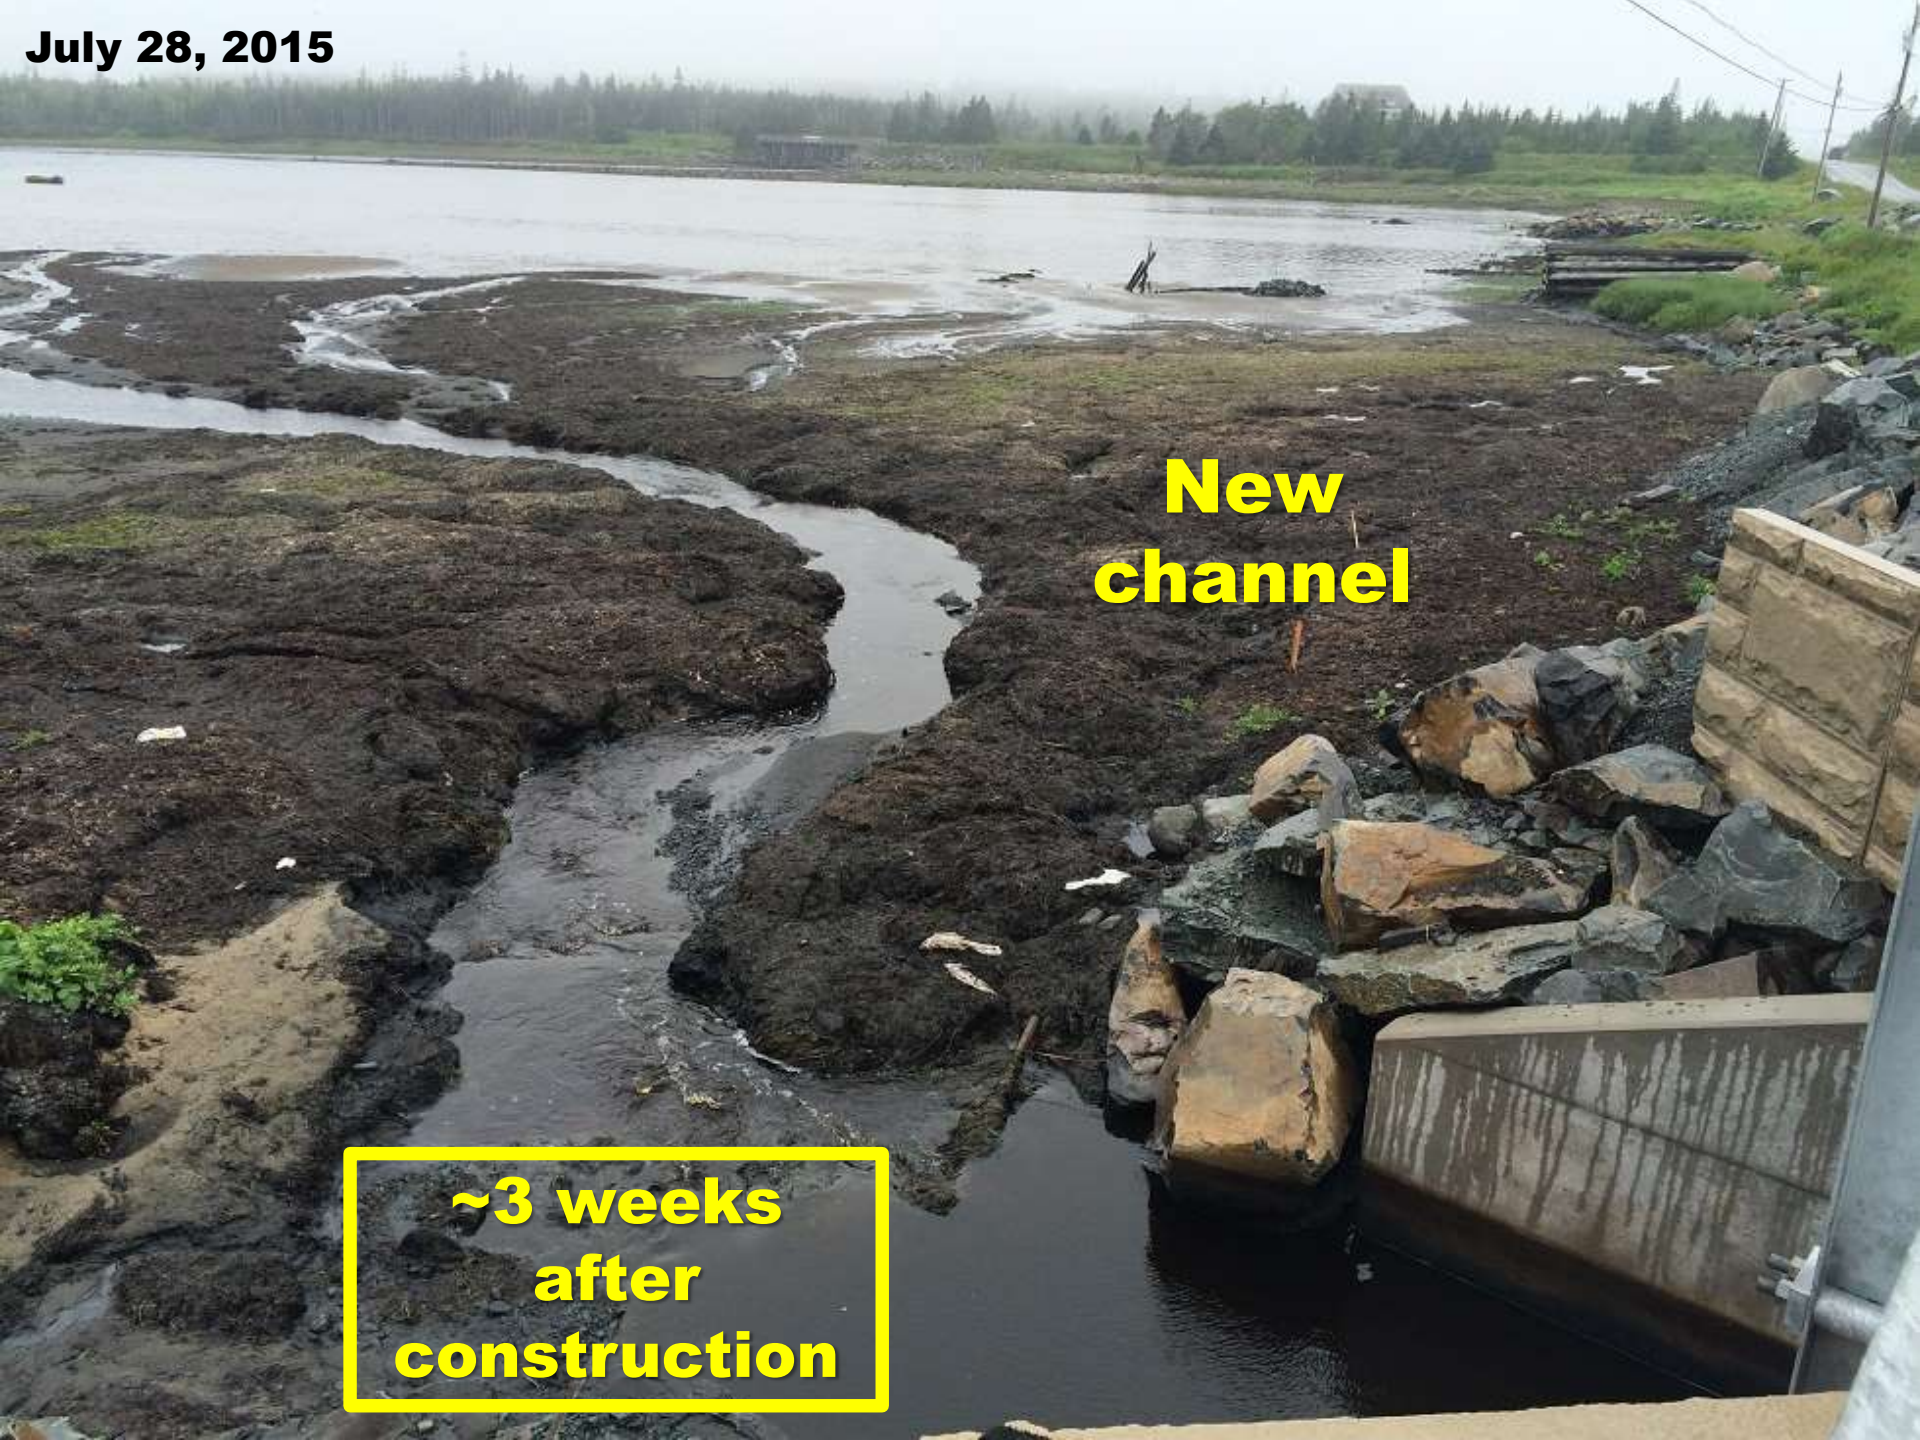
July 28, 2015

**New
channel**

**~3 weeks
after
construction**

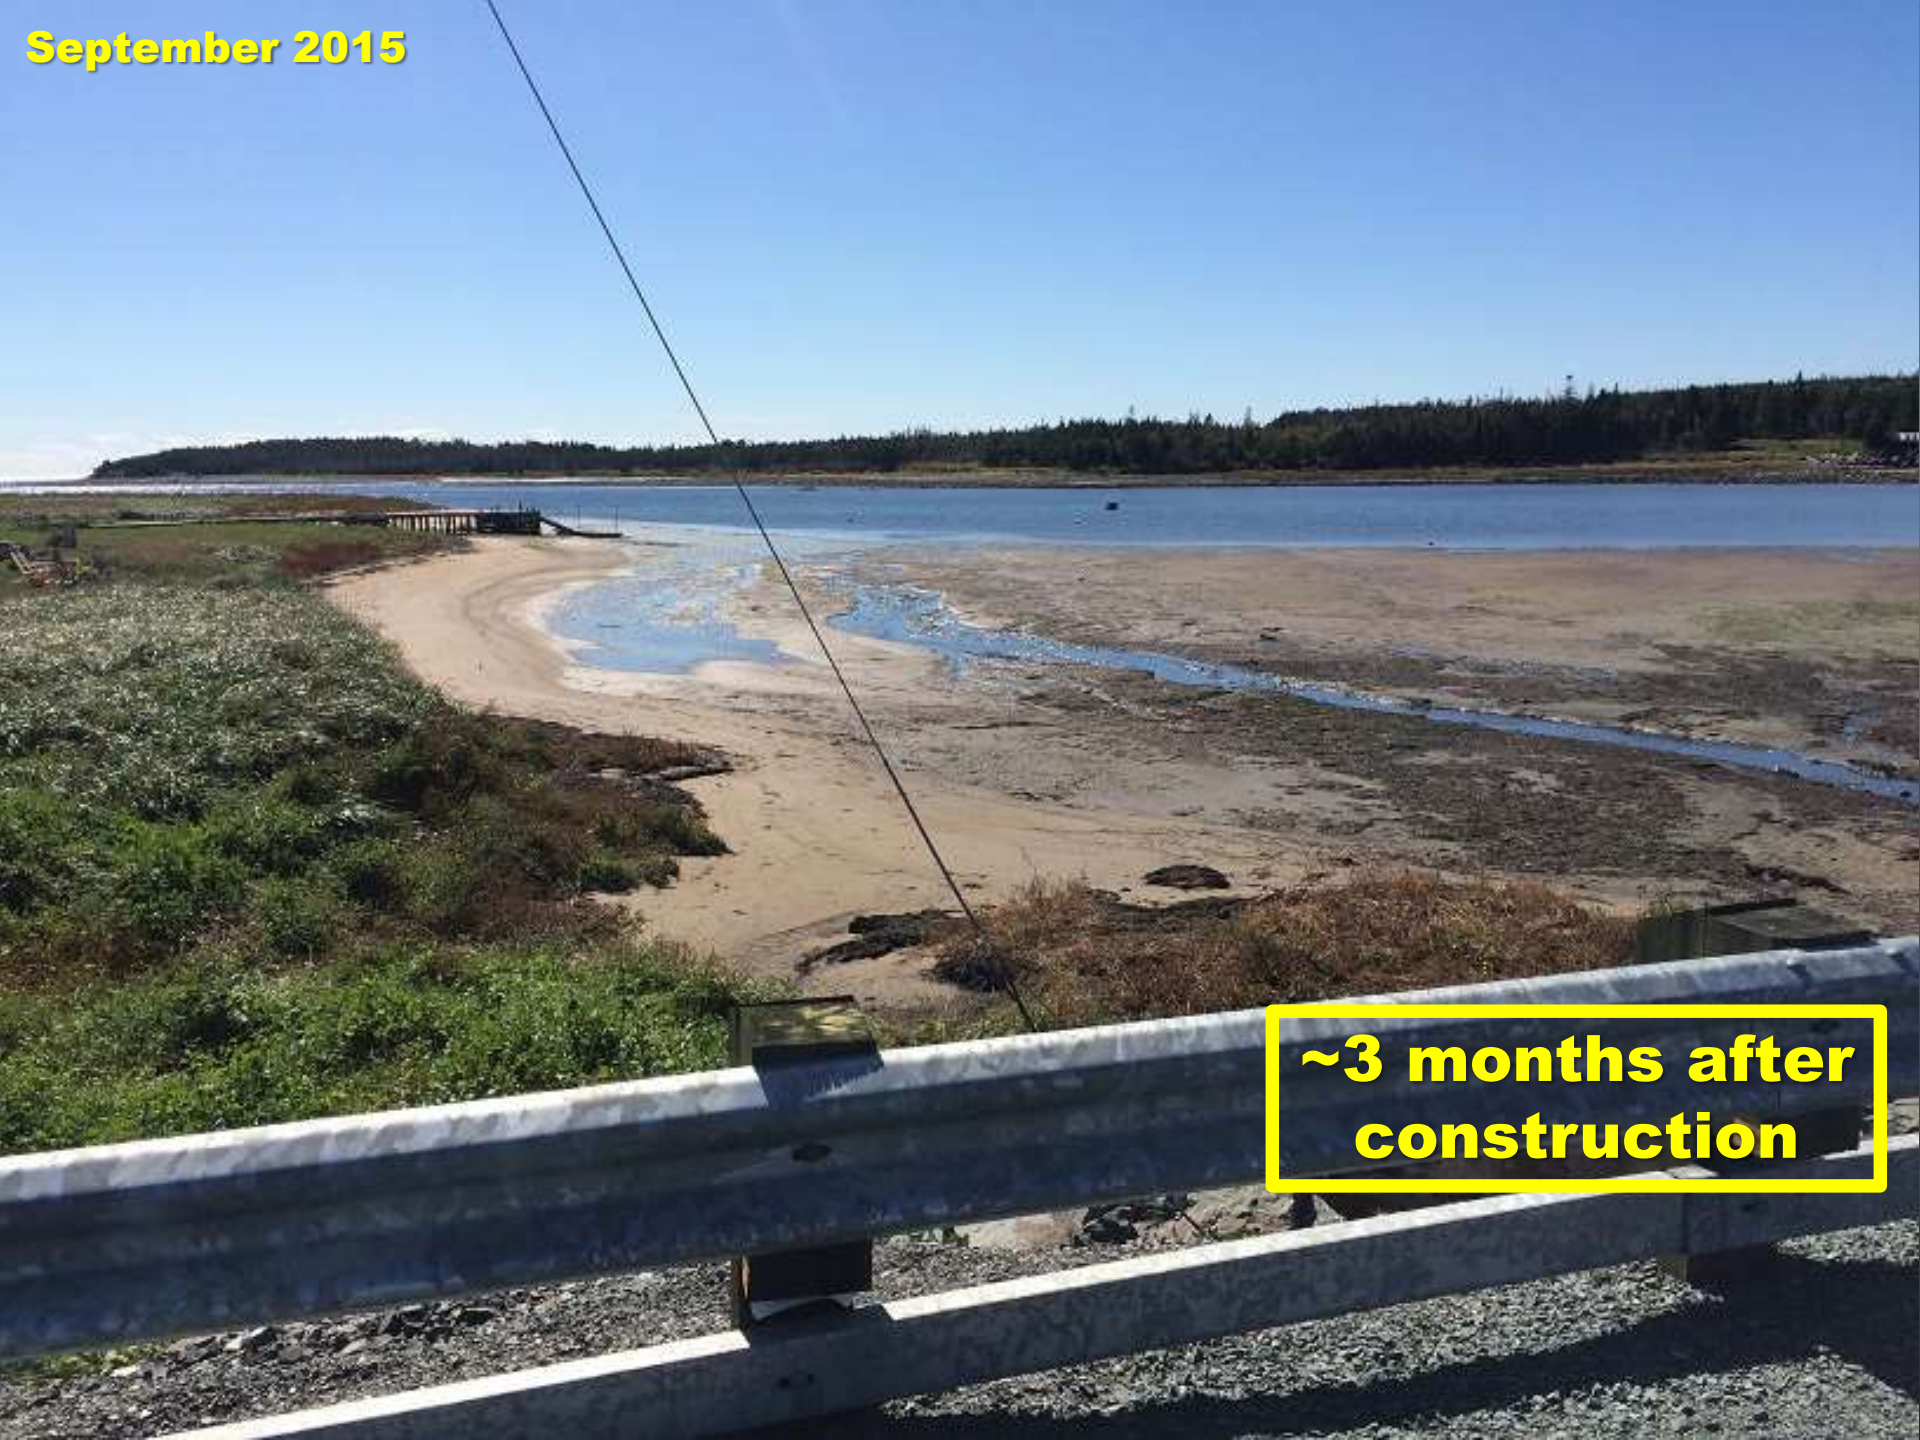
September 2015

**~6 weeks
after
construction**

Most of wrack gone!

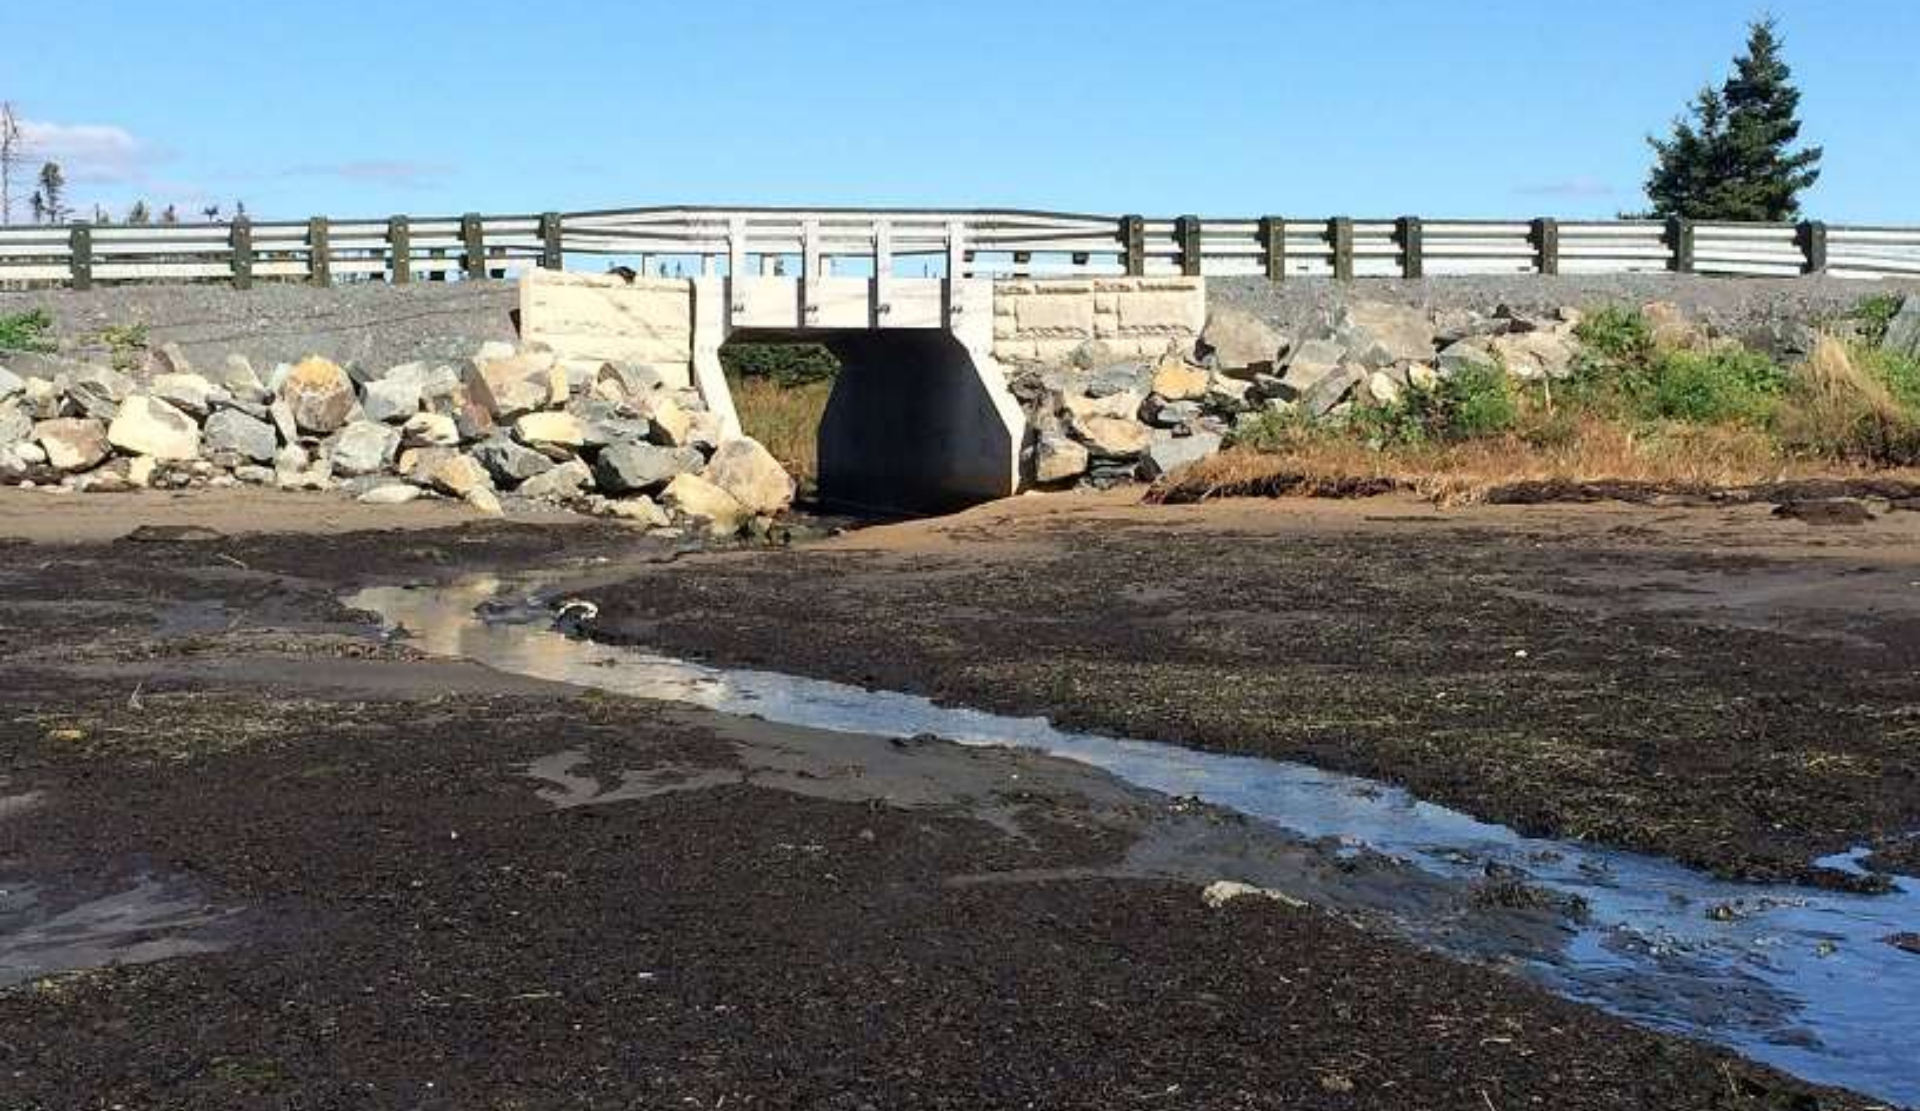
September 2015

The STINK was a temporary event and odours dissipated to background levels within 2-3 weeks of work completion.

As in previous 5 years, much of the accumulated wrack had cleared-off the beach in August. New tidal flows in and out of the 'pond' are anticipated to reduce future wrack deposition near the culvert.
