SD 19
2020 Annual Report

2020 Annual Report

Touquoy Gold Mine

Industrial Approval No. 2012-084244-08

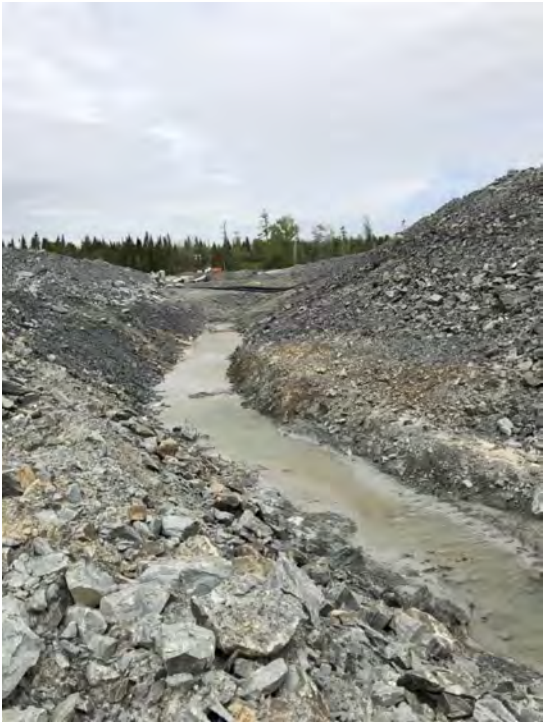
Client:	Atlantic Mining NS Corp	Project:	Spring 2020 Touquoy TMF DSI
Site Name:	Touquoy Mine Site	Site Location:	Middle Musquodoboit, NS
Photograph ID: 1

Photo Location: West Seepage Collection Ditch Near Station 0+550			
Image Date: 6/11/2020			
Photo Direction: North			
Comments: Showing bedrock excavated section			
File Name: IMG_3421.JPG			
Photograph ID: 2

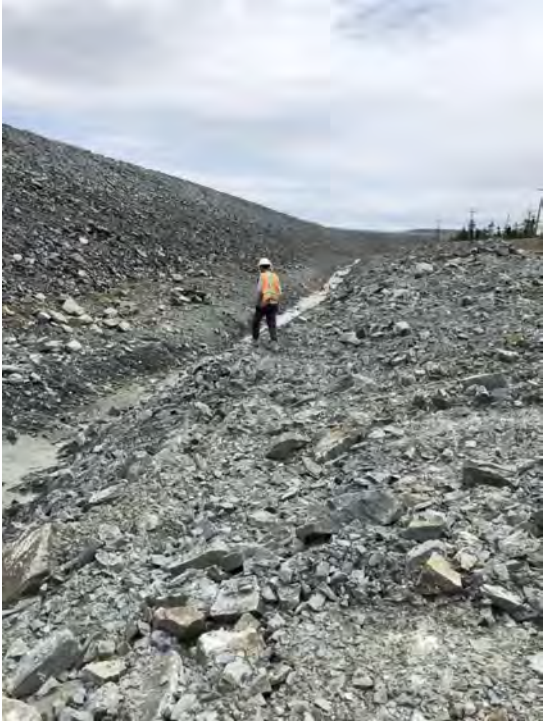
Photo Location: West Seepage Collection Ditch Near Station 0+550			
Image Date: 6/11/2020			
Photo Direction: South			
Comments: Bedrock excavated section			
File Name: IMG_3422.JPG

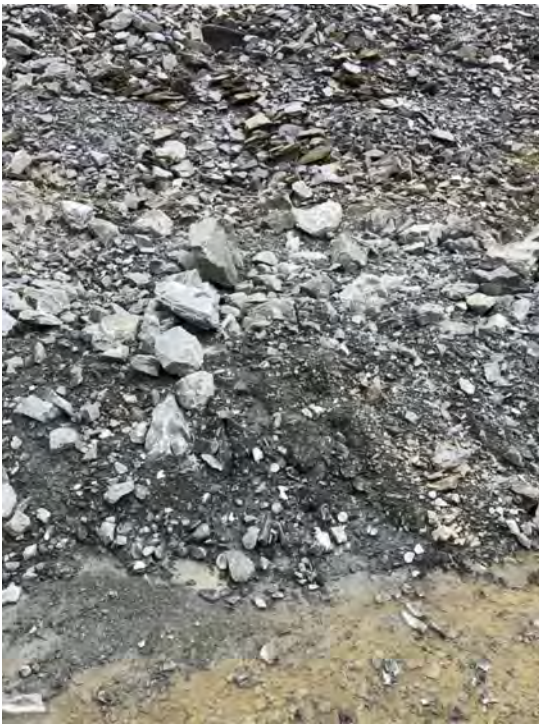
Client:	Atlantic Mining NS Corp	Project:	Spring 2020 Touquoy TMF DSI
Site Name:	Touquoy Mine Site	Site Location:	Middle Musquodoboit, NS
Photograph ID: 3

Photo Location: West Seepage Collection Ditch Near Station 0+550			
Image Date: 6/11/2020			
Photo Direction: East			
Comments: Location of toe seepage			
File Name: IMG_3423.JPG			
Photograph ID: 4

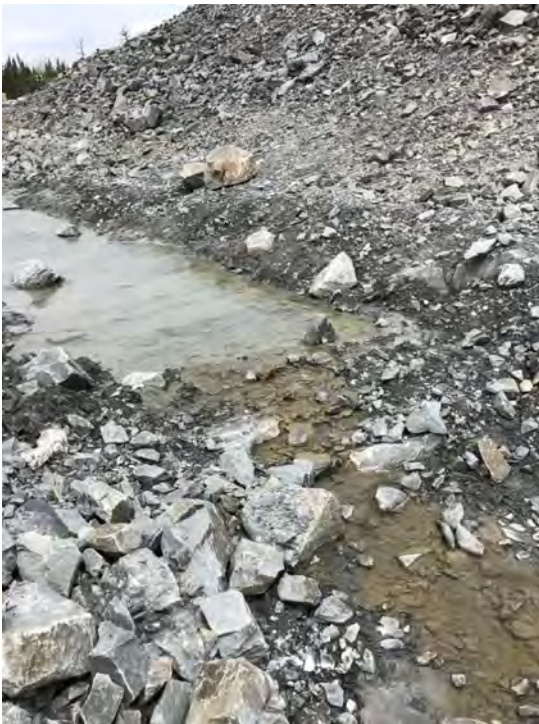
Photo Location: West Seepage Collection Ditch Near Station 0+550			
Image Date: 6/11/2020			
Photo Direction: North			
Comments: Bedrock ridge remaining in seepage ditch to be removed to allow drainage.			
File Name: IMG_3424.JPG

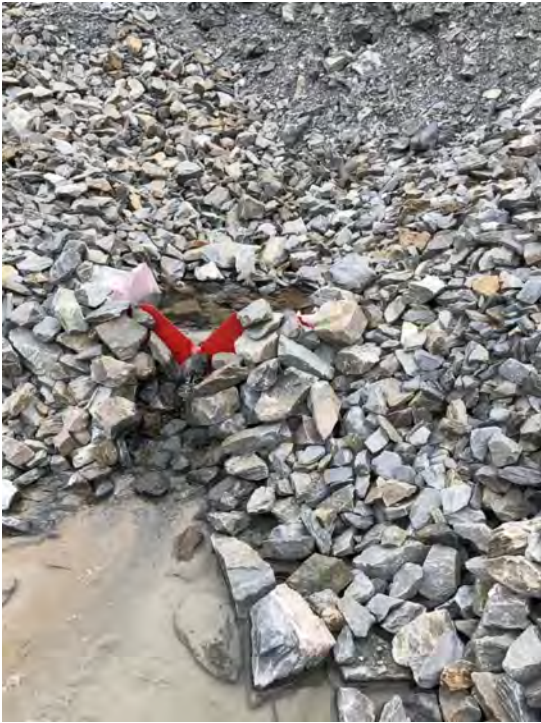
Client:	Atlantic Mining NS Corp	Project:	Spring 2020 Touquoy TMF DSI
Site Name:	Touquoy Mine Site	Site Location:	Middle Musquodoboit, NS
Photograph ID: 9

Photo Location: West Seepage Collection Ditch Near Station 0+800			
Image Date: 6/11/2020			
Photo Direction: East			
Comments: V notch weir installed to monitor seepage flow.			
File Name: IMG_3429.JPG			
Photograph ID: 10

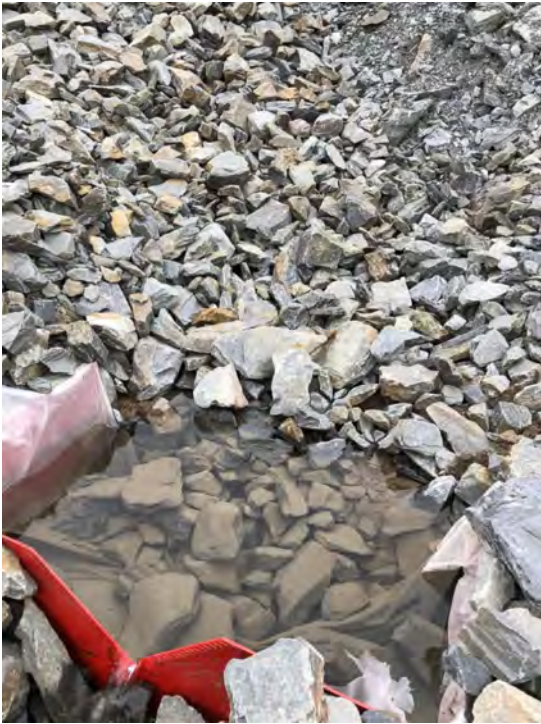
Photo Location: West Seepage Collection Ditch Near Station 0+800			
Image Date: 6/11/2020			
Photo Direction: East			
Comments: V notch weir installed to monitor seepage flow.			
File Name: IMG_3430.JPG

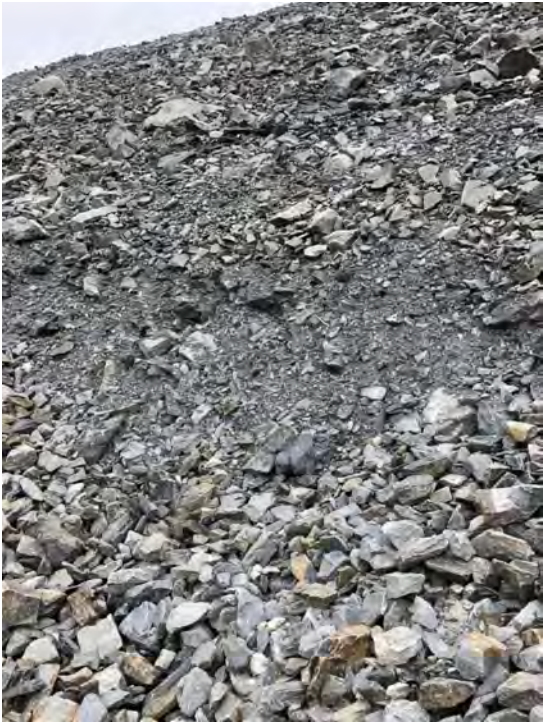
Client:	Atlantic Mining NS Corp	Project:	Spring 2020 Touquoy TMF DSI
Site Name:	Touquoy Mine Site	Site Location:	Middle Musquodoboit, NS
Photograph ID: 11

Photo Location: West Seepage Collection Ditch Near Station 0+800			
Image Date: 6/11/2020			
Photo Direction: East			
Comments: TMF Slope above V notch weir. Localized steepening.			
File Name: IMG_3431.JPG			
Photograph ID: 12

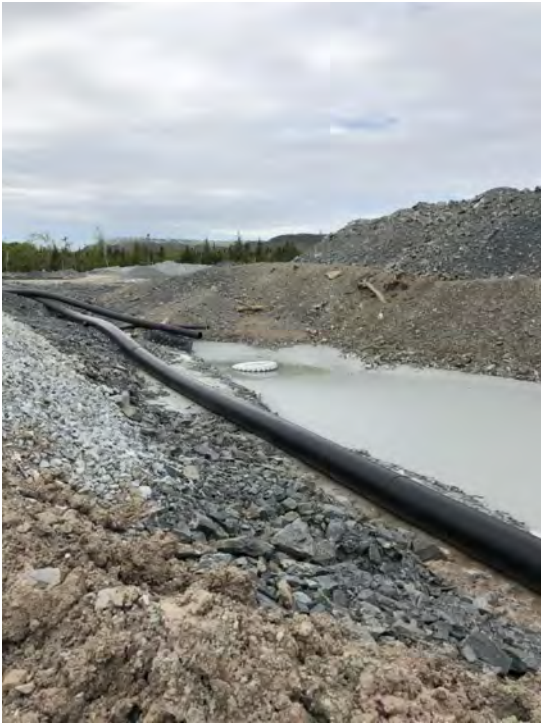
Photo Location: Northwest TMF near TMF Station 0+100			
Image Date: 6/11/2020			
Photo Direction: North			
Comments: Pit water discharge location. Contaminated waste stockpile at right.			
File Name: IMG_3444.JPG

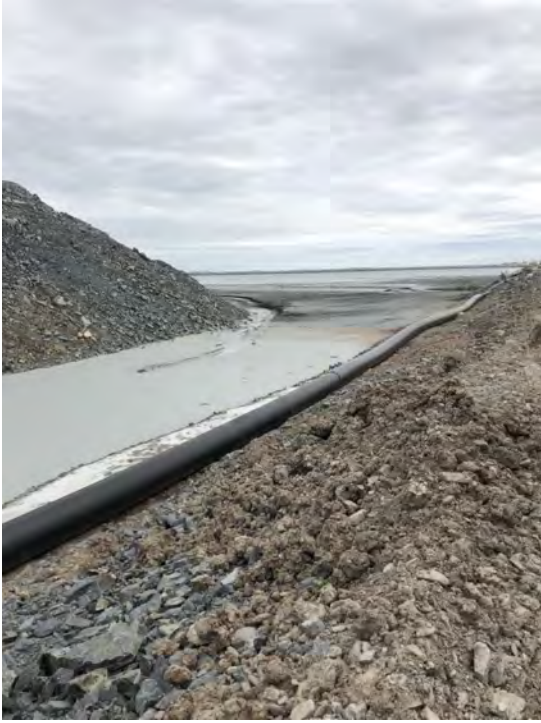
Client:	Atlantic Mining NS Corp	Project:	Spring 2020 Touquoy TMF DSI
Site Name:	Touquoy Mine Site	Site Location:	Middle Musquodoboit, NS
Photograph ID: 25

Photo Location: Northwest TMF near TMF Station 0+100			
Image Date: 6/11/2020			
Photo Direction: Southeast			
Comments: Pit water discharge location. Contaminated waste stockpile at left.			
File Name: IMG_3445.JPG			
Photograph ID: 26

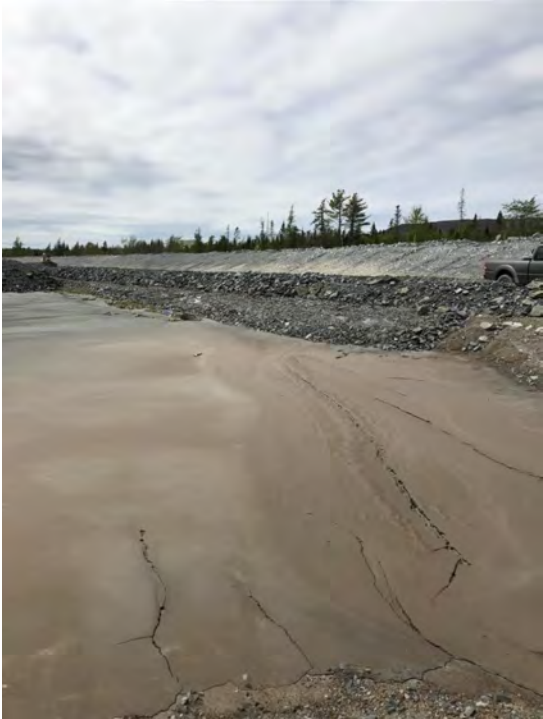
Client:	Atlantic Mining NS Corp	Project:	Spring 2020 Touquoy TMF DSI
Site Name:	Touquoy Mine Site	Site Location:	Middle Musquodoboit, NS
Photograph ID: 27

Photo Location: North TMF near Station 2+950			
Image Date: 6/11/2020			
Photo Direction: West			
Comments: Thin tailings over high ground. Approximately el. 123.5 m.			
File Name: IMG_3447.JPG			
Photograph ID: 28

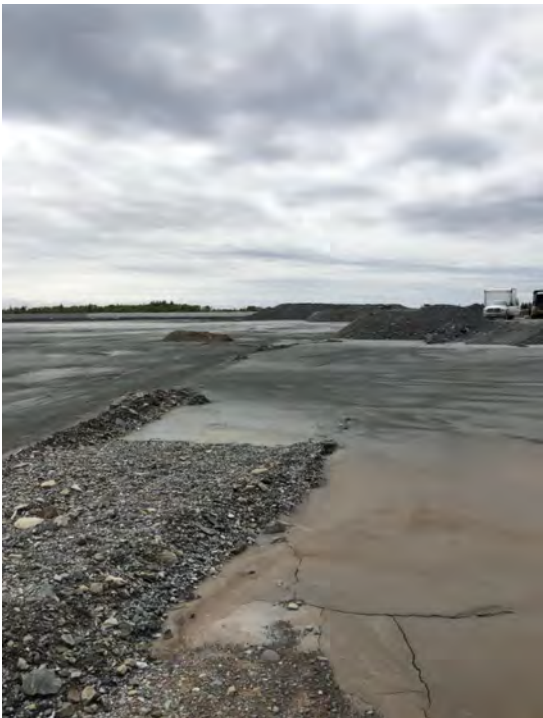
Photo Location: North TMF near Station 2+950			
Image Date: 6/11/2020			
Photo Direction: West			
Comments: Thin tailings over high ground. Approximately el. 123.5 m.			
File Name: IMG_3448.JPG

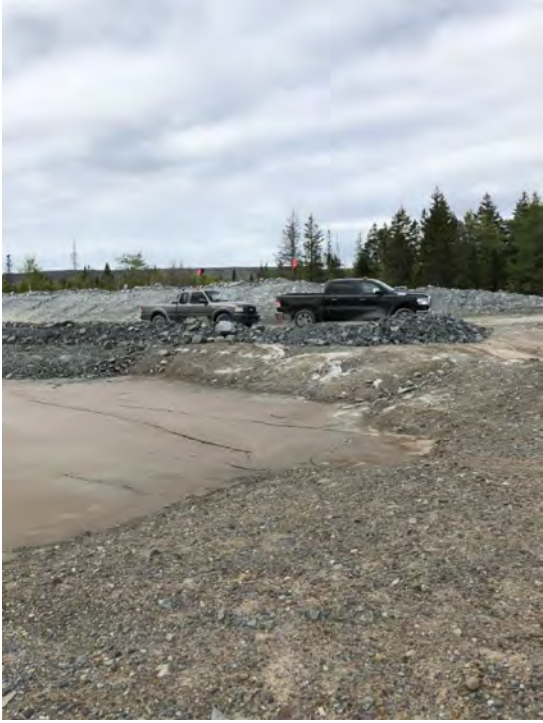
Photo Location: North TMF near Station 2+950			
Image Date: 6/11/2020			
Photo Direction: Northwest			
Comments: Vehicles at approximately el. 125.0 m; tailings at approximately el. 123.5 m			
File Name: IMG_3449.JPG			
Photograph ID: 30

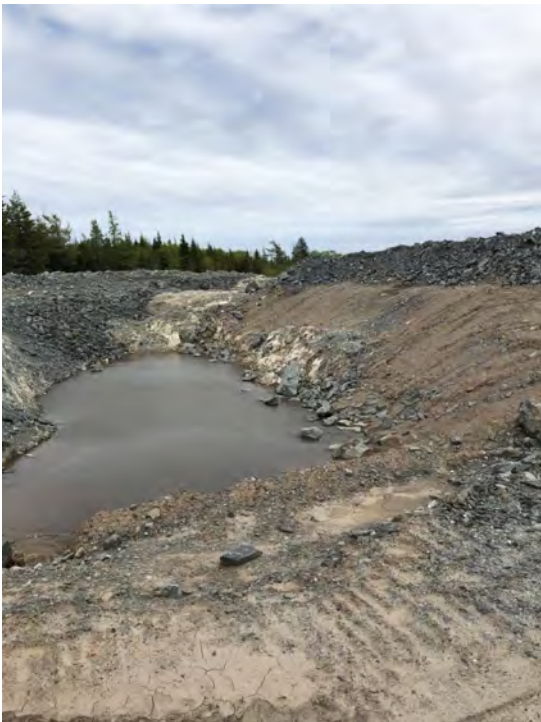
Photograph ID: 31

Photo Location: North TMF near Station 2+950	
Image Date: 6/11/2020	
Photo Direction: East	
Comments: Depression on bedrock outcrop near core filter location. to be filled with clay.	
File Name: IMG_3451.JPG

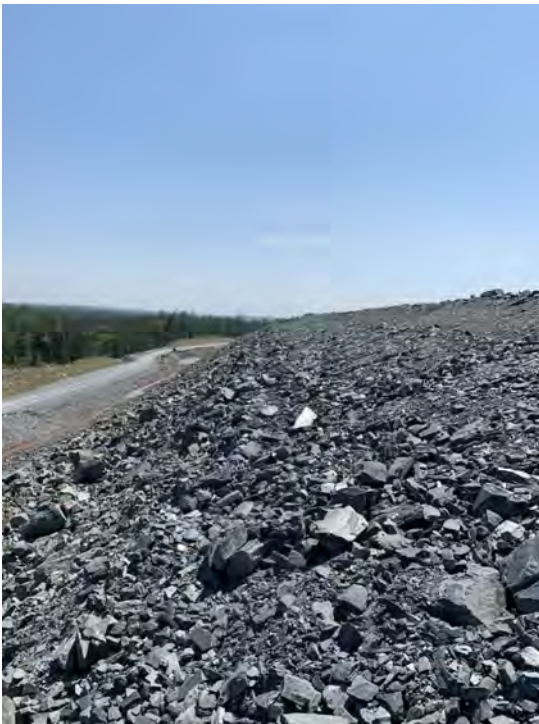
Photo Location: East TMF near Station 2+300 Downstream Slope			
Image Date: 7/28/2020			
Photo Direction: South			
Comments: Indicating irregular slope surface.			
File Name: IMG_0144.JPG

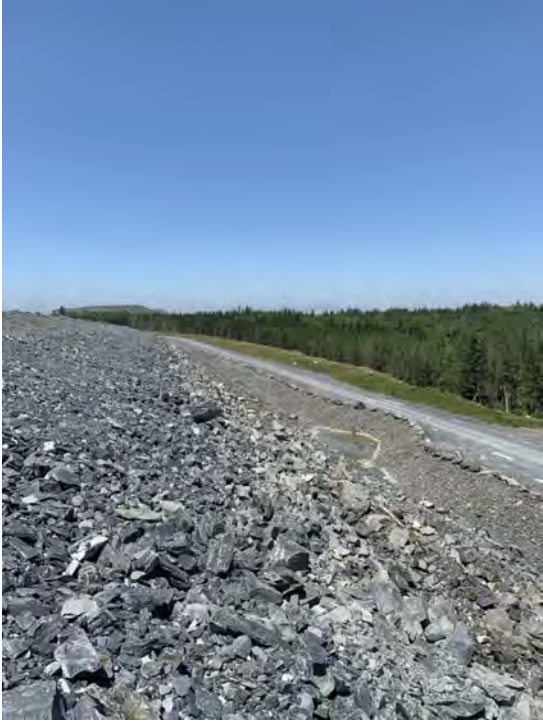
Photo Location: East TMF near Station 2+300 Downstream Slope			
Image Date: 7/28/2020			
Photo Direction: North			
Comments: Indicating irregular slope surface.			
File Name: IMG_0146.JPG			
Photograph ID: 36

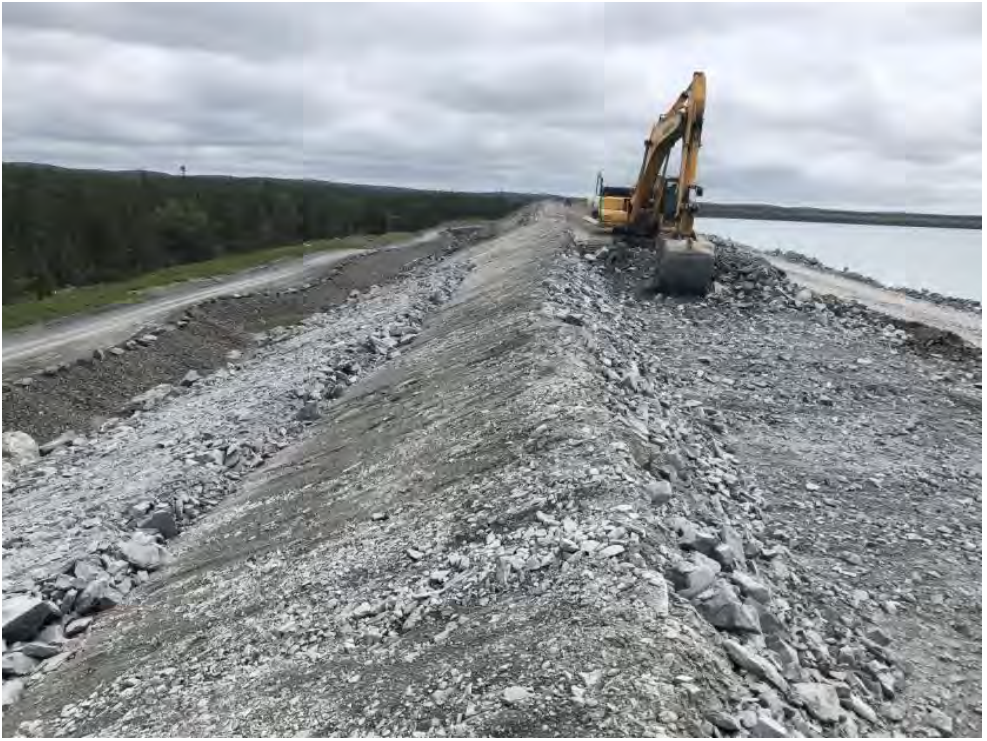
Photo Location: East TMF near Station Downstream Slope			
Image Date: 7/9/2020			
Photo Direction: South			
Comments: Indicating irregular slope surface.			
File Name: IMG_3826.JPG

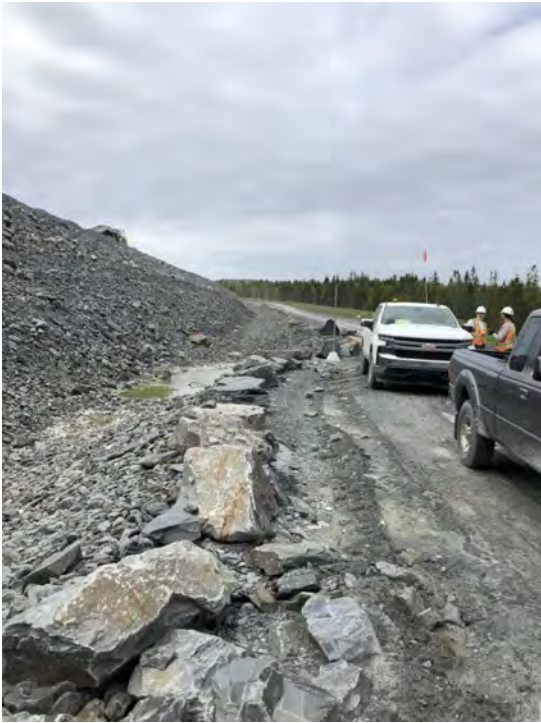
Photo Location: East Seepage Collection Ditch Near Station 0+310			
Image Date: 6/11/2020			
Photo Direction: Northwest			
Comments: First seepage pond on east collection ditch.			
File Name: IMG_3453.JPG			
Photograph ID: 40

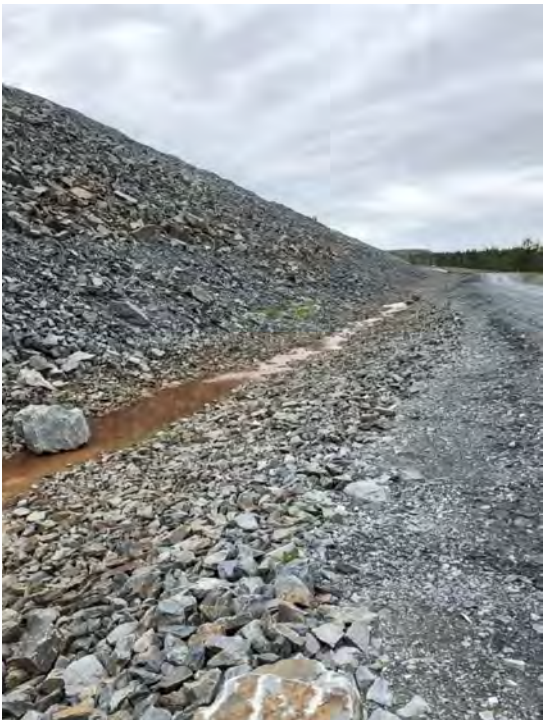
<p>A photograph showing a small, shallow, brownish seepage pond situated on a steep, rocky slope. The slope is covered in grey and brown rocks of various sizes. The sky is overcast and grey.</p>
<p>Photograph ID: 42</p> <p>Photo Location: East Seepage Collection Ditch Near Station 0+450</p> <p>Image Date: 6/11/2020</p> <p>Photo Direction: North</p> <p>Comments: Poorly drained section of east seepage collection ditch.</p> <p>File Name: IMG_3456.JPG</p>

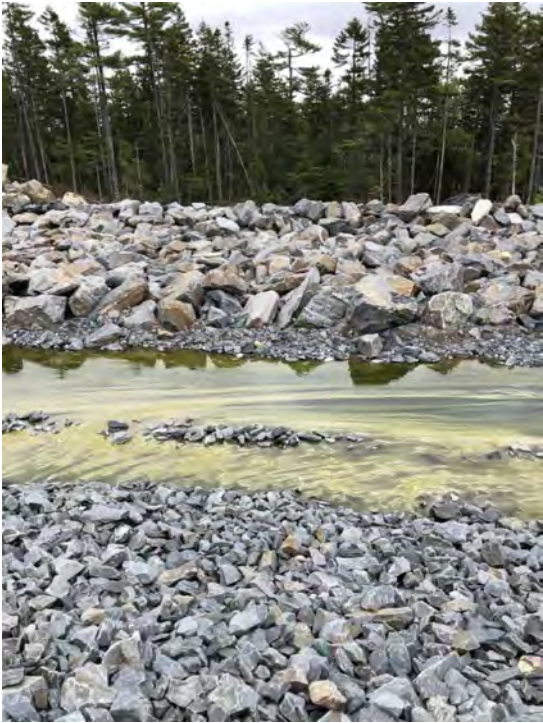
Photo Location: Access Road East of Engineered Wetland			
Image Date: 6/11/2020			
Photo Direction: East			
Comments: Ponded water downstream of wetland due to tracked vehicle ruts.			
File Name: IMG_3461.JPG			
Photograph ID: 48

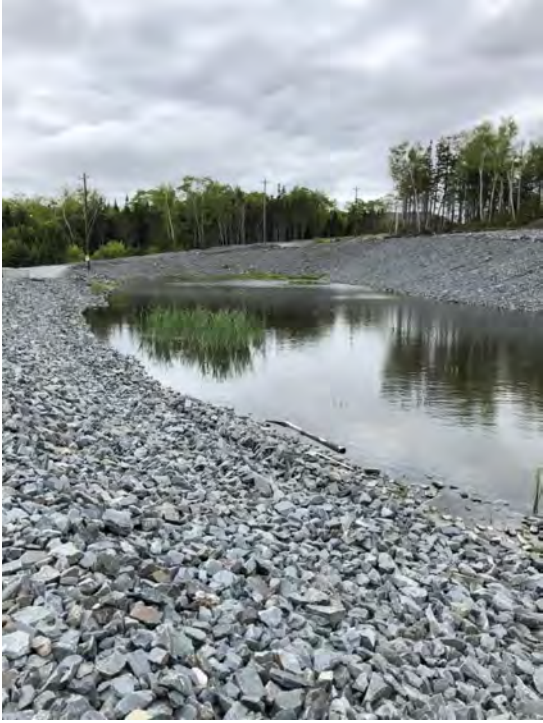
Photo Location: Engineered Wetland Centre Area			
Image Date: 6/11/2020			
Photo Direction: West			
Comments: Repaired slope, north side of wetland			
File Name: IMG_3463.JPG			
Photograph ID: 50

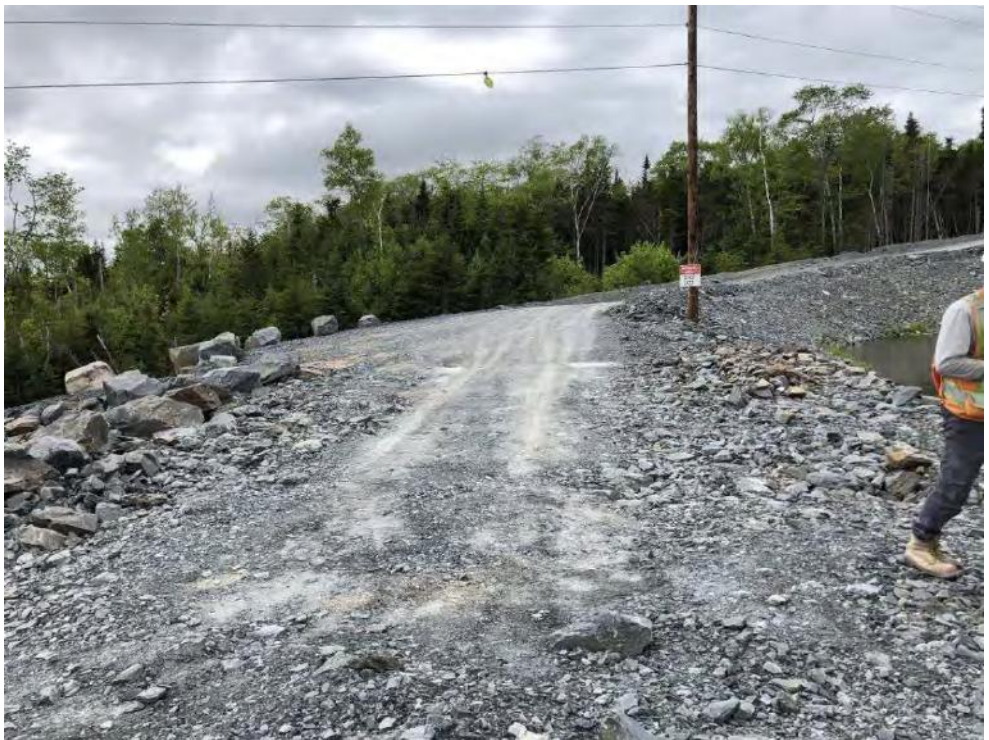
Photo Location:			
Engineered Wetland West End			
Image Date:			
6/11/2020			
Photo Direction:			
West			
Comments:			
Disturbed spillway area			
File Name:			
IMG_3465.JPG			
Photograph ID: 52

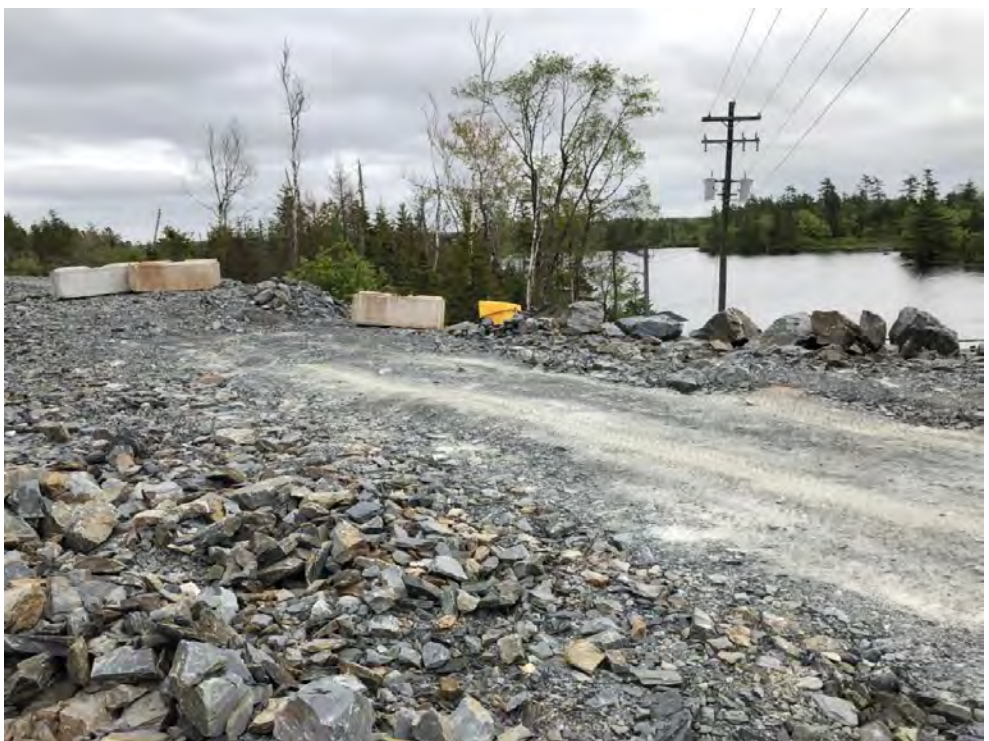
Photo Location:			
Engineered Wetland West End			
Image Date:			
6/11/2020			
Photo Direction:			
East			
Comments:			
Disturbed spillway area			
File Name:			
IMG_3466.JPG

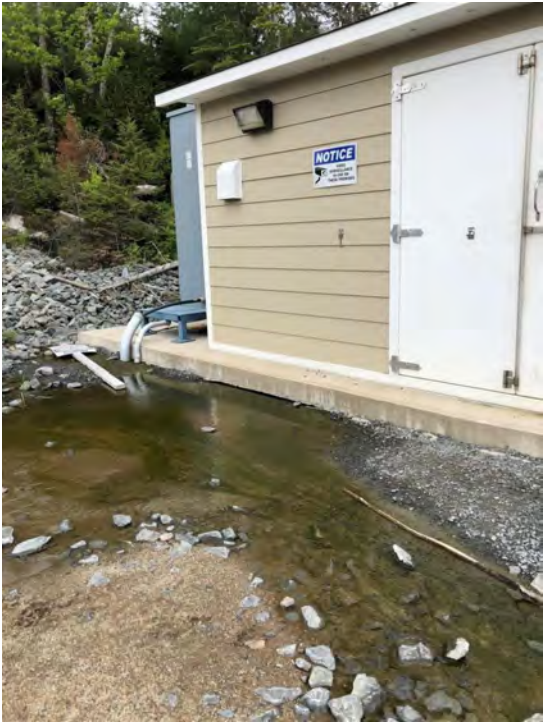
Photo Location: Access to Scraggy Lake Freshwater Intake Pump House			
Image Date: 6/11/2020			
Photo Direction: North			
Comments: Ponded water undermining Scraggy Lake Pump House			
File Name: IMG_3469.JPG			
Photograph ID: 56

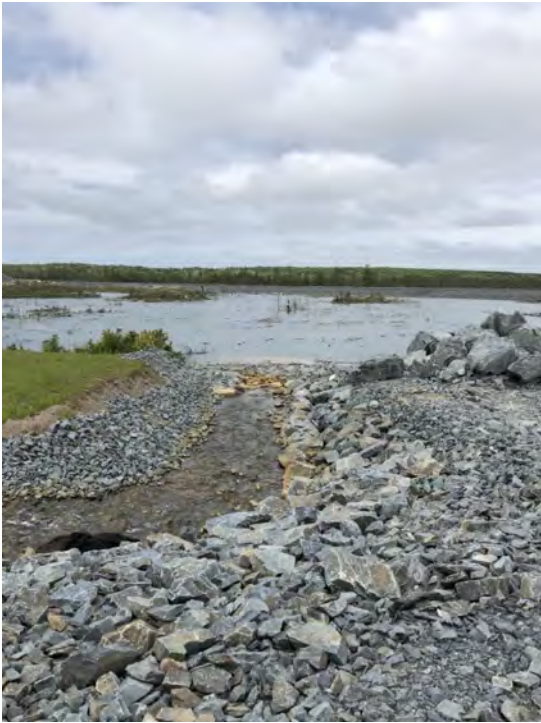
Photo Location: Geobag Area			
Image Date: 6/11/2020			
Photo Direction: Northeast			
Comments: Repaired washout area entering polishing pond.			
File Name: IMG_3472.JPG			
Photograph ID: 60

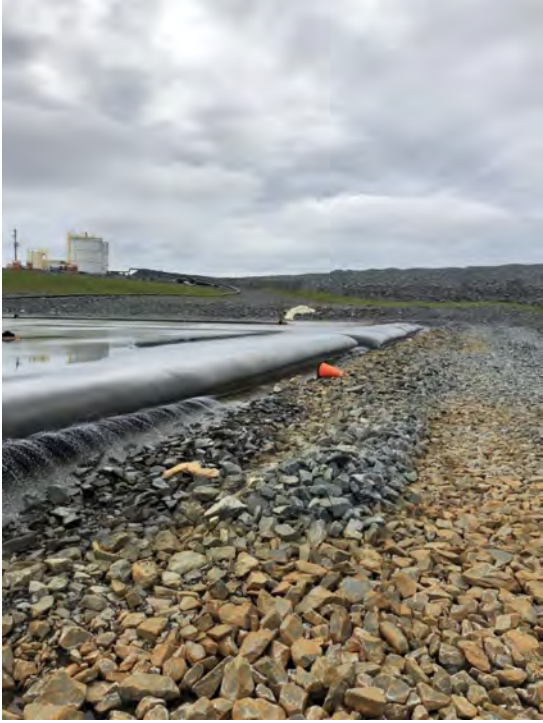
Photo Location: Geobag Area			
Image Date: 6/11/2020			
Photo Direction: West			
Comments: Geobag #2 and #3 flow into collection ditch			
File Name: IMG_3476.JPG			
Photograph ID: 64

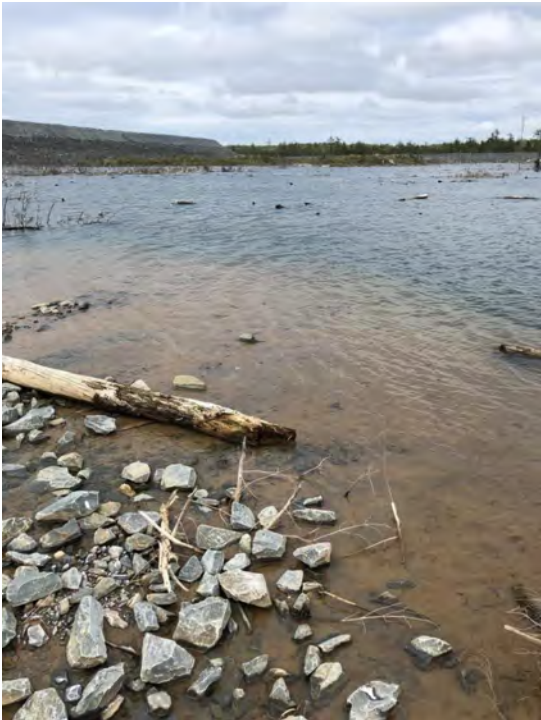
<p>Photograph ID: 65</p> <p>Photo Location: Geobag area outflow/Polishing Pond</p> <p>Image Date: 6/11/2020</p> <p>Photo Direction: Northeast</p> <p>Comments: Geobag outflow into west-end of polishing pond. Brown silt deposit on pond bottom.</p> <p>File Name: IMG_3478.JPG</p>

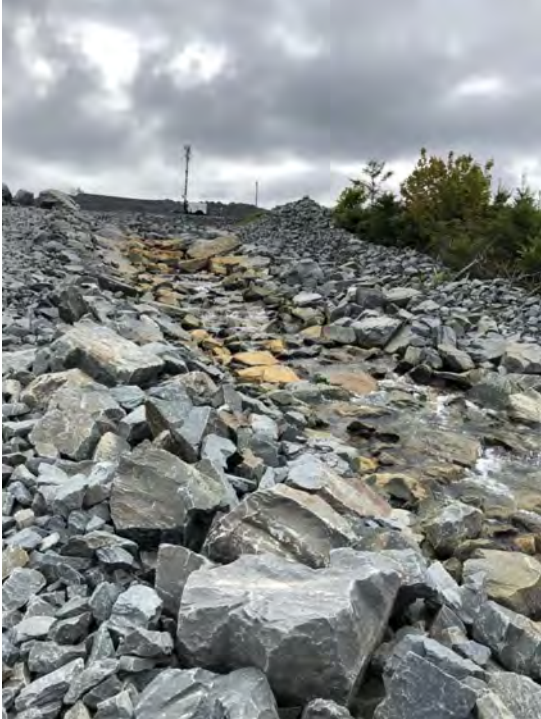
<p>Photograph ID: 66</p> <p>Photo Location: Geobag spillway area.</p> <p>Image Date: 6/11/2020</p> <p>Photo Direction: Southwest</p> <p>Comments: Terminus of repaired spillway showing larger rock placed erosion mitigation</p> <p>File Name: IMG_3479.JPG</p>

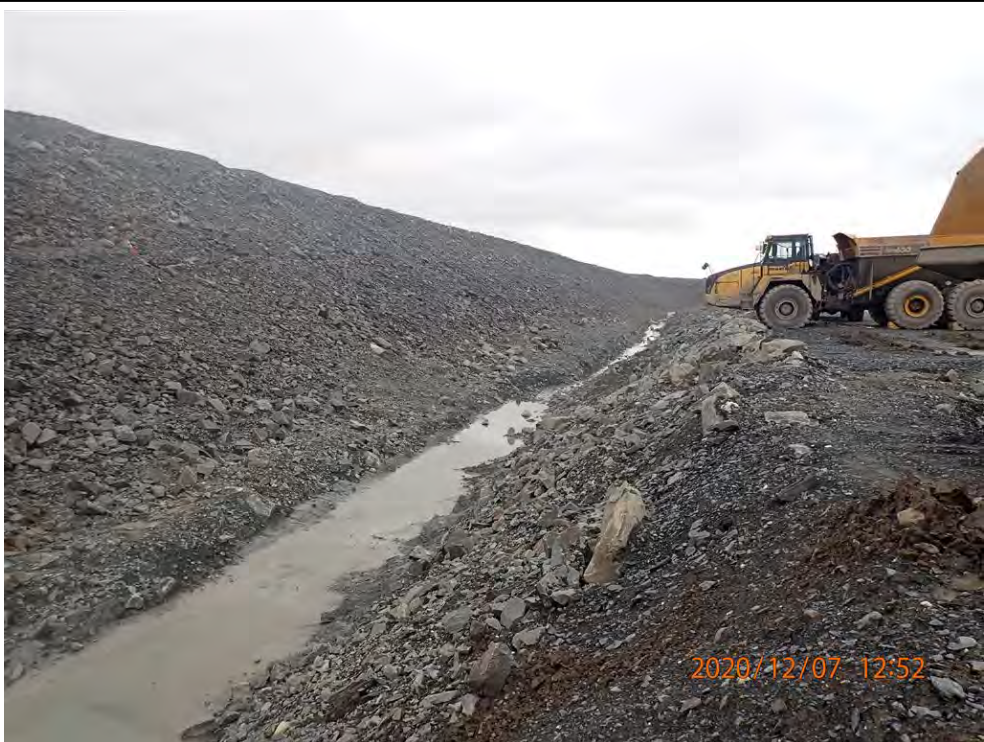
Photograph ID: 2

Photo Location: TMF Pond/Dam. West Seepage Collection Ditch Near Station 0+050	
Image Date: 12/7/2020	
Photo Direction: South	
Comments: TMF Pond/Dam Perimeter Seepage Collection Ditch. Bedrock excavated section

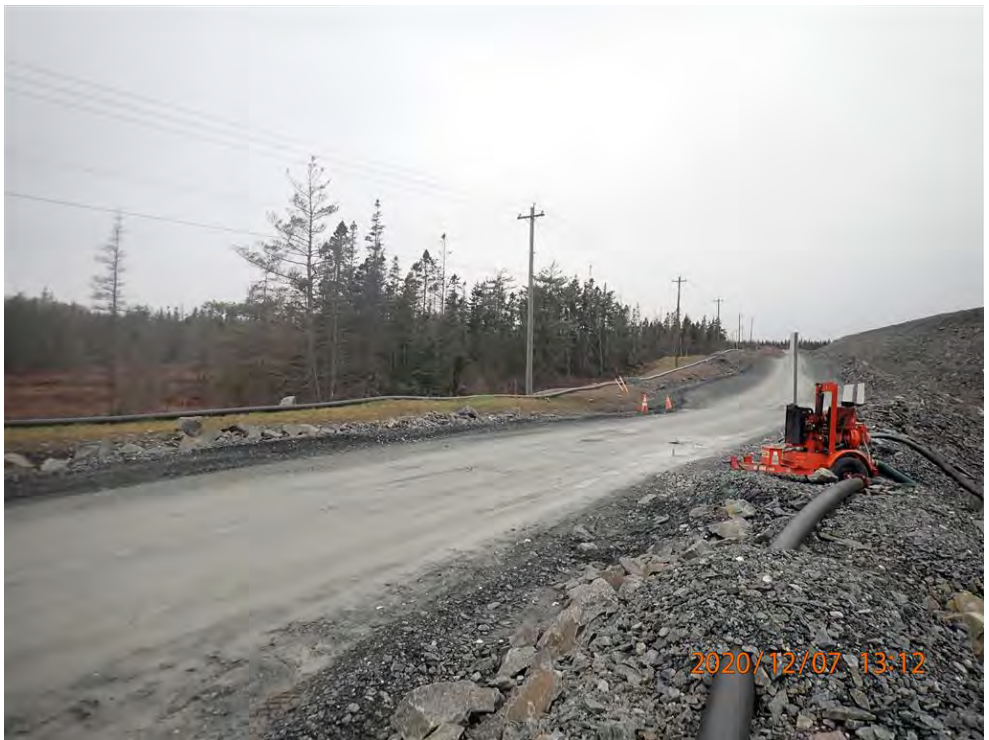
Client:	Atlantic Mining NS Inc.	Project:	Fall 2020 Touquoy TMF DSI
Site Name:	Touquoy Mine Site	Site Location:	Middle Musquodoboit, NS
Photograph ID: 9

Photo Location: TMF. West TMF Perimeter Road Near Station 0+450			
Image Date: 12/7/2020			
Photo Direction: North			
Comments: Perimeter Road, pumping equipment for West Pond 3 on right.			
Photograph ID: 10

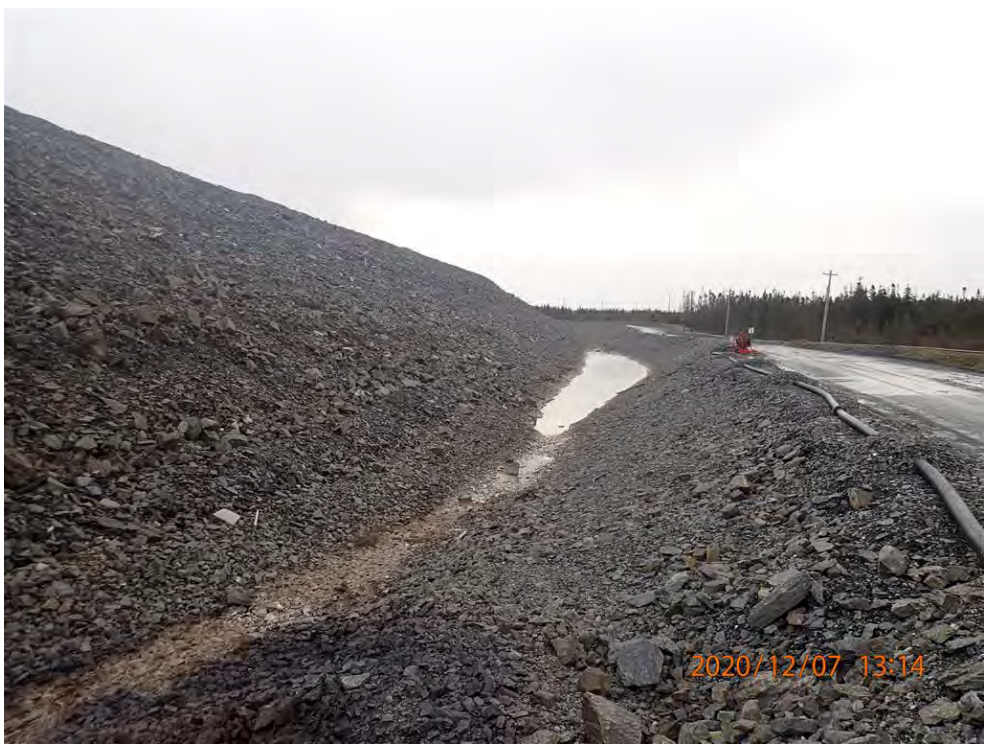
Photo Location: TMF Pond/Dam. West Seepage Collection Ditch Near Station 0+550			
Image Date: 12/7/2020			
Photo Direction: South			
Comments: West Pond 3 Seepage Collection Pond.

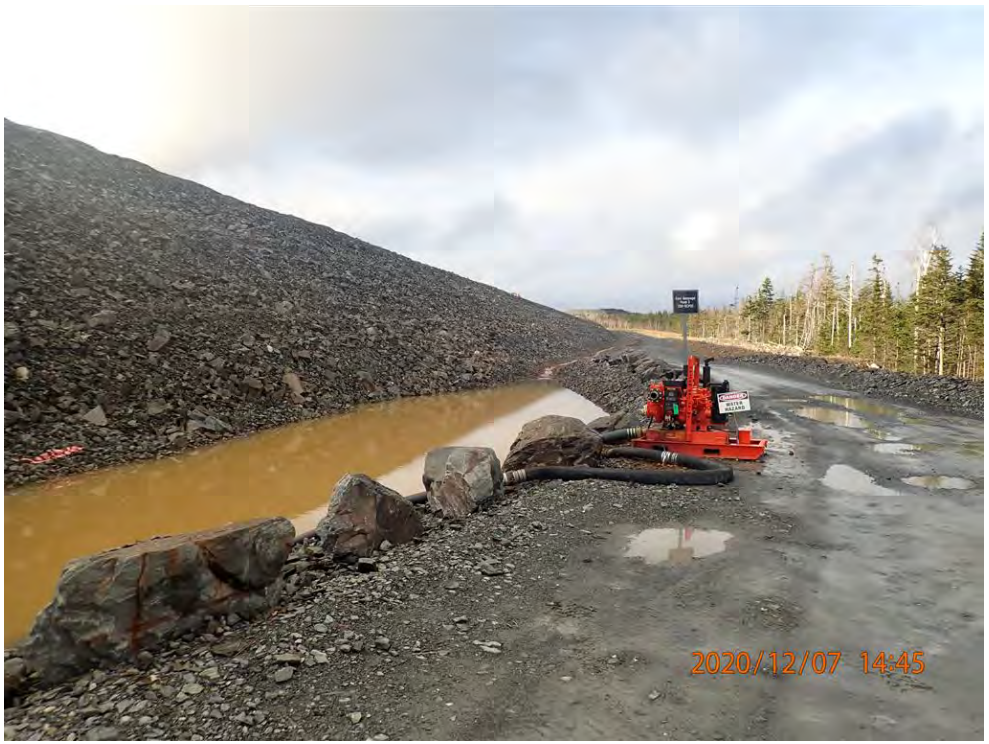
Client:	Atlantic Mining NS Inc.	Project:	Fall 2020 Touquoy TMF DSI
Site Name:	Touquoy Mine Site	Site Location:	Middle Musquodoboit, NS
Photograph ID: 27

Photo Location: TMF Pond/Dam. East Seepage Ditch near Station 2+000			
Image Date: 12/7/2020			
Photo Direction: North			
Comments: East Pond 2 Seepage Collection Pond.			
Photograph ID: 28

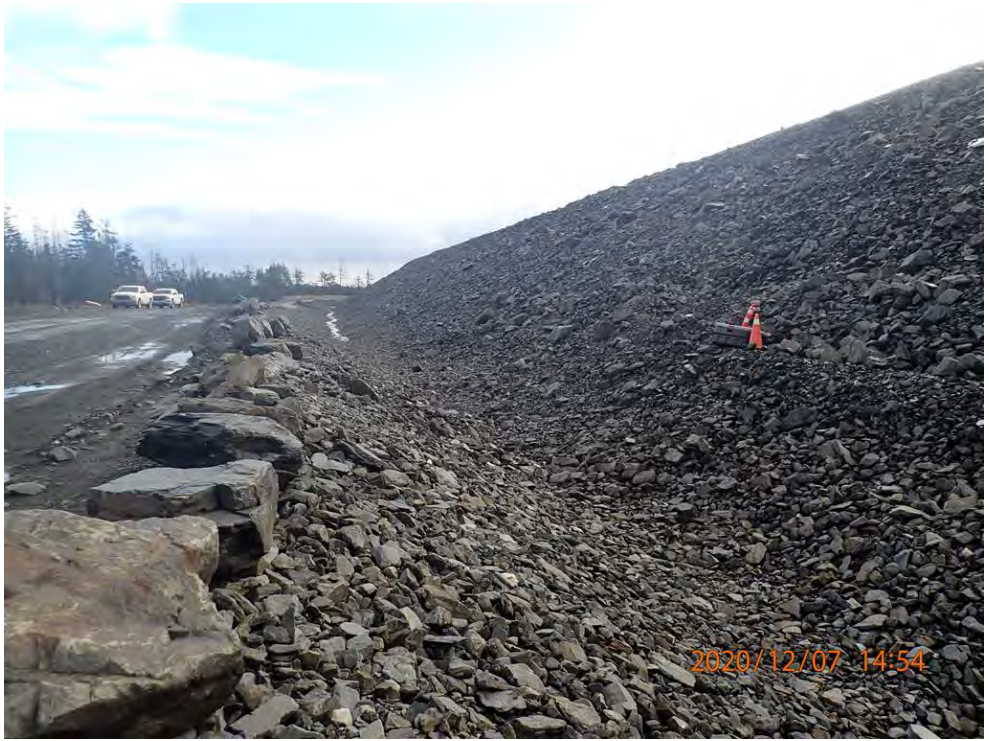
Photo Location: TMF Pond/Dam. East Seepage Ditch near Station 2+250			
Image Date: 12/7/2020			
Photo Direction: South			
Comments: East Seepage Ditch, with Piezometer Box on Downstream Slope

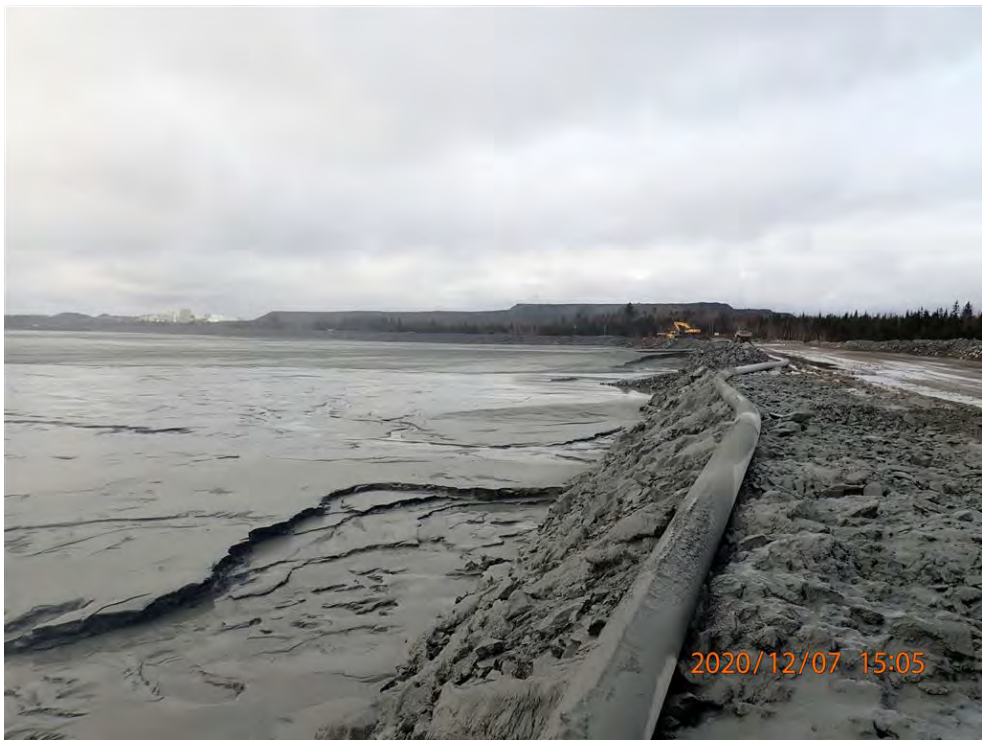
Client:	Atlantic Mining NS Inc.	Project:	Fall 2020 Touquoy TMF DSI
Site Name:	Touquoy Mine Site	Site Location:	Middle Musquodoboit, NS
Photograph ID: 31

Photo Location: TMF Pond/Dam. East TMF near Station 2+300, Tailings Pipe North East Slope			
Image Date: 12/7/2020			
Photo Direction: Northeast			
Comments: Tailings Beach.			
Photograph ID: 32

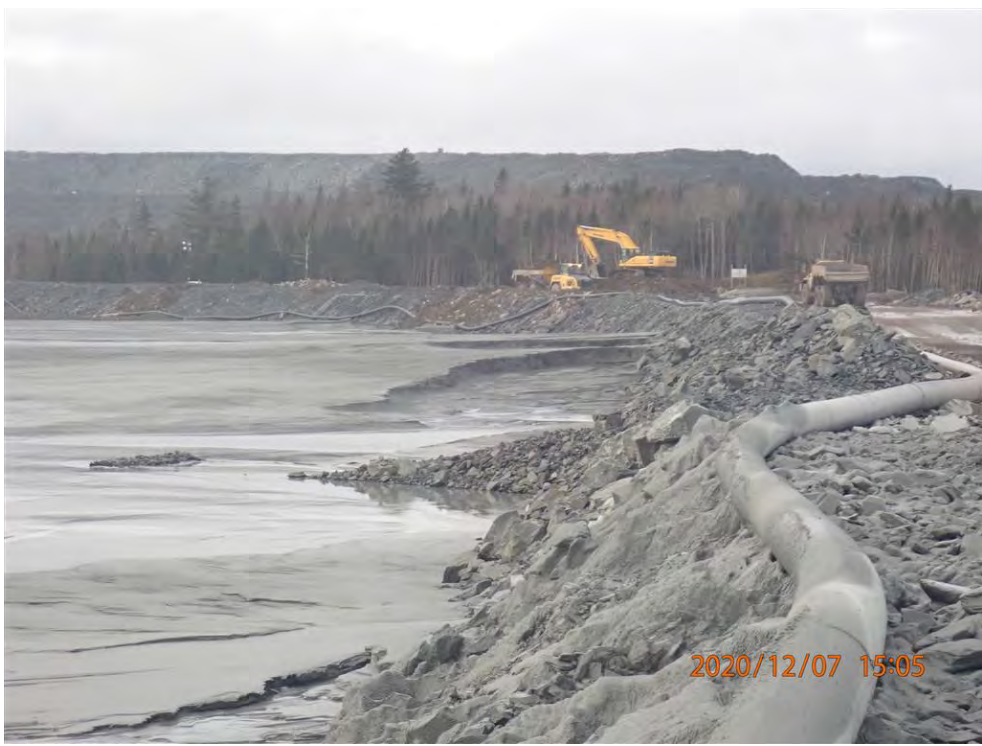
Photo Location: TMF Pond/Dam. East TMF near Station 2+300			
Image Date: 12/7/2020			
Photo Direction:			
Comments: Formation of tailings beach.

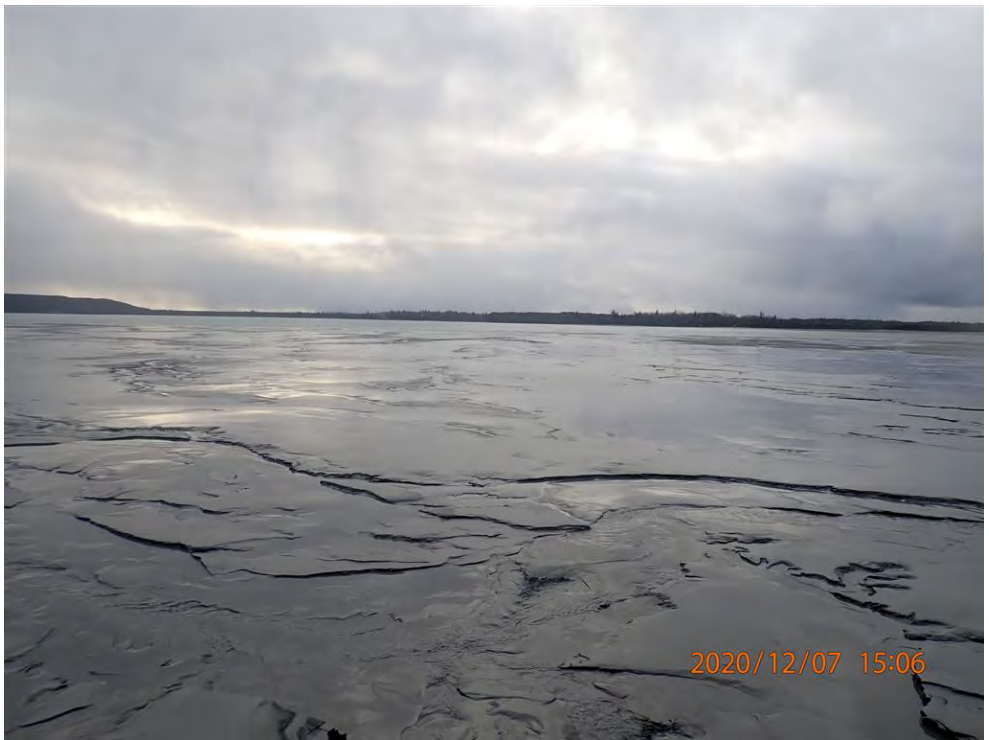
Client:	Atlantic Mining NS Inc.	Project:	Fall 2020 Touquoy TMF DSI
Site Name:	Touquoy Mine Site	Site Location:	Middle Musquodoboit, NS
Photograph ID: 35

Photo Location: TMF Pond/Dam. Northeast TMF near Station 2+300			
Image Date: 12/7/2020			
Photo Direction: West			
Comments: Tailings beach.			
Photograph ID: 36

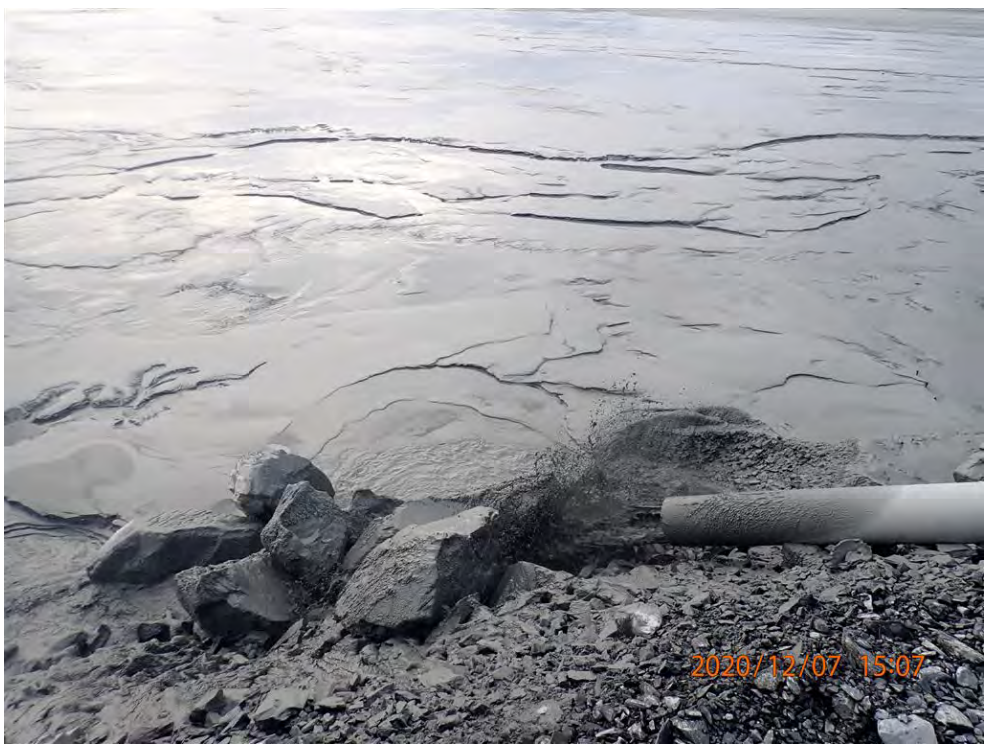
Photo Location: TMF Pond/Dam. East TMF near Station 2+300, Tailings Pipe North East Slope			
Image Date: 12/7/2020			
Photo Direction: West			
Comments: End of pipe tailings discharge.

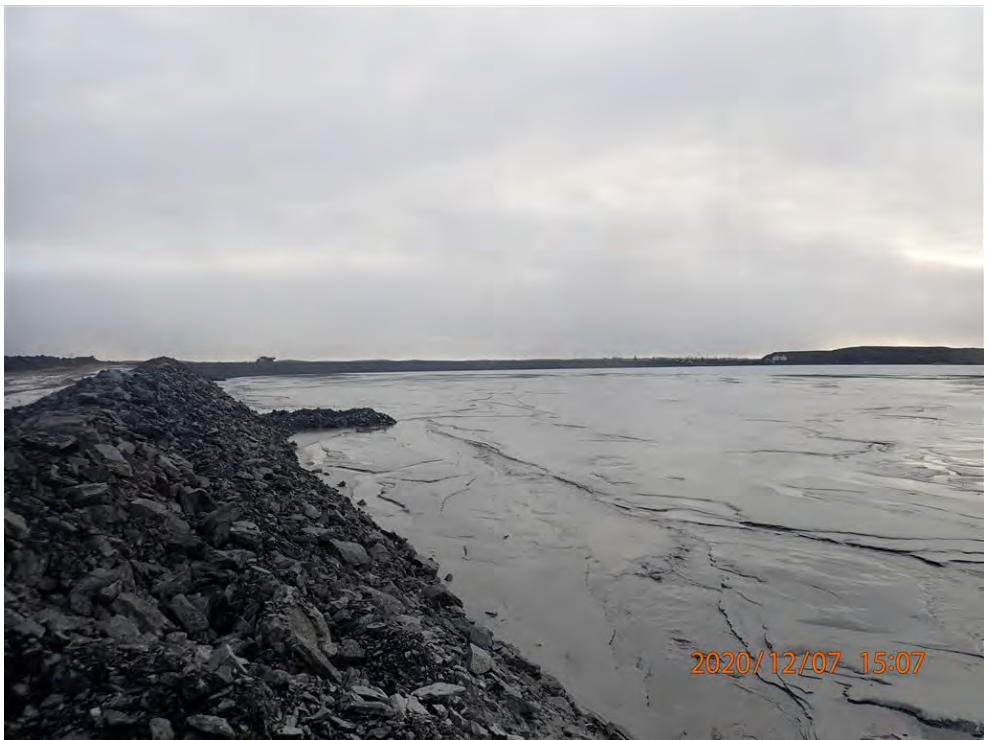
Client:	Atlantic Mining NS Inc.	Project:	Fall 2020 Touquoy TMF DSI
Site Name:	Touquoy Mine Site	Site Location:	Middle Musquodoboit, NS
Photograph ID: 39

Photo Location: TMF Pond/Dam. Northeast TMF near Station 2+300			
Image Date: 12/7/2020			
Photo Direction: Southeast			
Comments: Tailings beach.			
Photograph ID: 40

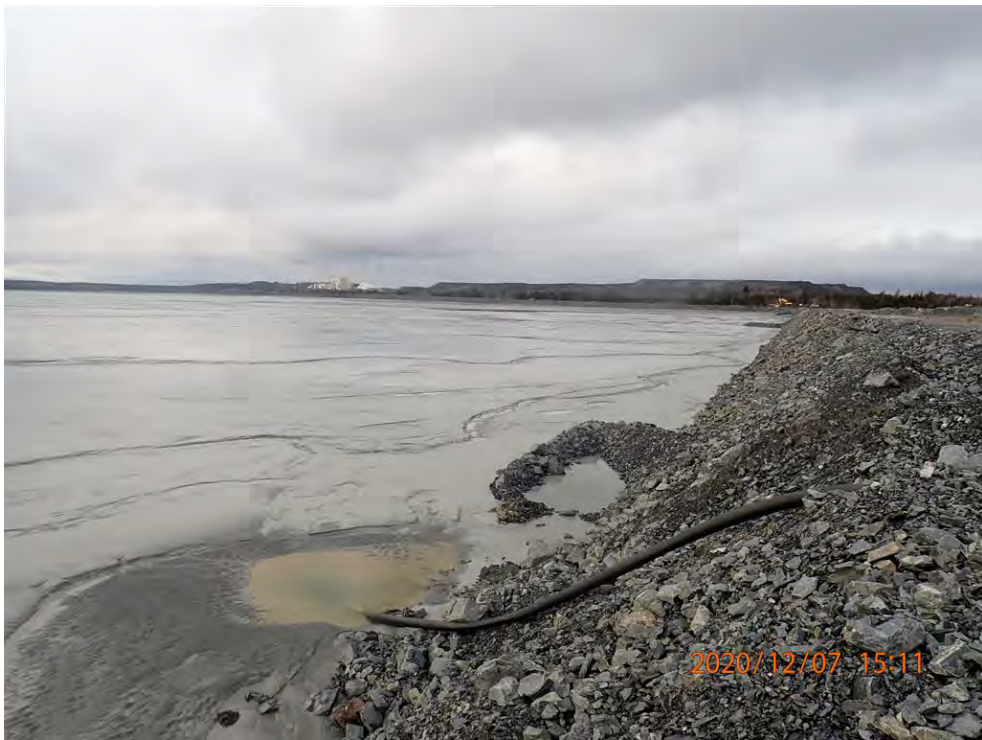
Client:	Atlantic Mining NS Inc.	Project:	Fall 2020 Touquoy TMF DSI
Site Name:	Touquoy Mine Site	Site Location:	Middle Musquodoboit, NS
Photograph ID: 41

Photo Location: TMF Pond/Dam. Southeast TMF near Station 2+100			
Image Date: 12/7/2020			
Photo Direction: North			
Comments: Seepage pipe pumping water into TMF from East Pond 2 Seepage Collection Pond			
Photograph ID: 42
