SD 19
2020 Annual Report

2020 Annual Report

Touquoy Gold Mine

Industrial Approval No. 2012-084244-08

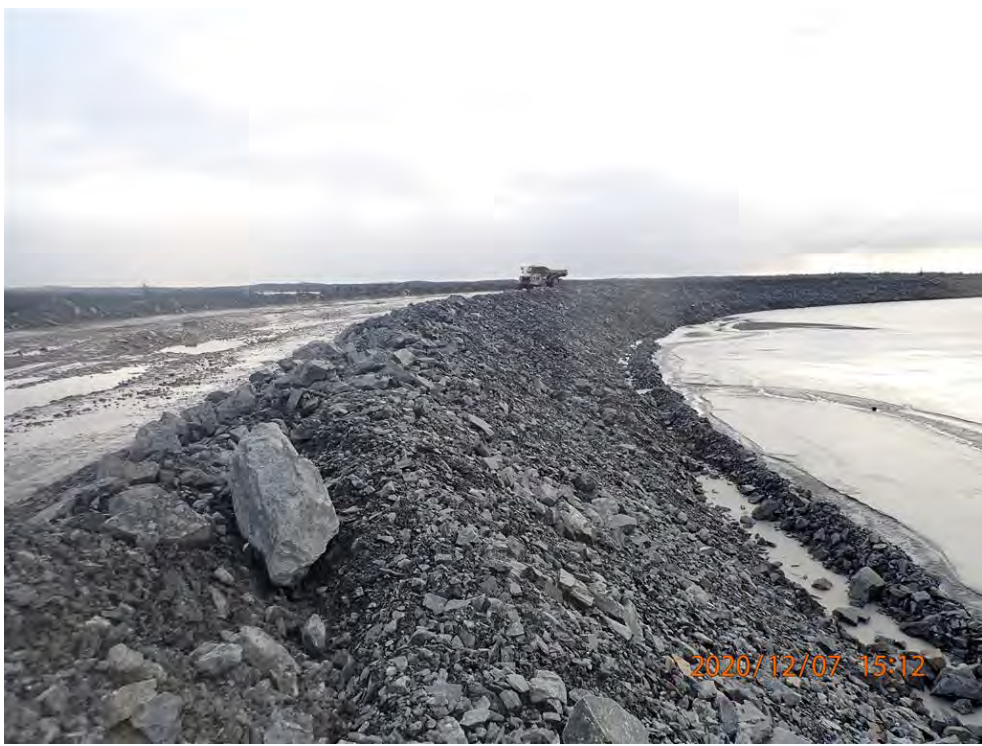
Photo Location: TMF Pond/Dam. Upstream Slope of East TMF near Station 2+050			
Image Date: 12/7/2020			
Photo Direction: South			
Comments: No evidence of erosion or instability on upstream slope.

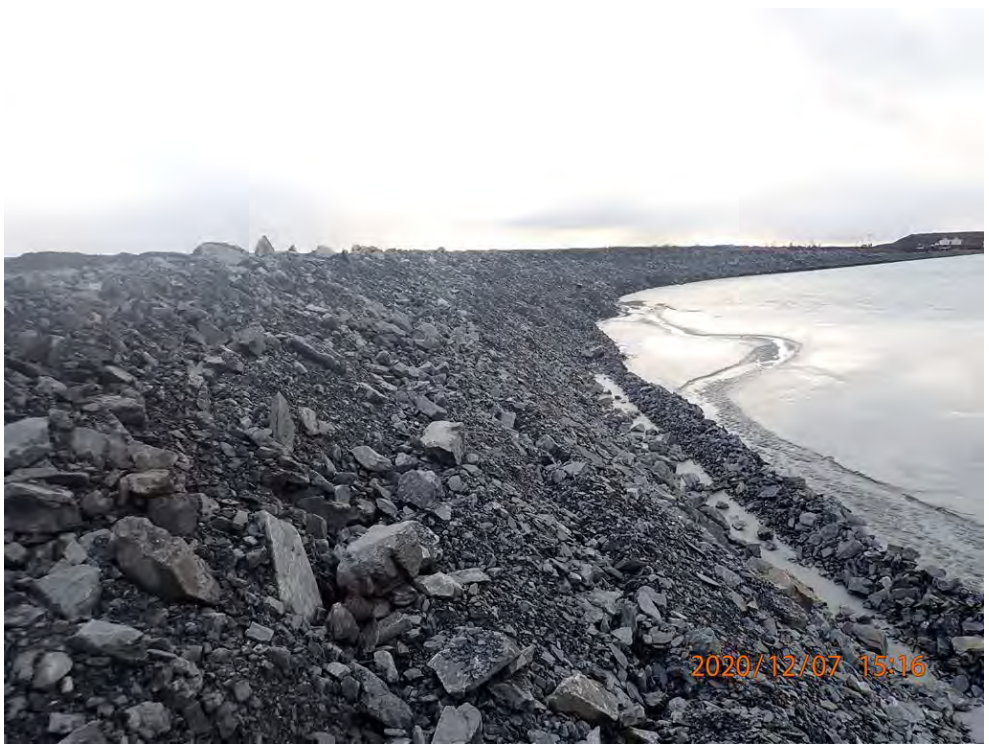
Photo Location: TMF Pond/Dam. Southeast TMF near Station 1+850			
Image Date: 12/7/2020			
Photo Direction: Southwest			
Comments: Upstream Slope at Station 1+850

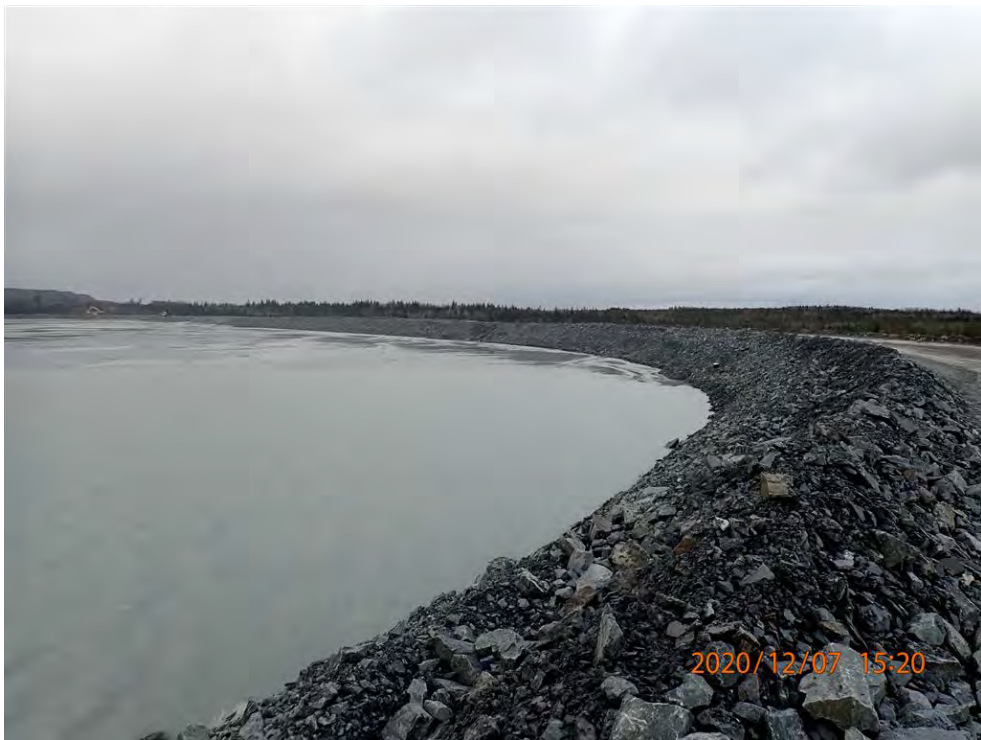
Client:	Atlantic Mining NS Inc.	Project:	Fall 2020 Touquoy TMF DSI
Site Name:	Touquoy Mine Site	Site Location:	Middle Musquodoboit, NS
Photograph ID: 45

Photo Location: TMF Pond/Dam. Southeast TMF near Station 1+850			
Image Date: 12/7/2020			
Photo Direction: Northeast			
Comments: Upstream Slope at Station 1+850			
Photograph ID: 46

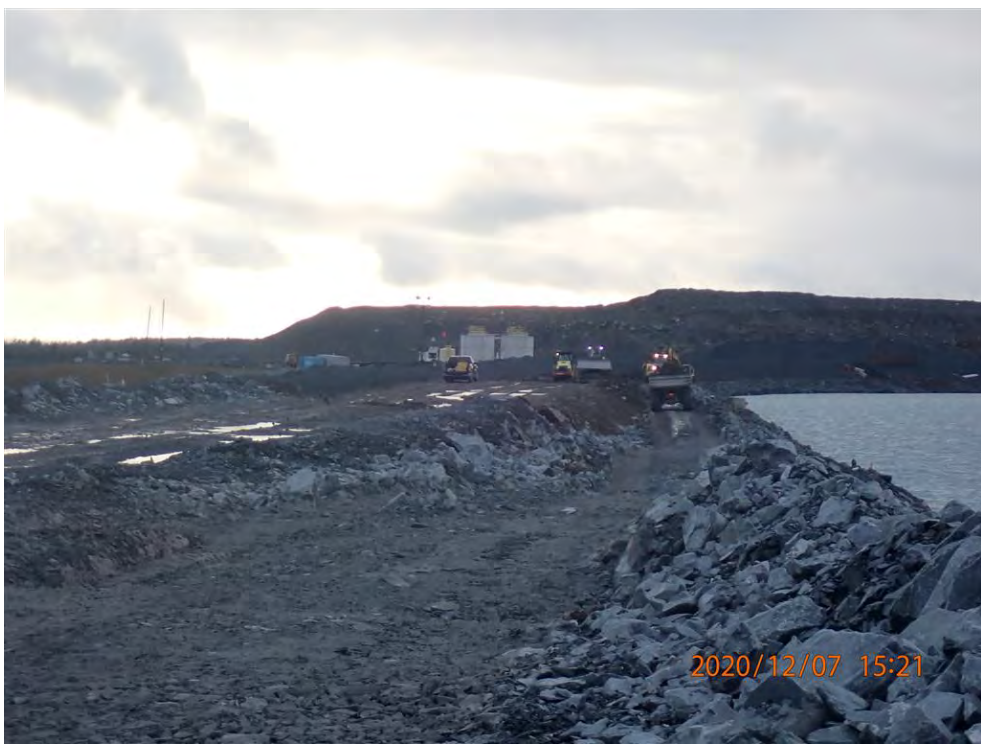
Photo Location: TMF Pond/Dam. South TMF near Station 1+750			
Image Date: 12/7/2020			
Photo Direction: West			
Comments: Ongoing Construction of Type 1 Clay Core Placement on South TMF.

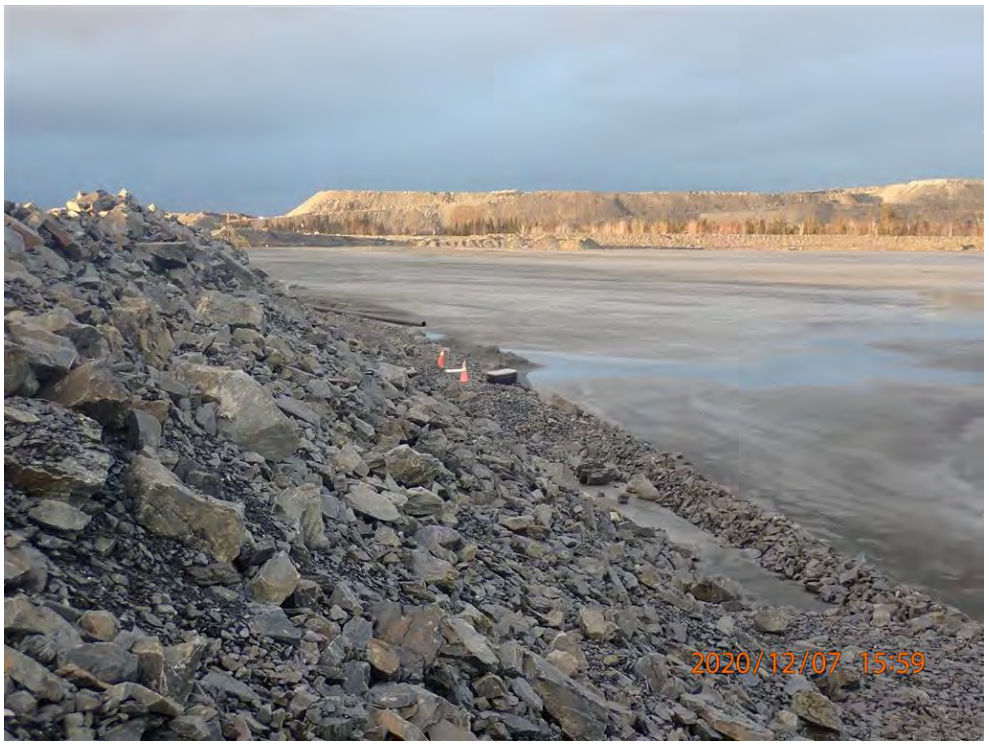
Client:	Atlantic Mining NS Inc.	Project:	Fall 2020 Touquoy TMF DSI
Site Name:	Touquoy Mine Site	Site Location:	Middle Musquodoboit, NS
Photograph ID: 53

Photo Location: TMF Pond/Dam. Southwest TMF near Station 0+400			
Image Date: 12/7/2020			
Photo Direction: Northeast			
Comments: Piezometer station in clay core with Tailings Beach.			
Photograph ID: 54

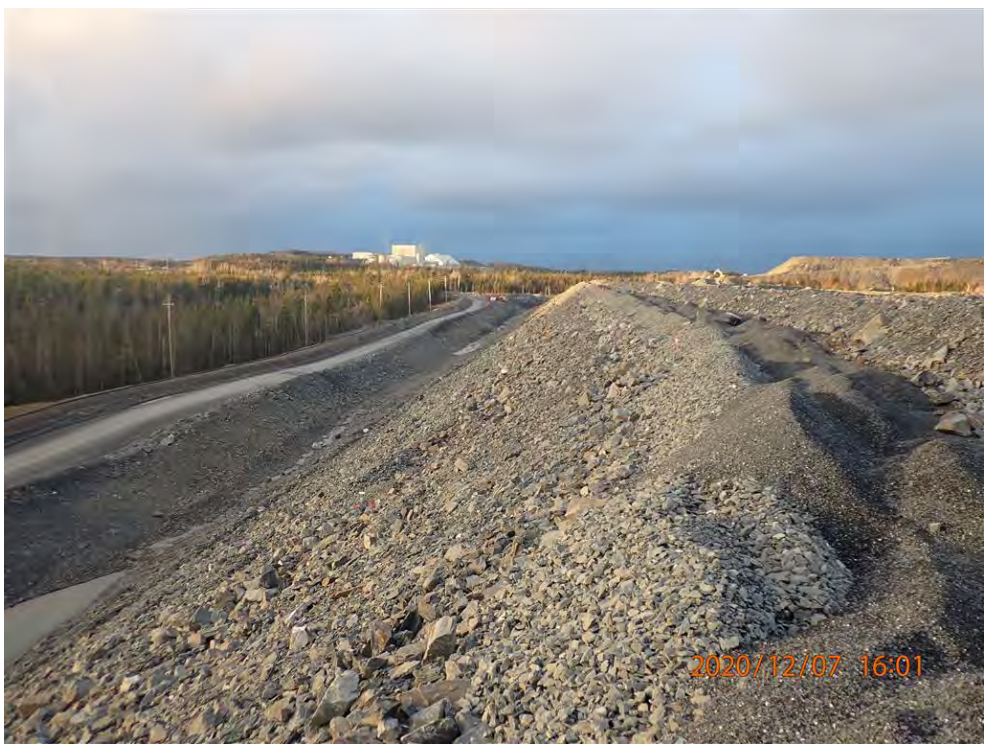
Photo Location: TMF Pond/Dam. Southwest TMF near Station 0+400			
Image Date: 12/7/2020			
Photo Direction: North			
Comments: Downstream Slope facing north showing West Seepage Ditch.

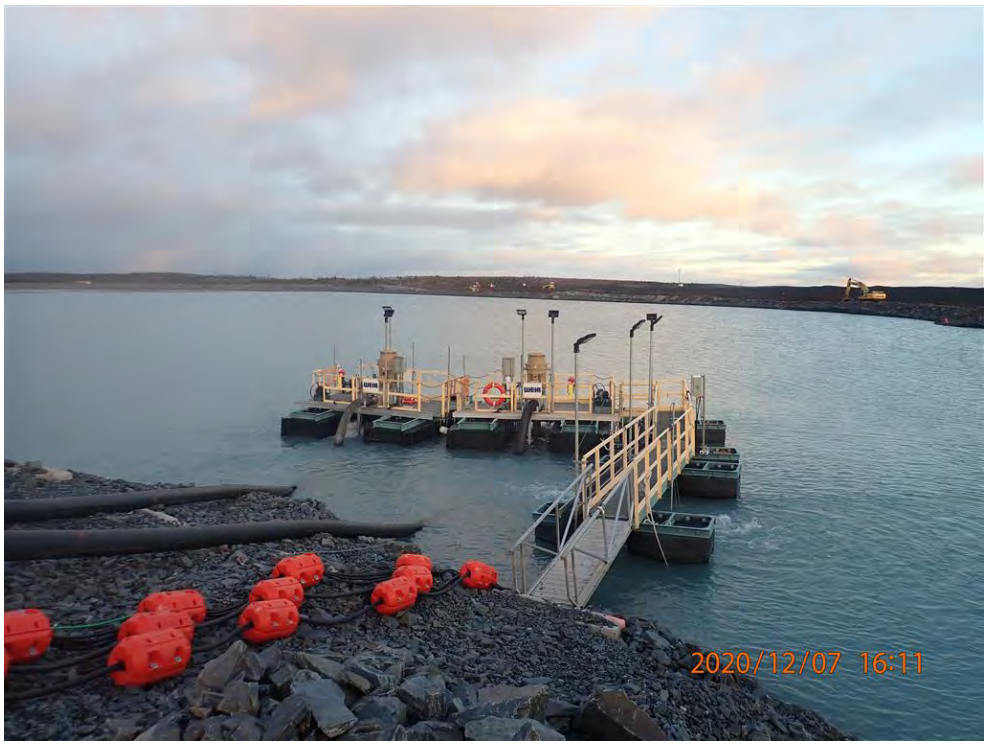
Client:	Atlantic Mining NS Inc.	Project:	Fall 2020 Touquoy TMF DSI
Site Name:	Touquoy Mine Site	Site Location:	Middle Musquodoboit, NS
Photograph ID: 59

Photo Location: TMF Pond/Dam. South TMF Pond			
Image Date: 12/7/2020			
Photo Direction: East			
Comments: Tailings pond decant barge.			
Photograph ID: 60

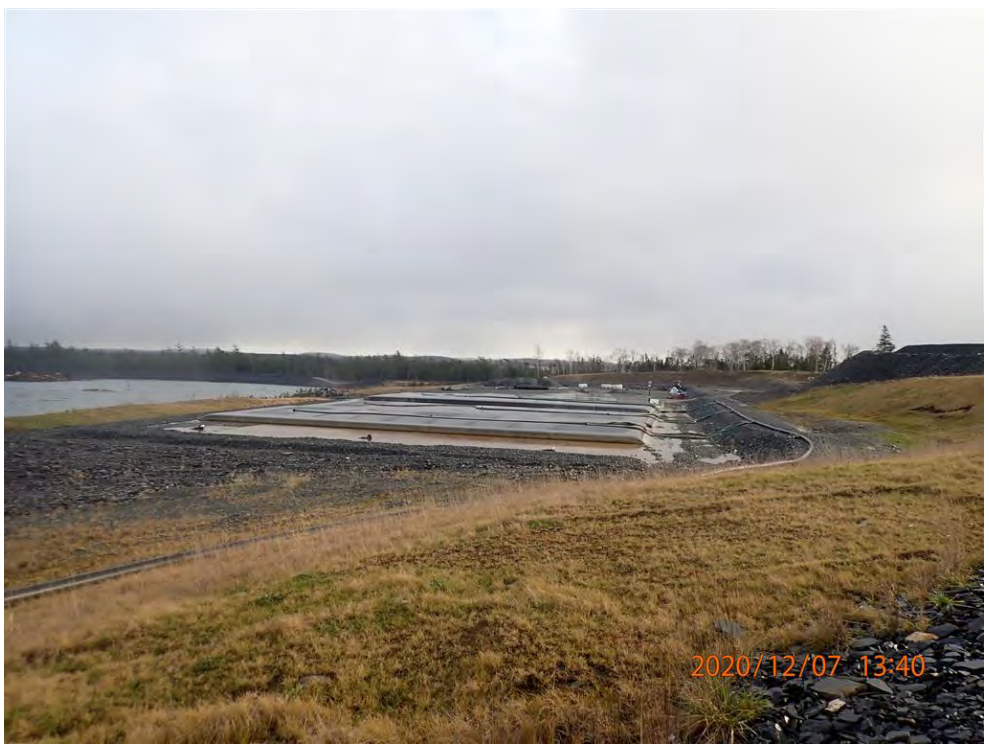
Photo Location: Geobag Area			
Image Date: 12/7/2020			
Photo Direction: South			
Comments: Overview of geobags used to filter water before discharge into polishing pond.

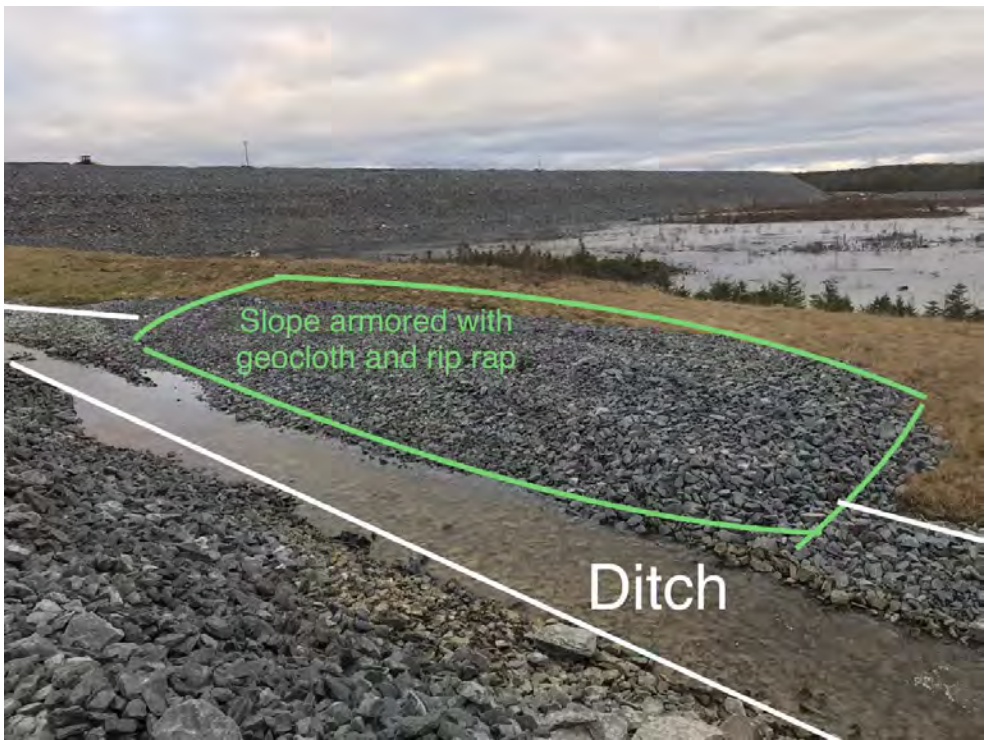
Client:	Atlantic Mining NS Inc.	Project:	Fall 2020 Touquoy TMF DSI	
Site Name:	Touquoy Mine Site	Site Location:	Middle Musquodoboit, NS	
Photograph ID: 67

Photo Location:				Geobag Area
Image Date:				12/9/2020
Photo Direction:				Northeast
Comments:				Completed repairs of previously eroded section of the geobag discharge channel. (Photo provided by S.McQuat, Stantec)
Photograph ID: 68

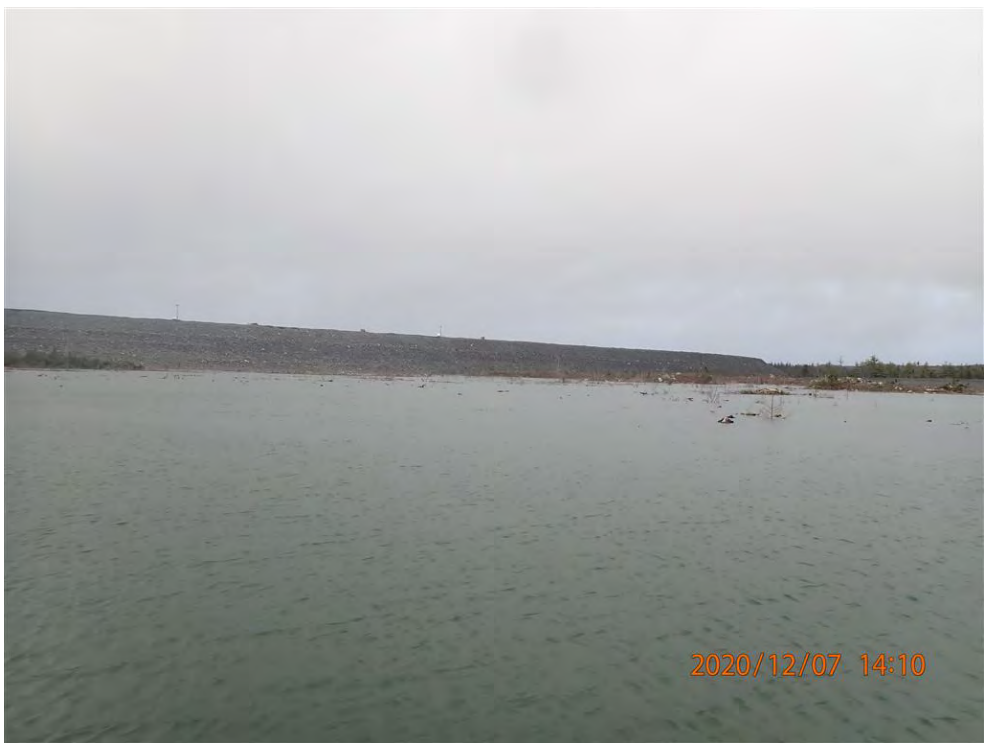
Photo Location:				Polishing Pond
Image Date:				12/7/2020
Photo Direction:				North
Comments:				Polishing Pond

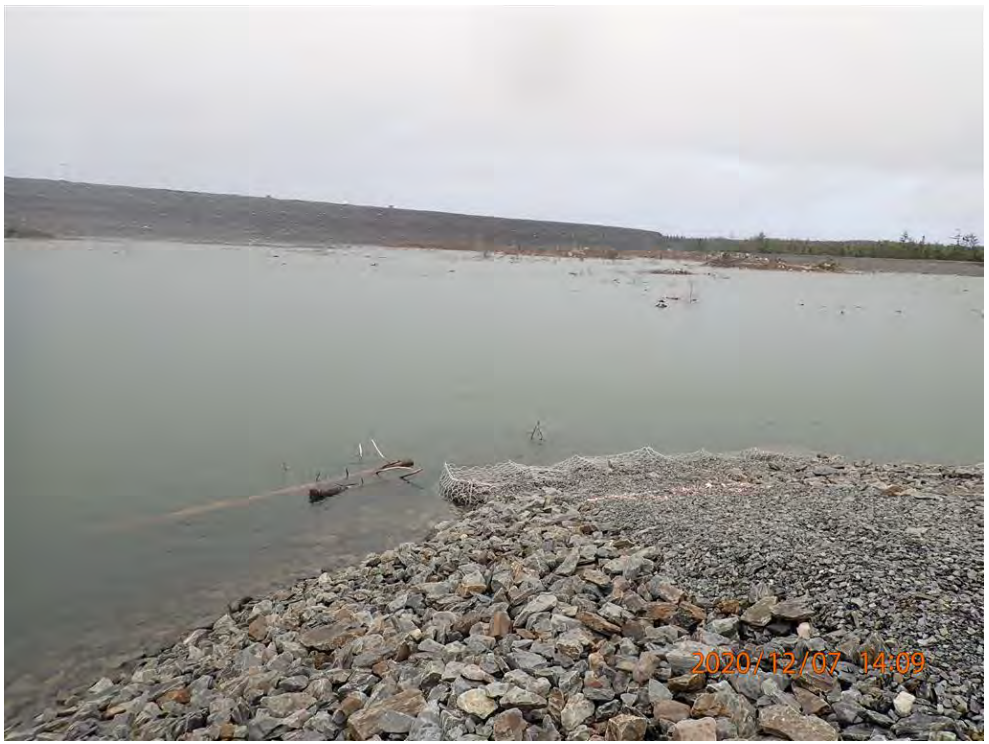
Client:	Atlantic Mining NS Inc.	Project:	Fall 2020 Touquoy TMF DSI
Site Name:	Touquoy Mine Site	Site Location:	Middle Musquodoboit, NS
Photograph ID: 69

Photo Location: Polishing Pond			
Image Date: 12/7/2020			
Photo Direction: North			
Comments: Some accumulation of debris near the intake.			
Photograph ID: 70

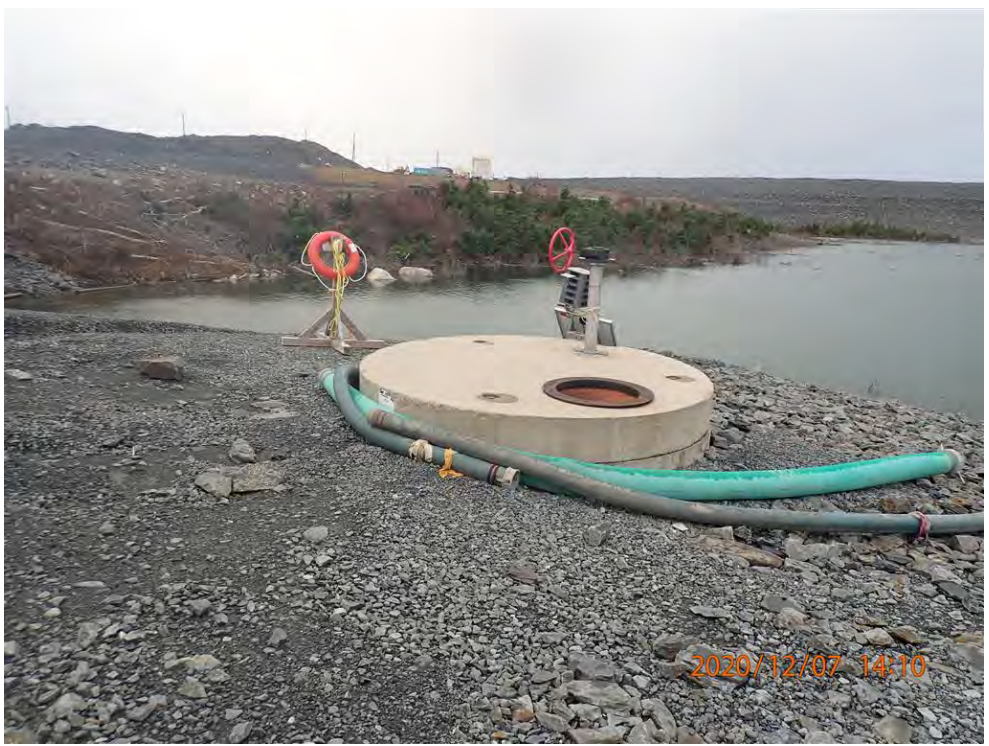
Photo Location: Polishing Pond			
Image Date: 12/7/2020			
Photo Direction: North			
Comments: Polishing Pond Outlet Control Structure

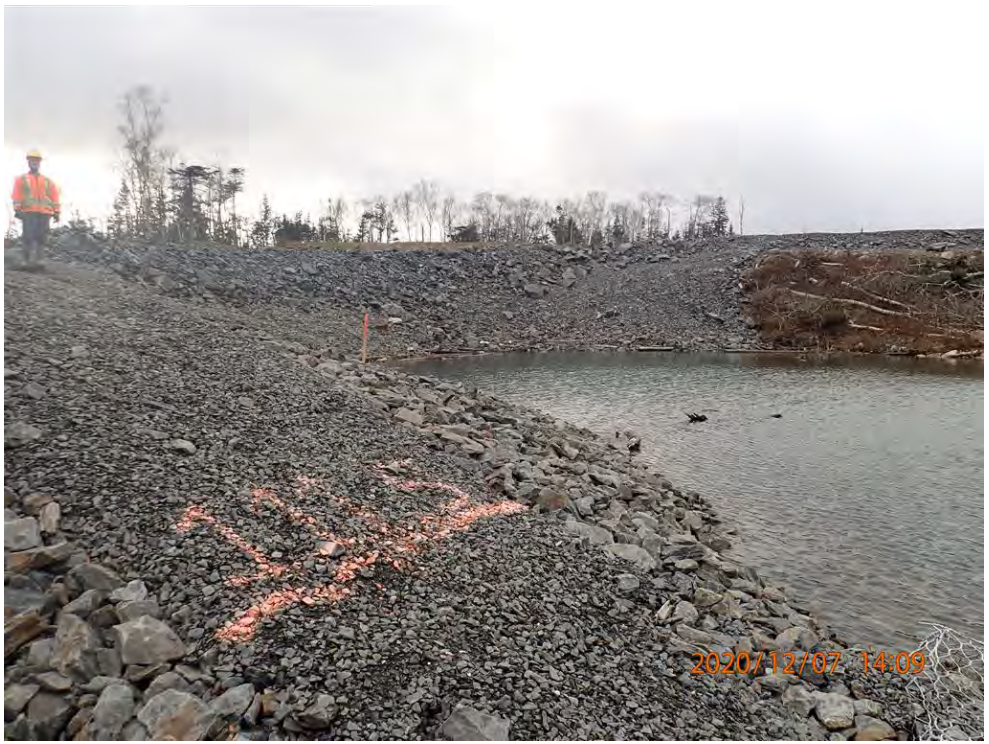
Client:	Atlantic Mining NS Inc.	Project:	Fall 2020 Touquoy TMF DSI	
Site Name:	Touquoy Mine Site	Site Location:	Middle Musquodoboit, NS	
Photograph ID: 71

Photo Location:				Polishing Pond
Image Date:				12/7/2020
Photo Direction:				South
Comments:				The water trigger level of 111.5 m marked on the shoreline.
Photograph ID: 72	 			
Photo Location:				Polishing Pond
Image Date:				12/7/2020
Photo Direction:				East
Comments:				Perimeter Road around Polishing Pond

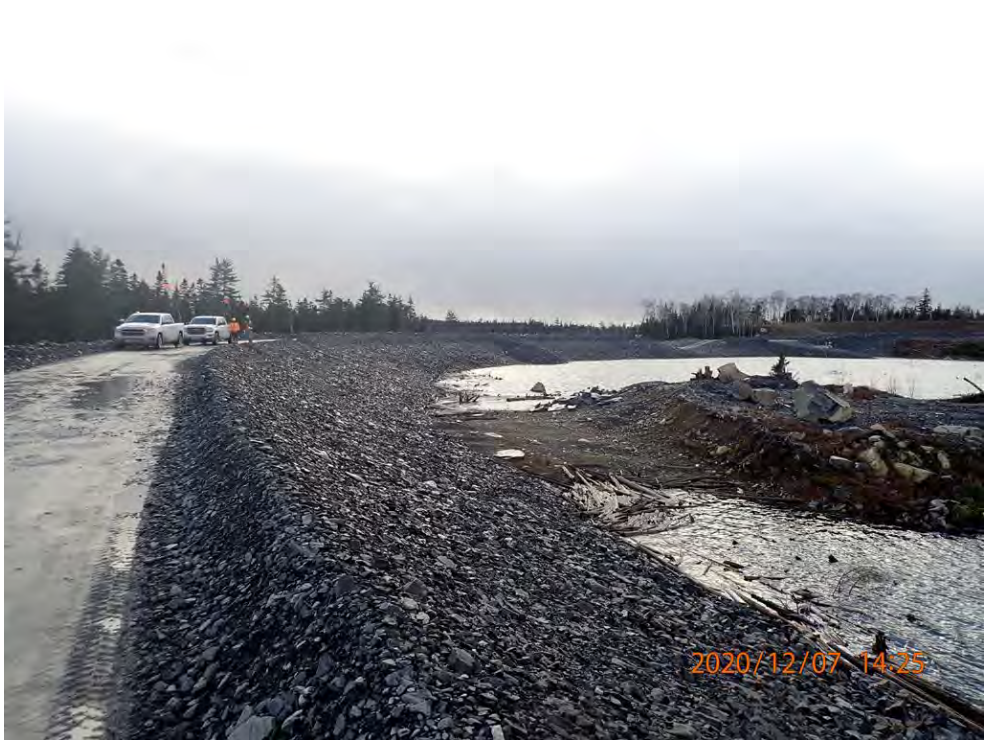
Client:	Atlantic Mining NS Inc.	Project:	Fall 2020 Touquoy TMF DSI
Site Name:	Touquoy Mine Site	Site Location:	Middle Musquodoboit, NS
Photograph ID: 79

Photo Location: Polishing Pond			
Image Date: 12/7/2020			
Photo Direction: Southwest			
Comments: Timber debris accumulating. To be removed.			
Photograph ID: 80

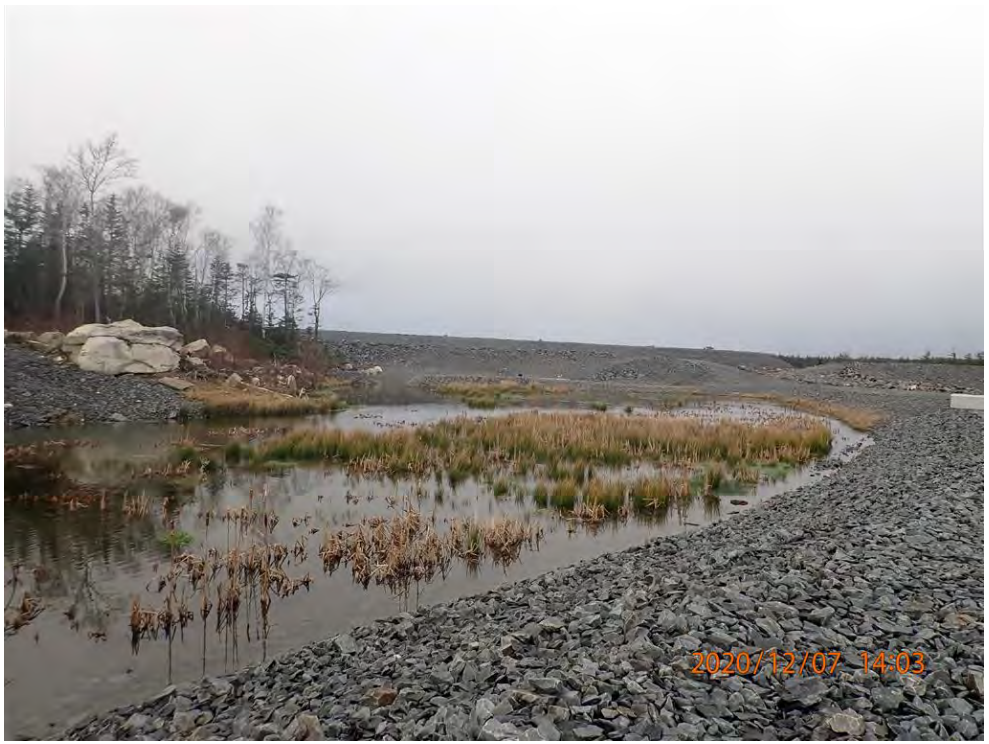
Client:	Atlantic Mining NS Inc.	Project:	Fall 2020 Touquoy TMF DSI
Site Name:	Touquoy Mine Site	Site Location:	Middle Musquodoboit, NS
Photograph ID: 83

Photo Location: Engineered Wetland			
Image Date: 12/7/2020			
Photo Direction: Northeast			
Comments: Vegetation within the Engineered Wetland			
Photograph ID: 84

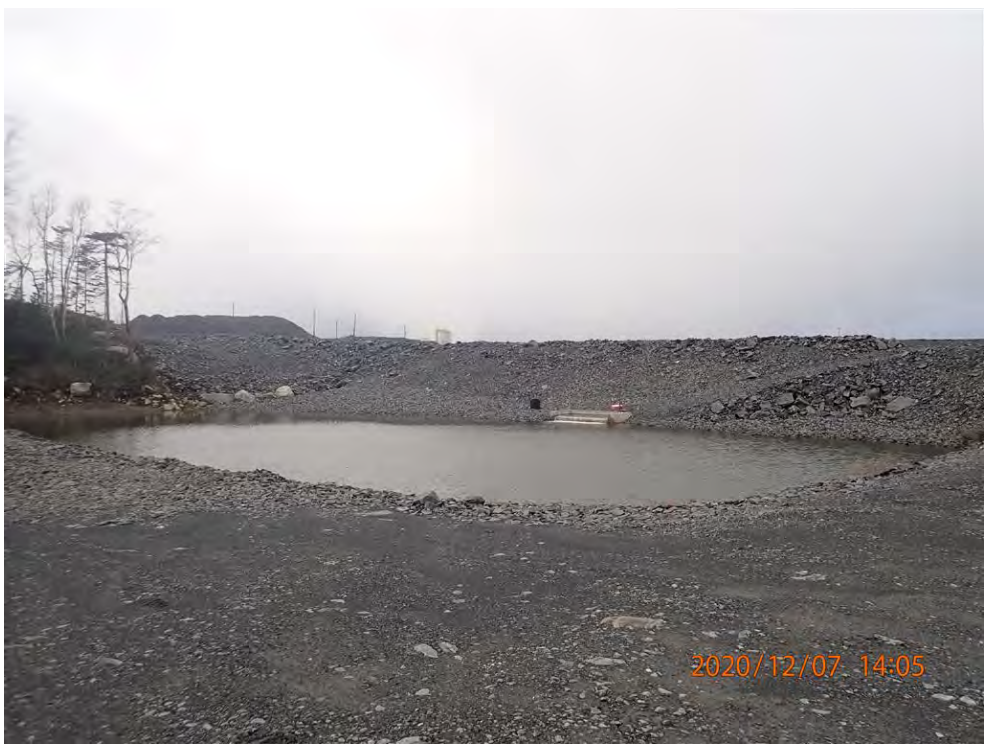
Photo Location: Engineered Wetland			
Image Date: 12/7/2020			
Photo Direction: West			
Comments: Outflow structure from Polishing Pond into Wetland. Broad crested weir with additional flow-meter instrumentation installed.

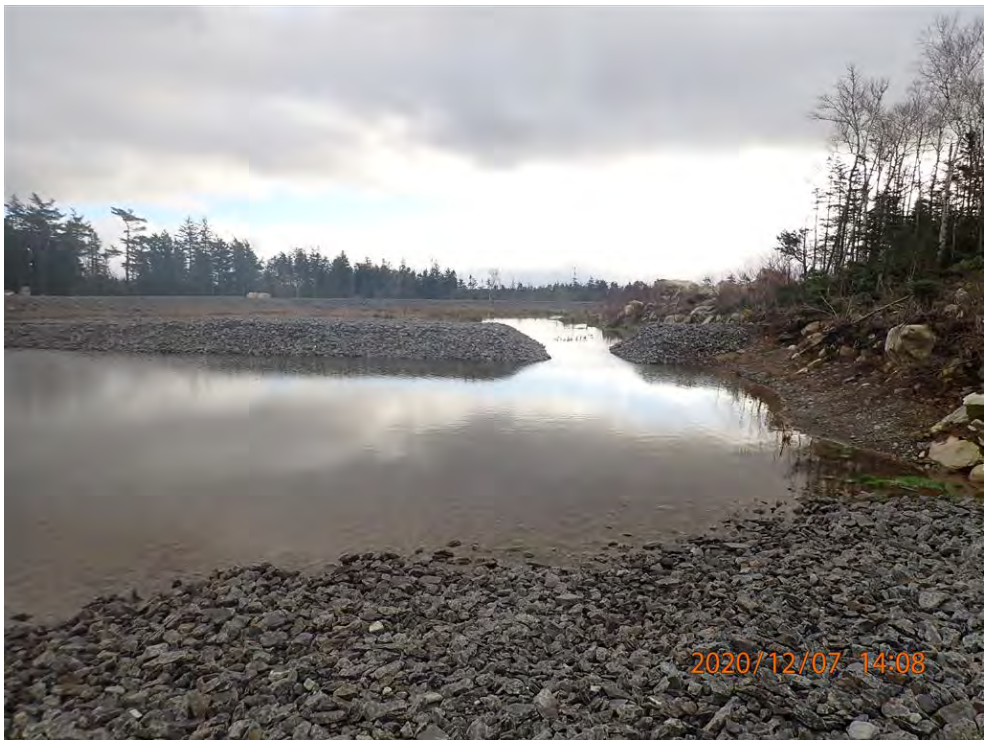
Client:	Atlantic Mining NS Inc.	Project:	Fall 2020 Touquoy TMF DSI
Site Name:	Touquoy Mine Site	Site Location:	Middle Musquodoboit, NS
Photograph ID: 85

Photo Location: Engineered Wetland			
Image Date: 12/7/2020			
Photo Direction: South			
Comments: East end of Engineered Wetland.			
Photograph ID: 86

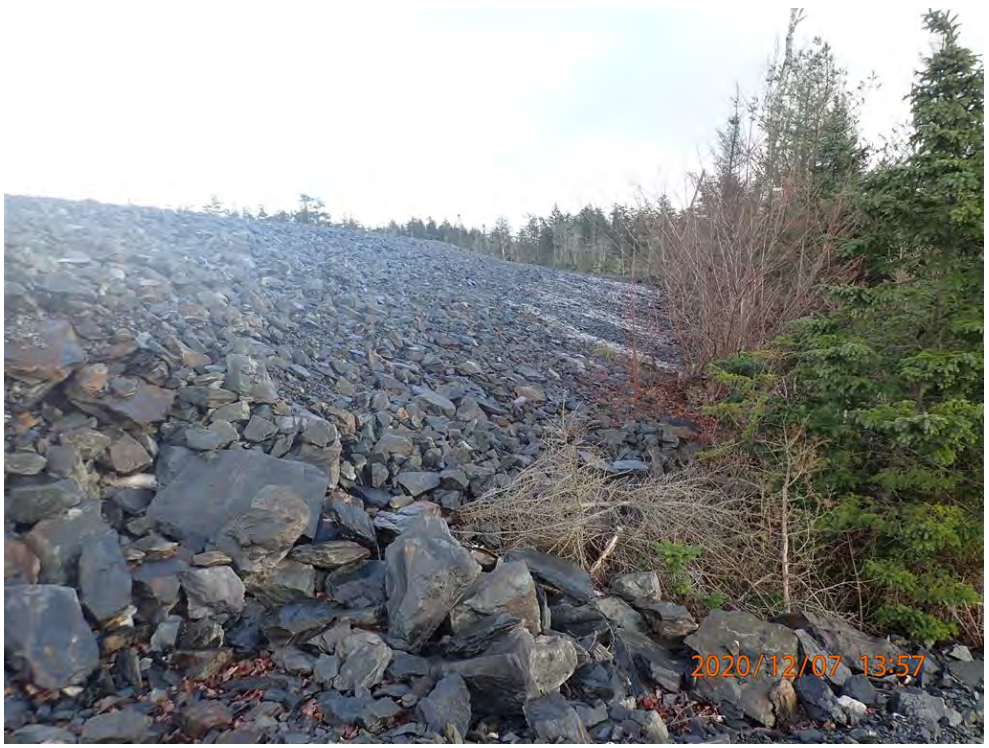
Photo Location: Engineered Wetland			
Image Date: 12/7/2020			
Photo Direction: East			
Comments: Sheet flow visible seeping through Engineered Wetland berm into the wooded area to the south.

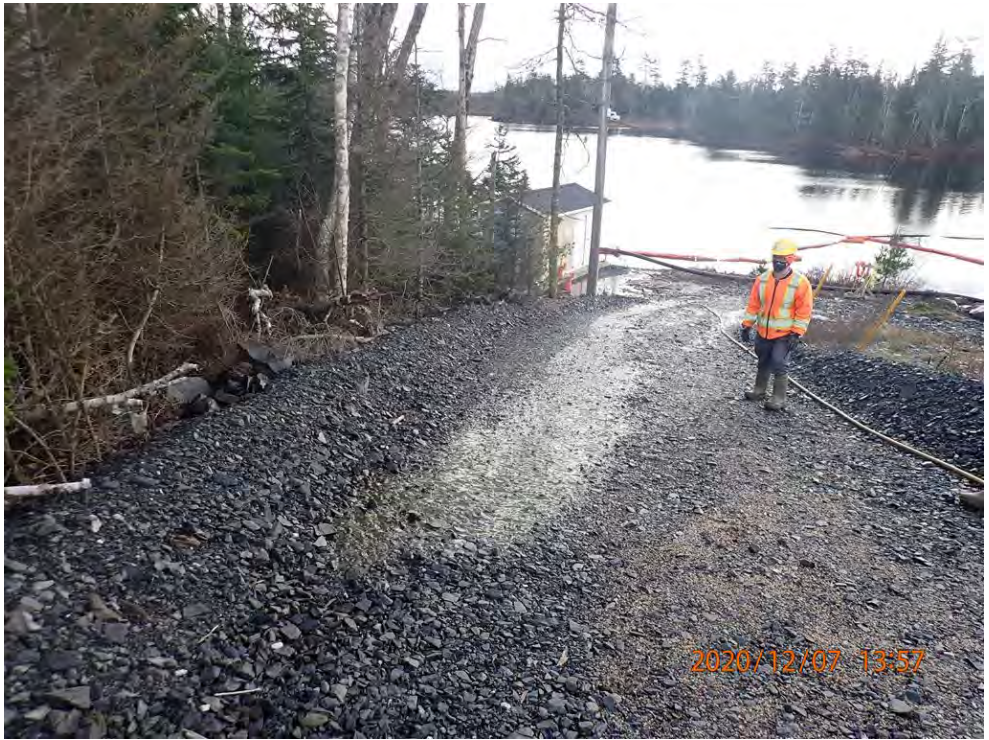
Client:	Atlantic Mining NS Inc.	Project:	Fall 2020 Touquoy TMF DSI
Site Name:	Touquoy Mine Site	Site Location:	Middle Musquodoboit, NS
Photograph ID: 87

Photo Location: Engineered Wetland			
Image Date: 12/7/2020			
Photo Direction: East			
Comments: Access to Scraggy Lake Freshwater Intake Pump House. Sheet flow from Engineered Wetland.			
Photograph ID: 88

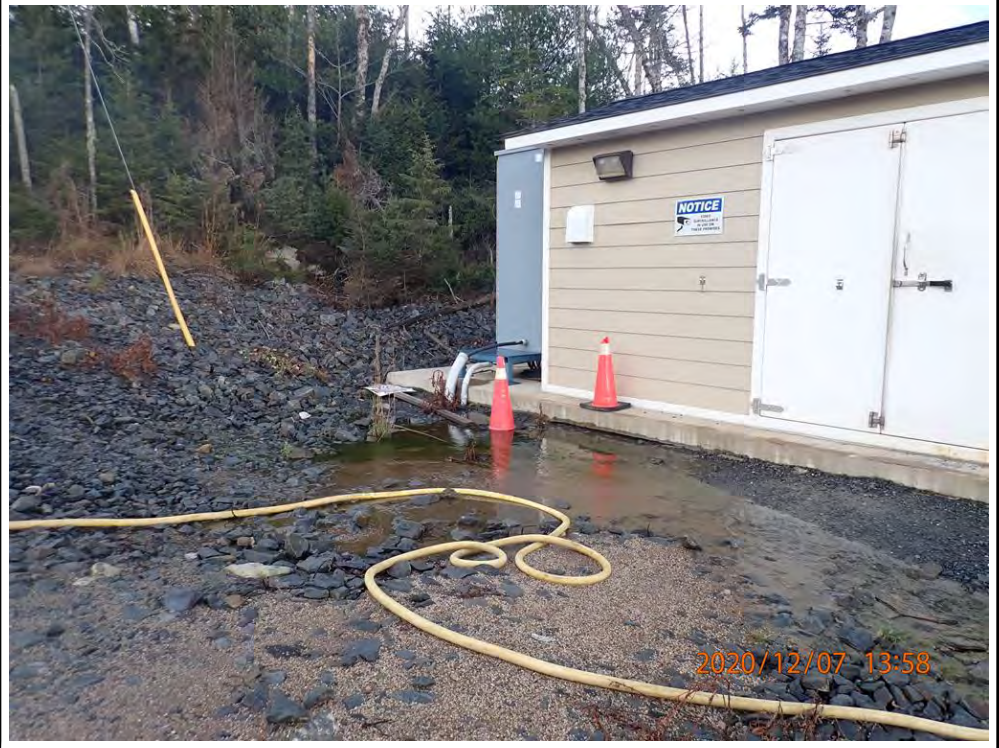
Photograph ID: 91
Photo Location: Engineered Wetland
Image Date: 12/7/2020
Photo Direction: North
Comments: Water discharging from the Engineered Wetland is concentrating at the bottom of the slope and starting to undermine the foundations of the Scraggy Lake Pump House. Noted in Spring 2020 DSI, repairs are yet to be completed.

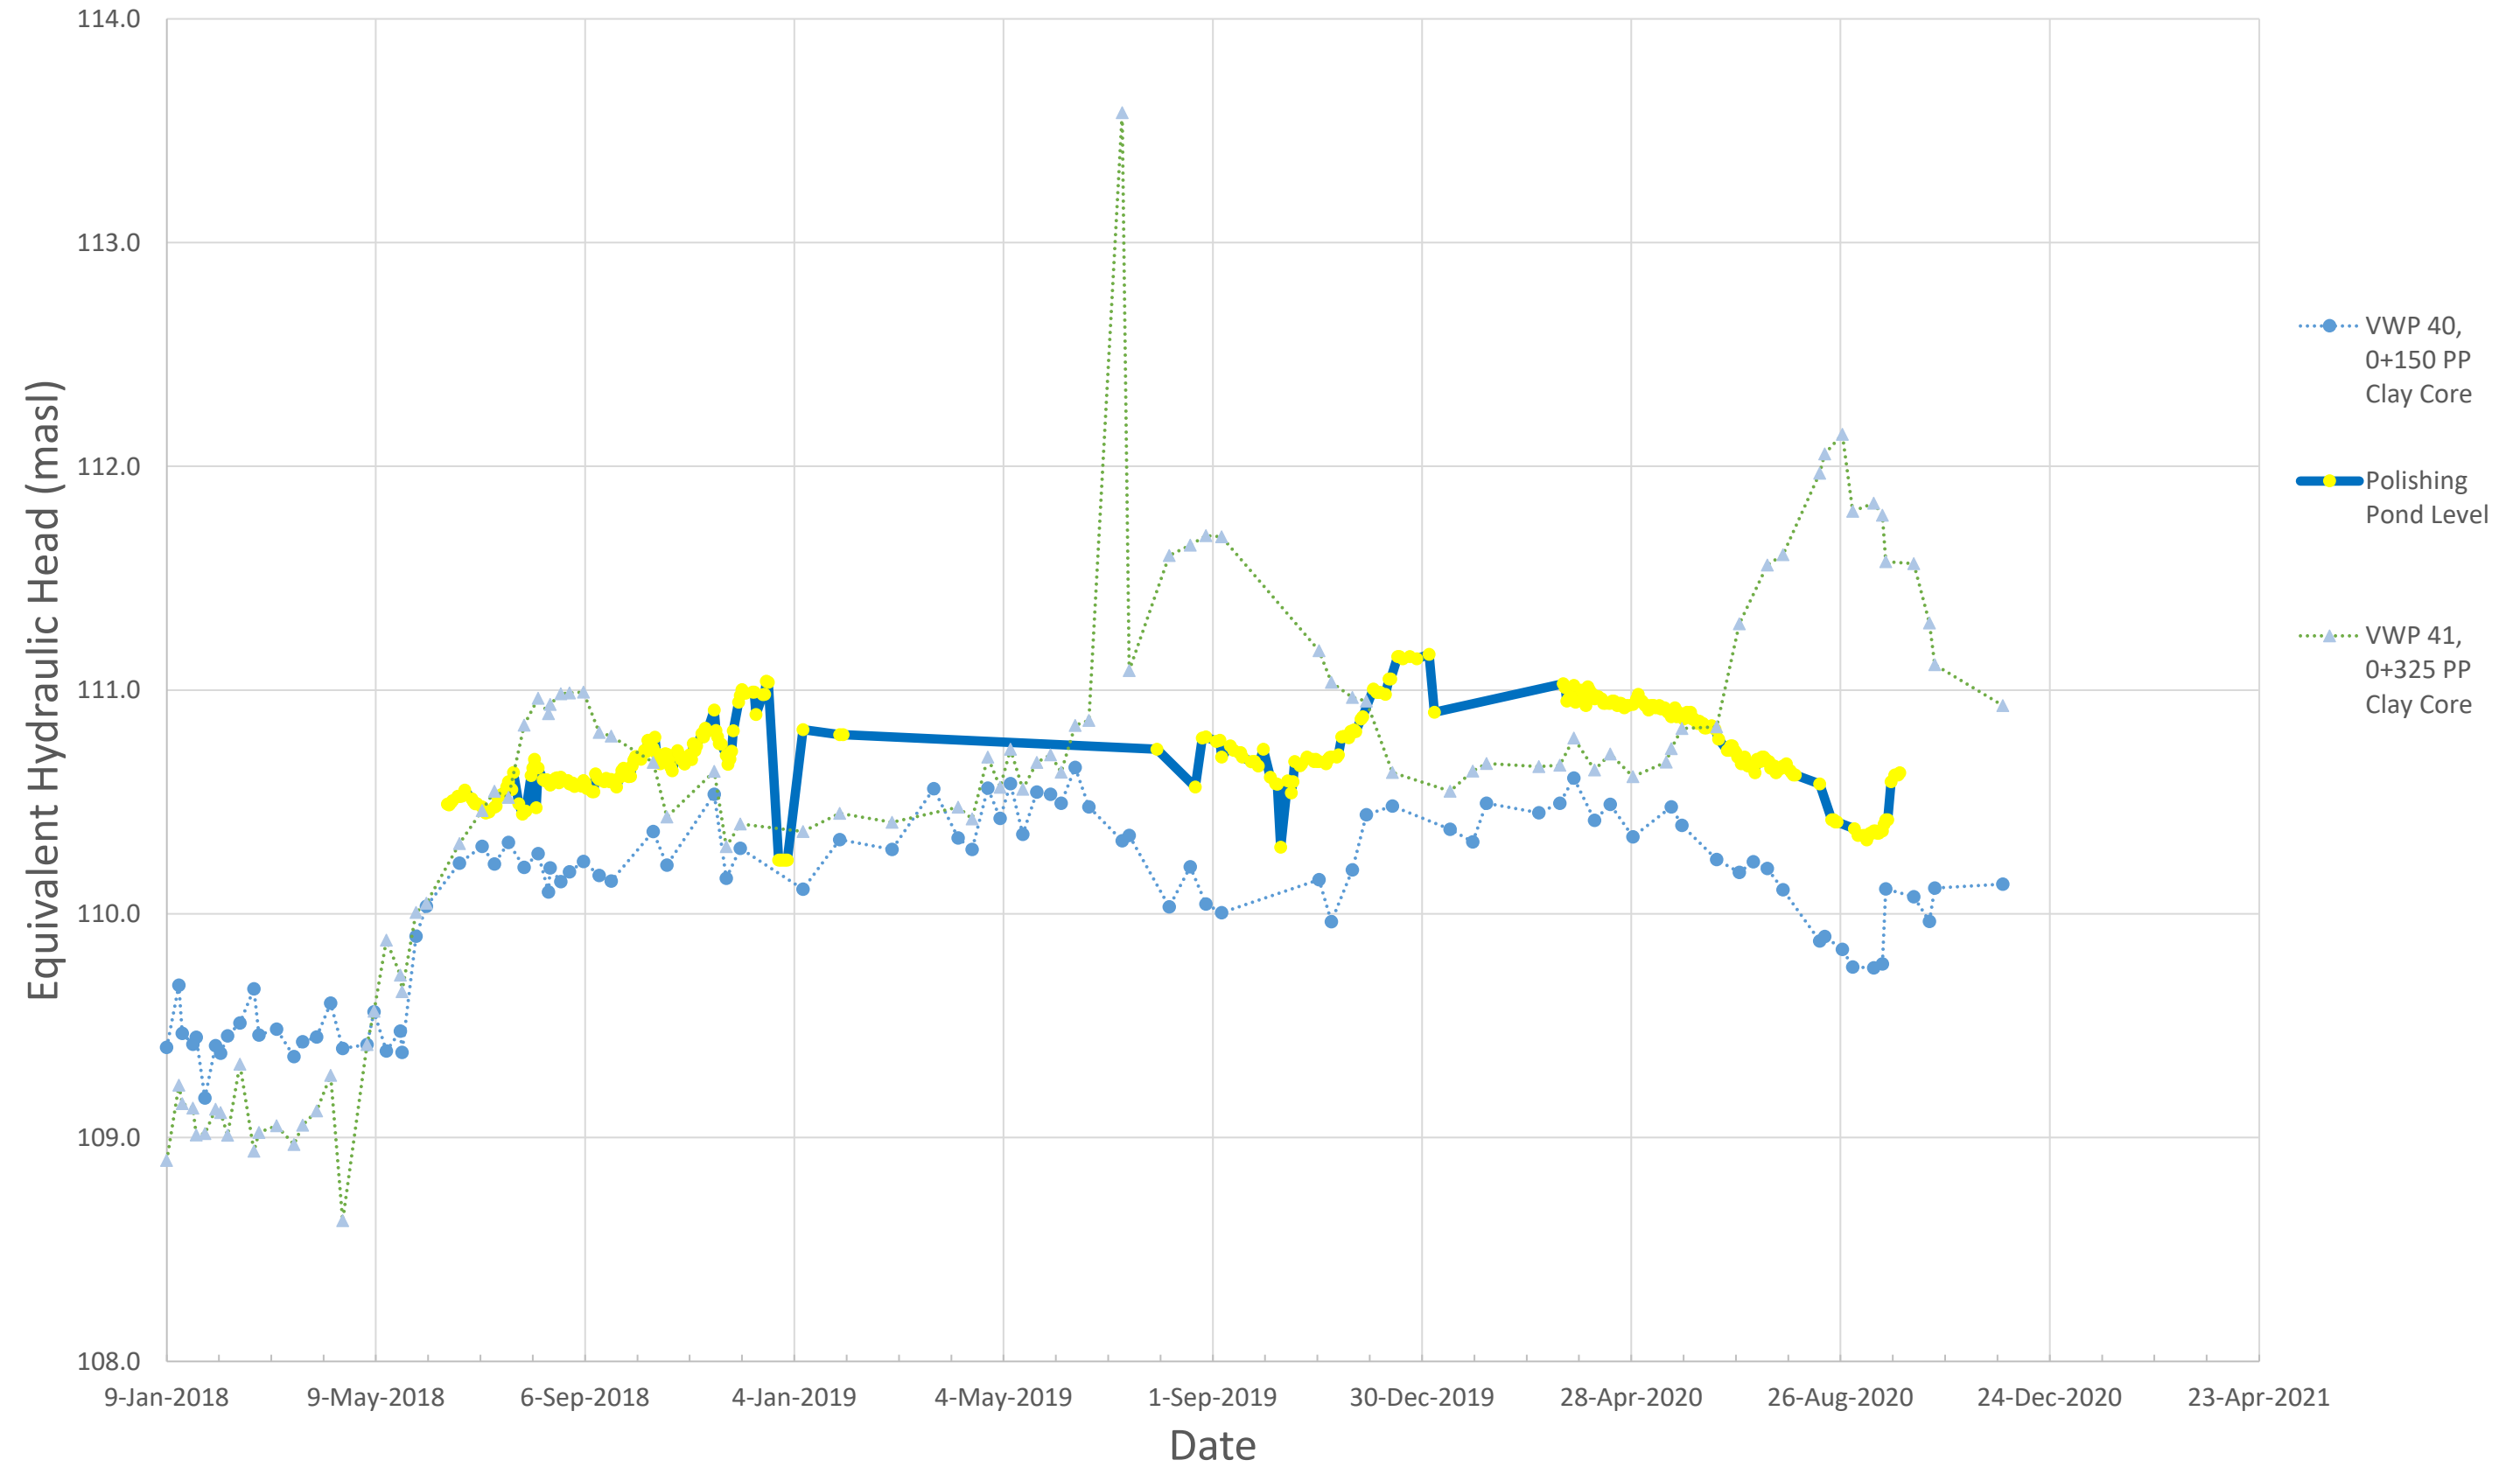
Figure 6 - Polishing Pond Dam Piezometers in Clay Core

The VWP No. 41 installed within the clay core of Polishing Pond is providing erratic data (plotted in Figure 6). A review and evaluation of this instrument is required and depending upon the findings, replacement of this instrument may be required.
