**Watercourse Fact Sheet: Fish Habitat - Page 1**

WATERCOURSE INFORMATION	
Watercourse ID:	<b>Watercourse BL-WC201a-3772</b>
General Site Location:	Bear Lake
Watercourse Assessor(s):	CJ,CM
Affiliation:	CBCL Limited
Field Assessment Date:	Nov 4 2022
UTM Coordinates:	Wp. 1587
Datum:	NAD 1983
HABITAT QUALITY	
Overall Habitat Quality	Good
Spawning	Good
Rearing	Moderate
Foraging	
Migration	
Overwintering	Moderate
POTENTIAL FOR FISH PRESENCE	
Overall Fish Potential	High
FISH OBSERVED	
No	
WATER QUALITY AND VELOCITY	
Temperature (Deg. C)	8.1
pH	4.6
Dissolved Oxygen (mg/l)	12.65
Dissolved Oxygen (%)	108
Conductivity (µs/cm)	33.33
Salinity (mg/L)	0.02
Total Dissolved Solids (g/L)	
Turbidity (NTU)	
Average Velocity (m/sec)	4.69
Velocity Location	Crossing

**Watercourse Fact Sheet: Fish Habitat - Page 2**  
**Watercourse ID: Watercourse BL-WC201a-3772**

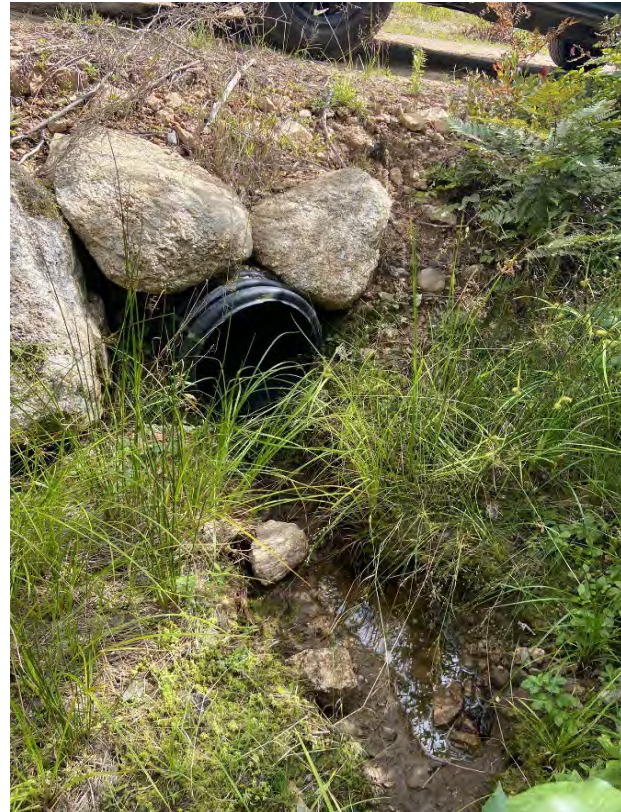
Photo 1: Upstream at approximate crossing location.

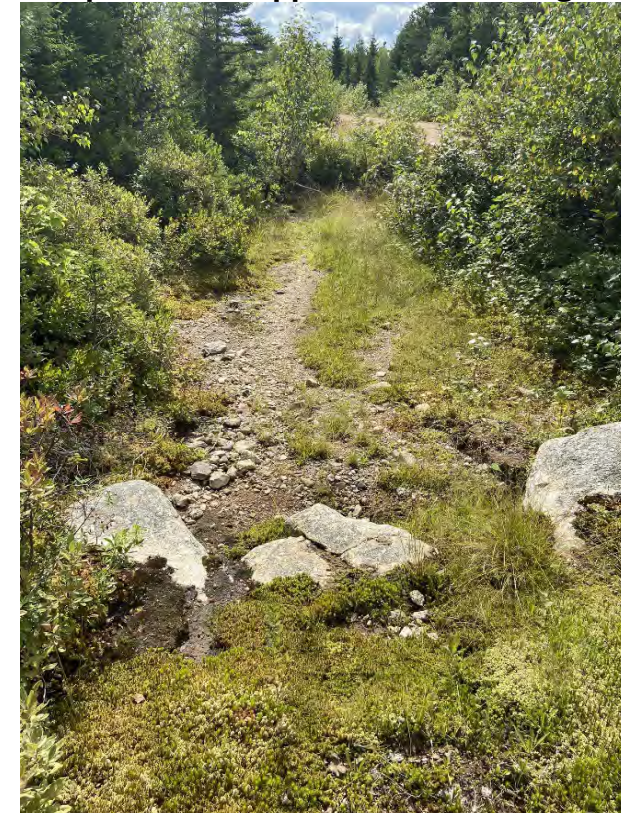
Photo 2: Downstream at approximate crossing location.

RIPARIAN VEGETATION SPECIES		
#	Common Name	Scientific Name
1		#N/A
2		#N/A
3		#N/A
4		#N/A
5		#N/A
6		#N/A
7		#N/A
8		#N/A
9		#N/A
10		#N/A
RIPARIAN INFORMATION		
Vegetation Stage		
IMPORTANT FEATURES OBSERVED		
Vegetated Across		<input type="checkbox"/>
Flows into Fish Habitat Downstream		<input type="checkbox"/>
Underground Sections or Groundwater		<input type="checkbox"/>
Surface Flow		<input type="checkbox"/>
Wetland Corridor (Flow Between Wetlands)		<input type="checkbox"/>
Barrier		<input type="checkbox"/>
Artificial Channelization		<input type="checkbox"/>
Culvert or Bridge		<input checked="" type="checkbox"/>
Water Flowing over Road (no Culvert)		<input type="checkbox"/>
No Defined Channel		<input checked="" type="checkbox"/>
ADDITIONAL NOTES		
U/S is ephemeral, no channel. Channel along the ditch D/S wp.1609 no defined channel found. Likely ephemeral rainage. Culvert

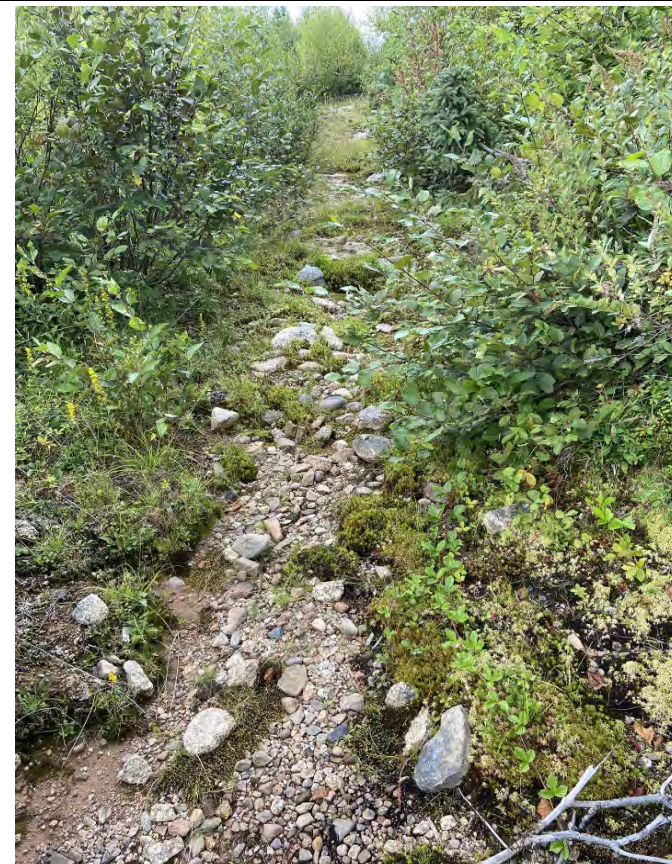
Photo 1: Upstream at approximate crossing location.

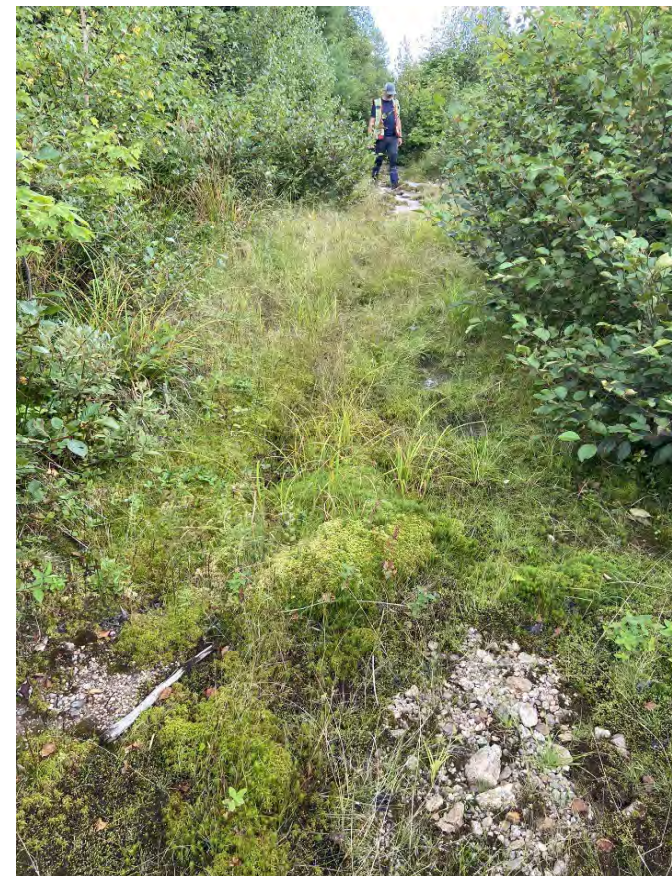
Photo 2: Downstream at approximate crossing location.

RIPARIAN VEGETATION SPECIES		
#	Common Name	Scientific Name
1		#N/A
2		#N/A
3		#N/A
4		#N/A
5		#N/A
6		#N/A
7		#N/A
8		#N/A
9		#N/A
10		#N/A
RIPARIAN INFORMATION		
Vegetation Stage		
IMPORTANT FEATURES OBSERVED		
Vegetated Across		<input type="checkbox"/>
Flows into Fish Habitat Downstream		<input type="checkbox"/>
Underground Sections or Groundwater		<input type="checkbox"/>
Surface Flow		<input type="checkbox"/>
Wetland Corridor (Flow Between Wetlands)		<input type="checkbox"/>
Barrier		<input type="checkbox"/>
Artificial Channelization		<input type="checkbox"/>
Culvert or Bridge		<input type="checkbox"/>
Water Flowing over Road (no Culvert)		<input type="checkbox"/>
No Defined Channel		<input checked="" type="checkbox"/>
ADDITIONAL NOTES		
Ephemeral drainage, new along ditch. Channalized section, small section. 44 cm channel. Wet but no depth or wetted.

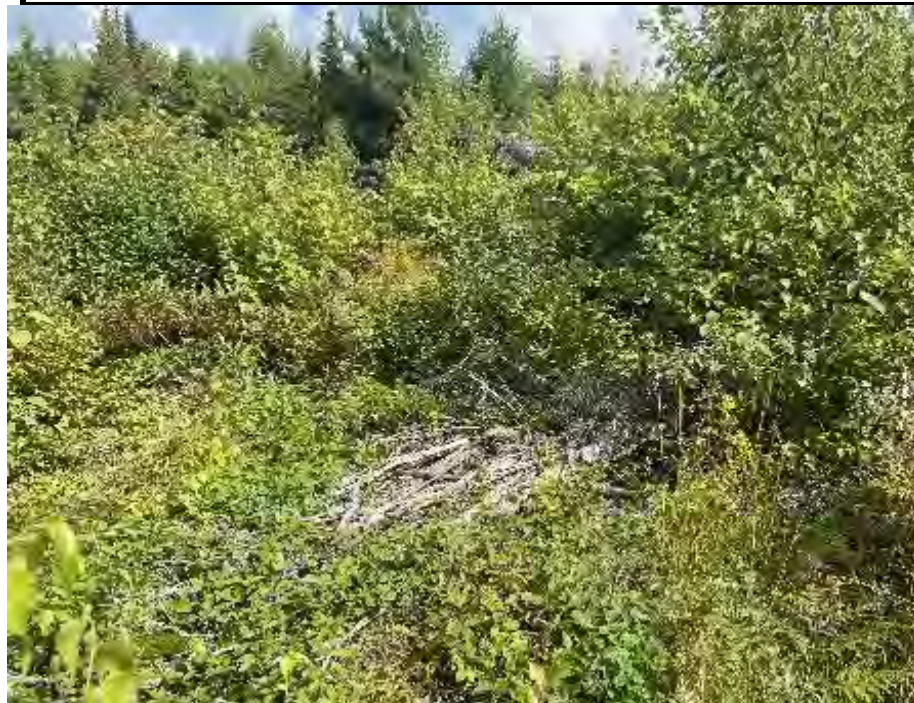
Photo 1: Upstream at assumed crossing

RIPARIAN VEGETATION SPECIES		
#	Common Name	Scientific Name
1	Cinnamon Fern	<i>Osmunda cinnamomea</i>
2	New york Fern	<i>Thelypteris noveboracensis</i>
3		#N/A
4		#N/A
5		#N/A
6		#N/A
7		#N/A
8		#N/A
9		#N/A
10		#N/A
RIPARIAN INFORMATION		
Vegetation Stage		
IMPORTANT FEATURES OBSERVED		
Vegetated Across	<input type="checkbox"/>	
Flows into Fish Habitat Downstream	<input type="checkbox"/>	
Underground Sections or Groundwater	<input type="checkbox"/>	
Surface Flow	<input type="checkbox"/>	
Wetland Corridor (Flow Between Wetlands)	<input type="checkbox"/>	
Barrier	<input type="checkbox"/>	
Artificial Channelization	<input type="checkbox"/>	
Culvert or Bridge	<input checked="" type="checkbox"/>	
Water Flowing over Road (no Culvert)	<input type="checkbox"/>	
No Defined Channel	<input checked="" type="checkbox"/>	
ADDITIONAL NOTES		
U/s no channel, likely ephemeral.

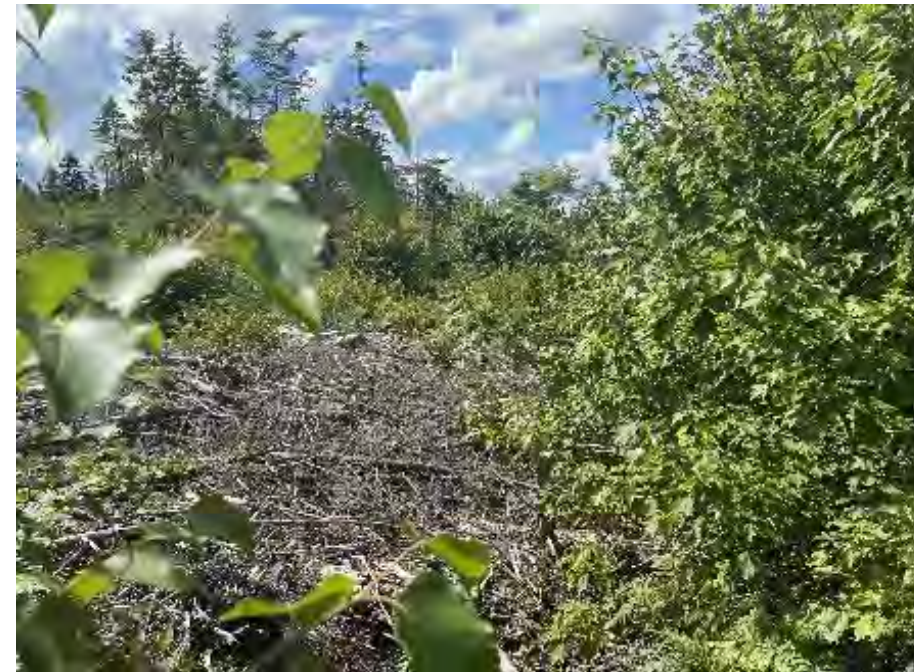
Photo 2: Downstream at assumed crossing

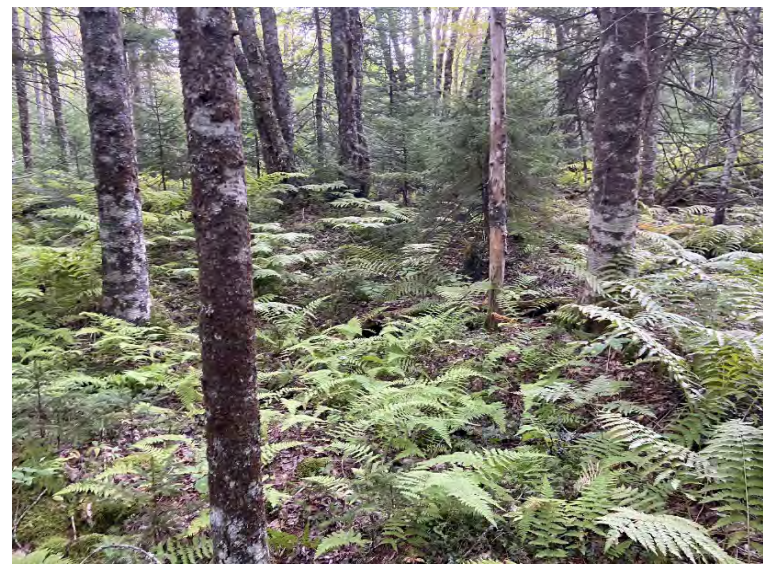
Photo 2: General habitat around watercourse

RIPARIAN VEGETATION SPECIES		
#	Common Name	Scientific Name
1		#N/A
2		#N/A
3		#N/A
4		#N/A
5		#N/A
6		#N/A
7		#N/A
8		#N/A
9		#N/A
10		#N/A
RIPARIAN INFORMATION		
Vegetation Stage		
IMPORTANT FEATURES OBSERVED		
Vegetated Across		<input type="checkbox"/>
Flows into Fish Habitat Downstream		<input type="checkbox"/>
Underground Sections or Groundwater		<input checked="" type="checkbox"/>
Surface Flow		<input checked="" type="checkbox"/>
Wetland Corridor (Flow Between Wetlands)		<input type="checkbox"/>
Barrier		<input type="checkbox"/>
Artificial Channelization		<input type="checkbox"/>
Culvert or Bridge		<input type="checkbox"/>
Water Flowing over Road (no Culvert)		<input type="checkbox"/>
No Defined Channel		<input type="checkbox"/>
ADDITIONAL NOTES		
<p>U/S mostly surface or underground flow. Wp. 1640 - Channelized section, no water, likely flows at some point. 44cm wide channel. U/S Wp.1641 Watercourse observed going underground. U/S Ephemeral with intermittent characteristics. Area had wetland vegetation, looked like hillside drainage, on slope, hydrology wasn't right.</p>

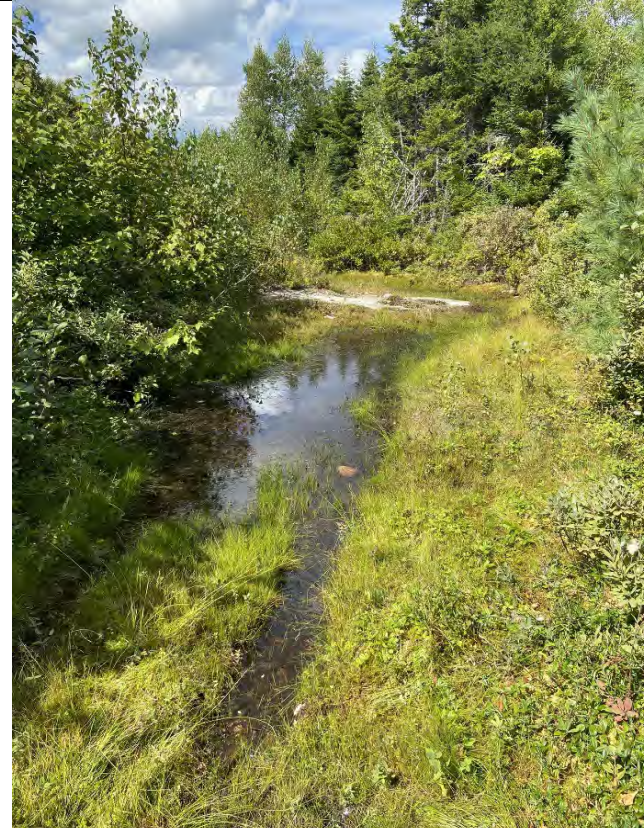
Photo 1: Upstream at approximate crossing location.

RIPARIAN VEGETATION SPECIES		
#	Common Name	Scientific Name
1		#N/A
2		#N/A
3		#N/A
4		#N/A
5		#N/A
6		#N/A
7		#N/A
8		#N/A
9		#N/A
10		#N/A
RIPARIAN INFORMATION		
Vegetation Stage		
IMPORTANT FEATURES OBSERVED		
Vegetated Across		<input type="checkbox"/>
Flows into Fish Habitat Downstream		<input type="checkbox"/>
Underground Sections or Groundwater		<input type="checkbox"/>
Surface Flow		<input type="checkbox"/>
Wetland Corridor (Flow Between Wetlands)		<input type="checkbox"/>
Barrier		<input type="checkbox"/>
Artificial Channelization		<input type="checkbox"/>
Culvert or Bridge		<input checked="" type="checkbox"/>
Water Flowing over Road (no Culvert)		<input type="checkbox"/>
No Defined Channel		<input checked="" type="checkbox"/>
ADDITIONAL NOTES		
Ephemeral drainage no defined channel, Wp. 1617 Culvert. Culvert is broken and collapsed. Wp. 1618 D/S no defined channel ephemeral drainage. Wp.1619 Bear Print

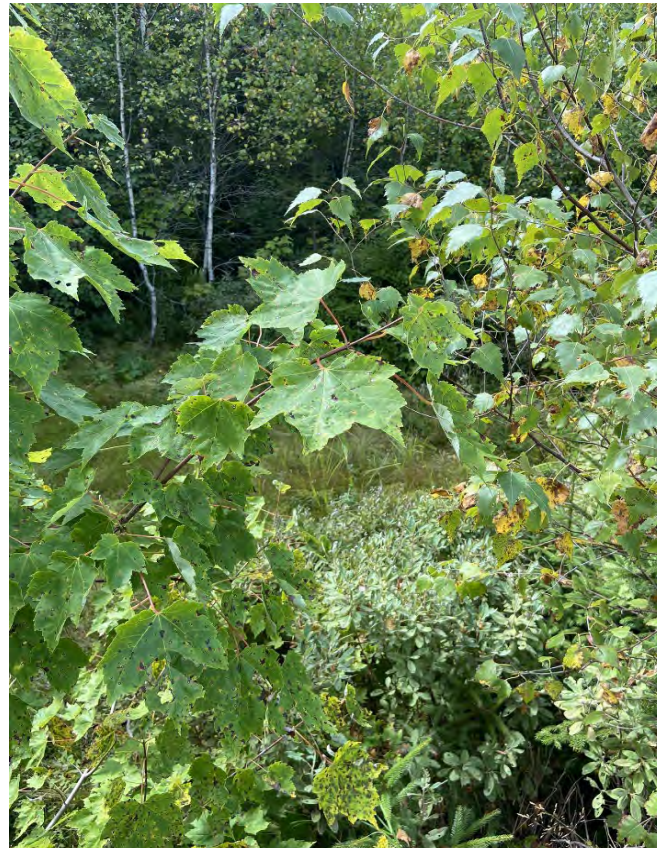
Photo 2: Downstream at approximate crossing location.

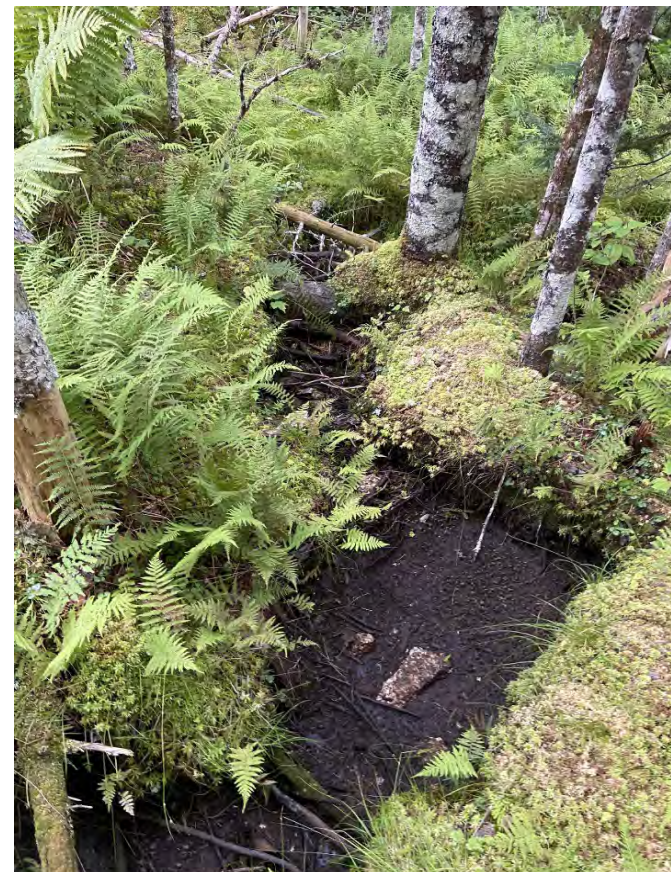
Photo 2: Downstream at approximate crossing location.

RIPARIAN VEGETATION SPECIES		
#	Common Name	Scientific Name
1		#N/A
2		#N/A
3		#N/A
4		#N/A
5		#N/A
6		#N/A
7		#N/A
8		#N/A
9		#N/A
10		#N/A
RIPARIAN INFORMATION		
Vegetation Stage		
IMPORTANT FEATURES OBSERVED		
Vegetated Across		<input type="checkbox"/>
Flows into Fish Habitat Downstream		<input type="checkbox"/>
Underground Sections or Groundwater		<input type="checkbox"/>
Surface Flow		<input type="checkbox"/>
Wetland Corridor (Flow Between Wetlands)		<input type="checkbox"/>
Barrier		<input type="checkbox"/>
Artificial Channelization		<input type="checkbox"/>
Culvert or Bridge		<input checked="" type="checkbox"/>
Water Flowing over Road (no Culvert)		<input type="checkbox"/>
No Defined Channel		<input type="checkbox"/>
ADDITIONAL NOTES		
No Defined Channel @ xing, ephemeral drainage. Wp.1631. Channelized area no flow, 66 cm channel with intermittent flows, likely in spring run off or heavy rain old machine tracks. D/S plunge pool (dry) at bottom of culvert. Scouring suggests there are heavy rainfall events or spring run off, plundge pool channel 112 cm wide. Channel dry 40 cm. Wp.1632 Channel Dry 47 cm looks like it flows.

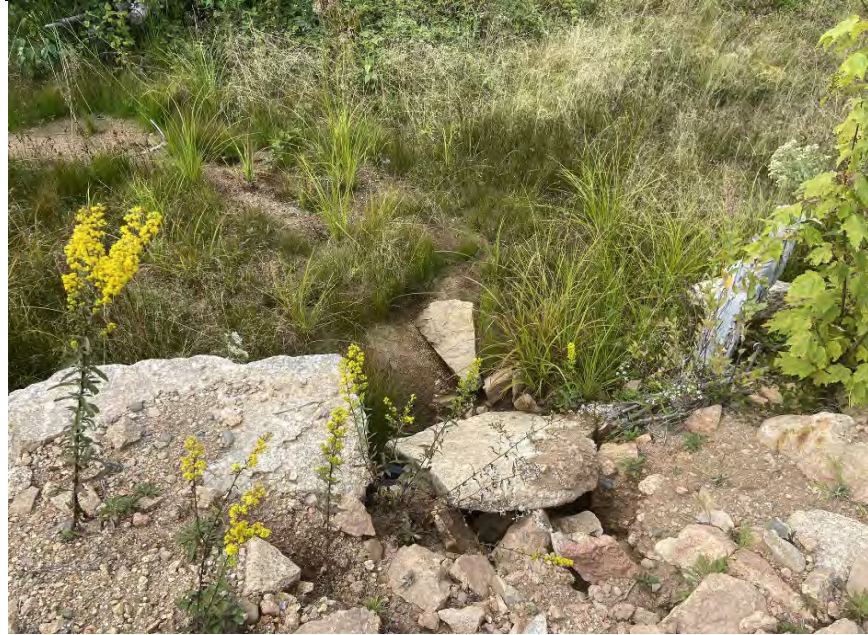
Photo 1: Upstream at approximate crossing location.

RIPARIAN VEGETATION SPECIES		
#	Common Name	Scientific Name
1		#N/A
2		#N/A
3		#N/A
4		#N/A
5		#N/A
6		#N/A
7		#N/A
8		#N/A
9		#N/A
10		#N/A
RIPARIAN INFORMATION		
Vegetation Stage		
IMPORTANT FEATURES OBSERVED		
Vegetated Across		<input type="checkbox"/>
Flows into Fish Habitat Downstream		<input type="checkbox"/>
Underground Sections or Groundwater		<input type="checkbox"/>
Surface Flow		<input type="checkbox"/>
Wetland Corridor (Flow Between Wetlands)		<input type="checkbox"/>
Barrier		<input type="checkbox"/>
Artificial Channelization		<input type="checkbox"/>
Culvert or Bridge		<input checked="" type="checkbox"/>
Water Flowing over Road (no Culvert)		<input type="checkbox"/>
No Defined Channel		<input checked="" type="checkbox"/>
ADDITIONAL NOTES		
No channel, emperial. U/S dry emperal when not likely runs down ditch. D/S ephemeral no channle dry, culvert.

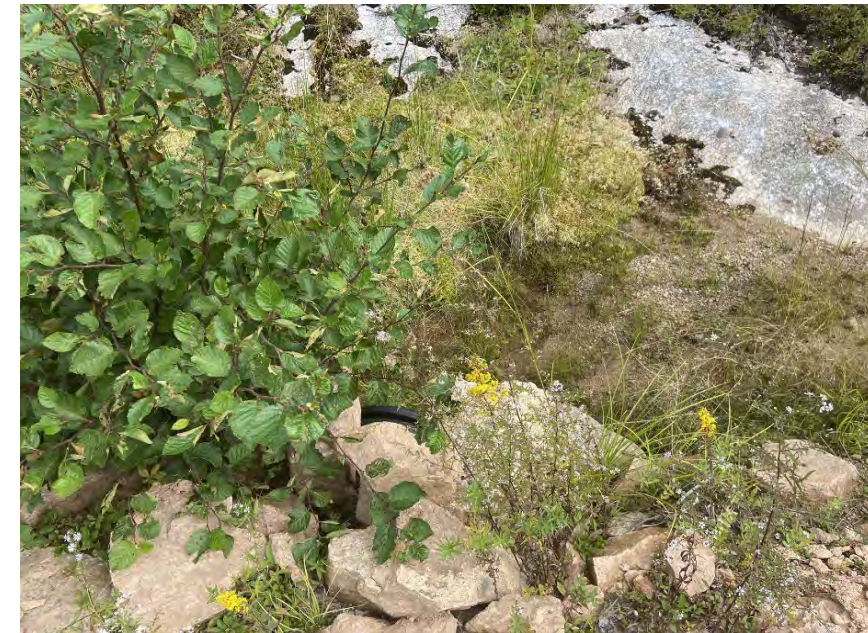
Photo 2: Downstream at approximate crossing location.
