As-Built Report for the East River, Highway 103, HADD Compensation Project (DFO HADD Authorization 04-G8-050): Fish Ladder and Culvert Baffles

Dr. Bob Pett, Environmental Services
October 2006

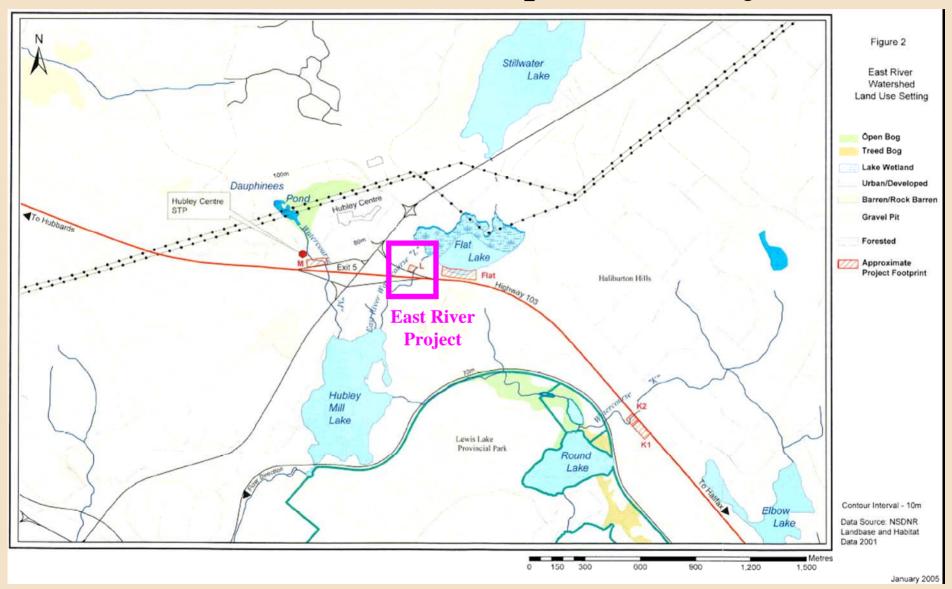
Diagram from Dillon Consulting Limited, 2005, Environmental Screening of Watercourse Crossings for the Highway 103 Twinning Project – East River Watershed, Halifax Regional Municipality.

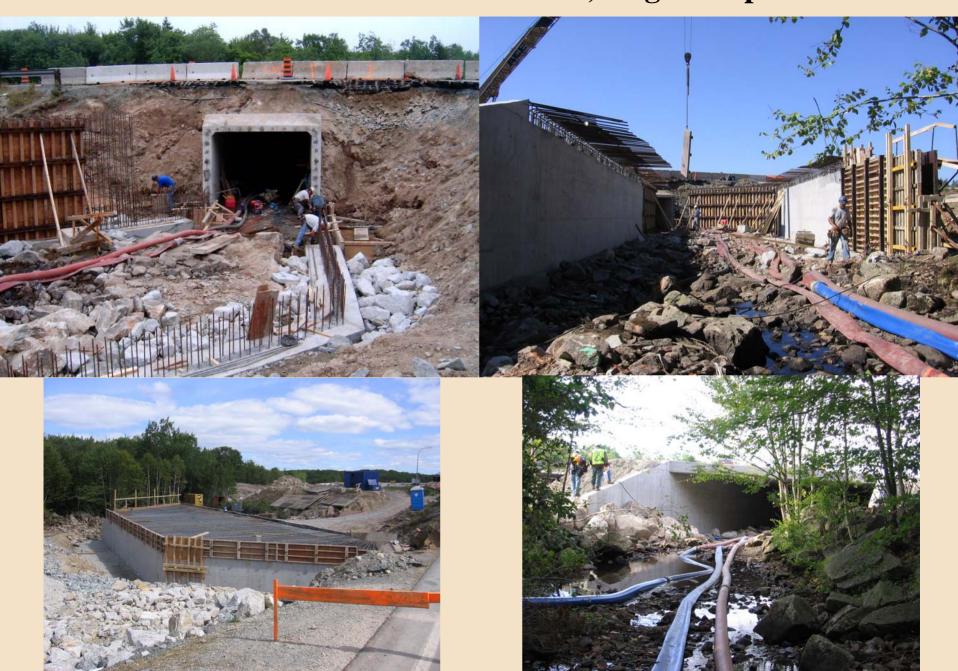
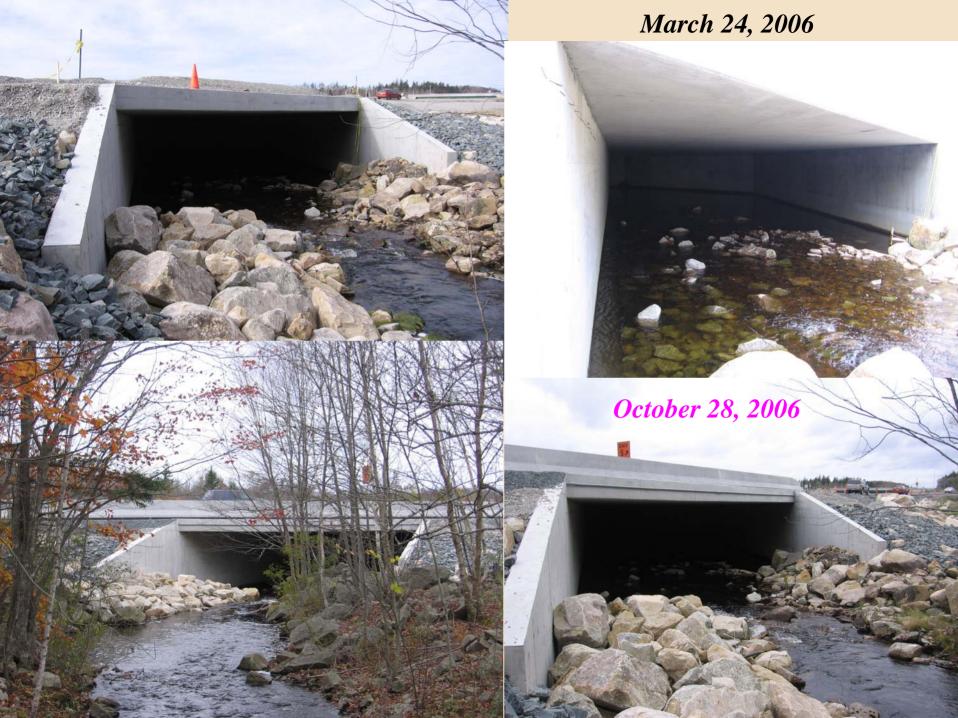
Construction of the box culvert extension, August-September 2005

- involved the extension of the upper end of the box culvert with a 30.5 m-long, three-sided, cast-in-place concrete structure that spanned the stream and preserved the stream bed (new box is 9.1 m-wide and 3.0 m high).
- 7 baffles were retrofit inside the old 3.64 m-wide, 3.04 m high, 60 m-long, box culvert in August-September 2005 (ensures ~25 cm water depth for fish passage through the old culvert).
 - Fish ladder with 4 boxes and a new plunge pool were completed at the downstream end of the culvert in October 2005.

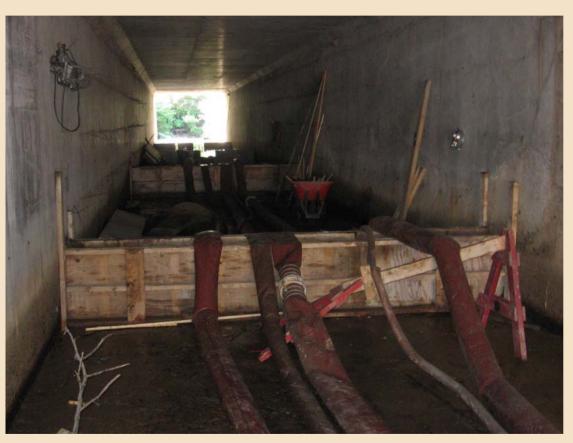
Construction of fish baffles in the East River culvert

- 7 baffles constructed inside the existing culvert (one at the downstream end and six more at +6 m, +12 m, +24 m, +36 m, +48 m, and the upper end of the culvert at +60 m; followed the recommendations of Bob Rutherford, TPW consultant, and Henry Caracristi, DFO).
- Baffles are 500 mm high with notches 500 mm wide and 250 mm deep.
