**Governors Brook / Nine Mile River
Compensation/ Restoration Project
As Built Report 2006
Monitoring Reports 2006-2008**

**Prepared by The Sackville Rivers Association
for
Nova Scotia Transportation and Public Works / Environmental Services**

Contract No. TPW-ESG File No. 4.133

November 28, 2008

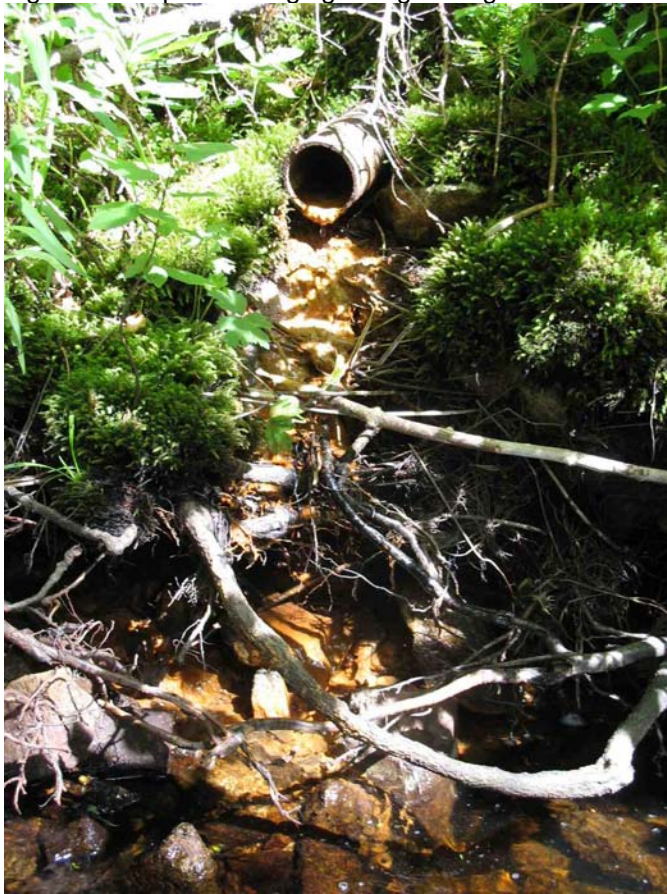
Structure is in good condition (Figure 14) and appears to be digging (Table 26). The structure is larger than required. Water concentration is appropriate, but low point is set higher off bottom than is optimal. Outfall pipe is discharging thick orange sludge into the pool at site 15 (Figure 15).

Figure 15. Pipe discharging orange sludge into site 15
