**NOVA SCOTIA  
GROUNDWATER  
OBSERVATION WELL  
NETWORK**

**2010 REPORT**

**Prepared: August 2010**

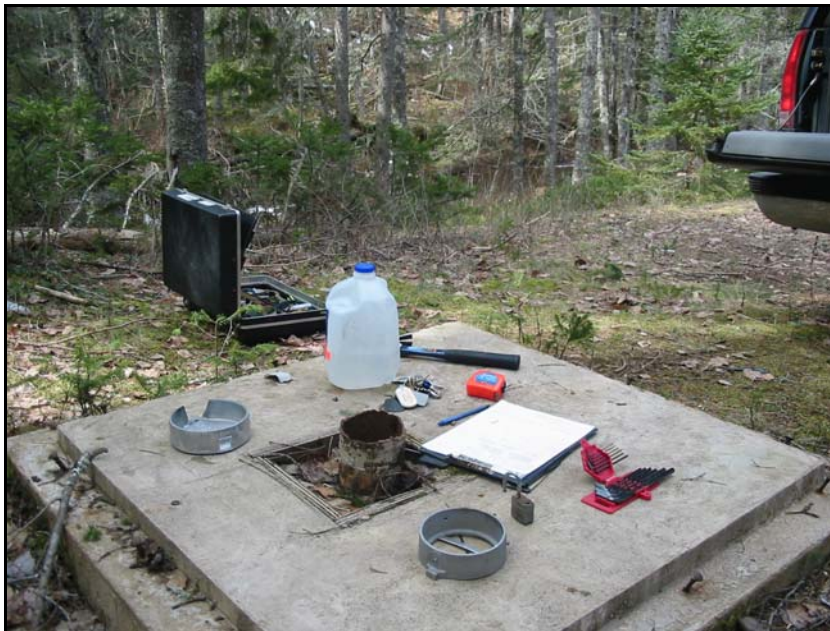
**Figure F.2b: Fraser Brook (004) Site Photograph**

The location of the Fraser Brook (004) observation well is shown in Figure F.2a, Appendix F. It is situated in a rural area where land use is primarily agricultural or undeveloped. The well was located in a wooded area (see Figure F.2b), however, in 2005 the majority of the trees were removed due to damage sustained during Hurricane Juan in 2003. The nearest water well is a domestic well, located approximately 1,000 m away.
