**Governors Brook / Nine Mile River
Compensation/ Restoration Project
As Built Report 2006
Monitoring Reports 2006-2008**

**Prepared by The Sackville Rivers Association
for
Nova Scotia Transportation and Public Works / Environmental Services**

Contract No. TPW-ESG File No. 4.133

November 28, 2008

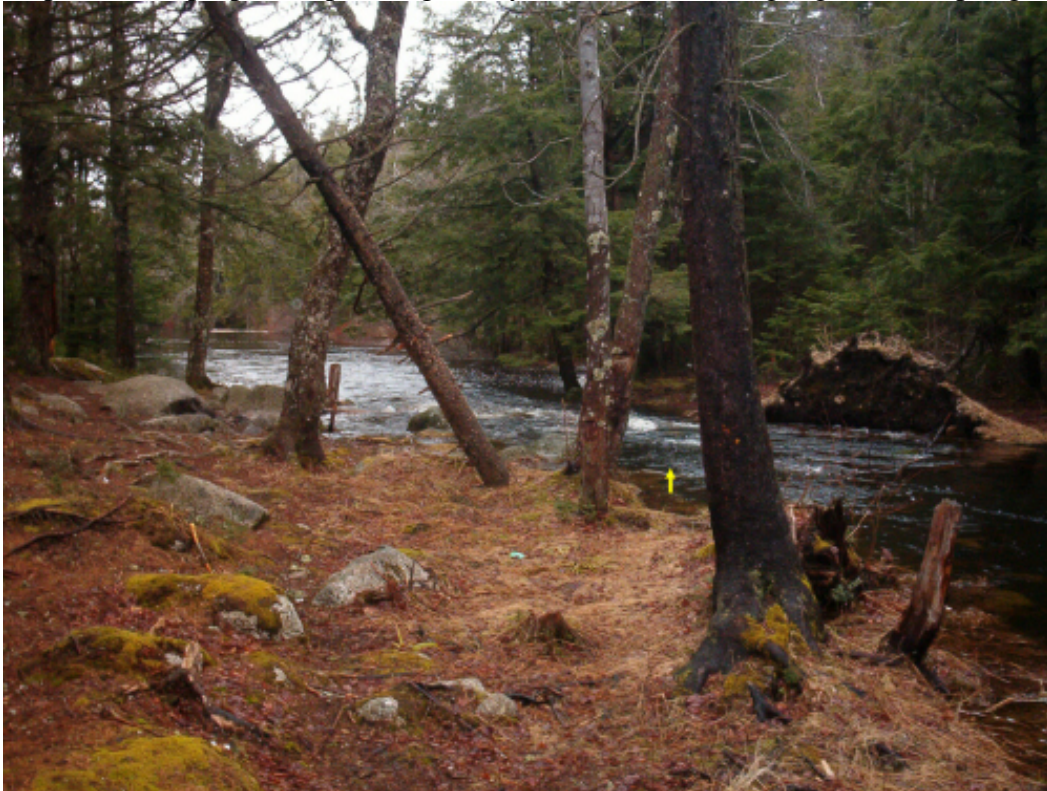
Upstream of proposed spawning bed (yellow arrow) during high water (spring)

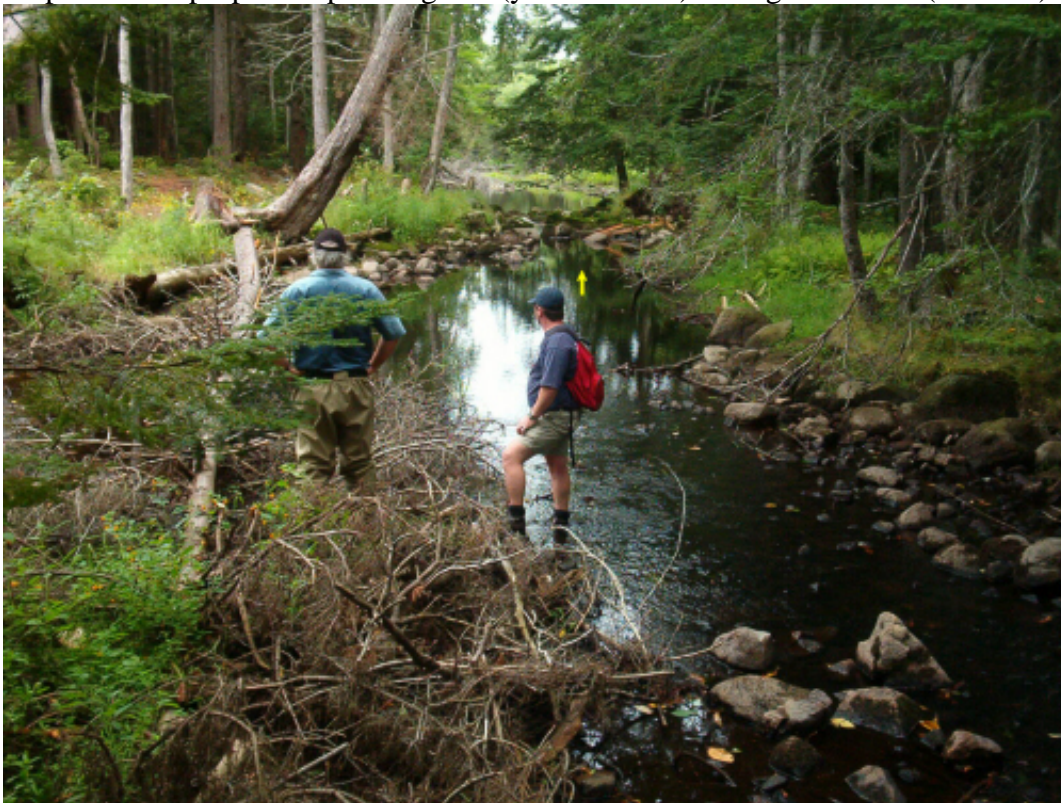
Upstream of proposed spawning bed (yellow arrow) during low water (summer)

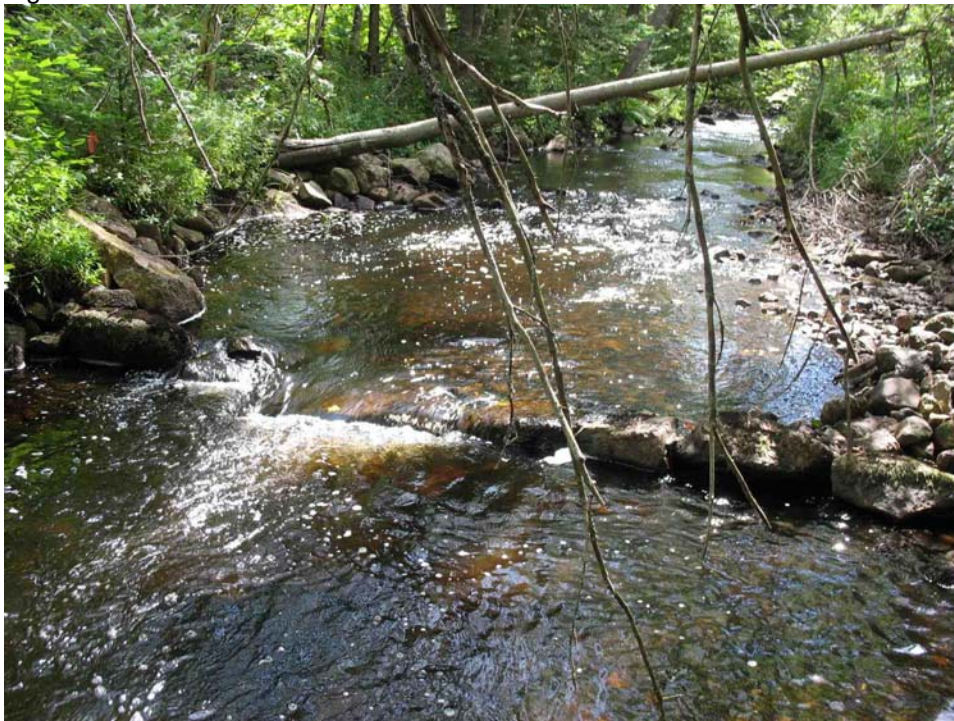
Figure 14. Rock sill at site 15

Structure is in good condition (Figure 14) and appears to be digging (Table 26). The structure is larger than required. Water concentration is appropriate, but low point is set higher off bottom than is optimal. Outfall pipe is discharging thick orange sludge into the pool at site 15 (Figure 15).
